ALASKA DEPARTMENT OF TRANSPORTATION

Vegetated Riprap Survey of Highways in Southcentral and Interior Alaska

December 2005

FHWA-AK-RD-05-08

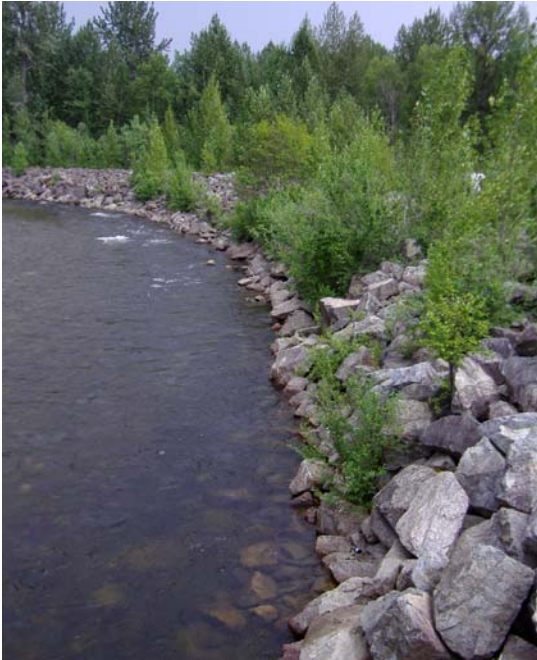
Photo 1 - Montana Creek (Parks Hwy)

Photos 1 and 2 illustrate a stream's OHW level by the lowest vegetated elevation level line along the stream bank.

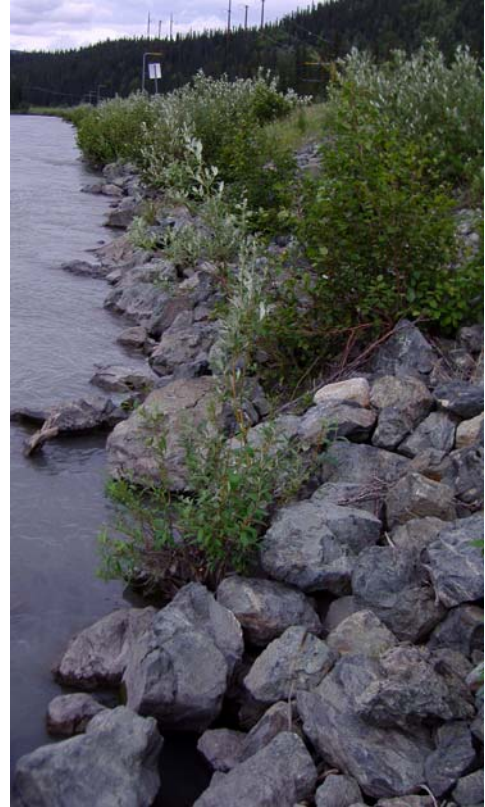
Photo 3 - Nenana River (Parks Hwy)

A bench or ledge might be implemented in an area where the bank toe warrants heavy protection. It was found that this configuration enabled sedimentation during higher flows on a grade that allowed the existing fines to retain moisture. This design may be desirable for a stream location that experiences potentially aggressive ice forces and/or periodic flows that would pose a threat to lightly armored bank toes. The toe can be armored with riprap and a step can be constructed at the approximate OHW level to prevent frequent inundation effects while allowing some overflow and sedimentation. Although this condition focuses on growth only on the surface of the ledge, overhanging vegetation can develop while the stream bank toe is protected with riprap.

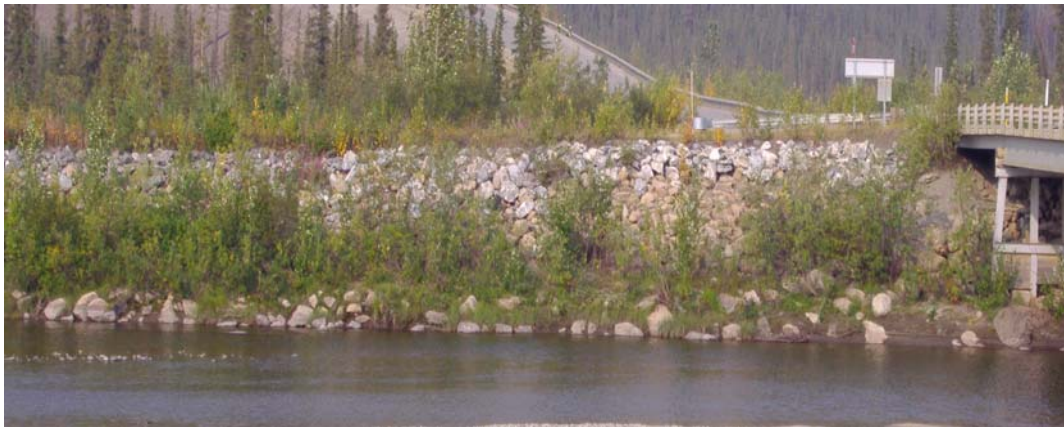
Photo 5 - South Fork Koyukuk River (Dalton Hwy)

Toe protection should be considered for this structure. **Photo 5** illustrates stabilizing toe protection while **Photo 6** illustrates evidence of bank erosion that may eventually eliminate the vegetated buffer zone.

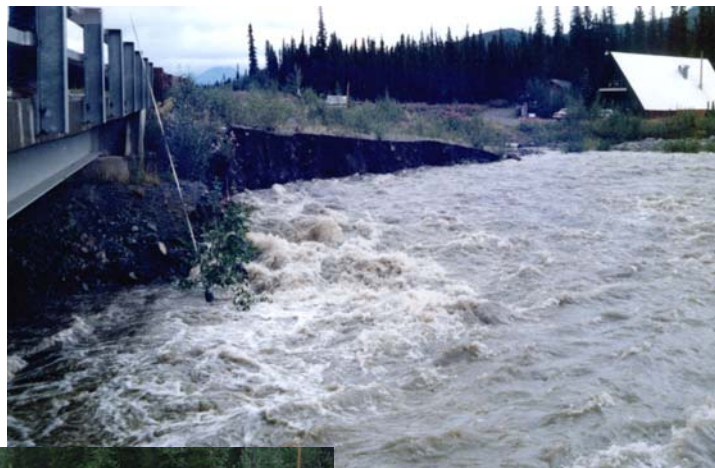
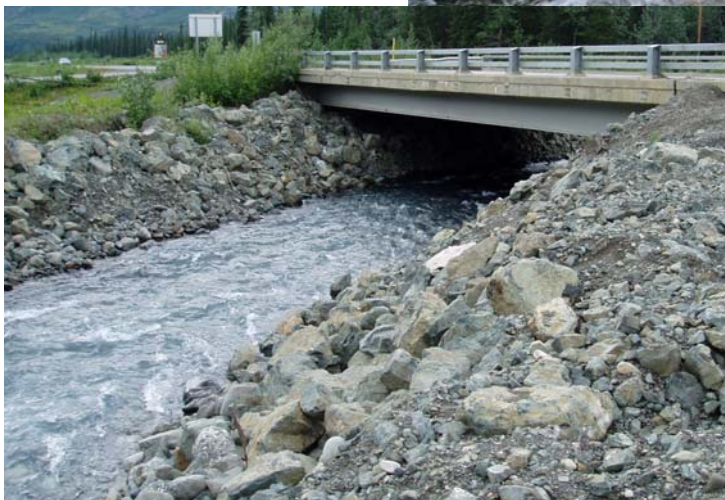
**Figure 11 – Frequent Inundation;
Carlo Creek (Parks Hwy)**

Historically, the site illustrated in **Figure 11** experiences periodic flooding which may demand emergency repair. The flooding and subsequent bank repair prevent vegetative stability.

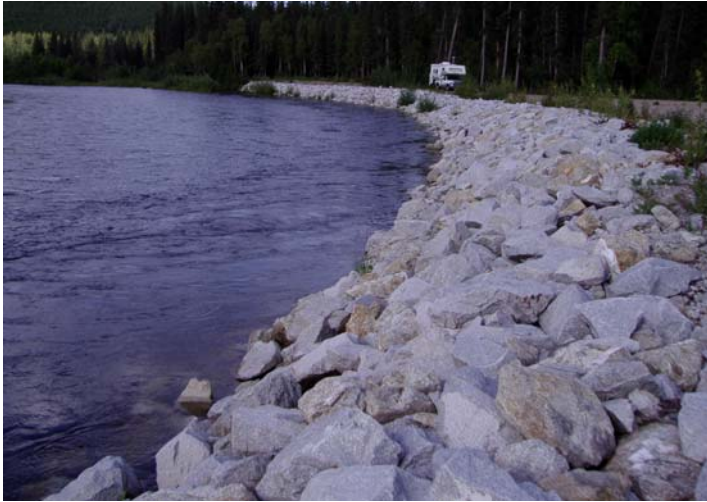
**Photo 9 - North Fork Chena River
(Chena Hot Springs Rd)**

A stream channel is characteristically deeper at its outside bends and shallower at its inside bends or points of inflection. Consequently, flow and average velocity is higher at the outside bend of a stream cross section than at the inflection point. Often, while equilibrating itself during discharge fluctuations, a stream's inside bend accretes with fine alluvial material and channel flow moves closer to the outside bend. The channel bed's thalweg shifts until it impinges on the outside bend bank with greater shear forces, higher average velocity, and the capacity to carry coarser material. The lower discharge energy on the stream's inside bend results in finer material deposition where stream sediment transport capacity is lower. As illustrated in **Photos 9 and 10**, outside bends maintain little to no vegetation

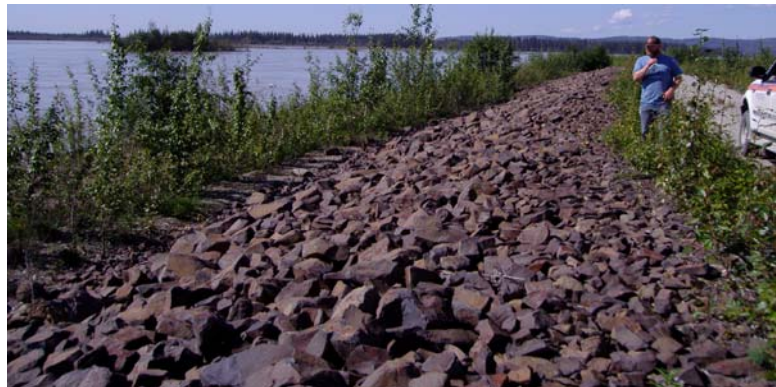
Photo 12 - Tanana River (Fairbanks Airport Dike)

If a solid mass armament is combined with a successful vegetative parameter such as a buffer bench zone **(Photo 12)**, vegetation exists at the toe and head of the riprapped bank where no riprap exists

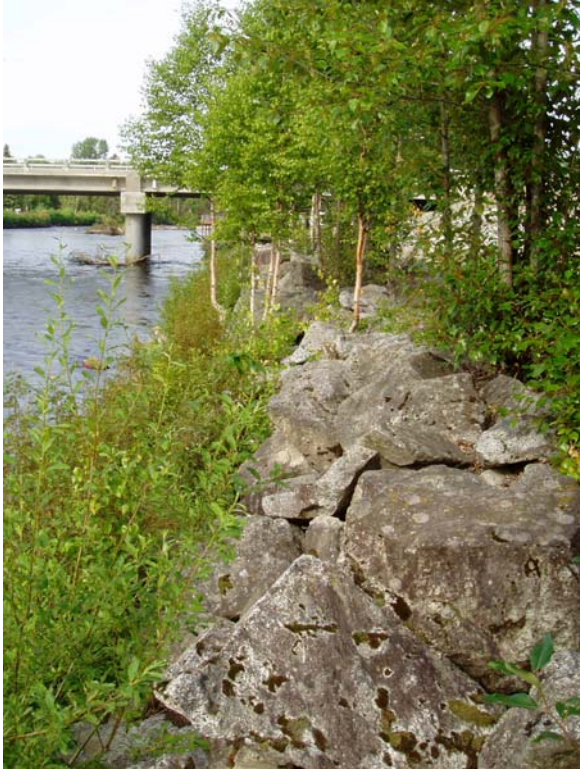
Photo 14 - Willow Creek (Parks Hwy)

---Note that some vegetation has propagated in the bank face, but primarily exists at OHW and bank head.

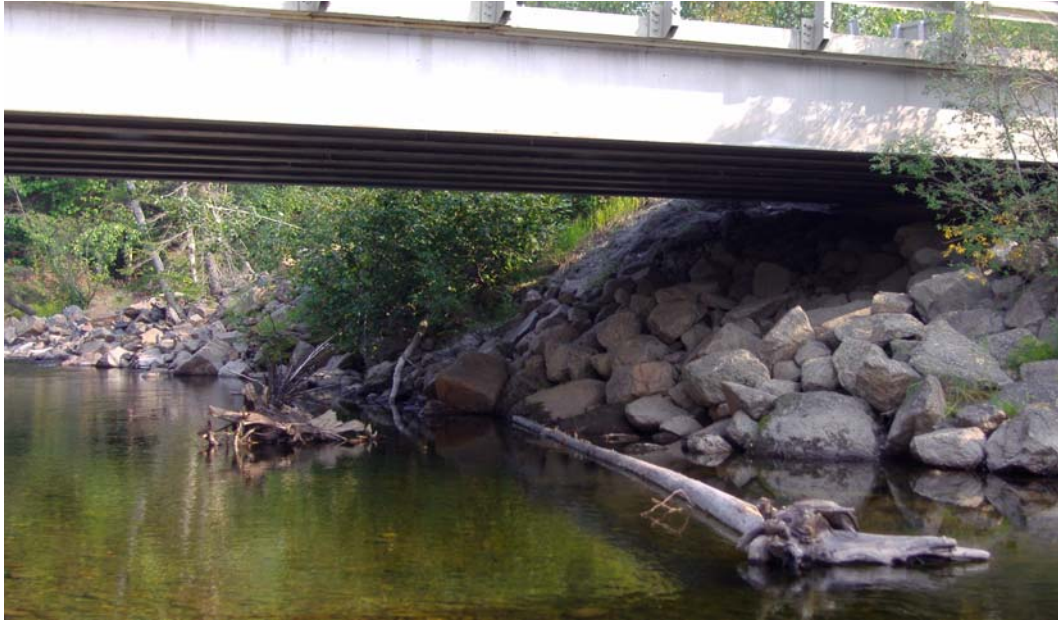
Photo 16 - Fish Creek (Dalton Hwy)

Most of the sites surveyed with riprapped areas directly underneath bridges had minimal plant cover. Many factors may play a role in this issue. The bridge may create a microclimate beneath it through shading and exclusion of precipitation. It also might reduce snow cover on establishing vegetation which would increase the plants susceptibility to winter kill. Increased water velocities and higher ice forces at a bridge crossing due to channel constriction may also contribute to the lack of vegetation.
