FIELD INSPECTION REPORT HECLA GREENS CREEK MINING COMPANY

Inspection Date: September 23, 2009
Report Date: September 29, 2009

Purpose of visit: Routine inspection.

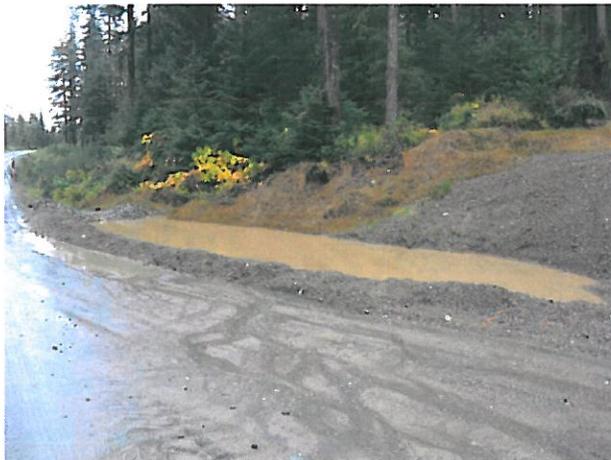
Sand Pit. The storm water sediment ponds had been enlarged; however the water was still turbid leaving the last pond. Chad Hood had walked down the path of discharge in the wooded area beyond the culvert discharge and found that even at fairly high flows the water dispersed and was absorbed into the forest duff. He did not see it re-emerge further down the slope.

Large settling pond

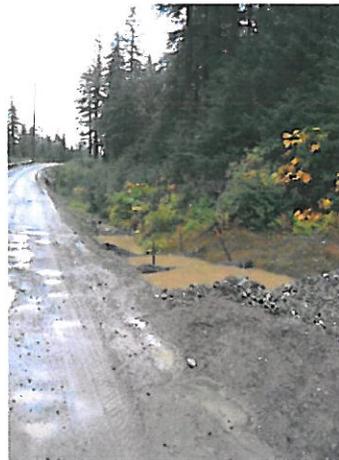
Series of secondary settling ponds

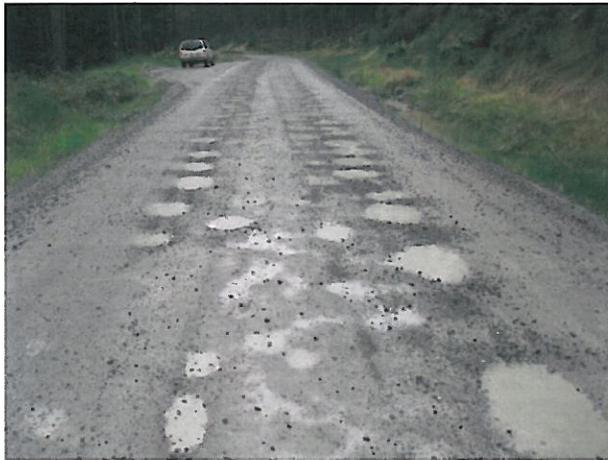
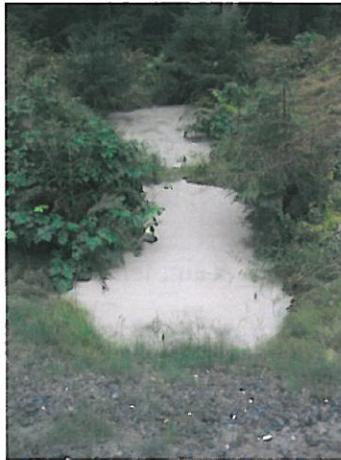
Ditches contained murky road runoff water; there was not a lot of sediment built up behind check dams.

Potholes formed in the road aggravate the discharge of sediment laden water. The recent rains had prevented graders from maintaining these portions of the road.

1. Look at how to prevent the clean water diversion pipe breaking away at the joint where it connects to the upland catchment at the ditch/tailings facility.
2. Fill potholes in the road to reduce sediment-laden water discharge to the ditches.
3. Look at whether it would be wise to create a temporary cover to the pump at Site E for ease of maintenance during early winter runoff periods.

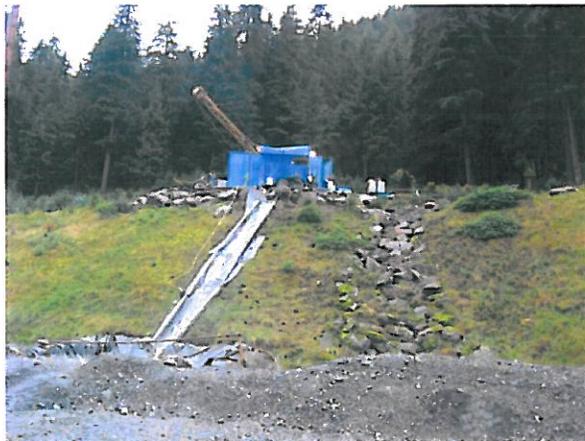
920 Mill area: A drill rig was drilling exploratory holes on a bench of the embankment behind the mill. Water from the operation was being pumped to Pond A for further treatment.

Drill rig

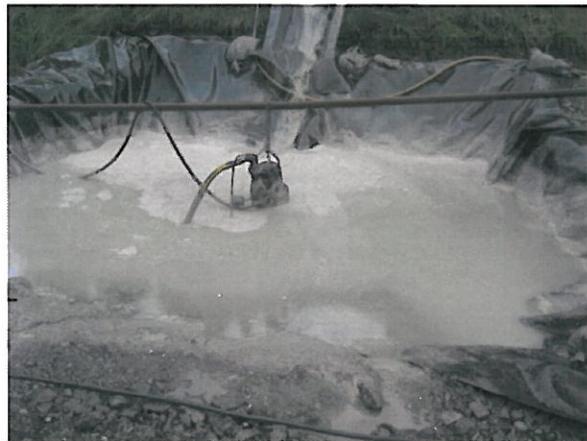
Drill rig discharge

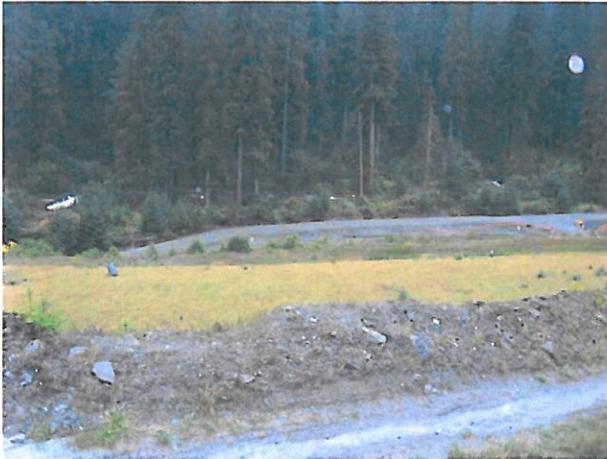
Pond "D": Berm replacement was complete.

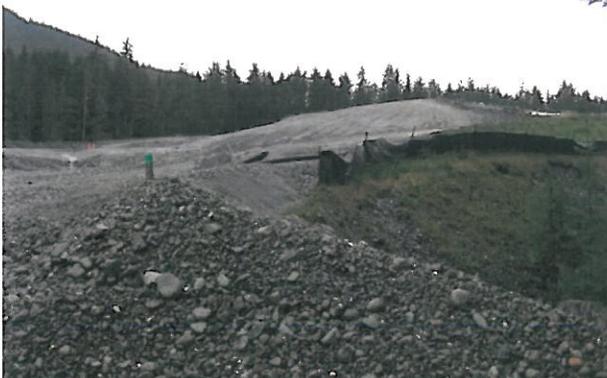
Site "E": 40,000 cy of waste/production rock had been removed and taken to the tailings storage facility. No more material is to be removed this year. The ground had been smoothed to enable surface runoff during the winter period. This material will not be covered. Water from the site is pumped from a sump to the polyethylene discharge pipe from the 920 area for discharge to Pond 7. It was suggested that a temporary cover be constructed to aid maintenance of the pump during inclement winter weather, including snow events.

Smoothed surface of pile

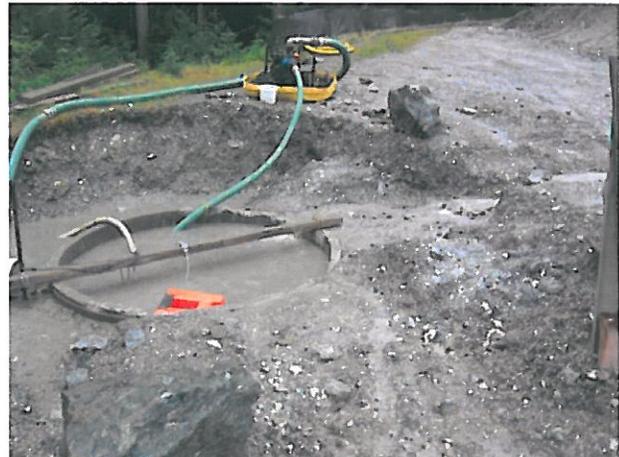
Sump / pump to main effluent line.

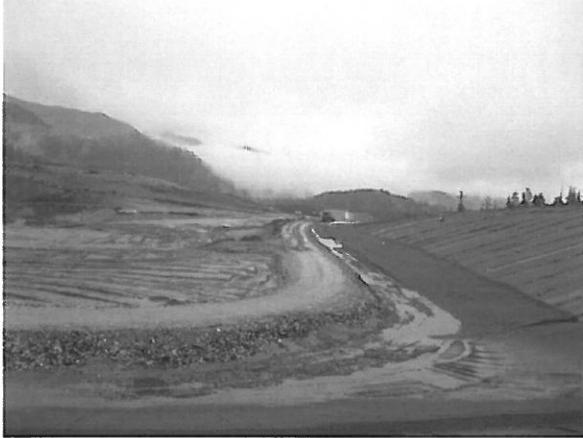
Tailings site: Tailings are currently being placed in the NW area. Additional rock adjacent to the clean road had been removed to the west of the facility. This area will receive a polyethylene liner prior to the placement of tailings in this area.

Tailings placement in NW corner

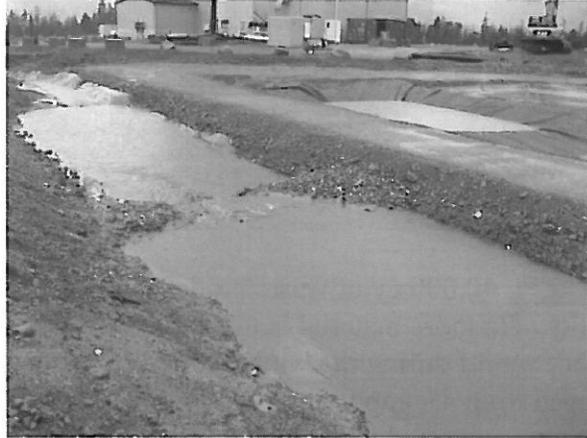
Sediment ponds have been constructed adjacent to the water treatment plant. These, in conjunction with “dirt bags” will collect tailings washed down from the TSF by storm flows, reducing the volume of this material to be removed from Pond 7.

Sediment ponds (lined) near dirt bags
