**ACTIVE TAILINGS AND PRODUCTION ROCK SITE  
2018 ANNUAL REPORT**

**Hecla Greens Creek Mining Company**

**April 30, 2019**

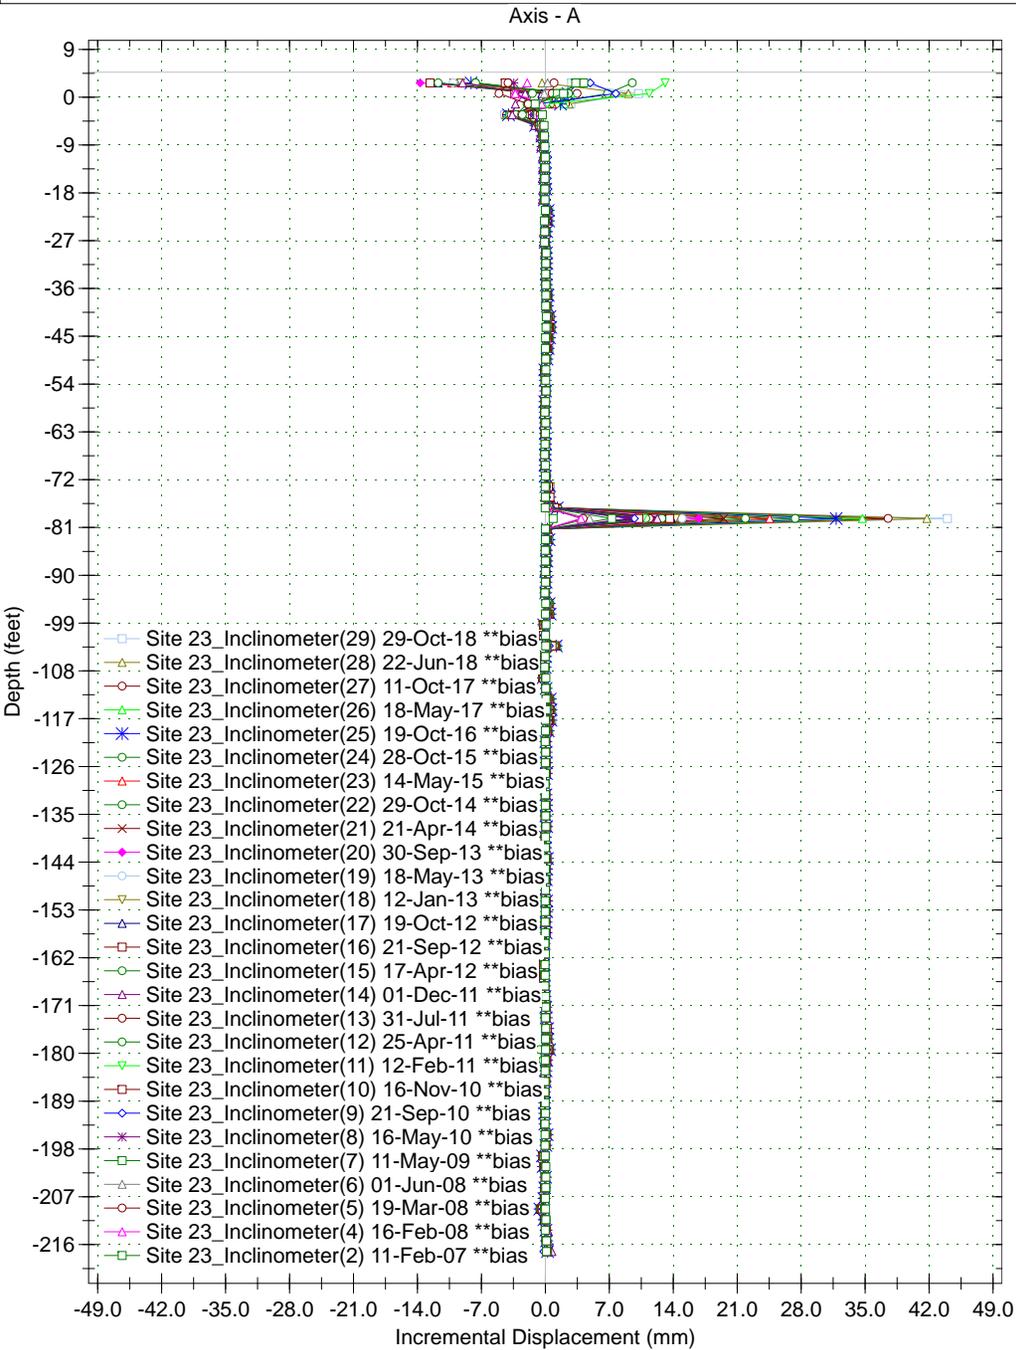
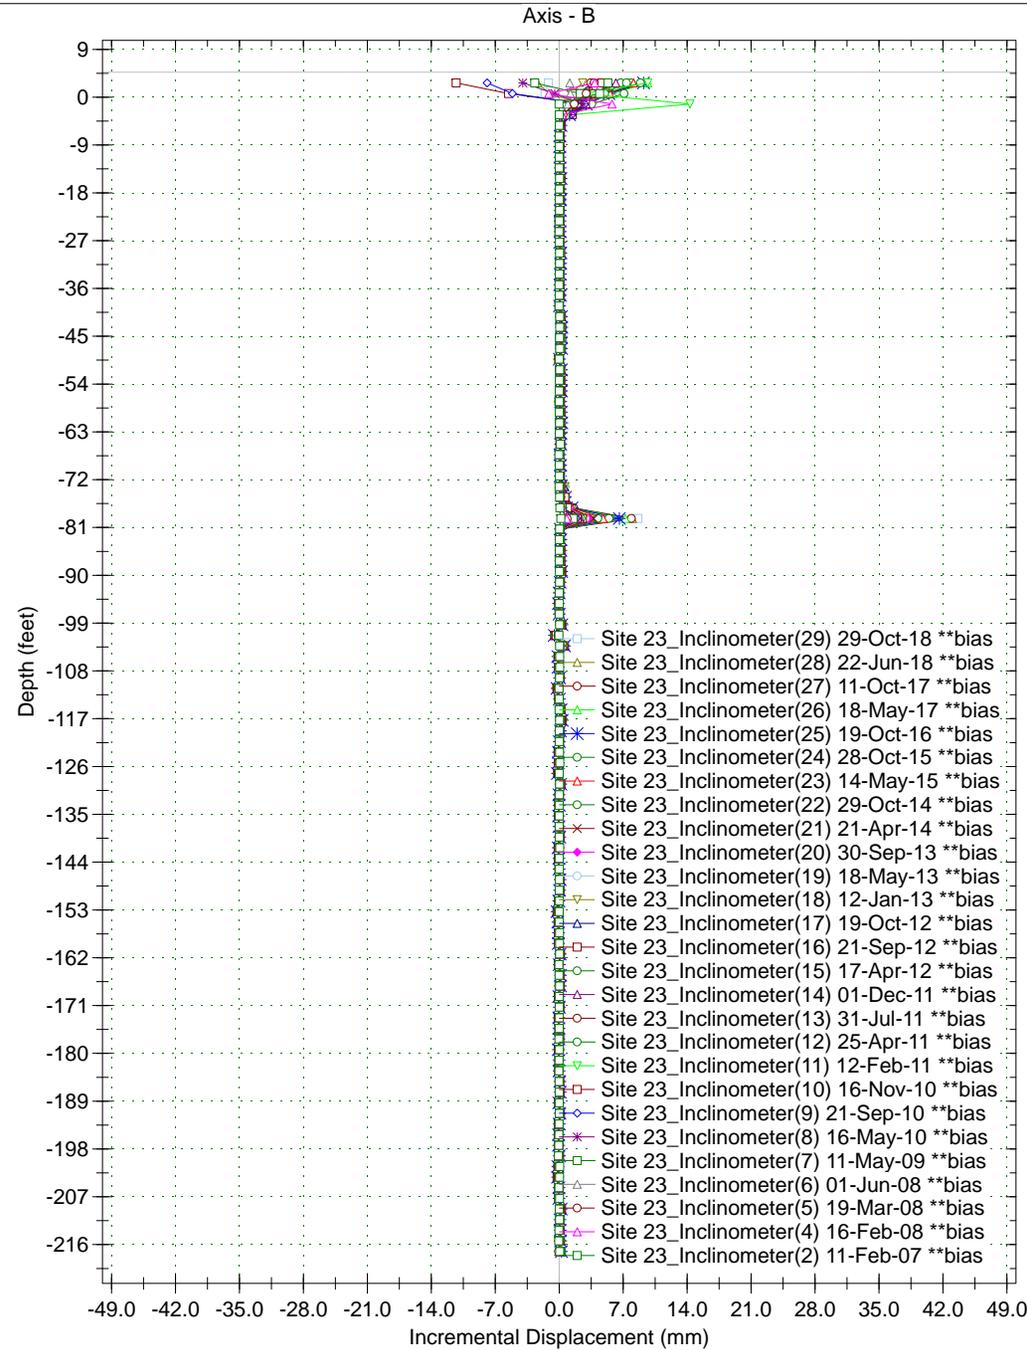
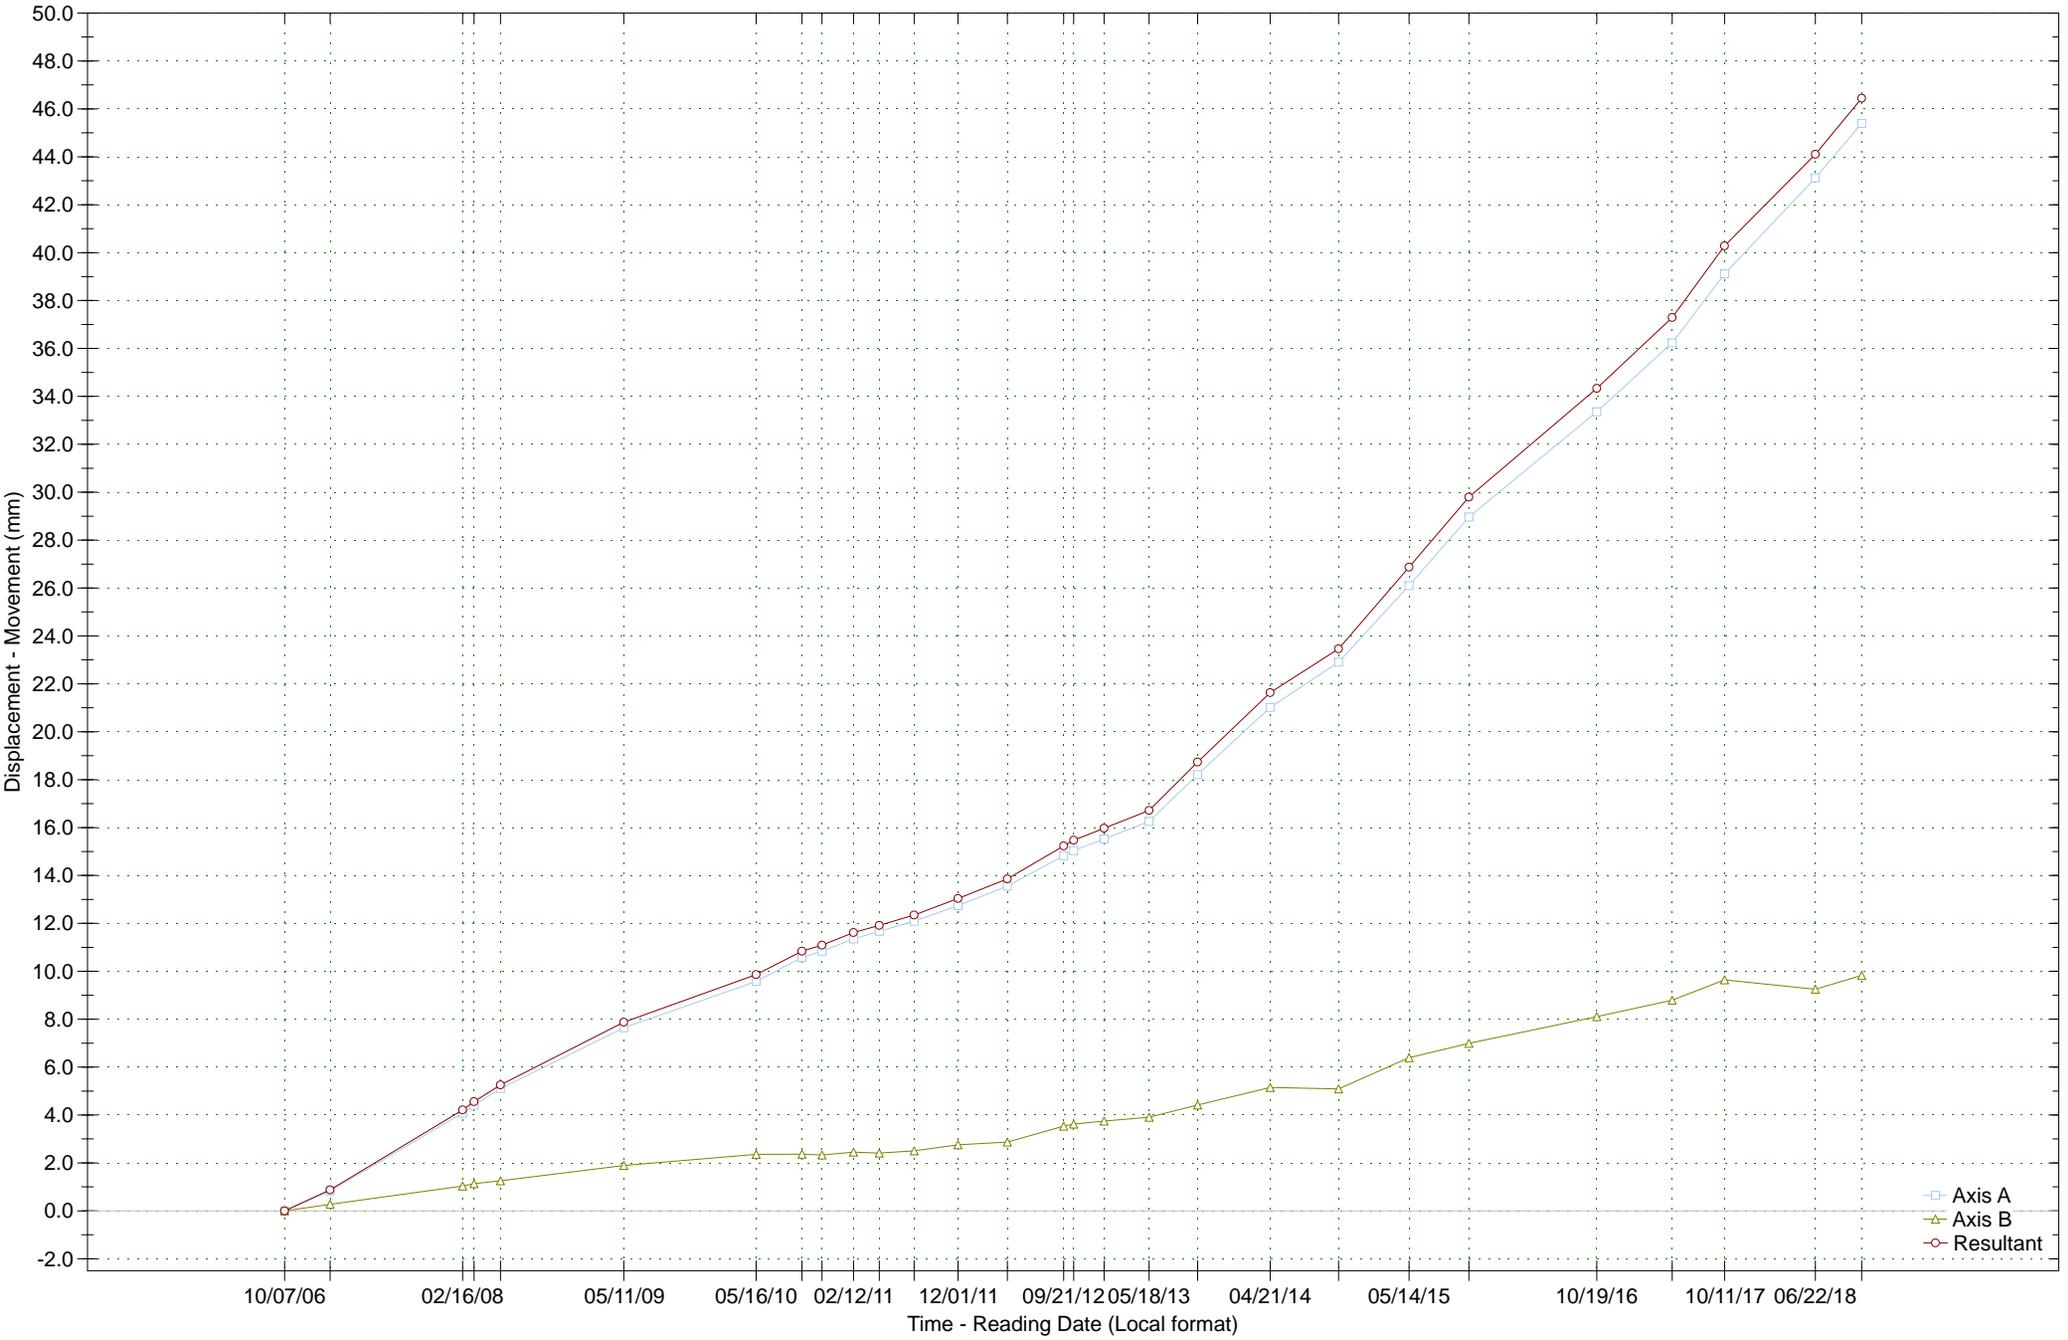
Borehole : Inclinometer  
 Project : Site 23  
 Location : IN-23-05-01  
 Northing : 20671.45 ft  
 Easting : 17186.42 ft  
 Collar : 948.84' Top of Casing  
 Collar Elev : 4.7 feet

Three additional inclinometers were installed at Site 23 during the summer of 2010 and baseline readings were taken September and November (after instrument calibration). Readings in inclinometers IN-23-10-01, IN-23-10-02, and IN-23-10-08 are consistent with the data obtained previously from IN-23-05-01. Inclinometer IN-23-10-01 was installed in the lower portion of Site D and no movement has been observed in this inclinometer. Inclinometer IN-23-10-02 was installed west of the mid-slope of Site 23 and approximately 2.0 mm of movement was observed at approximately 114.4 ft bgs from October 2017 to October 2018 (approximately 19.2 mm total incremental movement since November 2010). This movement is along a silty sand lens between silt and the glacial till. Inclinometer IN-23-10-08 was installed at the top of Site 23 and the movement zone ranges from 125.8 to 135.8 ft bgs. This movement zone is below the landslide materials and just above the glacial till. The maximum movement in this zone was about 1.8 mm at 131.8 ft bgs from October 2017 to October 2018, with rate remaining relatively constant (approximately 18.5 mm total incremental movement since November 2010).

Spiral Correction : N/A  
 Movement Depth : 82.0 - 86.0 feet  
 Borehole Total Depth : 222.0 feet  
 A+ Groove Azimuth : 135 degrees  
 Latest Reading : 2018 Oct 29 14:54  
 Initial Reading : 2006 Oct 07 10:28  
 Applied Azimuth : 0.0 degrees
