BEST MANAGEMENT PRACTICES PLAN 2018 ANNUAL REPORT

Hecla Greens Creek Mining Company

March 1, 2019

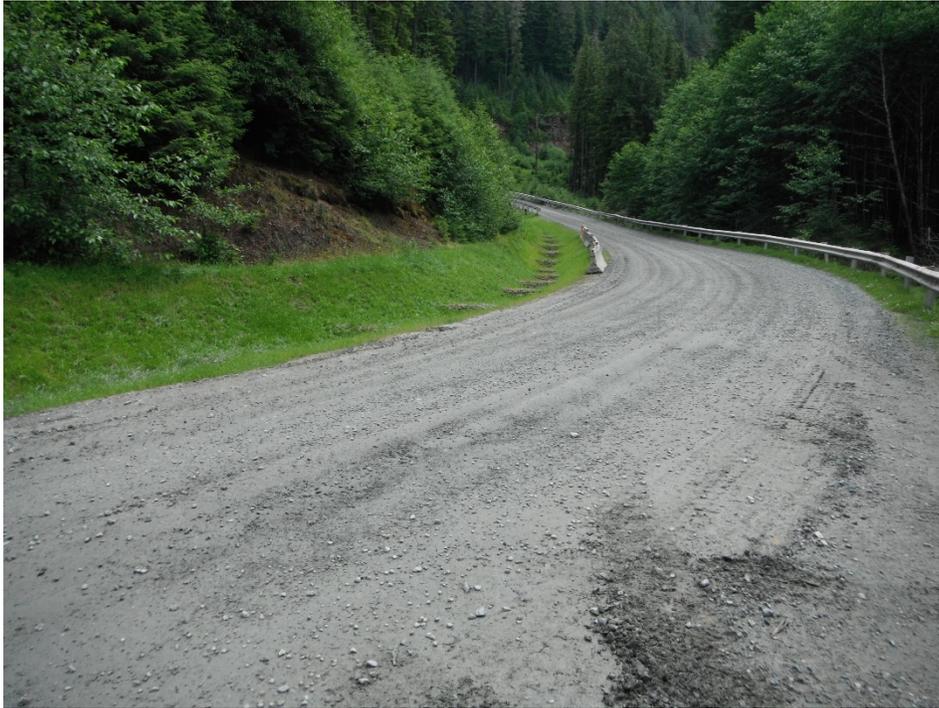
PHOTO 1. Ditch above 3.0-mile bridge showing rock check dams.

Several improvements were made to the BMPs in this area. The roadside ditch on the uphill side of the bridge was cleaned and enlarged and several rock check dams were installed. The ditch was then hydroseeded to establish vegetation. The settling pond that receives runoff from this ditch was also cleaned and enlarged. Beneath the 3.0-mile bridge, silt fences that had been utilized for many years to contain sediments were removed and replaced with rows of compost filter socks. Accumulated sediments were removed and the area was hydroseeded to establish vegetation.

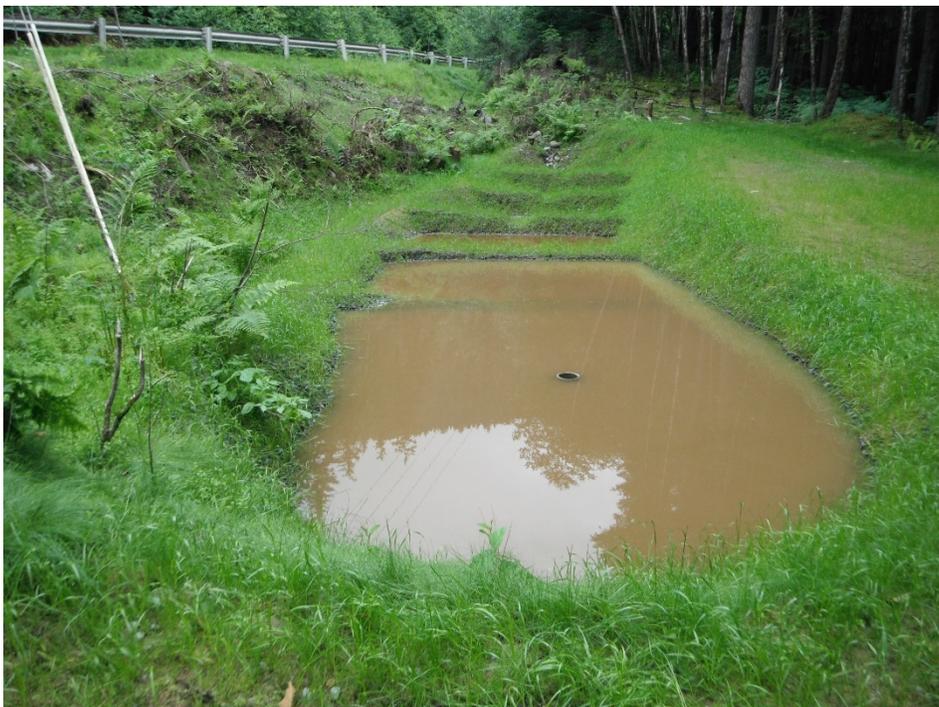
PHOTO 2. Improved settling pond above 3.0-mile bridge.

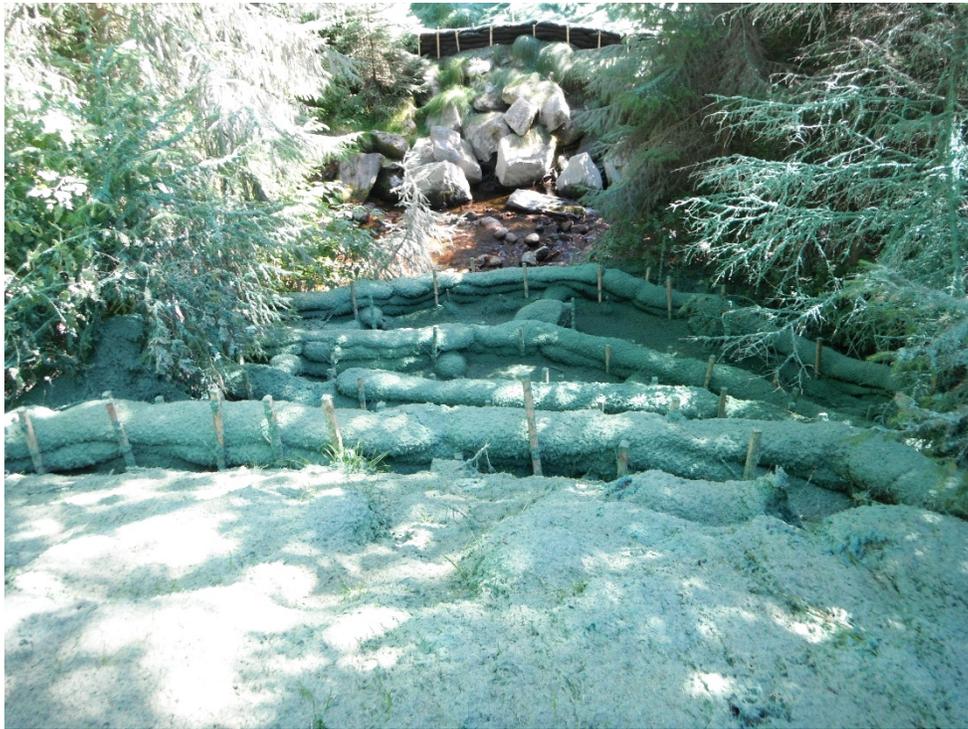
PHOTO 3. New BMPs under 3.0-mile bridge, after hydroseeding.

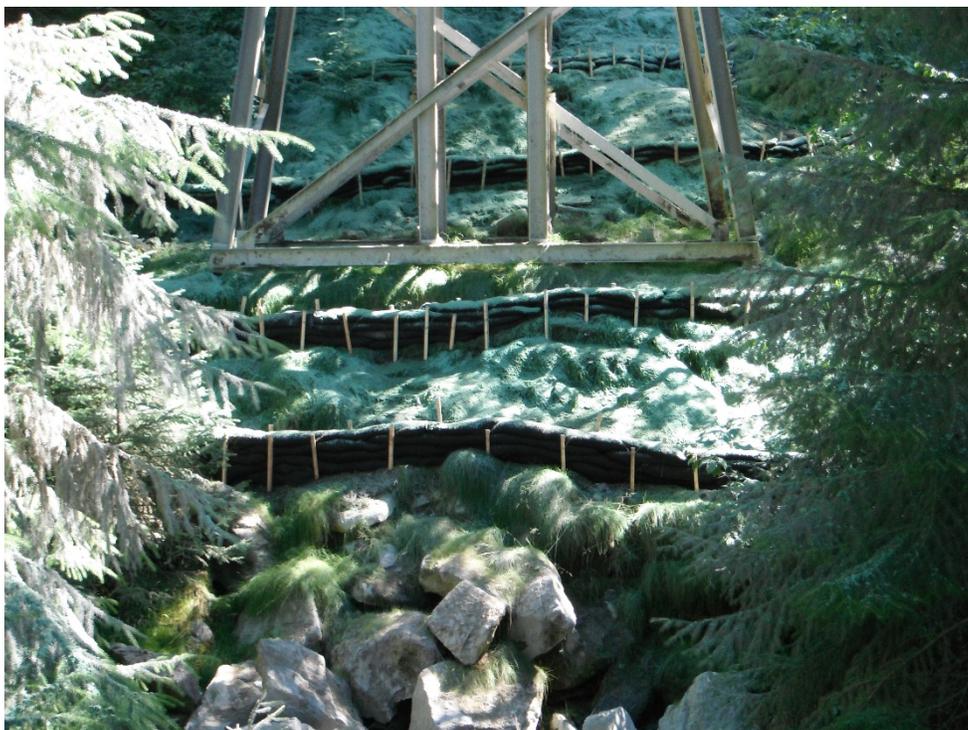
PHOTO 4. New BMPs under 3.0-mile bridge, after hydroseeding.

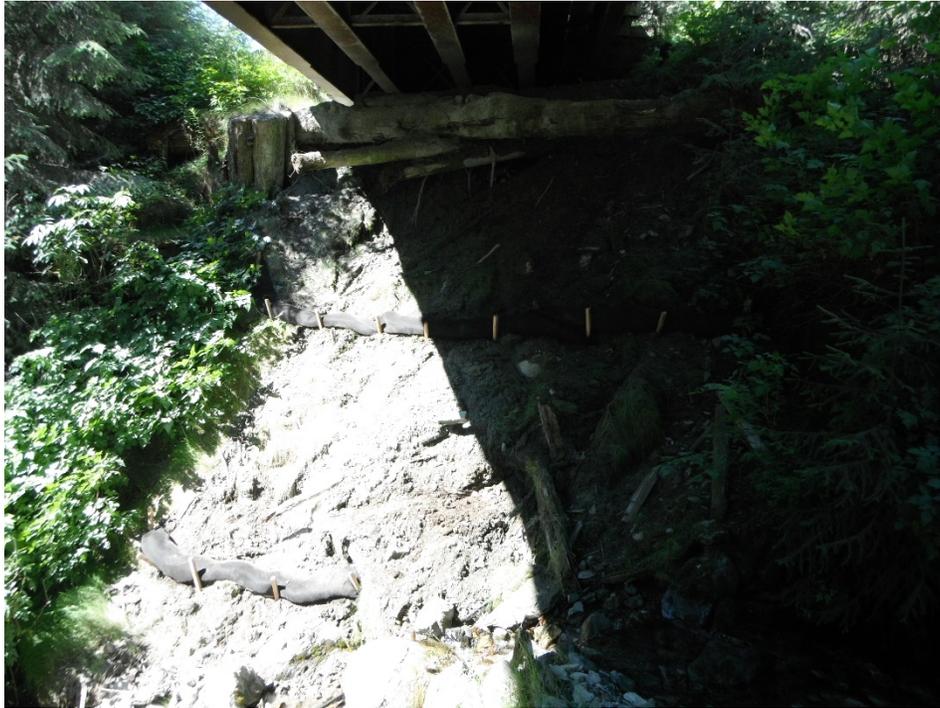
PHOTO 5. Compost filter sock under 7.4-mile bridge.

The accumulation of sediment at the ends of the B-Road bridges, primarily at 3.4-mile and 7.4-mile, and the potential for that sediment to reach the streams, was a concern noted in three of the 2018 agency inspection reports. To mitigate the concern, accumulated sediments were removed and sediment deflectors (2"x12" boards) were placed at each end of the bridges to prevent sediments from washing onto the face of the abutments beneath the bridges. With proper maintenance, these measures are effective at directing runoff away from the bridge ends and into established BMPs. Also, at the 7.4-mile bridge straw wattles and compost filter socks were placed in the ditch and on the abutment beneath the bridge to help filter runoff and contain sediment.

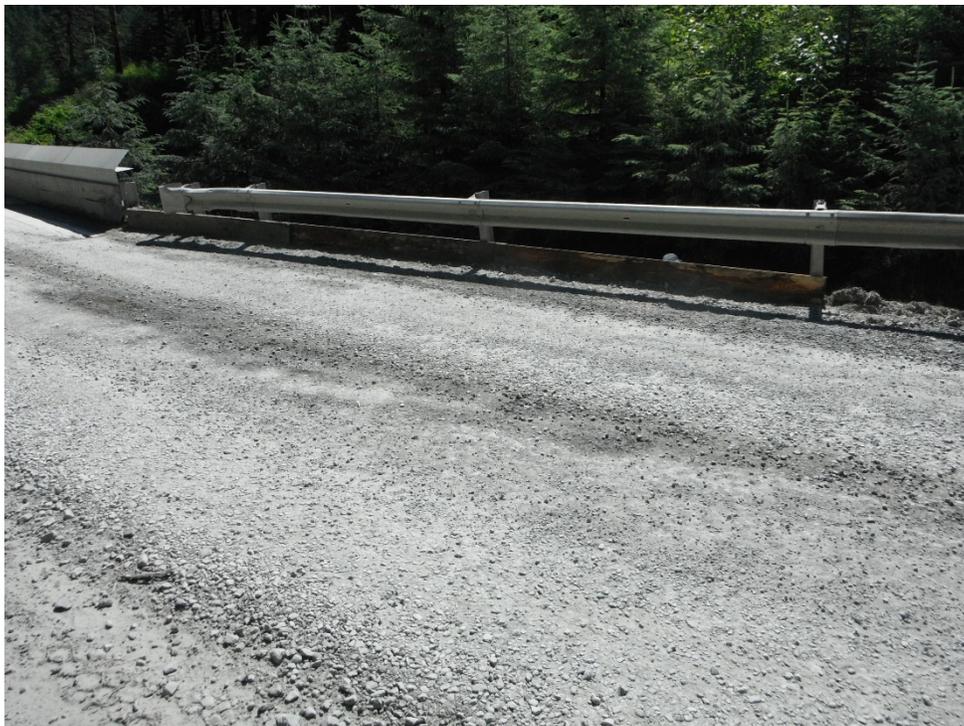
PHOTO 6. Sediment/runoff deflector at 7.4-mile bridge.

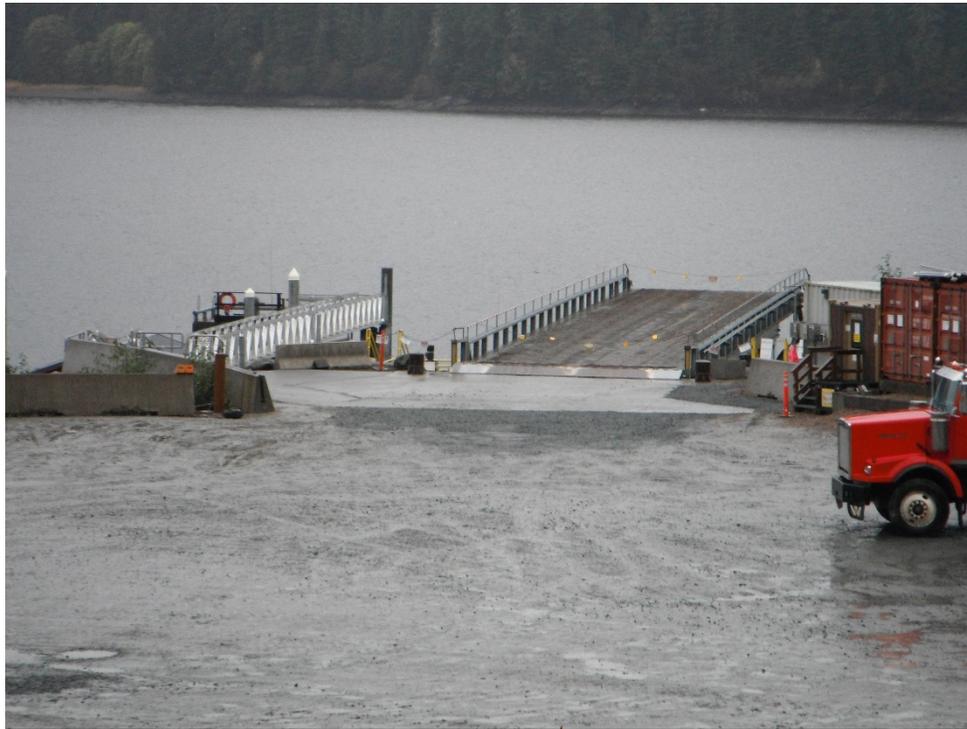
PHOTO 7. New concrete apron at Hawk Inlet freight barge ramp.

The rubber razor bar installed above the freight barge ramp in November 2016 functioned well to prevent turbid water from entering Hawk Inlet at this location. However, this BMP required periodic maintenance and replacement due to damage sustained by the heavy forklifts. To provide a more permanent, low maintenance solution, HGCMC installed a large concrete apron on the gravel approach ramp. The thick concrete apron will prevent the formation of ruts by the forklifts and is sloped to direct all runoff to the catch basin. This project was completed in October 2018.

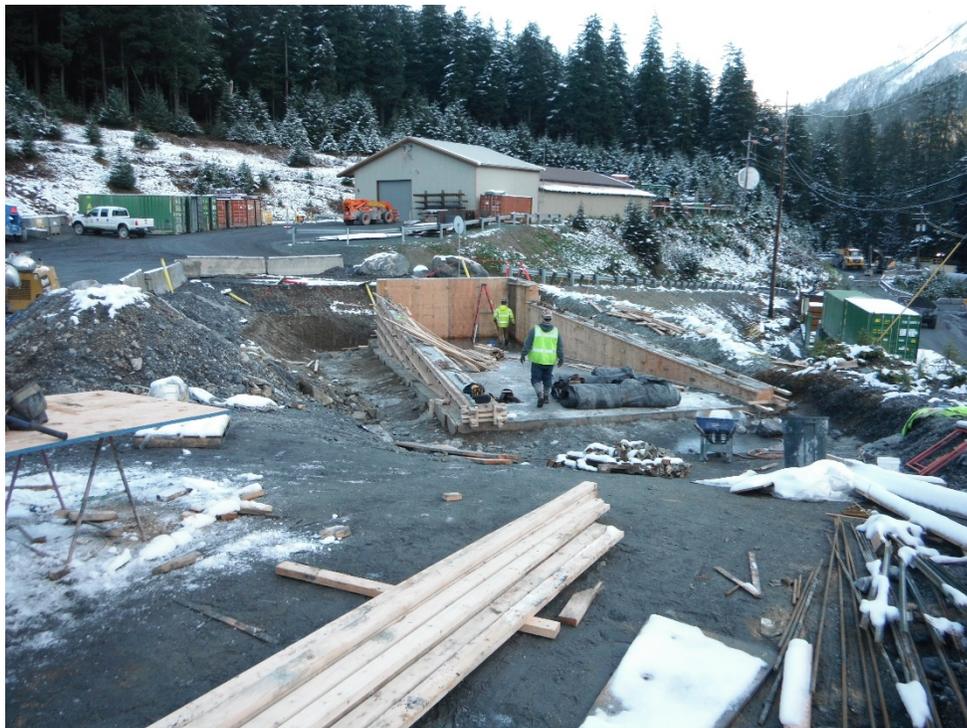
PHOTO 8. Construction of Ore Pad de-grit basin.

A new concrete de-grit basin was constructed which will receive all runoff from the ore pad to reduce the amount of sediment that accumulates in ditches and A Pond. The de-grit basin was completed in November.
