## INSPECTION REPORT: GREENS CREEK MINE

Date of Inspection: Monday November 5, 2018  
Date of Report: Monday November 19, 2018  
USDA Forest Service Inspector: Richard Dudek

The site inspection included the Access Road B, 920 area, 7.4 mile B-road Bridge (Killer Creek Bridge), Site E, 3.4 mile B-road Bridge (Falls Creek Bridge), 3.0 mile B-road Bridge (Zinc Creek Bridge), Tailings Disposal Facility (TDF), and 0.9 mile A-road.

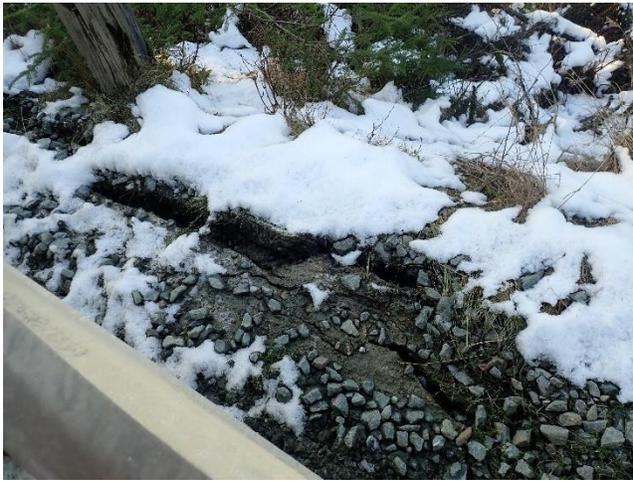
At the time of the inspection, the B-road was in adequate condition. A section of the road at mile marker 0.9 A-road has failed (Photo 1). HGCMC civil engineers are currently working on a plan to repair the road.

**Photo 1. A section of the edge of the road failure at 0.9 mile A-road.**

- **0.9 mile A-road requires slope stabilization due to a section of the shoulder failing.**

**Repairs made to the 0.9 mile A-road.**

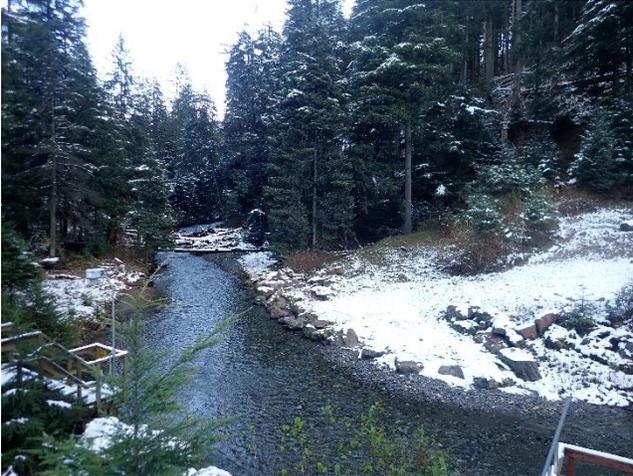
The recorded discharge rate for the Greens Creek weir (Photo 2) on 11/5/2018 was 27.80 cubic feet per second (cfs). The 920-area water withdrawal rate from Green Creeks was 1.5 cfs.

Photo 2. Greens Creek.

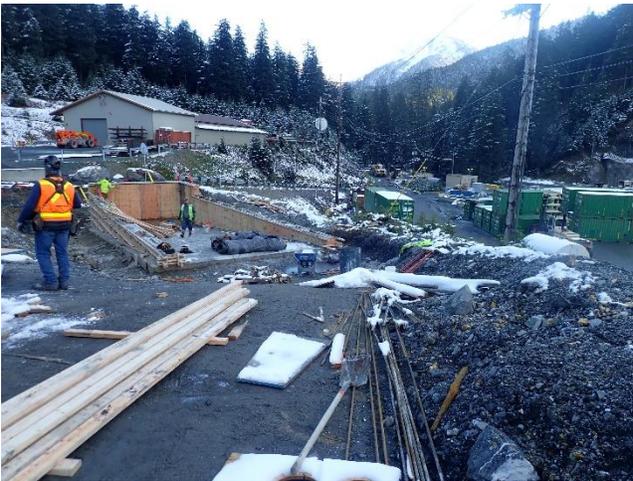
The contractors have completed the new 920 ore pad de-grit basin (Photo 3). All surface water runoff collected in the de-grit basin will be routed to Pond A.

Photo 3. Contractors finishing the construction of the new 920 ore pad de-grit basin.

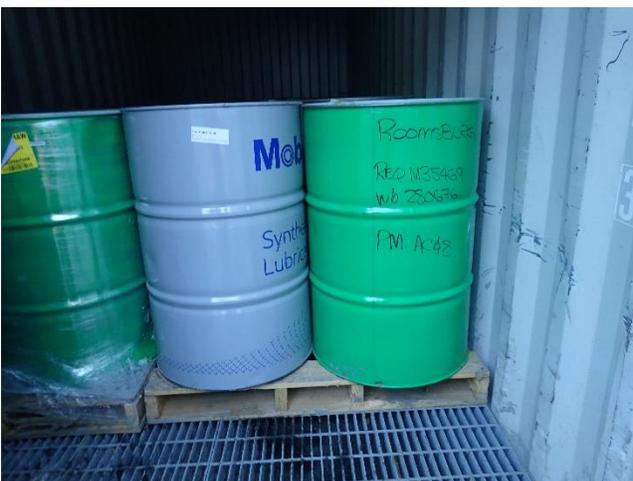
Good housekeeping practices were observed at the warehouse (Photo 4). All chemical and petroleum products were stored within secondary containment (Appendix 5 BMP plan; page 39).

Photo 4. 920 storage containers with Petroleum products stored within secondary containment.

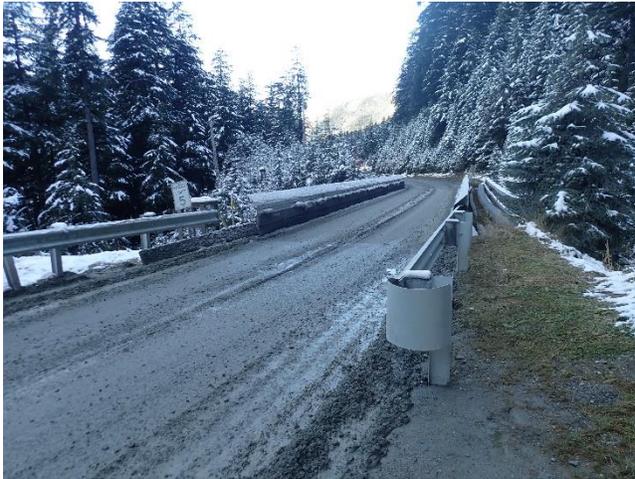
Contractors recently installed guard rails (Photos 6-7) that extend to the bridge ends. HGCMC Environmental Operations are currently designing plans to attach temporary sediment control barriers at bridge ends for all the B-road bridges.

**Photo 6. 7.4 Mile B-road Bridge (Killer Creek Bridge).**

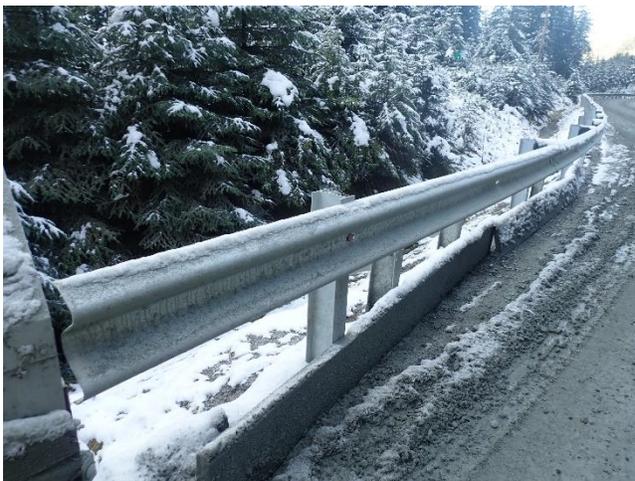
**Photo 7. Guardrails extending to the bridge.**

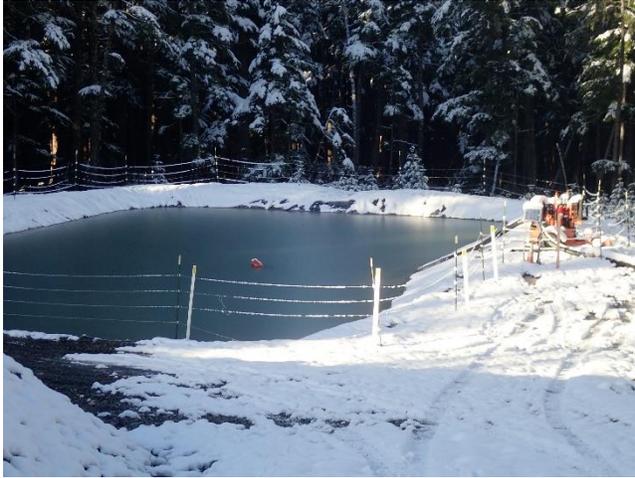
Reported in IR #399 from 10/10/2018, the water line from the storm water management pond to the site's influent pipeline was leaking (Photos 8-9). HGCMC has ordered pipe repair clamps, and is waiting for them to arrive. However, due to recent freezing temperatures, water is not being pumped from the pond. This site is currently being used as a staging area for road base material and emulsion tanks for underground blasting.

**Photo 8. The storm water management pond at Site E.**

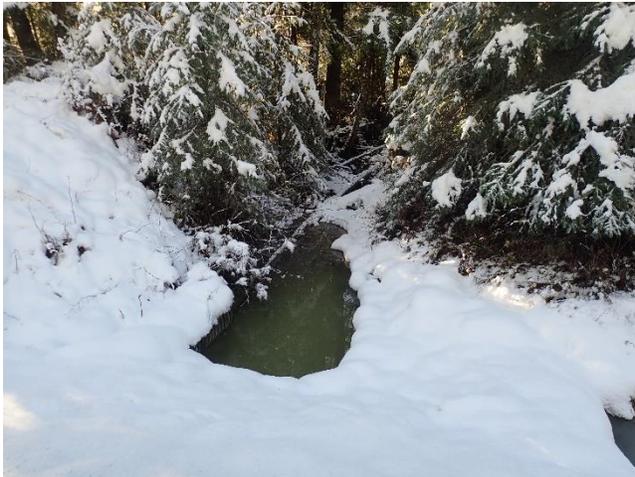
**Photo 9. The location where the leaking pipe was discovered near the sumps and pipelines.**

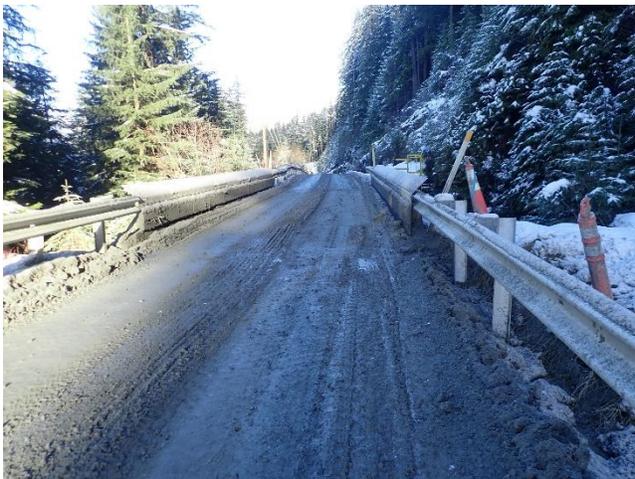
Contractors recently installed guardrails near the bridge ends (Photo 10). HGCMC will be adding additional temporary barriers at both bridge ends to help prevent sediment from flowing under the bridge.

**Photo 10. The 3.4 Mile B-road Bridge (Falls Creek Bridge).**

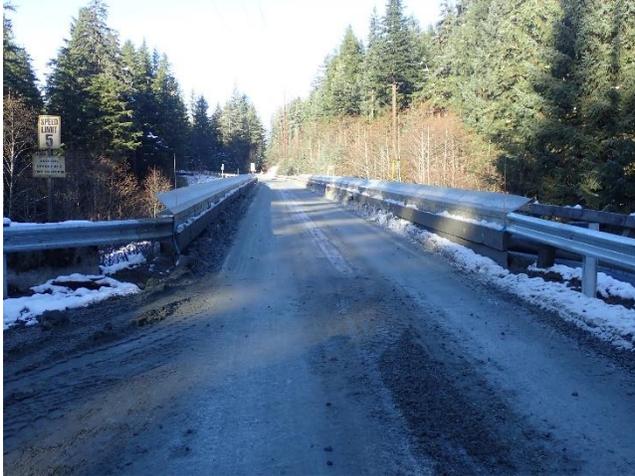
Contractors recently installed additional guardrails along the access road near the bridge (Photos 11-12).

**Photo 11. The 3.0 Mile B-road Bridge (Zinc Creek Bridge).**

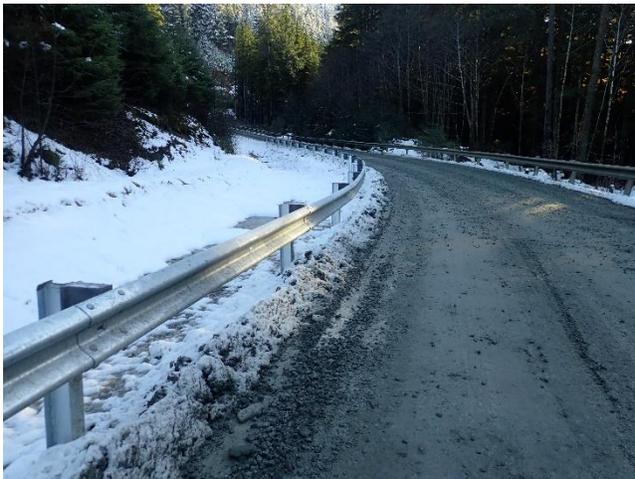
**Photo 12. New guardrails were installed across from the parking area near Zinc Creek Bridge.**

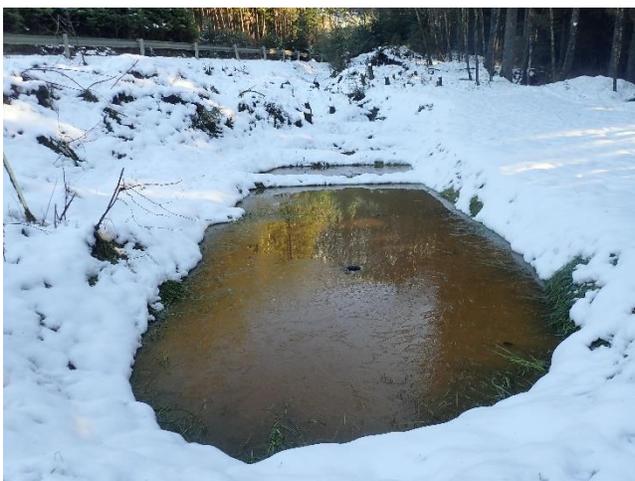
The structural BMPs (Photos 13) near the bridge's uphill abutment are working as intended.

**Photo 13. The structural BMPs were working as intended.**

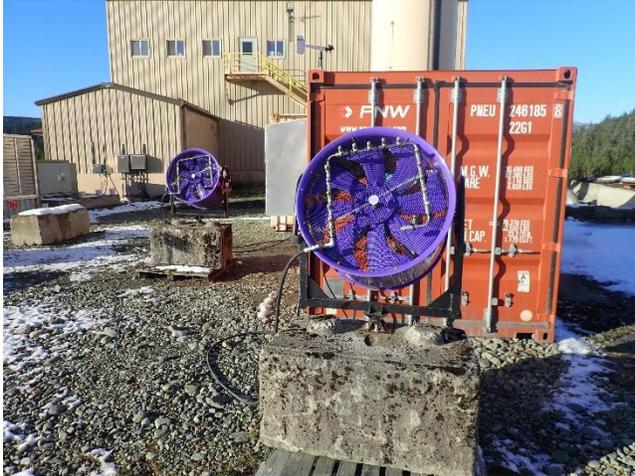
In the coming weeks, HGCMC will begin using a transportable water misting system (Photo 14) as an additional mitigation for reducing fugitive dust. The misting system will be staged up-gradient of the primary tailings placement area through the winter (Photo 15). The water source will be from Cannery Creek, and will undergo filtration (50 micron to 5 micron) prior to being used for the misting system.

Photo 14. The TDF water misting system will be used for mitigation control for fugitive dust.

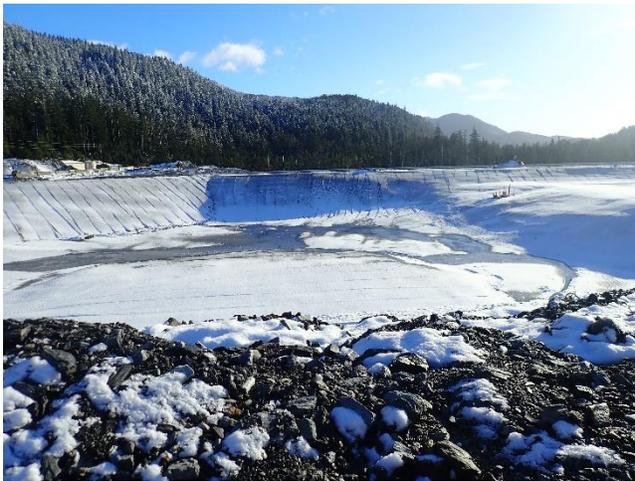
Photo 15. The location and direction (facing south) where the misting system will be staged to emit water mist.

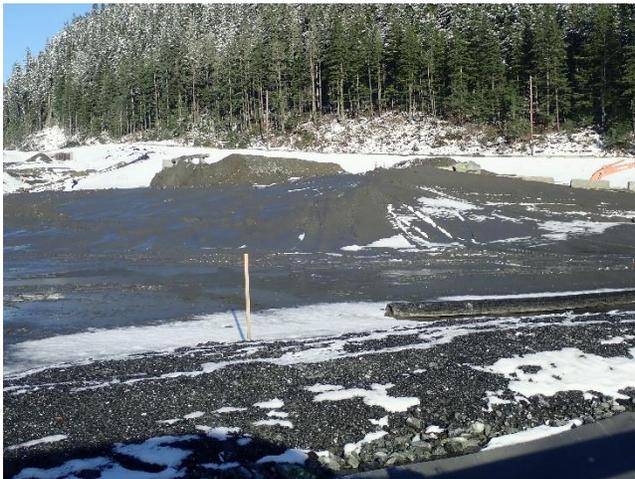
Surface Operations continue to deposit tailings in the S3P1 expansion area (Photo 16).

Photo 16. The S3P1 TDF expansion area.

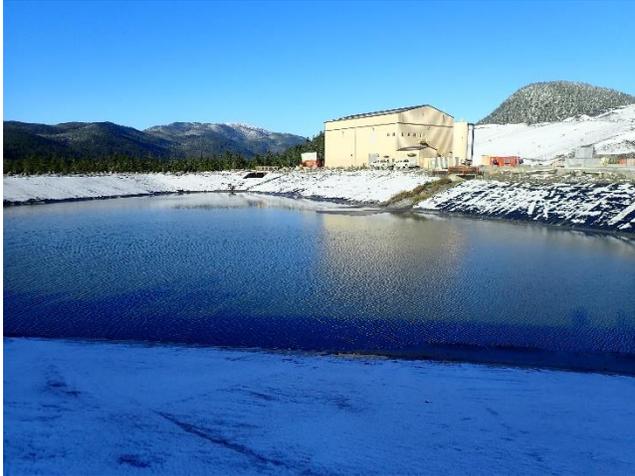
**Photo 17. Pond 7.**

Pond 7 (Photo 17) was receiving influent water, and Pond 10 (Photo 18) is collecting only direct precipitation.
