## INSPECTION REPORT: GREENS CREEK MINE

Date of Inspection: Thursday October 24, 2019  
Date of Report: Friday November 1, 2019  
USDA Forest Service Inspector: Richard Dudek

Ranger District: Admiralty National Monument, Juneau Ranger District  
Weather Conditions: Cloudy with some rain. Temperature: Mid 40's (°F).

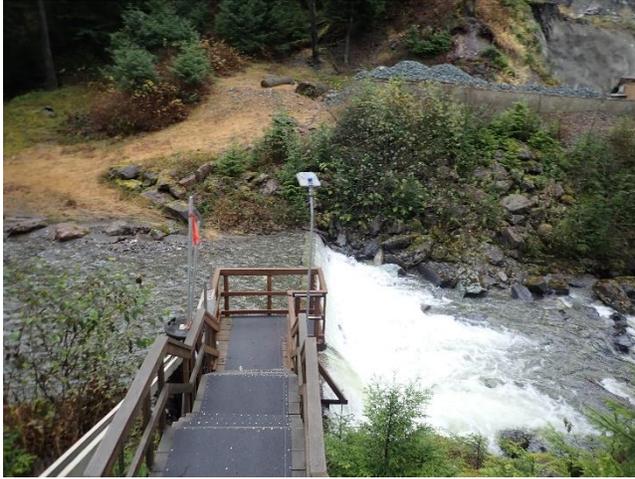
The recorded flow rate for Greens Creek (Photo 1) on 10/24/2019 was 71.01 cubic feet per second (cfs). The 920-area water withdrawal rate from Greens Creek was approximately 1.5-cfs.

**Photo 1. Greens Creek weir.**

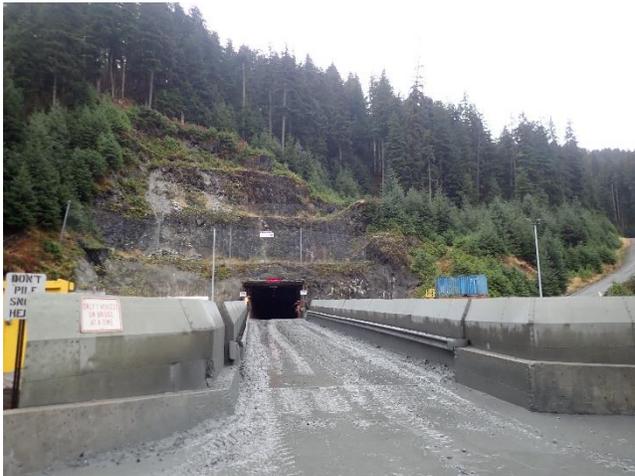
The 920 Bridge's splash guards are preventing sediment splash over from vehicular traffic (Photo 2).

**Photo 2. The 920 Bridge.**

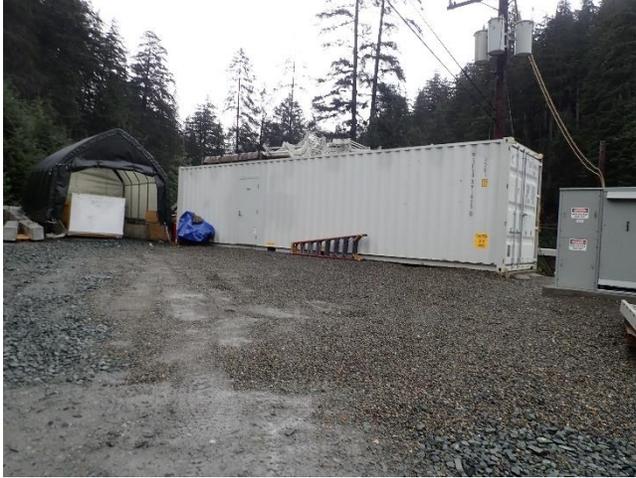
The electrical switchgear box is online and is supplying power to the underground mine (Photo 3).

**Photo 3. The electrical switchgear for the underground mine.**

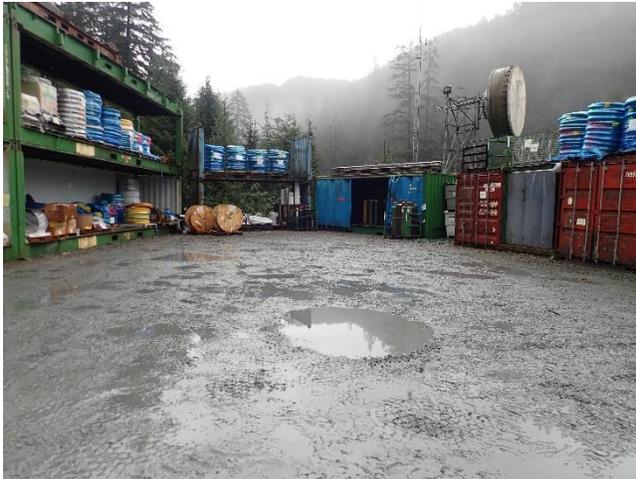
Good housekeeping practices were observed at The 920 warehouse (Photo 4). All petroleum/chemicals were properly stored within appropriate secondary containment (Photo 5).

**Photo 4. The 920 warehouse storage area.**

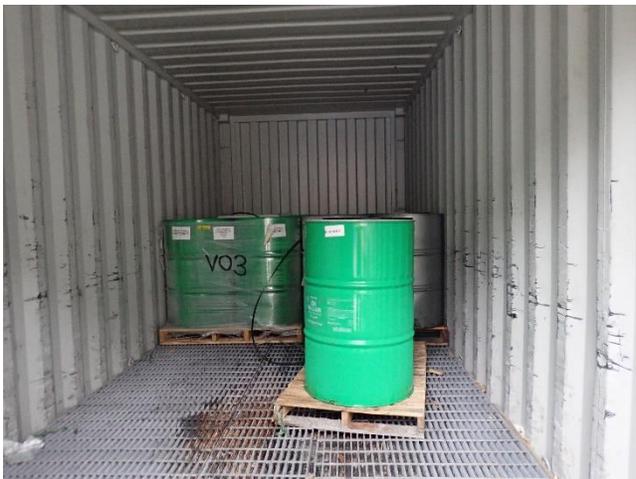
**Photo 5. Petroleum products stored within secondary containment.**

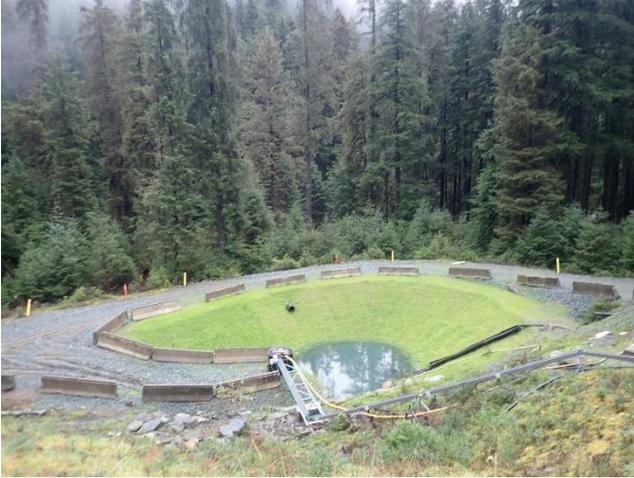
At the time of the site inspection, C pond was functioning as intended (Photo 6). The diesel-powered pump will remain on site as as backup to the primary electrical pumps.

**Photo 6. Lower C Pond.**

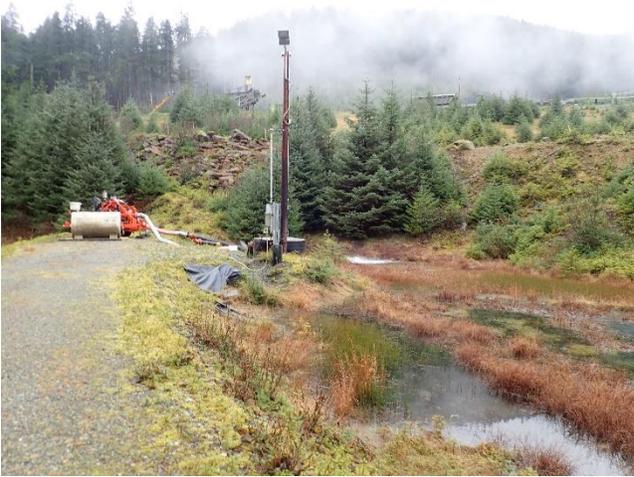
The pond was functioning as intended (Photo 7). The diesel-powered pump (Photo 8) staged here will remain on site and serve as backup power to the primary electric pumps.

**Photo 7. D Pond.**

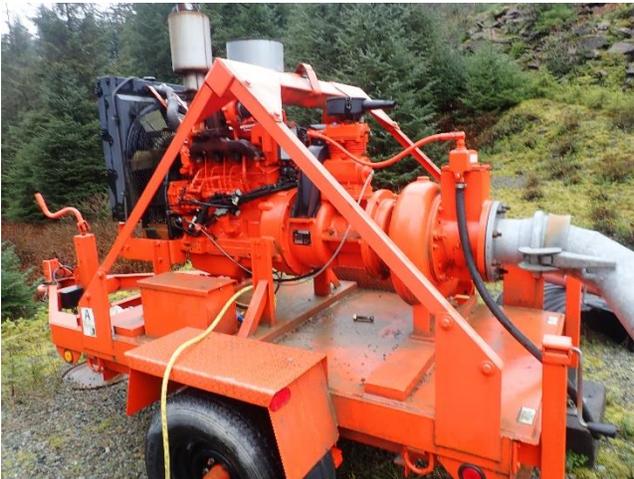
**Photo 8. The auxiliary pump for D pond.**

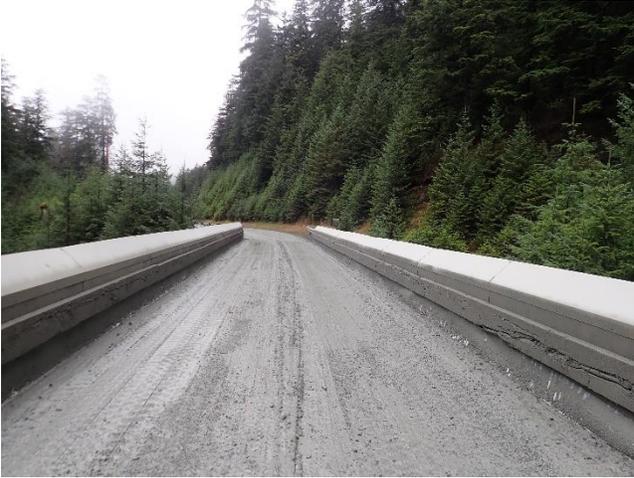
**Photo 9. 7.4 Mile B-Road Bridge (Killer Creek Bridge).**

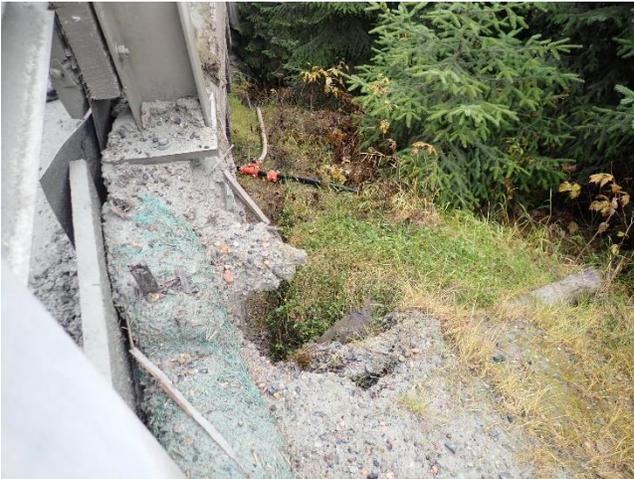
The bridge is being maintained by HGCMC Surface Operations (Photo 9). Some erosion was observed on the downhill side abutment and requires mitigations to prevent further erosion (Photo 10). Surface Operations recently made improvements to the sediment sump by installing straw wattles, and mucking out the sediments (Photo 11).

**Photo 10. Erosion along the downhill side abutment.**

- **Additional mitigations are required to prevent further erosion along the 7.4 Mile B-Road Bridge downhill side abutment.**

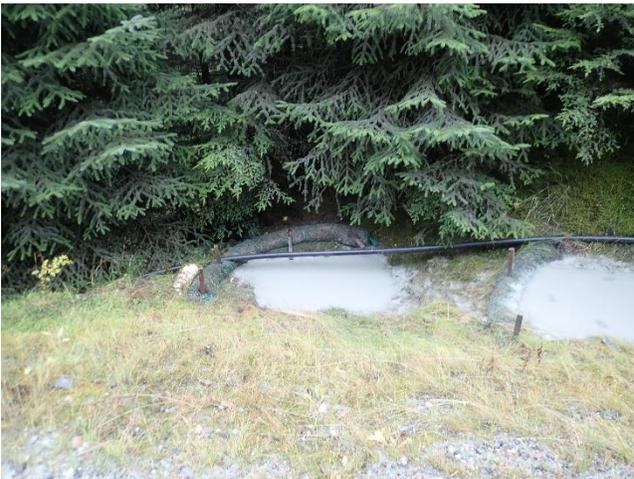
**Photo 11. Surface Op's installed straw wattles along the sediment sumps.**

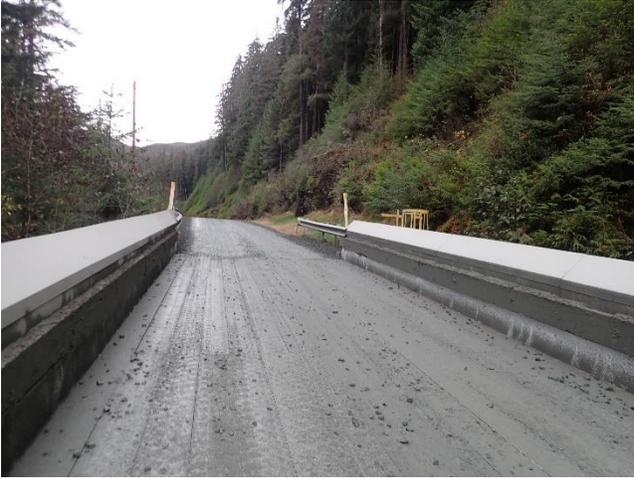
**Photo 12. 3.4 Mile B-Road Bridge (Falls Creek Bridge).**

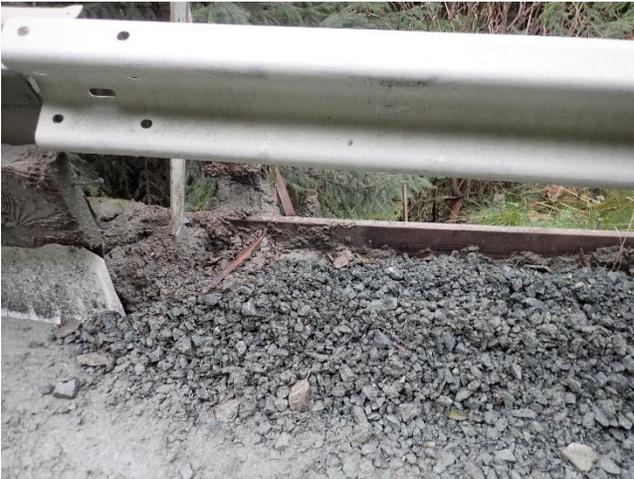
The bridge is being maintained by HGCMC Surface Operations (Photo 12). Surface Operations recently re-decked and installed a new liner for the bridge's biennial maintenance. Sediment accumulation at the bridge ends exceed the sediment barrier's design criteria height of one-third, and need to be removed (Photo 13) (Appendix 05 BMP Plan; page BMP-12).

**Photo 13. The removal of sediments is required along the 3.4 Mile B-Road Bridge sediment barriers.**

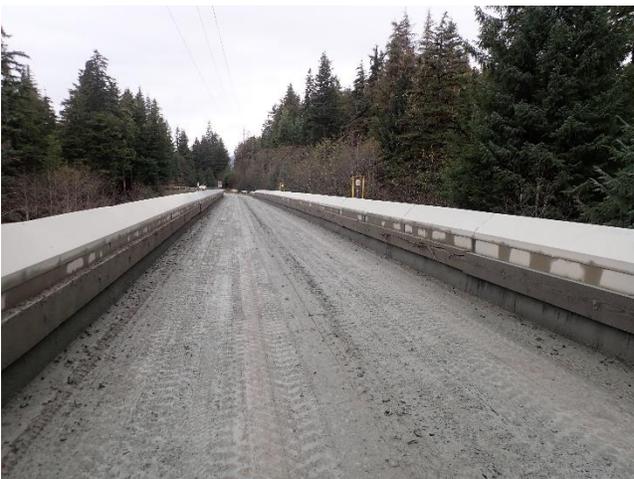
**Photo 14. 3.0 Mile B-Road Bridge (Zinc Creek Bridge).**

- **On 10/31/2019, Surface operations plan to replace the wear layer decking for the 3.0 Mile B road Bridge (Zinc Creek Bridge).**

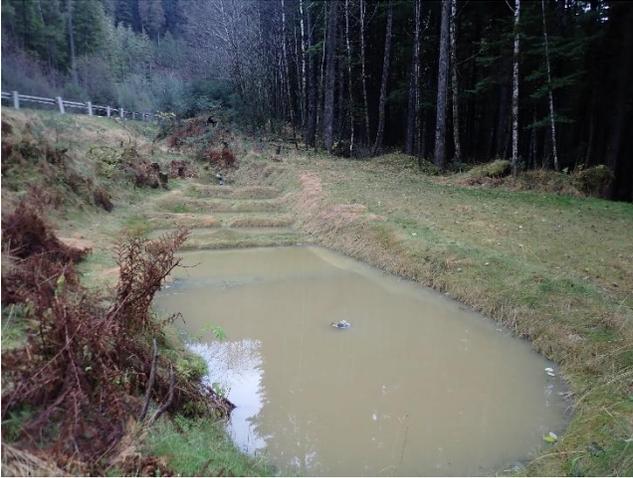
HGCMC Surface Operations are maintaining the bridge (Photo 14), and the structural BMPs located on the uphill side abutment are functioning as intended (Photos 15-16).

**Photo 15. BMPs (sediment sumps) along the uphill abutment.**

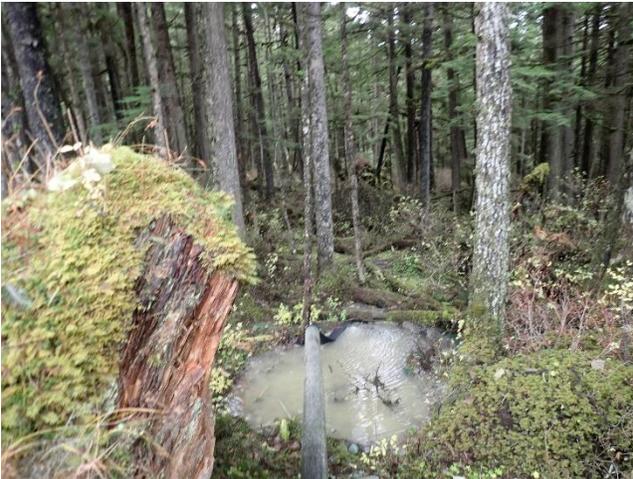
**Photo 16. The stand pipe discharge line with a silt sock attached at the opening.**

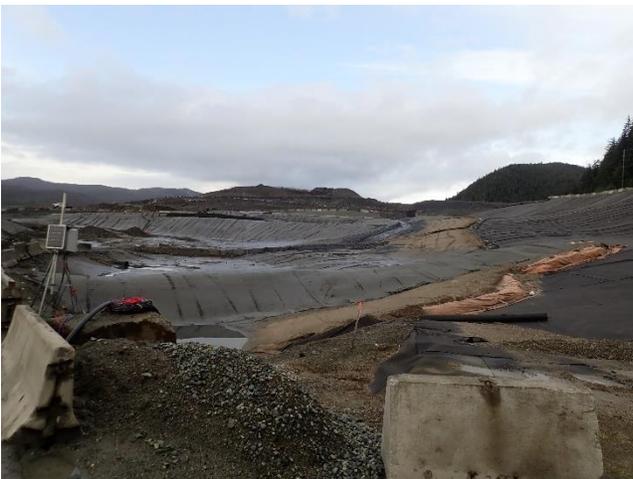
Surface Operations continue depositing tailings in the S3P1 expansion area (Photo 17).

**Photo 17. The Stage 3 Phase 1 (S3P1) tailings expansion area.**

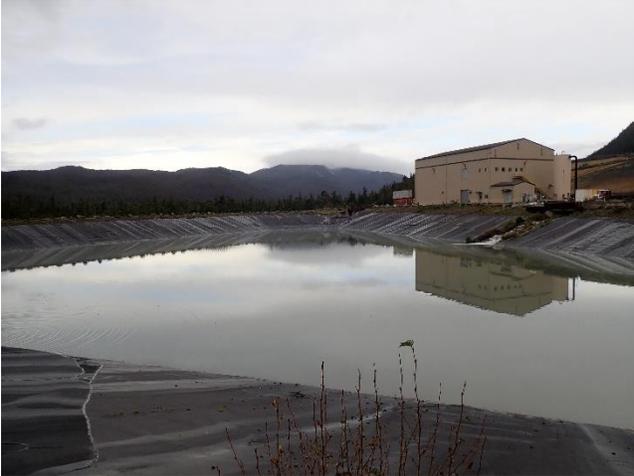
Pond 7 (Photo 18) was collecting mine site water, and recirculated water from the TDF water treatment plant. Pond 10 (Photo 19) is only collecting direct precipitation.

**Photo 18. Pond 7.**

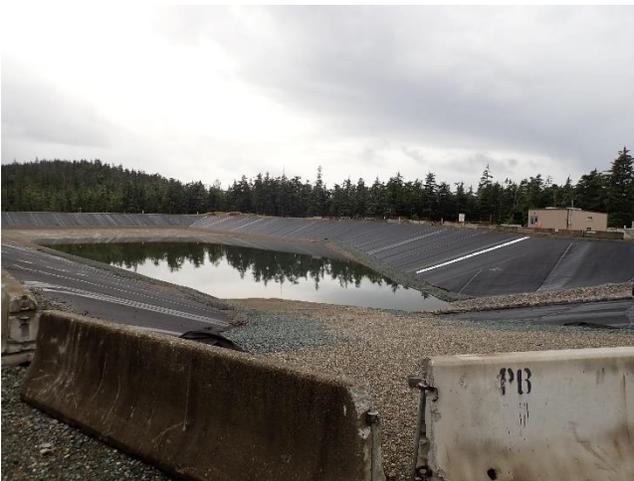
**Photo 19. Pond 10.**
