I. Introduction

This 2009 Best Management Practices (BMP) and Storm Water Report is submitted by Hecla Greens Creek Mining Company (HGCMC) pursuant to Sections II.F.1 and II.F.2 of NPDES Permit AK-004320-6, effective 1 July 2005. It summarizes the scope and dates of the comprehensive site compliance inspections/evaluations, major observations related to implementation of the BMP Plan, corrective actions taken as a result of the inspections/evaluations, identification of potential incidents of noncompliance as they pertain to the BMP Plan, description of the quantity and quality of the storm water discharged, and BMP Plan modifications made during the year. The final section of this report contains the required annual certification under Section II.F.2.

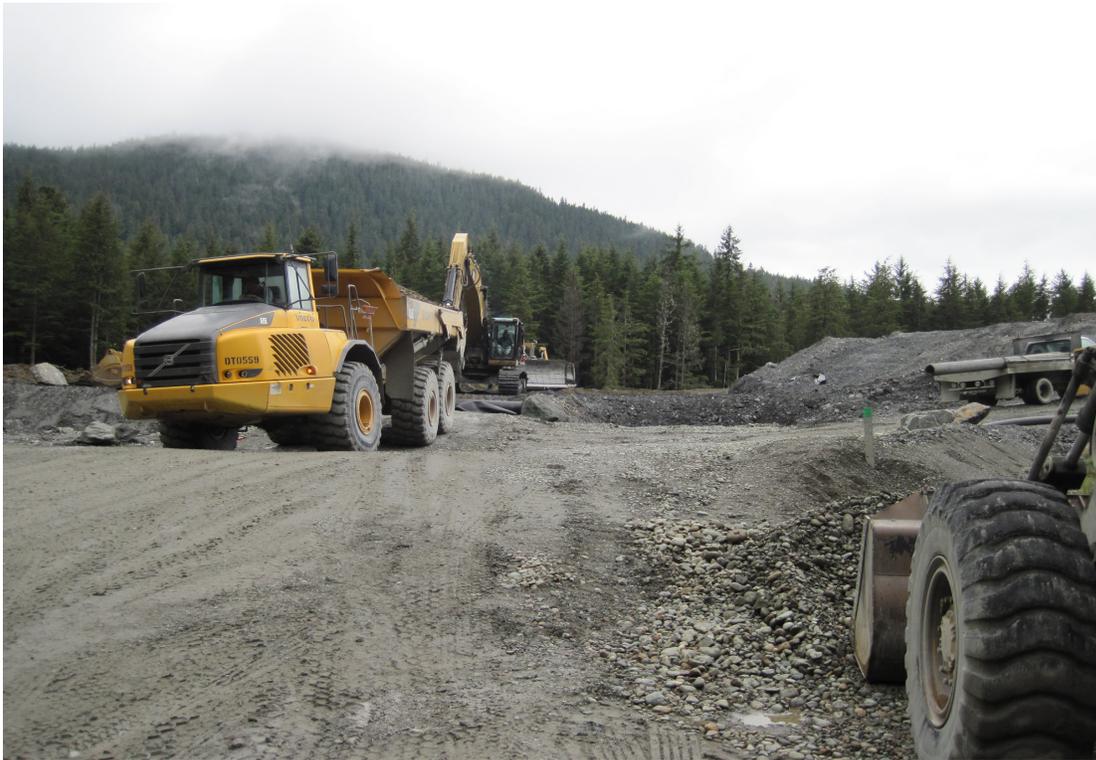
Approximately 40,000 cubic yards of waste rock was removed from Site E in 2009. The HGCMC *Site E Removal: Waste Rock and Tailings Co-Disposal Plan* was approved by the agencies and implemented prior to the commencement of removal activities. The Plan outlined additional BMP activities that would be instituted during active removal, including capture and pumping of water to treatment from the work area. Additional removal of waste rock will be undertaken in 2010, and extend over the next 5 years, with activities scheduled to commence in the spring (April 1st), and

end prior to the fall rainy season (September 1st). Photo 1 shows Site E on August 11, 2009 during removal activities.

PHOTO 1. Site E Waste Rock Removal Activities - August 11, 2009

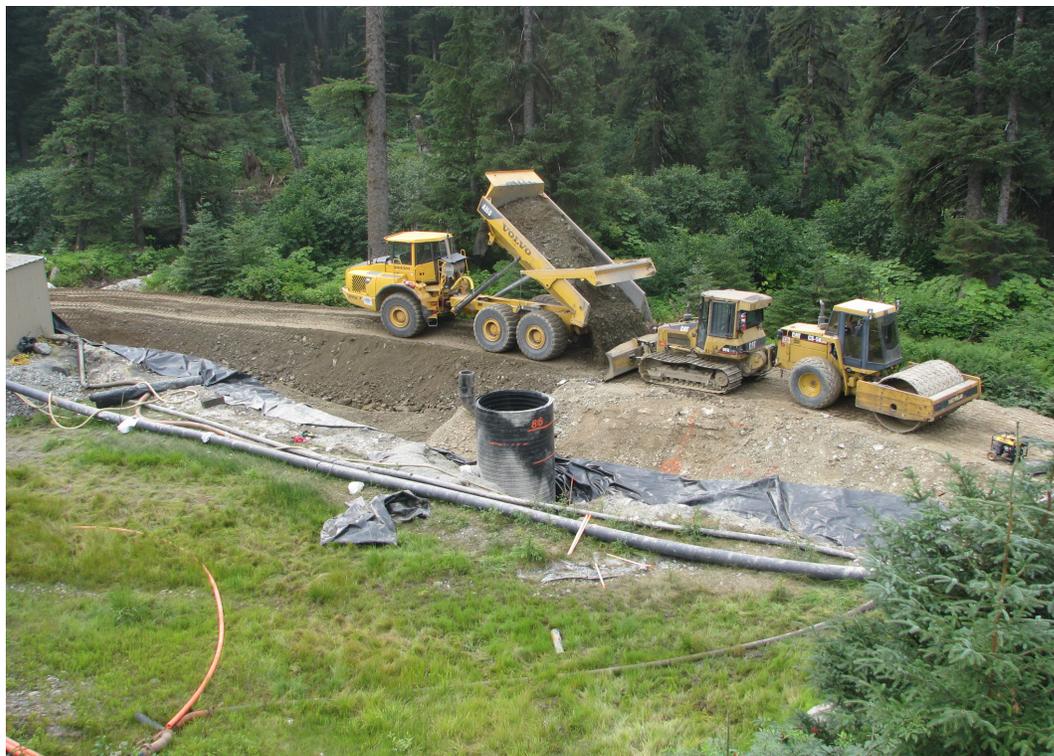
To significantly increase HGCMC's ability to manage large storm water flows from the 920 area, improvements have been made to the Pond D site. In 2009, these improvements included installation of a larger pump system to increase pumping capacity. Also, Pond D pyretic berm material was removed and replaced with clean, low permeability fill. The improvements at this site over the past few years will prevent Pond D from overflowing to Greens Creek during large storm events. Photo 2 shows Pond D activities in August 2009, including the active replacement of berm material, and the location of the new caisson.

PHOTO 2. Pond D Activities August 2009, showing replacement of berm material, and new caisson

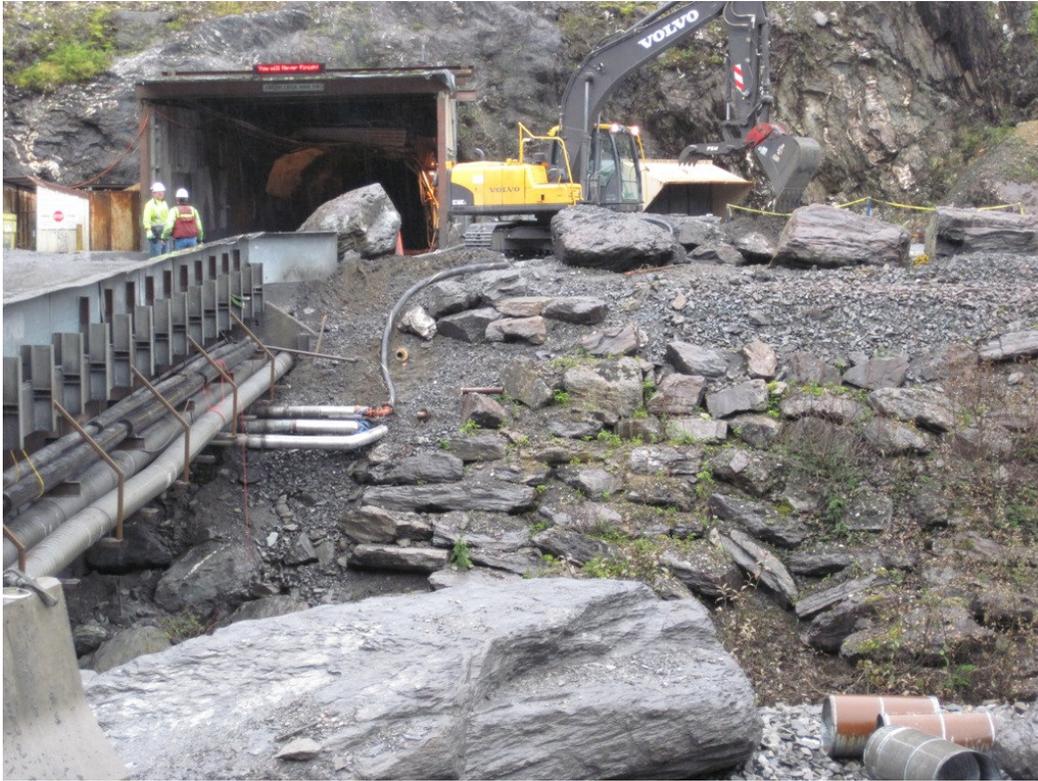
The pipelines that carry process water from the mine to the mill and fresh water to the mine were replaced in 2009. The process water pipeline has dual containment. Photo 3 (attached) shows the pipeline replacement work in progress.

PHOTO 3. Pipeline replacement project – Greens Creek Bridge 2009
