**TAILINGS AND PRODUCTION ROCK SITE
2011 ANNUAL REPORT**

Hecla Green Creek Mining Company

April 15, 2012

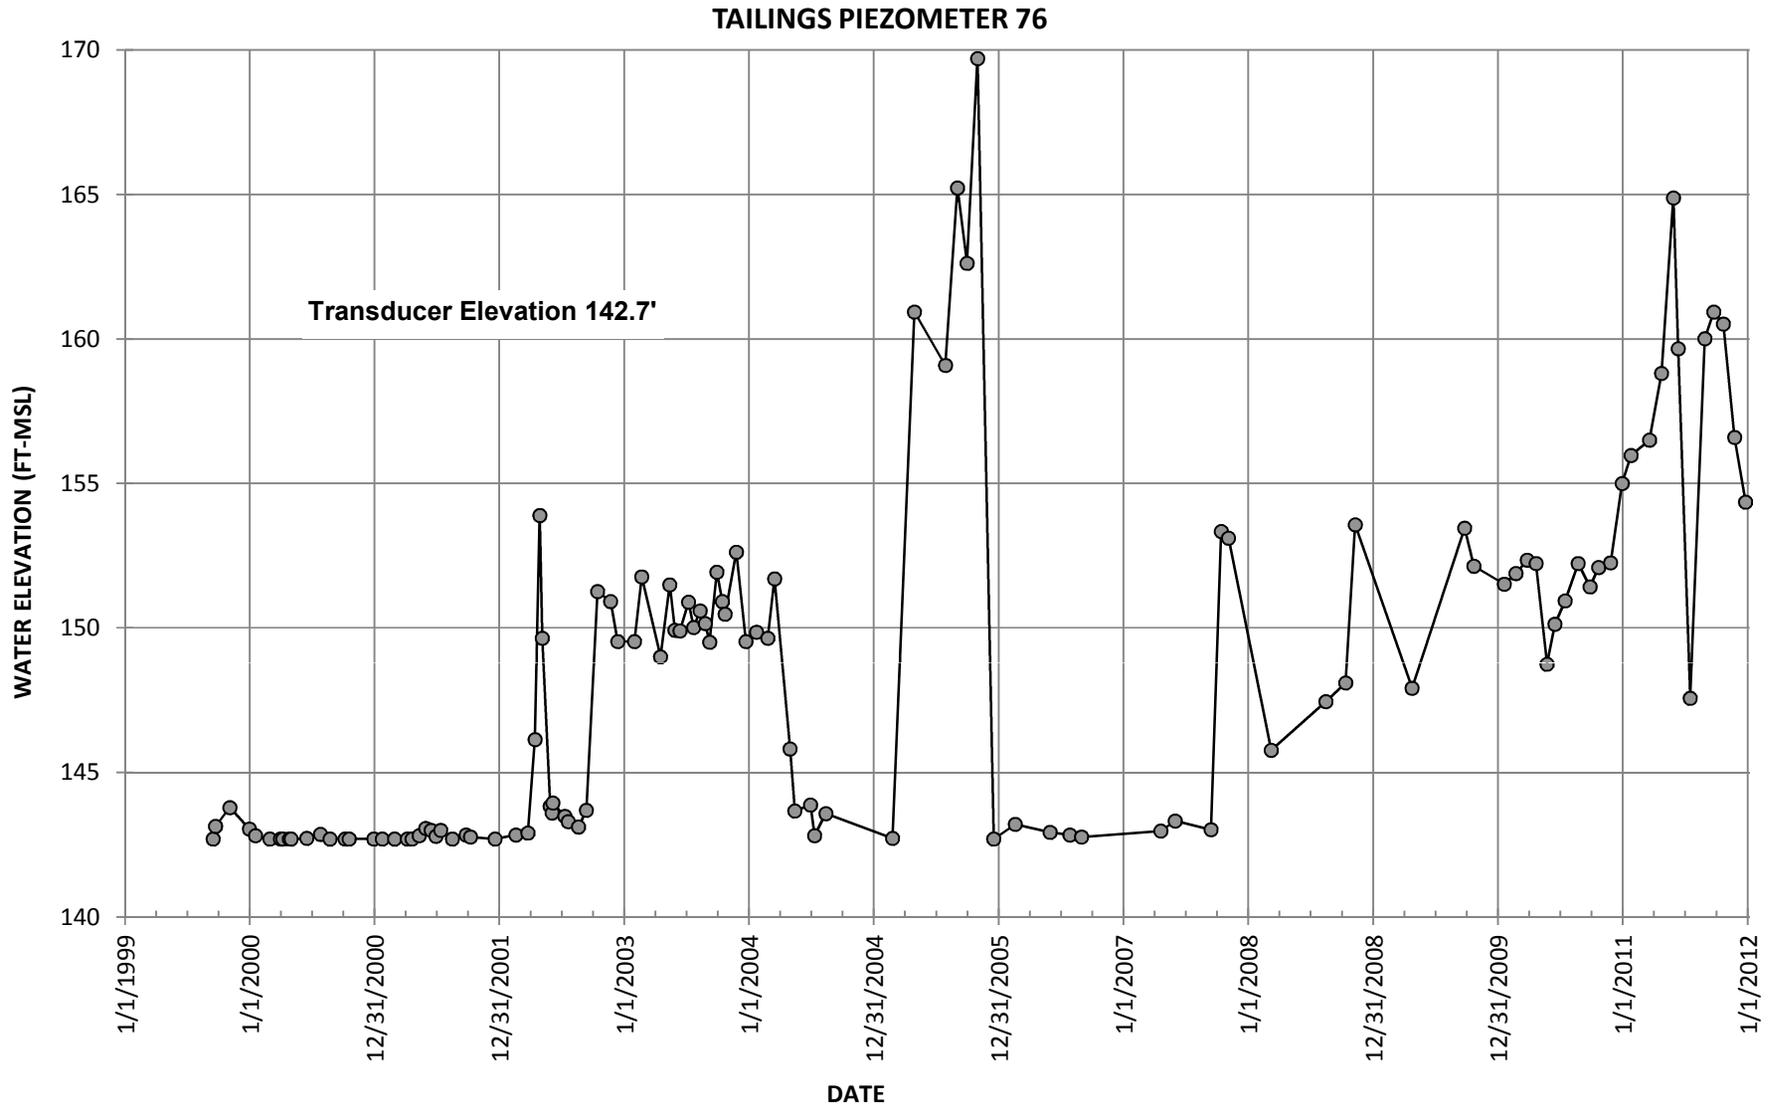
Figure 2.10 Water Level Data for Piezometer 76

The data from standpipe and pneumatic piezometers completed above the blanket drain (Piezometer 76, PZ-T-00-01, PZ-T-00-02, PZ-T-00-03 in Figures 2.10, 2.11, 2.12, 2.13) indicate that saturated conditions can develop above the unsaturated underdrains to a thickness of approximately 12 feet. This is consistent with the low permeability of the tailings and the uncapped condition of the pile. Covering the pile will help minimize the saturated zone in the pile. This was demonstrated by the over 10 foot decrease in the water table that occurred from 1995 to 1997 when the pile was covered (see Figures 2.1 to 2.7). Water levels have rebounded to, and in some cases above, 1994 elevations in most areas. Areas where water levels exceed their

Periodic spikes in water levels in the wells and piezometers are due to a variety of factors including extreme weather events (e.g. Fall/Winter 2005-2006), changes to water management infrastructure (e.g. decommissioning of Wet Well 2 from 2005-2008), damage to instrumentation (Piezometer 76 in 2004), and measurement errors (e.g. MW-T-00-05A in 2002-2003 and 2007).

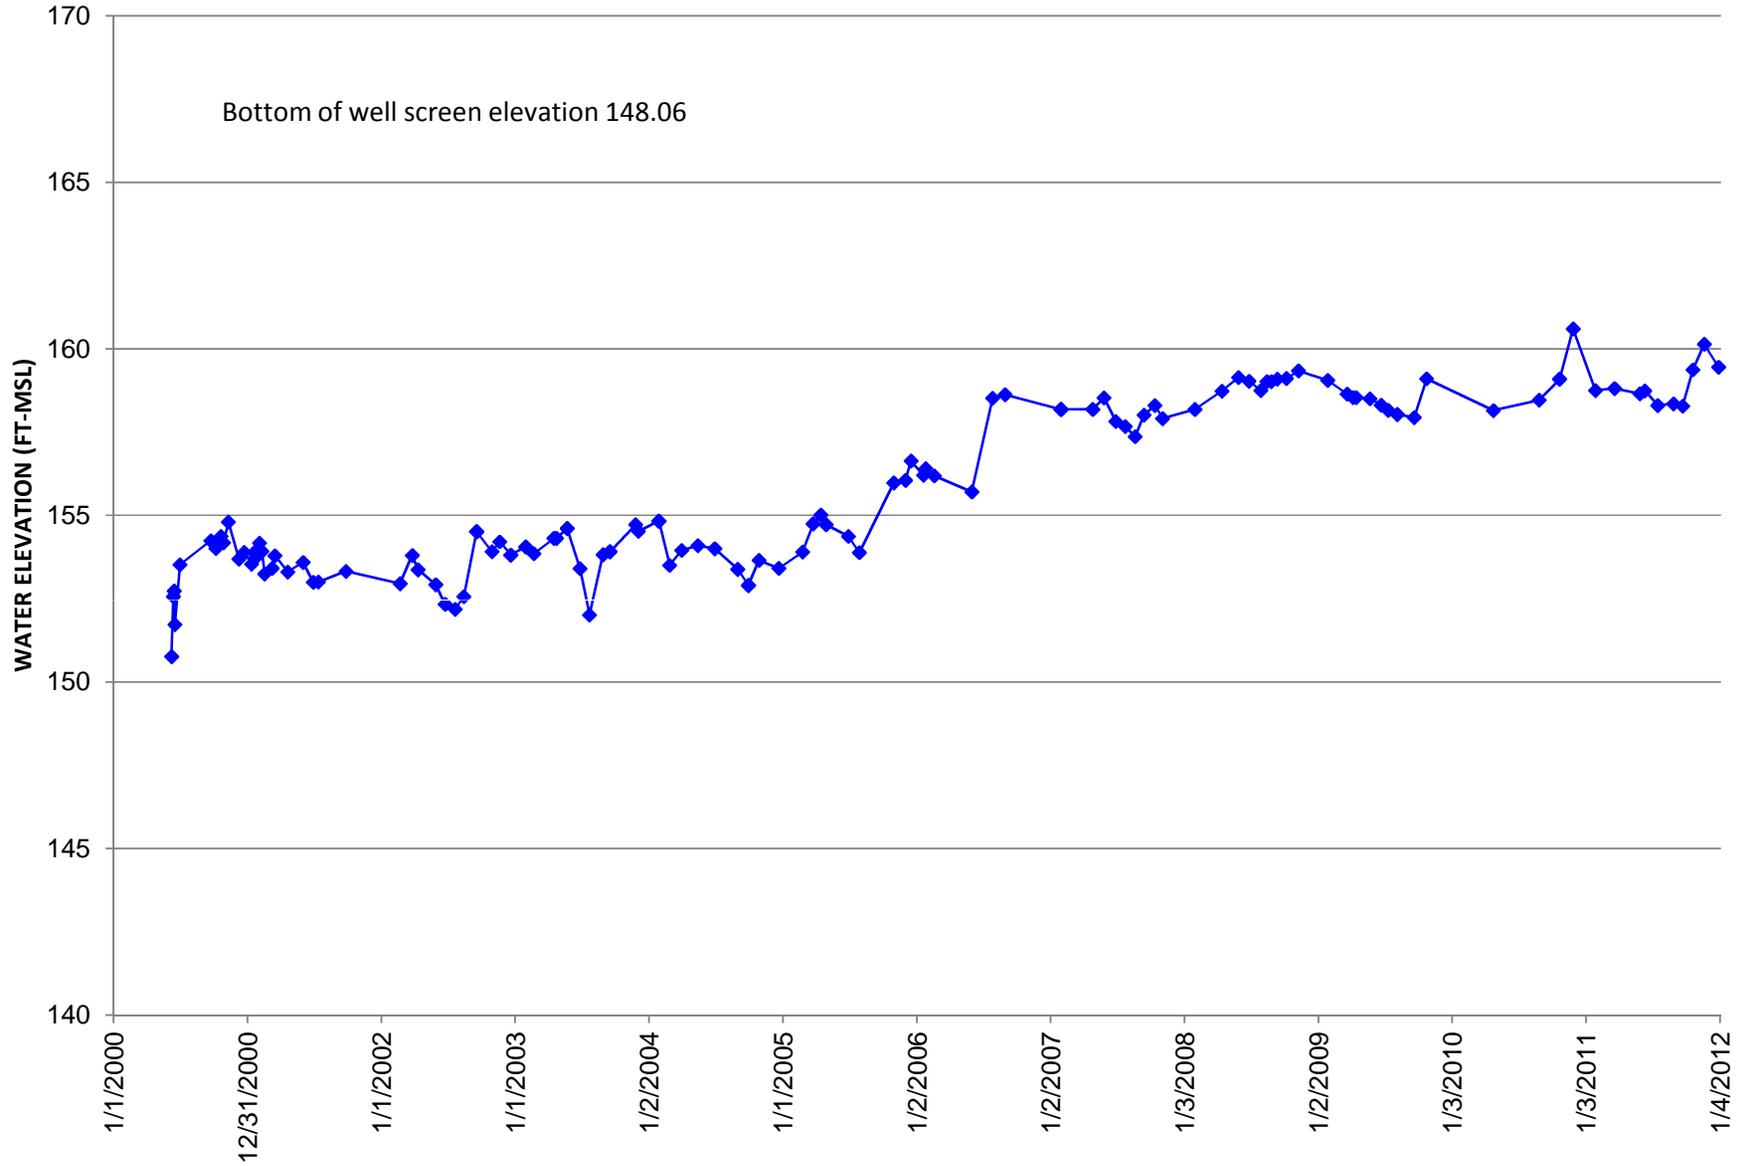
Figure 2.11 Water Level Data for Standpipe Piezometer PZ-T-00-01

1994 values are areas where the pile is considerably thicker than it was in 1994. The increase in water levels observed in PZ-T-00-01 (and to a lesser extent in instruments nearby) from 2005 to 2007 is likely a result of new tailings placement in the area and staged decommissioning of Wet Well 2.

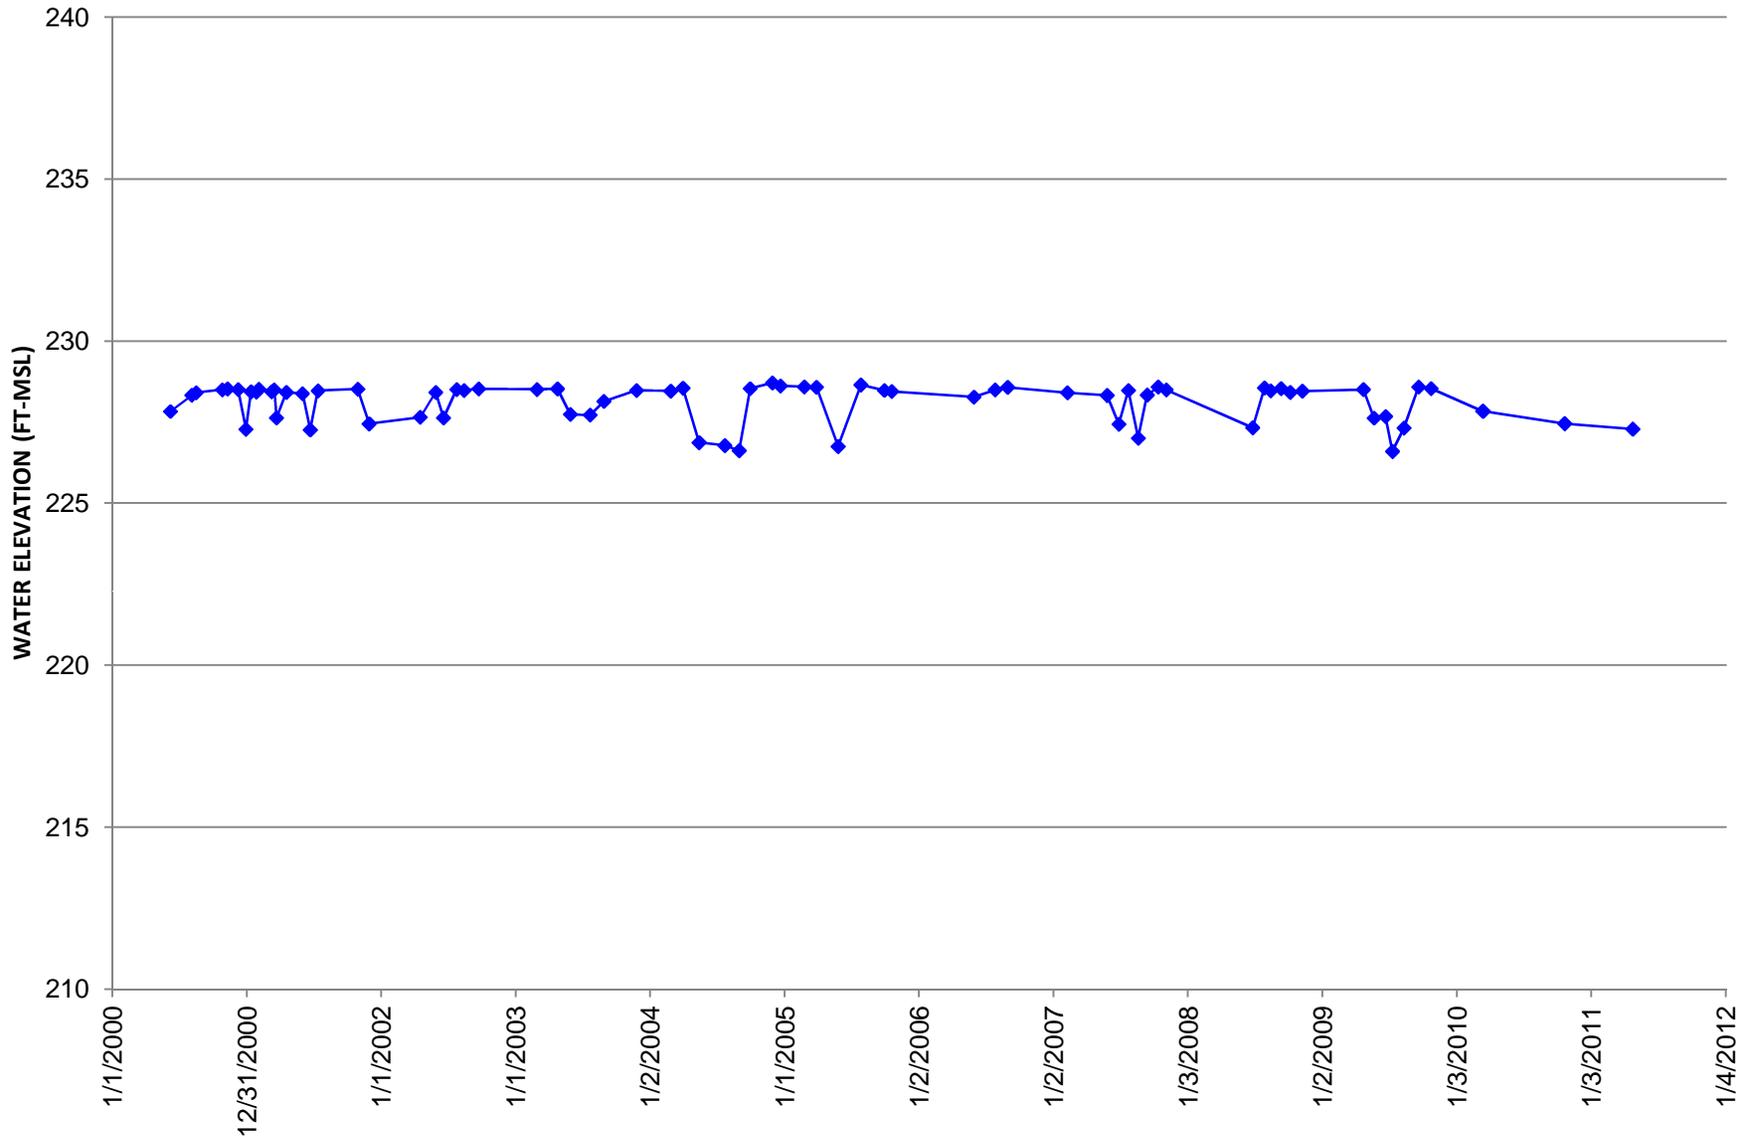
Figure 2.15 Water Level Data for Well MW-T-00-03A

Water levels in four wells completed east and west of the pile are shown for comparison in Figures 2.15 to 2.18. The eastern wells, MW-T-00-03A (Figure 2.15) and MW-T-00-03B (Figure 2.16), are completed in the shallow sands 12 and 17 feet, respectively, below ground surface. The figures for these wells show that the water elevation in shallow completions in native materials can be readily influenced by abnormal weather conditions. Wells MW-T-01-03A and MW-T-01-03B are installed west of the pile. Their water levels are shown in Figures 2.17 and 2.18, respectively. MW-T-01-03A is completed in bedrock to a depth of 20 feet and MW-T-01-03B is completed in clayey silt to a depth of 12 feet. These wells show similar water level fluctuations with weather conditions as the two eastern wells. However, the water level in MW-T-01-03B shows a larger differential than MW-T-01-03A because silts and clays hold more water in tension, so a small increase in water content causes a large change in head. The ground surface elevation is 134 feet in the proximity of these two wells. Both MW-T-01-03A and MW-T-01-03B were damaged by bears in 2006 and attempts to recover them were not successful until 2010. A rapid decrease followed by a gradual increase to levels above recent historical values occurred in MW-T-01-03A in 2011. The cause for the change is not known at this point, however this type of behavior has been documented in the companion well (MW-T-01-03B).

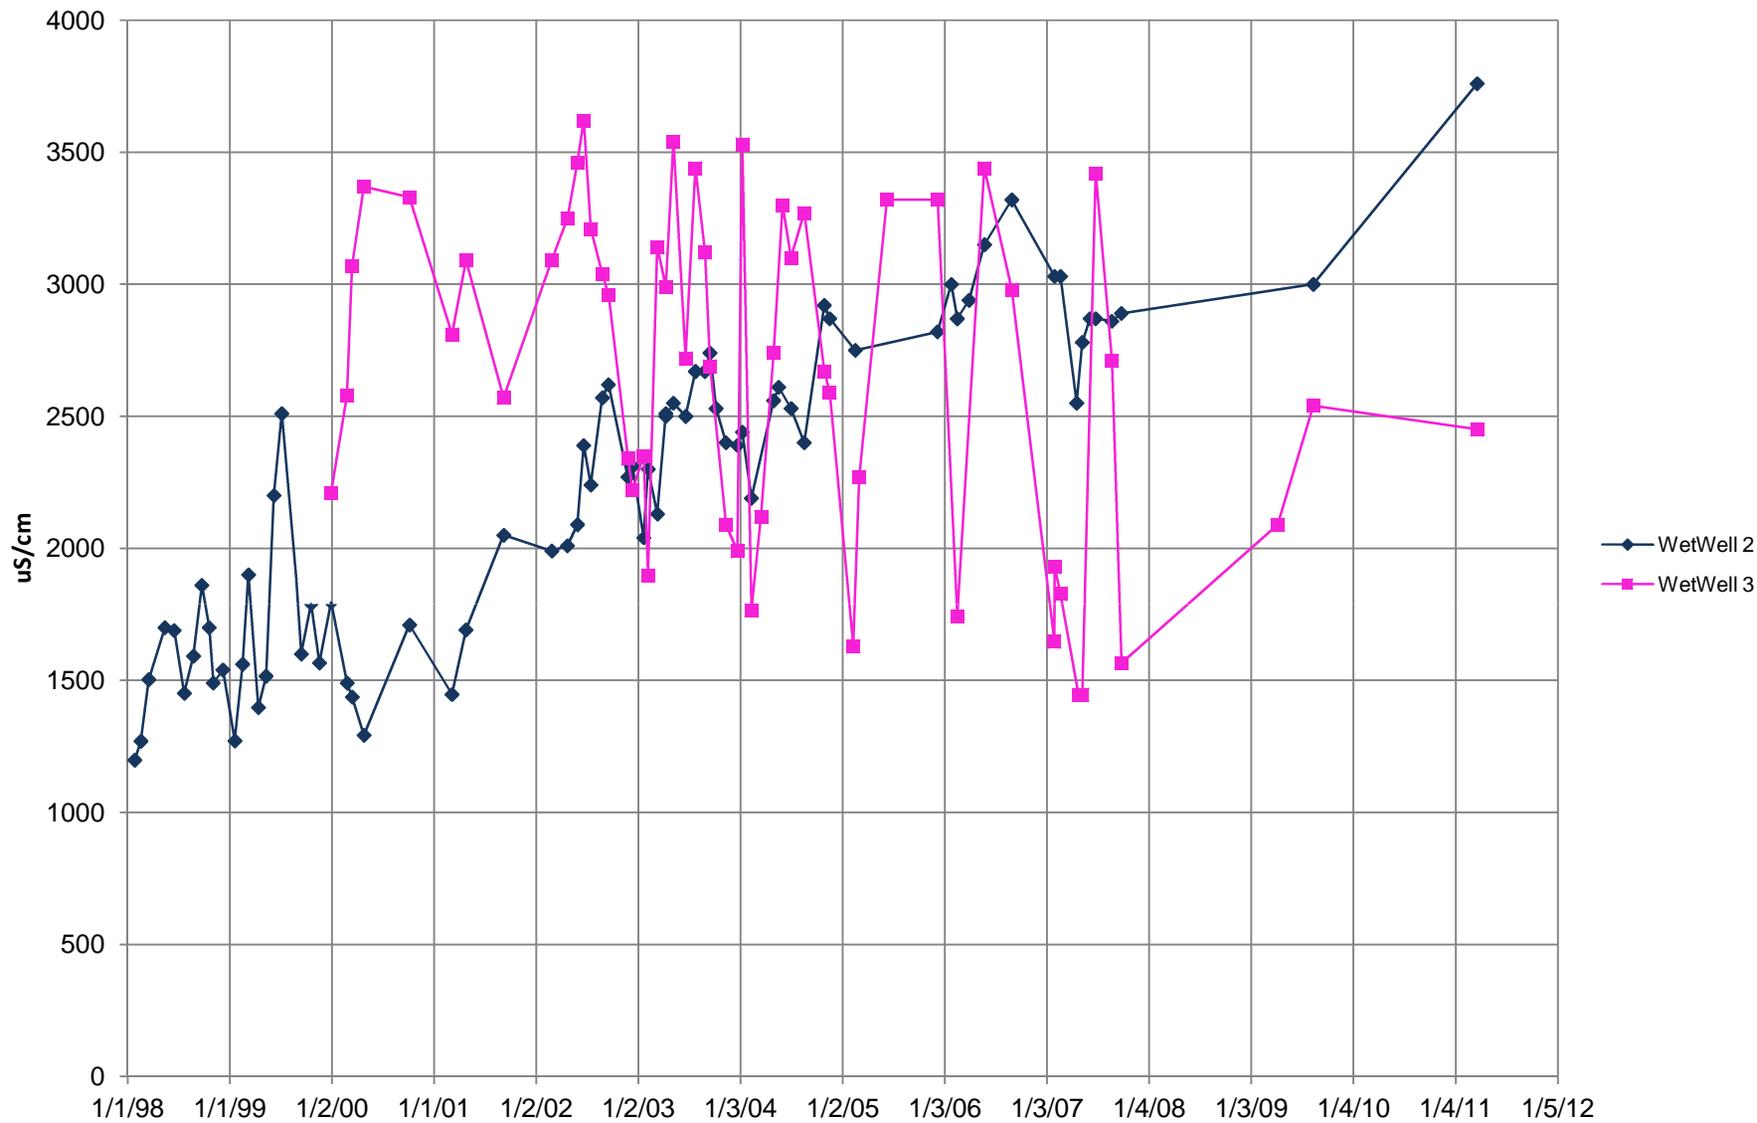
Figure 2.22a GREENS CREEK TAILINGS INTERNAL MONITORING SITES:
WET WELLS - CONDUCTIVITY DATA

The conductivity results from internal monitoring site waters are presented in Figures 2.22a, b, and c. Conductivity measurements in 2011 ranged between 3,760 (wet wells), 3,860 (wells completed in tailings) and 2,990 (suction lysimeters) uS/cm. The higher conductivity of the site contact waters reflects a larger dissolved load caused by weathering of the tailings. Pyrite oxidation and carbonate dissolution contribute dissolved ions such as sulfate, bicarbonate, calcium and magnesium to the contact waters, increasing their conductivity. Wet Well 3 has a different capture area than Wet Well 2 and shows a different pattern with respect to conductivity. The changes in conductivity observed in Wet Well 3 suggest changes in the relative contributions from runoff, addition of the Northwest Diversion Ditch flow, infiltration and groundwater as the West Buttress was constructed. The increase in conductivity seen in Wet Well 2 over the past several years likely reflects an increasing contribution from contact water in the drain system and an increase in the dissolved load from migration/remobilization of oxidation products in the pile. In 2008 Wet Well 2 was routed to Wet Well A, a new wet well located in the newly modified Pond 6 area. Suction lysimeter samples are drawn from the smallest pore spaces of the unsaturated zone. Water held in these pores is often isolated from flow paths and thus usually has higher dissolved constituent concentrations than water from the saturated zone and foundation drains.

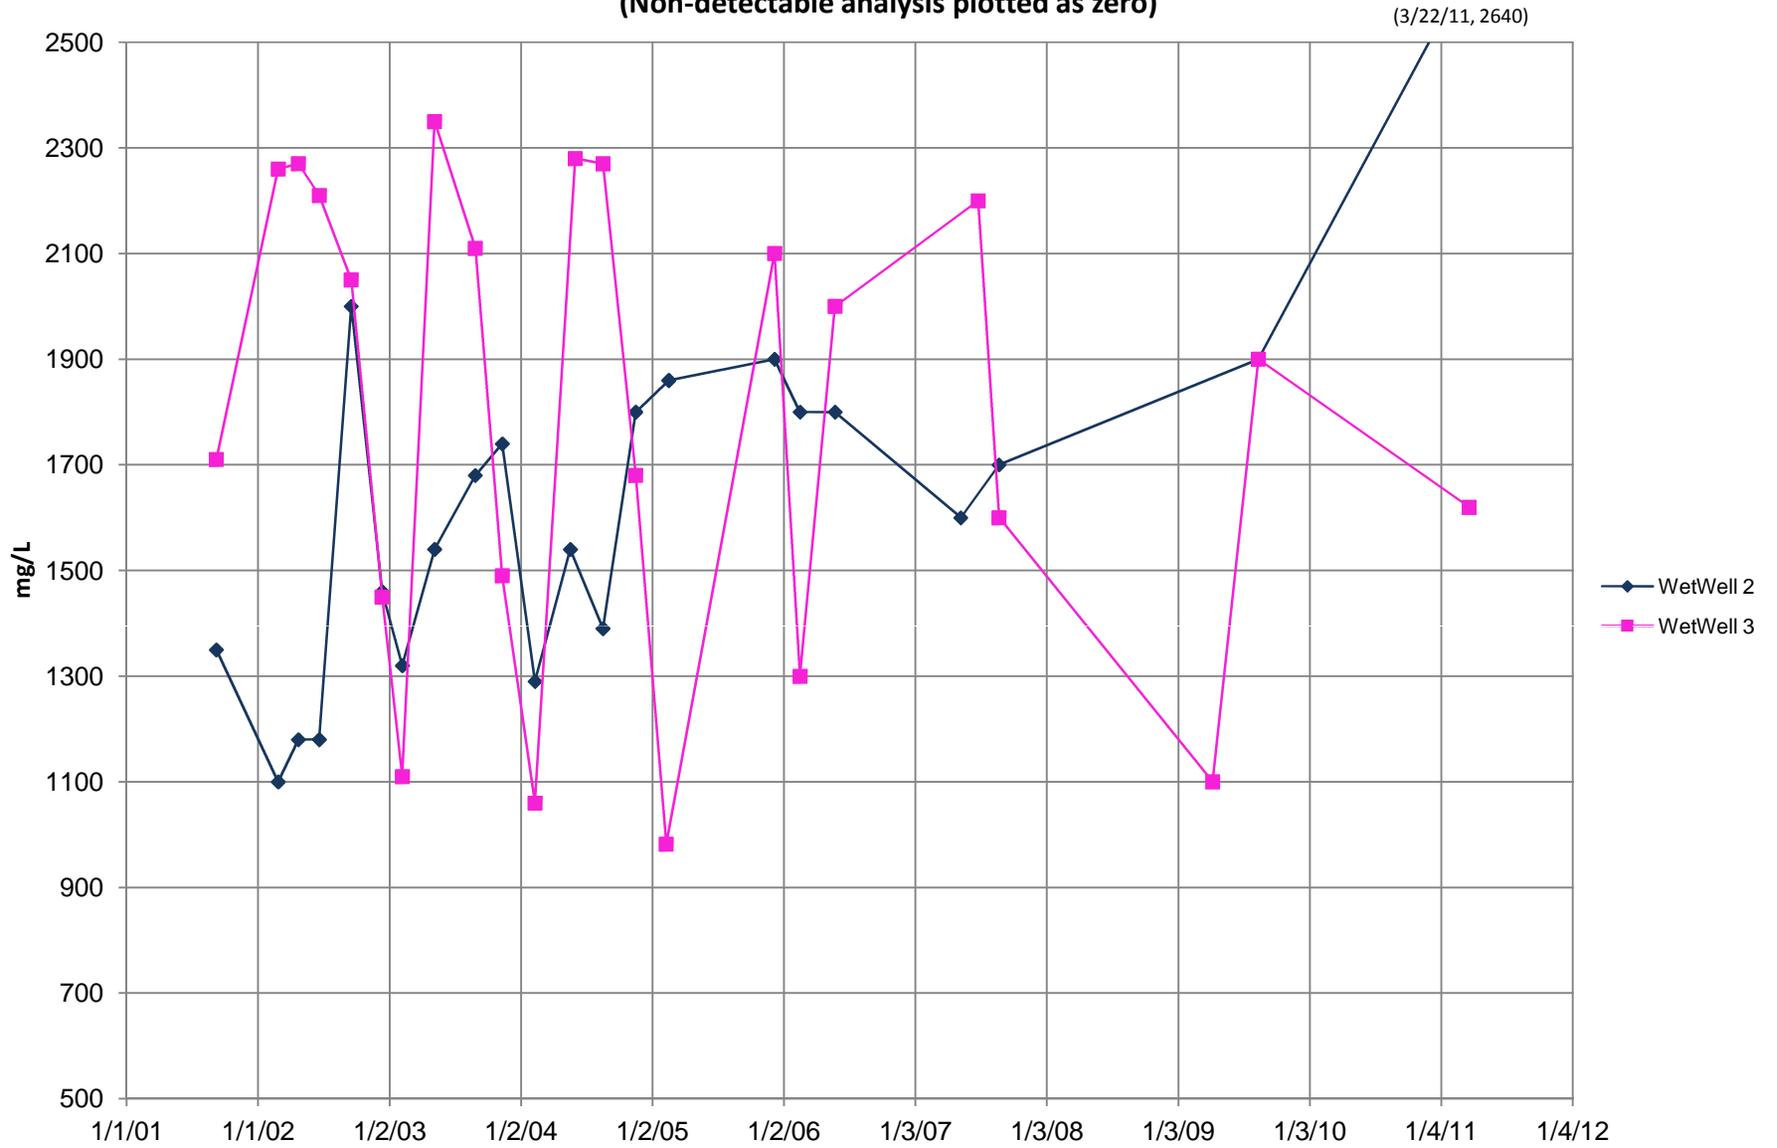
**Figure 2.23a GREENS CREEK TAILINGS INTERNAL MONITORING SITES:
WET WELLS - HARDNESS DATA
(Non-detectable analysis plotted as zero)**

Hardness and sulfate concentrations remain consistent with the conductivity results. Calcium and magnesium are the primary contributors to hardness (Figures 2.23a and b) and reflect dissolution of carbonate minerals, such as calcite and dolomite. Carbonate dissolution neutralizes acidity formed by sulfide oxidation, which is also the source of sulfate shown in Figures 2.24a, b, and c. Sulfate concentrations typically range between 150 and 5,000 mg/L in the tailings pile waters. The increase in sulfate and other constituents seen in PZ-T-00-03 likely reflects the replacement of interstitial process water with infiltrating surface water, which carries a higher dissolved load.

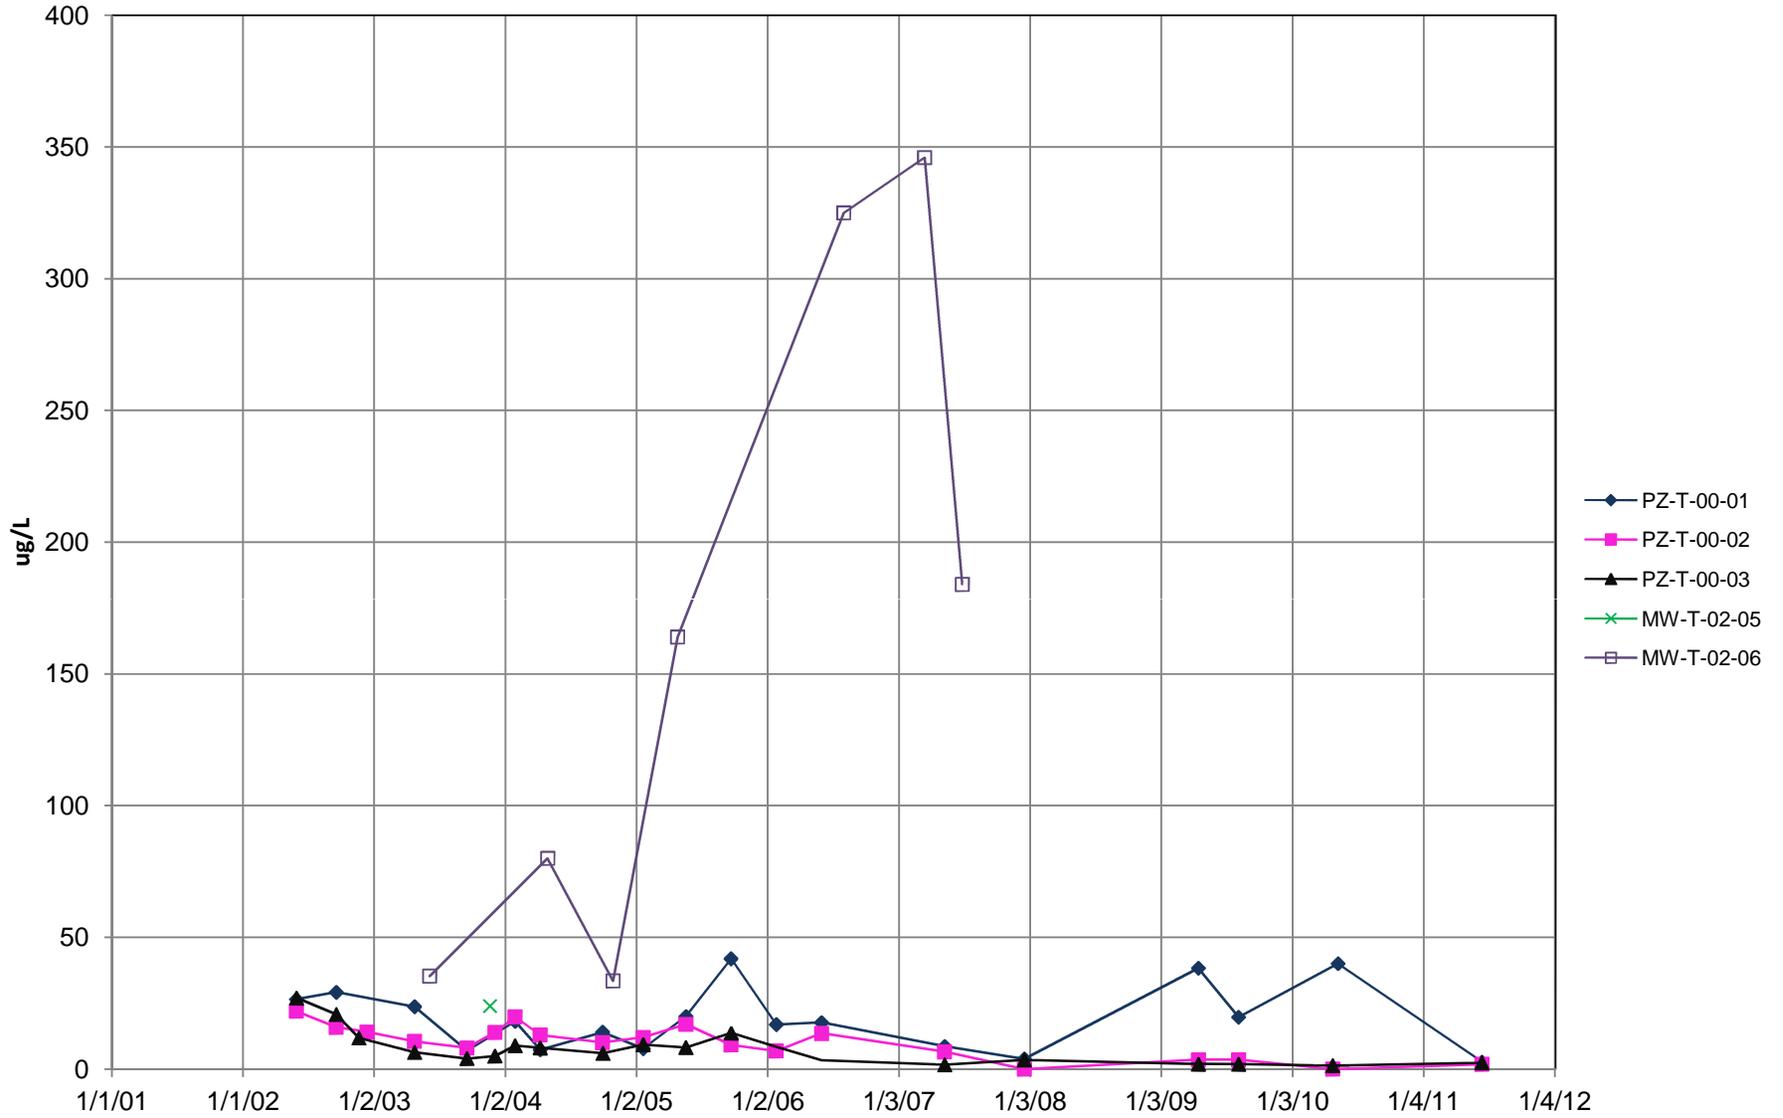
**Figure 2.25b GREENS CREEK TAILINGS INTERNAL MONITORING SITES:
TAILINGS COMPLETIONS - ARSENIC DATA
(Non-detectable analyses plotted as zero)**

Arsenic data are presented in Figures 2.25a, b and c. The variability in arsenic concentrations observed in Wet Well 2, MW-T-02-06, and some suction lysimeters is related to evolving redox conditions in the pile. As arsenic-bearing minerals such as tetrahedrite/tennantite (and to a lesser extent pyrite) weather, the arsenic that is released is typically co-precipitated with iron oxyhydroxides. As the pile grows, reducing conditions overtake areas that were once oxidizing. This was particularly true as the water table rose following removal of the temporary PVC cover that was placed on the pile in 1995 (removal began in 1997). Dissolution of oxyhydroxides (and possibly sulfates) is expected as the waters respond to the changing redox conditions. This will contribute arsenic and iron (Figures 2.30a, b and c) to the drainage water. Arsenic concentrations in the pile drainage will therefore decrease when redox conditions in the pile stabilize (e.g. with closure and capping of the pile). Sulfate reduction may also lower arsenic concentrations. This is apparent in the composition of waters from the saturated zone and in some of the SRMP test cells, which are discussed in more detail below.

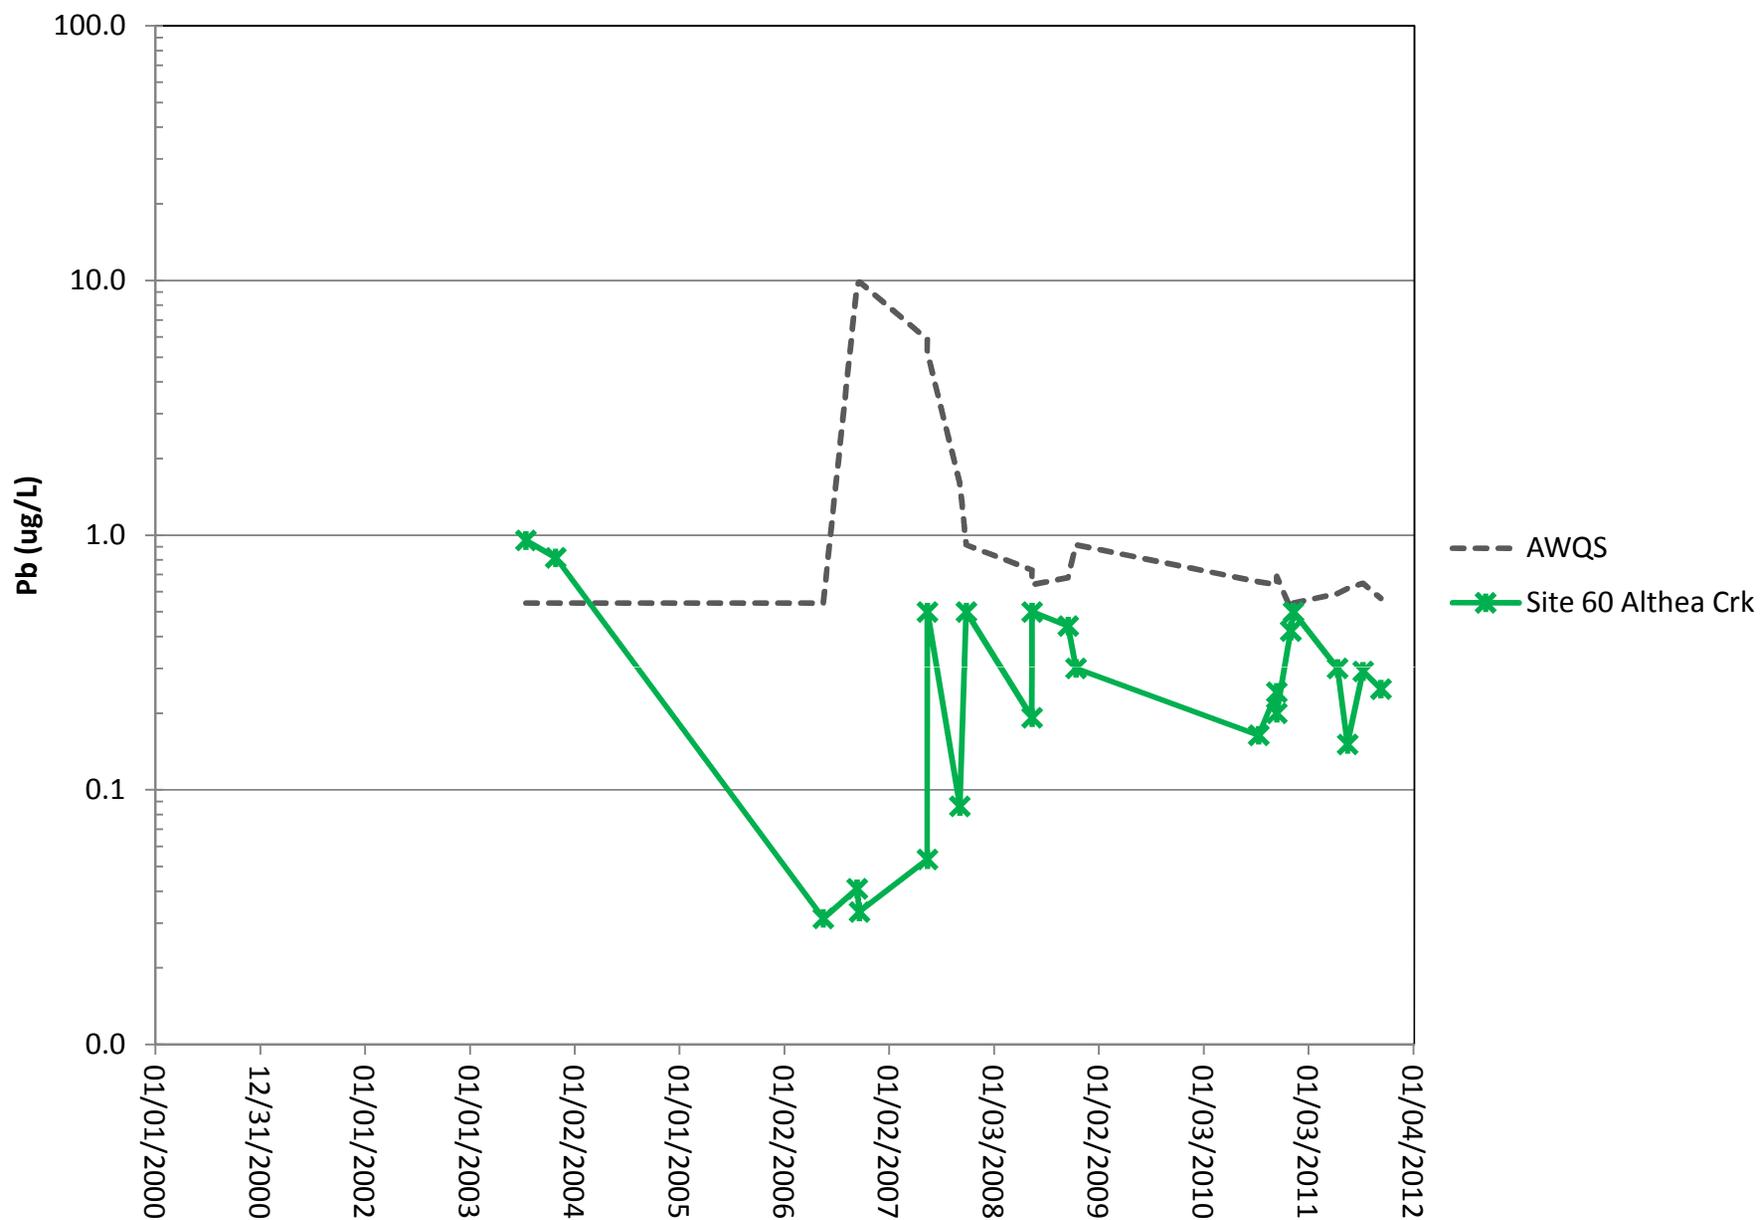
Figure 2.43 Site 60 Lead Concentration

- Zinc and lead concentrations at Site 60 area shown in Figures 2.42 and 2.43. Zinc concentrations are very low (< 11 ug/L). As the hardness at Site 60 decreases toward background conditions, the AWQS for lead, which is hardness dependent, may approach the lead concentration at Site 60.

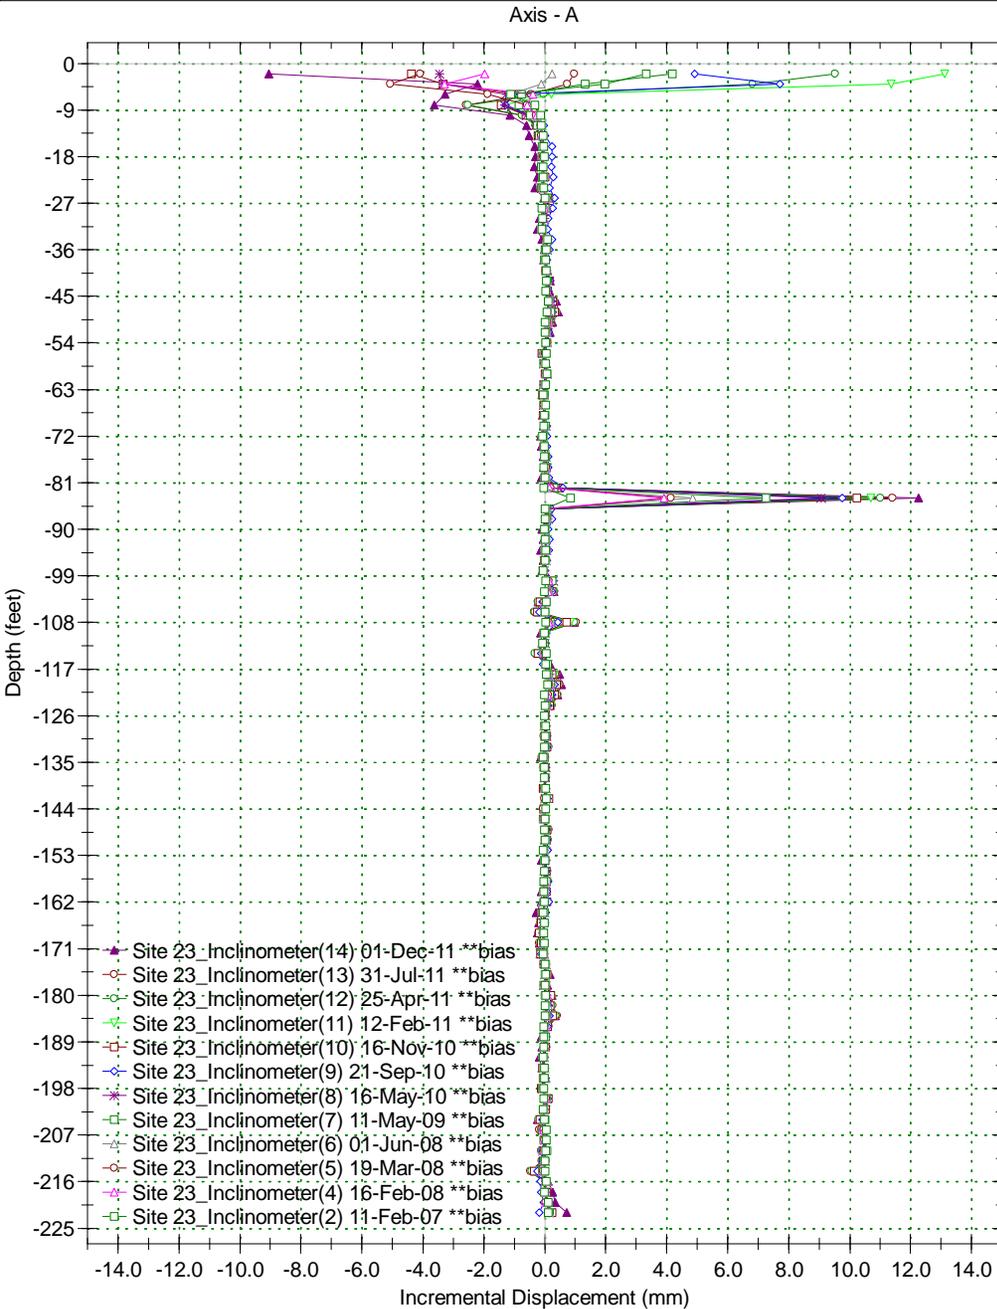
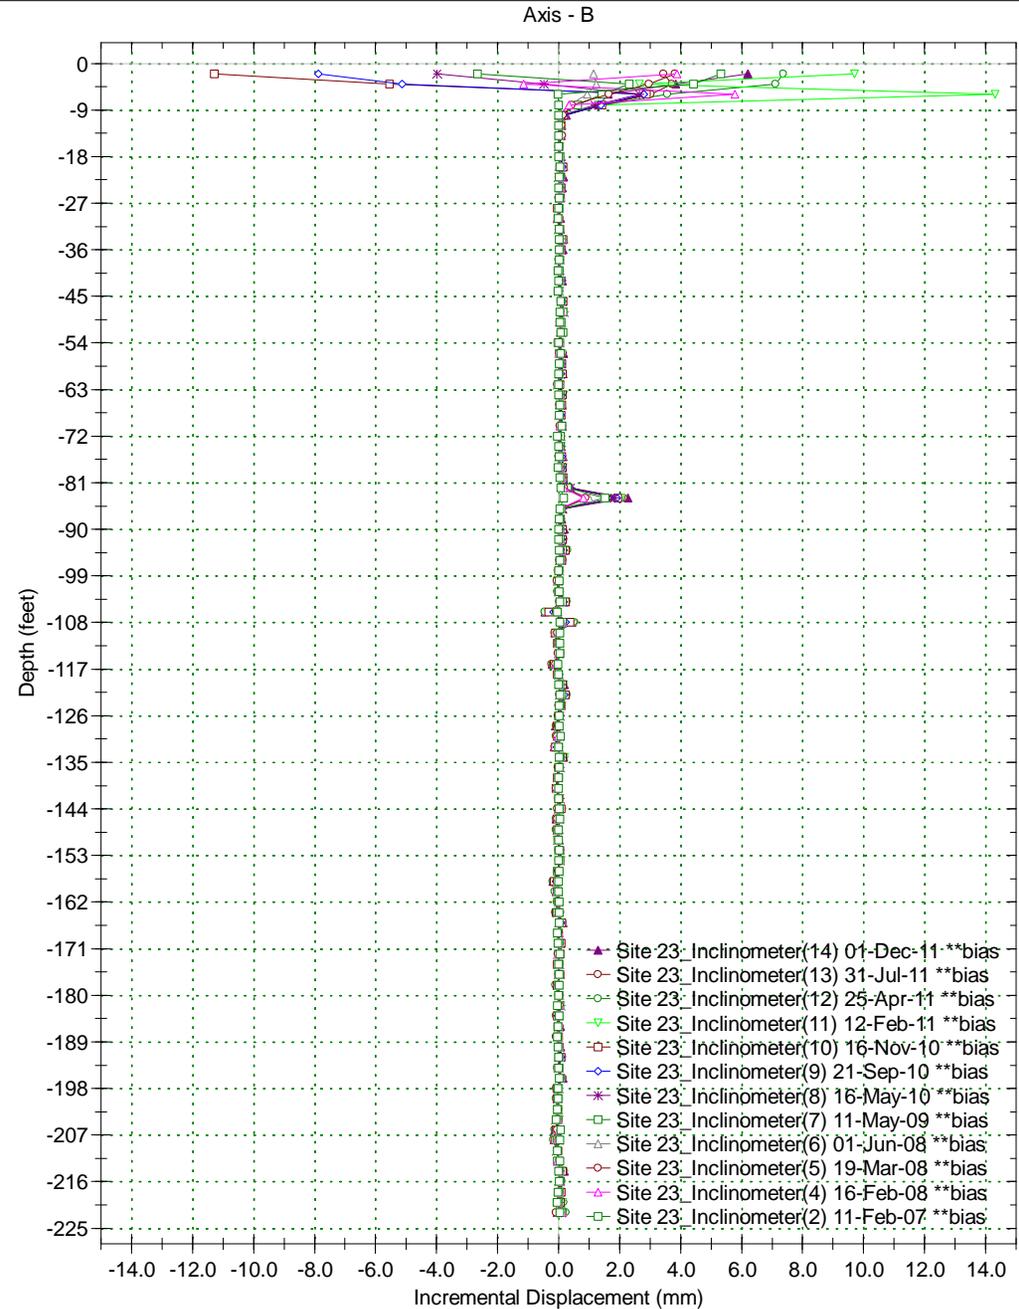
Notes:
 Zero reference is top of casing, at ~4.7 ft above ground surface.
 Top section of casing/damage joint replaced in July 2011.
 Bias-shift correction by pinning data sets at 150-ft depth (A_B axis).

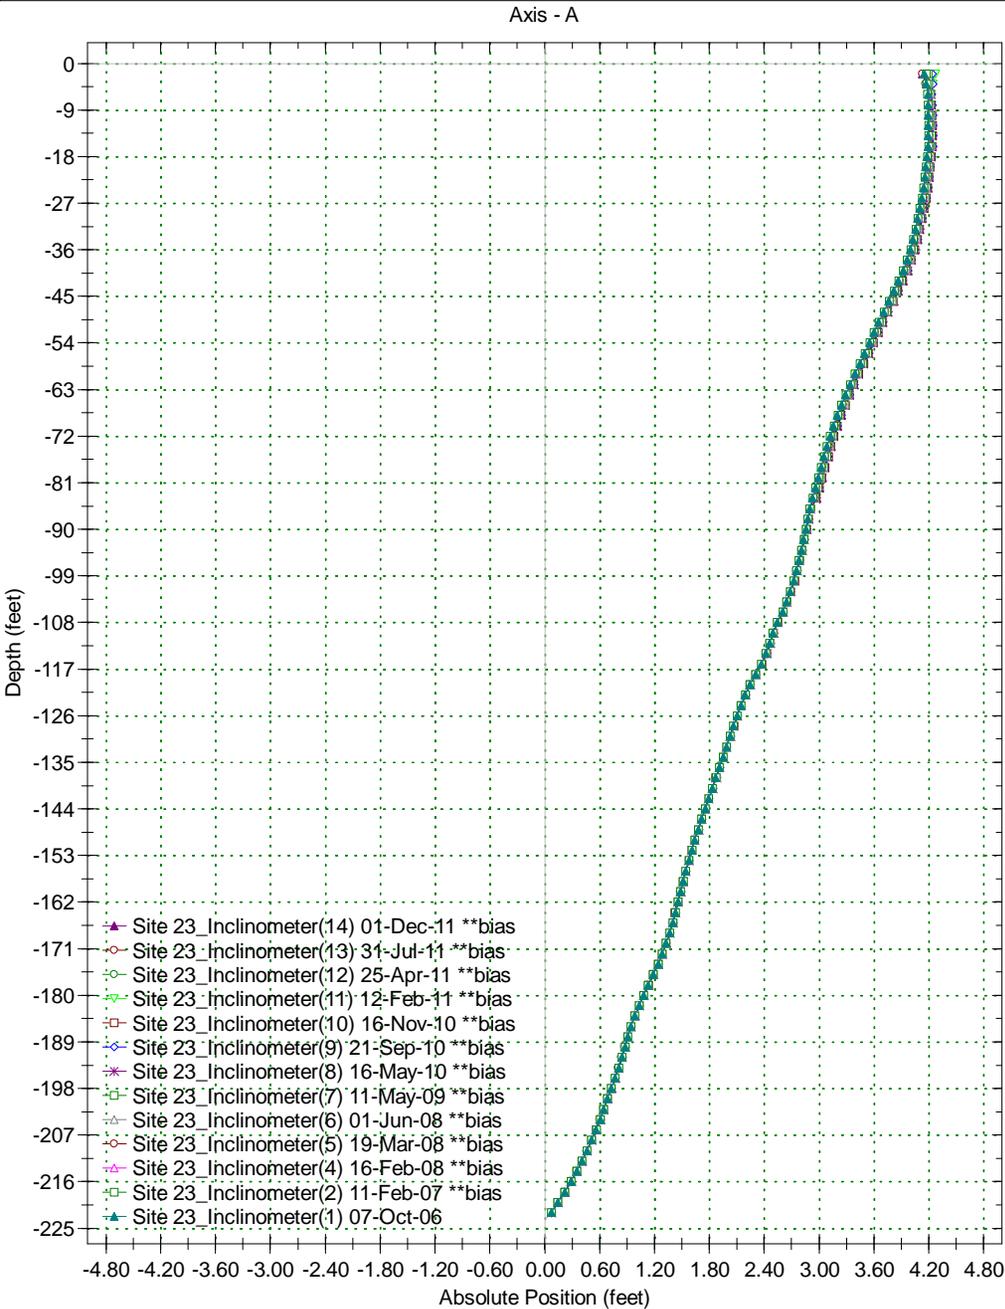
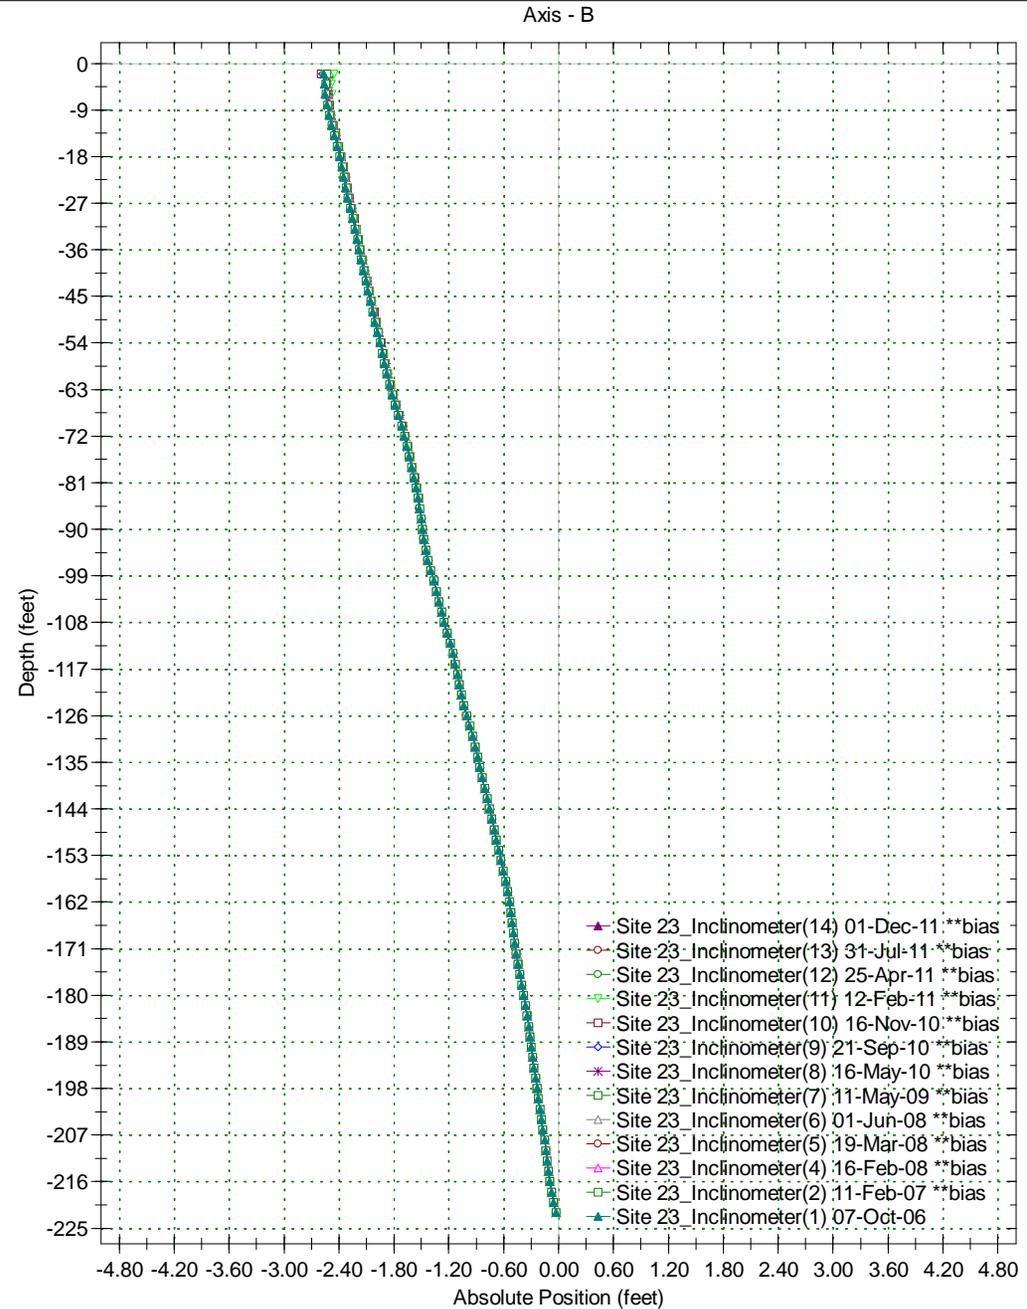
Figure 3.31 Site 23 Inclinator Absolute Displacement

Notes:
 Zero reference is top of casing, at ~4.7 ft above ground surface.
 Top section of casing/damage joint replaced in July 2011.
 Bias-shift correction by pinning data sets at 150-ft depth (A_B axis).
