**INACTIVE PRODUCTION ROCK SITES AND QUARRIES
2012 ANNUAL REPORT**

Hecla Greens Creek Mining Company

April 15, 2013

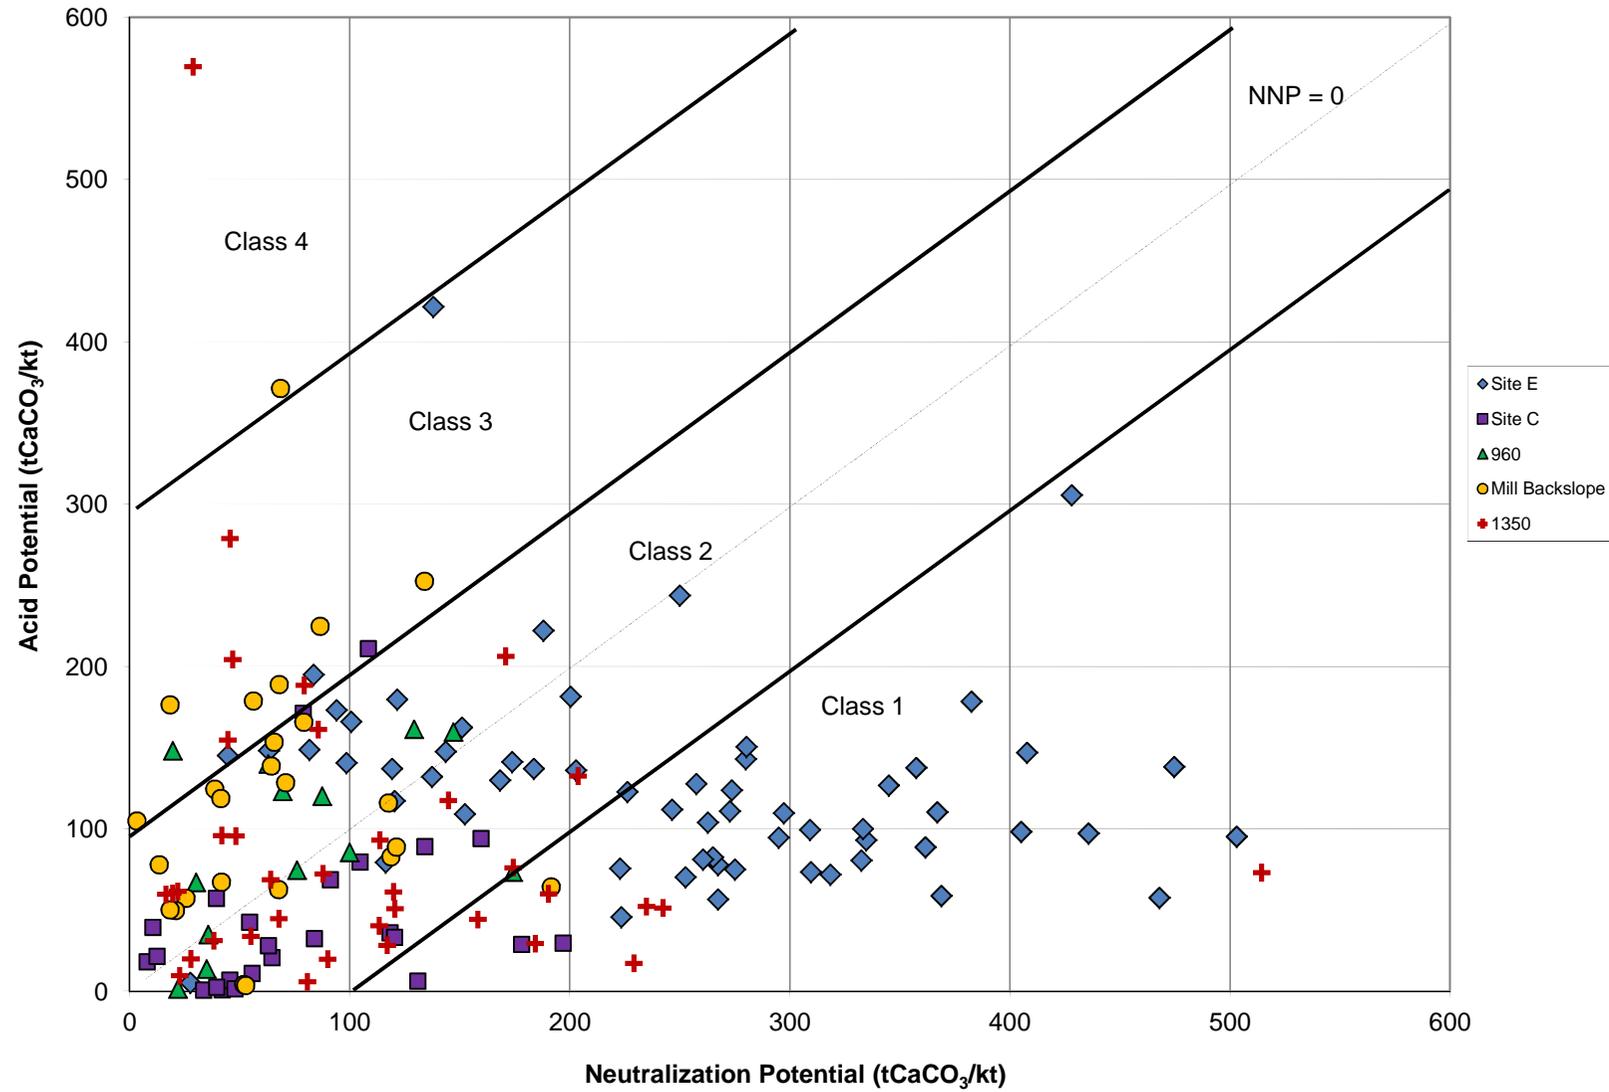
FIGURE 2.3 2002-2008 INACTIVE SITE ABA DATA

Figure 2.3 compares acid potential (AP) with neutralization potential (NP) for surface grid samples for the inactive sites. The inactive sites were constructed prior to development of the classification protocol that HGCMC currently uses. At the time the inactive piles were constructed HGCMC did not classify or segregate its production rock. Symbols in Figure 2.3 represent actual laboratory data points. Lines indicating the currently utilized production rock

classes are shown on Figure 2.3 for reference only. Figure 2.3 shows the distribution of potentially acid generating (upper left half of figure) and potentially acid neutralizing (lower right half of figure) samples. Many samples from Site E have more neutralization potential than those from other sites, reflecting a greater proportion of argillite. Samples from the mill backslope and the 1350 site generally have a higher acid generation potential than those from the other sites. Reclamation activities at the 960, 1350 and Site E have removed significant quantities of potentially acid generating material from these sites.

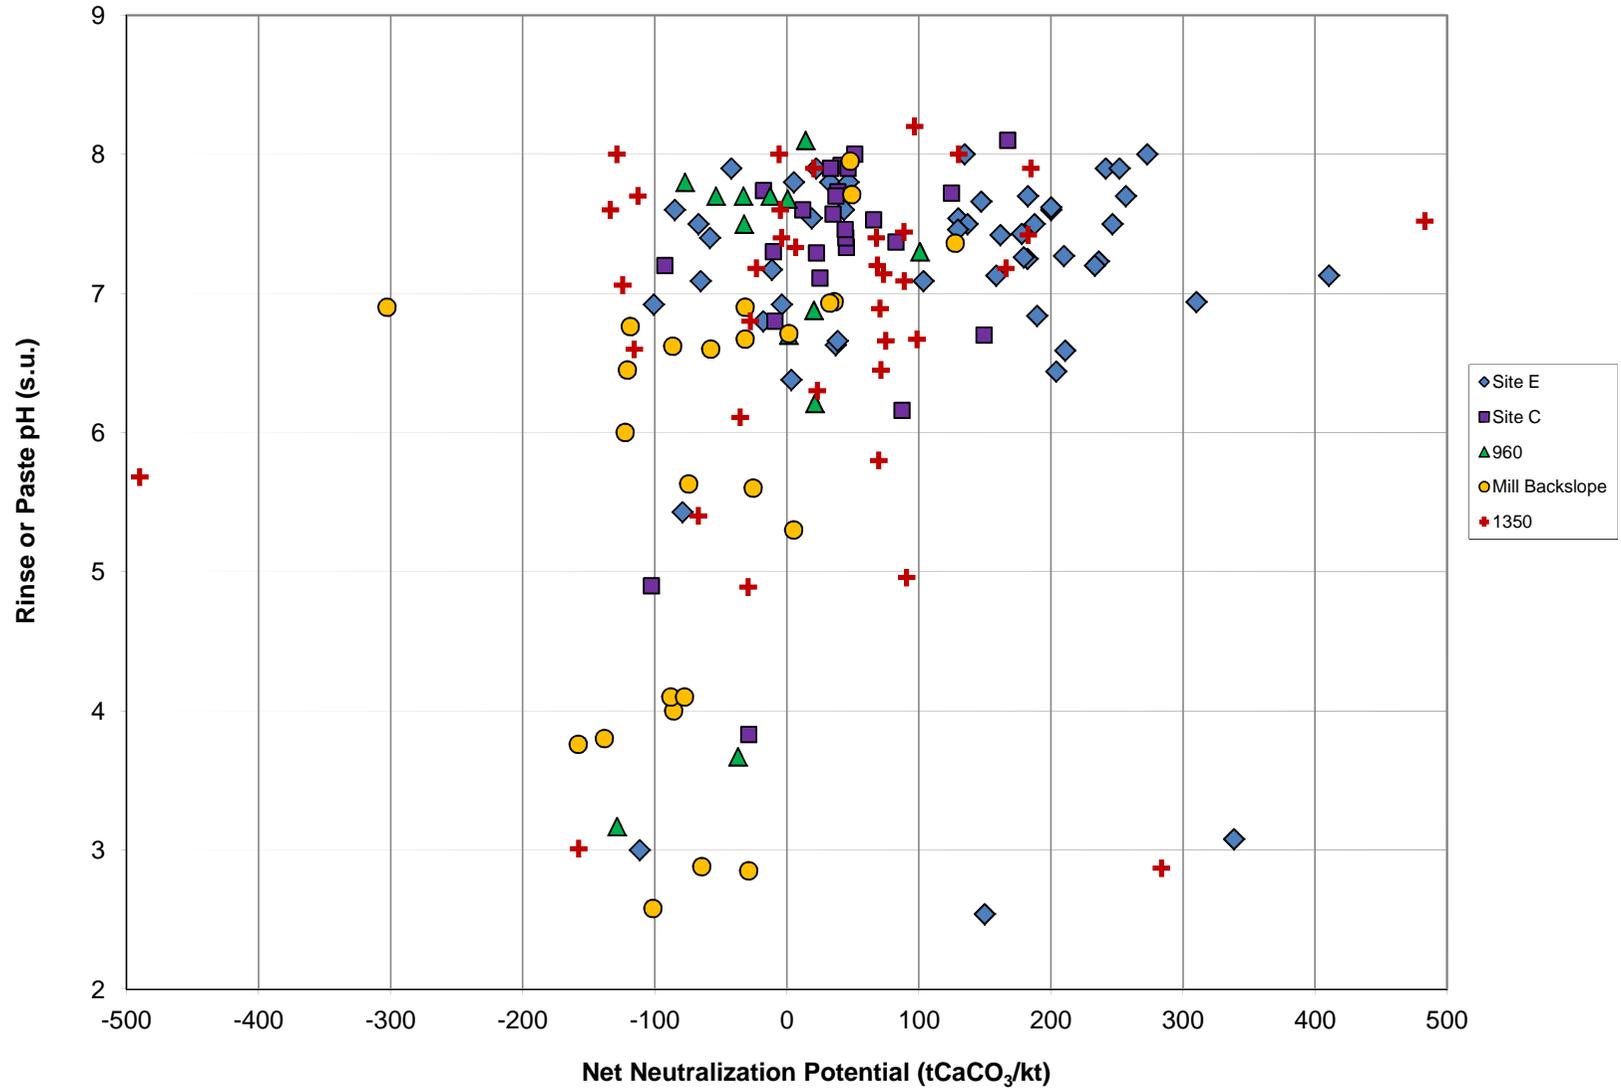
FIGURE 2.4 2002-2008 INACTIVE SITE ABA DATA (NNP vs pH)

Figure 2.4 shows the results of rinse pH relative to net neutralization potential (NNP) for the five inactive sites. Most samples produced a rinse pH greater than 6.0; however, each site has produced at least two samples with rinse pH values less than 5.0. This is consistent with the distribution of NNP values and the duration of waste rock exposure. Grid sampling occurs at the surface of the piles where oxidation rates are greatest. Drainage from the inactive sites remains near neutral because the bulk of the material in the piles contains sufficient carbonate to neutralize the acidity formed by pyrite oxidation near the pile surface. There are a few cases where samples produced a low rinse pH and high NNP. This is likely a result of accumulated acidic oxidation products in the fines fraction of the sample and remaining carbonate minerals in the coarse fraction.

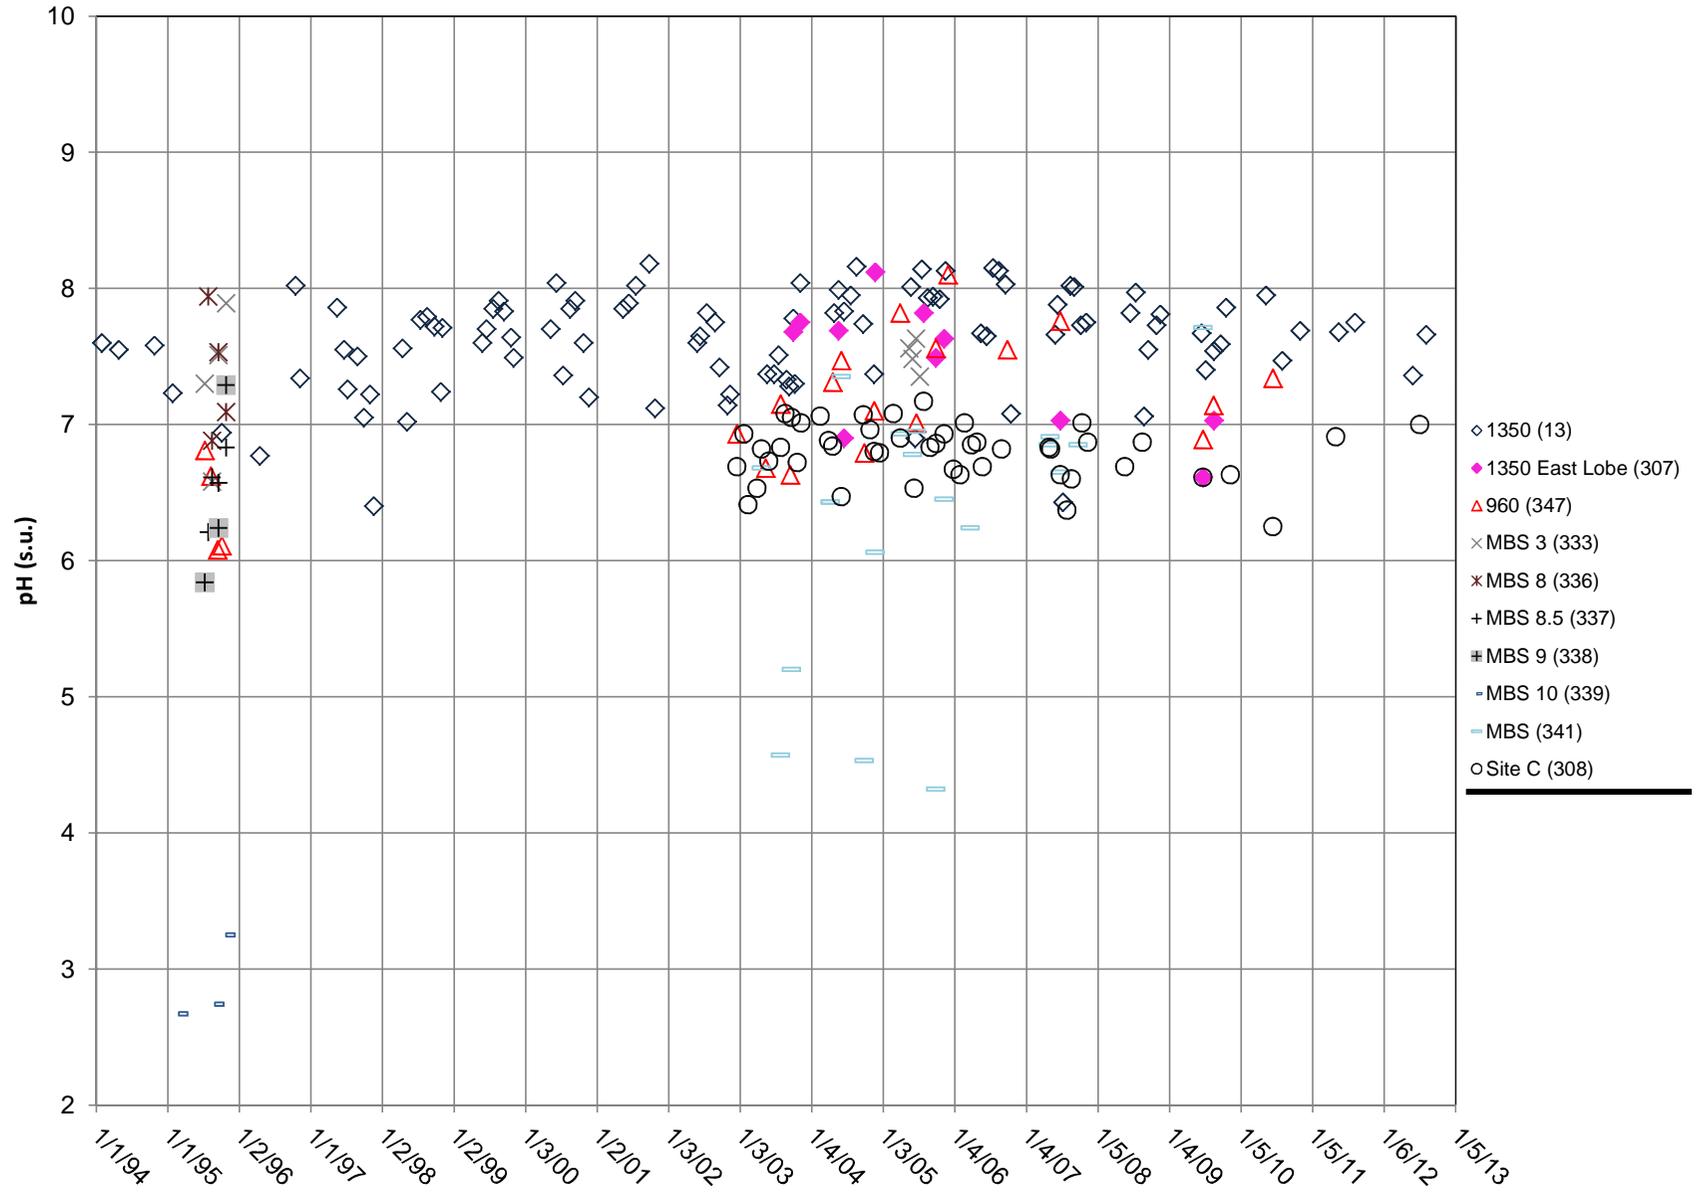
Figure 2.6 Inactive Production Rock Site pH Data

Figures 2.6 and 2.21 show pH data from inactive site sampling locations. Lower pH values can represent influences from pyrite oxidation and/or organic acids from muskeg and forest soils. The data show that the vast majority of the site drainage remains above pH 6.0. The sample from the Mill Backslope in 1995 was runoff collected from a bench containing zones of heavily pyritized rock. For a brief period in 1998 and 1999, acidic conditions began developing at the 960 (site 347). HGCMC applied lime and removed 1000 cubic yards of oxidized pyritic rock from the site in 2000. The pH of the drainage quickly rebounded and has remained near-neutral since 2000. Removal of additional Site 960 material in 2003, 2004 and 2005 is discussed below in Section 2.3. The material removal activities may also be responsible for the pH of 8.0 measured at the 960 site in 2005. This is the highest recorded for this site. The reason for the elevated pH is likely due to the removal of pyritic rock that had consumed much of its readily available buffering capacity. Fresh carbonate mineral surfaces exposed during the excavation and the placement of the toe buttress may have contributed to the higher pH values observed. Alkalinity data presented in Figures 2.7 and 2.22 are consistent with the pH results in Figures 2.6 and 2.21. Sample locations continued to maintain measurable alkalinity provided by dissolution of carbonate minerals.

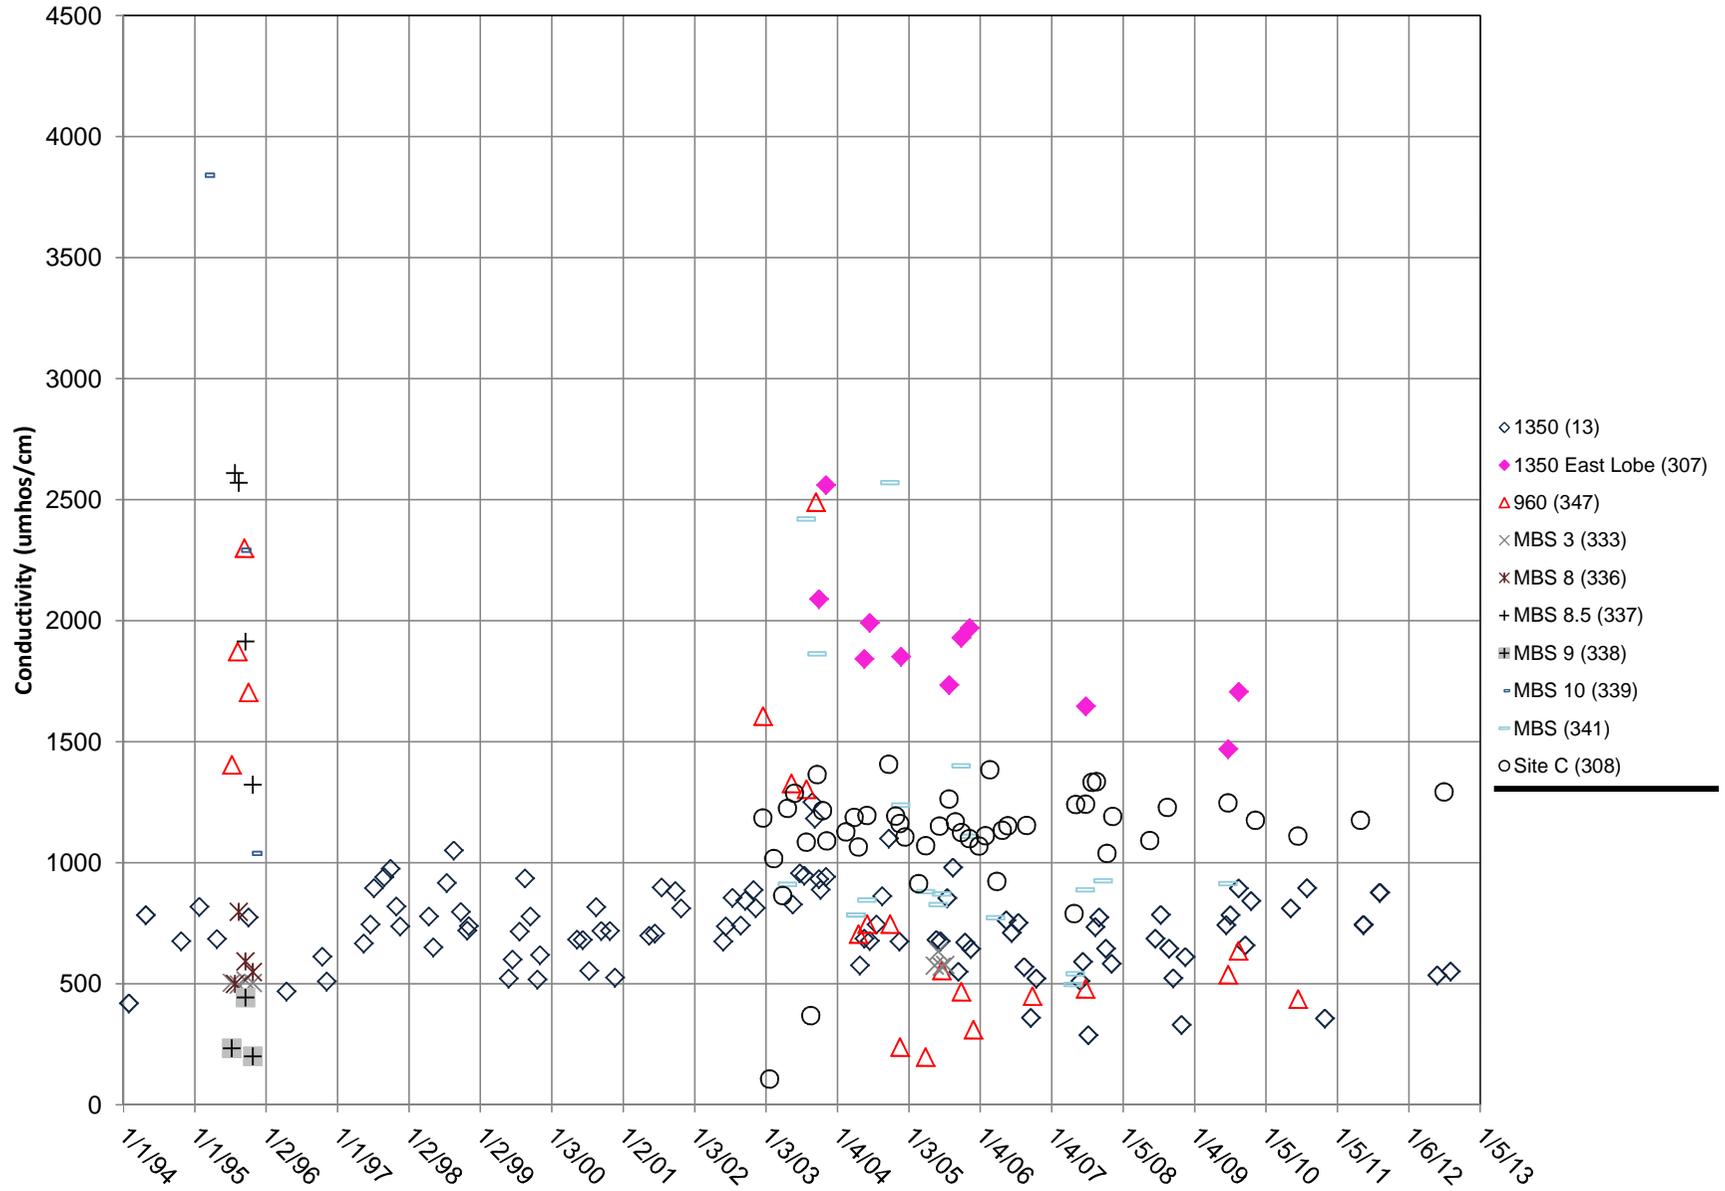
Figure 2.8 Inactive Production Rock Site Conductivity Data

Conductivity data are shown in Figures 2.8 and 2.23. Conductivity indicates the amount of dissolved constituents in the water. HGCMC samples having higher conductivity values usually have higher sulfate, calcium and magnesium (hardness) concentrations, reflecting influences from sulfide oxidation and carbonate mineral dissolution. Water that has contacted production rock is expected to have higher conductivity values than background waters. The 960 (Site 347) shows an overall decreasing trend in conductivity, while the Site 1350 data remains unchanged. The combined drainage from the Mill Backslope area (Site 341) continued to have a lower dissolved load relative to 2003 and 2004 values. The decreasing trends apparent in Figures 2.8 and 2.23 are

the result of decreasing reactive surface area available for oxidation and dissolution. The reactive surface area decreases as reactants are consumed and mineral surfaces become coated with oxidation products. The results for sulfate, magnesium and hardness, shown in Figures 2.9 and 2.24, 2.10 and 2.25, and 2.11 and 2.26, respectively, correlate with conductivity results and are consistent with the concept of generally decreasing or static reactive surface area.

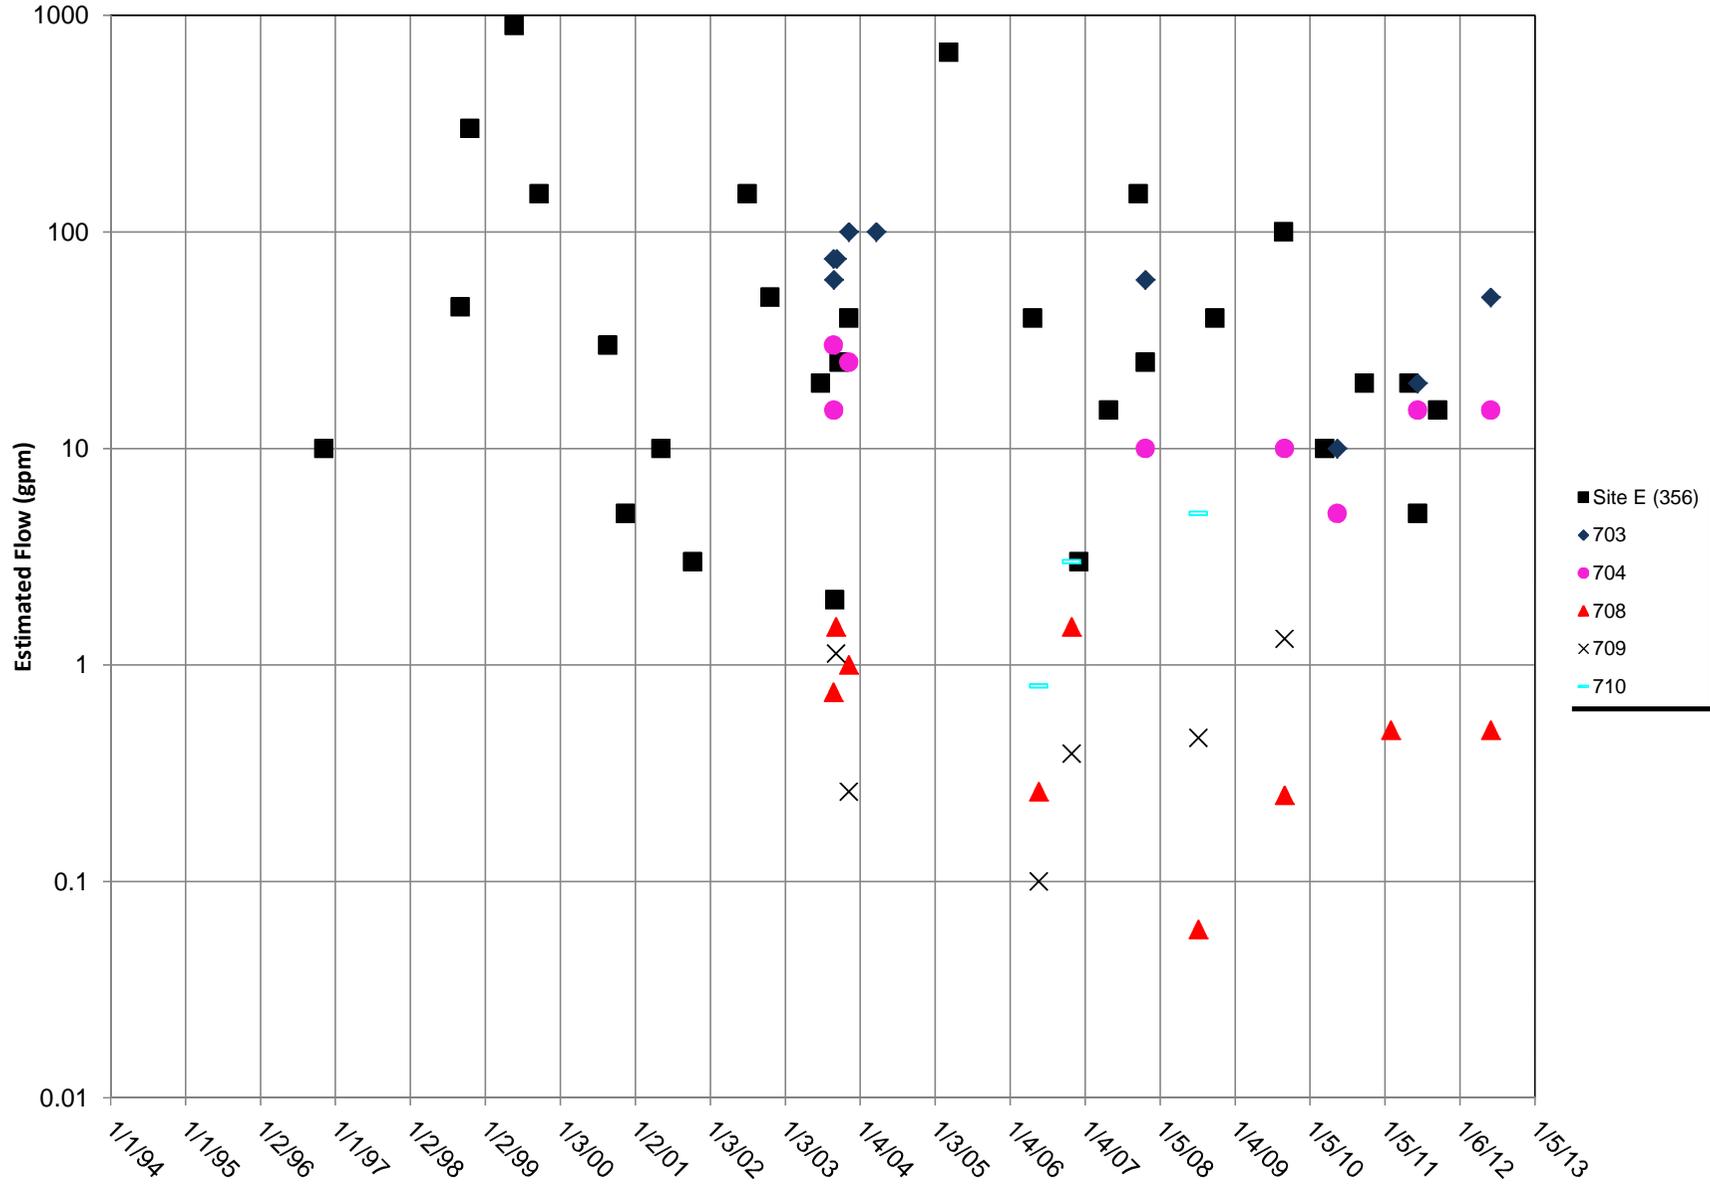
Figure 2.20 Inactive Production Rock Site E Flow Data

Flow data presented in Figures 2.5 and 2.20 demonstrate that flows at most of the sample locations are generally low (less than 10 gpm) with the exception of Site E. Some of the flow data were collected as part of the APDES stormwater monitoring program. Collected during or following storm events, flow data from these locations (e.g. Site E 356, 960 347) represent short-term maximum flow values in response to relatively large precipitation events. Lack of significant flow from inactive sites is a positive characteristic because it reflects minimization of potential off-site impacts.

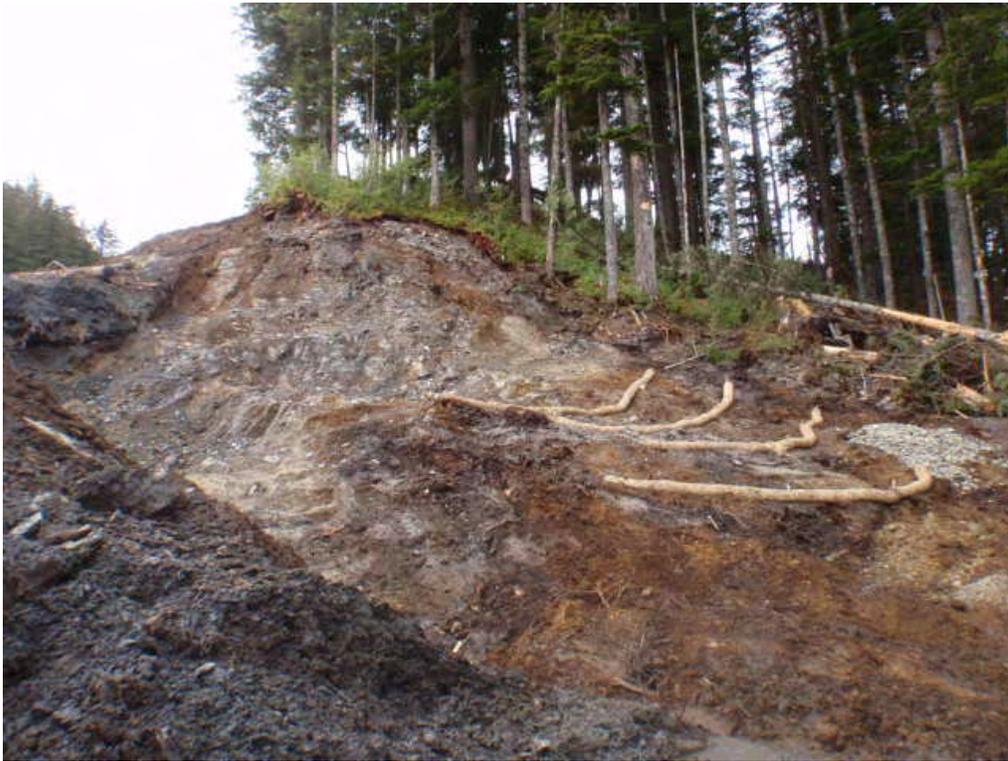
Figure 2.35a 1350 Area - June 2011 During Removal Activities

An area of hydrocarbon contaminated soil was encountered during 2010 and 2011 removal activities. This contamination was believed to be associated with the 1978 camp fuel tank spill. An estimated 20 to 30 cy of soil was excavated (to bedrock) and disposed of offsite during 2010 with an additional 315 cy excavated in 2011. Excavated areas were hydroseeded to stabilize the soil surface and minimize erosion (see Figure 2.35a and b).

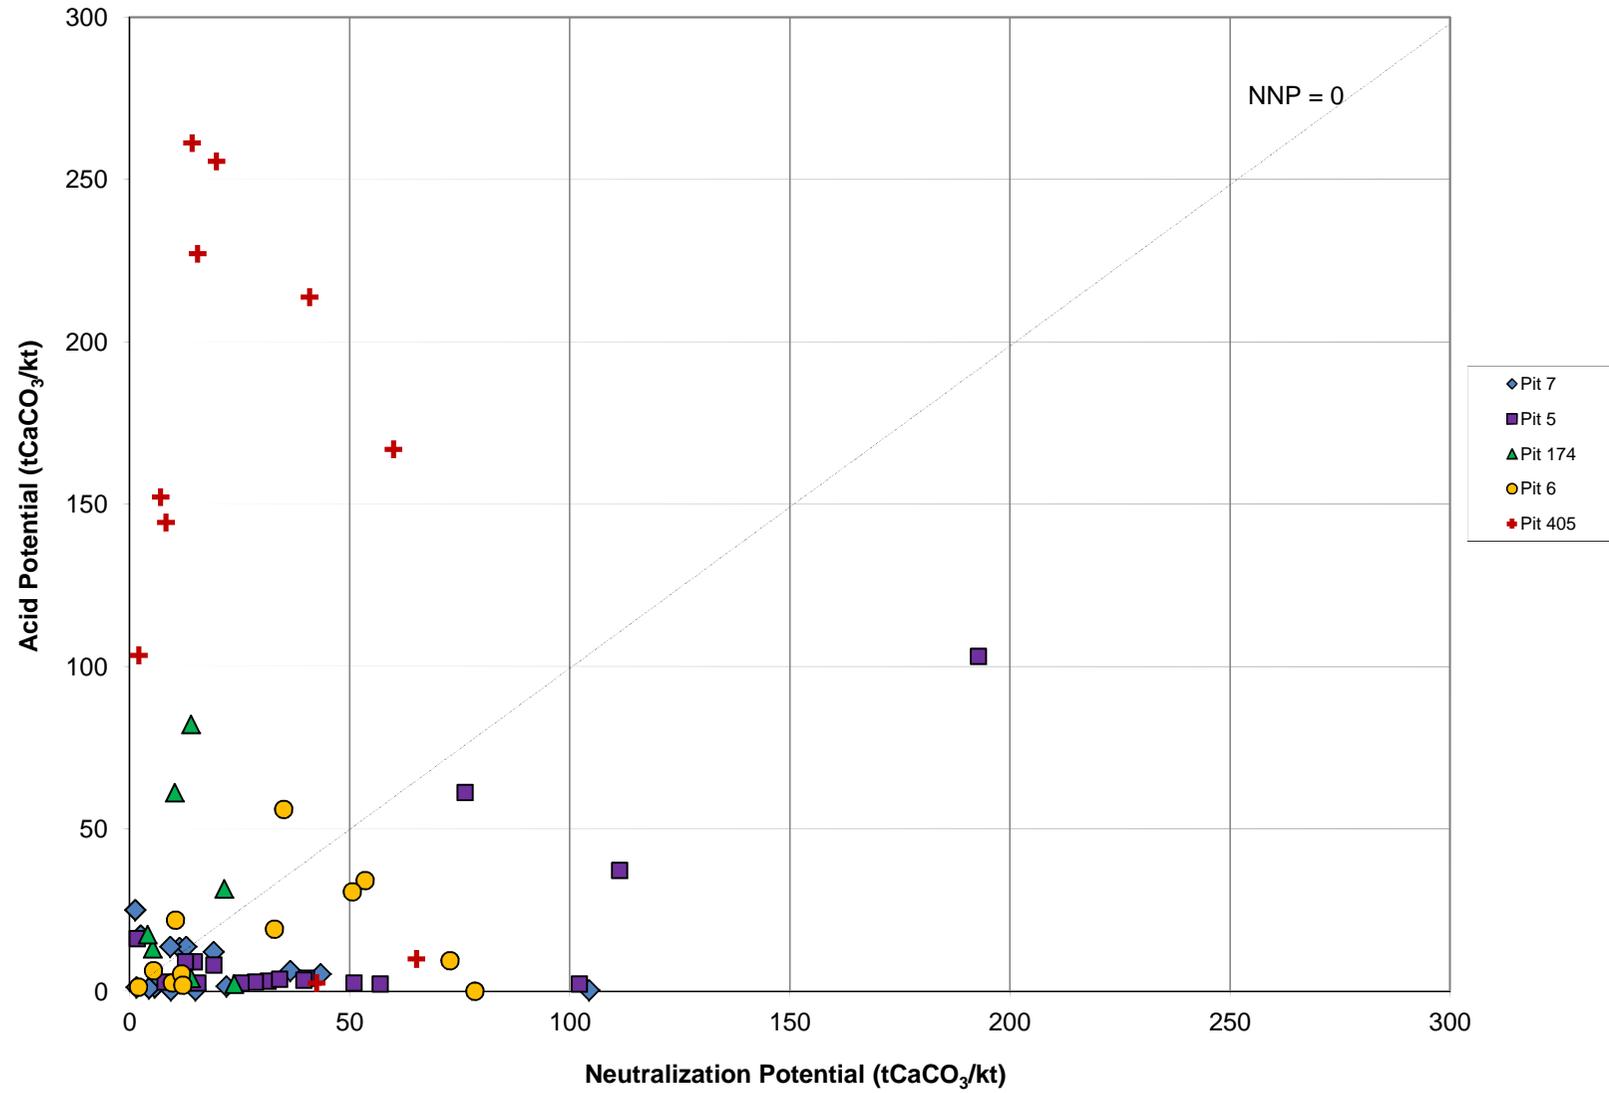
FIGURE 3.16a 2002-2008 QUARRY SITE ABA DATA

Acid Base Accounting data collected from 2002 to 2008 are summarized in Figures 3.16a and 3.16b. Pit 405 and Pit 174 have significant exposures of potentially acid generating rock and produced several samples with acidic rinse pH. Pit 6 and Pit 7 produced samples showing a broad distribution of NNP and rinse pH, and Pit 5 generally produced acid neutralizing samples with alkaline rinse pH. Buildup of oxidation products (salts) on overhanging quarry walls was noted at each of the five quarry sites and may have contributed to the lower rinse pH readings for several samples.
