INSPECTION REPORT: GREENS CREEK MINE

Date Of Inspection: Tuesday, May 14, 2013
USDA FS Inspector: Jessica Lopez Pearce
Ranger Districts: Admiralty National Monument
Juneau Ranger District
Weather Conditions: cloudy, light rain, temps in the 40s

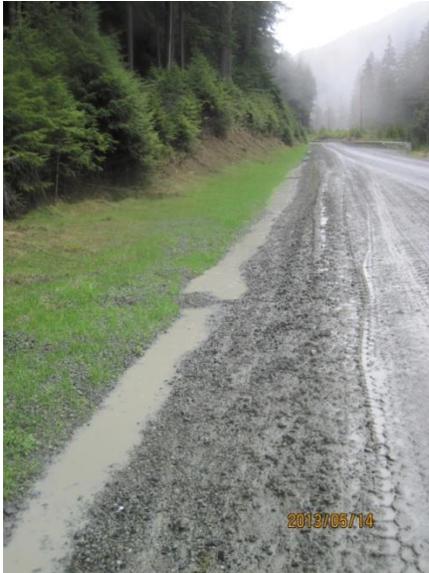
Since Spring break-up, the roads had become muddy and potholed. The A-Road was graded during the night of May 9 and was much improved since the last visit. The B-Road was graded on May 7. At the time of our visit, the ditches and culverts were being cleared (Photos 1a and 1b). Hydroseeding of the roadsides is planned to occur soon.

(1a. B-Road before ditch cleaning)

Photos 1a and 1b. Ditch cleaning along the B-Road.

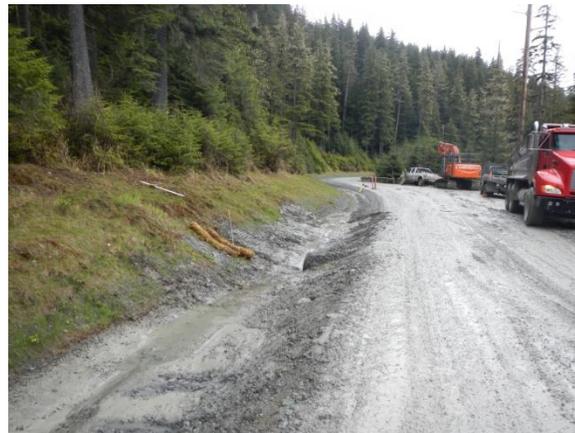
(1b. B-Road after ditch cleaning)

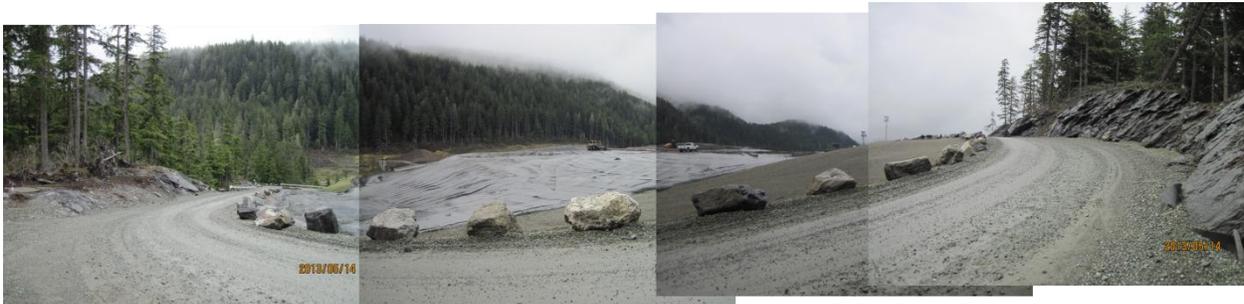
Tailings placement was occurring near the far northern point of the TDF during this inspection. Photos were taken at all of the three tracking points established in February 2013: the northern high point looking south (Photo 2), directly adjacent to the water treatment plant, looking northeast (Photo 3), and from milepost 1 on the B-Road looking west (Photo 4).

Photo 2. Tailings Disposal Facility taken from the northern photopoint.

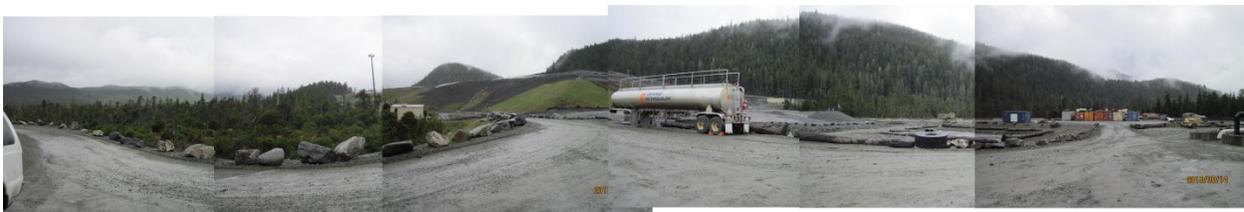
Photo 3. Tailings Disposal Facility taken from the Water Treatment Plant photopoint.

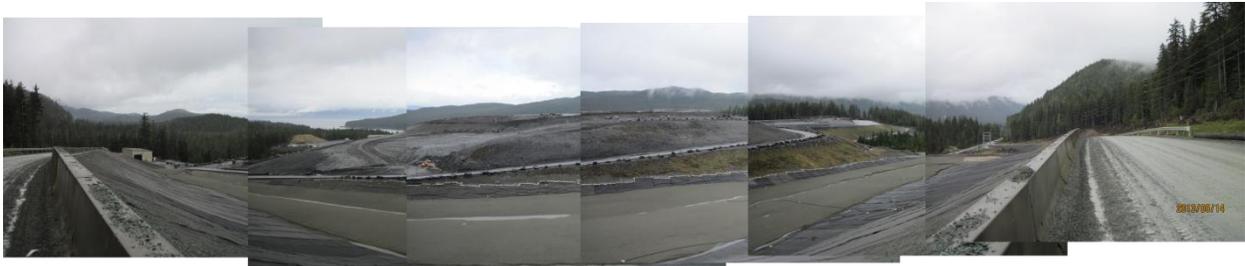
Photo 4. Tailings Disposal Facility taken from the eastern photopoint.

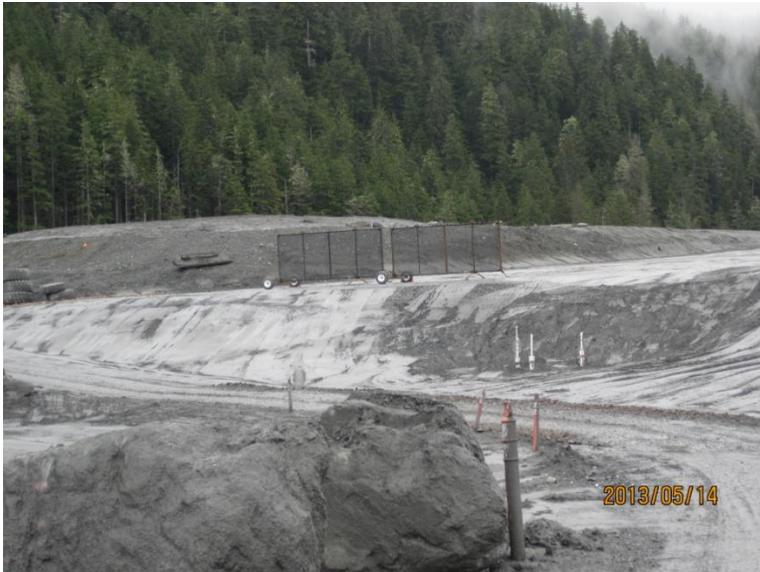
A second large portable windscreen has been fabricated and installed in the TDF. The two windscreens were placed south of the active tailings placement with an east-west orientation (Photo 5). The most recent pail test collection occurred on May 2. HGCMC is awaiting the lab results from these samples.

Photo 5. Two large portable windscreens at the TDF.

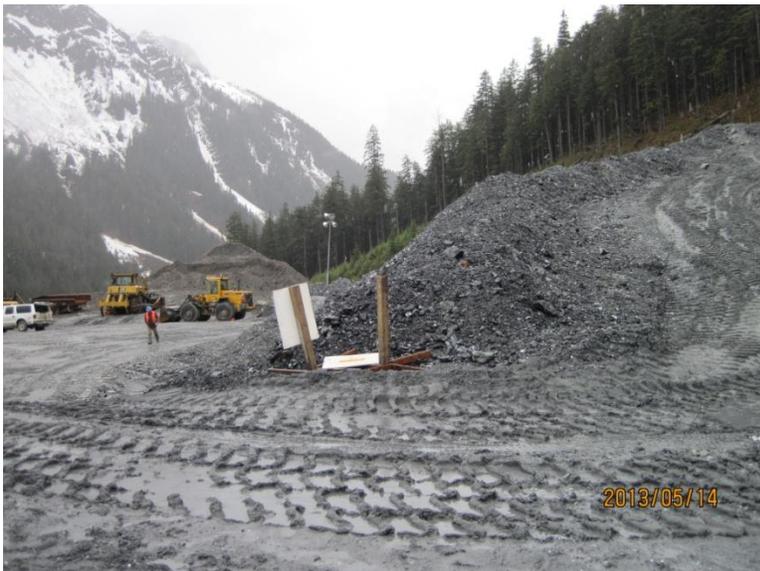
The removal of the central pile of Class 2/3 waste rock continues within Site 23. This material is being relocated underground. Meanwhile, the Class 1 waste rock pile continues to grow (Photo 6). This pile of material was adequately signed. Another small pile of Class 2/3 waste rock is located on the eastern side of the site. It was missing signage.

Photo 6. The Class 1 waste rock pile and one of the two Class 2/3 waste rock piles were adequately signed.

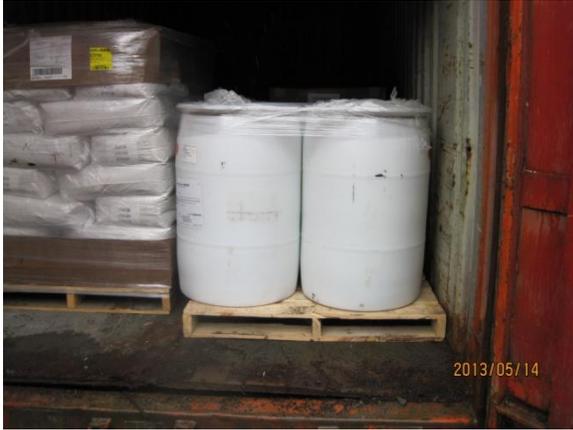
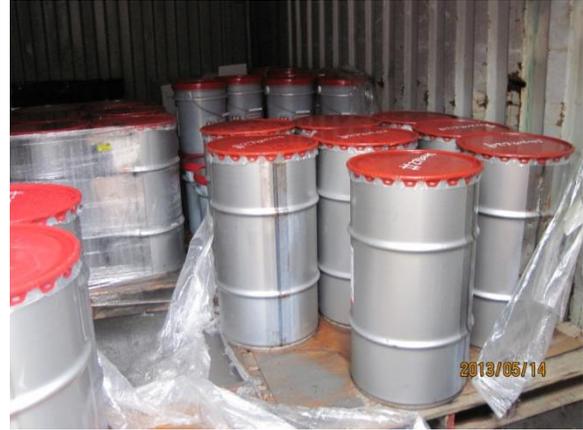
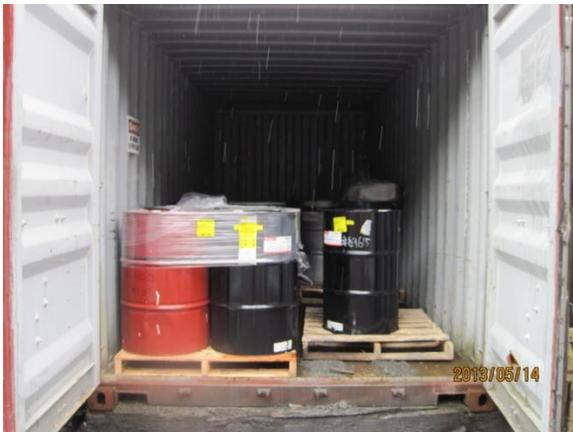
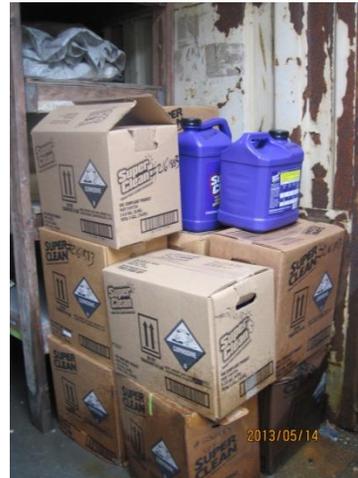
The warehouse area contained multiple secondary containment issues. Several shipping containers stored flocculants, cleaning products, and petroleum products without secondary containment (Photos 7a, 7b, 7c, 7d). This is a recurring issue from past inspections. According to Chris Wallace, HGCMC is costing out the price of installing three shipping containers with built-in secondary containment for this location. Also evident at the warehouse was the inappropriate placement of a snow push pile. The gravel left over after the snow melted indicated that the pile had been pushed too far and sediment from the pile was draining into a lined ditch that ends in Greens Creek (Photo 8).

Photos 7a, 7b, 7c, 7d. Multiple secondary containment issues at the 920 Warehouse.

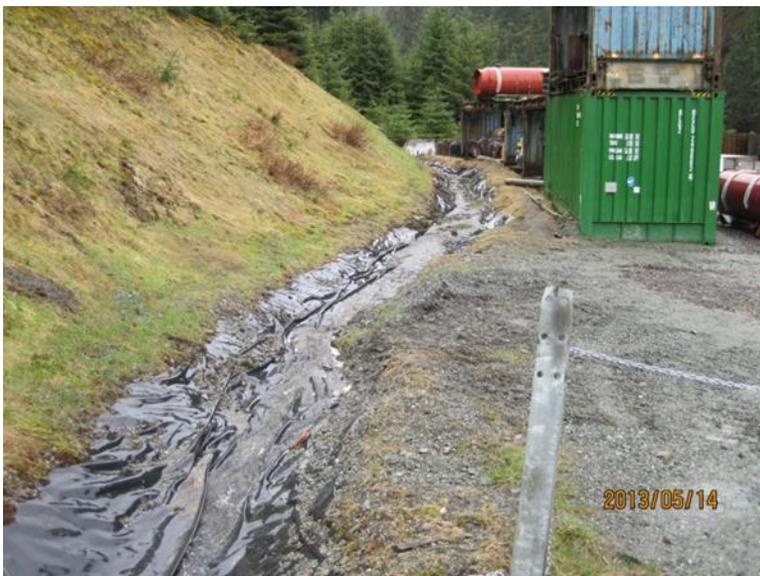
Photo 8. After the snow melted, there is remaining evidence that the snow push pile was inappropriately placed.

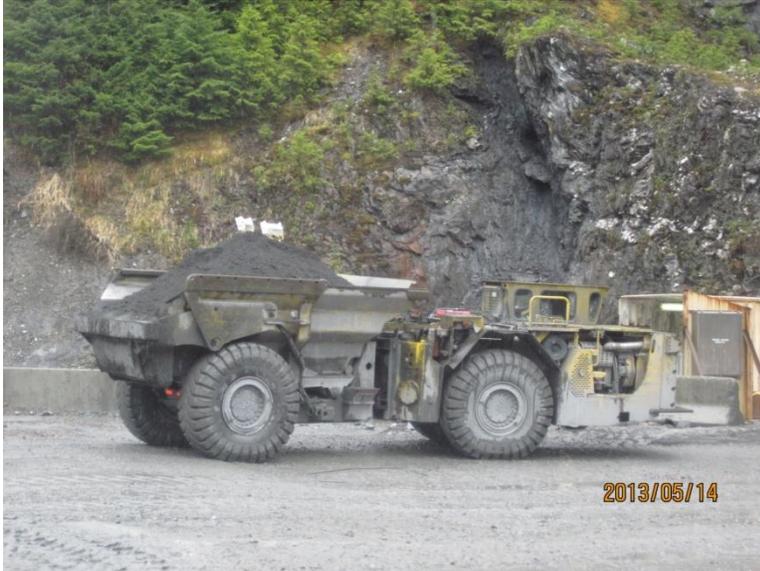
The Portal area contained piles of gravel that will be used for underground road maintenance imminently. Also to occur soon is additional work on the concrete pads at the Portal and maintenance/reconstruction on the Greens Creek Bridge. The access up to the 1350 level was still covered with snow. Several backfill trucks were observed entering the portal with loads of tailings that appeared excessively high (Photo 9). These tall loads of tailings create a greater opportunity for tailings spills onto the road surface. As discussed with HGCMC employees on previous occasions, new employee training is key to reducing the incidence of overloaded backfill trucks.

Photo 9. Overfilled backfill truck at the 920 Portal.

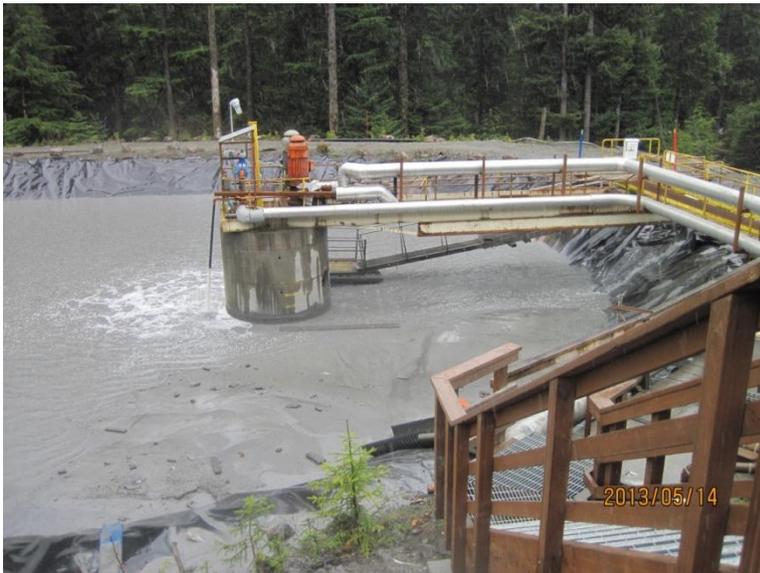
Pond A appeared to contain additional sediment and debris since my last visit to the site (Photo 10). Maintenance activities began on May 20 to remove sediment buildup in Pond A.

Photo 10. Pond A held a large volume of sediment.

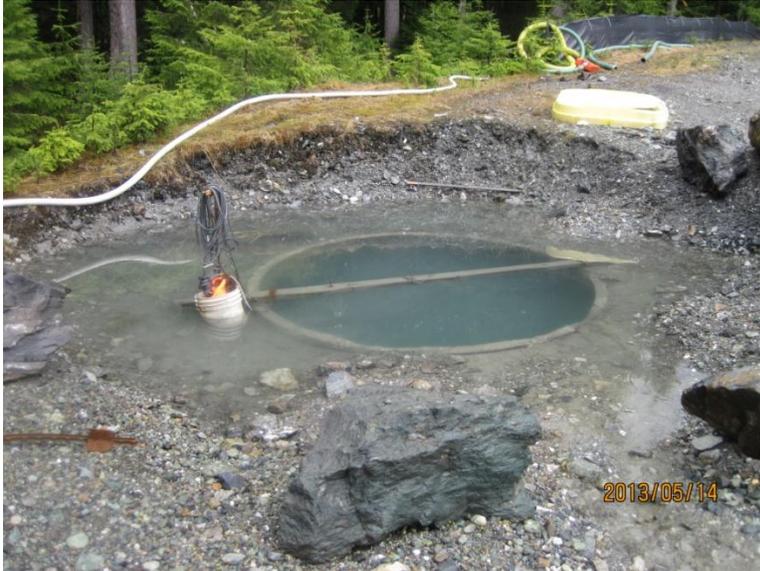
Shane King performed a Special Use Permit inspection at this location. Site E was completely free of snow. The caisson at the entrance gate appeared to be extremely full (Photo 11). Pond E also appeared to be near capacity. After my visit, Mitch followed up and reported that the Site E caisson and the Site E pond were pumped to Pond 7 for treatment on May 21.

Photo 11. The caisson at Site E was extremely full of water. It has subsequently been pumped to Pond 7 for treatment.
