Inspection Report: Hecla Greens Creek Mine

Date of Inspection: Thursday, September 19, 2013
Date of Report: Tuesday, November 05, 2013
USDA Forest Service Inspector: David Schmerge

Ranger District: Admiralty National Monument, Juneau Ranger District
Weather Conditions: Light rain, temperature about 50.

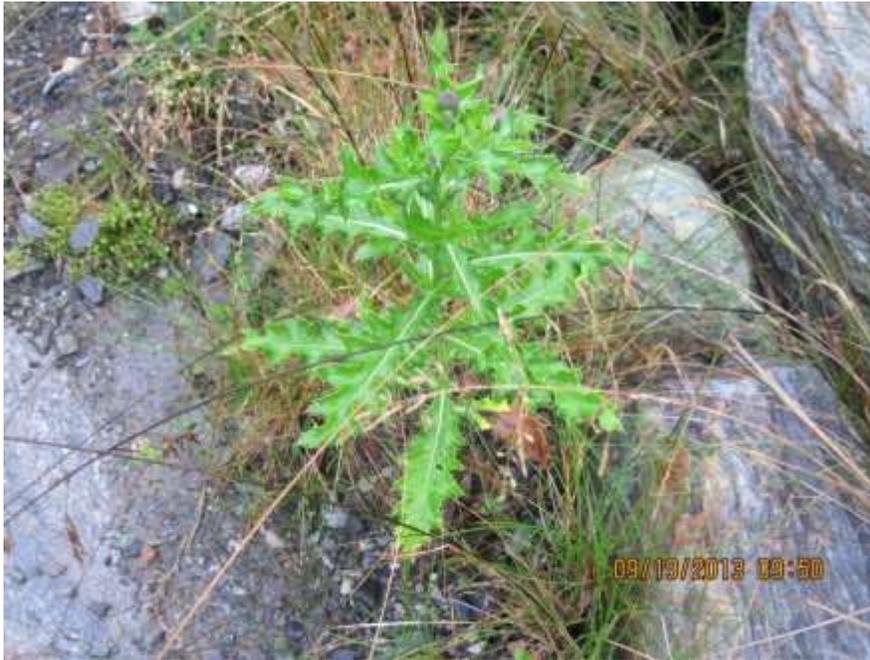
Several species of invasive plants are still present at Pit 7. Canada thistle is less abundant than a year ago (photo 01); Mitch said they have pulled the plants several times this year before they were blooming. Several plants of Tansy were found again as well, but it was not in bloom (photo 02). Mitch said they have not pulled the Tansy this year, but they will pull it.

Photo 01. This invasive Canada Thistle was found growing at Pit 7. Hecla is working on eradicating it by pulling and incinerating the plants.

1. A meeting between Hecla and the Forest Service should be scheduled to discuss the eradication of invasive plants at Greens Creek.
2. All hay and straw bales should be removed, and their use should be discontinued. The BMP Plan should be modified to reflect this change.
3. Monitoring of pH at the Zinc Creek Bridge should be added to the Fresh Water Monitoring Plan in order to determine the effectiveness of the application of lime to mitigate the low pH values.
4. The chemicals at the warehouse storage area should be moved to a concrete surface that drains to Pond A as soon as practical. Alternatively, a revised BMP Plan should be submitted for approval.

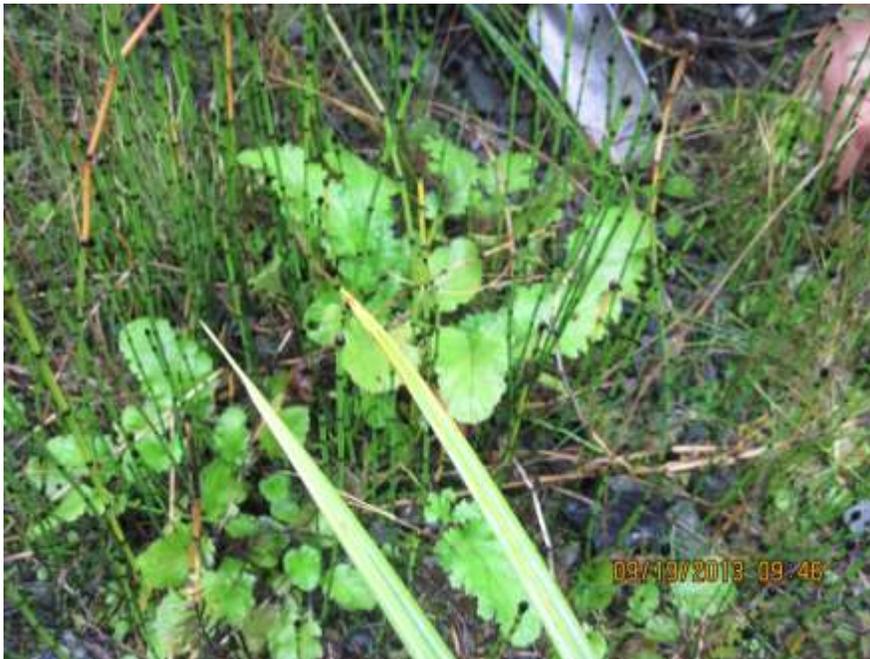
Photo 02. This invasive Tansy was found again at Pit 7. It was first found at the site last year.

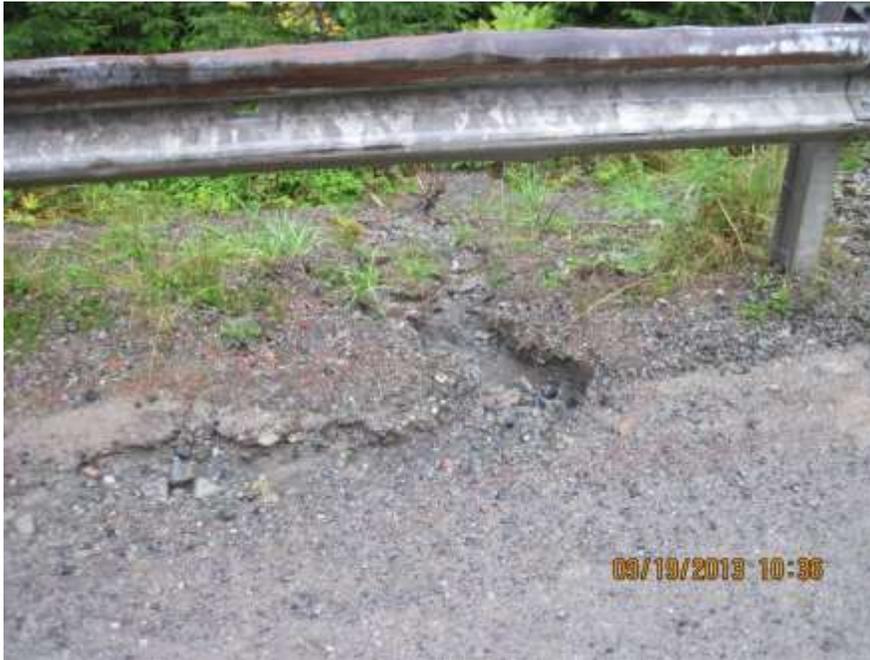
Some erosion was observed along the edge of the A Road at the 1.4 mile A road pit (photo 03), but there was no apparent impact to any water body. Road maintenance work to repair the

Photo 03. This erosion was observed at the edge of the A road at mile 1.4. There is no immediate impact to any water body.

damage should be done as soon as practical.

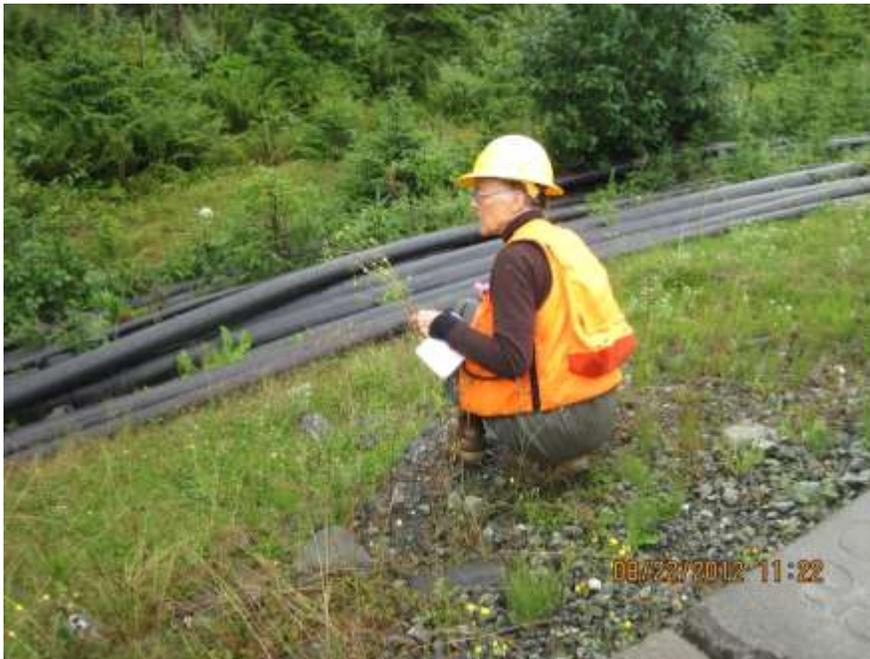
We discussed the presence of the invasive plant *Crepis tectorum* (Narrowleaf hawkbeard) that was found last year at the tailings facility and site E (photo 04). The plant is too abundant to be practically pulled, but the 2013 FEIS (section 3.10.3.1) requires the removal of existing invasive plant populations. Before the plant is eradicated, a process beginning with a minimum requirements analysis will need to be completed. The form to use to for the minimum requirements analysis is called the "Minimum Requirements Decision Guide." It may also be necessary to have approval from the State.

Photo 04. *Crepis tectorum* was found last year at the tailings facility and site E. It is wide spread and should be eradicated.

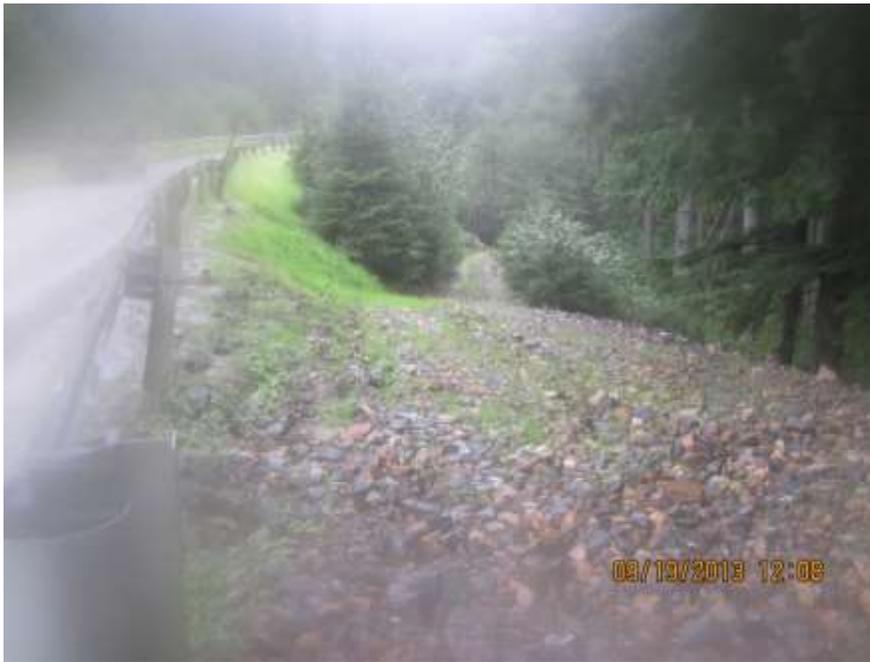
Maintenance work was conducted this summer around the Zinc Creek bridge. The spur road on the north side of the creek has been re-established by clearing small trees and rocks (photo 05). Accumulated sediment under the bridge has been removed, and the silt fences have been repaired (photo 06). Lime was applied to the north abutment in August to mitigate the historically low pH values caused by acid generation from the rocks used to construct the abutment. This site should be added to the Freshwater Monitoring Plan in order to monitor the effectiveness of the mitigation efforts.

Photo 05. Small trees and rocks were removed from the spur road on the north side of Zinc Creek this summer.

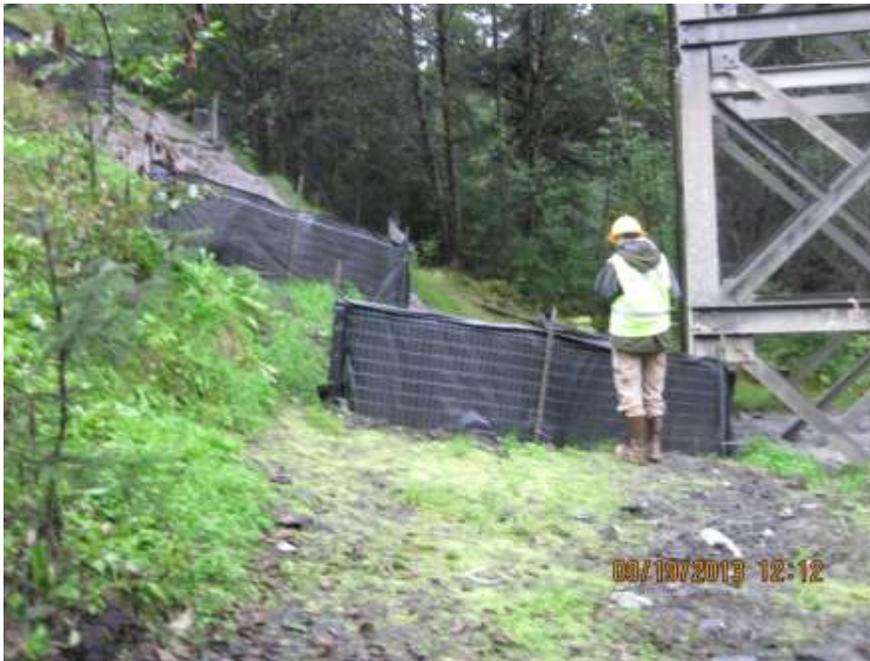
Photo 06. Accumulated sediment under the Zinc Creek bridge has been removed, and the silt fences have been repaired.

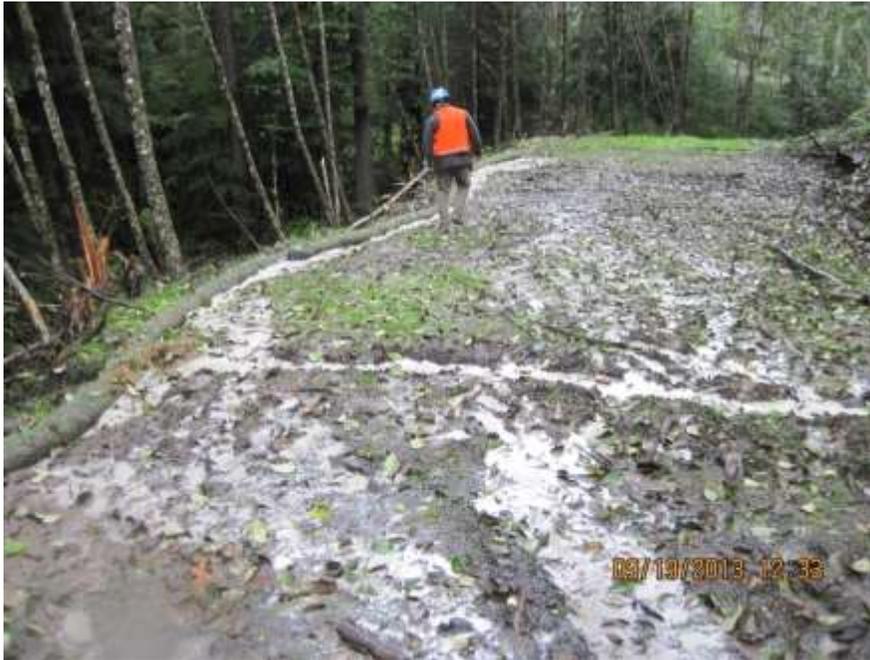
Stormwater runoff was found on the south side of the bridge, (photos 07 and 08) and turbid water could be seen draining into Zinc Creek. Mitch told me that they would work on it, and on September 30, Chris Wallace (Environmental Manager, Hecla Greens Creek Mining Company) informed me that the problem had been addressed.

Straw logs were being used (photo 07) to control erosion. I found no discussion of their use in the Plan of Operations, but the 2013 FEIS states in section 3.10.3.1 that erosion control materials should be weed seed free. Chris sent me a fact sheet from Northwest Linings & Geotextile Products, Inc. that indicates that PermeaLok Straw Logs are 100% free of noxious weed seed and non-straw plant residue.

Photo 07. Stormwater Runoff was found on the south side of Zinc Creek.

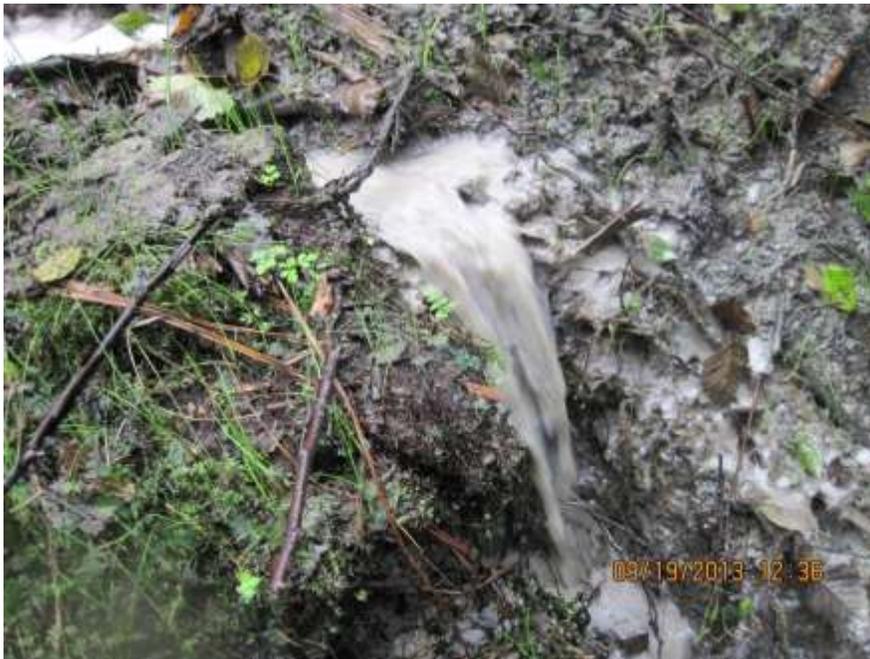
Photo 08. Stormwater Runoff was flowing into Zinc Creek.

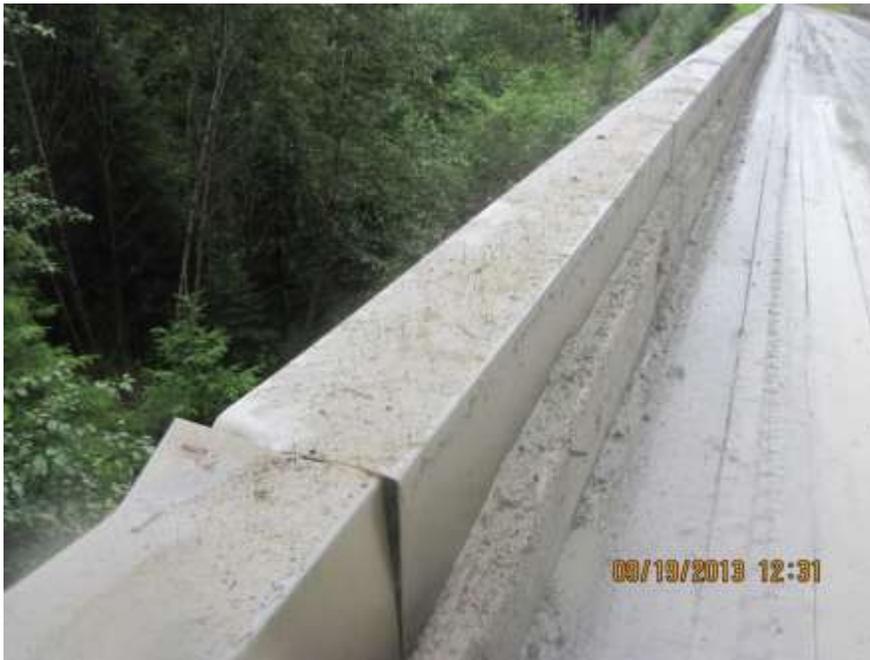
Sediment was found on top of the splash guards of Zinc Creek Bridge (photo 09). This suggests that some sediment may be splashed over the splash guards and fall directly into the Creek. Site specific BMPs for the bridge are found on page 5-46 of the Greens Creek Best Management Practices Plan. It states that splash guards should be extended as needed. Therefore, the height of the splash guard should be extended enough to prevent sediment from being splashed directly into the creek.

Photo 09. Sediment on top of the splash guard of the Zinc Creek bridge suggests that some sediment is being splashed into the creek.

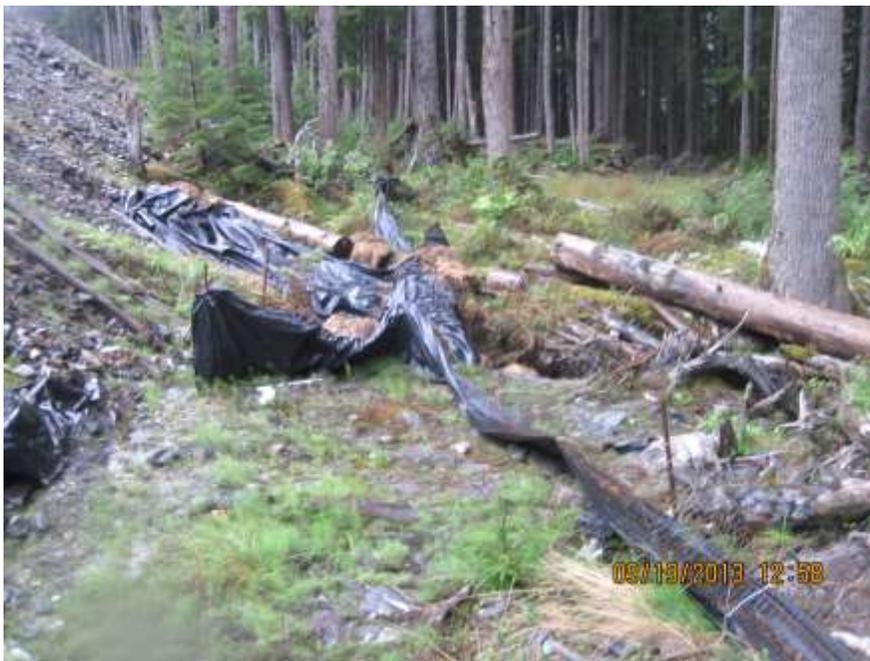
No waste rock has been removed from Site E this year. However, after the recent Record of Decision on the Greens Creek Mine Tailings Disposal Facility Expansion Final Environmental Impact Statement, it is more likely that material will be removed from Site E next year. We walked the perimeter of the site and discussed the condition of the silt fence and the presence of straw bales (photo 10). The silt fence is generally in poor condition. This is not presently a significant concern because the site has not recently been disturbed. However, water quality exceedances have occurred at this site in the past, and during periods of disturbance, water quality exceedances are more likely. Therefore, it is recommended that the silt fence be repaired before the waste rock is moved from site E to the tailings facility. The 2013 FEIS states in section 3.10.3.1 that the use of hay or straw bales for erosion control is to be avoided. Therefore, the bales should be removed.

Photo 10. The silt fence surrounding site E is in poor condition in many places, and should be repaired before any material is removed from the site. The straw bales should be removed.

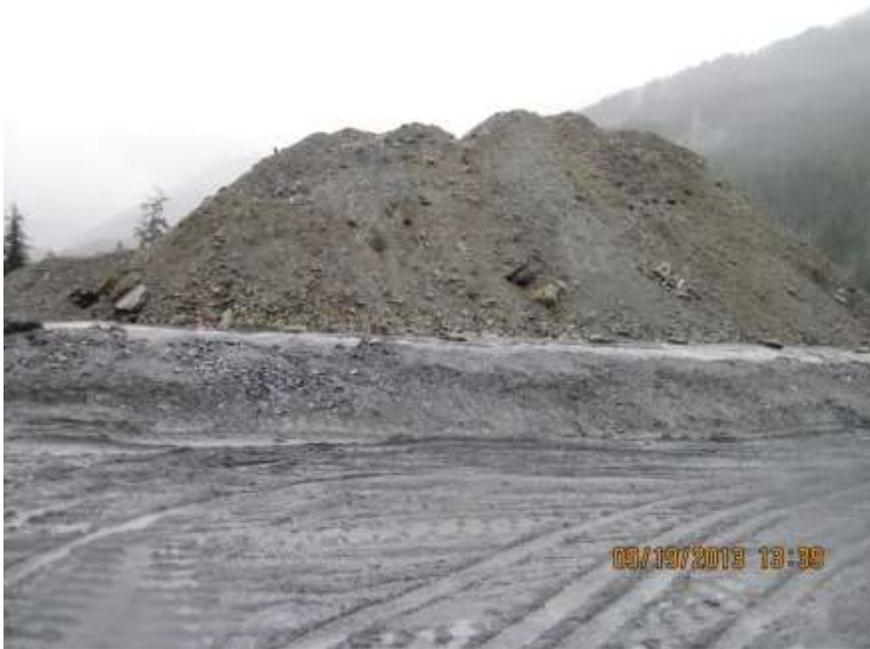
About 5,500 cubic yards of waste rock was removed from the 1350 area this summer and placed on a liner at Site 23 (photo 11).

Photo 11. Waste Rock from the 1350 area is now stored on a liner at Site 23.

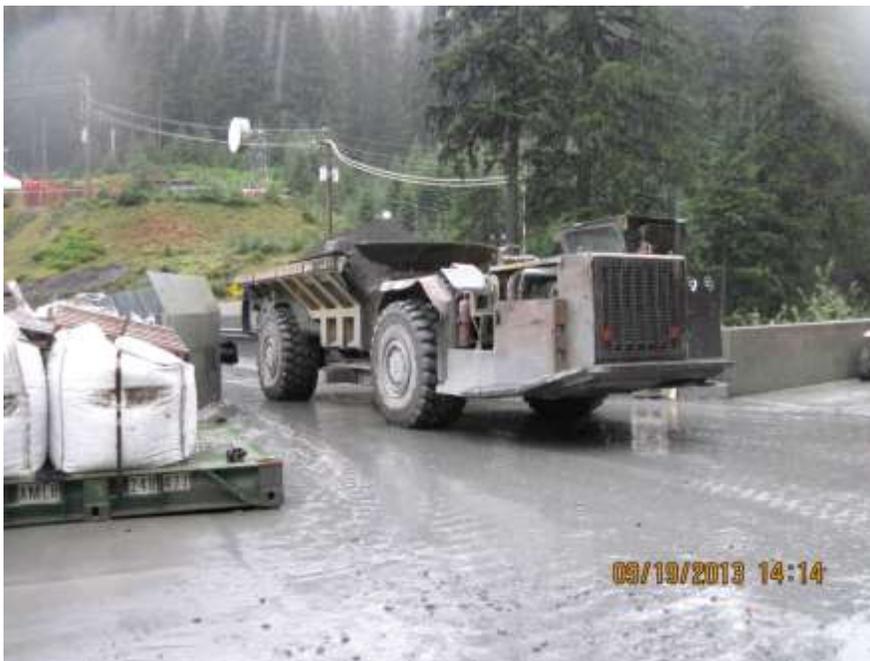
in currently uncontained areas, and to overlay stable roadway surfaces to improve drainage problems in and around the 920 area of the mine. This summer, the Greens Creek bridge and portal road were overlain with 4 to 6 inches of concrete, and the wall and splash barrier were then completed (photo 12). This allows surface water to be contained at the edge of the creek and pumped to the mine's main sump.

Photo 12. The bridge and road at the 920 portal were overlain with 4 to 6 inches of concrete this summer, and the wall and splash barrier have been completed.

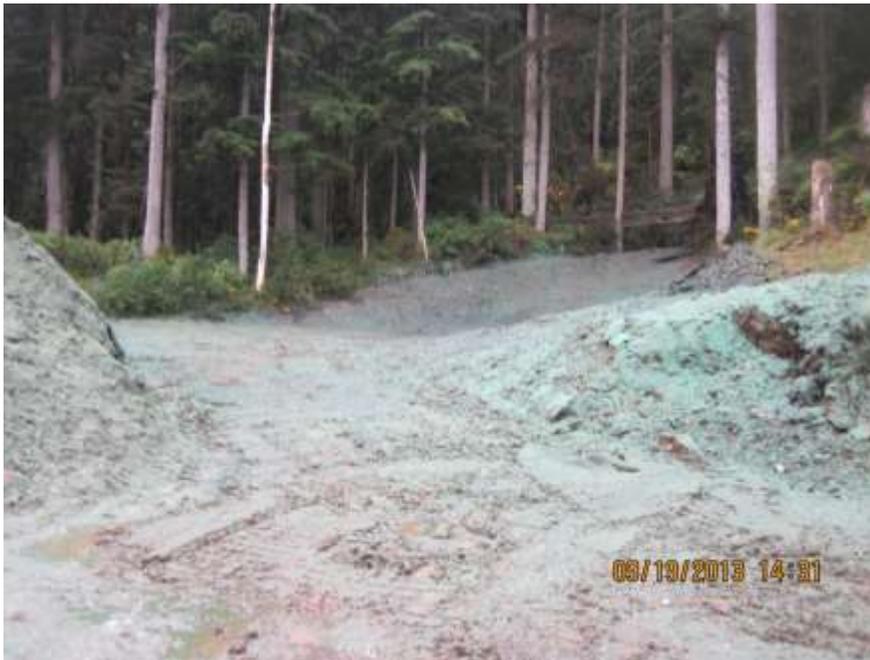
The 1350 area has recently been seeded after waste rock was removed from the site (photo 13). An estimated 15,000 cubic yards of waste rock still needs to be removed from the site.

Photo 13. About x tons of waste rock were removed from the 1350 portal this summer. The area has recently been seeded.

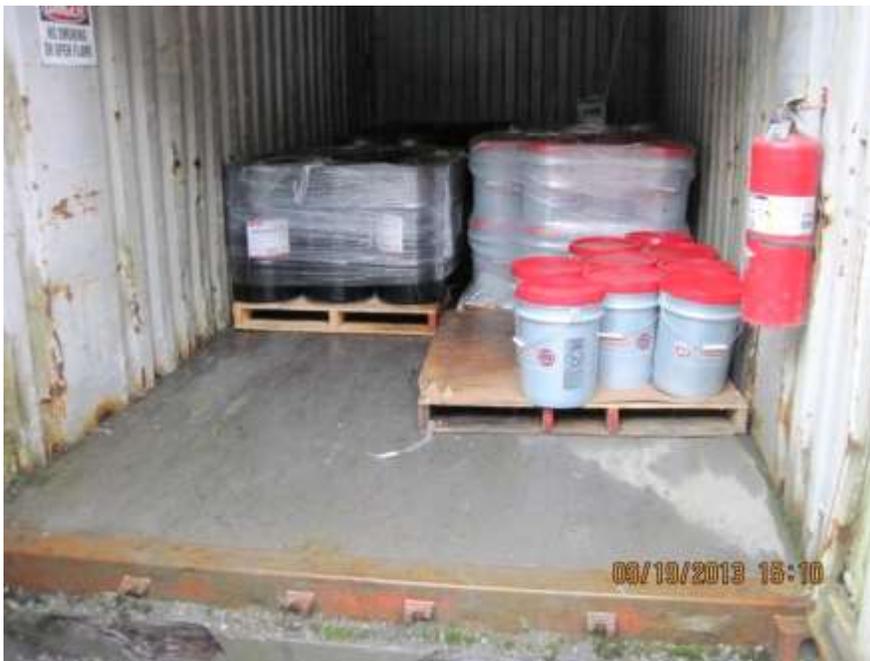
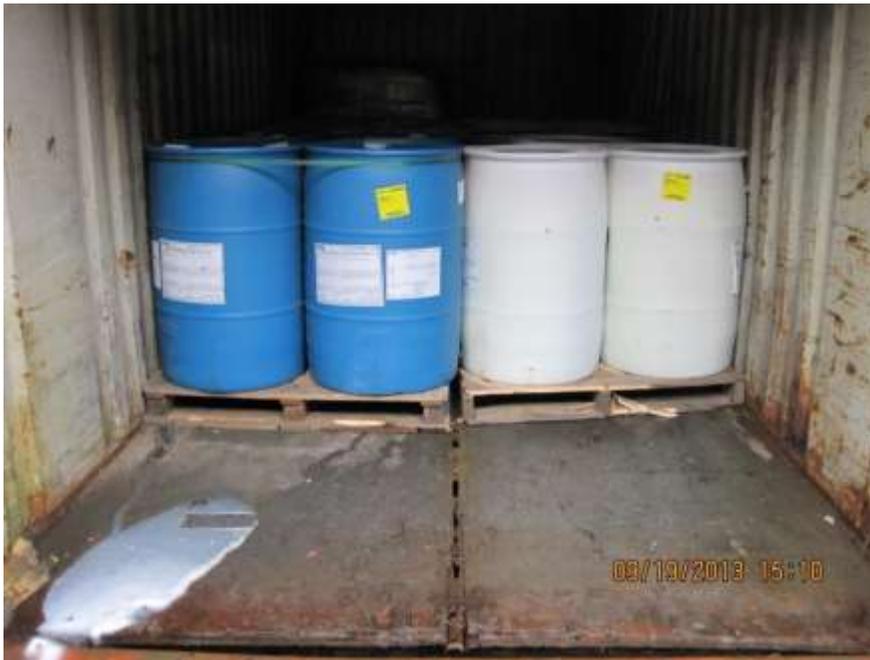
There are ongoing concerns regarding the storage of chemicals at the warehouse storage area at the mill. I found two sea vans storing chemicals without secondary containment (photos 14 and 15), and there was an uncontained chemical spill outside one of the sea vans (photo 16). In the last Forest Service inspection report, Jessica Lopez Pearce stated, "Mitch said that secondary containment structures for warehouse items will be installed in the fall of 2013." I questioned Mitch about this, and he described these structures as sea vans with the secondary containment built into them. However, this does not meet the requirement of the Greens Creek BMP Plan (Plan). The Plan states on page 5-21 that chemicals are to be stored in areas that drain across concrete surfaces to the lined containment ditch which flows to Pond A. The sea vans at the warehouse storage area are not on concrete. I talked to Chris about this and advised him that Greens Creek should either comply with the Plan by storing all chemicals on concrete surfaces that drain to Pond A, or submit a modified BMP Plan that allows the storage of chemicals in these new secondary containment structures off of the concrete. I also informed Chris that a modified BMP Plan would need to be approved by the Forest Service and ADEC.

Photo 14. The chemicals in this sea van lack secondary containment.

Photo 15. The chemicals in this sea van lack secondary containment.

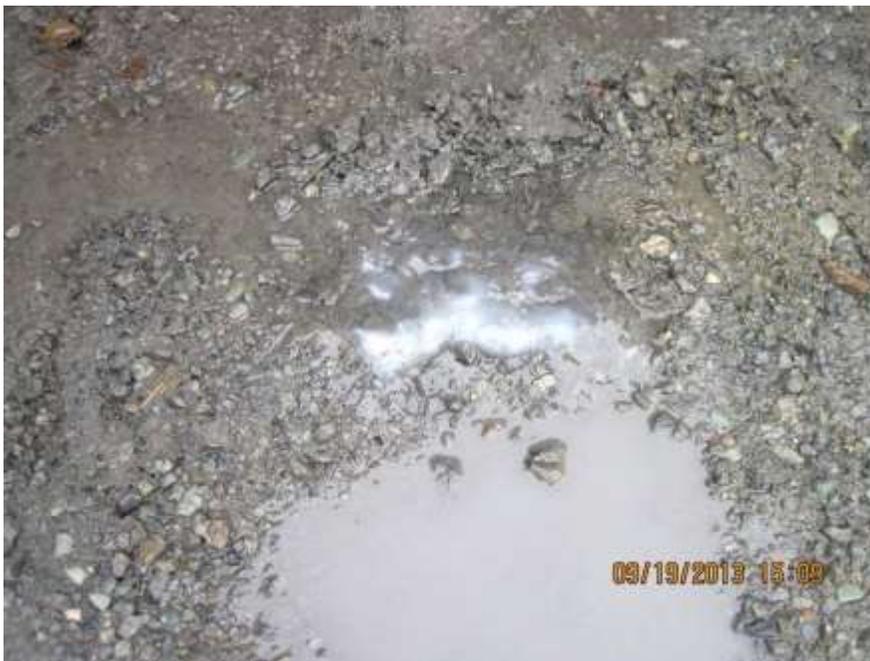
Photo 16. This uncontained chemical spill was found outside one of the sea vans.
