Inspection team:
David Wilfong – ADNR
Curtis Caton – USFS
Cody MacCabe – USFS
Mitch Brooks - HGCMC

February 27, 2014 Inspection of the Greens Creek Mine

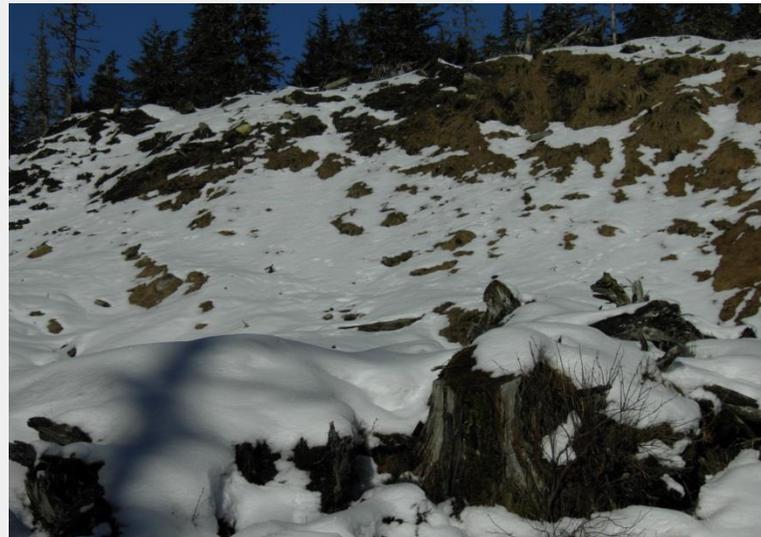
Figure 1 Reclamation material stored in Pit 7.

trailers, but the trailers were not present at the time of inspection. Due to the subfreezing temperatures, there was little water seepage coming from the toe of the pile. No issues were observed anywhere at Pit 7.

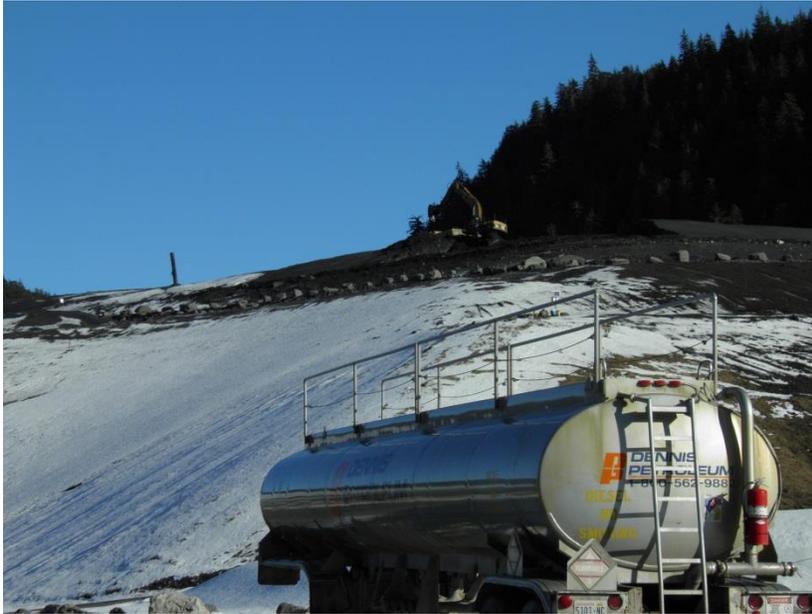
Figure 2 Clean snow on the slope of the tailings pile. This may indicate successful fugitive dust mitigation measures.

After leaving Pit 7, the inspectors traveled to the Tailings Disposal Facility (TDF). Tailings placement was occurring in the central section of the pile. During previous inspections while snow was present, discoloration of the snowpack could be seen due to fugitive dust. However, no discoloration was observed during the February 27th inspection. The lack of discolored snow (Figure 2) may be an indication of successful mitigation measures that HGCMC has instated to lessen the effects of windblown snow. The mitigation measures include portable wind fences, pre-determined placement areas during dry, cold, windy days, and more. The weather conditions during the inspection (dry and cold) were typical of the weather that would cause fugitive dust, but no dusting was observed.

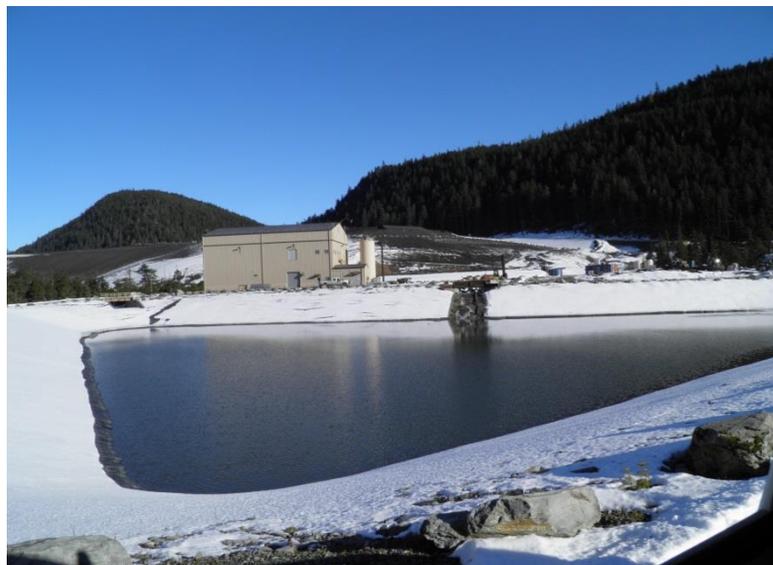
Figure 3 Pond 7.

The team traveled on a “clean road” around the perimeter of the TDF to the Water Treatment Plant (WTP). Both the inside and the outside of the WTP were clean and well organized, and no problems were noted. After a tour inside the WTP, the inspectors drove around the perimeter of Pond 7 (Figure 3). The pond had been dredged during the previous summer, and the water level was noticeably lower due to the lack of sediment in the lined pond. The truck wheel wash at the tailings facility was operating despite the cold temperatures.

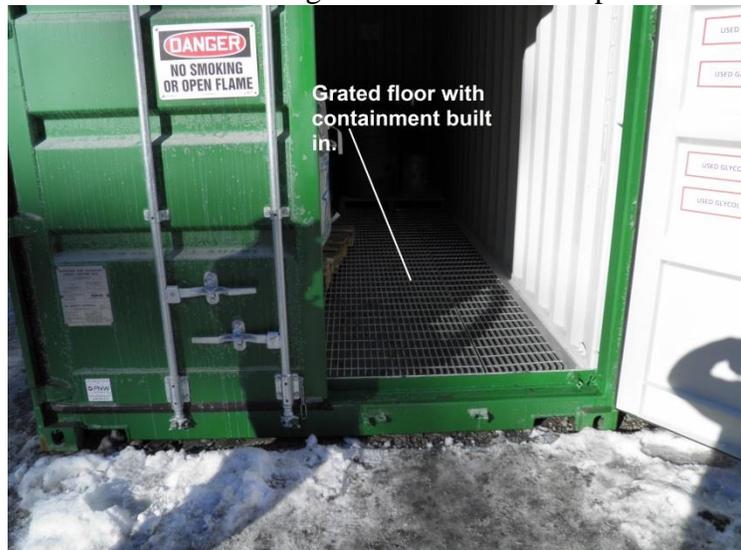
Outside of the mill building, a partially full barrel of used ethylene glycol (antifreeze) was missing a bung, and several 55 gallon containers lacked secondary containment. However, the few containers lacking containment were a marked improvement over earlier inspections, and it was apparent that the warehouse and mill workers were making an extra effort to keep chemicals in secondary containment, and the area clean and tidy. The inspectors opened one of the new 20 foot containers with built in secondary containment. The container in Figure 4 can hold a volume of about 300 gallons in its secondary containment. Hecla obtained several of these “sea vans” to ensure that all chemicals used at the mill and other parts of the mine would be stored in secondary containment. Several more of the special containers were to be moved and placed near the warehouse facility when the area becomes clear of snow. Some of those containers will be modified to hold 600 gallons so they can accommodate large totes.

Figure 4 Twenty foot container with built in secondary containment.

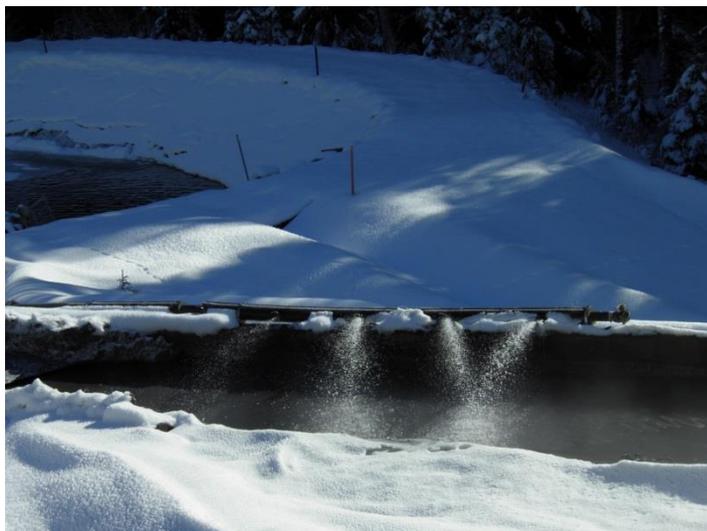
Existing degrit basins have been retrofitted with piping and spray nozzles to make snow melting basins. The nozzles were spraying, but no snow had been recently placed in them (Figure 5). The melting basins spray warm, treated water recycled from the mill on plowed snow placed in the basins. During past inspections, plowed snow that may have been contaminated with pyritic fines

Figure 5 Snow melting basin.

from ore and tailings could be found heaped outside of the diversion ditch, and therefore outside of containment. The snow melting basins were installed to alleviate this problem, and appeared to be working well. Also, obstacles were placed in strategically chosen areas to prevent snow from being pushed outside of containment. The team observed a cemented-tailings back fill haul truck being filled and trucked underground. The fill will be placed in mined out stopes to add support to the underground mine. The warehouse area was inspected and no problems were
