INSPECTION REPORT: GREENS CREEK MINE

Date of Inspection: Wednesday, December 16, 2015
Date of Report: Tuesday, December 22, 2015
USDA Forest Service Inspector: Edward Gazzetti

Ranger District: Admiralty National Monument, Juneau Ranger District
Weather Conditions: Overcast. Temperatures: 30's (°F).

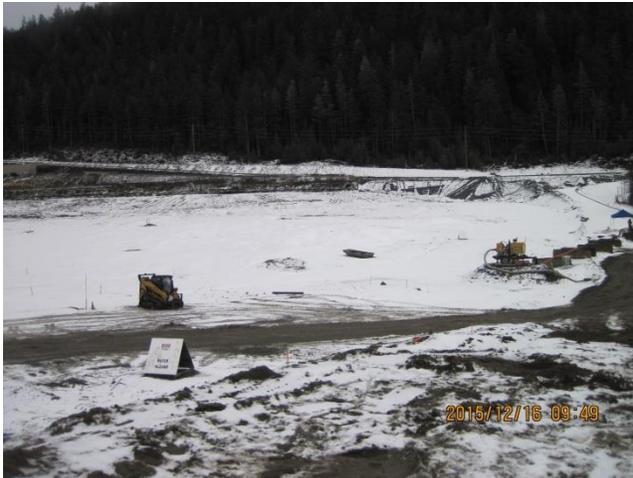
Water has been drained from the tailings expansion area since the last inspection (Photo 1). A drill crew is actively placing inclinometers (4) along the edge of the area as part of a geotechnical investigation (Photo 2). A corduroy road constructed of timbers provides the crew access to areas where the water table is too close to the surface to allow safe passage of heavy equipment (Photo 3). The road will be reclaimed and allowed to revegetate naturally upon completion of the investigation.

Photo 1. Tailings expansion area completely drained of ponded water.

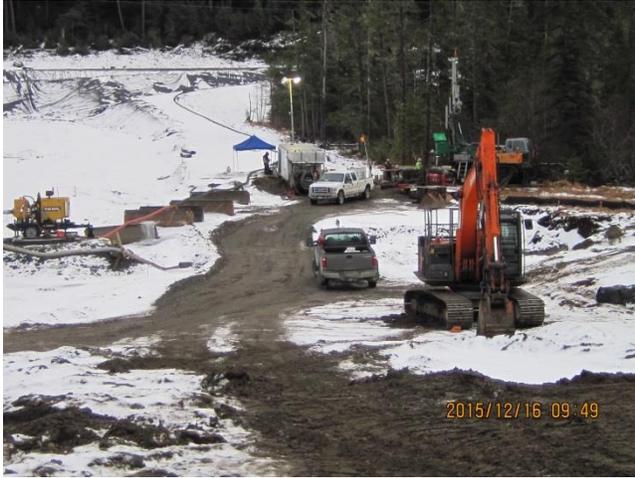
Photo 2. Drill crew preparing to install an inclinometer near the edge of tailings expansion area.

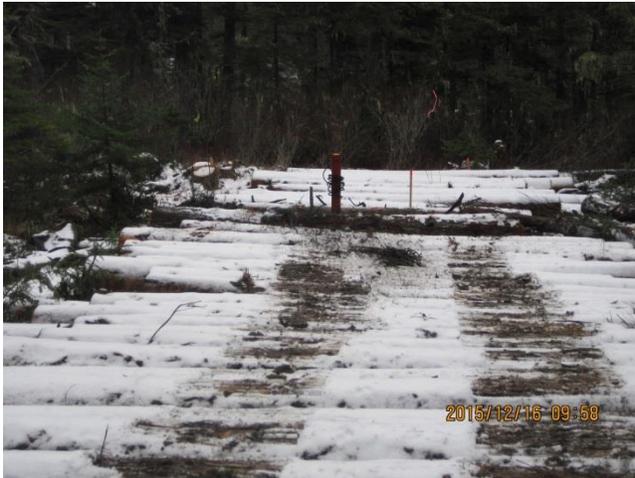
Photo 3. Corduroy road leading to a completed inclinometer.

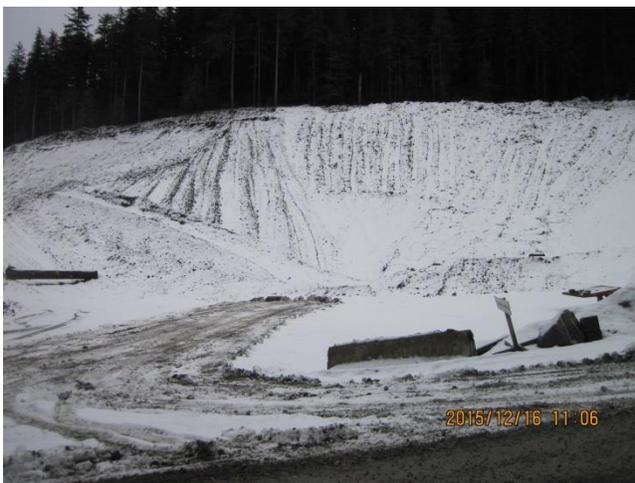
Excavation has ceased for the season and all heavy equipment removed (Photo 4).

Photo 4. Sand pit excavation has ceased for the season.

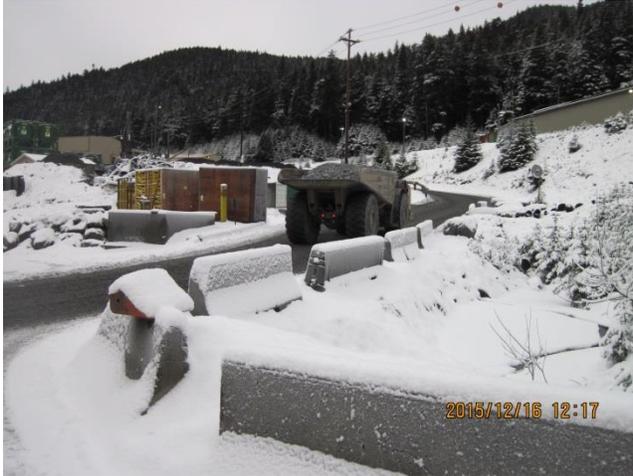
The site is active and tidy. A truck hauling ore from the mine is shown in Photo 5. Haul trucks observed during the inspection had a safe amount of material in each load (i.e. there was no spillage). The road to 1350 was covered in snow/ice so we could not reach the portal for an update on the adit drains mentioned in October's report (Photo 6).

Photo 5. Haul truck carrying ore from the 920 portal.

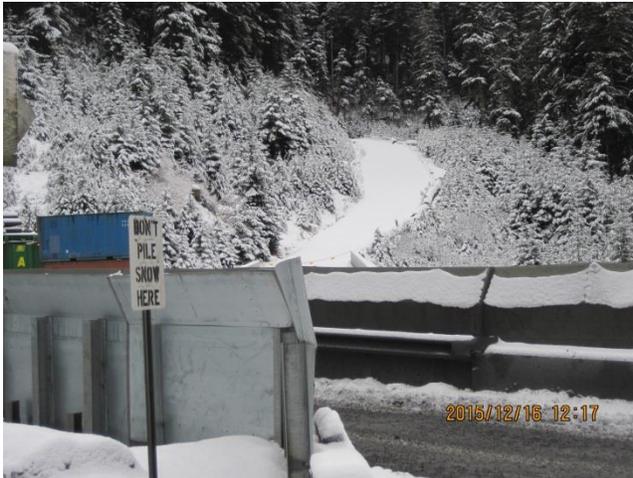
Photo 6. Road to 1350 portal covered in snow.

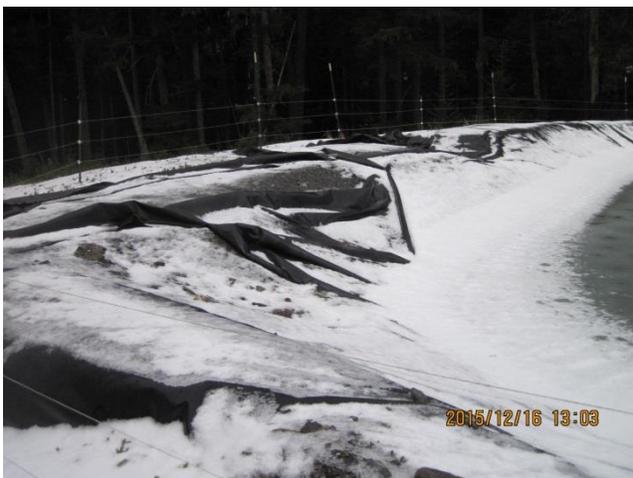
Site E settling pond is in disrepair and does not comply with the BMP plan strategies listed for Site E in Appendix 5, Figure 8 (Photo 7). The pond needs to be relined or repaired before active excavation resumes to prevent site runoff from discharging into the watershed.

Photo 7. Torn liner at Site E needs to be repaired or replaced before active excavation resumes.

- **Zinc Creek bridge sump maintenance, BMPs**
- **Site E pond needs to be relined or repaired before active excavation resumes**

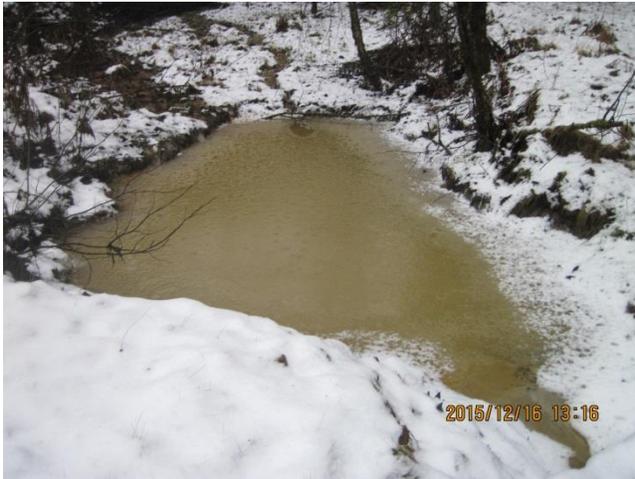
A sump located near the South abutment is currently overflowing into the forest via channelized flow (Photos 8-13). The sump, which does not appear in the BMP plan strategies found in Appendix 5, Figure 7, collects runoff from the nearby roadway. The sump needs regular maintenance to prevent channelized flow from entering the forest. Straw wattles downstream of the sump are ineffective in controlling sediment runoff due to their placement and overall poor condition. Wattles need replacement and readjustment to control sediment runoff.

Photo 8. Sump near the Zinc Creek bridge filled with fine-grained, tan colored sediment.

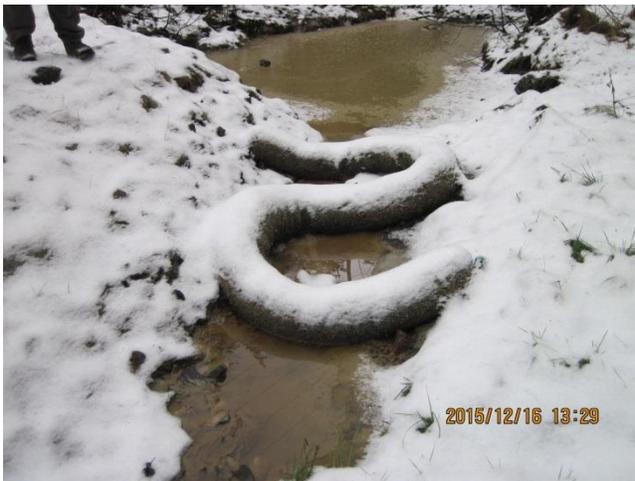
Photo 9. Looking “upstream” to the sump area. Straw wattle is ineffective in containing sediment.

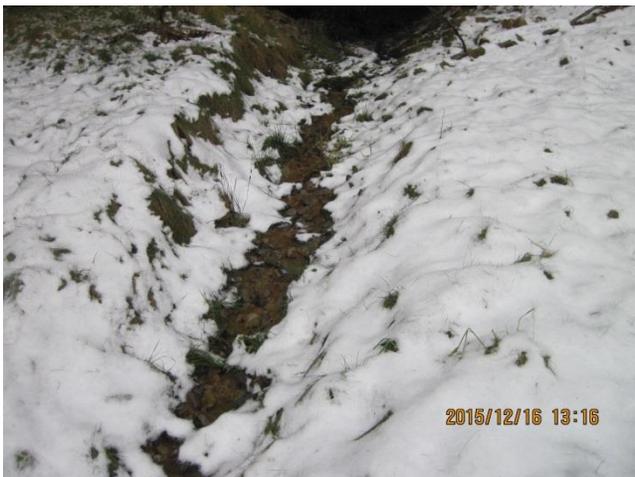
Photo 10. Looking downstream. Water and sediment discharge from the sump travel downstream into the forest.

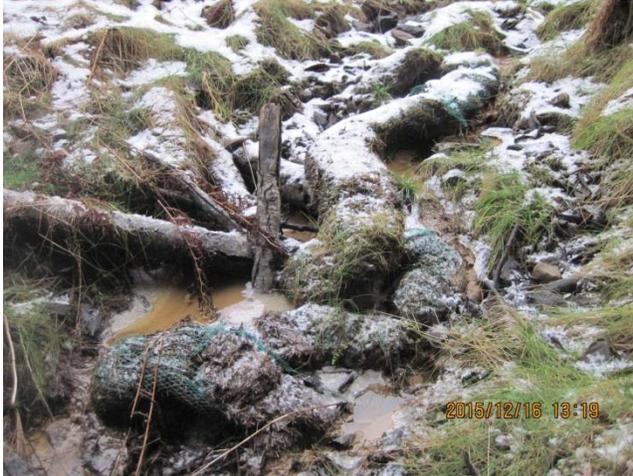
Photo 11. Looking upstream from forest edge. Torn and improperly placed straw wattle is ineffective in containing sediment.

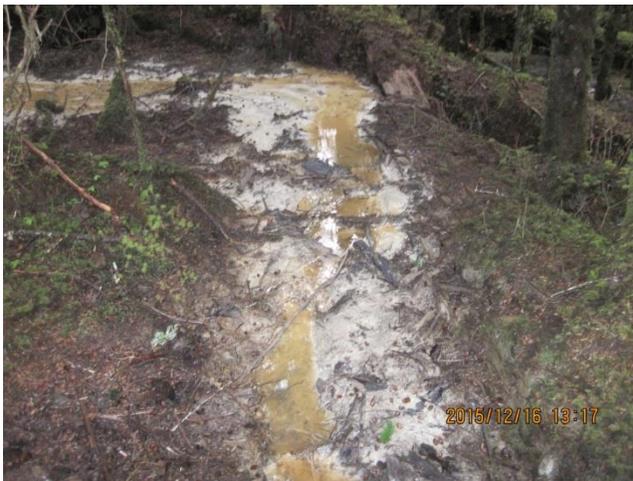
Note: Greens Creek responded to this issue on December 17 and 18, stating they plan to investigate the source and signature of the sediment and conduct future maintenance/BMPs at the sump as needed. They suspect a majority of the tan sediment shown in Photos 12 and 13 is recently exposed sediment that was originally deposited years ago.

Photo 12. Sediment deposited along the channelized flow path.

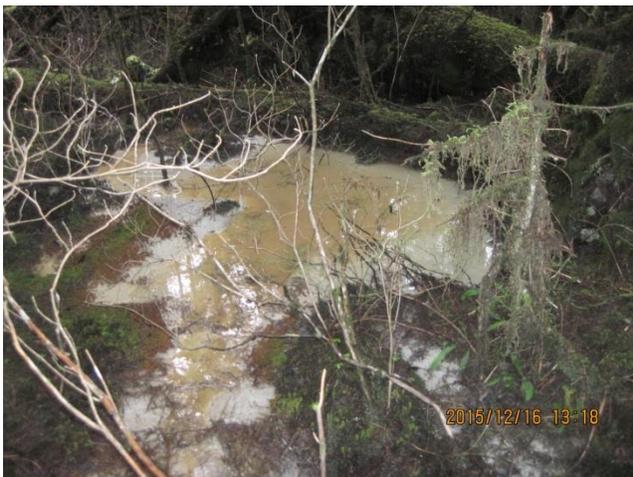
Photo 13. A pool of water and sediment on the forest floor. There are at least two other similar pools that exist downstream in the forest.

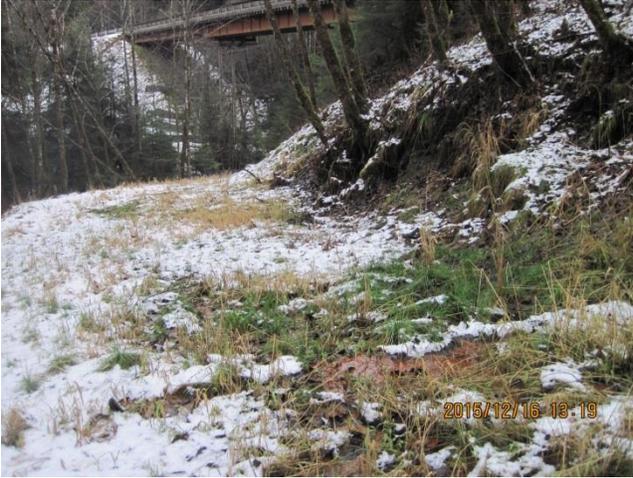
A bright red discharge seeps out of the ground near the South abutment (Photos 17 and 18).

Photo 14. Bright red seep near the Zinc Creek bridge.

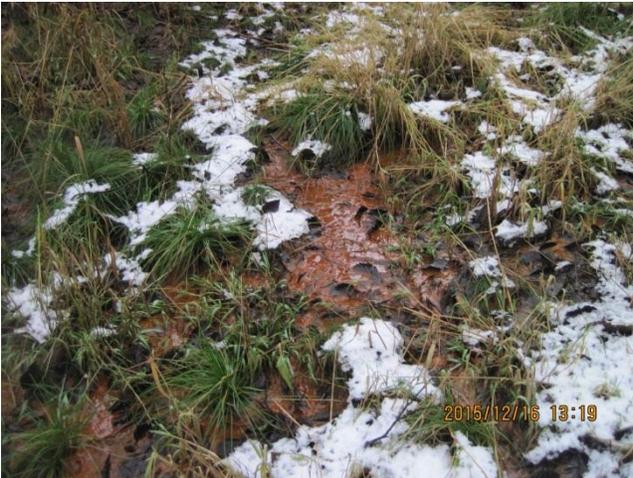
Photo 15. Close-up of seep.

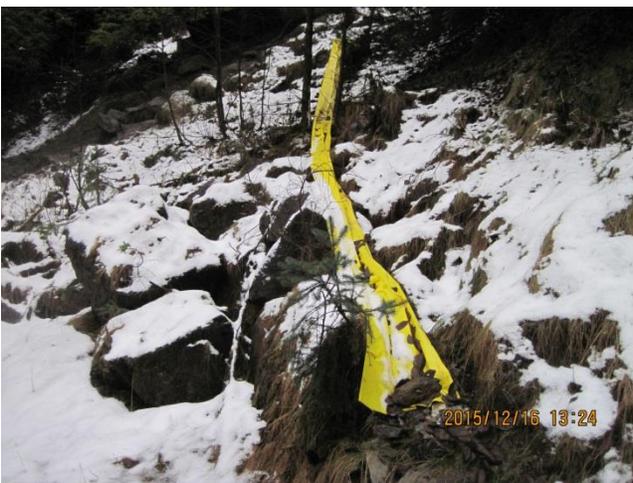
A drainage hose beneath the South abutment is freely discharging sediment and water onto the ground. The ground beneath the hose is saturated with milky, tan colored water (Photos 14-16). The hose may require a filter sock at its outlet and/or regular inspections, as there is a large hole about two feet from its end (possibly caused by wildlife).

Photo 16. Yellow hose slowly discharges a milky substance below the Zinc Creek bridge.

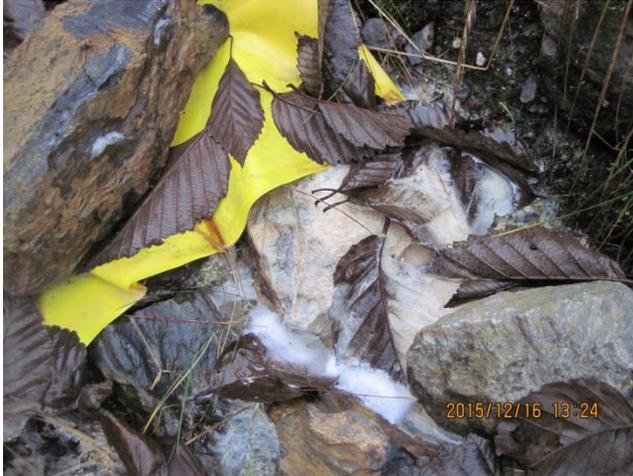
Photo 17. Sediment and water discharge from the hose below the Zinc Creek bridge.

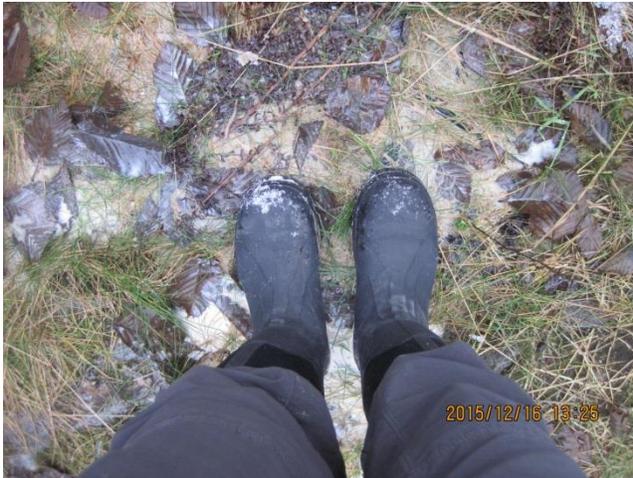
Photo 18. The ground near the yellow hose's discharge point is saturated with the milky substance.

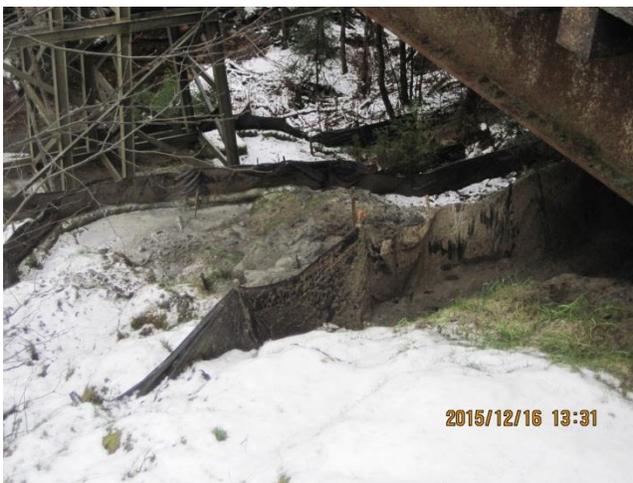
Sediment accumulates beneath the bridge, both on the ground and on silt fencing (Photo 19). Sediment covering the entire height of the silt fencing suggests dripping from the bridge may still be occurring (Photo 20). Cleaning and regular monitoring of the fencing will determine whether the HDPE bridge liner is working properly (without cleaning the fences, it is difficult to say whether the sediment on them was deposited before or after insertion of HDPE bridge liner).

Photo 19. Silt fencing does a good job of blocking sediment as it moves downhill. However, sediment covering the entire height of the fence suggests dripping from the bridge above.

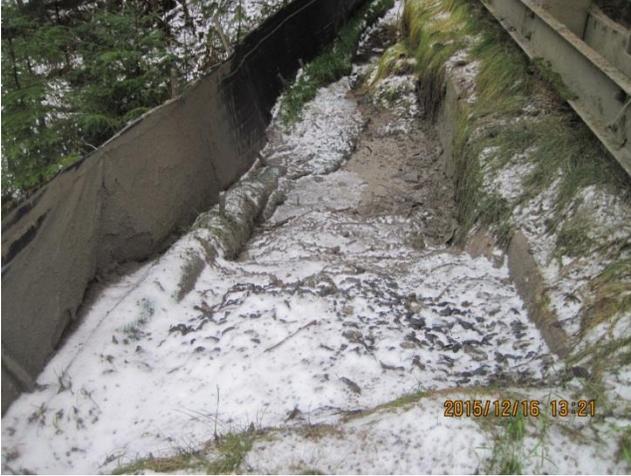
Photo 20. Sediment from the bridge trapped behind silt fencing. Note the sediment covering the height of the fence.
