# MEMORANDUM

Department of Fish and Game  
Division of Habitat

SUBJECT: 2016 Greens Creek Mine  
Site Visit Trip Report #2

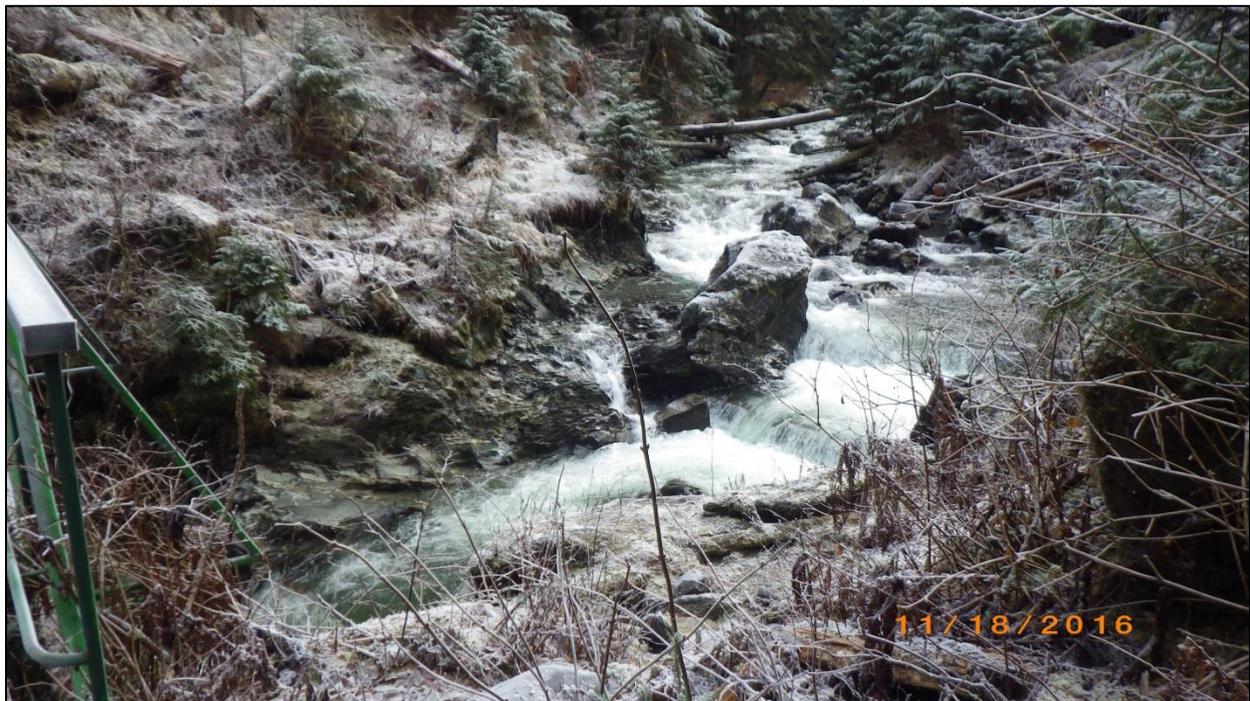
The fish pass was functioning properly and we did not observe debris that could impede fish passage (Figure 1). We did not observe adult coho salmon transiting the fish pass, though it may have been too late in the spawning season. Greens Creek discharge was about 80 cfs at the time.<sup>a</sup>

Figure 1.—Greens Creek fish pass.

1. Revisit the fish pass in spring 2017, per the quarterly monitoring agreement.
2. Investigate fish use in Falls Creek below the B Road bridge in spring 2017.

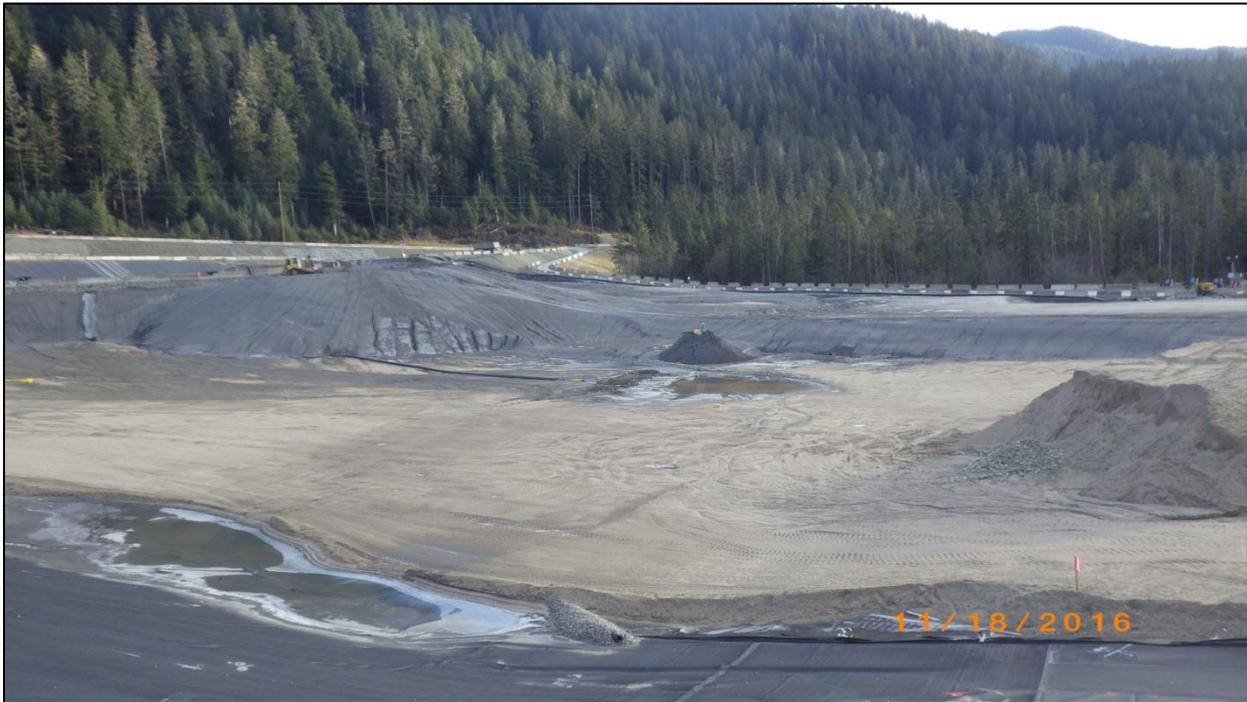
Hecla began disposing tailings in the new 18 acre TDF expansion area in early August 2016 (Figure 2), and Pond 10 construction was nearly complete.

Figure 2.—TDF expansion area and active tailings disposal, looking southeast.

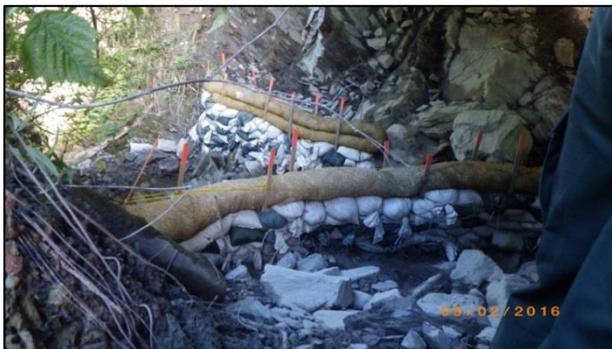
Figure 3.—Falls Creek bridge BMPs on 9/2/2016.

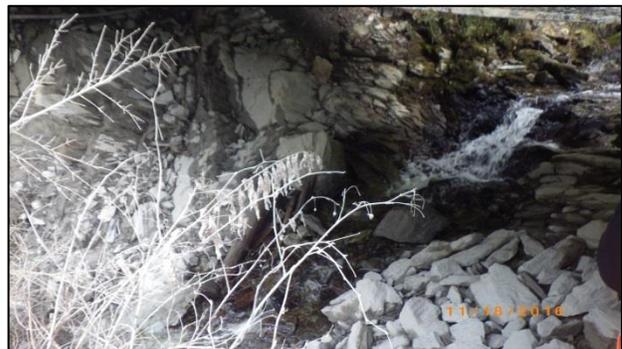
The sediment catchment basins at the toe of the Falls Creek bridge abutments failed and washed downstream since my last visit on September 2, 2016 (Figures 3, 4). Hecla is developing a new plan to prevent fines from the road and bridge entering the creek, a tributary to Zinc Creek (Stream No. 112-65-10230). I surveyed the lower portion of Falls Creek on September 2, 2016 and nominated the water body for inclusion in the 2017 Anadromous Waters Catalog. I will complete the stream survey below the bridge<sup>b</sup> in spring 2017.

Figure 4.—Falls Creek bridge BMPs absent on 11/18/2016.

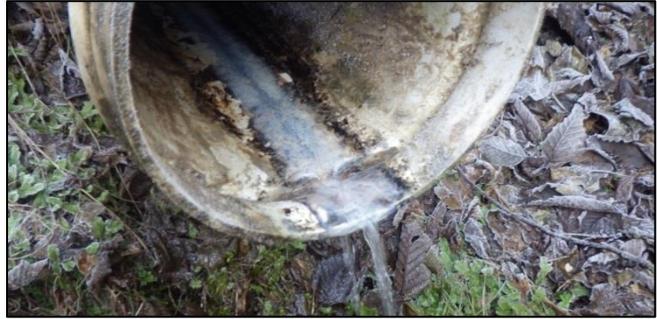
We observed white material along the bottom of a 4 inch plastic pipe draining the Zinc Creek bridge south abutment (Figure 5). USFS staff first noticed the white material during an October 7, 2016 inspection. Hecla Environmental Manager Chris Wallace collected a sample of the white material that he will dry, weigh, and preserve in water for measuring total metals concentrations.

Figure 5.—Zinc Creek bridge abutment drain and white material.

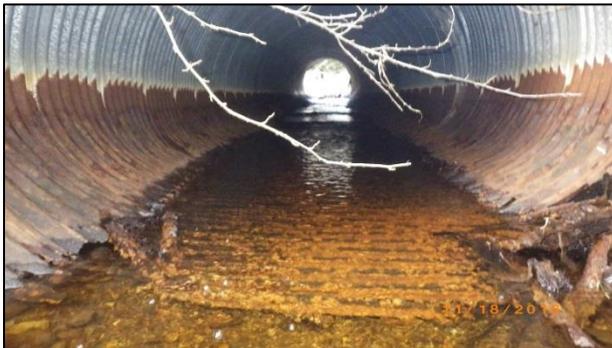
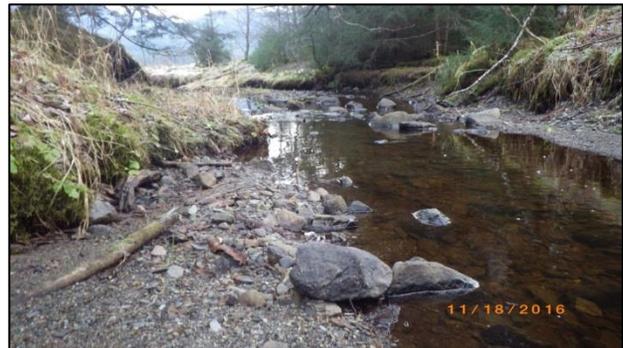
Hecla plans to replace the A Road culvert in Stream No. 111-41-10190<sup>c</sup> during 2017 (Figures 6, 7). The bottom is corroded and broken in several places, causing water to flow beneath the culvert. Habitat Division issued Hecla FH14-I-0109 for the structure, which was installed in the 1980s, and a permit amendment is required for its replacement.

Figure 6.—Stream No. 111-41-10190 culvert outlet, looking upstream.

Figure 7.—Stream No. 111-41-10190 culvert outlet, looking downstream.
