## INSPECTION REPORT: GREENS CREEK MINE

Date of Inspection: Friday, February 3, 2017  
Date of Report: Friday, February 17, 2017  
USDA Forest Service Inspector: Richard Dudek

Ranger District: Admiralty National Monument

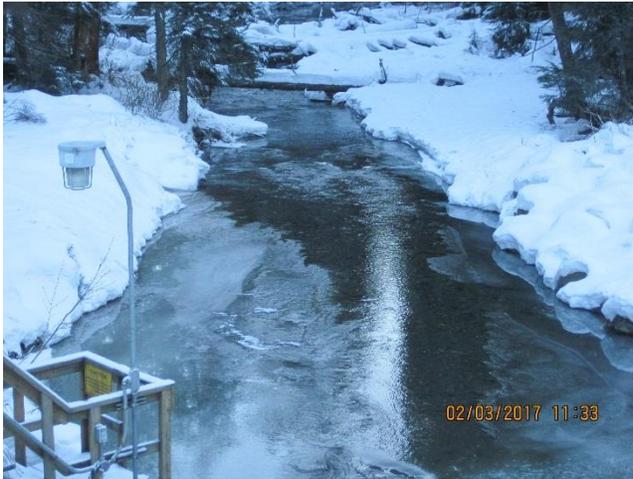
The flow rate for Greens Creek (Photo 1) on 02/03/2017 was 10.2 cubic feet per second (cfs). HGCMC Surface Operations are properly maintaining the 920 Bridge, de-grit basin DB-01 (Photos 2-3), and DB-02 during the winter months. The 920 warehouse storage vans are tidy; all chemical and petroleum products were properly stored within secondary containment (Photo 4). At the 920 ore pad, two ore piles were observed (Photo 5). The purpose for the two piles is to allow for the blending of the ore to minimize inconsistency in the grade. On 1/10/2017, a diesel fuel spill occurred during the refueling of an underground lube truck (Photo 6). Approximately ten gallons of fuel spilled onto the concrete refueling pad. The fuel was immediately removed from the pad using sorbent pads, and contaminated snow and ice was removed and placed in large plastic totes to melt. Sorbent pads were placed inside the large plastic totes to capture any remaining fuel. The meltwater was disposed of in DB-04 which was pumped to Pond 7 for treatment. The sorbent pads used were properly disposed of in a hydrocarbon absorbent tote and shipped offsite.

**Photo 1. An upstream image of Greens Creek.**

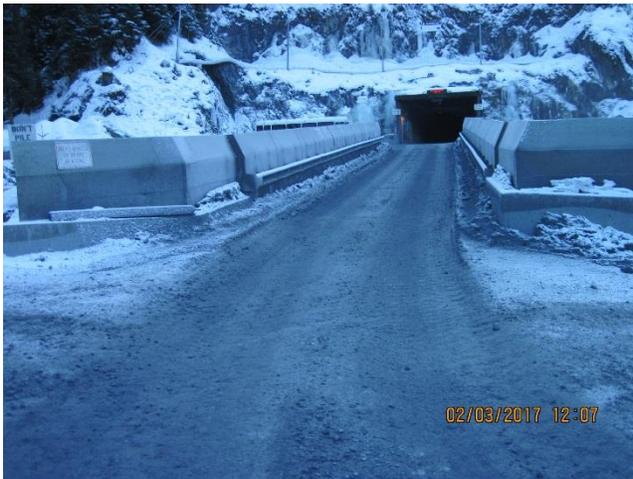
**Photo 2. 920 Bridge.**

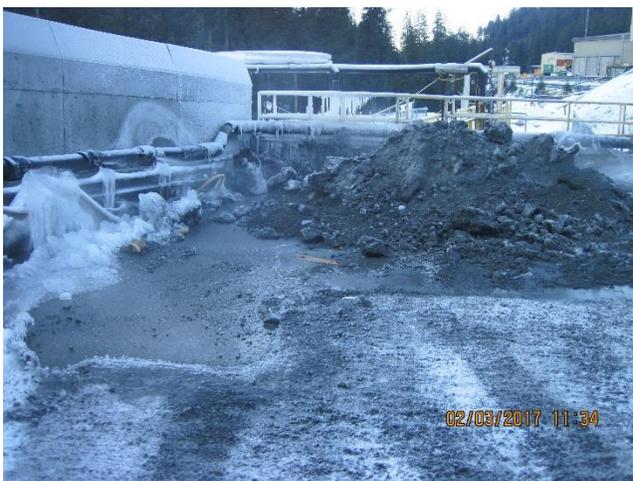
**Photo 3. DB-01.**

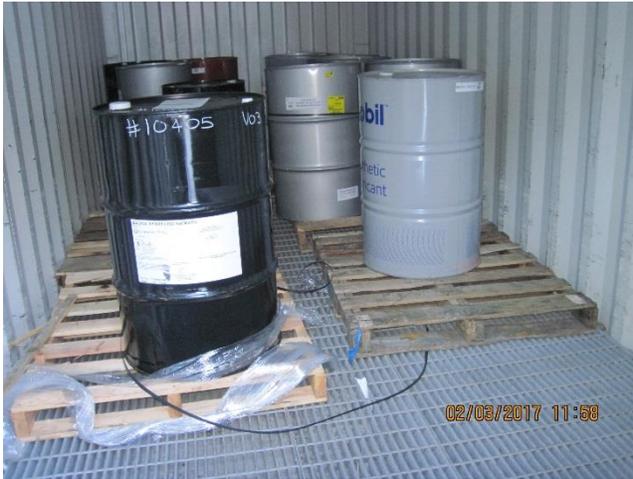
Photo 4. Petroleum products stored within secondary containment.

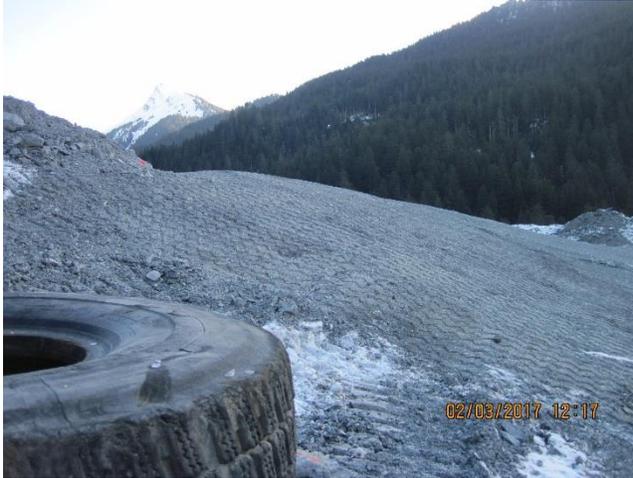
Since the previous inspection on 12/16/2016, additional Class 2/3 waste rock has been stockpiled at Site 23 (Photos 7). Class 2/3 waste rock is stockpiled separately from Class 1 waste rock due to the neutralization/acid generating potential (Appendix 1 Integrated Monitoring Plan page 3-1).

**Photo 7. Class 2/3 waste rock stockpile.**

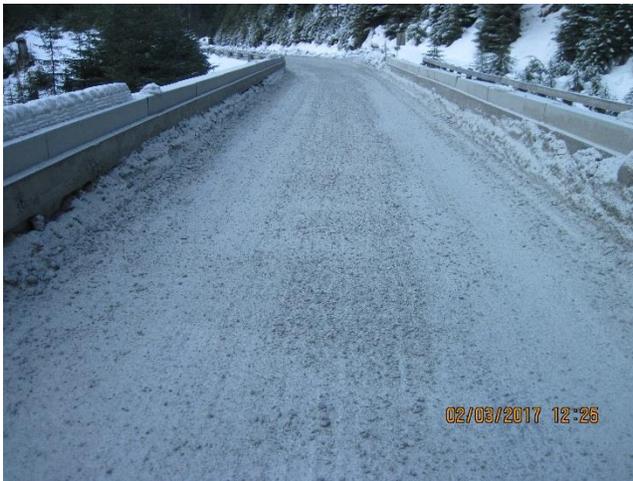
Surface Operations personnel are properly maintaining the bridge decking (Photo 8). Below the bridge, Killer Creek was mostly covered in snow and ice. During the winter months, plowing of snow from the access roads and bridges increases the sediment load at the bridge ends. HGCMC has contracted an engineering firm for sediment mitigation controls for all the bridges.

**Photo 8. 7.4-mile B-road Bridge (Killer Creek Bridge).**

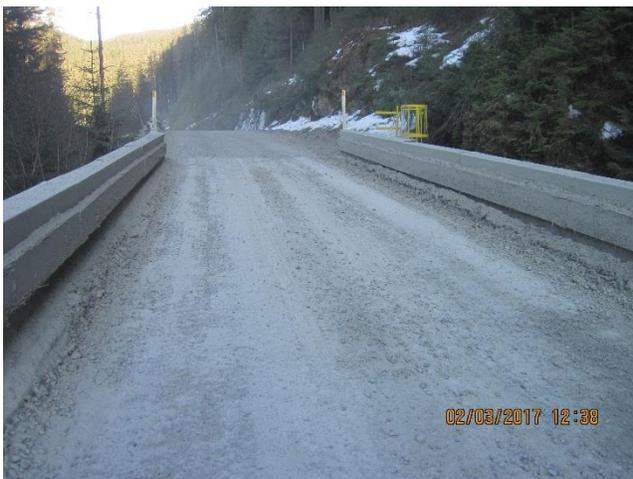
**Photo 9. Falls Creek Bridge (3.4 mile B-road).**

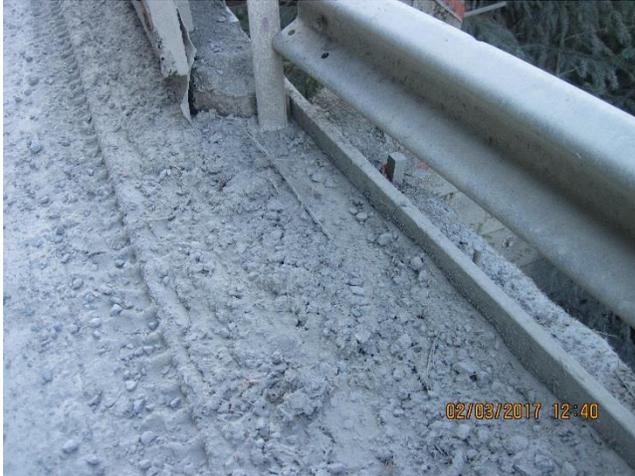
- Falls Creek Bridge (3.4-mile B-road): Temporary barrier for sedimentation control has reached its maximum sediment accumulation.

Surface Operations personnel are properly maintaining the bridge decking (Photo 9). However, a temporary sediment barrier located on the downhill/downstream side requires maintenance (Photo 10). This temporary barrier meets the design criteria for silt fencing. When sediment accumulation reaches approximately one-third (1/3) of the fence or barrier height, new fencing is to be installed and or sediments are to be removed (Appendix 5 BMP plan page BMP-12).

**Photo 10. A wooden temporary sediment barrier.**

3.4 mile B-road (Falls Creek Bridge): Temporary barrier sediments have been removed.

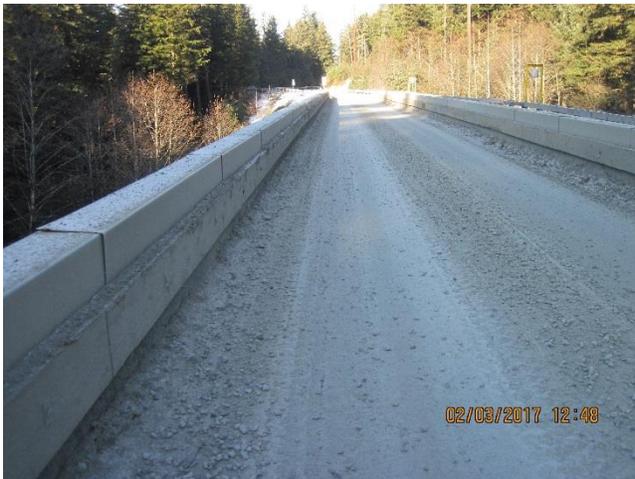
Surface Operations are properly maintaining the bridge decking (Photo 11). The 3.1-mile B-road removable sediment screen and other structural BMPs for sediment mitigation control are frozen over

**Photo 11. Zinc Creek Bridge (3.0 mile B-road Bridge).**

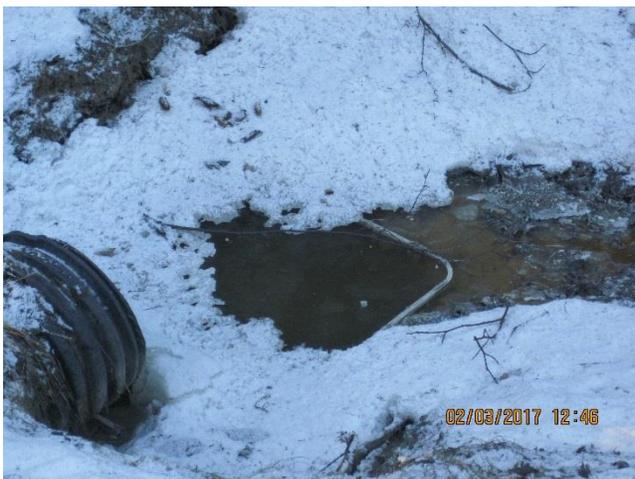
or covered in snow (Photos 12-13). HGCMC has not received the results for the composition for the white precipitate found inside the abutment drain.

**Photo 12. Ice covering the 3.1 mile B-road removable sediment screen.**

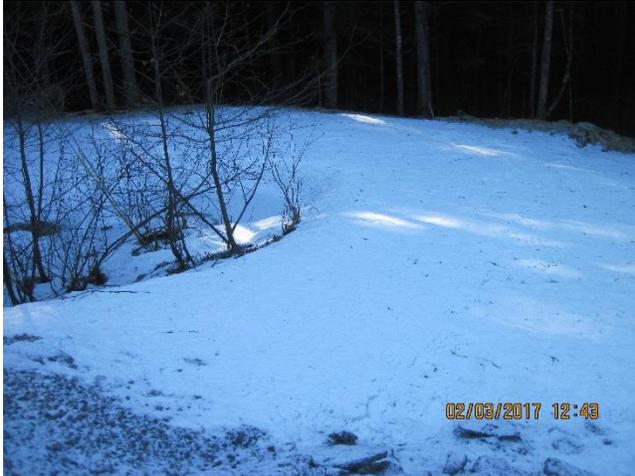
**Photo 13. Snow covered sediment mitigations (Zinc Creek Bridge).**

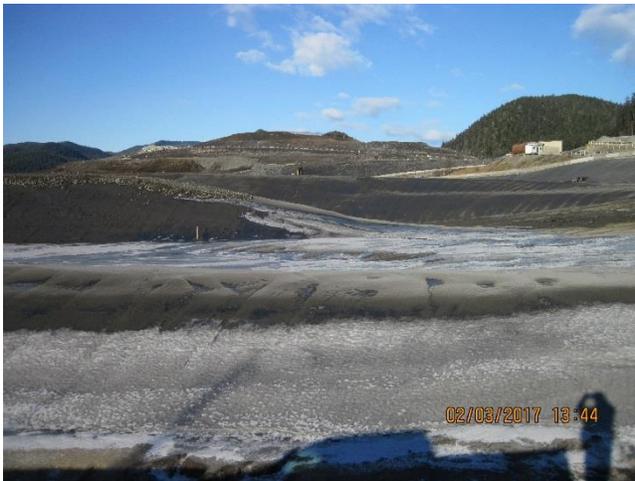
HGCMC continues to place tailings in the eastern section of the S3P1 TDF expansion area (Photo 14). During this inspection, HGCMC was placing tailings along the east ridge of the TDF (Photo 15). The blasted bedrock from Pond 10 construction is being utilized as road fill material within the TDF (Photo 16). HGCMC continues using a number of dust mitigation controls such as water, minimizing active placement areas, and windscreens. Portable windscreens are staged at the crest and southern end of the TDF area (Photo 17-18). Fixed windscreens have been positioned along the southern TDF perimeter access road jersey barriers (Photo 19). The TDF treatment plant was treating 700 gallons of water per minute (gpm). The TDF water treatment facility was tidy and in order.

**Photo 14. S3P1 eastern section of the TDF expansion.**

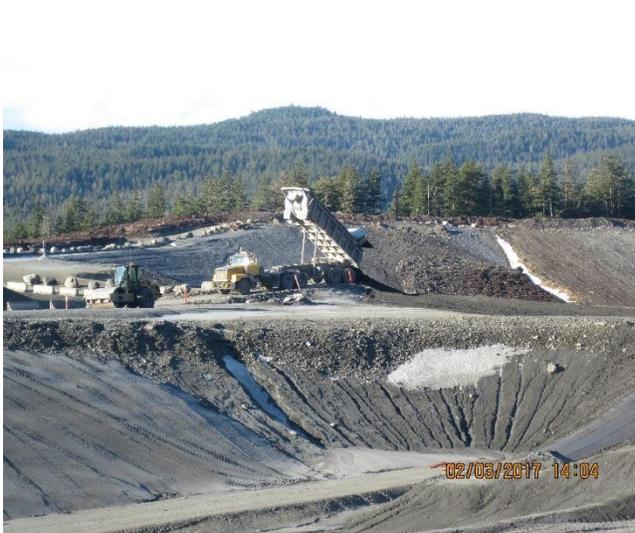
**Photo 15. Tailings are placed along the eastern ridge of the TDF.**

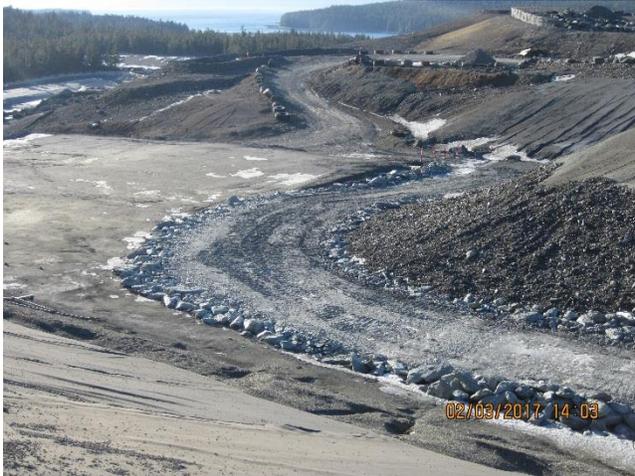
**Photo 16. Blasted bedrock is being utilized as road fill material at the TDF.**

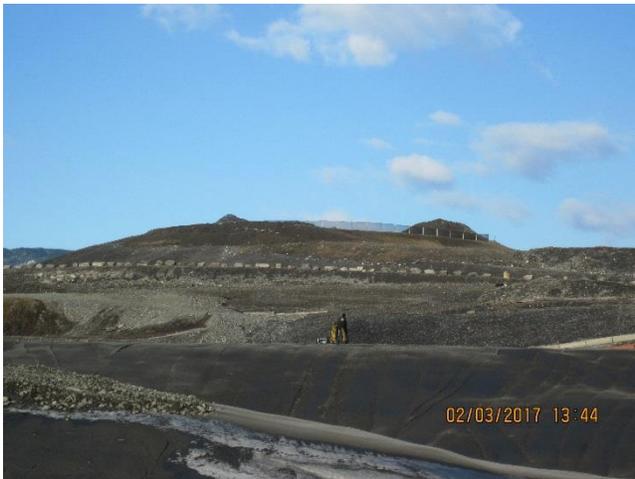
**Photo 17. Portable windscreens are staged at the crest of the TDF.**

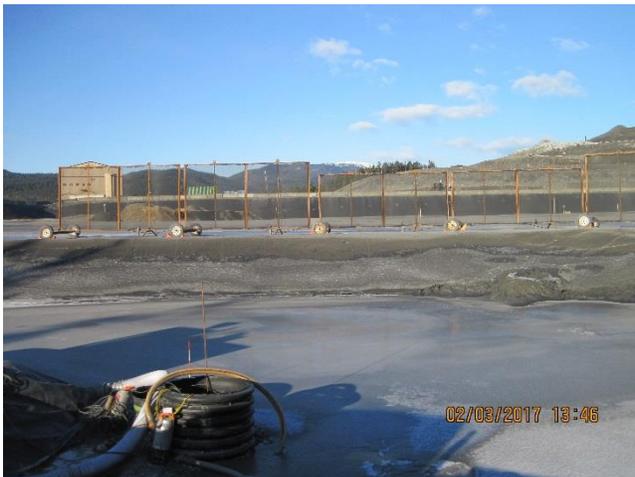
**Photo 18. Portable windscreens staged at the southern end of S3P1 TDF expansion area.**

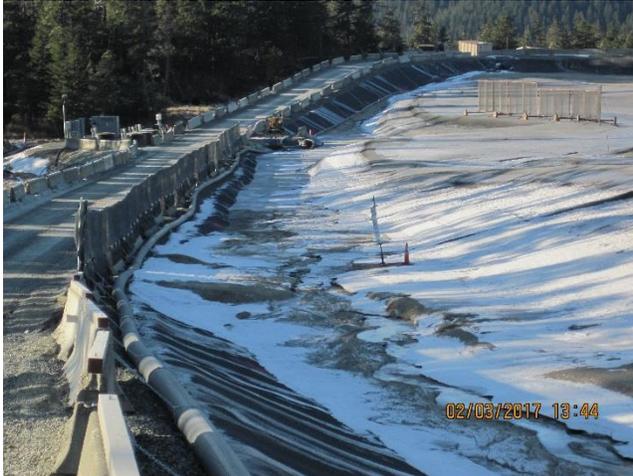
**Photo 19. Fixed windscreens and portable windscreens are staged at the southern end of the S3P1 TDF expansion area.**

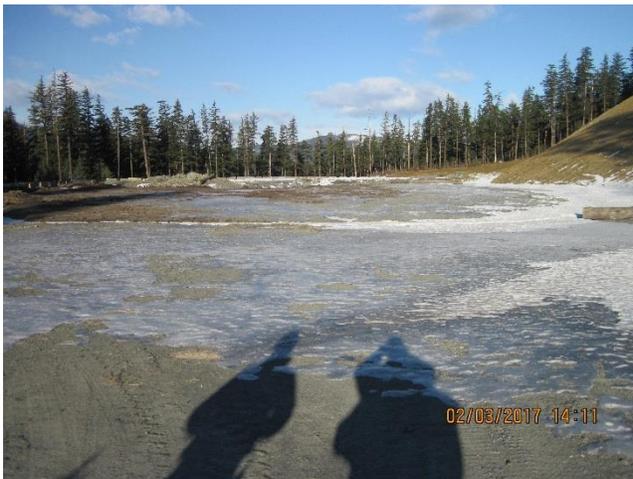
The Sand pit is inactive during the winter months (Photo 20).

**Photo 20. Sand Pit (1.4 mile A-road).**
