## INSPECTION REPORT: GREENS CREEK MINE

Date of Inspection: Friday, March 17, 2017  
Date of Report: Friday, March 31, 2017  
USDA Forest Service Inspector: Richard Dudek

Ranger District: Admiralty National Monument  
Weather Conditions: Slight wind and cloudy. Temperature: Low to 30's (°F).

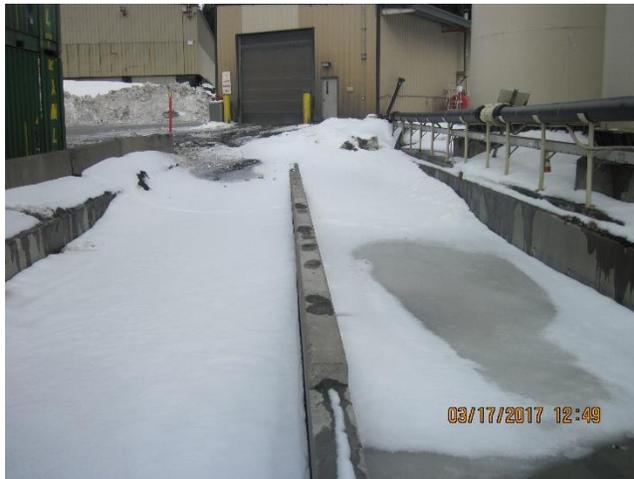
Surface Operations personnel are properly maintaining DB-04 (Photo 1). The melt water is sent from DB-04 to Pond-7 for treatment and discharge under the APDES permit. All of the sediments collected at all the degrit basins are disposed of in the TDF.

**Photo 1. DB-04 located at the Hawk Inlet port facilities.**

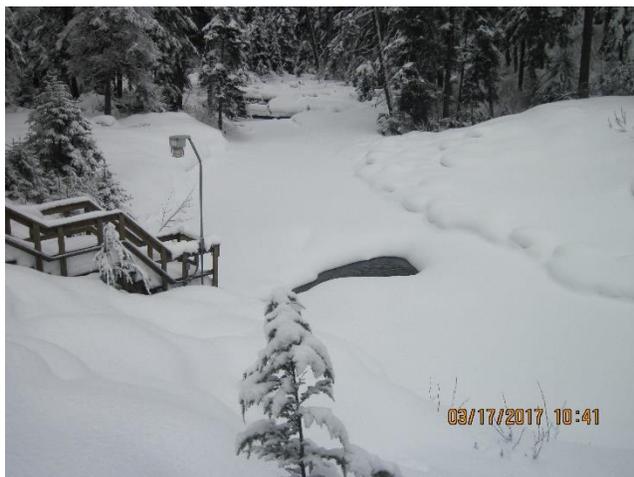
The flow rate at the Greens Creek weir (Photo 2) on 03/17/2017 was 4.0 cubic feet per second (cfs). Prior to water withdrawal the creek flow was 5.5 cfs. The 920 bridge (Photo 3) and DB-01 (Photo 4) are being properly maintained. DB-02 (Photo 5) is operational; however, the misting system was not in use during the inspection. All melt water from DB-01 and 02 is sent to Pond-A, then routed to Pond-7 for treatment and discharged under the APDES permit. The 920 warehouse was tidy and in order (Photo 6). At the 920-ore pad, HGCMC continues to have two stockpiles of ore (Photo 7). One stockpile is the current end dumping location and the other stockpile is for the mill hopper. This ensures a consistent reagent concentration, which will maximize metal recovery.

**Photo 2. Greens Creek.**

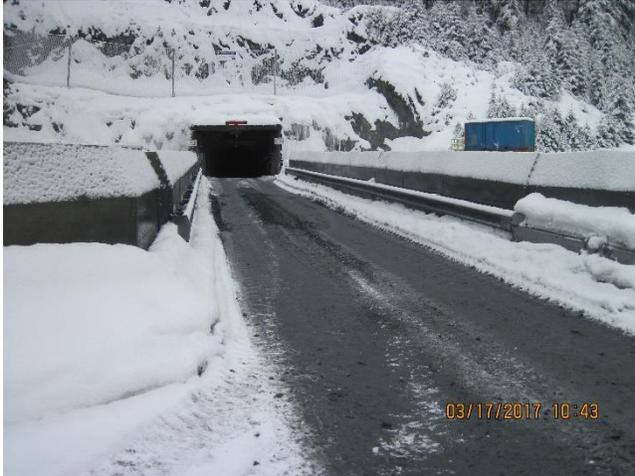
**Photo 3. 920 Bridge.**

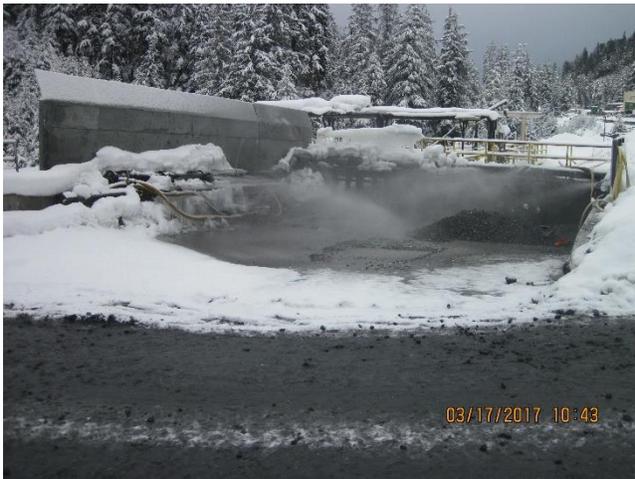
**Photo 4. 920 area DB-01.**

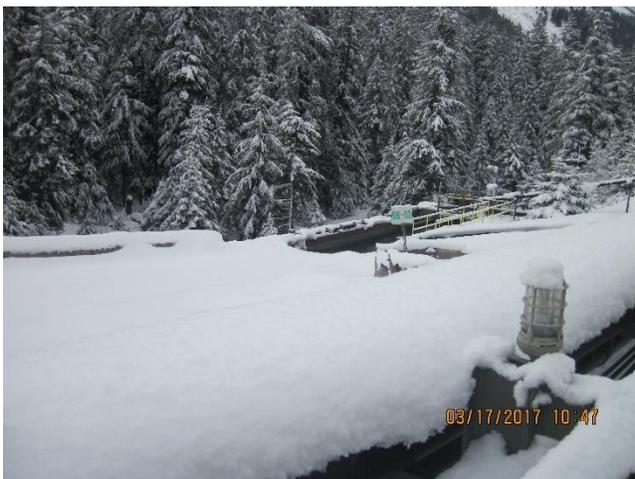
**Photo 5. DB-02**

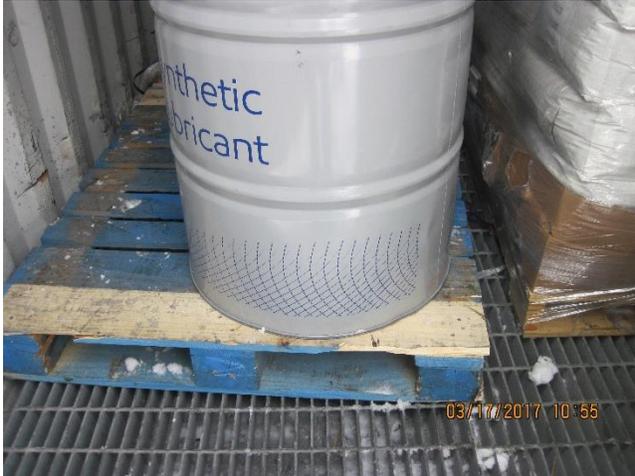
**Photo 6. A 55-gallon barrel of synthetic lubricant stored within secondary containment (920 warehouse).**

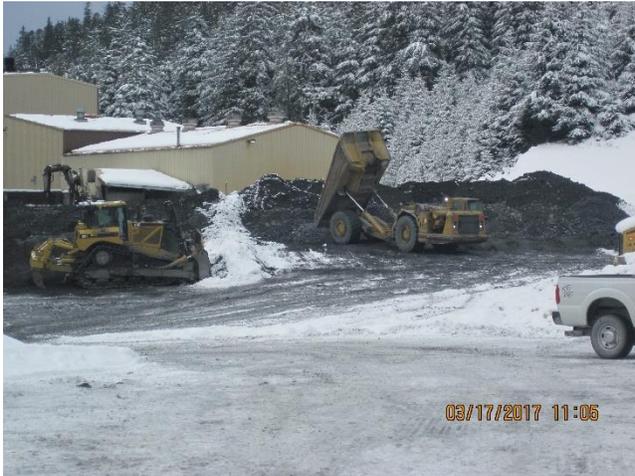
Drainage improvements for the 920 ore pad/920 warehouse area are scheduled for this summer.

**Photo 7. 920 ore pad.**

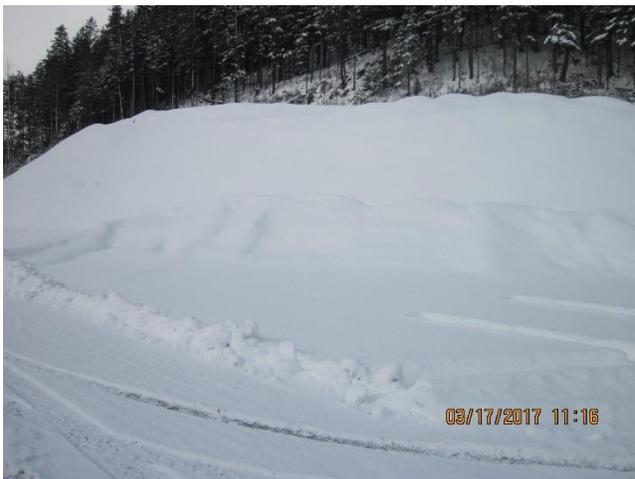
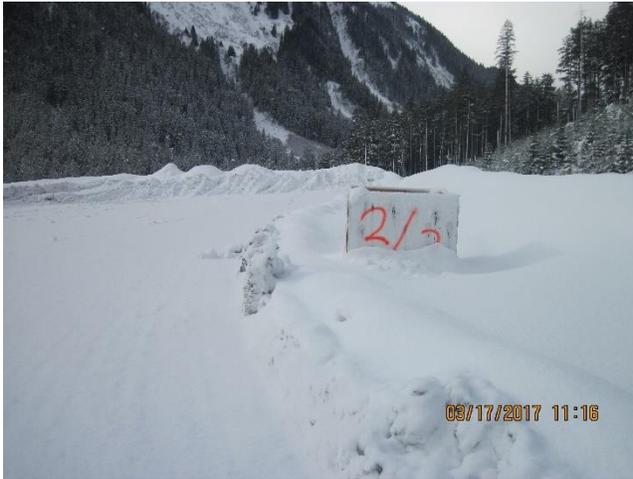
This site was inactive and covered in snow (Photos 8-9).

**Photo 8. Site 23 Class-1 waste rock stockpile.**

**Photo 9. Site 23 Class 2/3 stockpile.**

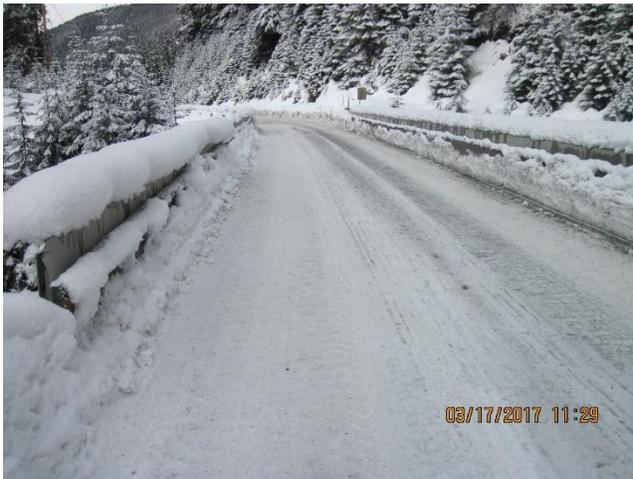
Surface Operations personnel are properly maintaining the bridge decking (Photo 10). Below the bridge, Killer Creek was mostly covered in snow and ice. Increased road sediment accumulation at the bridge ends is due to snow plowing of the access roads. HGCMC has contracted an engineering firm for sediment mitigation controls for all the bridges.

**Photo 10. 7.4-mile B-road Bridge (Killer Creek Bridge).**

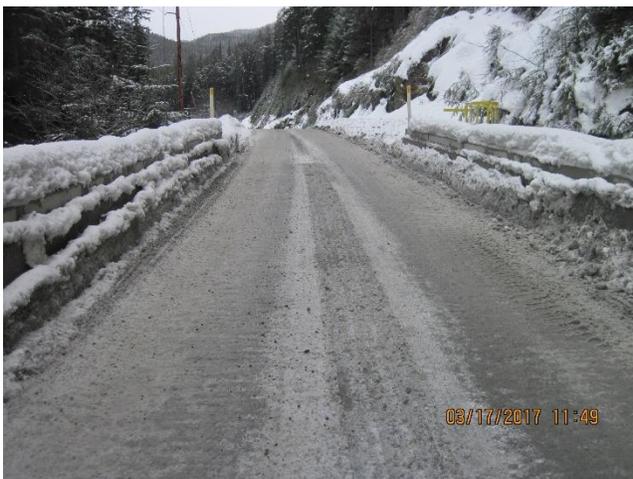
Surface Operations personnel are maintaining the bridge decking (Photo 11). Below the bridge, snow and ice covered Falls Creek.

**Photo 11. 3.4-mile B-road Bridge (Falls Creek Bridge).**

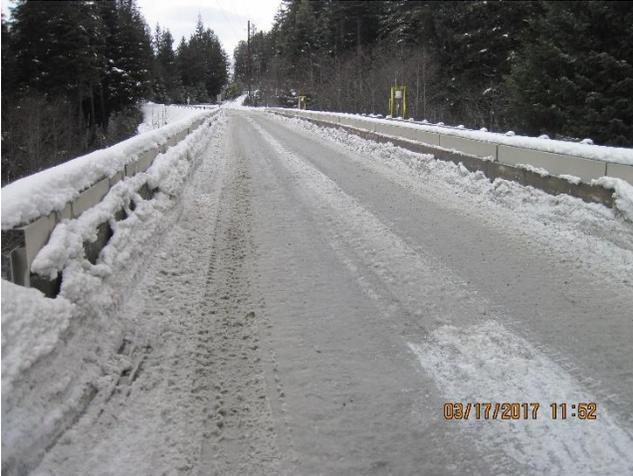
Surface Operations are maintaining the bridge decking (Photo 12). The 3.1-mile B-road removable sediment screen and the uphill/downstream side sediment mitigation controls are covered in snow (Photo 13).

**Photo 12. 3.0-mile B-road Bridge (Zinc Creek Bridge).**

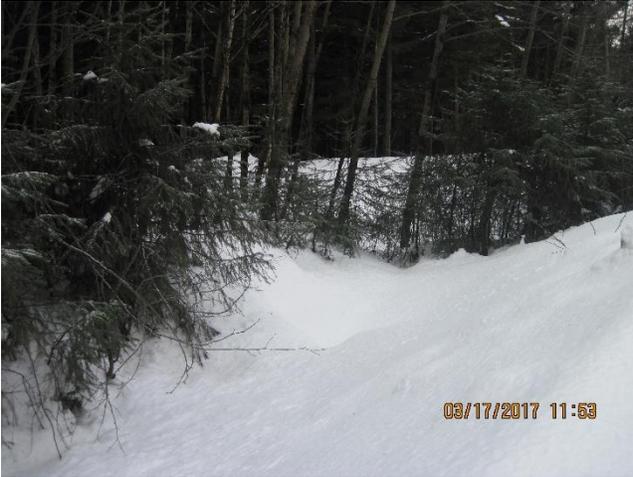
**Photo 13. The 3.1-mile B-road removable sediment screen is covered in snow.**

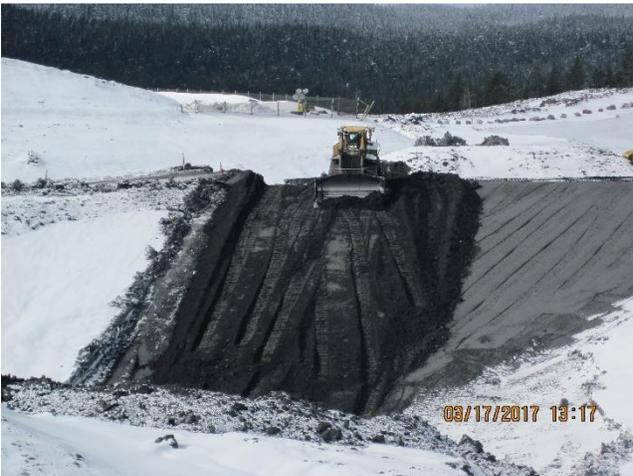
HGCMC continues to place tailing at the East Ridge expansion of the TDF (Photo 14). HGCMC continues using a number of dust mitigation controls such as water, minimizing active placement areas, and windscreens. Portable and fixed windscreens are staged at the crest and southern end of the S3P1 TDF expansion area (Photos 15-16). The TDF water treatment plant (Photo 17) was discharging 367 gallons of water per minute (gpm).

**Photo 14. A bulldozer is spreading tailings in the East Ridge Expansion portion of the TDF.**

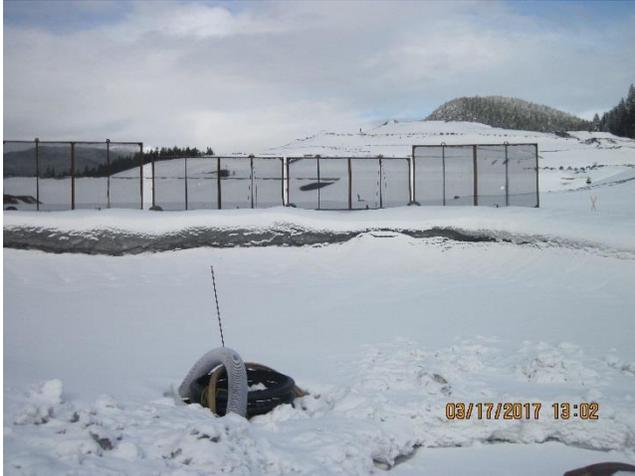
Photo 15. Portable windscreens staged at the crest and southern end of the TDF.

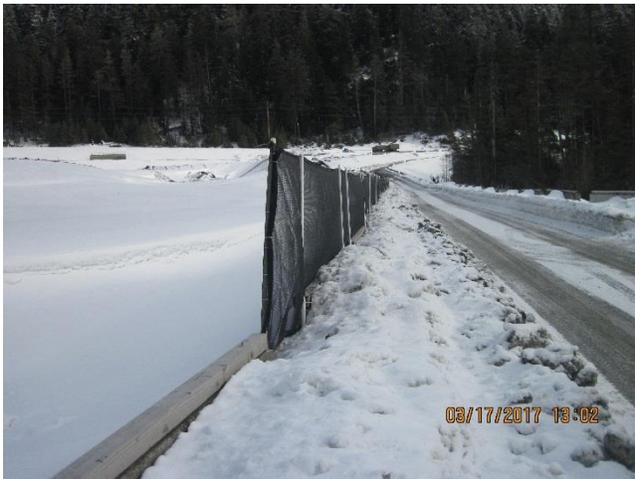
Photo 16. Fixed windscreens are staged along the jersey barriers at the southern end of the S3P1 TDF area.

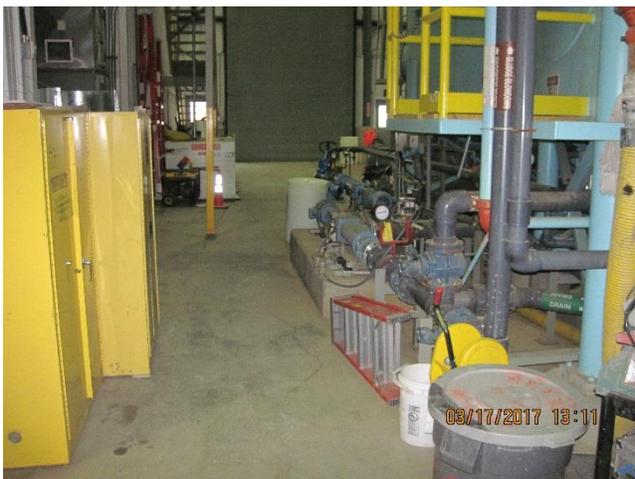
Photo 17. HGCMC's water treatment plant.

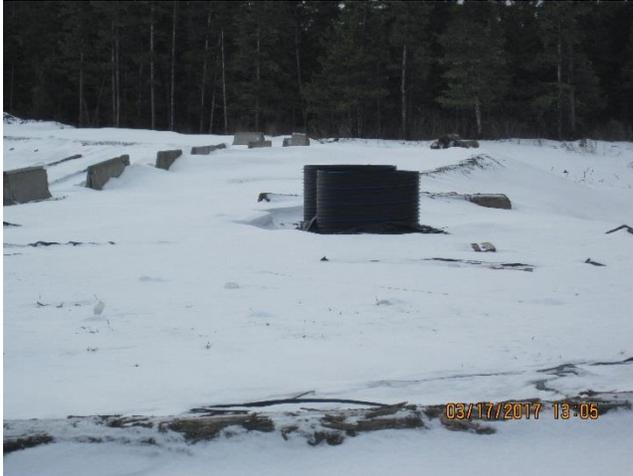
Two caissons were installed at the end of the 2016 construction phase for Pond 10 (Photo 18). The caissons or wet wells are for collecting water above and below the liner. Wet well 10 collects water above the liner and wet well 11 collects water below the liner. When Pond-10 is completed, the water will be collected for treatment, and then discharged under the APDES permit. The two caissons (wet wells) are not in operation.

**Photo 18. Pond-10 caissons (wet wells).**
