I. Introduction

This 2011 Best Management Practices (BMP) and Storm Water Report is submitted by Hecla Greens Creek Mining Company (HGCMC) pursuant to Sections II.F.1 and II.F.2 of NPDES Permit AK-004320-6, effective 1 July 2005. Authority over the federal permitting, compliance and enforcement NPDES program transferred to the State (ADEC) in November of 2010 for the mining industry. The Report summarizes the scope and dates of the comprehensive site compliance inspections/evaluations, major observations related to implementation of the BMP Plan, corrective actions taken as a result of the inspections/evaluations, identification of potential incidents of noncompliance as they pertain to the BMP Plan, description of the quantity and quality of the storm water discharged, and BMP Plan modifications made during the year. The final section of this report contains the required annual certification under Section II.F.2.

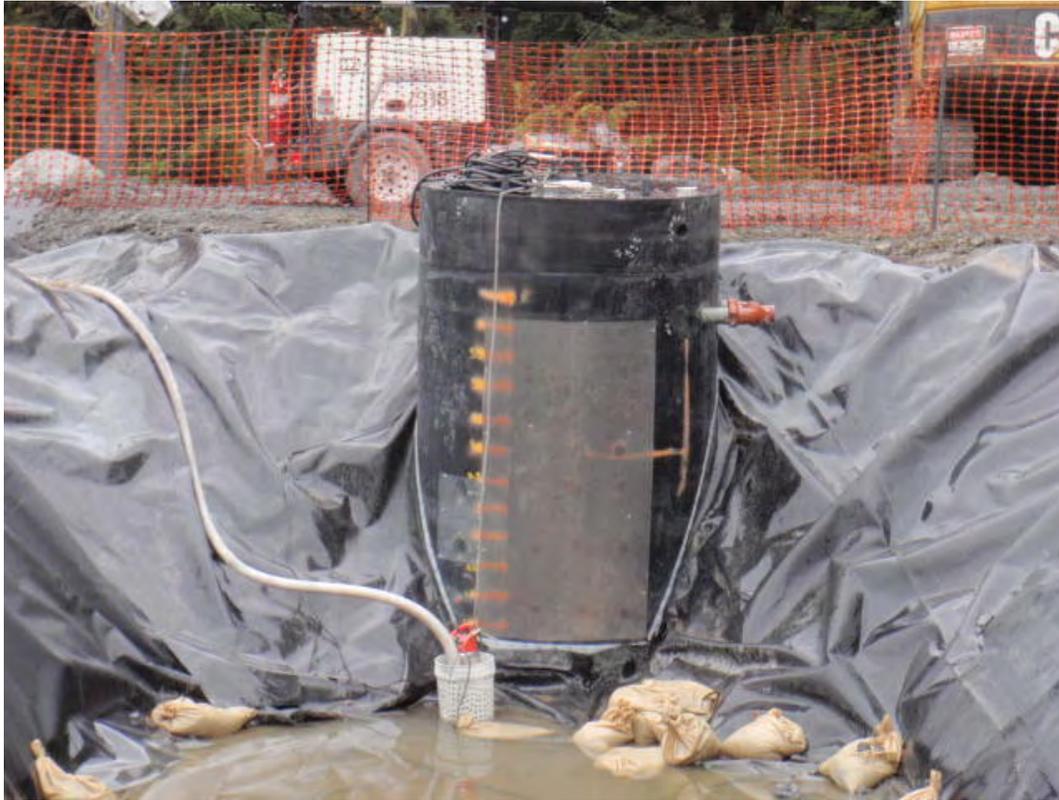
An intermittent seep was observed on the exterior of the lower C Pond berm, indicating that the Pond C pumpback system in the lower pond was not operating effectively. To address this, work completed at Pond C in 2011 included lining the upper pond and installing a pump system. The upper Pond C area was excavated and an underdrain, lined collection pond, caisson, and duplex pump system were installed (see Photo 1). The lower Pond C caisson now pumps to upper Pond C which is then pumped to the Site 23 ditch along the B Road which reports to treatment. As of December 2011, the routed stormwater flow from the B Road routes to the lower Pond C. This flow will be rerouted to the upper Pond C in 2012. Metering capabilities and freeze protection modifications to the upper pond piping system will be implemented in 2012.

PHOTO 1. New Upper Pond C Caisson, September 2011

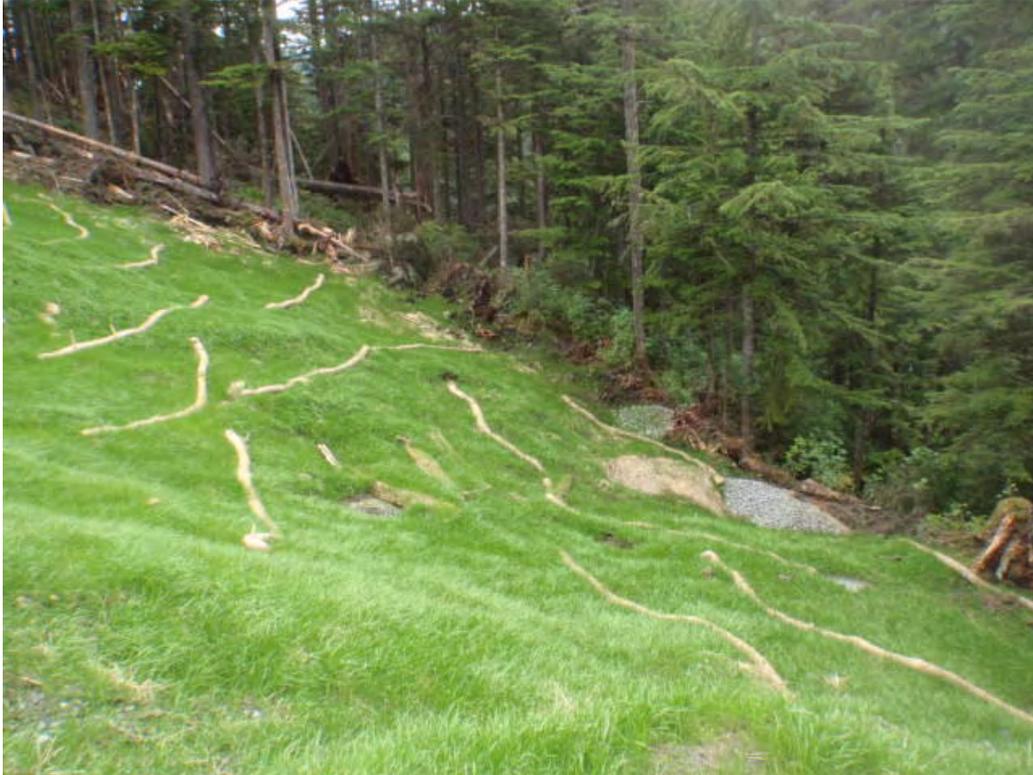
Approximately 13,000 cubic yards of waste rock was removed from the 1350 site in 2011 (see Photo 2). Excavation and haul activities were performed from 10 June through 9 July 2011 by the HGCMC surface operations department. Access road preparation initiated several days prior to the haul and included re-grading of the road, Jersey barrier installation, and re-establishment of rock check dams from the 920 area to the 1350 portal. Installation of guardrail was installed along steeper sections of the access road. Due to the steep slopes of the areas worked and the potential for significant soil erosion, all 2011 disturbed areas were hydroseeded rather than allowing natural revegetation.

PHOTO 2. Site 1350 Post Removal Area (hydroseeded), August 2011

Proposed haulage for 2012 is 15,000 cubic yards. Along with removal activities, there will be continued grading efforts to ensure that contact water from this area is routed to collection at the 1350 portal. Material from this site is transported to the temporary holding pad at Site 23, mixed with lime, and taken underground for permanent disposal when void space becomes available.
