# INSPECTION REPORT

Alaska Department of Environmental Conservation

**PHOTO ADDENDUM – KENSINGTON TAILINGS DISPOSAL FACILITY –DECEMBER 10, 2009**

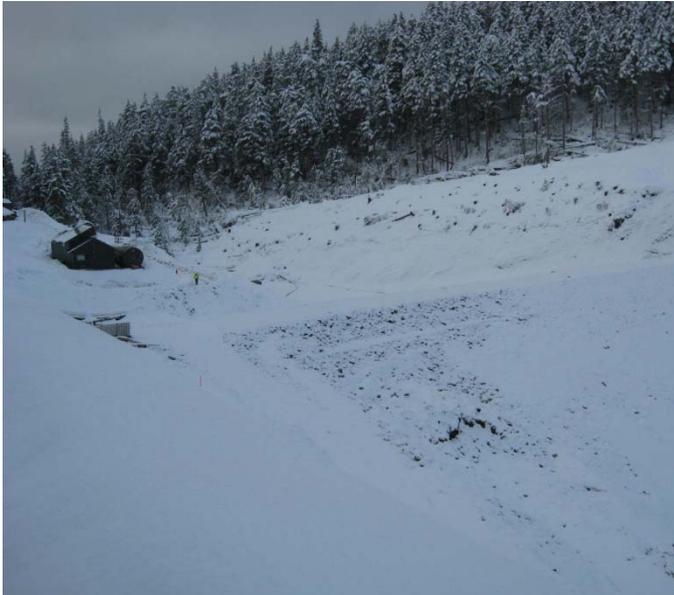
**PHOTO 1. DAM SITE FROM TTF SIDE**

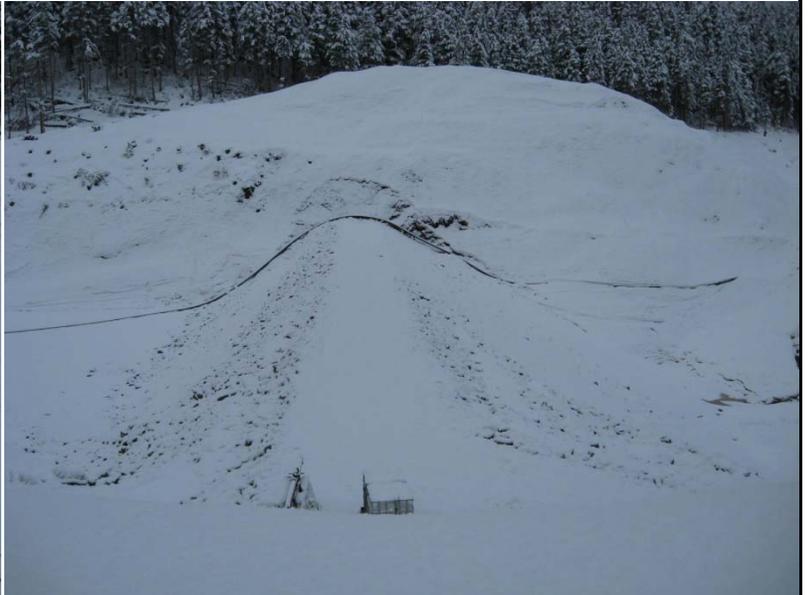
The dam has been constructed to the final Phase 1 elevation of 690 ft. The trench has been excavated for the Upper Slate Lake bypass pipe Parshall Flume. Over 50% of the pipeline and services trench has been excavated. At the time of the visit 6000' of trench was open and ready for pipelaying.

**PHOTO 2. DAM FROM EAST EMBANKMENT**

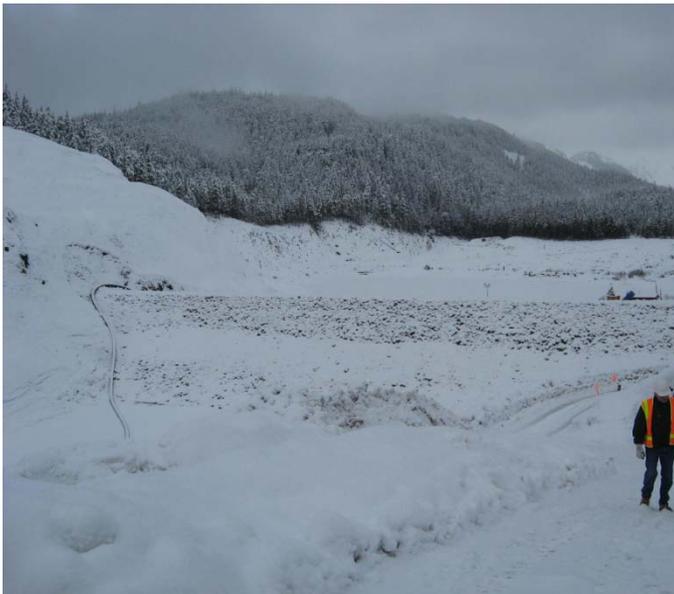
**PHOTO 3. DAM SITE FROM DOWNSTREAM SIDE**

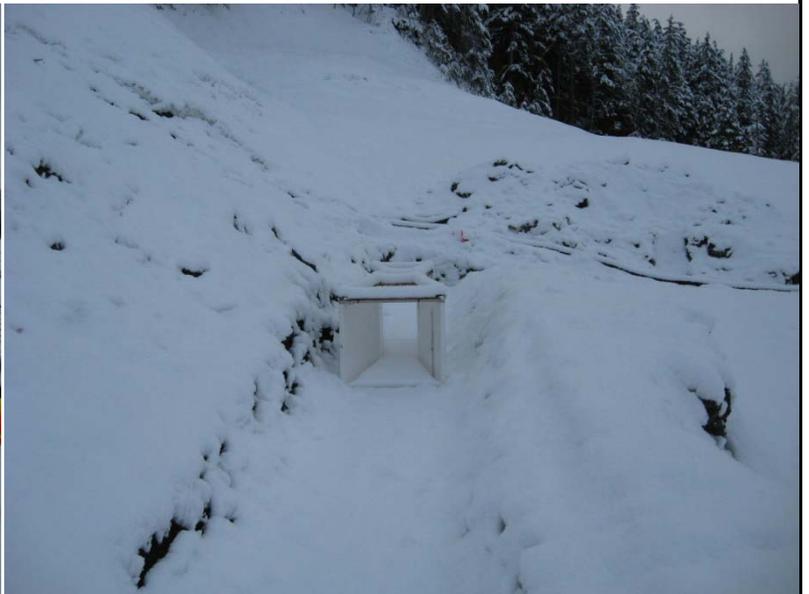
The trench for the bypass pipe channel and Parshall Flume had been excavated, but there was no work being done on it at the time of the site visit. The Parshall Flume had been put in position, but it will be lifted out and set into concrete when the channel is formed.

**PHOTO 4. TRENCH AND PARSHALL FLUME FOR USL BYPASS**

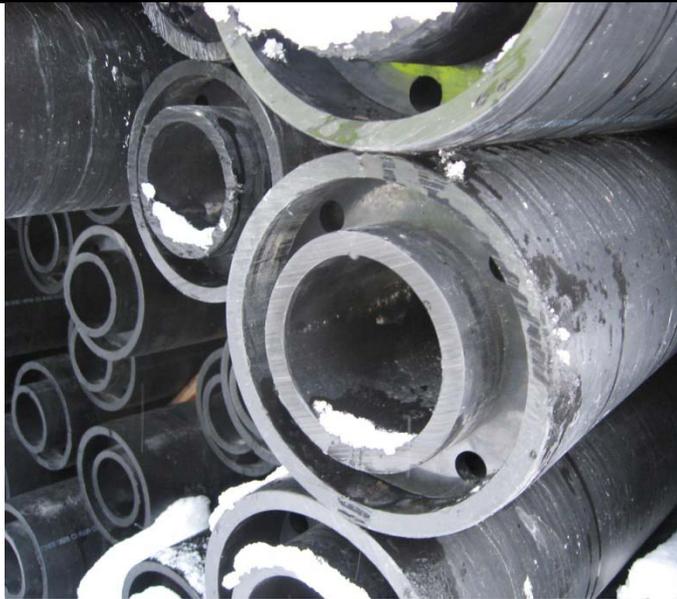
PHOTO 5. DOUBLE-WALLED TAILINGS PIPE

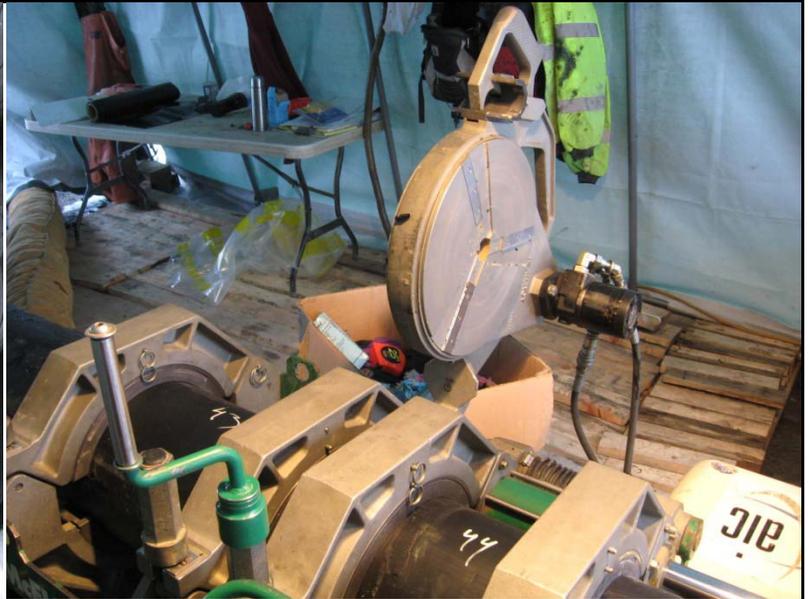
PHOTO 6. PIPE TRIMMER/WELDER

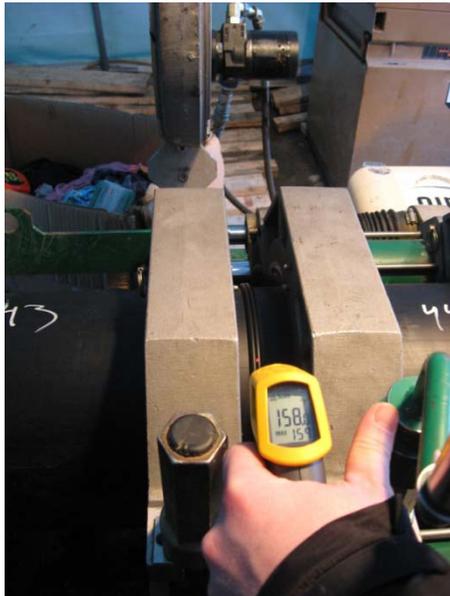
PHOTO 7. JOINT COOLING DOWN

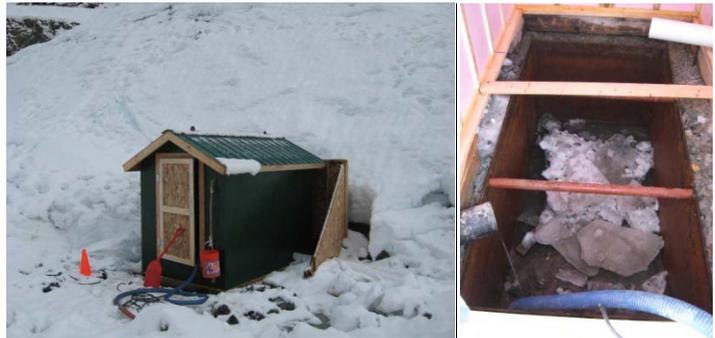
The small shed was in place over the sump to allow easy access to the sump and protection from the elements. Water from the remediation cell was trickling into the sump and being pumped to the 20,000-gallon storage tank. There was no flow from the pipe capturing seepage water from the graphitic phyllite pile.

PHOTO 8. HUT AT GRAPHITIC PHYLLITE AND SUMP
