INSPECTION REPORT

Alaska Department of Environmental Conservation

Name and Location of Site/ Facility Inspected		Entry Time	Permit Effective Date												
Tailings Treatment Facility (TTF) dam construction and Acid Rock Drainage area adjacent to LSL. Comet WTP expansion		10:20	September 1, 2005												
		Exit Time 12:30	Permit Expiration Date August 31, 2010												
Loc: Lat: 58d 49' 58"N Long: 134d 57' 58"W Source: NPDES permit															
On-Site Representative		Additional Participants:													
Kevin Eppers, Env. Superintendent, Jeff Stacy, Coeur Construction Manager		Chad Hood, USFS													
Responsible Official(s):															
Clyde Gillespie, Surface Operations Manager, Kevin Eppers, Environmental Superintendent x Contacted

PHOTO ADDENDUM – KENSINGTON TAILINGS DISPOSAL FACILITY –APRIL 15, 2010

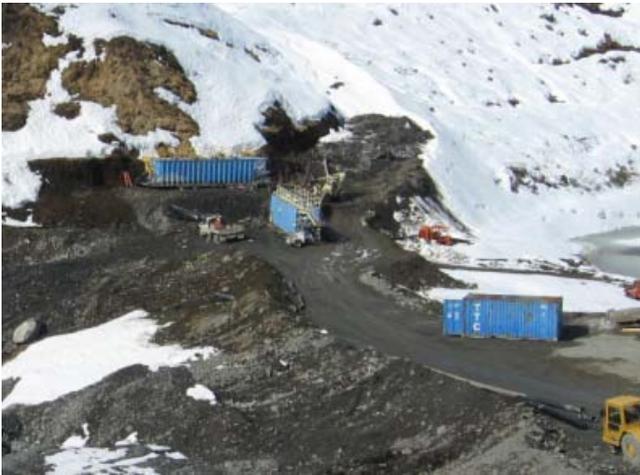
Rain for Rent portable treatment units are in place at the base of the dam (Photo 1). They are planned to be operational in 4-5 days.

PHOTO 1. RAIN-FOR-RENT TANKS AT FAR SIDE OF DAM

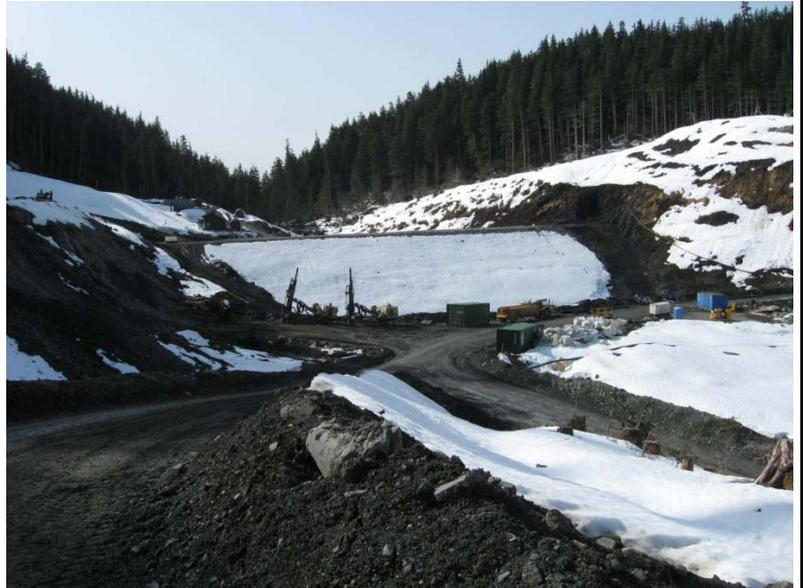
Drill rigs are ready to commence grouting around the dam (Photo 2); the tentative schedule to start this is next Wednesday.

PHOTO 2. GROUT DRILL RIGS AT BASE OF DAM

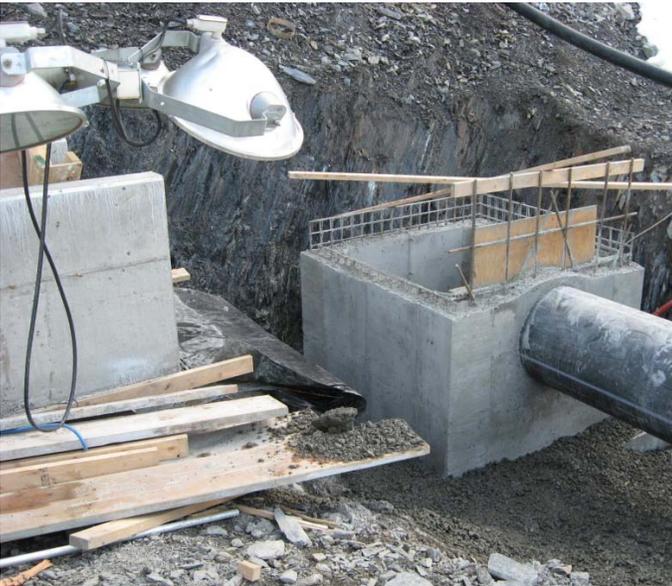
Work was under way on the bypass Parshall Flume and chamber for the pipe connection (Photo 3). The pipe had been laid from the chamber down the hillside and under the road (Photo 4).

PHOTO 3. BYPASS PARSHALL FLUME/PIPE CONNECTION

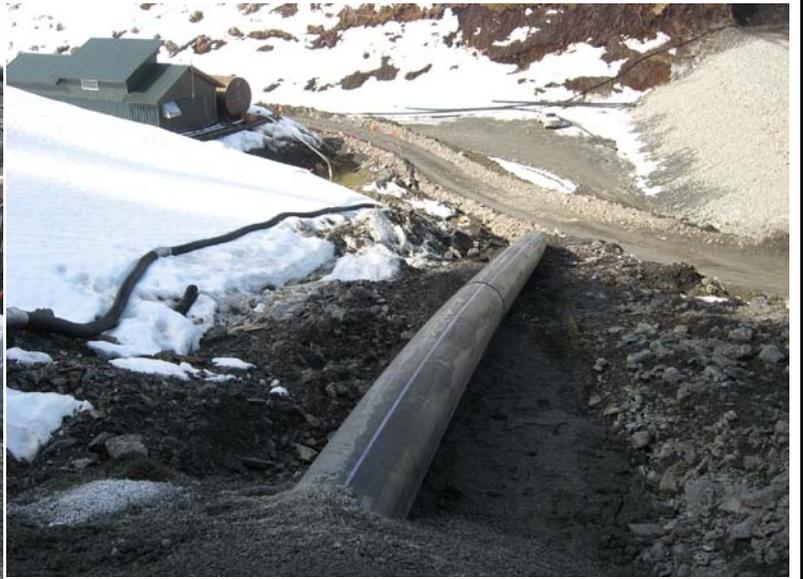
PHOTO 4. BYPASS PIPE AFTER PARSHALL FLUME GOING DOWN THE HILLSIDE.

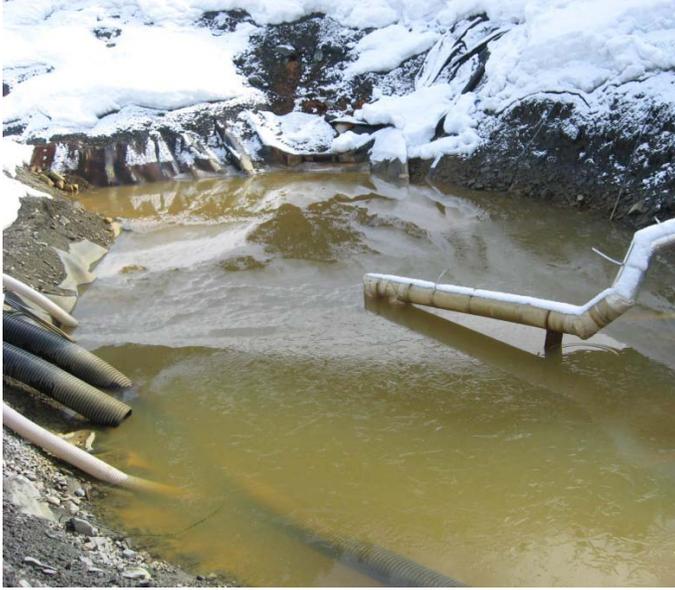
Water was standing in the sump and the polyethylene liner was below the level of the water (Photo 5). It also appears to be lapped, rather than welded, but this may have been an artifact of what could be observed. This liner should be re-established to prevent outflow of collected seepage water into the surrounding rock containment. The plant operator said there was water in the sump because it had just been brought over from the ARD seepage collection tank at Pit 4 for treatment in the facility. The pH of the water from Pit 4 was said to be around 7.0. The plant was operating at approximately 29 gpm.

PHOTO 5. ARD SUMP BELOW SEEP WTP

1. Re-locate the liner in the ARD seepage water collection sump and ensure it makes a watertight seal such that it is able to contain the water.
2. Remove sediments from Pond 1 as soon as convenient.

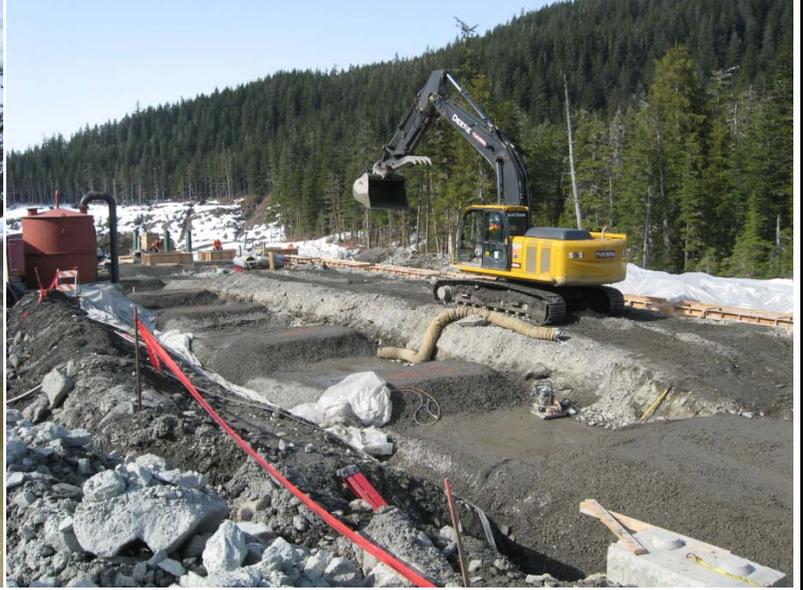
Preparatory work was underway at the TTF treatment plant, placing and compacting rock under the footings for the walls (Photo 6). The proposal is to pour concrete for the foundation next Tuesday.

PHOTO 6. PREPARATION FOR TTF TREATMENT PLANT WALL FOUNDATION

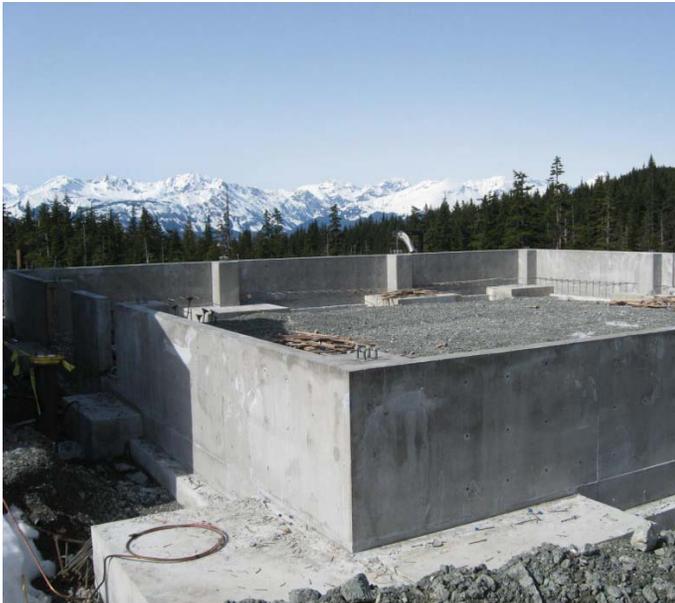
The concrete foundation and stub walls had been constructed (Photo 7). There is a considerable amount of sediment that has built up in Pond 1 (Photo 8). The vacuum truck removes this sediment and parts are awaited for its repair.

PHOTO 7. COMET WTP EXPANSION

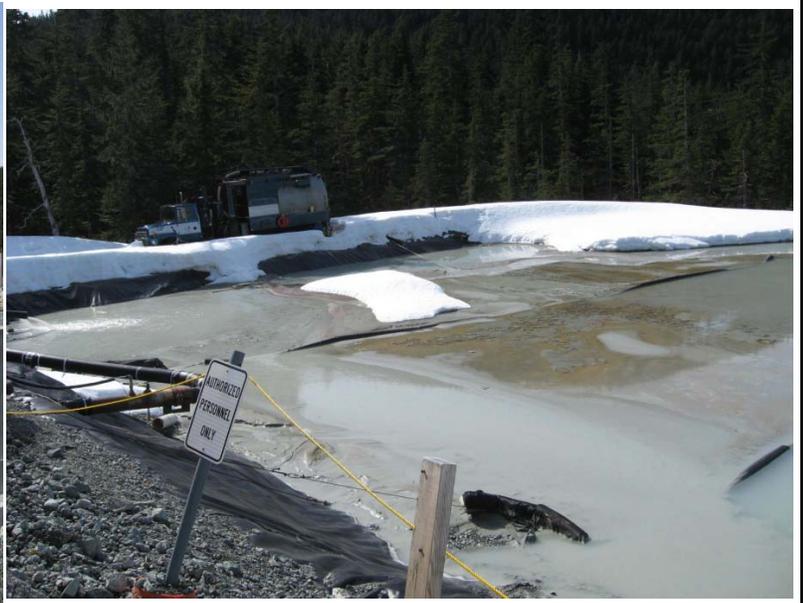
PHOTO 8. SEDIMENT IN POND1 AT COMET WTP
