DEPT. OF ENVIRONMENTAL CONSERVATION
DIVISION OF WATER
WASTEWATER DISCHARGE AUTHORIZATION PROGRAM

INSPECTION FORM – KENSINGTON LSL DAM CONSTRUCTION

Date: September 24, 2009

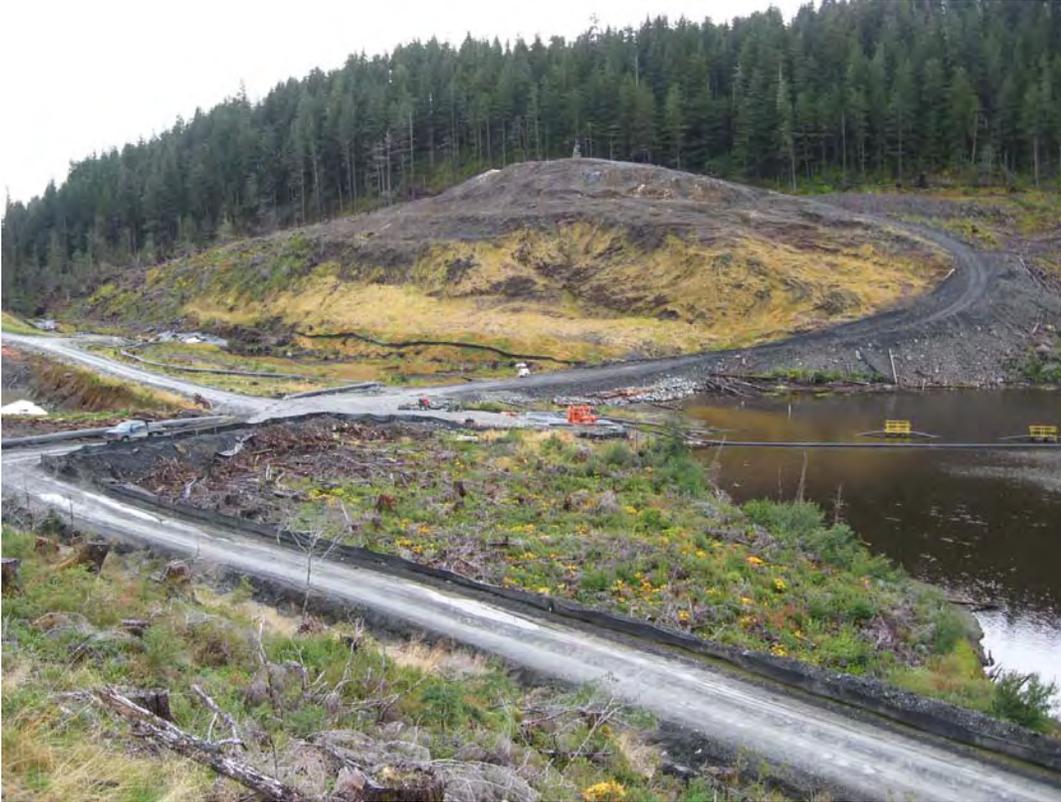
Construction of the cofferdam has been completed (photo 1).

Photo 1 – Cofferdam and dam site

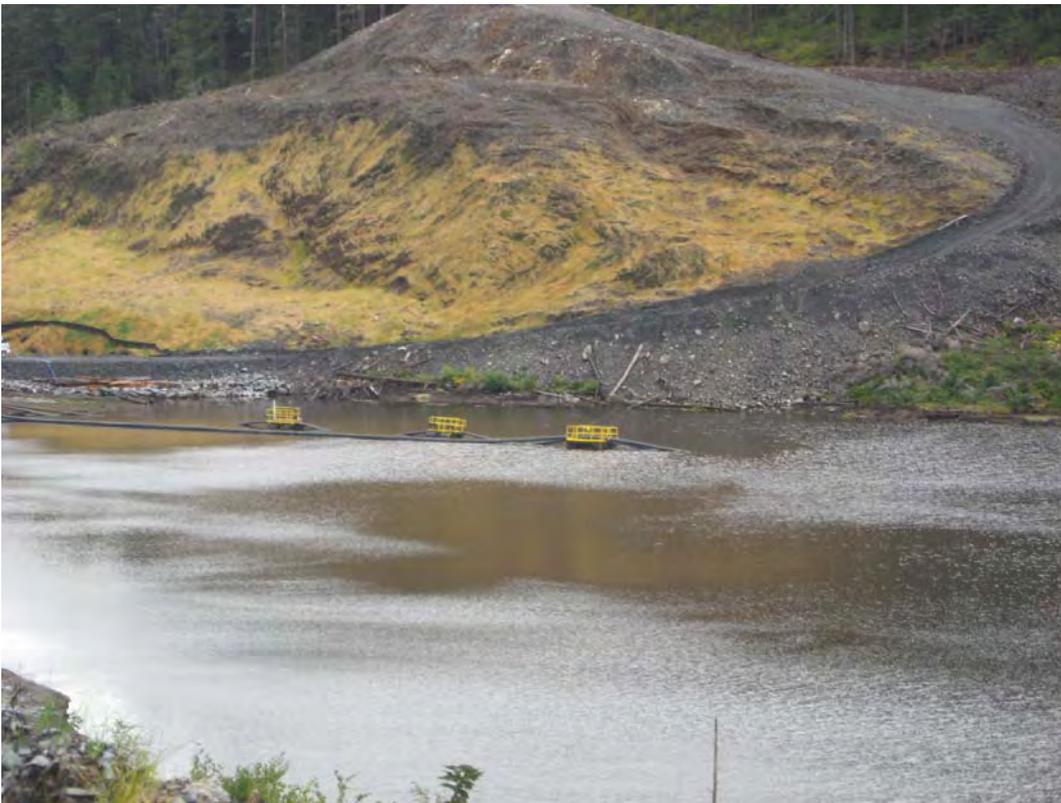
Pumping down LSL (three floats and an unscreened suction 2-5 feet underwater (photo 2). Depth of water at the intake estimated around 20 feet. Discharge is to a large bag placed at the head of East Fork Slate Creek (photo 3) to capture solids. The water level had dropped 3-4 feet; however with the heavy rains the day before, the water level had risen 1 foot. Pumping is at a rate of 6000 gpm.

Photo 2 – dewatering intake and dam west abutment

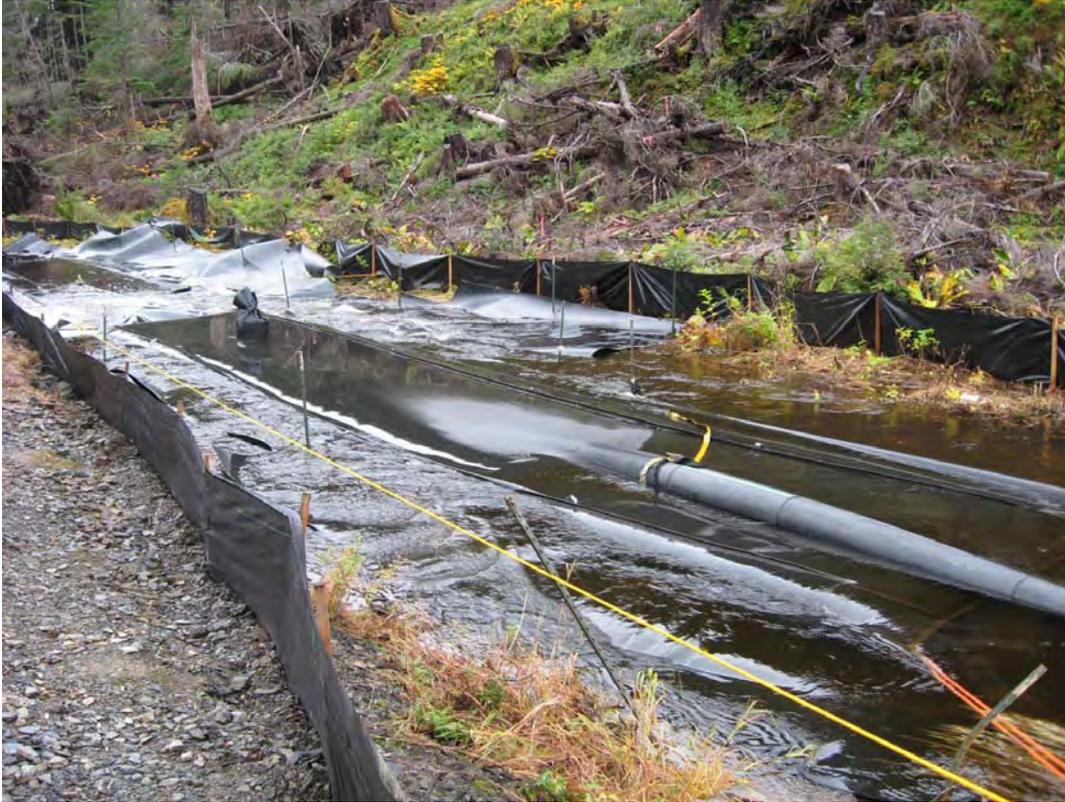
Photo 3 – TSF construction dewatering pump outlet / sediment bag

Plunge pool to be constructed at the head of E. Fork Slate Creek in the general vicinity of the dewatering sediment collection bag. A geologist will check to make sure it is not in an area where graphitic phyllite would be excavated. The bypass pipe and dewatering sediment bag will have to be relocated to enable the plunge pool to be constructed.

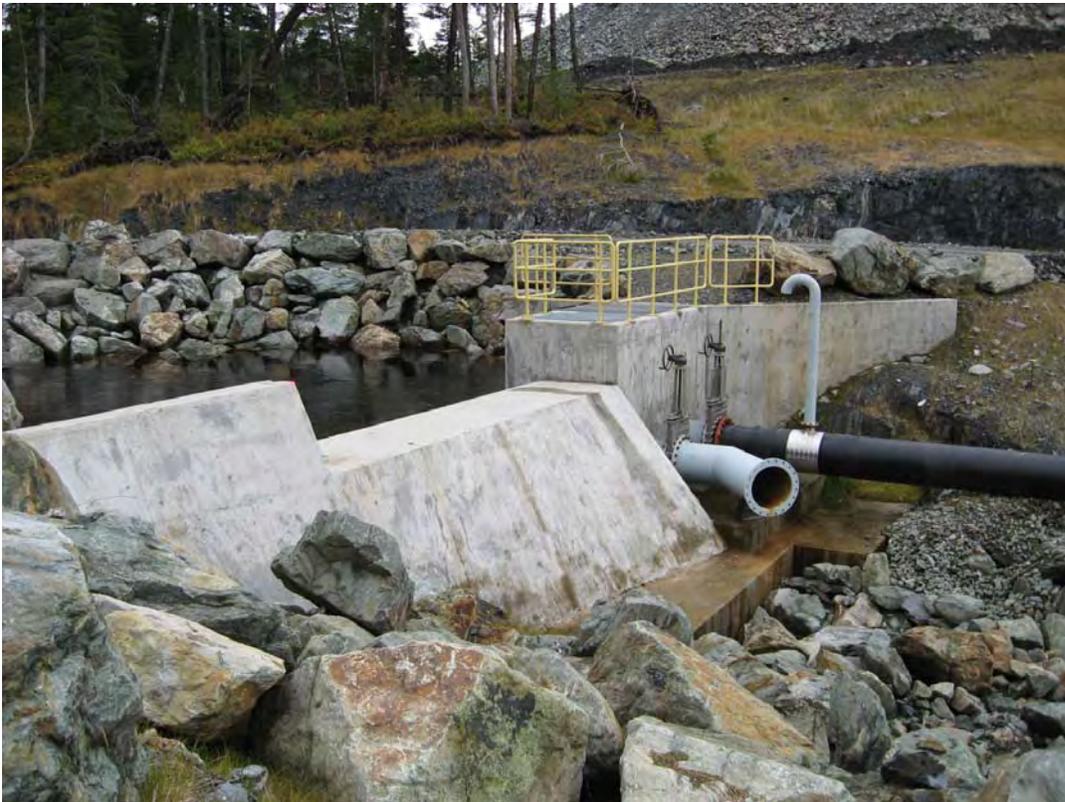
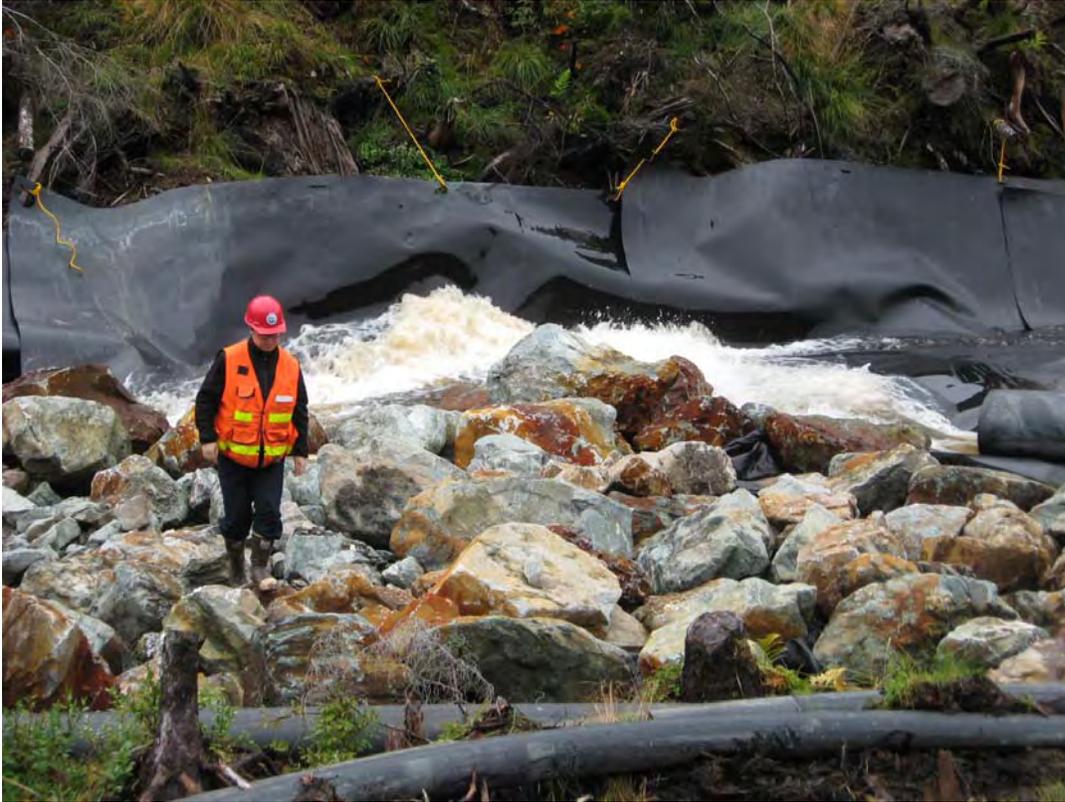
Bypass of Upper Slate lake water operational with a discharge to the head of East Fork Slate Creek (photos 4 & 5).

Photo 4 – Upper Slate Lake bypass intake structure

Photo 5 – Upper Slate Lake bypass discharge

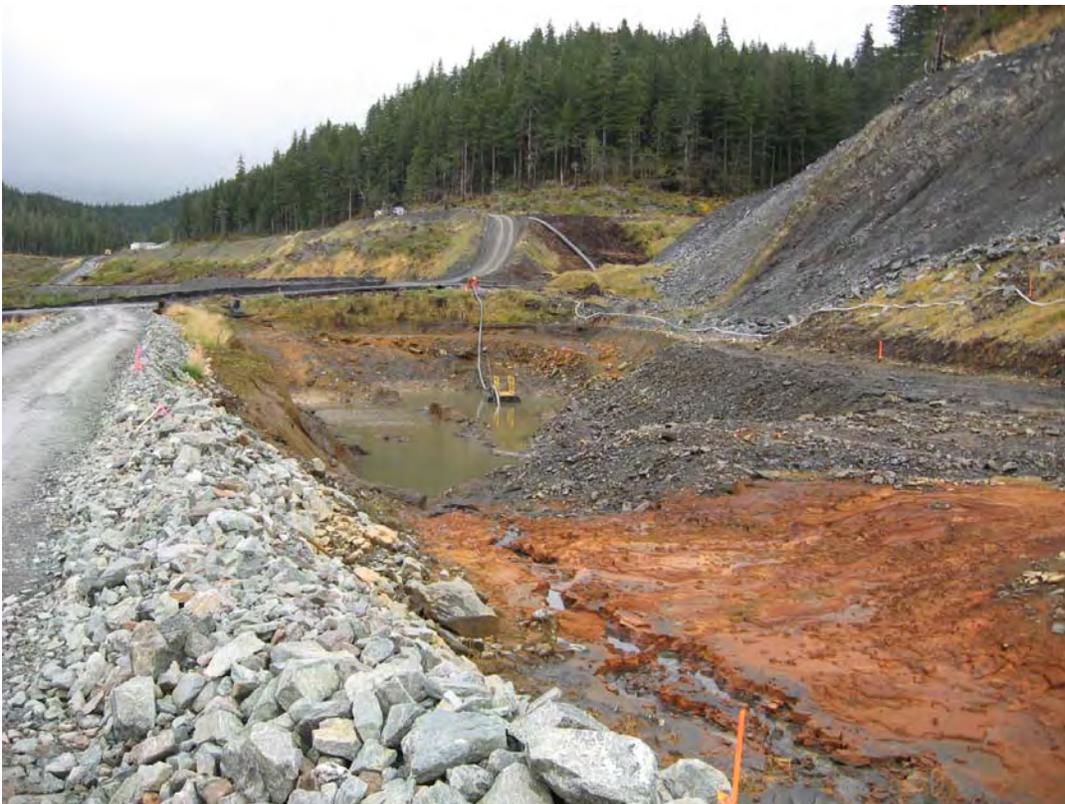
The hole excavated for the dam foundation (the Big Hole) had been dewatered (photo 6).

Graphitic phyllite in the "Big Hole" (photo 6). Approximately 500-1000 yd³ of graphitic phyllite material was pushed into the Big Hole to prevent further oxidation of the pyrite and the release of metals. This material needs to be removed promptly in order to prepare the dam foundation. Coeur proposes to excavate this material for temporary storage on a lined pad in Pit 4 that was previously used for soil remediation (photo 11); this material would be covered with a polyethylene liner while stored; all contact water would drain to lined sump

Photo 6 – dewatered “Big Hole” and graphitic phyllite (near - red/gray)

Graphitic Phyllite: Coeur and ADEC to agree on the next steps to enable temporary storage of the materials from the "Big Hole".

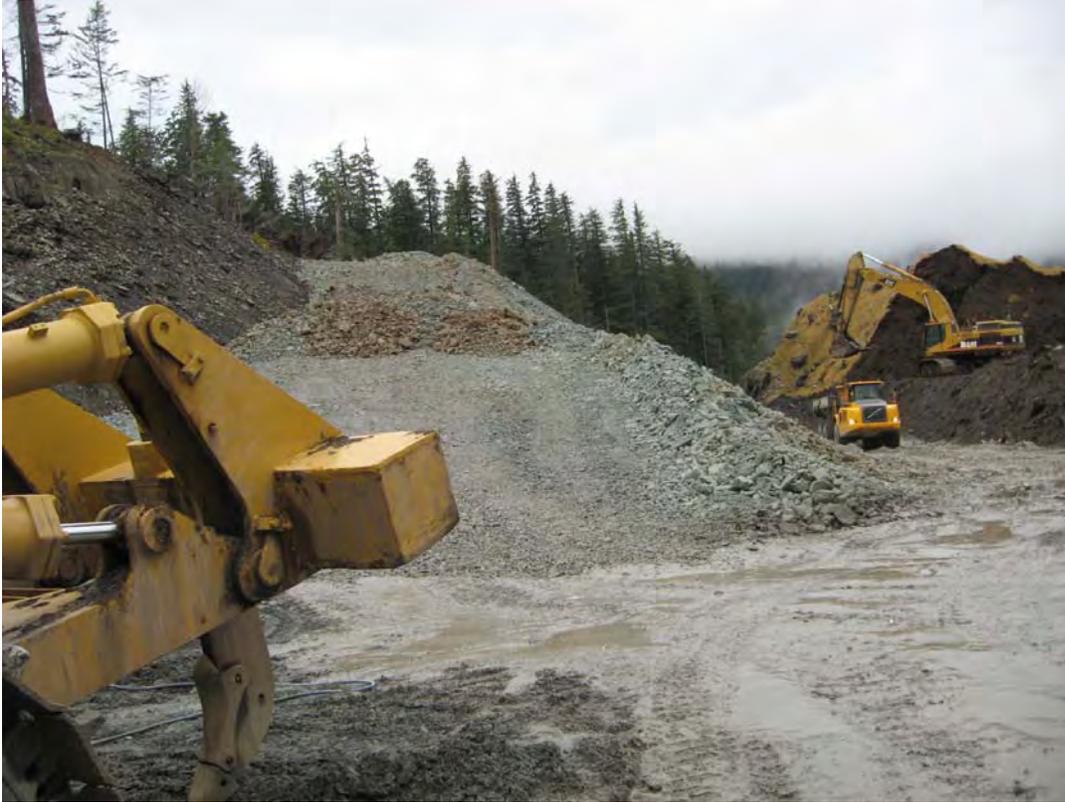
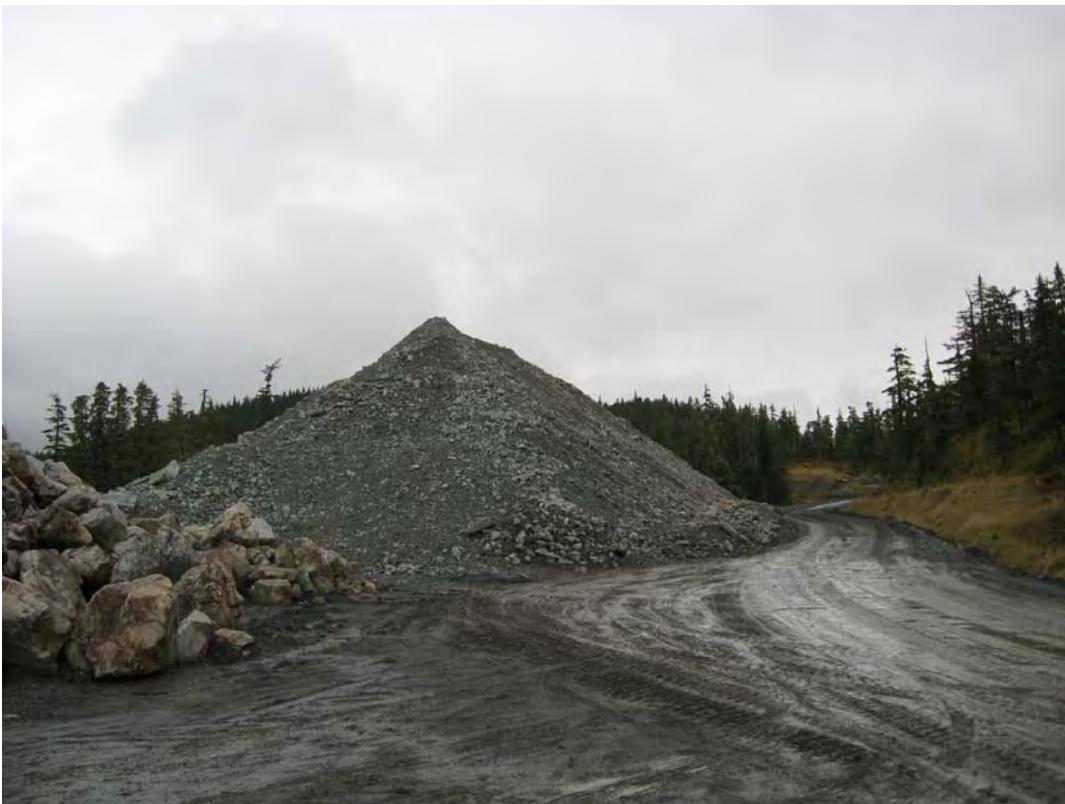
Diorite production rock from the mill area (30,000 yd³) hauled to two temporary storage areas adjacent to the Tailings Storage Facility (TSF) road, one for rock to be crushed, the other not (photos 7 & 8).

Photo 7 – diorite to be crushed

Photo 8 – diorite that will not be crushed

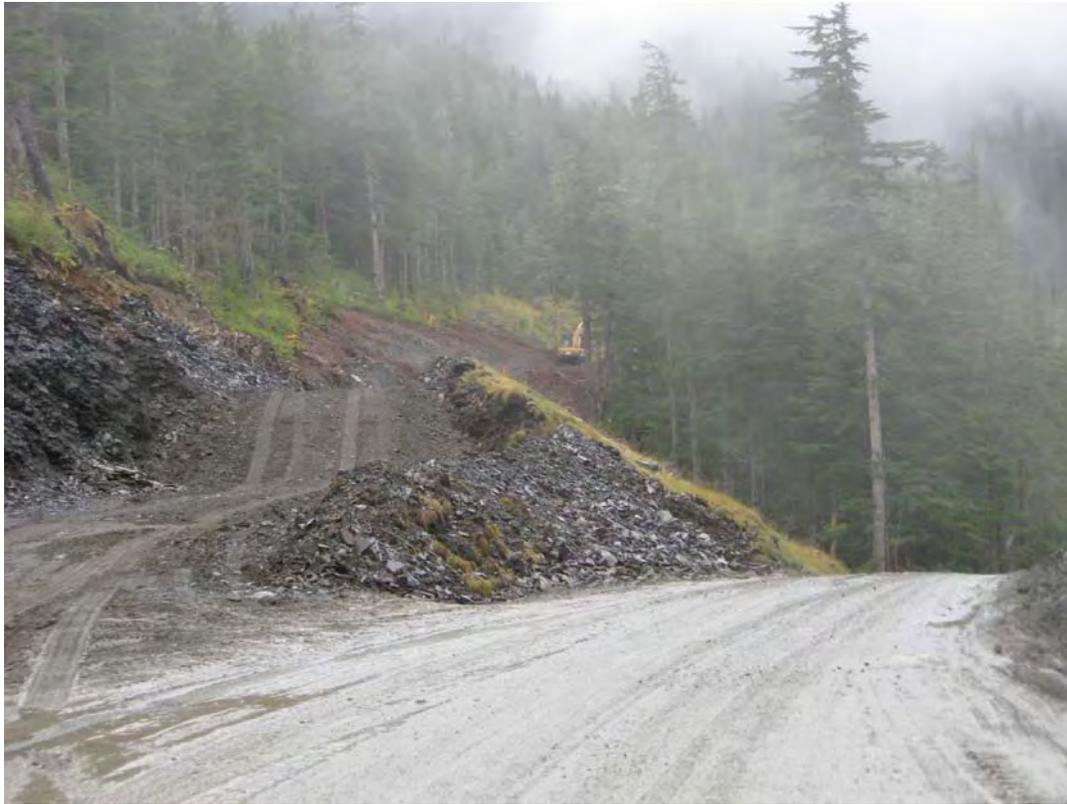
Tailings pipeline from the mill. Work had commenced on construction of the access road where the pipeline will meet the TSF road (photo 9).

Photo 9 – tailings pipe access road under construction

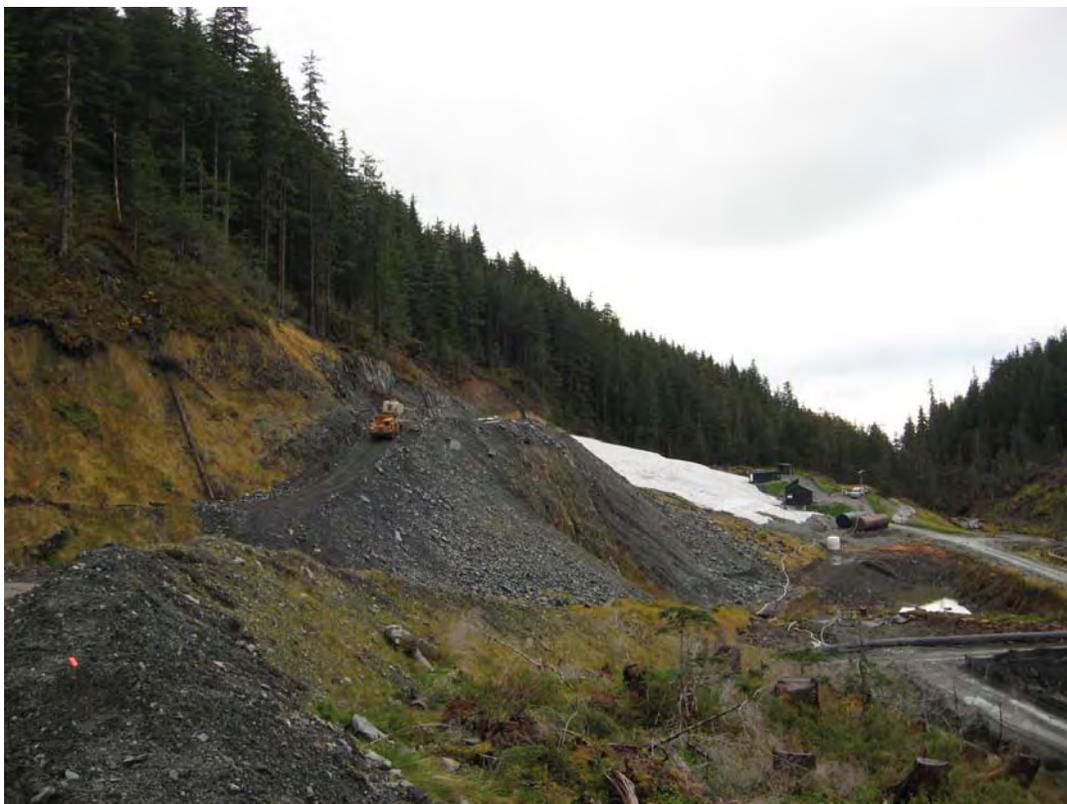
Drilling / working on creating an access/USL diversion pipe route around the east abutment of the dam (photo 10).

Photo 10 – construction of diversion pipe route on west abutment

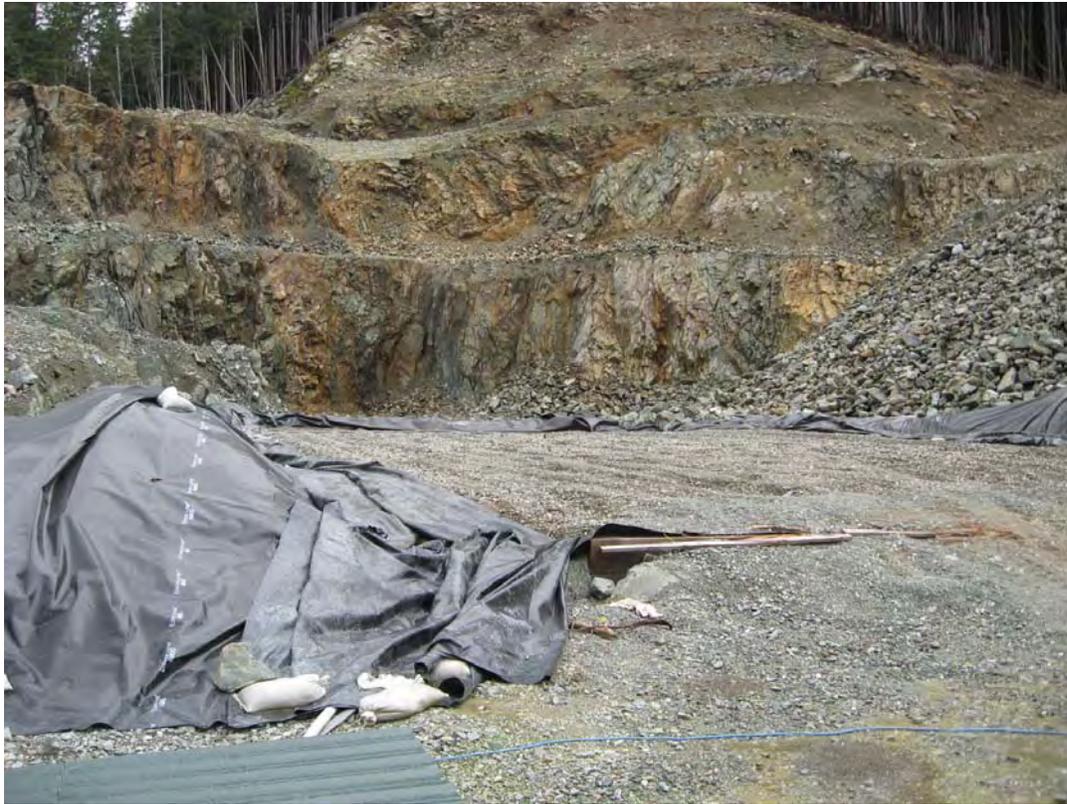
Photo 11 – lined soil remediation area in Pit 4

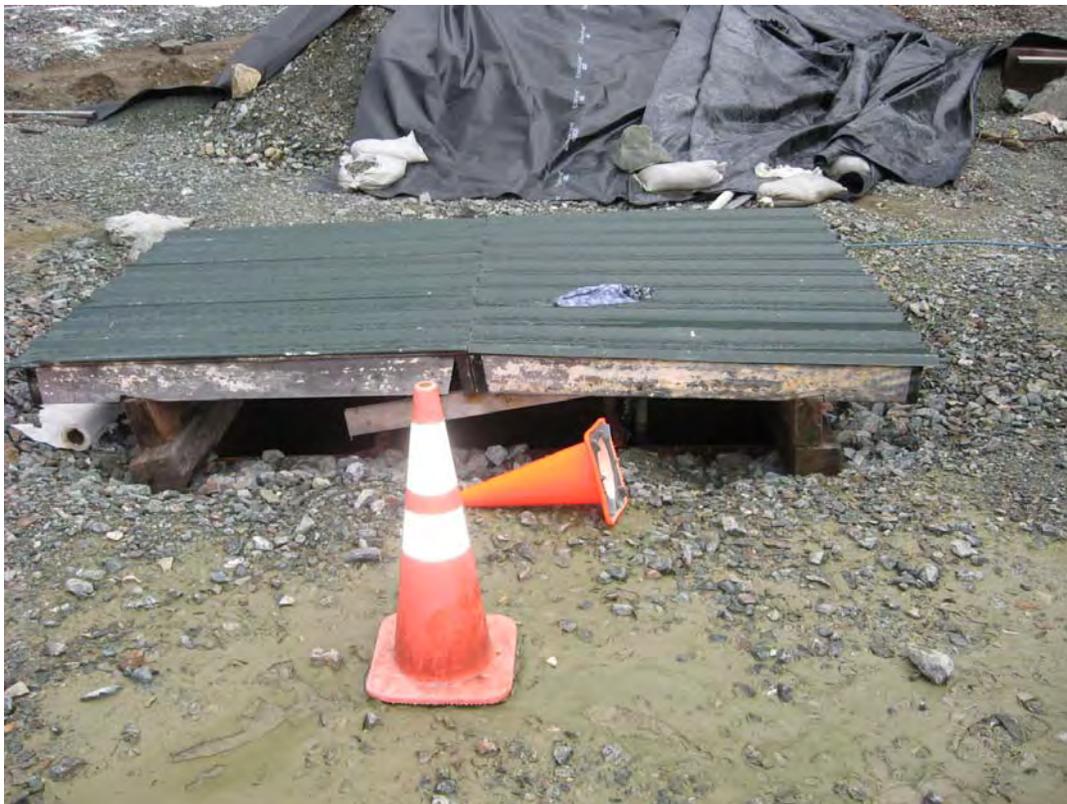
(photo 12), removed and transported to the seep Water Treatment Plant. A teleconference between Gillespie, George and McGee took place in the afternoon regarding Coeur's proposal.

Photo 12 – lined sump for the soil remediation area in Pit 4

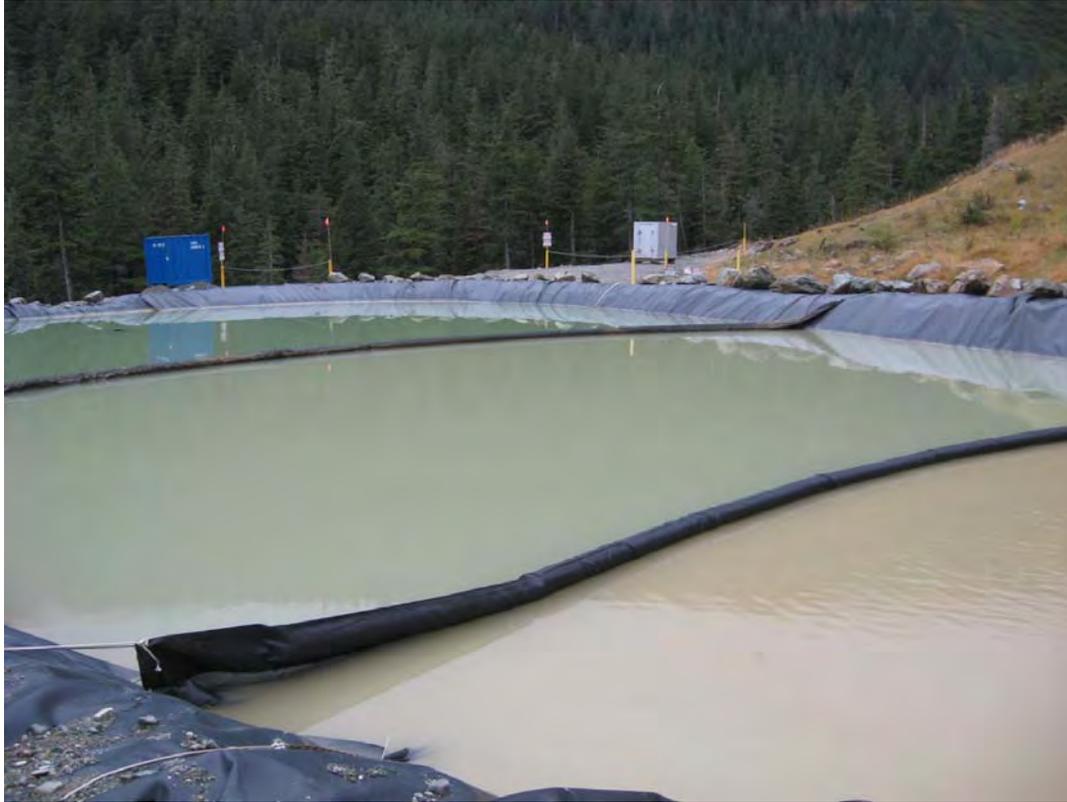
Storm water catchment and sediment ponds: Because of the heavy rains the water in the ponds contained fine sediments and appeared cloudy, however the BMP's, such as the hanging fabric curtains, aided in retaining fine sediment (photo 13). At the time of the visit, when there was no rainfall, there was no visible discharge from the ponds (photo 14). Ditches alongside the storage site for unsuitable/reclamation materials had considerable amounts of sediment that had built up from recent rain events. A 5-man crew was working on maintaining storm water BMP's (photos 15 & 16).

Photo 13 – storm water sediment pond with silt curtains

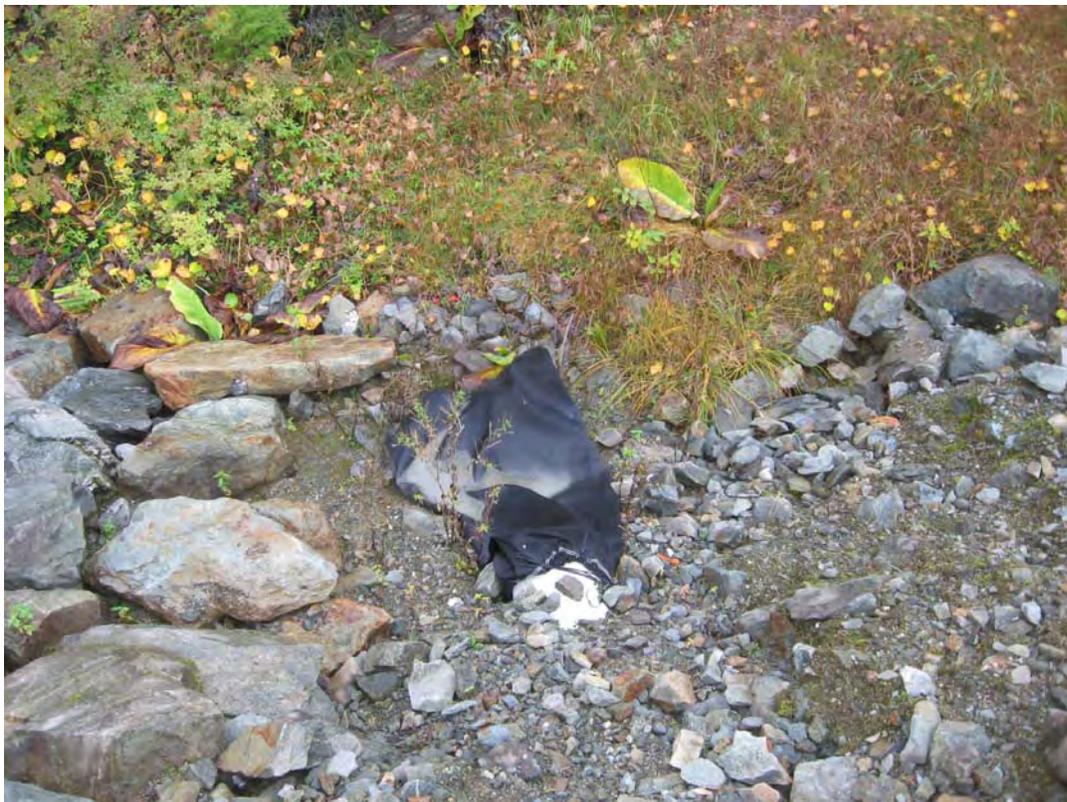
Photo 14 – outlet to storm water sediment pond – sock to catch fines

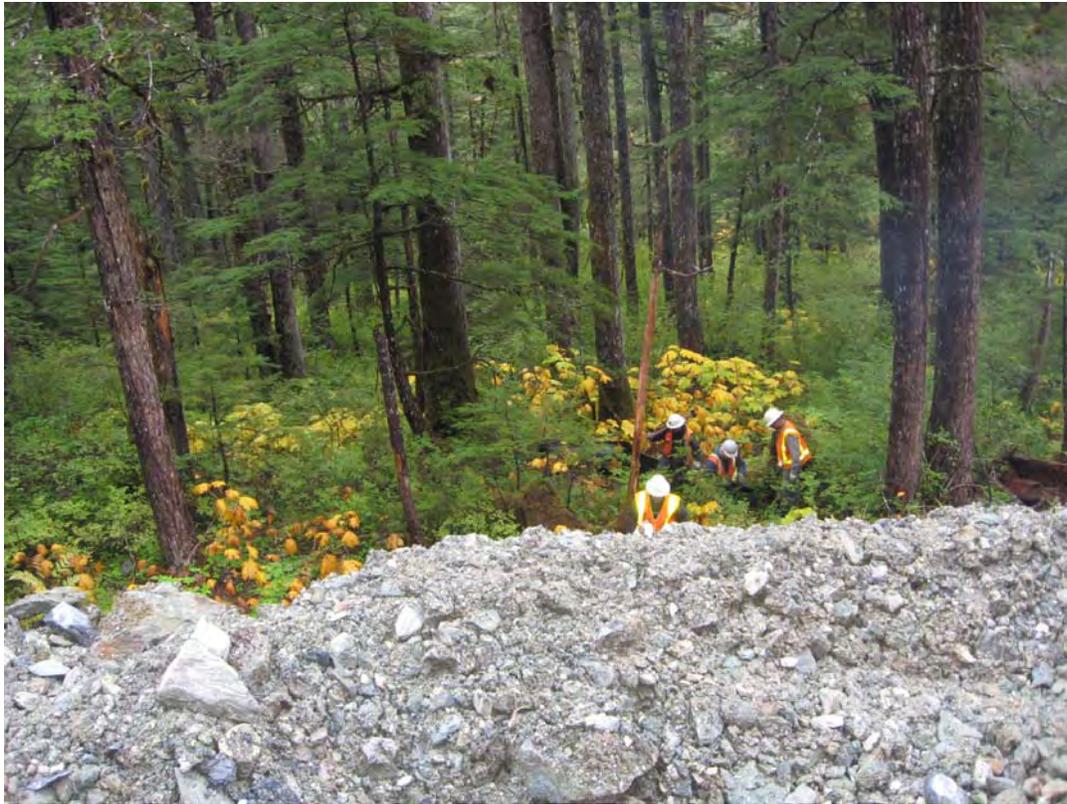
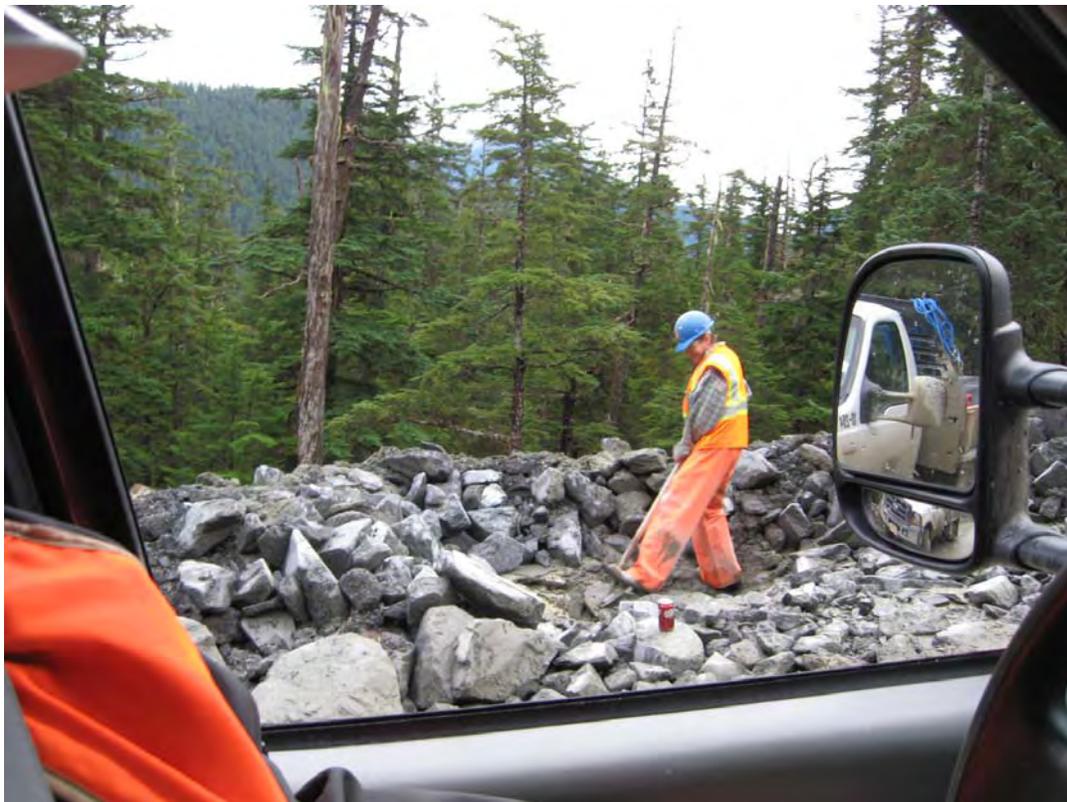
Photo 15 – storm water BMP crew working on a silt fence

Photo 16 – storm water BMP crew working on a catchment/diversion

Storm water ditches: Sediment to be removed behind the straw bales.

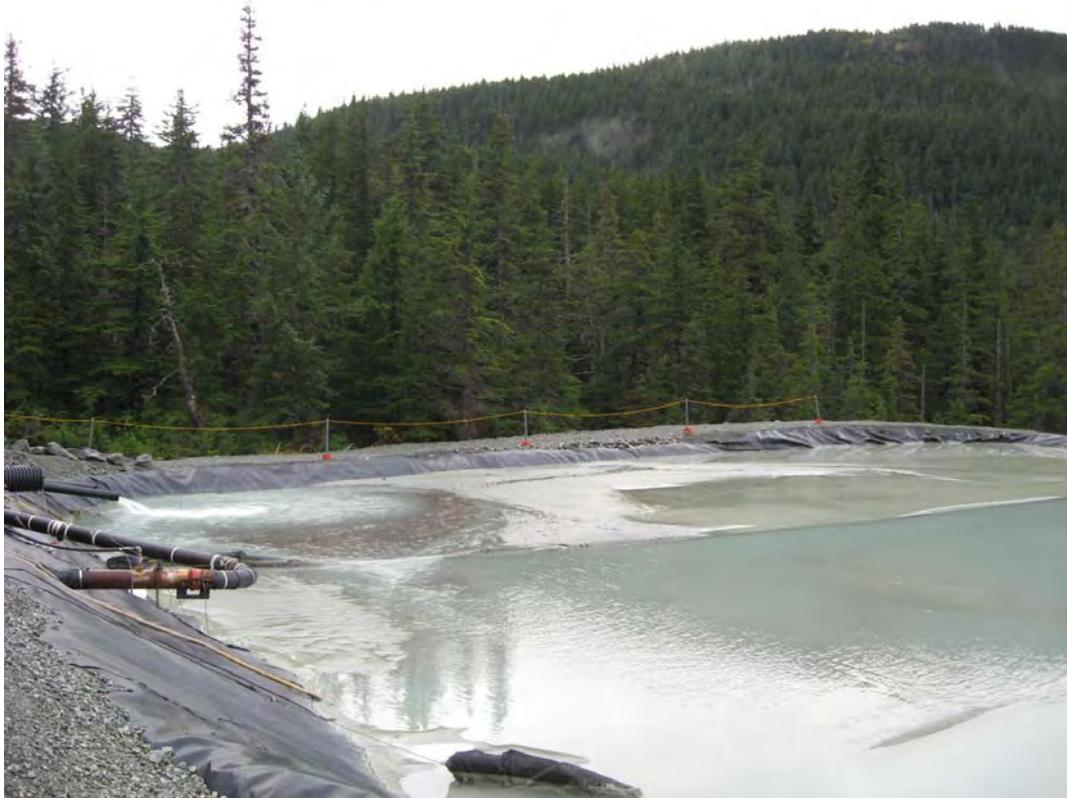
Kensington WTP: Mine dewatering water (approximately 1100 gpm) goes to a sediment pond. Sediment has built up within the pond (photo 17) and is to be removed with a vacuum truck.

Photo 17 – sediment in mine dewatering WTP pond

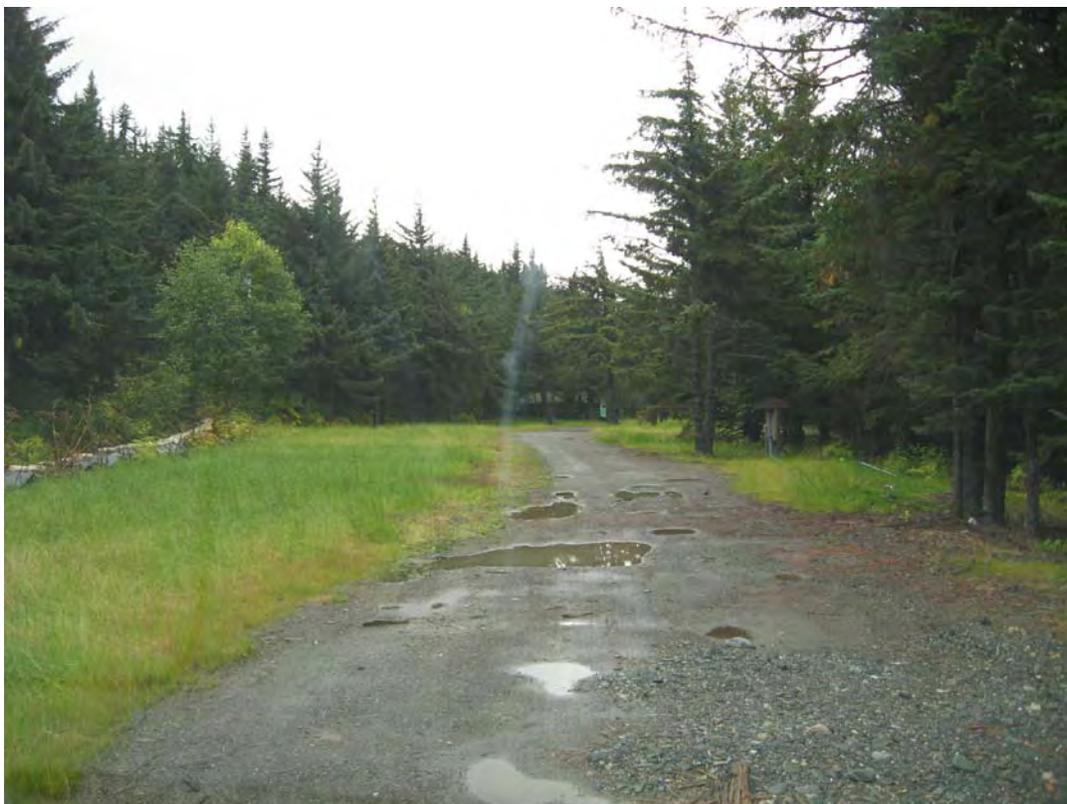
Old Kensington camp site: All buildings have been removed except a couple of buildings including a workshop. Grass seed was spread and grew well on a rocky soil with little organics (photo 18).

Photo 18 – seeded “old Kensington camp” area
