INSPECTION REPORT

Alaska Department of Environmental Conservation

Name and Location of Site/ Facility Inspected		Entry Time	Permit Effective Date
Tailings Treatment Facility (TTF) dam construction and Acid Rock Drainage area adjacent to LSL.	Loc: Lat: 58d 49' 58"N Long: 134d 57' 58"W	09:00	September 1, 2005
	Source: NPDES permit	Exit Time 12:30	Permit Expiration Date August 31, 2010
On-Site Representative		Additional Participants:	
Kevin Eppers, Environmental Superintendent		Sarah Samuelson, USFS Kate Kanouse, ADF&G Chandler Engel, ADNR (Separate inspection)	
Responsible Official(s):		Yes No	
Clyde Gillespie, Surface Operations Manager, Kevin Eppers, Environmental Superintendent x Contacted Clyde: 523-3309 Kevin: 523-3328		Samples Taken?	X
		Photos Taken?	X
		Analytical Results?	X

PHOTO ADDENDUM – KENSINGTON TAILINGS DISPOSAL FACILITY –APRIL 27, 2010

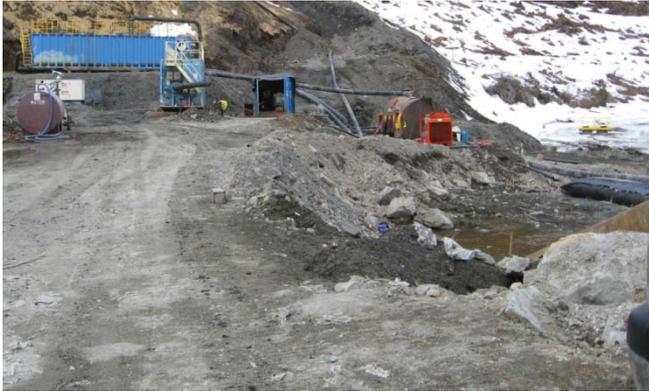
PHOTO 1. RAIN-FOR-RENT TANKS AT FAR SIDE OF DAM

Rain for Rent portable treatment units were being commissioned. Water was being treated and pumped to a sediment bag within the impoundment. Experimentation ongoing with ferric chloride and polymer feeds to fine-tune the system. The incoming lake water to the units has a turbidity varying between 6 and 12 NTU. (Photo 1).

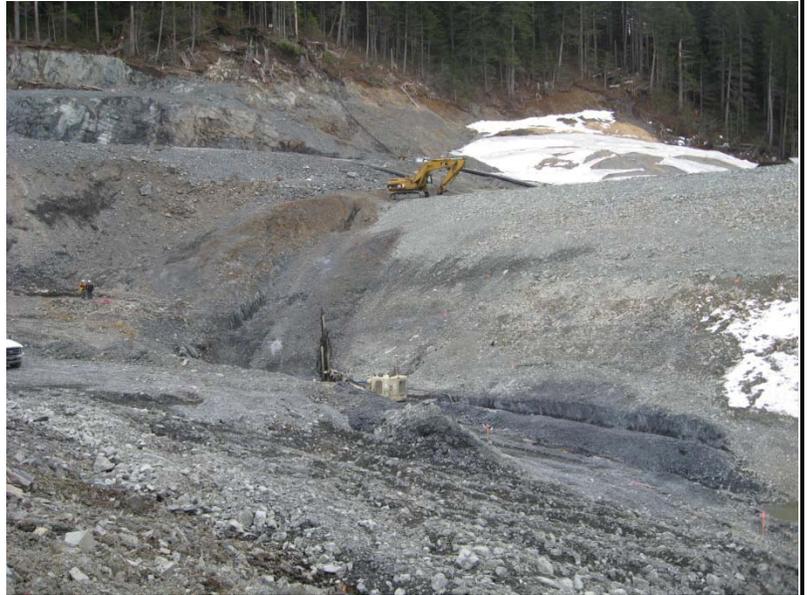
PHOTO 2. GROUT DRILL RIG AND GROUT TRENCH AT BASE OF DAM

Drill rigs were drilling holes; some of the holes have been grouted. Chandler Engel was on site to inspect the drilling and grouting operation. Cory Aurala, P.E., Knight Piesold: Holes are drilled vertically and at angles up to 60° to cross nearby vertical cracks and fissures. The procedure for grouting is to grout a hole, then move to another location, then after a minimum of 24 hours return to a hole 30 feet away and grout that hole, then let this cure for 24 hours, then drill a hole mid-way between these two holes and grout it. There are then grout holes on 15' centers. A nearby core shows whether the grouting was successful and the holes are pressure tested with water. The pressure is increased 1 psi per foot, up to 15 psi. At the sides of the dam solid rock was encountered at around 30' deep and the holes were taken down to 60' deep. At the base of the dam the solid rock was just below the surface and the holes were taken down to around 30' deep. The grout used is 3:1 cement water mix. This grout will also be placed in a trench above the grout holes. The sides of this trench are graphitic phyllite, but the face will be covered and sealed by the grout. The geomembrane on the face of the dam will be tied into, and incorporated into the grout in the trench. If all goes well the grout work should be complete in about 2 weeks. Cory said additional work may be required at the low part of the foundation to the west if a fault exists at that location and there is increased fracturing. They will determine this when they get to that location. (Photo 2).

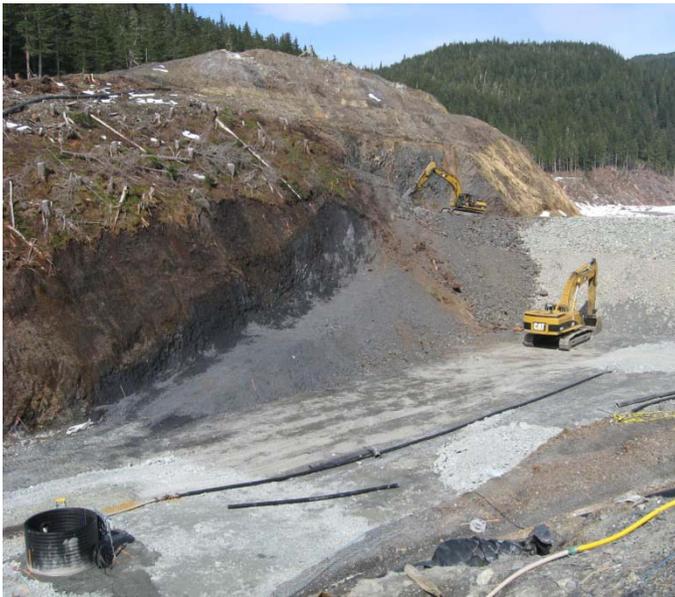
PHOTO 3. EXCAVATING FOR THE SPILLWAY

Excavation was under way on the west embankment for the spillway. (Photo 3). Drawings for the location and plunge pool

details should be out this Friday. The pool will have a geoliner and shotcrete to prevent water from travelling upstream to the dam seepage sump.

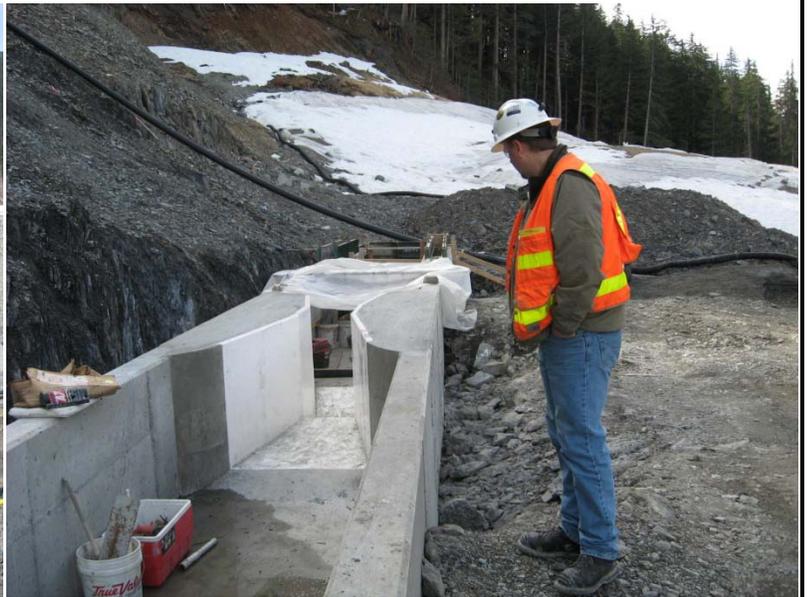
PHOTO 4. PARSHALL FLUME

Work had continued on the bypass Parshall Flume and chamber for the pipe connection (Photo 4).

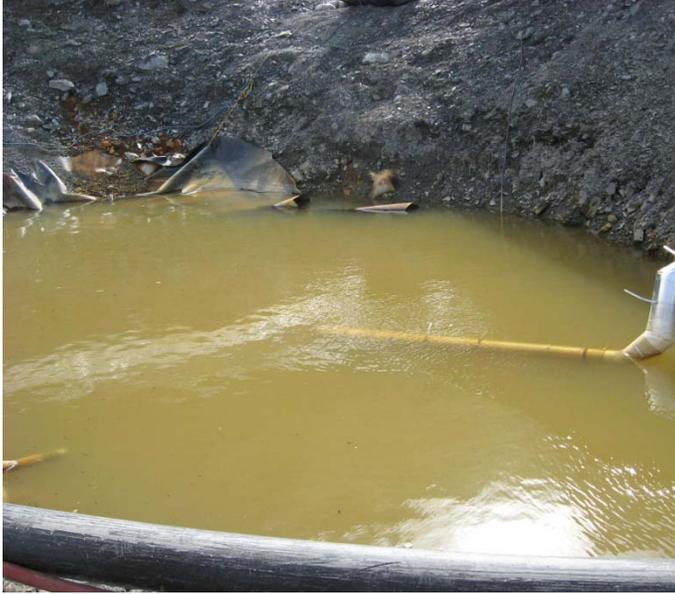
PHOTO 5. ARD SUMP BELOW SEEP WTP

Water was standing in the sump and the polyethylene liner was below the level of the water, as had been the case on previous visits (Photo 5). It would also seem there could be seepage out of the sump into the surrounding rock, however Clyde said he had not seen any seepage on a rock face on the far side of the road towards the creek. The plant operator said there was water in the sump because 10,000 gallons had been brought over from the ARD seepage collection tank at Pit 4 the previous day for treatment in the facility. This occurs about once per week at the moment. The plant was operating at just under 20 gpm. The operator said there were problems with the equalizer tank when the flow got above 25 gpm. The manufacturer is being brought in to look into this issue. Clyde said he thought the plant would be able to treat 35-40 gpm. The design is for 60 gpm. Filter bags have to be changed every 30-60 minutes. This takes about 5 minutes and the plant throughput is reduced during these changes. Plant throughput is also reduced during shift changes. During the previous 6 hours the average rate of flow through the plant was 8.26 gpm. The pH of the effluent was 6.62 at the time of the visit. A minor leak was noted in the pipe leading from the drainage capture ditch to the sump. The spray ran down the rock sides of the sump and into the sump. Kevin noted this and said he would have it fixed. High metals values had been recorded at sample site #5 in February and March. This site was viewed to see if a cause for the high metals values could be seen. (Photos 6 & 7).

1. Re-locate the liner in the ARD seepage water collection sump and ensure it makes a watertight seal such that it is able to contain the water.
2. Repair the small leak on the pipeline above the ARD treatment plant sump.

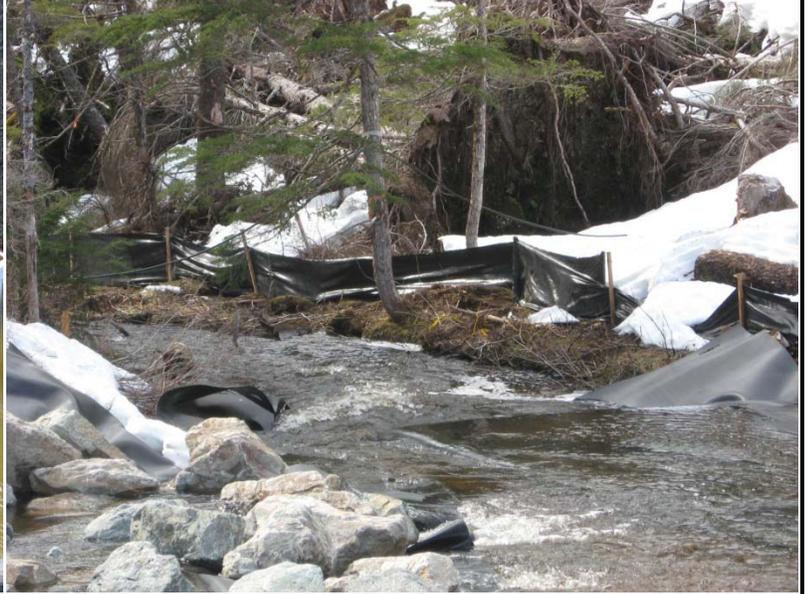
PHOTO 6. SAMPLE LOCATION #5 (ADJACENT TO TREE WITH TAPE)

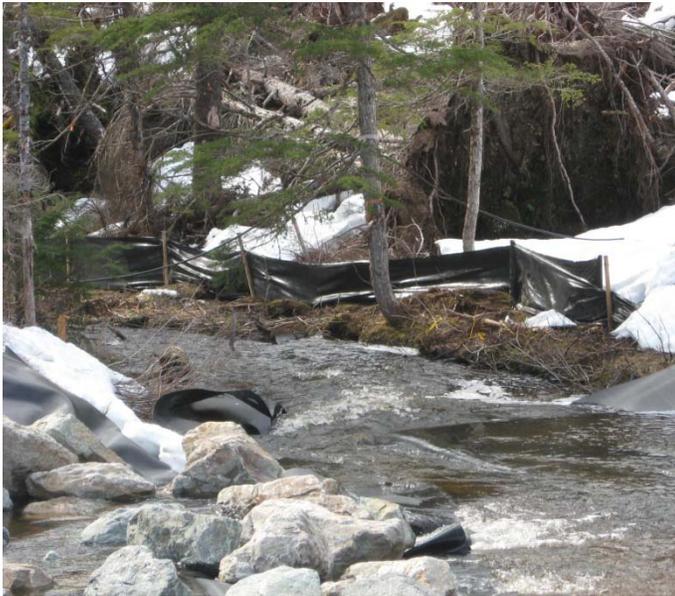
PHOTO 7. USL WATER ENTERING E FORK SLATE CREEK

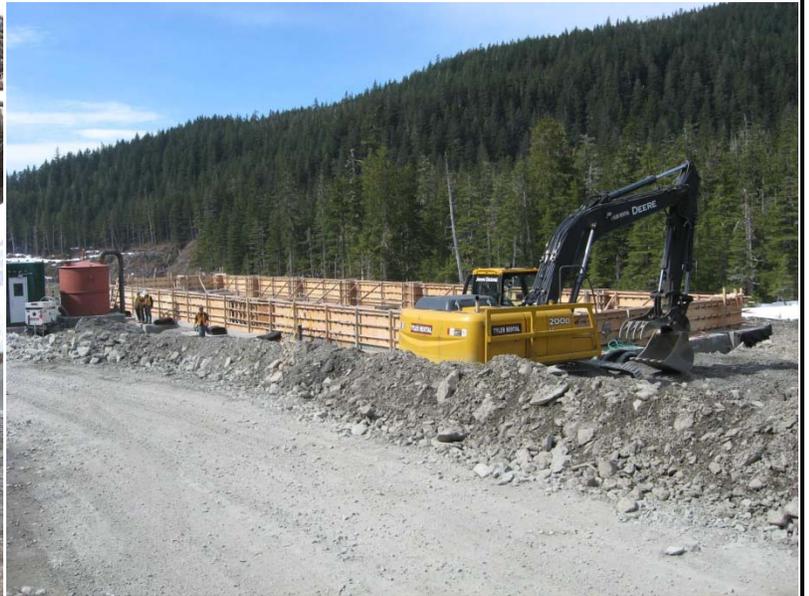
PHOTO 8. TTF WTP FORMWORK

Work continued on the Tailings Treatment Facility Water Treatment Plant. The foundation concrete had been poured and forms were in place for the base of the walls (Photo 8).
