FIELD INSPECTION REPORT COEUR ALASKA/KENSINGTON MINE

Inspection Date: June 18, 2013, 07:30 – 10:30
Report Date: June 19, 2013
Weather: Calm, overcast at first, then clear, temperature ~ 60-70F
Coeur Personnel: Kevin Eppers, Environmental Manager
Agency Personnel: ADEC: Kenwyn George, Jill Weitz (Compliance)

Purpose of visit: Inspect the work done to mitigate ARD surface seeps at the north end of the Tailings Treatment Facility

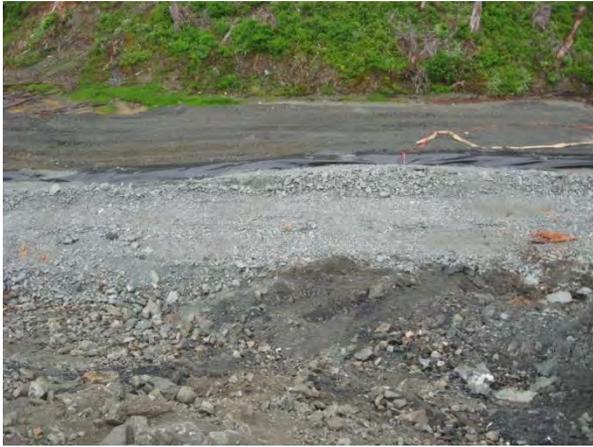
Photo 1 – Valley floor mid section

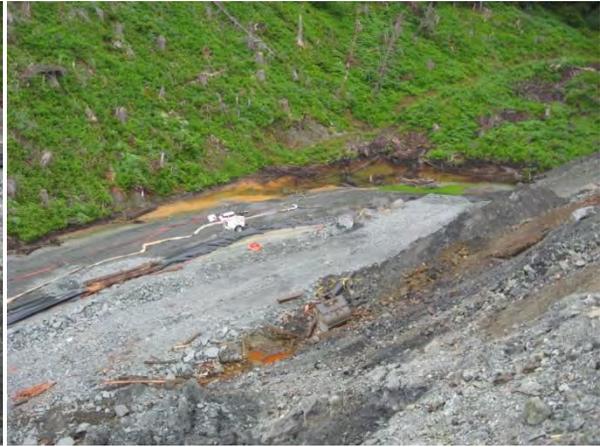
Photo 2 – Valley floor North area

Infiltration trench

Lined collection ditch

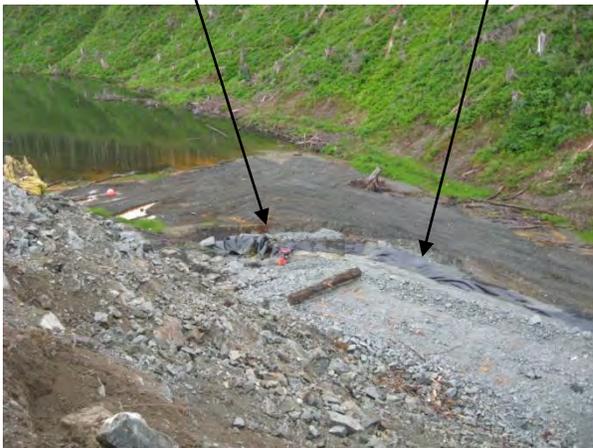
Photo 3 - Valley floor South area

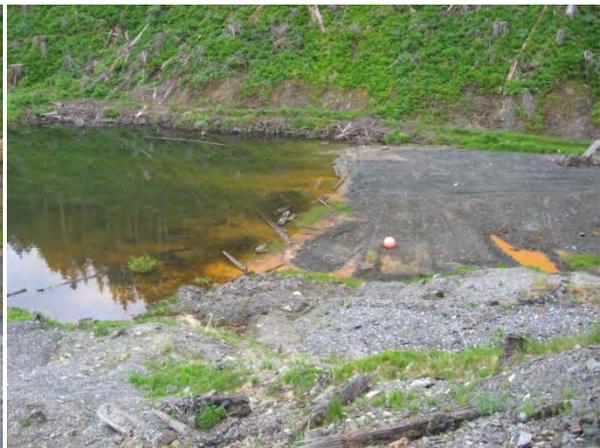
Photo 4 - Valley floor at TTF

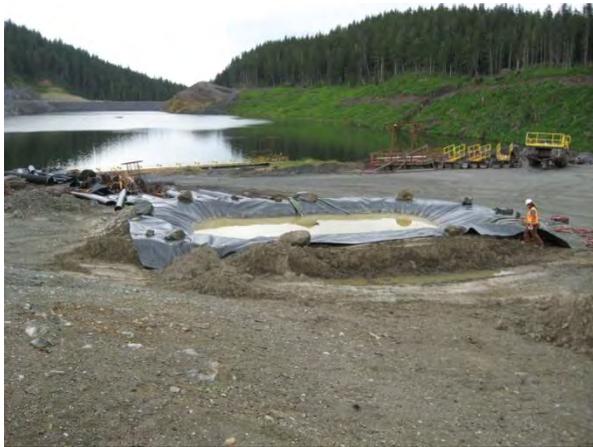
Photo 5 – Seepage water collection pond

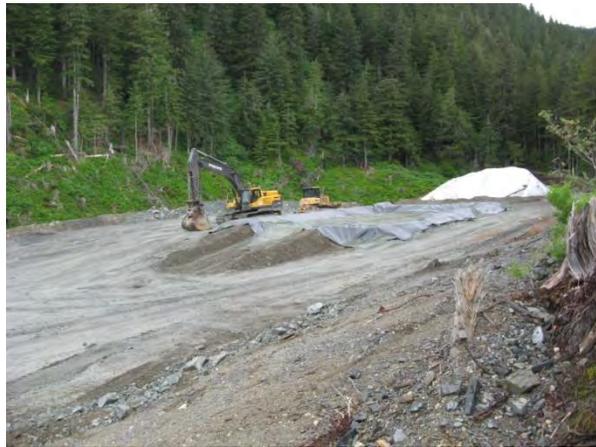
Photo 6 – Temporary GP rock pad

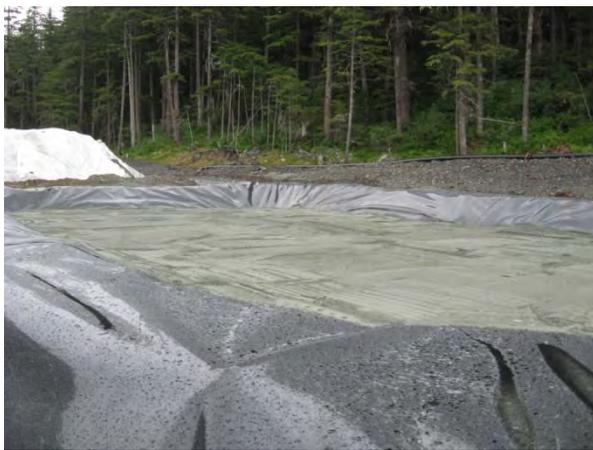
Photo 7 – Temporary GP rock pad

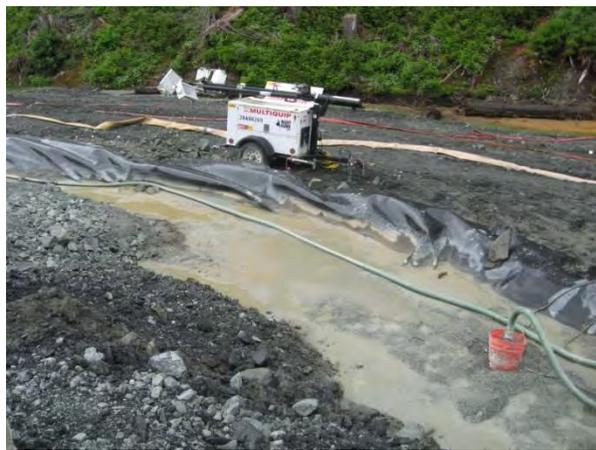
Photo 8 – diorite-filled collection ditch

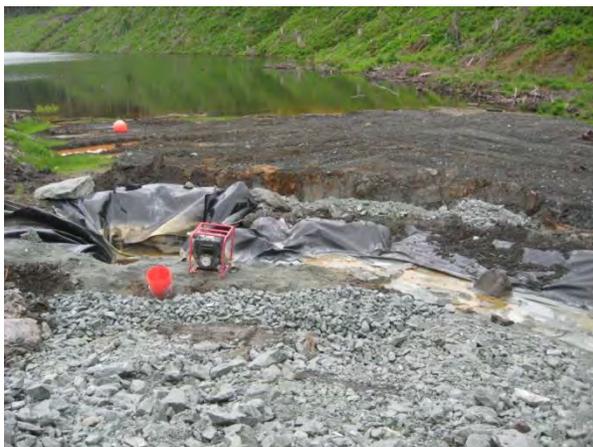
Photo 9 –Trench, sump and infiltration ditch.

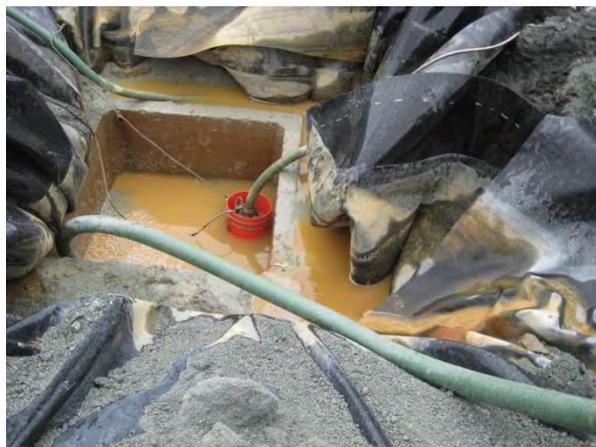
Photo 10 – Sump in collection ditch
