June 13, 2013

## June 11 Inspection of the Kensington Gold Mine

David Wilfong  
Alaska Department of Natural Resources  
Division of Mining, Land and Water – Mining Section

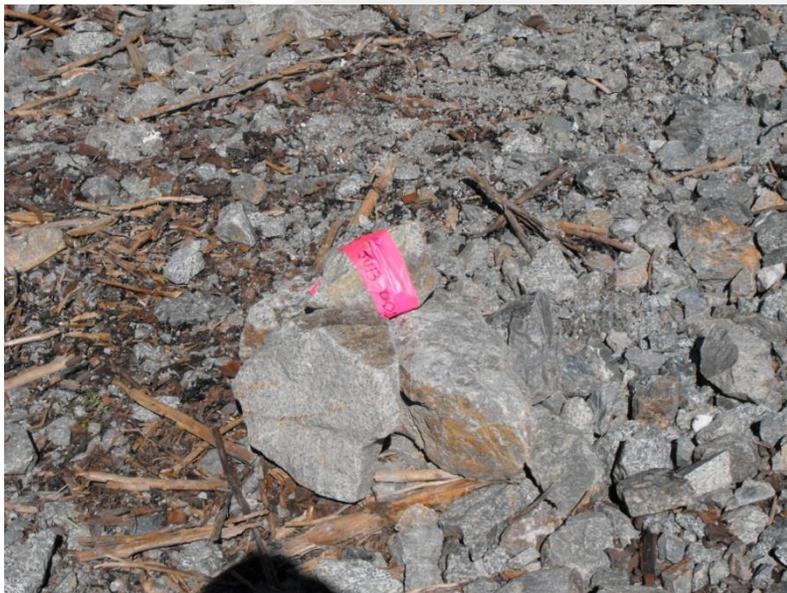
Two of the prospective drill pad sites were located on the existing Pipeline Road, and were marked by rock piles and pink ribbons (Figure 1). The Pipeline Road sites are attractive to Coeur because they are located on a prepared flat surface, and easy access for the drill rig and crews is already available. In addition, Will stated that there is historic data available from previous operations that had drilled from these same locations. After documenting that there were no

Figure 1 Rock pile and flag marking a potential drilling site on the Pipeline Road

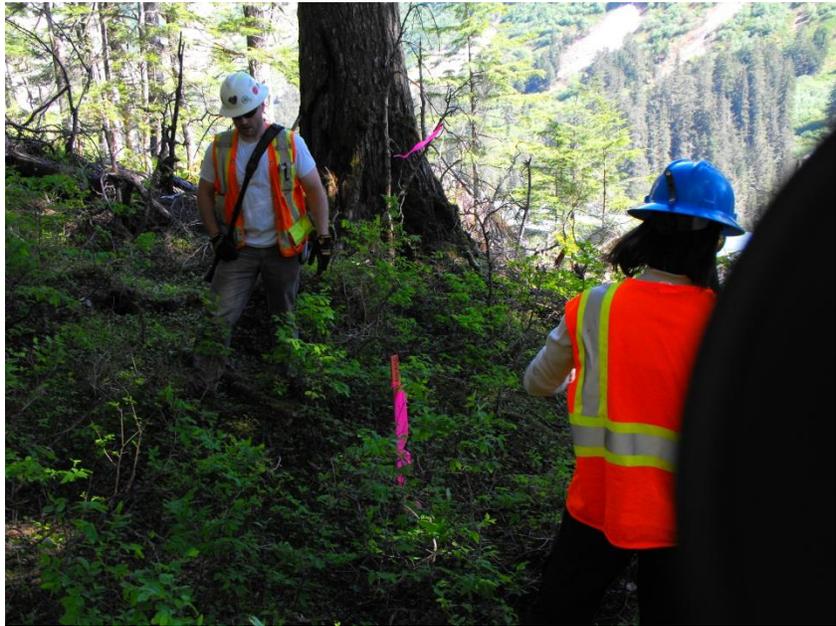
Figure 2 Stake and flag in the forest above the Mill Bench

hunger with donated blood through any exposed skin, but more than one bug died for their cause. We visited several more potential drill sites, and all were marked with pink ribbon tied to a tree, or a stake (Figure 2). One of the stakes was hard to locate as it had been knocked over, presumably by a bear. No archaeological sites were found. However, evidence of previous drilling operations, such as empty 5 gallons buckets of drill mud and cement sacks were found scattered around the area. After inspecting all of the potential drill sites, the group scrambled out of the forest, and headed back to the Kitchen and Dining Room facilities to break for lunch. Ben and Kevin met up with the rest of the team after finishing their inspection of the Tailings Treatment Facility (TTF).

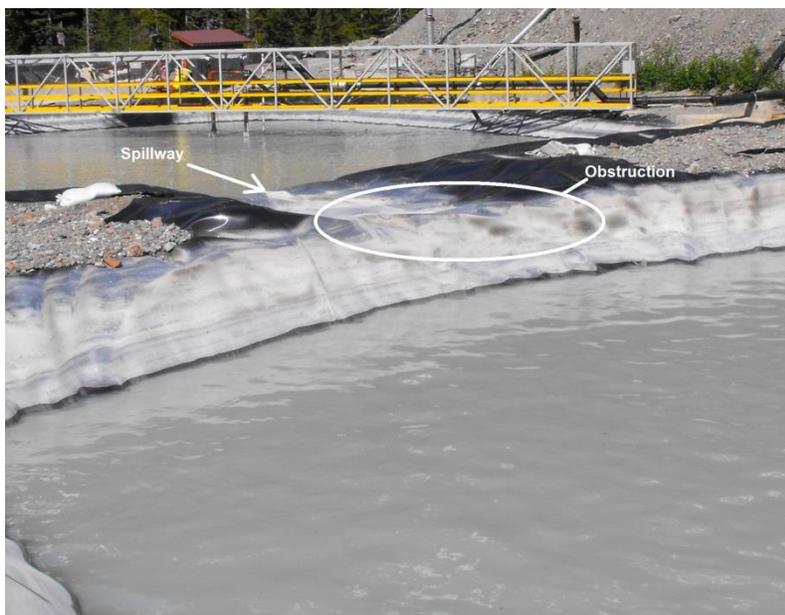
overtopped slightly during the peak flows of the spring runoff previous to this inspection. The ponds are designed so that if Pond One nears its capacity, the water will flow through an HDPE lined spillway into Pond Two. At the time of the inspection, the rate of snowmelt had subsided, and the water level in the pond lowered enough so that the cause of the overtopping was apparent.

**Figure 3** Bulged liner in the spillway

The HDPE liner had bulged in the spillway near the rim of Pond One, effectively raising the inlet to the channel by about one foot (Figure 3). The bulged liner caused the water level in Pond One to rise higher than expected, and the turbid water flowed over the rim in at least one area. Sandbags had been placed at the point of the overtopping to hold the water back (Figure 4). There was no evidence that the small flow of water caused any erosion or structural instability to the

- Address the bridges in poor condition on the Comet Road.
- Address the blockage in the spillway running between Pond 1 and Pond 2 to ensure that water does not overtop the liner in Pond 1 during a high water event.
- Lower the level of diesel in the tank at the Comet water treatment plant, and make sure the tank does not get overfilled in the future.
- Continue to implement the approved removal plan for the acid generating material in the Tailings Treatment Facility.

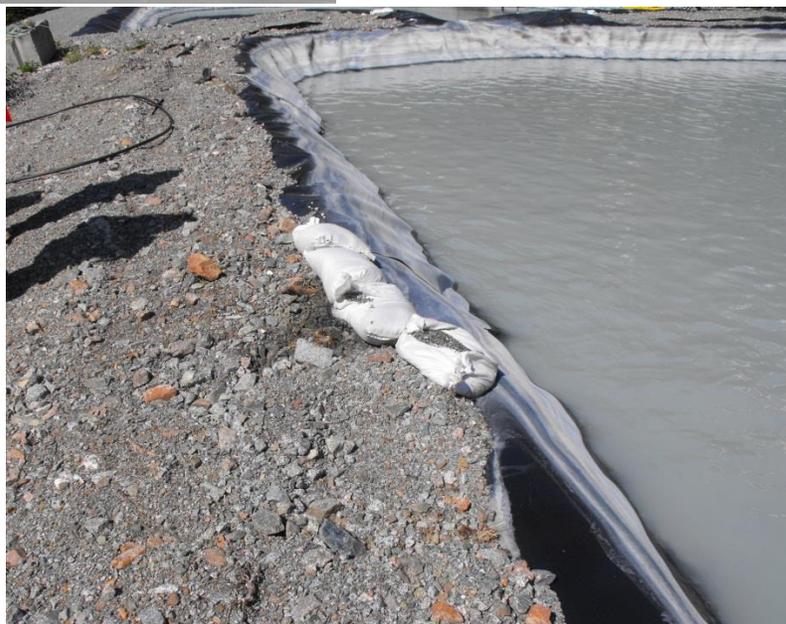
**Figure 4** Sandbags at the rim of Pond One

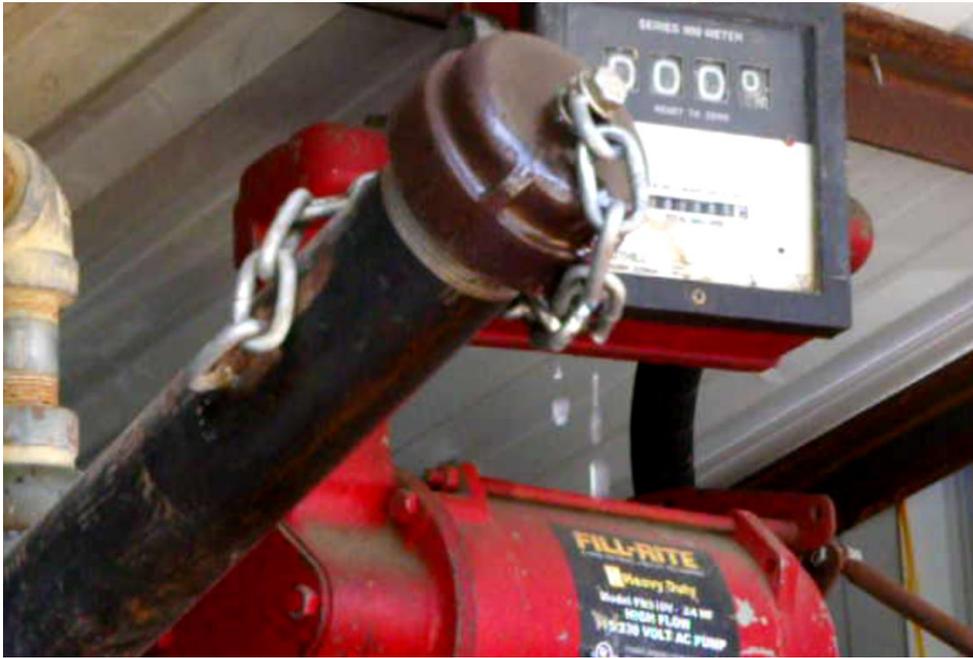
Figure 5 Diesel dripping from the fuel tank's filler neck

Before leaving the water treatment area, a leak was found at a fueling station (Figure 5). The tank had been topped off with diesel fuel earlier in the day, and when the sun began shining on the tank, the fuel may have expanded enough

to flow out the filler neck. Kevin was alerted, and oil absorbent pads were placed on the tank to soak up the dripping fuel in the interim until the fuel level could be lowered. The leaking fuel was confined in the secondary containment, and none was released into the environment. A worker at the Water Treatment Plant was asked to top off the fuel in his pickup so the level in the tank would be lowered enough to stop the leak.
