## Inspection Report: Kensington Gold Mine

Tongass National Forest, Minerals Group  
8510 Mendenhall Loop Road  
Juneau, Alaska 99801  
(907) 789-6276 – office  
(907) 586-8808 – fax

Date of Inspection: Tuesday, July 16, 2013  
Date of Report: Friday, July 26, 2013  
USDA Forest Service Inspector: David Schmerge

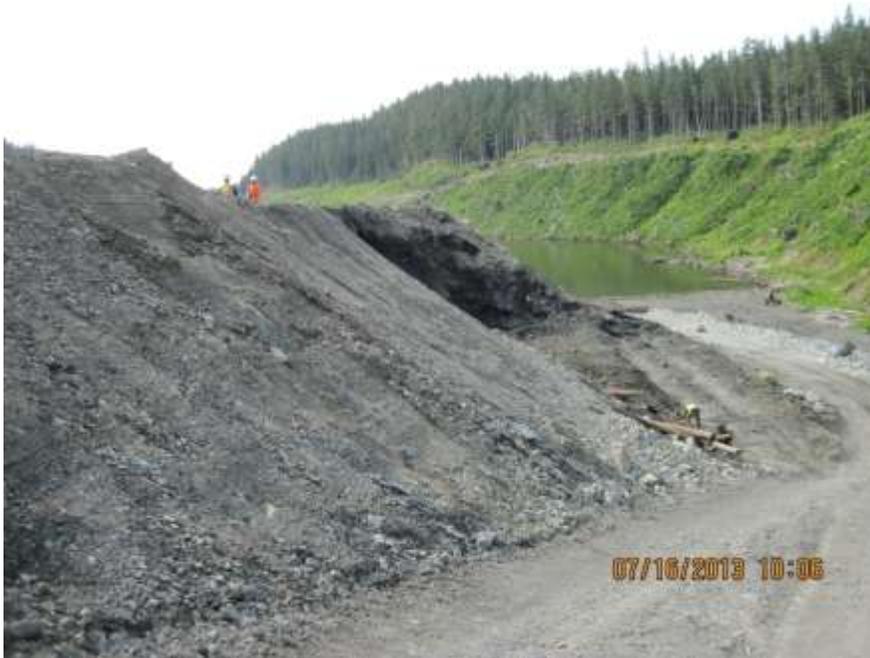
Progress has been made on the excavation of the acid generating graphitic phyllite, but it was apparent that there is still some graphitic phyllite present (photo 01). Bob Chernikoff (Surface Operations Supervisor, Coeur Alaska) stated that Clint Degenhart (Geologist, Coeur Alaska) would be inspecting the site soon to assess how much more needs to be excavated. The temporary containment cell at the TTF was full (photo 02). No excavating or hauling was in progress during our visit; there was 1 haul truck on site but it was not in use (photo 02), and there were no excavators on site. Kevin Eppers (Environmental Manager, Coeur Alaska) reported that there was no excavating or hauling for several days prior to our inspection, but the operators were busy with ancillary duties building the secondary containment structure during that time-frame.

Photo 01. The graphitic phyllite excavation has progressed, but the excavator was not on site during our visit. The black material in the center of the photo is graphitic phyllite.

1. Update the "Proposed Corrective Actions and Timeline" table found in the ARD Remediation Plan and provide it to the Forest Service.
2. Provide Clint Degenhart's estimate of the amount of graphitic phyllite still to be excavated to

the Forest Service as soon as it is available.

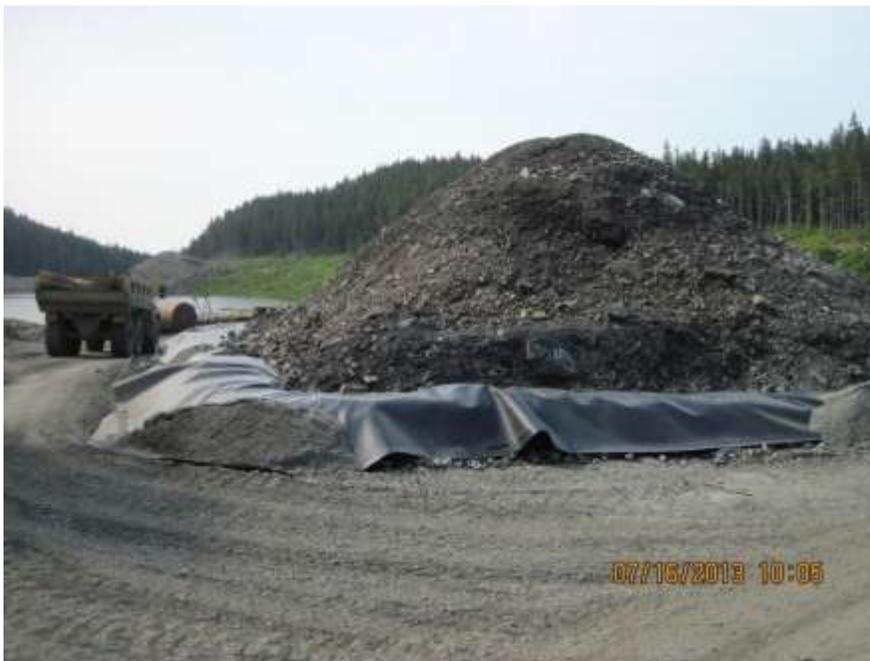
Photo 02. The temporary containment cell at the TTF is full. The haul truck is not in use.

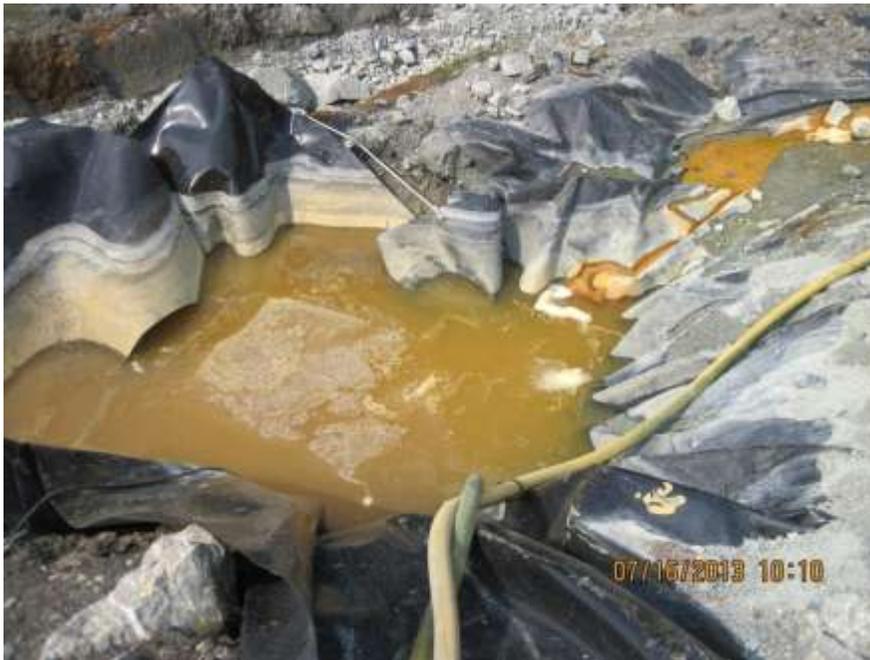
I measured the water quality at the site at multiple points with pH test strips. The pH at the sump (photo 03) was about 3. The pH of the water in the pond to the northwest of the graphitic phyllite (photo 04) was about 5, and the pH at the north end of Lower Slate Lake (photo 05) was about 6. Peter stated that Coeur had recently collected more water quality samples.

Photo 03. The ARD seepage is being collected in this sump and sent to the graphitic phyllite water treatment plant.

3. Submit all available ARD water quality results to the Forest Service as they become available.
4. As soon as the drill rig is removed from its current location, remove the platform so that the reclamation test plot construction can begin. The abandoned drill rig platform on Snowslide Gulch also needs to be removed.
5. On day(s) in which one or more of the haul trucks are not being utilized for the ARD remediation, they should be utilized to haul soil to Snowslide Gulch.
6. If there is a several day period in which one or more of the excavators are not being utilized for the ARD remediation, they should be utilized to spread the topsoil for the reclamation test plots.

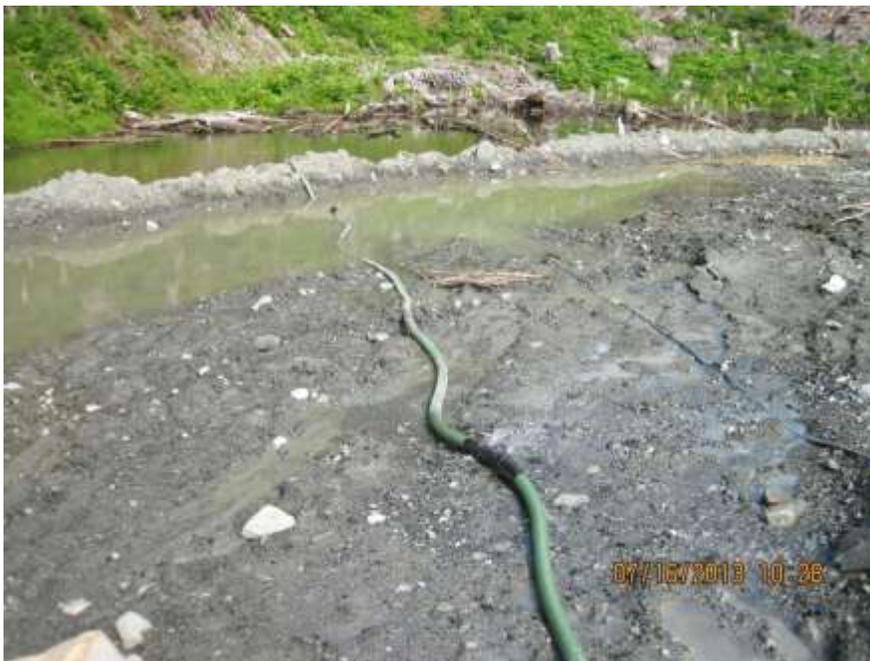
Photo 04. Water from the pond at the northwest corner of the graphitic phyllite is being pumped to the constructed pond where it is temporarily stored before it is sent to the graphitic phyllite water treatment plant.

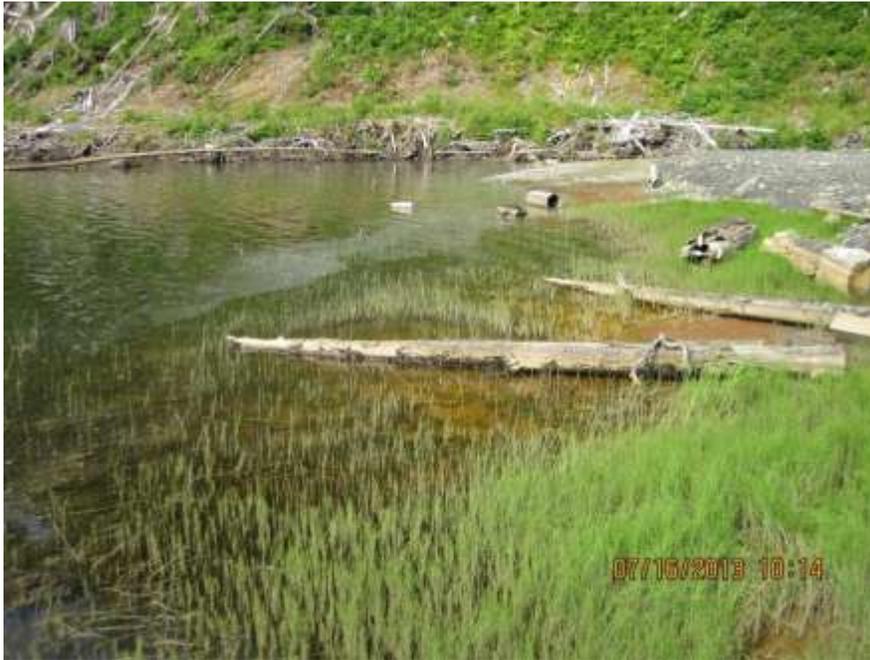
Photo 05. The pH of the water at the north end of Lower Slate Lake was about 6.

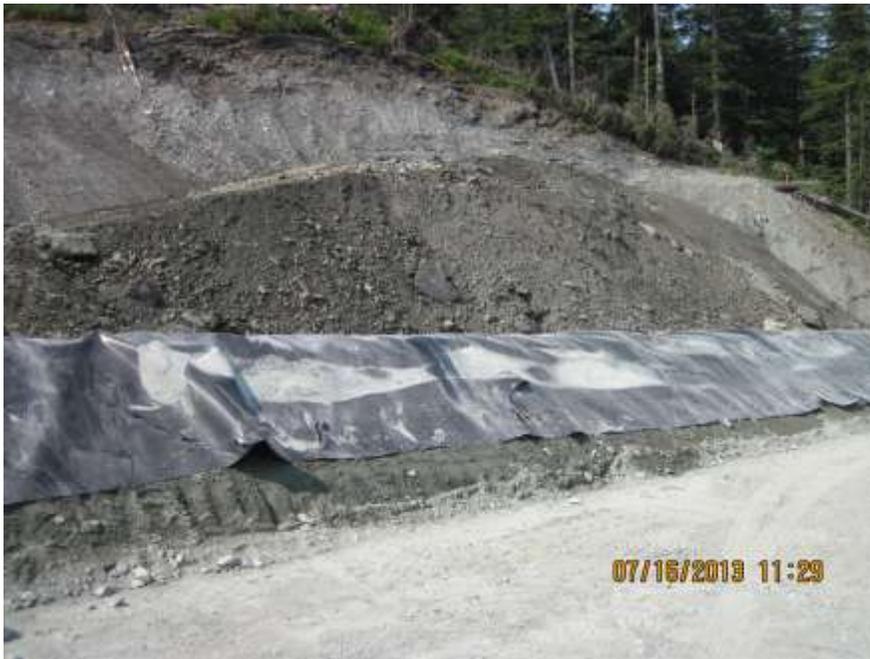
A containment cell for temporary storage of the graphitic phyllite was recently constructed at Pit 7, and it has been filled with graphitic phyllite (photo 06). A second temporary containment cell was partially constructed (photo 07), and Bob stated that it would be able to hold 4000 tons of graphitic phyllite. There were 2 excavators and 1 haul truck at the site, but were not in use (photos 07, 08, and 09). Kevin stated that the operators were unavailable to run the equipment because they were conducting ancillary tasks associated with constructing the containment cell.

Photo 06. A recently constructed containment cell at Pit 7 is temporarily storing graphitic phyllite.

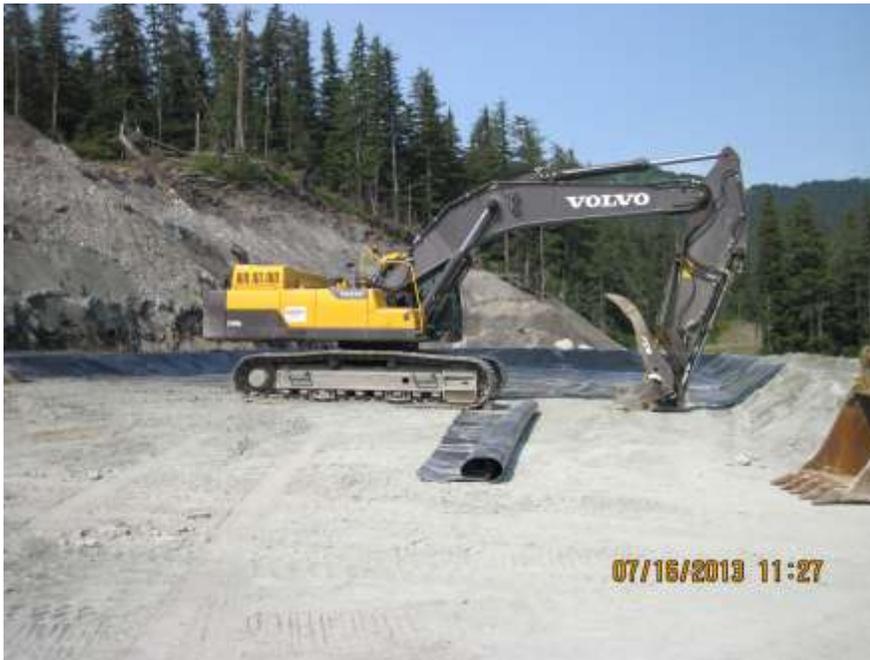
Photo 07. A second containment cell at pit 7 is partially constructed. The Volvo excavator in the foreground was not being used on the day of our inspection.

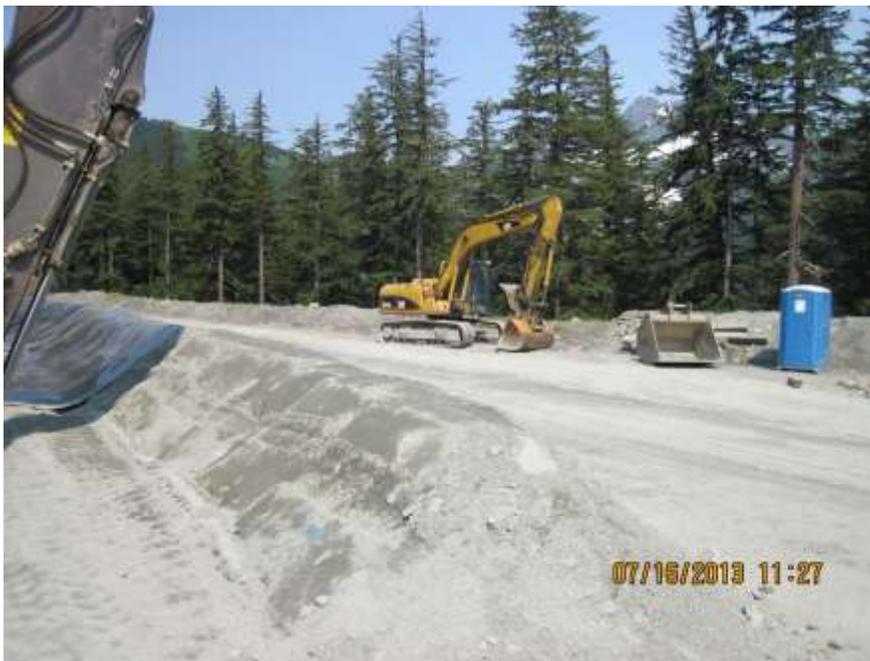
Photo 08. This Cat excavator at pit 7 was not being used during the day of our inspection.

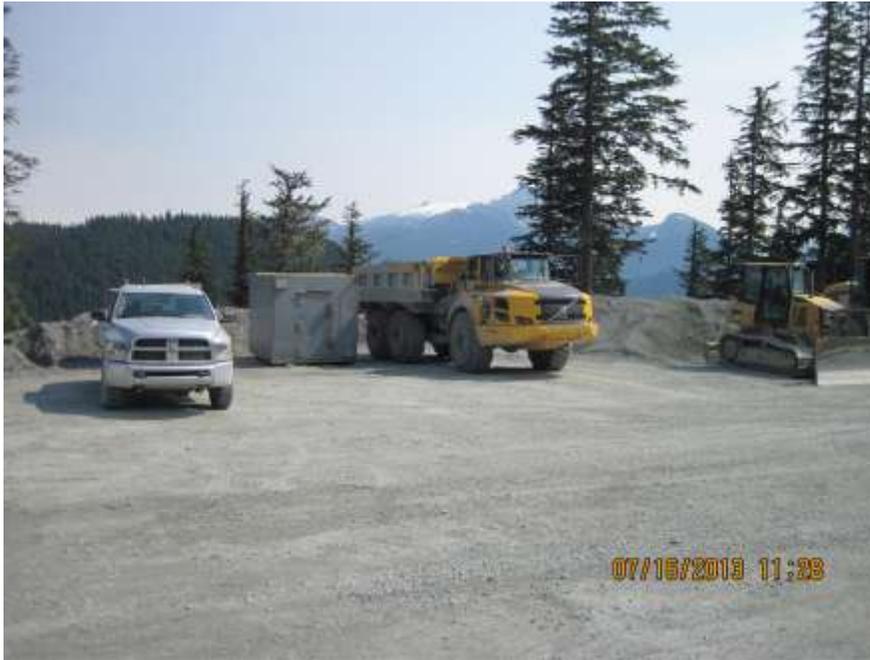
Photo 09. This haul truck at pit 7 was not being used during the day of our inspection.

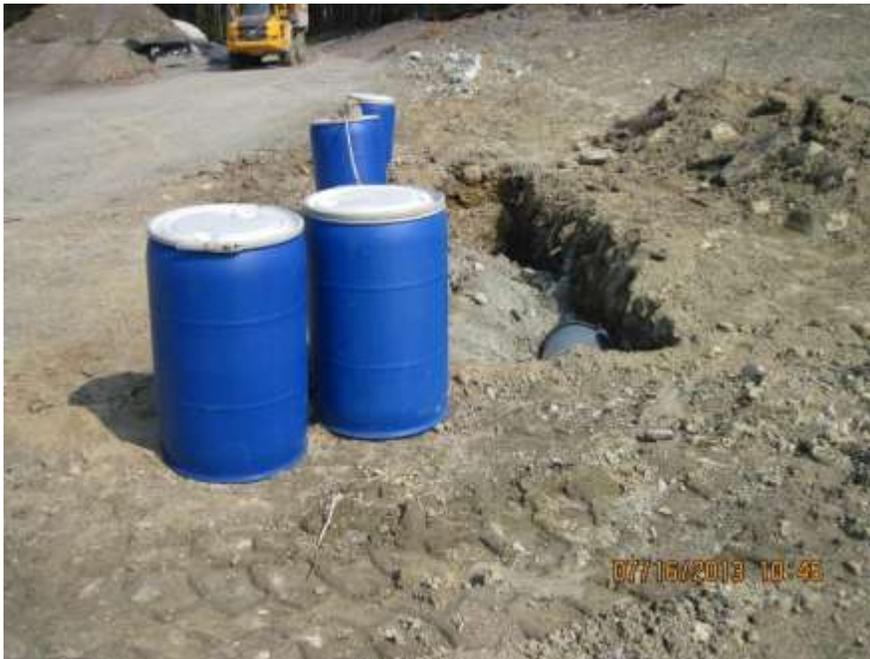
The preparation of the graphitic phyllite field test cells was underway (photo 10). There was a lot of fine grained material in the four graphitic phyllite samples (photos 11 and 12). I discussed with Peter the necessity of large grained material without the fines.

Photo 10. The barrels for the graphitic phyllite field test cells are on site and the trench is being dug for the placement and securement of the sample containers.

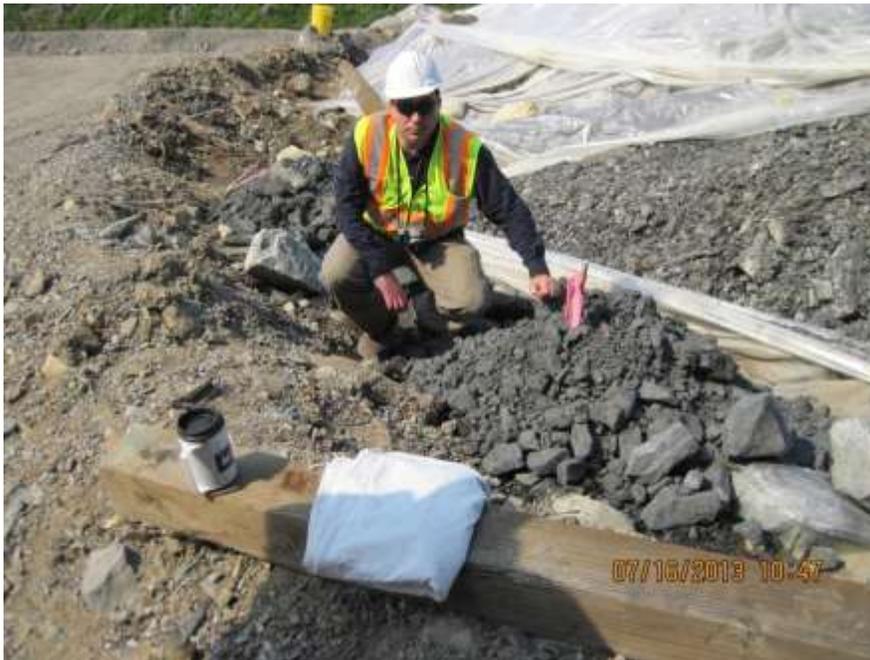
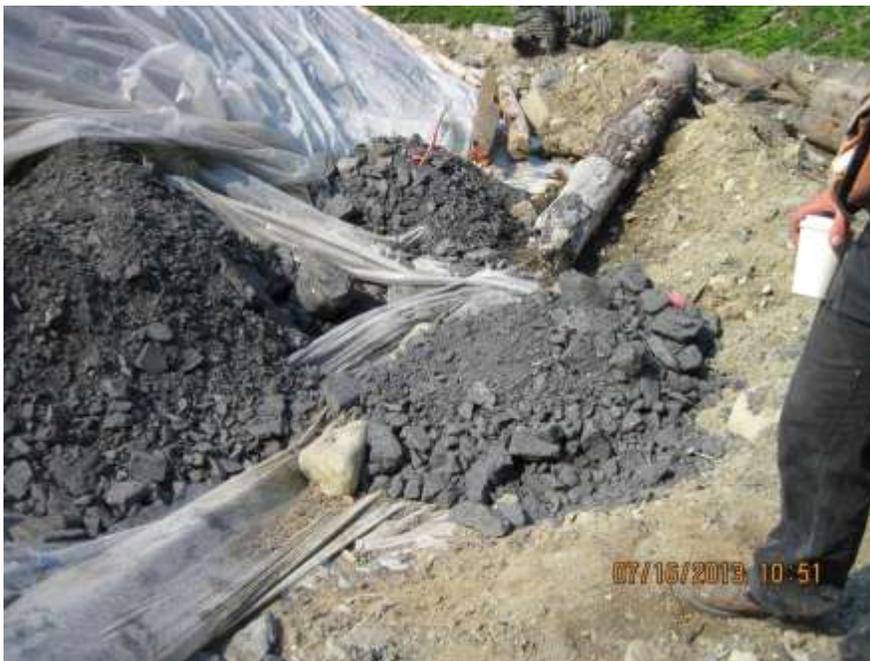
Photo 11. Graphitic phyllite samples are being collected and sorted for the field test cells. There is a lot of fine grained material in the samples.

Photo 12. Graphitic phyllite samples are being collected and sorted for the field test cells. There is a lot of fine grained material in the samples.

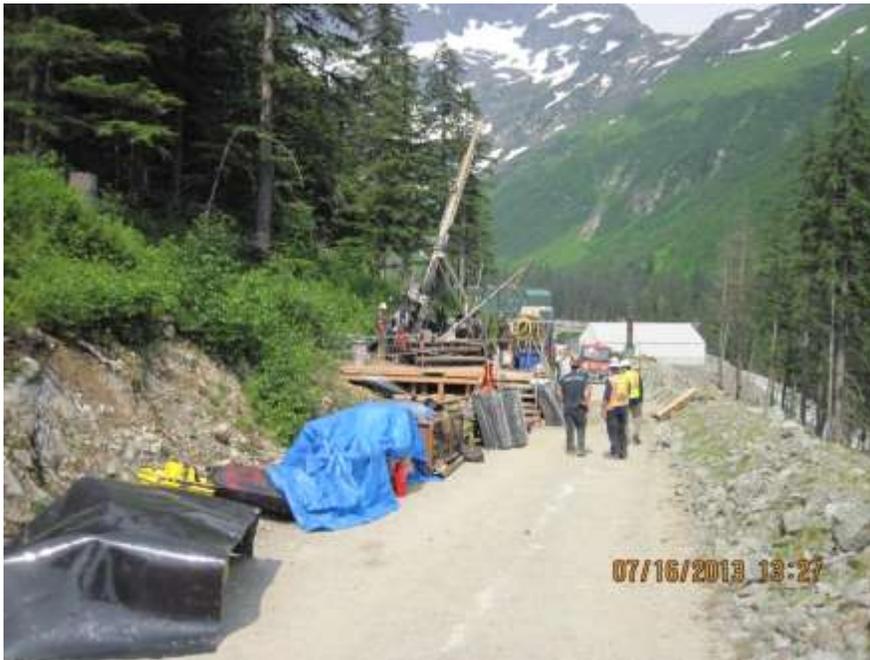
We inspected a surface exploration site on Snowslide Gulch. The drill rig platform is partially blocking the road, and it will have to be removed before the reclamation test plot construction can begin (photo 13). A second drill rig platform that was recently abandoned will also have to be removed (photo 14). Pete will prepare a separate and complete surface exploration report.

Photo 13. This drill rig and platform will have to be removed before a haul truck can deliver the soil to Snowslide Gulch for the reclamation test plots.

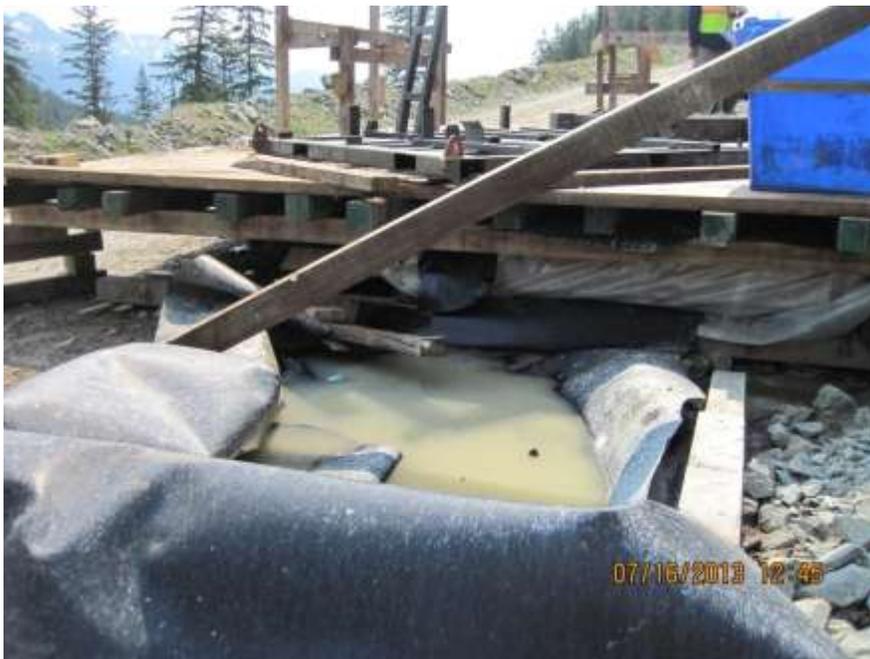
Photo 14. This recently abandoned drill rig platform needs to be removed before the reclamation test plots can be constructed.

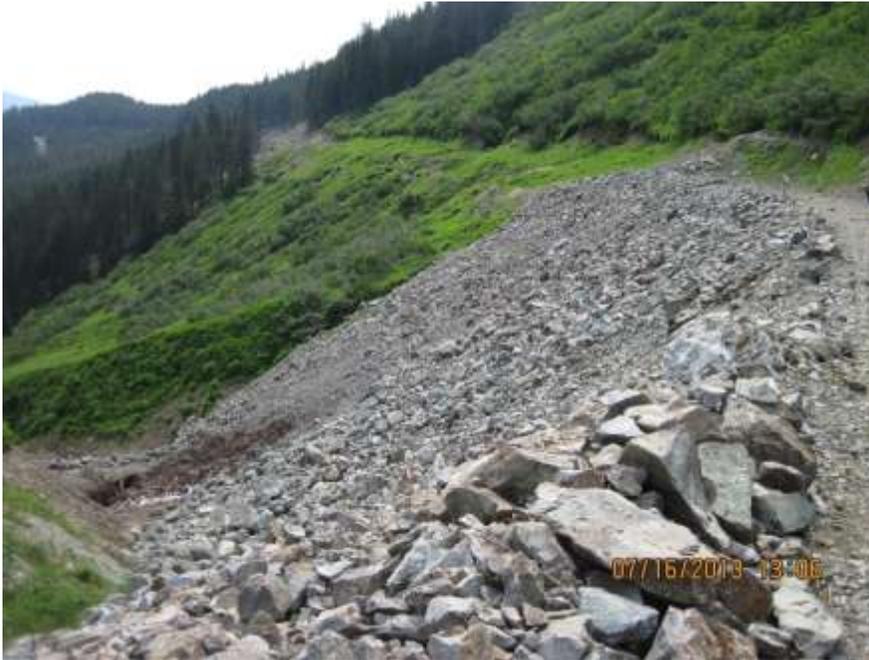
Work on the reclamation test plots at Snowslide Gulch has not yet started (photo 15). The deadline for seeding the test plots was July 15. On July 2, Coeur sent a letter to the Forest Service requesting an extension of the deadline to August 15. The letter stated, "Current resources that were planned for the construction of the proposed test plots have been diverted to remediation of Acid Rock Drainage (ARD) at the Tailings Treatment Facility. Due to this unexpected remediation effort and urgency of completing the remediation of the ARD, Coeur is requesting that this window for seeding be extended to August 15th." The Forest Service has not approved the extension.

Photo 15. The reclamation test plots have not yet been constructed on Snowslide Gulch.

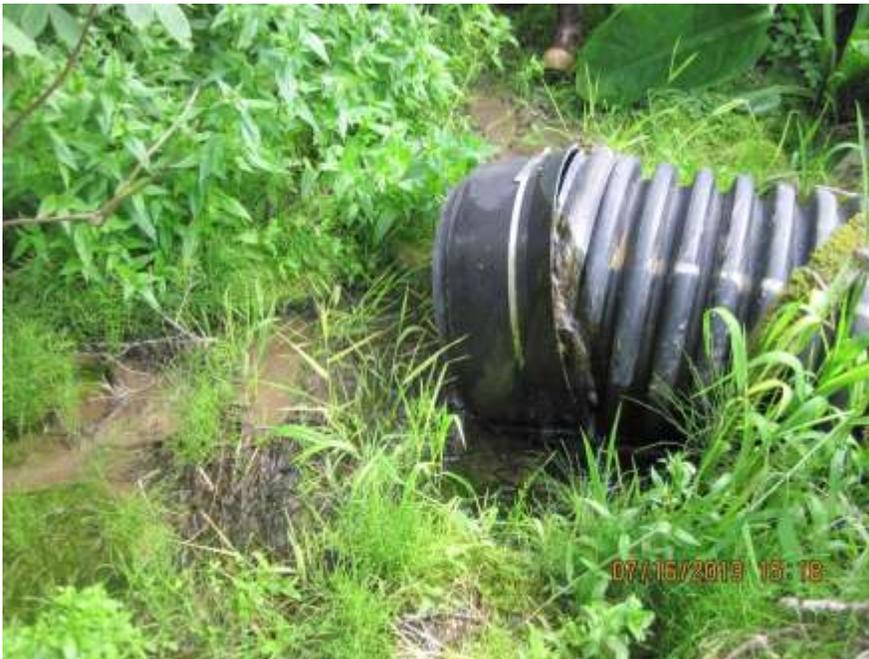
Several water quality standard exceedances for aluminum, iron, and manganese occurred at JS5 in 2012. The Freshwater Monitoring Plan is a joint requirement of the Forest Service and DEC. It requires monitoring at JS5; and potential causes and actions implemented to address water quality standard exceedances are required to be identified. JS5 is located on Johnson Creek approximately 600 feet below bridge number 2 near the Jualin administration and laydown areas. Coeur has previously hypothesized that the source of exceedances at JS5 is Snowslide Gulch, but Snowslide Gulch enters Johnson Creek about 0.4 miles below bridge number 2. I discussed this with Peter, and he agreed that Snowslide Gulch is not a plausible source of the exceedances. Cassandra, Pete, Dave and I walked around a sediment pond located just downstream of bridge number 2. A drainage pipe below the sediment pond has a cap that is leaking (photo 16). This leaking pipe is only 1 possible source of the water quality exceedances. More work will need to be done to determine the source(s) of the exceedances. This drainage pipe and JS5 are on patented claim land. Therefore, I am forwarding this information to DEC, and they will take the lead on this issue.

Photo 16. This pipe has a cap that is leaking. It is presently unknown if this could be a source of the water quality exceedances at JS5.
