PERIODIC SAFETY INSPECTION REPORT NO. 2 – LOWER SLATE LAKE TAILINGS DAM

**Alaska Jurisdictional Dam No. AK00308
Kensington Mine, Alaska**

December 16, 2014

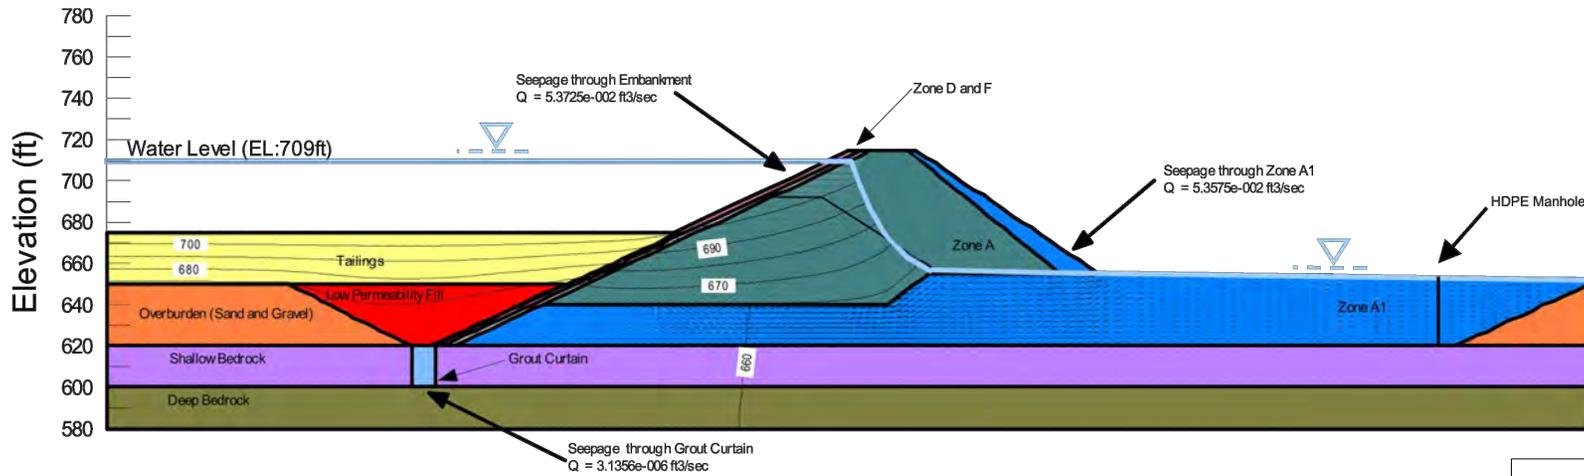
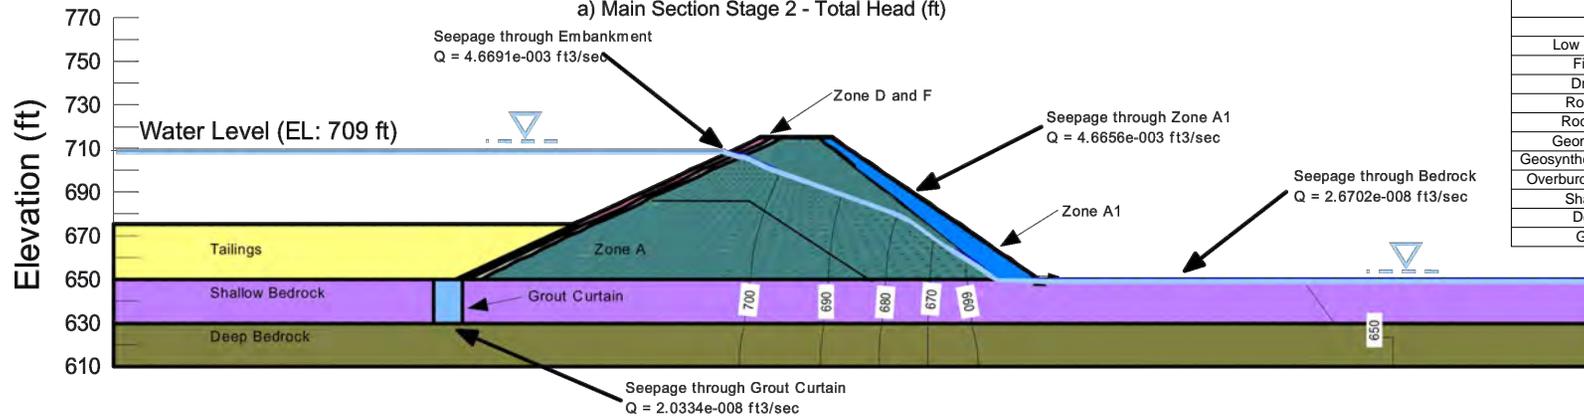
a) Main Section Stage 2 - Total Head (ft)

The post-closure scenario seepage analyses results for Stage 2 (geomembrane degraded) section is shown in Figure 6. The seepage results for the Stage 2 section estimated a total of about 1 gallon per minute (gpm) for the operational case (geomembrane functional) and about 3,400 gpm for the post-closure case (geomembrane degraded). The seepage exit gradient for each scenario was less than 0.1, which provided a factor of safety over 10 assuming a critical seepage gradient between 1 and 1.2.

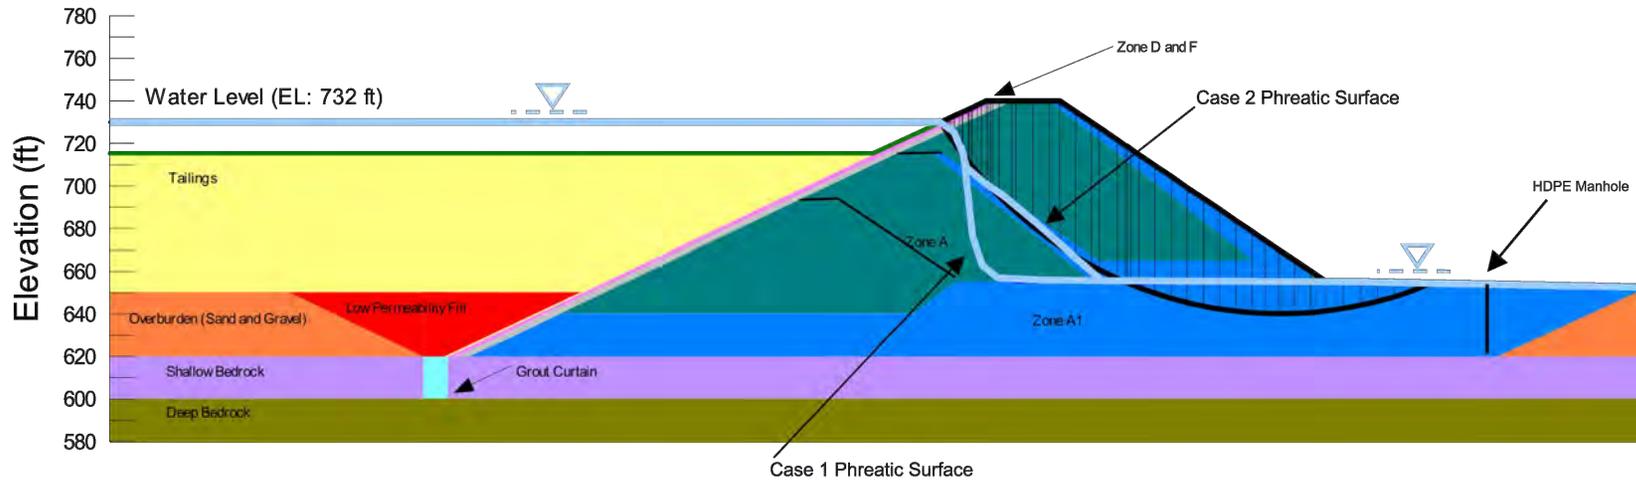
EXAMPLE OF SLOPE STABILITY SECTION AND FAILURE SURFACE (DOWNSTREAM SLOPE, POST-CLOSURE CASE)

The results of the slope stability analyses are summarized in Figure 7 that also shows an example of the modeled section and downstream failure surface for the post-closure scenario. The factors of safety values were the same for the static and post-liquefaction condition for each scenario, which indicated the failure surface was not controlled by the tailings condition as the critical potential slip surfaces did not pass through the tailings. The factor of safety values ranged from 1.58 to 2.66; therefore, they were all greater than the minimum factor of safety for static pre-earthquake (1.5) and post-liquefaction (1.1). In contrast, the factor of safety values for the seismic stability scenarios were reported to be all less than one, but the evaluation actually only considered deformations and not the factor of safety.
