INSPECTION REPORT: KENSINGTON GOLD MINE

Date of Inspection: Wednesday, April 01, 2015
Date of Report: Monday, April 06, 2015
USDA Forest Service Inspector: Curtis Caton

The inspection included Comet Development Pile, Comet Water Treatment Plant, Sherman Creek Outfall, Mill Bench, Ore Pad, Jualin Development Pile, Tailings Treatment Facility (TTF), Tailings Water Treatment Plant, and Pit 4.

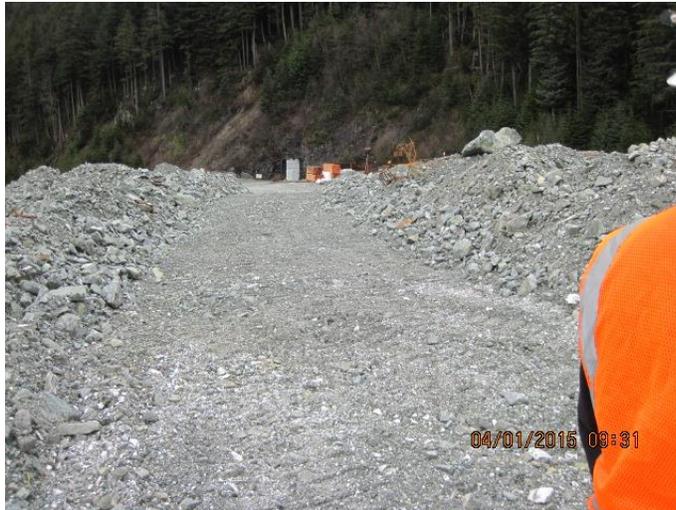
Coeur is considering realigning the Comet Development Pile Access Road, which will also require a relocation of the buried utilities next to the access road. Currently, the access road and the buried utilities that connect the Comet Water Treatment Plant to mine infrastructure are sited between the locally steep terrain and the Comet Waste Rock Development Pile and route from the Comet Portal to the Comet Water Treatment Plant (CWTP) following the old railroad grade. The Comet Access Road relocation proposal is early in the developmental stages and has not been presented to the Forest Service. The proposal will seek to redirect the access road and utilities across the top of the development pile, which will then route following the contour of the development pile downslope toward the CWTP. Realignment of the access road may open additional space for storage of waste rock in the Comet area (Photos 01-03).

Photo 01. Approximate location of realigned Comet access road. Portal in background but not visible.

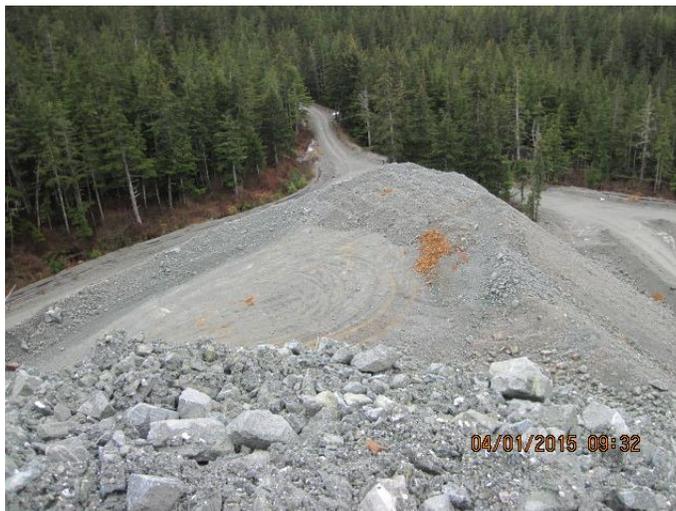
Photo 02. Approximate location of realigned Comet access road following contours off Comet development pile towards the Comet Water Treatment Plant.

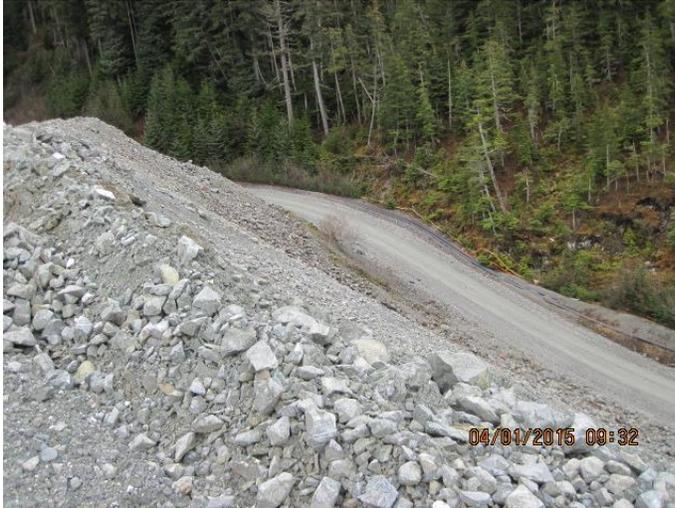
Photo 03. Current location of Comet access road and buried utilities against terrain. Photo taken from top of development pile at approximate realignment position.

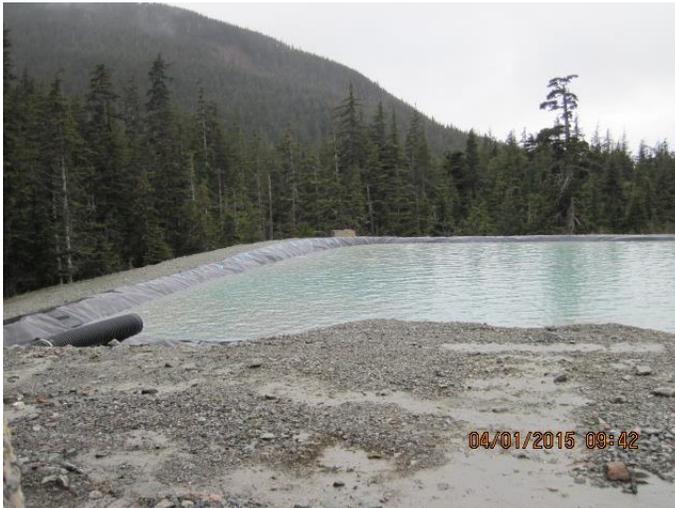
Pond 1 was active and near capacity while Pond 2 was comparatively empty and inactive. Low seasonal runoff has reduced the need to operate both settling ponds simultaneously. Although receiving waters to Pond 1 looked clear, accumulated sediment was visible in Pond 2 and dredging of the settling ponds is scheduled to continue throughout this year. Dredging in the future will be minimized because of the addition of the triple sumps underground, which have greatly reduced the sediment load from the interior of the mine reaching settling Ponds 1 and 2 (Photo 04-05).

Photo 04. Pond 1 at capacity.

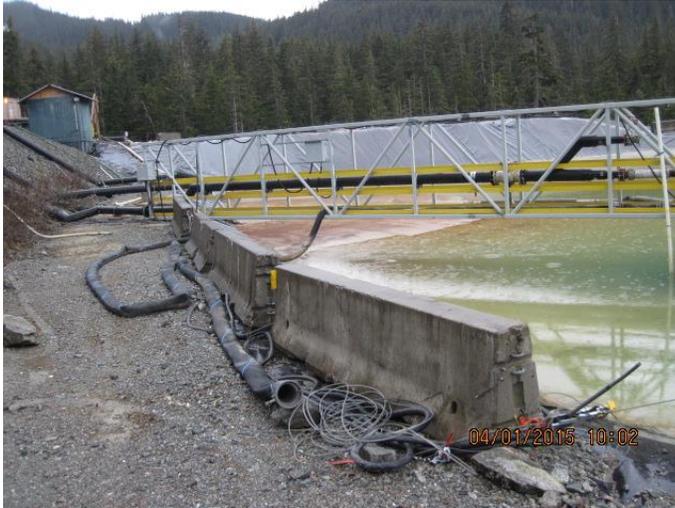
Photo 05. Pond 2.

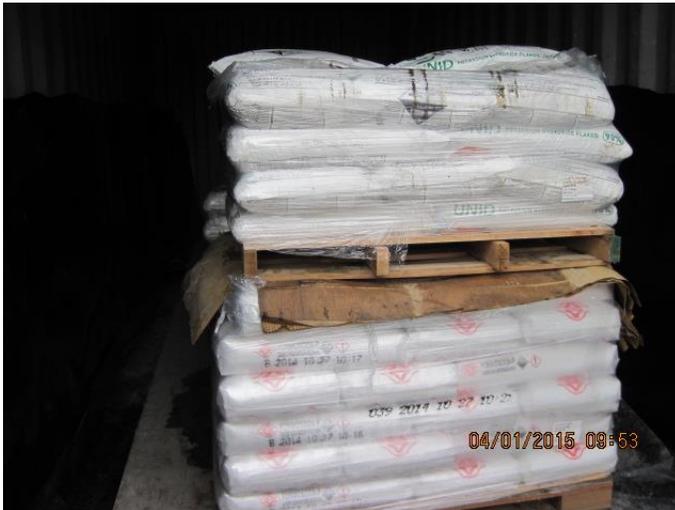
Coeur is transitioning to using dry chemicals instead of liquids where possible at the CWTP to ease the concern of transportation, spills, and secondary containment of liquids (Photo 06).

Photo 06. Dry chemical storage at CWTP.

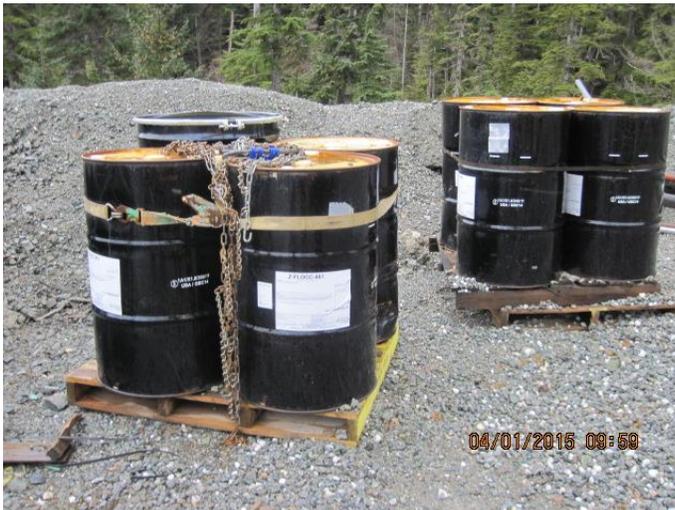
Two pallets each holding four, fifty-five gallon barrels was located outside the CWTP, the barrels contained a material (Z-FLOCC-401) used in the milling process. Several barrels exhibited signs of impact by forklift and two barrels were punctured, one was already in secondary containment, and the other was not. The leaking material from the punctured barrel was viscous and had not reached the surface of the ground. A downloaded MSDS for the product Z-FLOCC-401 identified the substance as non-toxic and listed no hazardous materials (Photos 07-08). The Z-FLOCC-401 should be returned to the Mill and stored properly; any spilled material should be cleaned up accordingly.

Photo 07. Pallets at CWTP with damaged barrels.

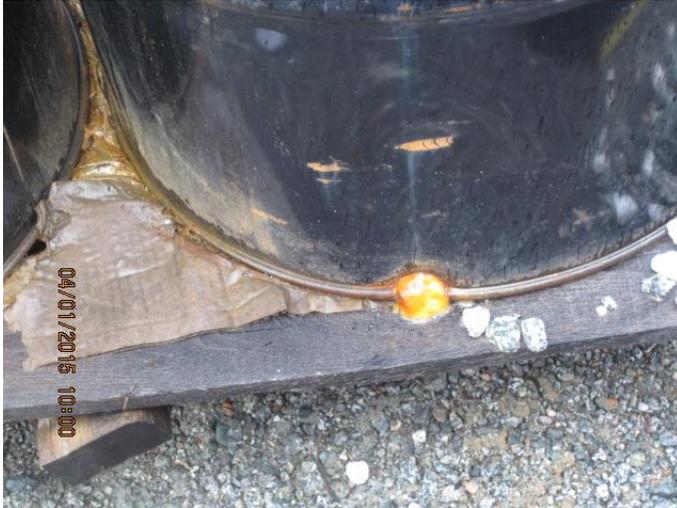
Photo 08. Small leak in one palletized barrel.

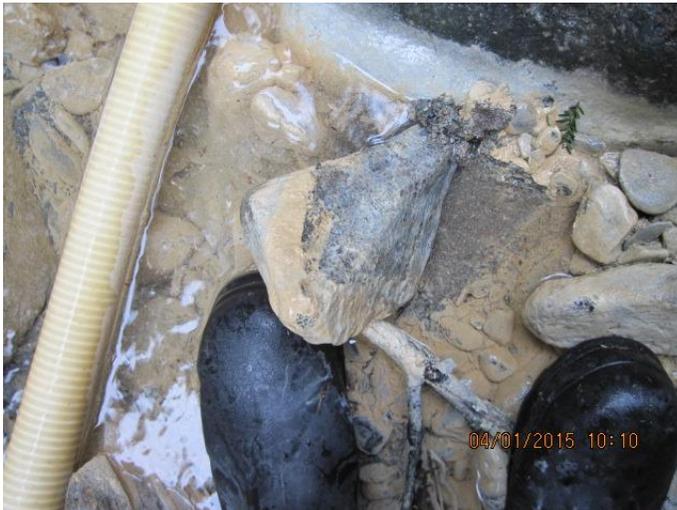
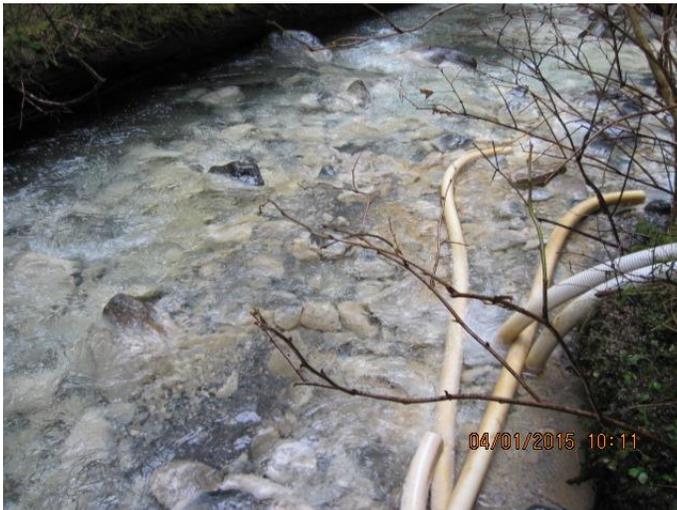
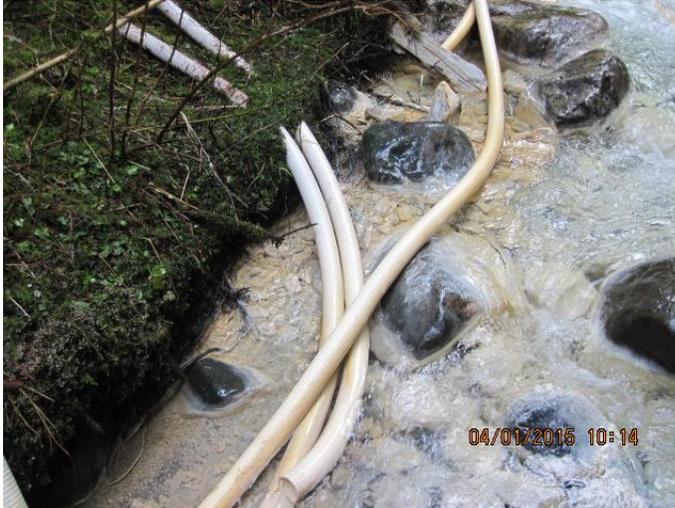
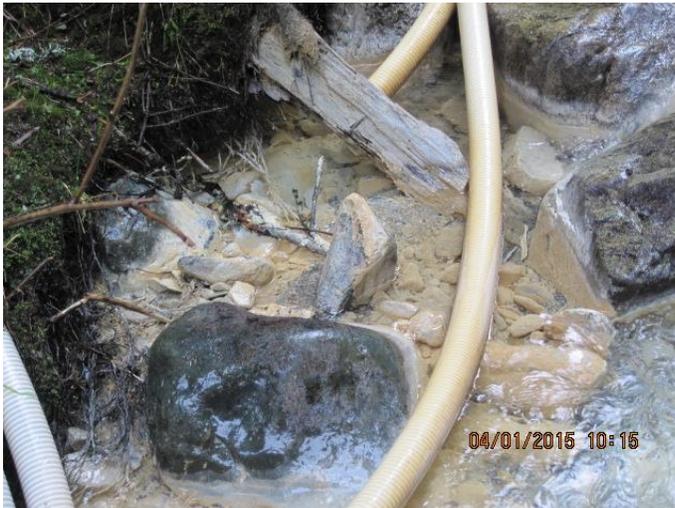
Photo 09. Sherman Creek.

The white matter discovered last fall at the Sherman Creek outfall was detected again on this inspection. The white matter envelops all objects in the streambed at and below the water line with thin mucus like coating. The white matter is not visible upstream from the outfall location and continues downstream for approximately 100-150 meters (Photos 09-12). Although testing has occurred, Coeur has been unable to identify the cause or the source of the white matter. Photos documenting the outfall were provided to ADFG.

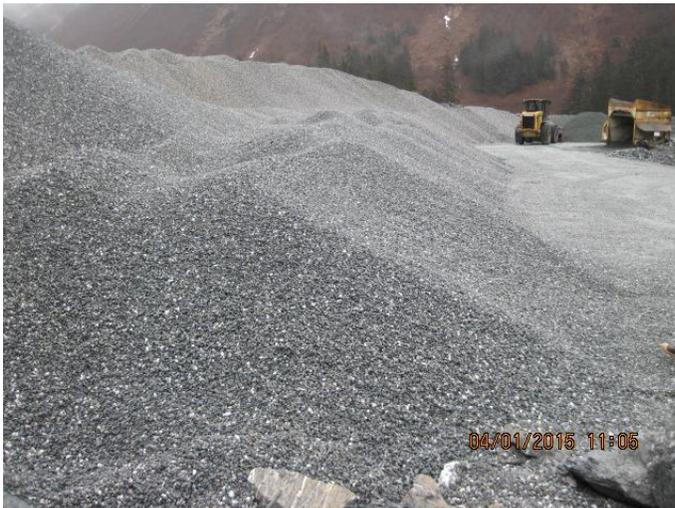
the reject material does still contain a small percentage of mineralization. Coeur plans to rerun the reject material through an X-Ray sorting process to recover any remaining ore. The rejected material from this separation process will be used as construction gravel aggregate; the recovered ore will be reprocessed at the mill (Photo 13).

Photo 13. Jualin reject pile.

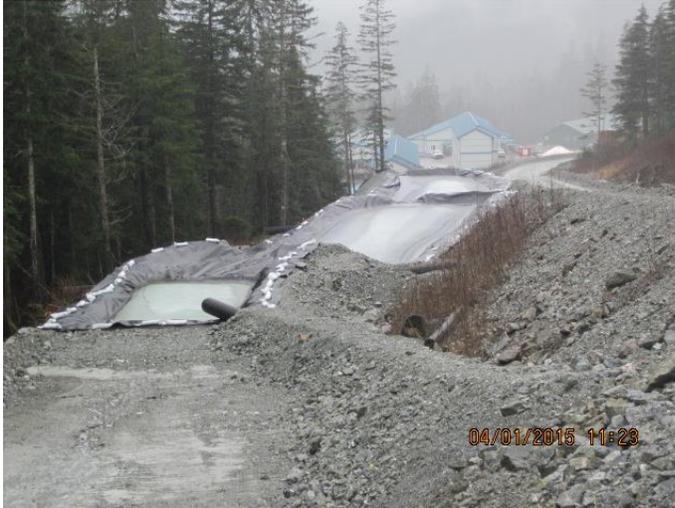
Expansion of the Jualin Development Pile has caused the need to relocate two settling ponds that rest between the mine camp and mill bench, the ponds are positioned to best capture stormwater runoff from the Mill Bench and the Mill Bench access road. Minor improvements would help redirect some of the runoff into the settling ponds instead of pooling in front of them (Photo 14).

Photo 14. New pond location near camp. Small puddle of stormwater runoff accumulating.

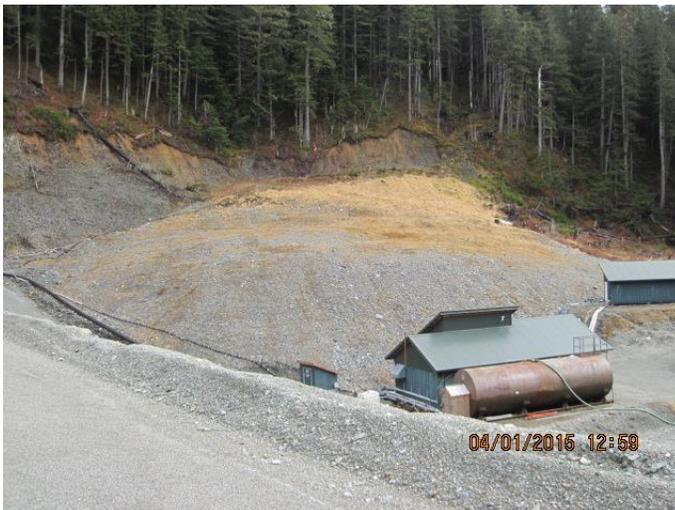
Phase 3 construction of TTF dam is scheduled for 2016 and Coeur estimates approximately 9 years of storage capacity in the TTF at the current rate of production. Coeur is planning to relocate the graphitic phyllite (GP) batch plant and to excavate the graphitic phyllite infiltration gallery before dam construction commences. The GP batch plant will be relocated to the north end of the TTF closer to the water treatment plant and will be used to treat small batches of water collected from the GP seeps located at the north end of the TTF (Photo 15). The stockpiled GP material from the chimney drain near the TTF dam will be excavated and transported to Pit 4. At Pit 4, the GP material will be mixed with cement and then transported underground for permanent disposal.

Photo 15. GP batch plant with GP chimney drain in background.

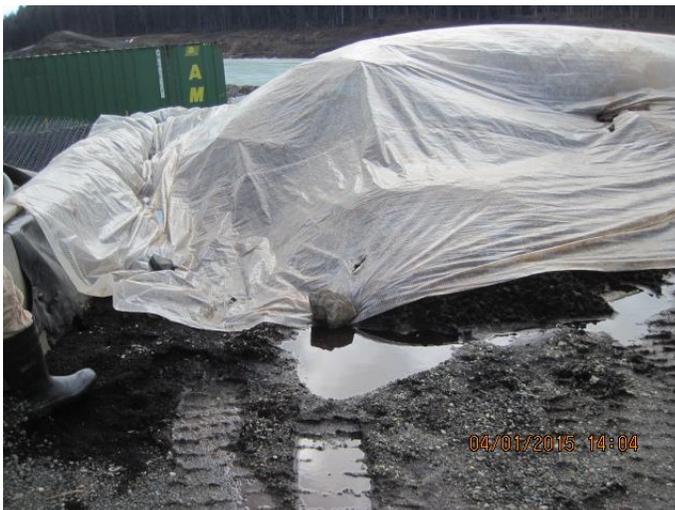
Minor housekeeping is needed at the filter cake storage area at the TTF Water Treatment Plant (Photo 16). The filter cake material should not be allowed to come in contact with soil off the HDPE liner and should be covered more effectively to prevent precipitation from entering. The filter cake material is hydraulically dewatered sediment that has been filtered during the water treatment process at the facility. After dewatering, the cakes are temporarily stored at the TTF and eventually transported underground where they are added into a cement paste mixture for permanent disposal.

Photo 16. Filter cake storage area at TTF WTP.

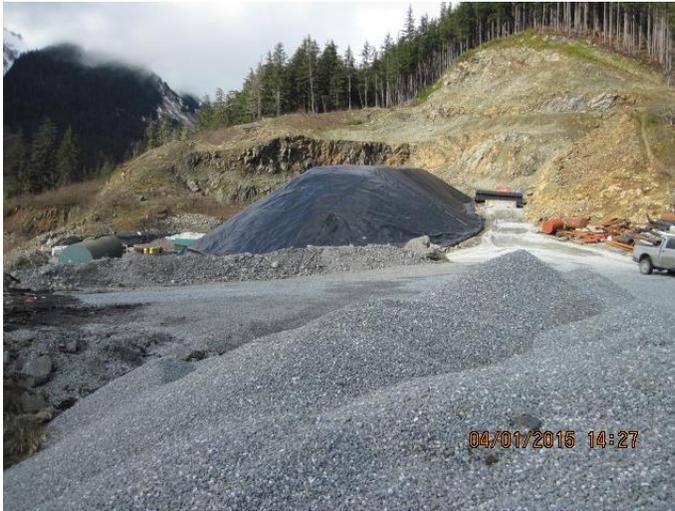
Reject material from the Jualin Development Pile has been stockpiled at Pit 4 because of limited space at Jualin. Specialized sorting equipment is scheduled to arrive on site in June of this year and will separate all reject material into either a construction gravel aggregate, or ore aggregate. The ore aggregate will return to the Mill for inclusion into the milling process and the gravel aggregate will be used as construction aggregate for cement. The cement will be mixed in a pug plant that Coeur plans to install at Pit 4 along with the specialized sorting equipment this summer.

The pug plant will be used to encase GP material stored on site within a cement mix, which will prevent ARD of the GP material once placed underground for permanent disposal. GP material has been stored in four places on site; north end TTF, Pit 4, Mud Dump, and the chimney drain near the TTF dam (Photo 17). The heaps of GP at the TTF, Pit 4, and the Mud Dump have been encased in layer of HDPE to prevent acid rock drainage (ARD) from occurring while awaiting disposal.

Photo 17. Reject material storage at Pit 4. HDPE encased GP in background.
