## INSPECTION REPORT: KENSINGTON GOLD MINE

Tongass National Forest Minerals Group  
8510 Mendenhall Loop Rd  
Juneau, AK 99801  
(907) 789-6275 – office  
(907) 586-8808 – fax

Date of Inspection: Thursday, January 07, 2016  
Date of Report: Thursday, January 14, 2016  
USDA Forest Service Inspector: Richard Dudek

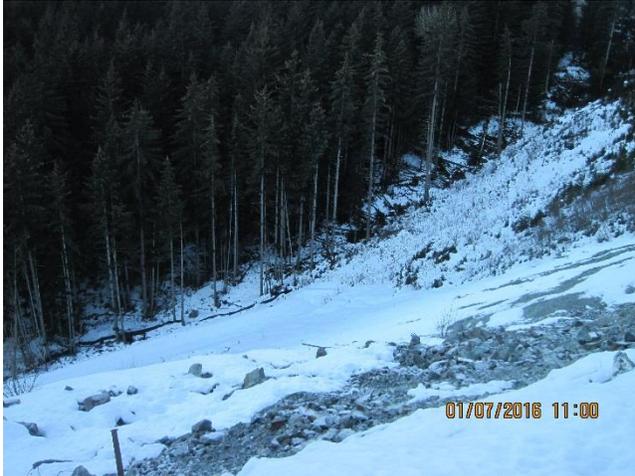
The Comet Development Pile silt fence is designed for trapping sediments from depositing into Ophir Creek. During the site inspection, sections of the silt fence appeared overburdened with snow and debris build up (Photo #1). The Comet Development Pile also showed additional waste rock added prior to this inspection (Photo #2).

Photo #1. Comet Development Pile silt fence.

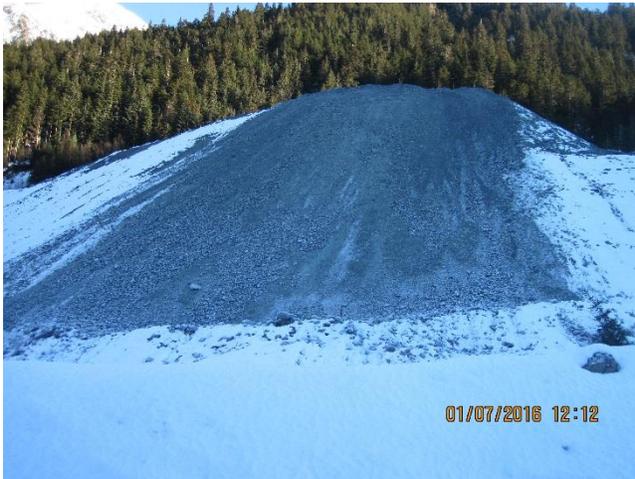
Photo #2. Comet Development Pile.

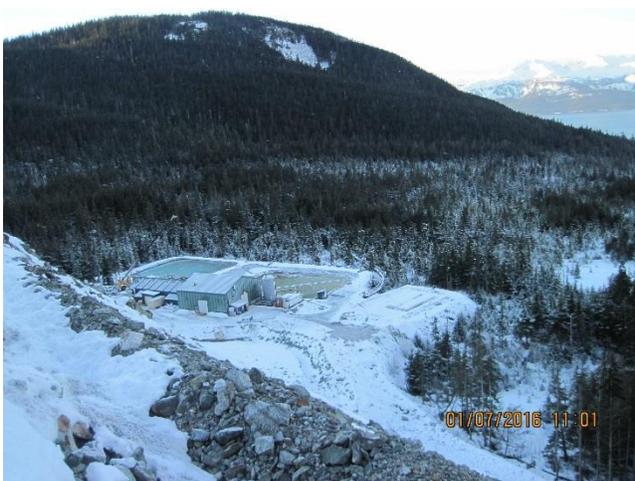
All underground mine drainage is redirected to the Comet Water Treatment Plant (Photo #3). After the water has gone through the treatment process. The treated water is then discharged into Sherman Creek. Maintenance is currently underway for new and more durable pumps for transferring water at the Comet Water Treatment Plant (Photo #4). During a walkthrough of the Comet Water Treatment plant, there was some white material found on the floor below a water quality instrument (Photo #5). Other traces of the white material found was in a floor drain (Photo #6) and around the bottom of a barrel (Photo #7). Possible source for the white material may have resulted from the removal of sediments from the underground 445 level sediment sump. Personnel at the Comet Water Treatment Plant continue to monitor for residual white material from the 445 level sediment sump.

Photo #3. Comet Water Treatment Plant.

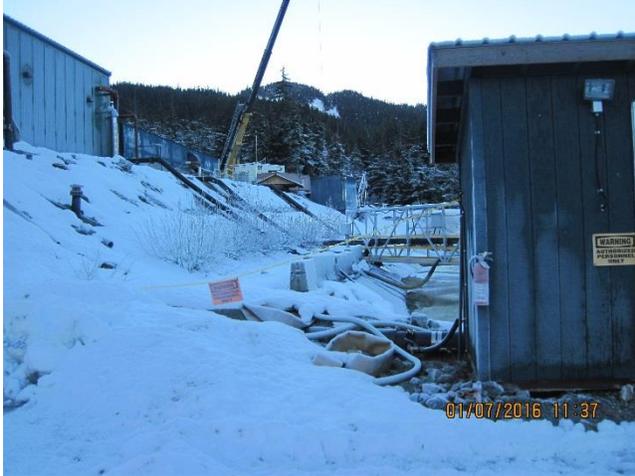
Photo #4. New pump installation at Comet Water Treatment Plant.

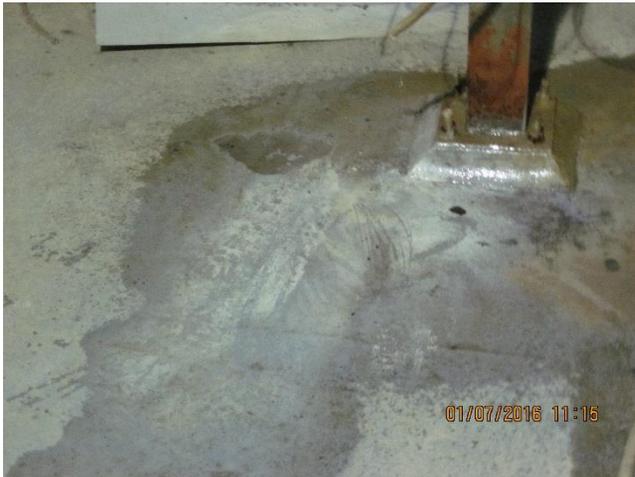
Photo #5. White substance residue found on floor.

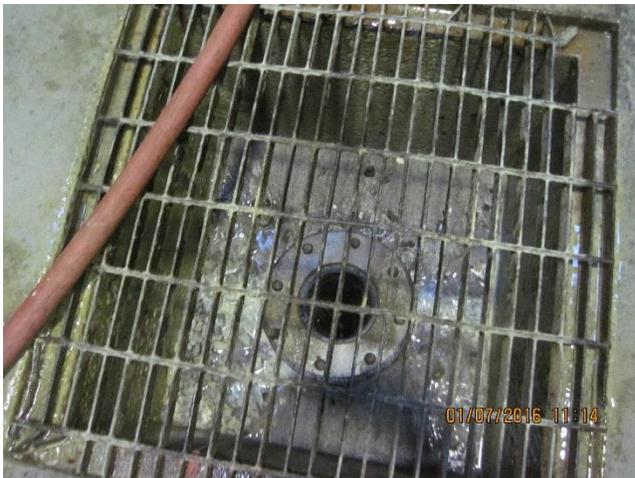
Photo #6. White substance found in floor drain.

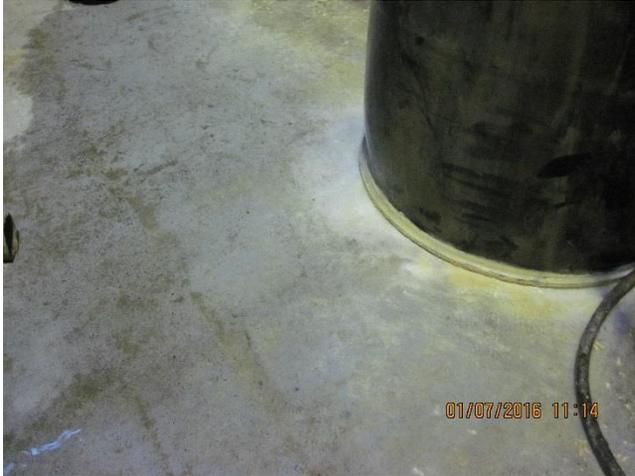
Photo #7. Dried white substance on bottom of barrel.

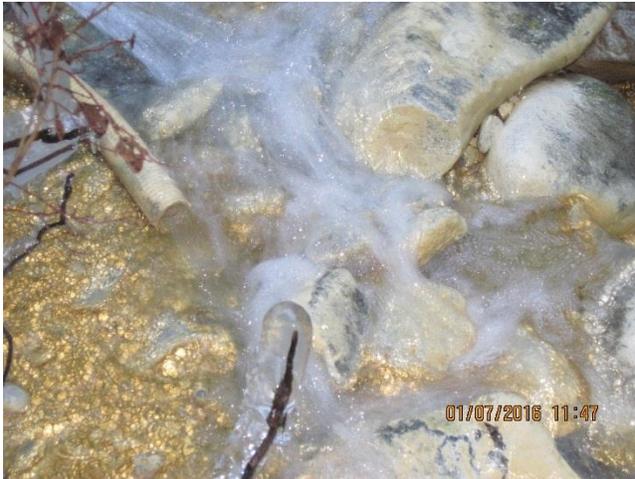
Sherman Creek flows west from Lions Head Mountain to Lynn Canal. The white material in Sherman Creek was again visible during this inspection. Ten days prior to this inspection, Coeur Alaska documented the re-occurrence of the white material at the Sherman Creek Outfall. Personnel at Coeur Alaska continue to monitor for white material that may enter Sherman Creek (Photo #8-10).

Photo #8. White substance found on rocks in Sherman Creek.

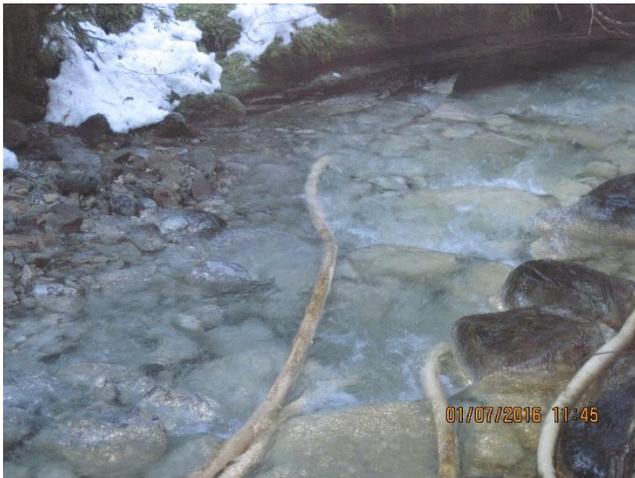
Photo #9. Water discharging into Sherman Creek.

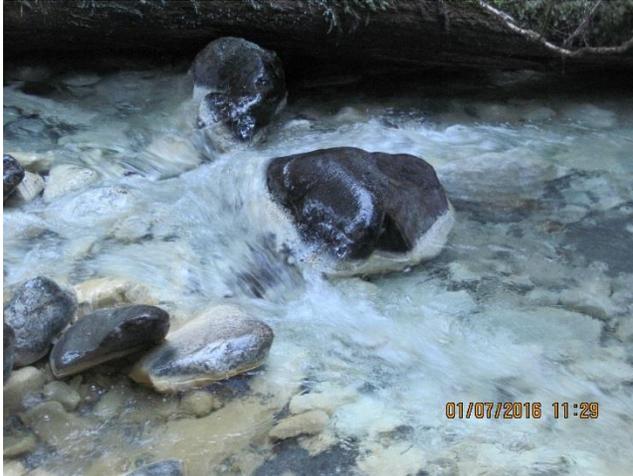
Photo #10. White substance coating on streambed rocks.

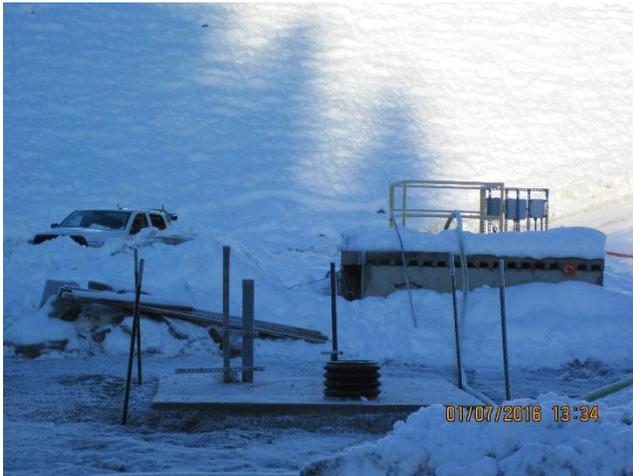
With ongoing operations for treating naturally occurring acid rock drainage (ARD) from graphitic phyllite outcrops. A new graphitic phyllite Seepage Water Treatment Plant is under construction with operations coming online in March. In addition, a new sump system is now in place and will be used for the spillway plunge pool. (Photo #11). During the site inspection, the water discharge from the Water Treatment Plant

Photo #11. New sump system for spillway plunge pool.

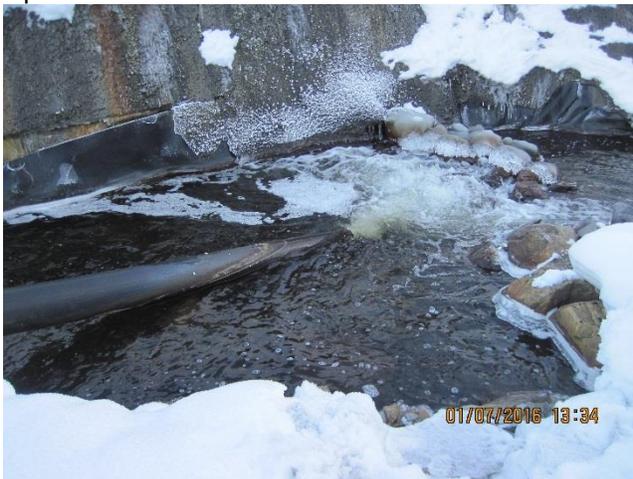
and Upper Slate Lake was entering into the outfall. (Photo #12). The majority of the Phase 2 Dam spillway plunge pool (Photo #13) was covered in snow and frozen over.

Photo #12. Lower Slate Lake outfall.

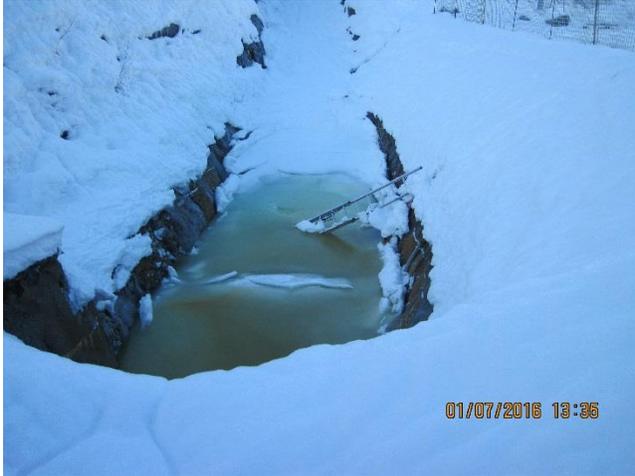
Photo #13. Dam spillway plunge pool.

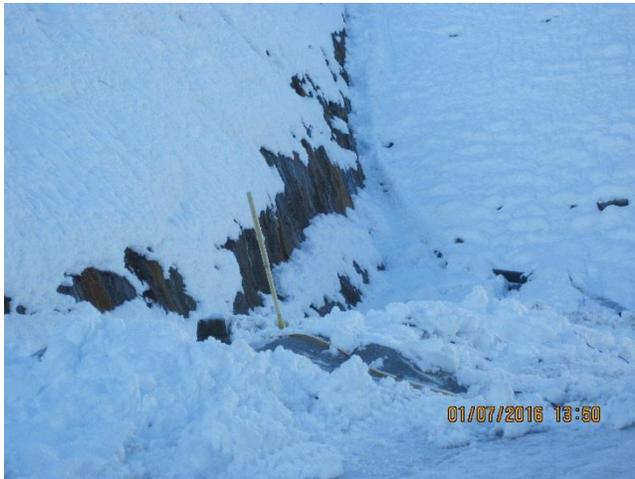
To prevent water lines from rupturing during the winter months, electrical heating coils and insulation mats are being used. A small generator used for power was on site. (Photo #14-15).

Photo #14. Insulation mats to protect exposed water lines.

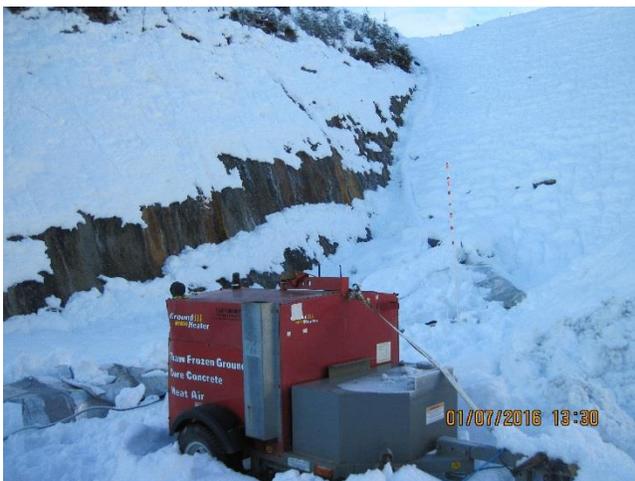
Photo #15. Generator used powering heating coils wrapped around water lines.

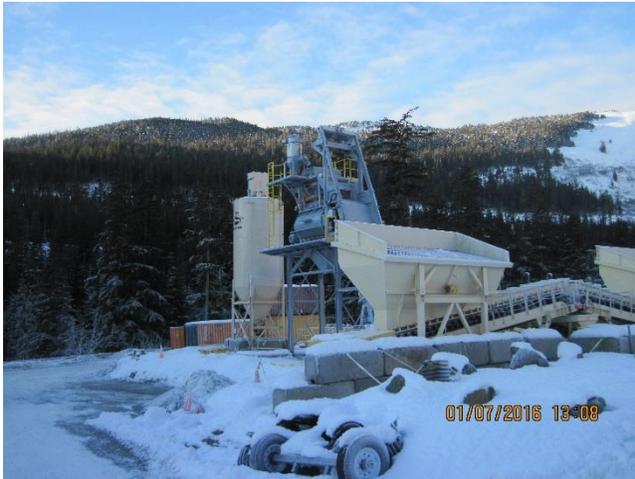
The Pug Plant located at Pit 4 is still in the building process. The primary use for the Pug Plant will be for mixing graphitic phyllite material with concrete and later reject rock mixed with concrete for underground backfill storage in the stopes (Photo #16).

Photo #16. Pug Plant located at pit 4.
