INSPECTION REPORT: KENSINGTON GOLD MINE

Date of Inspection: Wednesday, February 17, 2016
Date of Report: Tuesday, March 8, 2016
USDA Forest Service Inspector: Richard Dudek

This inspection included access roads, Comet Development Pile, Jualin Development Pile, Sherman Creek Outfall, Comet Beach, Pit 4, Tailings Treatment Facility (TTF) and the GP Seep treatment facility.

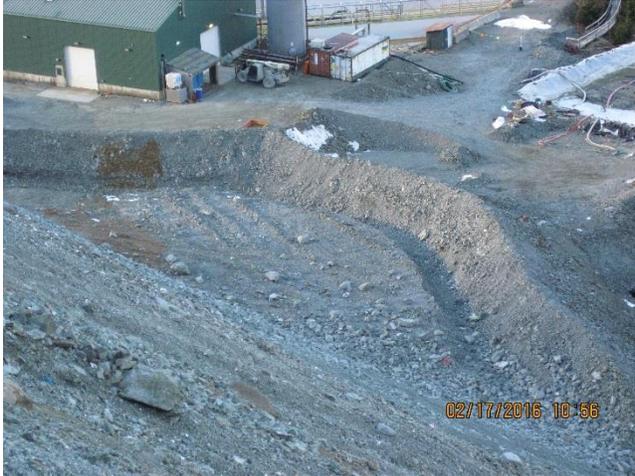
Coeur Alaska has recently expanded the southwest toe section of the Comet Development Pile for development rock storage (Photo 1). The toe expansion will be constructed by a lift method of deposits to create the base of the toe. This method involves end dumping the waste rock, then bulldozing the pile into a flat and compacted the layer. This method is repeated several times to create a more compacted base layer. In addition to waste rock being permanently stored at the Comet Development Pile, the water treatment plant's byproduct material (filter press cakes) are also stored into the development pile. This complies with Coeur Alaska's **2012 BMP plan found on page 18; section 4.2.4** treatment for waste disposal to assure against any discharge of contaminates flow into navigable waters (Photo 2).

Photo 1. Comet development Pile southwest toe expansion.

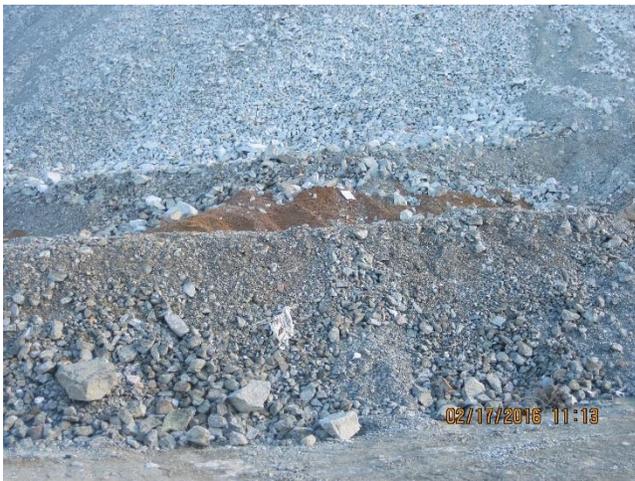
Photo 2. Sediments the water treatment plant are deposited into the development pile to prevent pollution discharge.

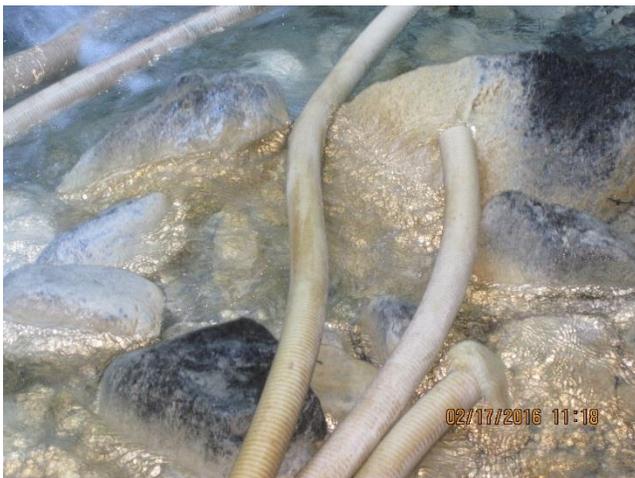
White material was visible again in the streambed of Sherman Creek during this inspection (Photo's 3-6). During the site inspection, trace amounts of white material was observed at the mouth of Sherman Creek (Photo 7). The white material may be a result of mucking the sumps at the 445 level, which remobilized the sediment into the mine drainage. Coeur Alaska is currently bench testing different treatment methods for settling the white material out at the underground sumps.

Photo 3. Sherman Creek Outfall. White material covering streambed rocks.

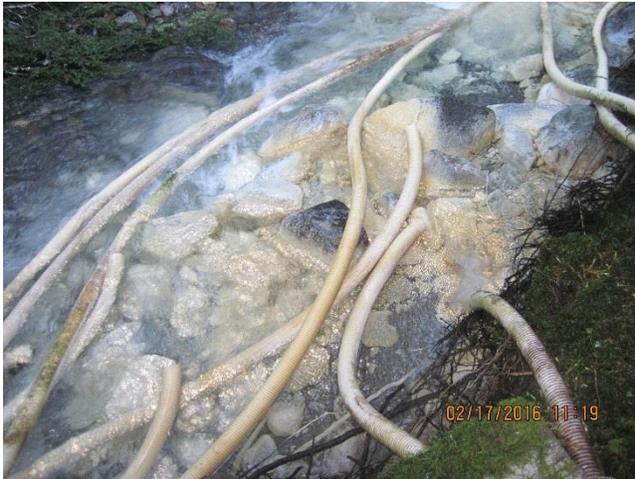
Photo 4. White material accumulation covering rocks.

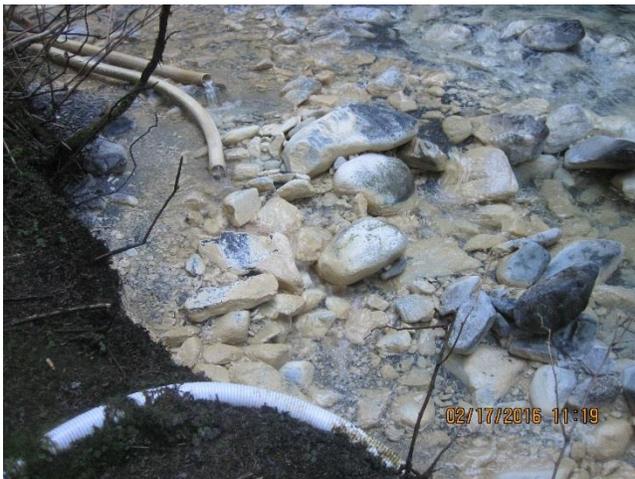
Photo 5. Upstream view of Sherman Creek Outfall with white material covering rocks.

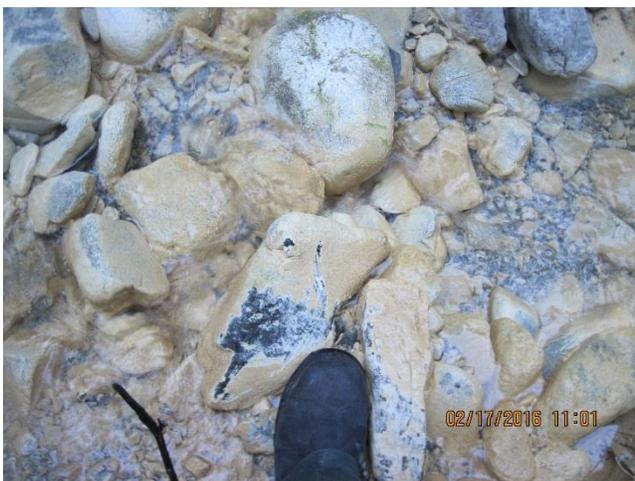
Photo 6. White material scrapped off shows a gradual accumulation.

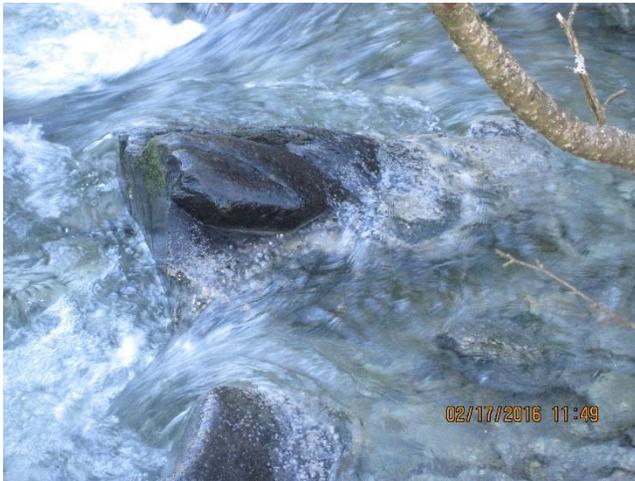
Photo 7. Traces of white material covering rocks at the mouth of Sherman Creek.

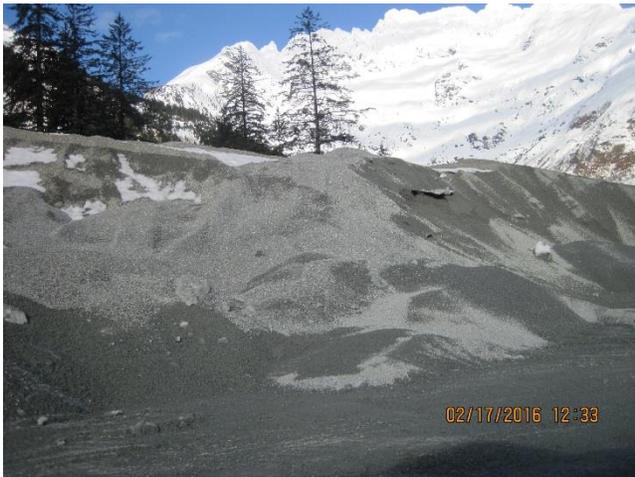
Ore and reject rock from the milling process are temporarily stored at the Jualin Development Pile (Photo 8). Coeur will rerun the reject rock material through an X-ray sorter to recover any remaining mineralized rock.

Photo 8. Reject rock stored at the Jualin Development Pile.

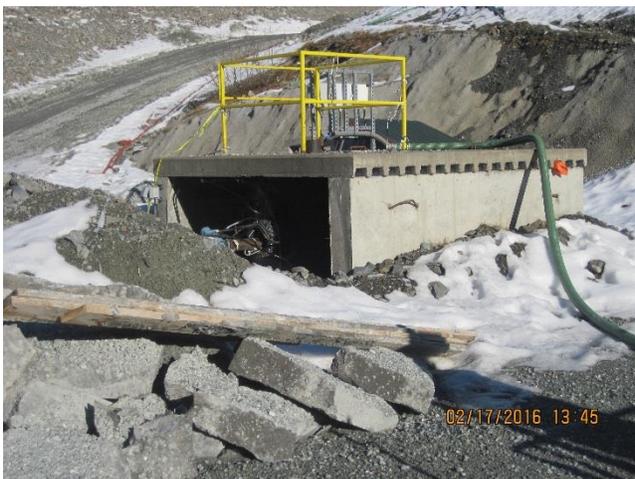
The TTF had minor ice coverage and no tailings were visible in the TTF. A back pump system is used for capturing seepage around the toe and abutments of the TTF dam (Photo 9). The back pump system pumps the seepage back into Lower Slate Lake. The GP sump system is for capturing (ARD) in the TTF spillway (Photo 10). The captured ARD is pumped to the GP seep plant, the water is then sent to an infiltration gallery near the TTF. At the TTF spillway, effluent water from the water treatment plant and Upper Slate Lake were entering the Slate Creek outfall (Photo 11). The temporary dam spillway had snowmelt and minor amounts of ARD accumulating into the plunge pool (Photo 12).

Photo 9. TTF Dam pump back system.

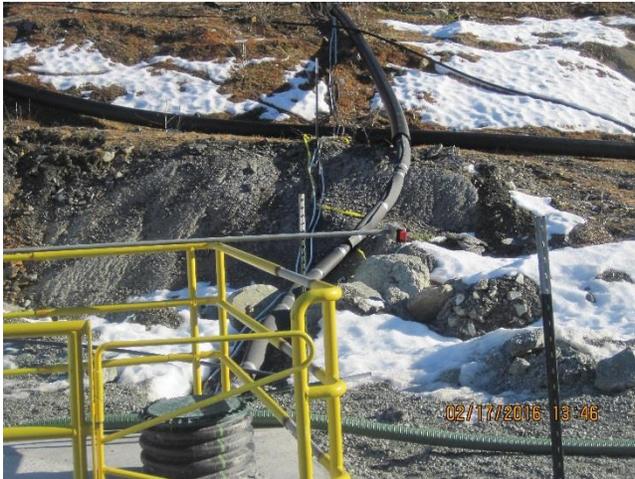
Photo 10. TTF GP-ARD Seepage sump system.

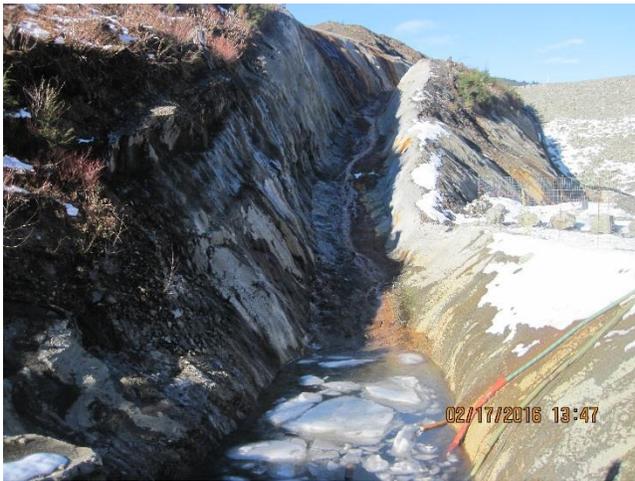
Photo 11. Temporary TTF dam spillway/plunge pool.

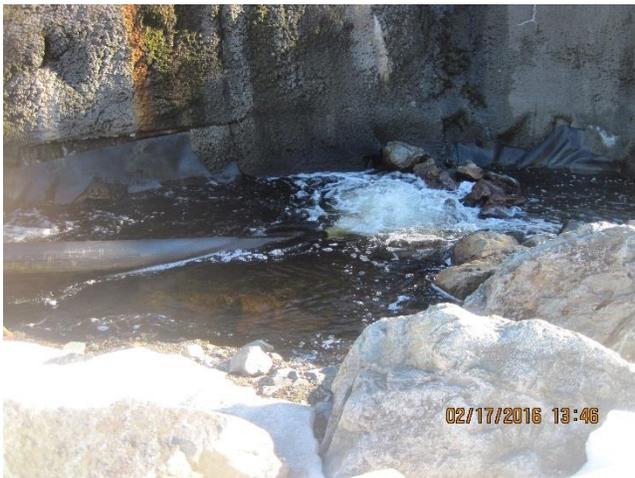
Photo 12. Upper Slate Lake diversion and the water treatment plant plunge pool.

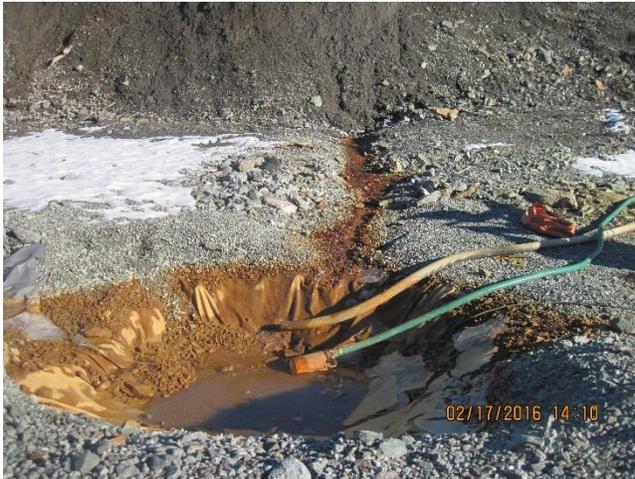
The GP stockpile located at the northern section of the TTF is from the stage 1 and stage 2 TTF dam construction. At the base of the GP stockpile, ARD was seeping through the pile and into a poly-lined catchment (Photo 13 -14). The captured ARD is then pumped to a series of holding tanks. A tanker truck pumps the ARD from the larger holding tank and hauls it to the GP seep treatment plant. The GP seep plant will be fully online this spring and the older GP seep plant will be decommissioned.

Photo 12. Northern TTF ARD catchment.

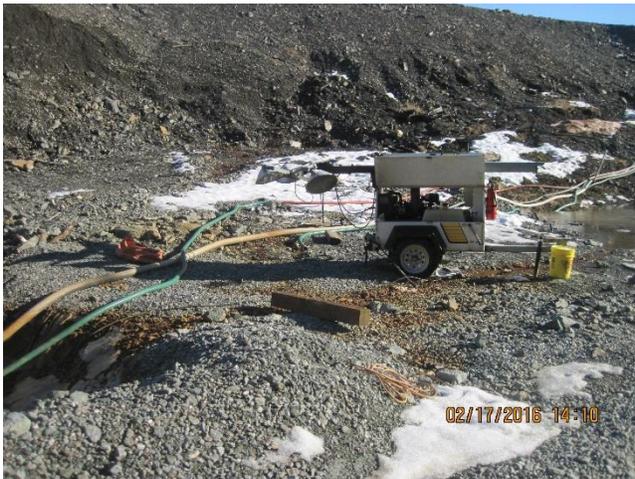
Photo 13. Diesel generator used to power the northern TTF ARD pump.

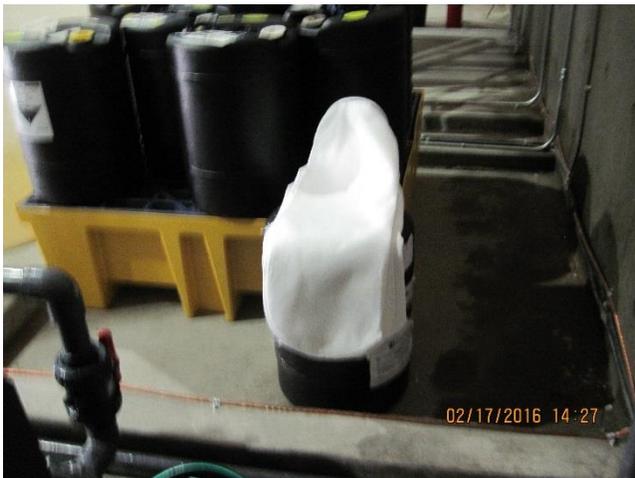
Photo 14. Secondary containment inside the GP seepage treatment plant.
