INSPECTION REPORT: KENSINGTON GOLD MINE

Date of Inspection: Thursday August 4, 2016
Date of Report: Thursday August 18, 2016
USDA Forest Service Inspector: Richard Dudek

This inspection included Kensington Port, Fuel Depot, Access roads, Comet Development Pile, Comet water treatment plant, Sherman Creek Outfall, Ophir Creek, Reclamation test plots, Avalanche berm, Pit 4, and the TTF area.

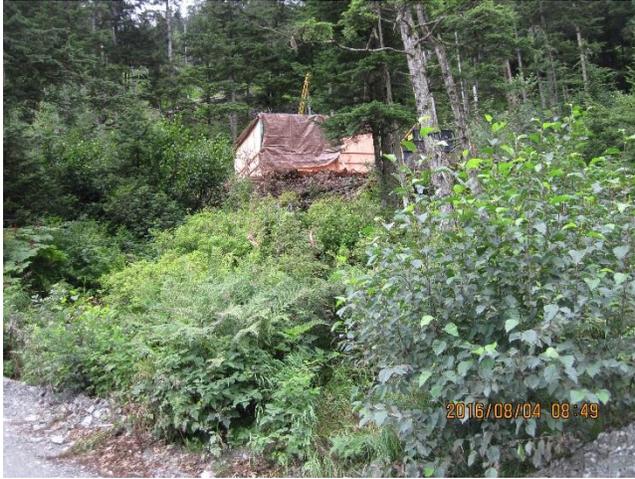
Surface drilling exploration has begun with a six total exploration drill holes for 2016 (2016 Surface Exploration CE) (Photo 1).

Photo 1. Surface drilling pad.

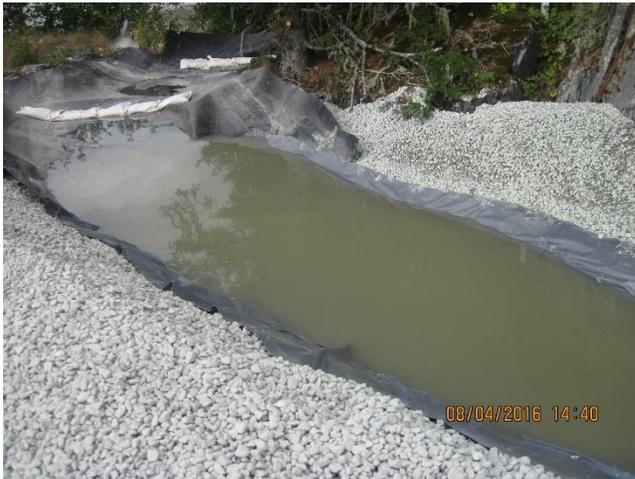
The Kensington port was actively being worked on during this inspection. A diversion ditch was reconstructed with a liner, a culvert, and multiple sumps for capturing stormwater runoff from the road (Photos 2-3). The silt fence and sumps at the port need to be frequently maintained and monitored by Coeur Alaska's Surface operations.

Photo 2. Kensington port lined sump installed.

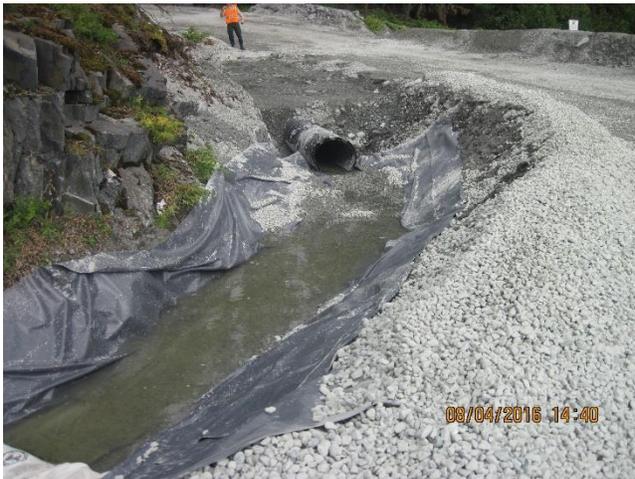
Photo 3. Located at the Kensington port a culvert was installed for water conveyance.

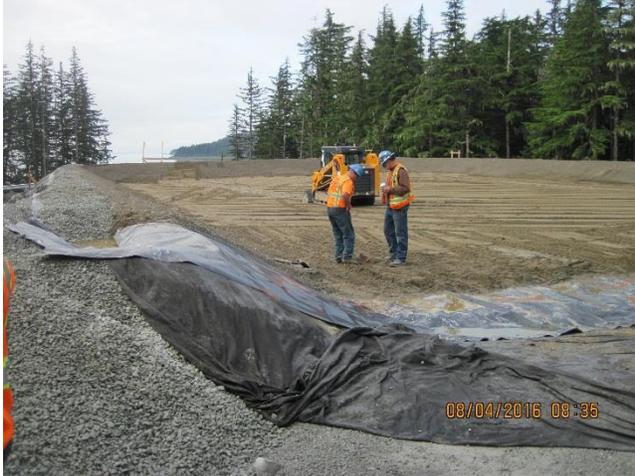
Construction has begun for the approved Fuel Depot (Photo 4). Contractors have installed the liner and service sand layer for the fuel depot. The pipeline stands are in place from the Kensington port to the fuel depot (Photo 5). The fuel tanks for the fuel depot will be arriving in mid-August.

Photo 4. Fuel depot location, showing geotextile, liner, and service sand layer installed.

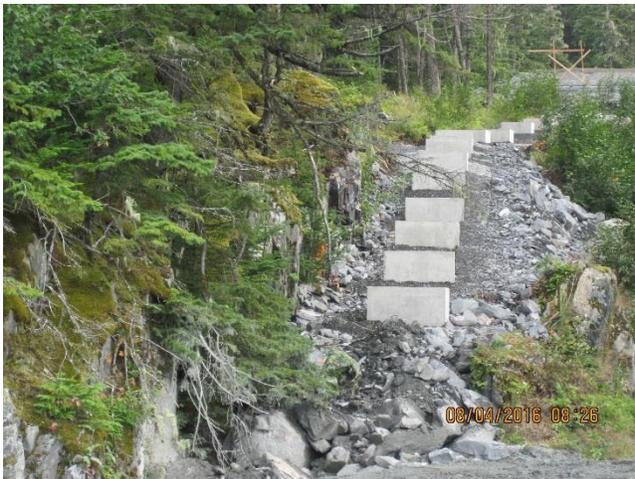
Photo 5. Fuel depot pipeline stands.

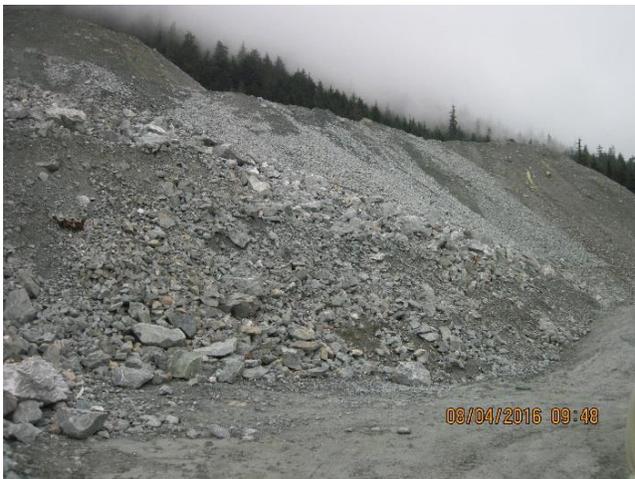
In early 2016, Coeur Alaska began expanding the southwest section of the toe, and is currently adding waste rock (Photos 6). Coeur Alaska recently surveyed the southwest toe expansion and determined the estimated total amount of waste rock deposited is 1,140,000 tons.

Photo 6. Comet development pile South-West toe expansion.

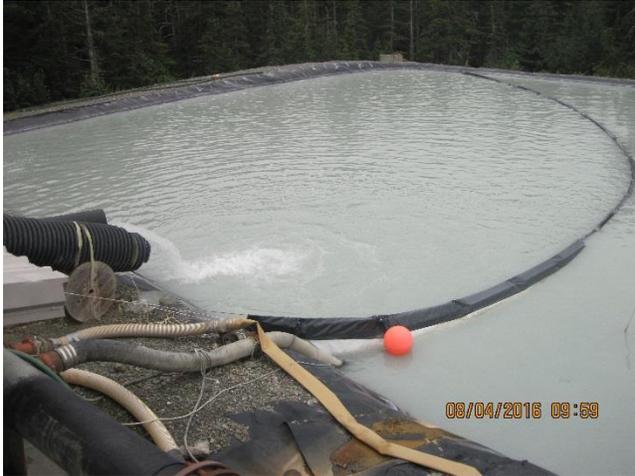
The Comet water treatment plant is currently treating 1100 gallons of water per minute. Pond-1 was active and receiving influent water (Photo 7) and Pond-2 was inactive during this inspection. It was documented on 5/18/2016 (Inspection report 143) that a diversion ditch near Pond-1 was washed out. The diversion ditch still needs major improvements to facilitate better water conveyance (Photo 8). During the site visit, containers of liquid chemicals (Photo 9) used for the water treatment process were being placed in storage containers with secondary containment (Photo 10). All chemicals and petroleum products were properly stored within appropriate secondary containment.

Photo 7. Comet water treatment plant Pond-1.

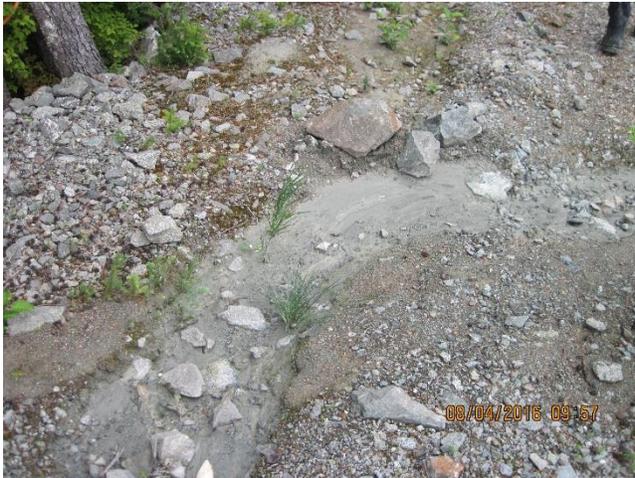
Photo 8. Diversion ditch is in need of major improvements.

- **Comet water treatment plant: Improvements to stormwater diversion ditch near Pond-1.**
- **Sherman Creek Outfall: White material continues to be observed in Sherman Creek.**
- **Ophir Creek: Ophir Creek is migrating towards the Comet development pile.**
- **Ophir Creek: Silt fencing requires some re-routing near the northern end of the Comet development pile.**
- **Pit 4: Graphitic Phyllite (GP) stockpile liner requires immediate repairs on the bottom left section.**

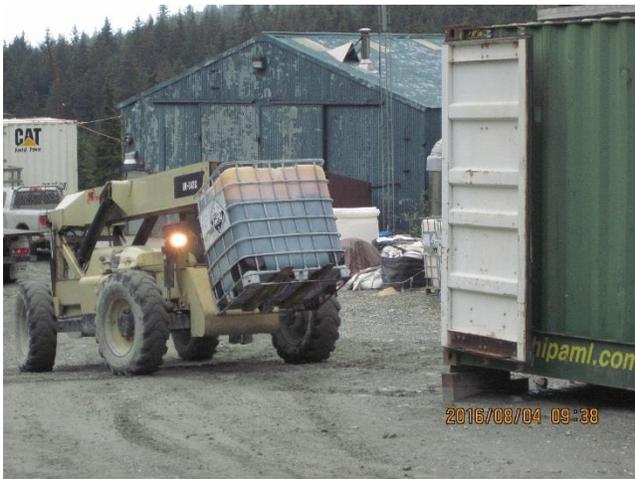
Photo 9. Liquid chemicals are being offloaded and placed into storage containers at the Comet water treatment plant.

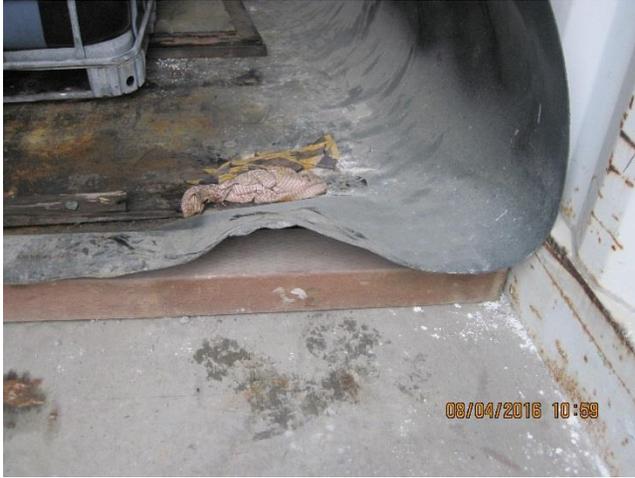
Photo 10. Storage container with secondary containment.

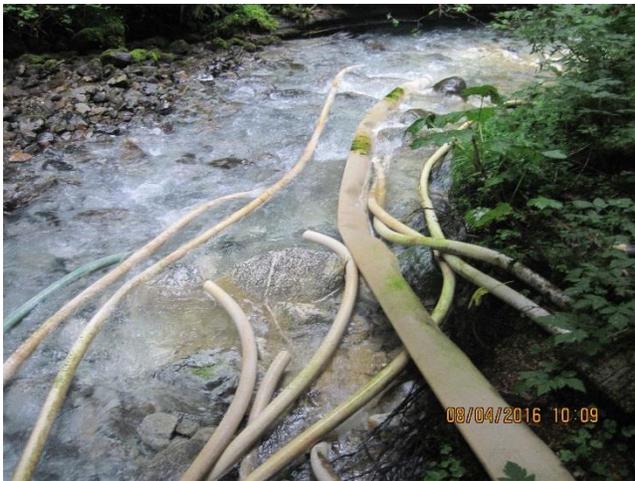
The white material continues to be observed at this location (Photos 11-12), and has been observed and documented often at this location since September 2014. Coeur Alaska is currently bench testing different flocculants and coagulants for the white material settling out of solution prior to the water treatment process. Coeur Alaska continues to monitor for the white material at the downstream water sampling locations. Coeur Alaska has also placed clean rocks in the creek to monitor any white material adhering these rocks.

Photo 11. Sherman Creek outfall.

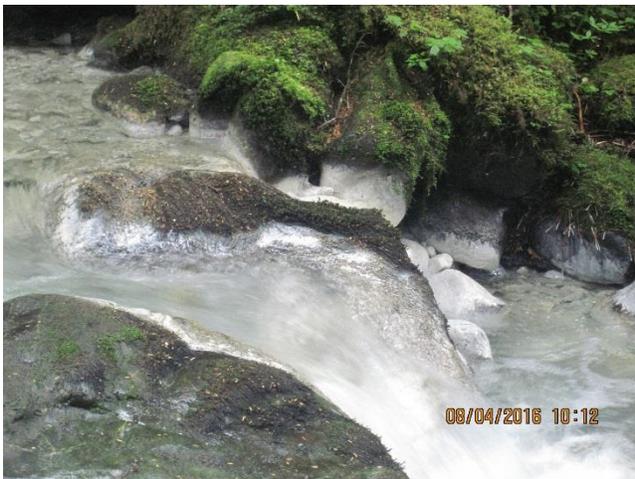
Photo 12. White material is adhering to rocks throughout the outfall.

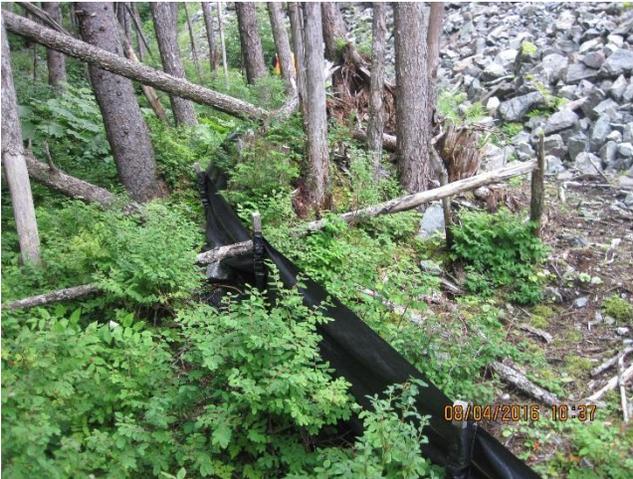
Ophir Creek is one of four principle tributaries of Sherman Creek and it flows adjacent to the Comet development pile. Silt fencing and a waste rock berm are in place to prevent sediments and rockslides from entering into the creek (Photos 13-14). A short section of silt fencing has been undermined by the creek and is no longer functional, requiring some re-routing or replacement (Photo 15). The migrating

Photo 13. Silt fencing between Ophir Creek and the Comet Development pile.

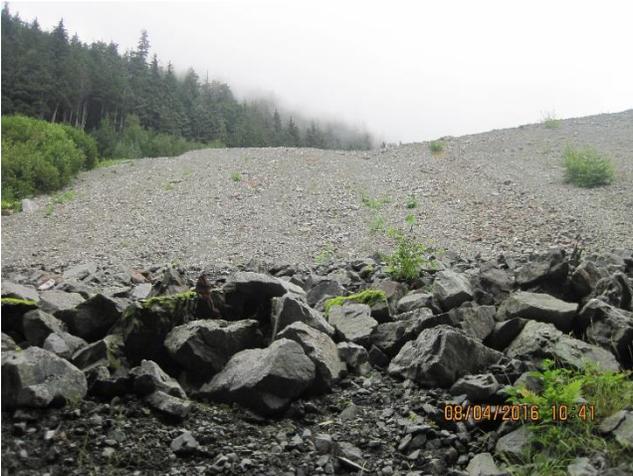
Photo 14. Image of the Comet development pile from Ophir Creek.

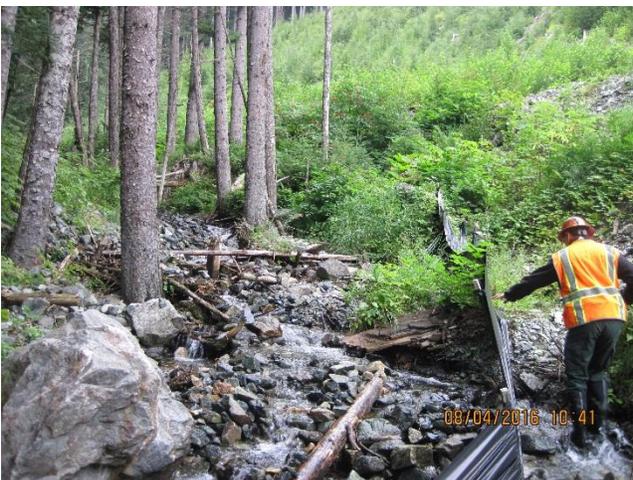
Photo 15. Silt fencing undermined by Ophir Creek near the toe of the Comet development pile.

creek should be frequently monitored to ensure stability of the toe of the development pile, and mitigated if necessary.

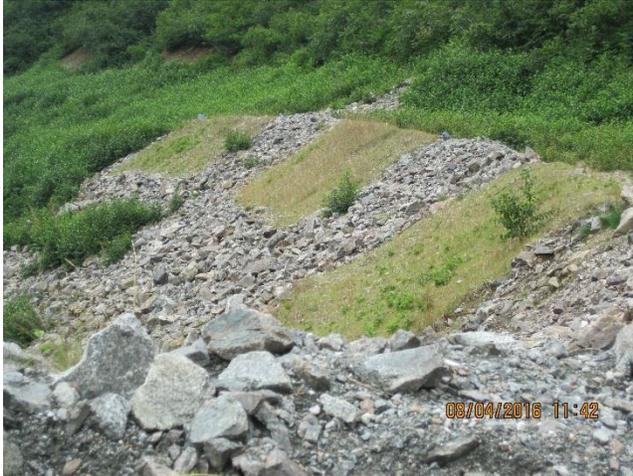
The three waste rock reclamation test plots (Photo 16) were developed as a quantitative approach to growth potential for native plant species. The same seed mixture was applied to all three plots, the difference being the soil amendments for each plot. The three plots did show grass was germinating, however further review is required by plant specialists to evaluate the success.

Photo 16. The three reclamation test plots.

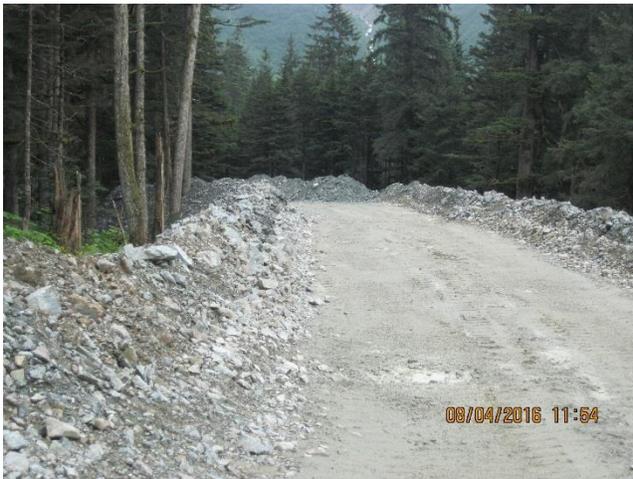
Directly above the Jualin mill site, Coeur Alaska has begun constructing an avalanche berm road to dissipate the energy from a possible avalanche (Photo 17). The Jualin adit waste rock is being used for constructing the berms. Culverts were installed for water conveyance due to the berms crossing an ephemeral stream.

Photo 17. Berms are currently being constructed to dissipate the energy from a possible avalanche.

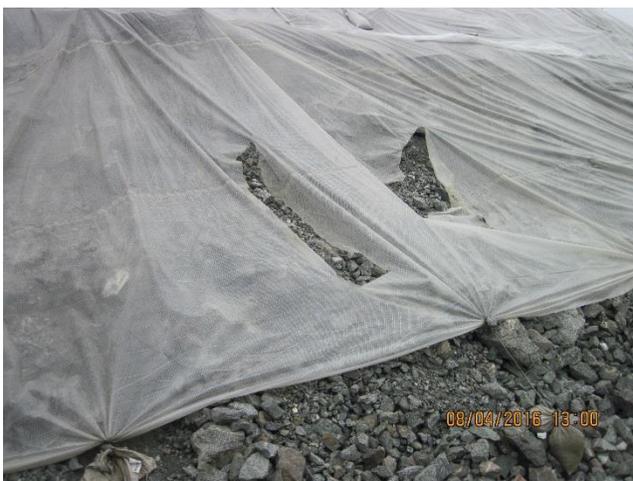
There are two tears observed at the bottom left section of a liner that covers the foundation berm for a GP stockpile (Photo 18). These repairs need to be completed in a timely manner to ensure the tears do not migrate towards the GP material. The construction of the structural steel for the Pug plant (Photo 19) is almost completed. The Pug plant is scheduled to come online in late August. The Pug plant will mix the GP material with cement and Diorite then transport the mixed cement underground for backfilling the stopes.

Photo 18. Tears in a liner for a GP stockpile.

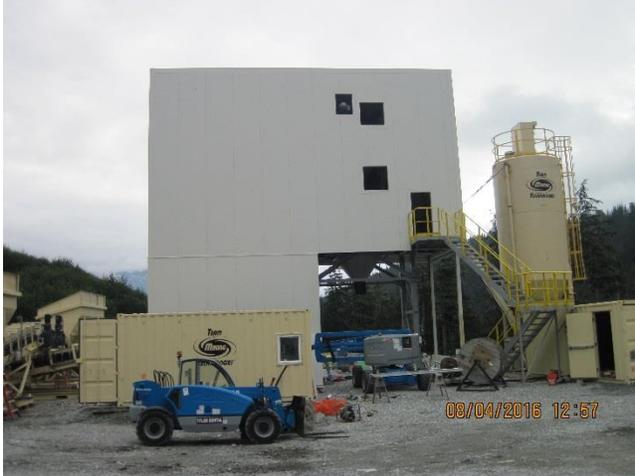
Photo 19. Pug plant will be used for mixing GP material with cement and Diorite rock.

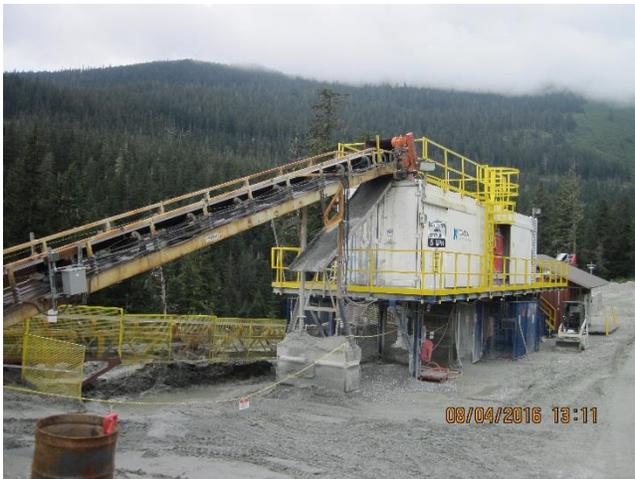
The X-ray sorter (Photo 20) located at Pit 4 is for reclaiming mineralized pebble rock. Since the commissioning of the x-ray sorter, approximately 5000 tons of pebble rock has been reclaimed and sent back to the Jualin mill for processing. The X-ray sorter was inactive during this site inspection.

Photo 20. X-ray sorter.

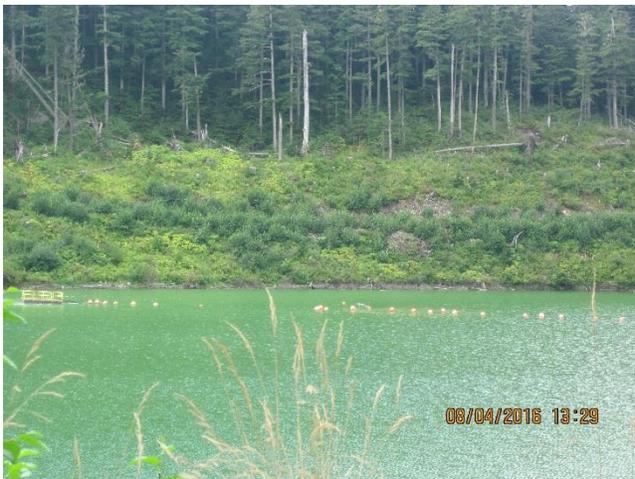
The water level for the TTF was 693.6 feet. An area of shallow water was identified within the TTF (Photo 21). This may indicate sections of the TTF may not be under nine feet of water. The nine feet of water cover is the minimum water cover within the TTF for all stages of development (Coeur Alaska's Plan of Operations (page 70)).

Photo 21. TTF. Buoys to the right in the image is where the high spot was observed.

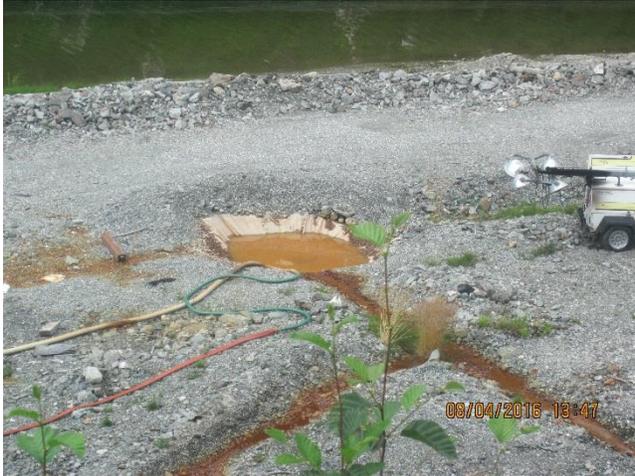
At the northern section of the TTF, acid rock drainage (ARD) (Photo 22) is pumped to a series of holding tanks. The ARD is transferred from the second holding tank to the seep plant for water treatment. The treated water is discharged into an infiltration gallery near the TTF. The sludge waste collected during the water treatment process is used as backfill for the underground stopes.

Photo 22. Northern TTF ARD catchment.

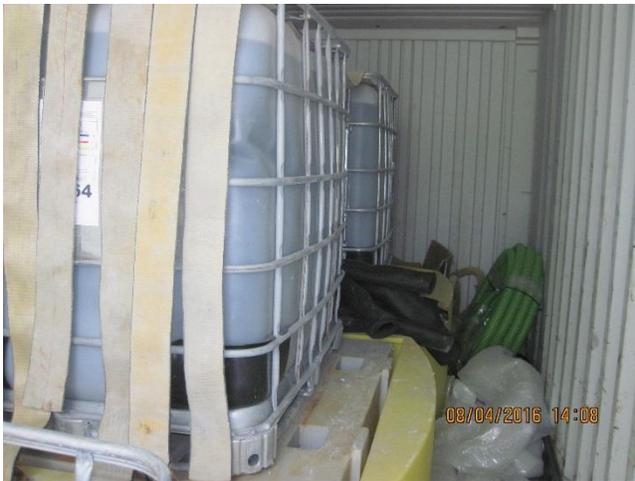
The TTF water treatment plant is currently treating approximately 900 gallons of water per minute. The storage containers for chemicals and petroleum products were properly stored with secondary containment (Photo 23).

Photo 23. TTF storage containers.
