INSPECTION REPORT: KENSINGTON GOLD MINE

Date of Inspection: Wednesday, December 14, 2016
Date of Report: Thursday, January 5, 2017
USDA Forest Service Inspector: Richard Dudek

Ranger District: Juneau Ranger District

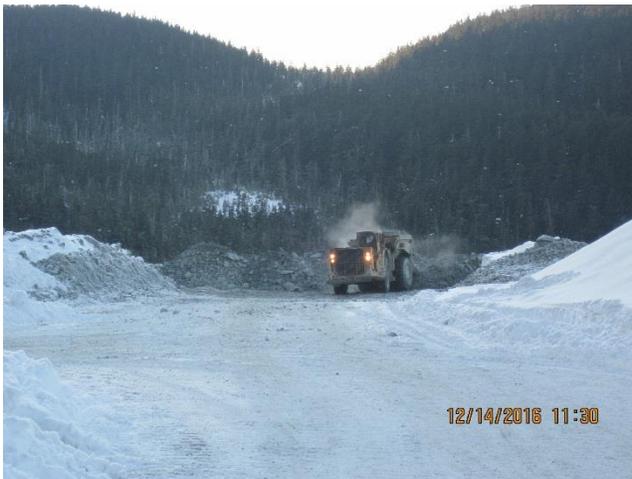
Haul trucks continue to deposit waste rock at the southern end of the pile (Photos 1).

Photo 1. A haul truck depositing waste rock at the south end of the Comet Development pile.

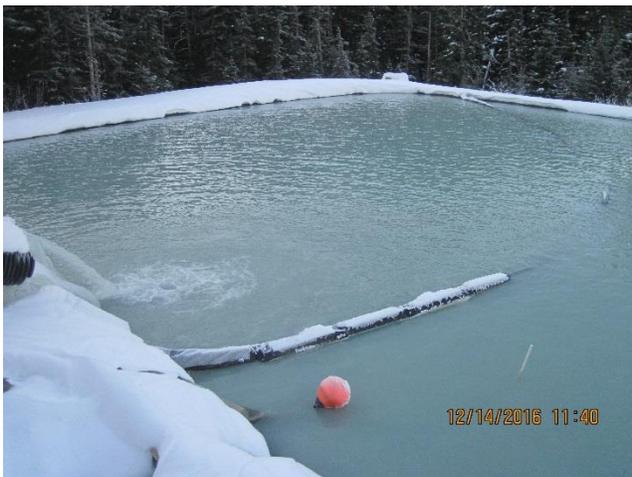
Photo 2. Comet water treatment plant, Pond-1.

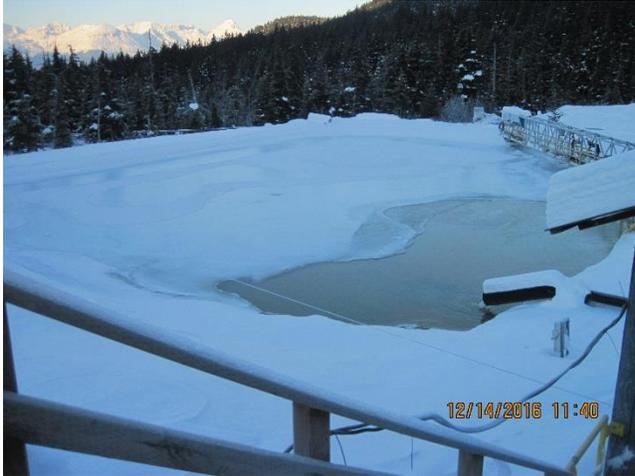
Photo 3. Comet water treatment plant, Pond-2.

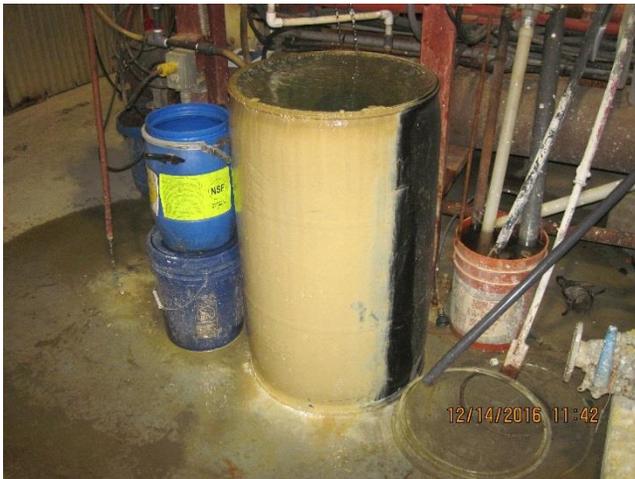
The Comet water treatment plant is currently treating 1,000 gallons of water per minute (gpm). Pond-1 (Photo 2) was receiving mine-site water, and Pond-2 (Photo 3) was inactive. To help monitor white material accumulation, Coeur Alaska uses a barrel (Photo 4-5) filled with treated mine-site water. This is a good approach for monitoring white material accumulation; however, an accumulation rate has not been defined. The Forest Service recommends weekly observations for the barrel's white material accumulation. This can give a timetable for underground activities such as mucking of sumps and white material reappearing. Coeur Alaska is still using a dewatering bag at the underground 445 level sump. This is an additional mitigation for capturing white material prior to the chemical treatment of mine-site water. The Comet water treatment plant was tidy and in order with all chemical products properly stored within secondary containment.

Photo 4. The barrel used for white material monitoring.

- Sherman Creek outfall: White material observed at the outfall.
- Comet water treatment plant: A weekly accumulation rate should be documented for the barrel used for monitoring white material.

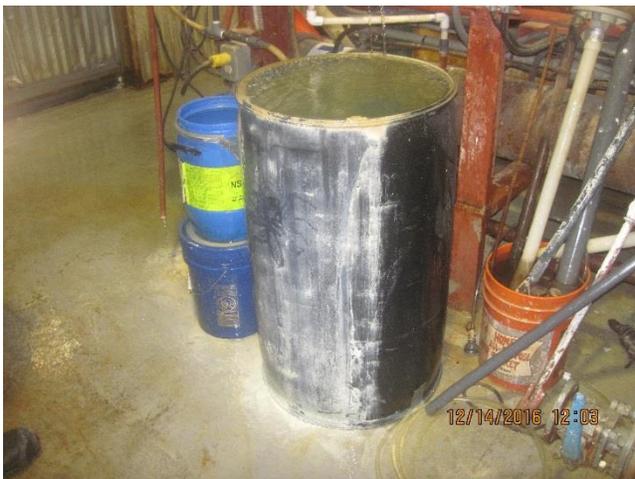
Photo 5. The white material wiped off the side of the barrel, with no timetable as to when the white material started to adhere to the barrel.

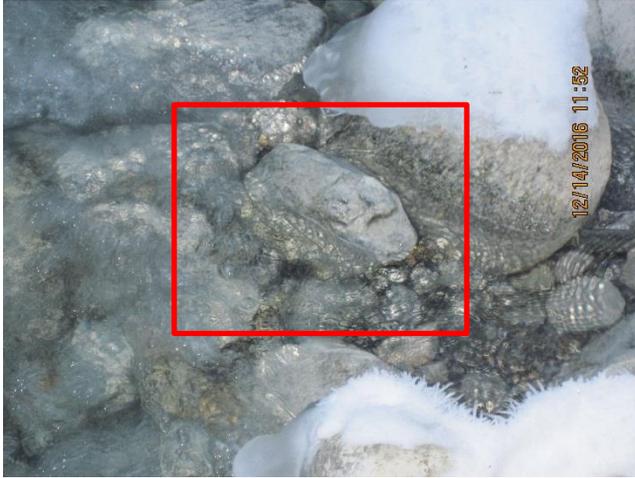
White material in Sherman Creek appeared to be decreasing. Coeur Alaska places a single clean rock (Photo 6) in the creek bed as a visual indicator for the presence of white material. Coeur Alaska continues to bench test different coagulants and flocculants for removing white material out of solution, during the water treatment process.

Photo 6. In the highlighted area, is a reference rock used in Sherman Creek outfall for monitoring white material accumulation.

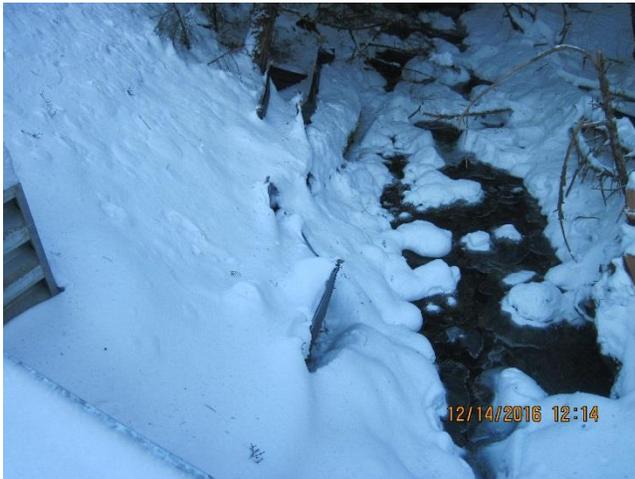
Listed in the inspection report from 10/27/2016, sections of silt fencing at the Upper Sherman Creek Bridge was torn or pushed down. The sections of silt fencing have been replaced (Photo 7).

Photo 7. Silt fencing at the Upper Sherman Creek Bridge (Comet access roads).

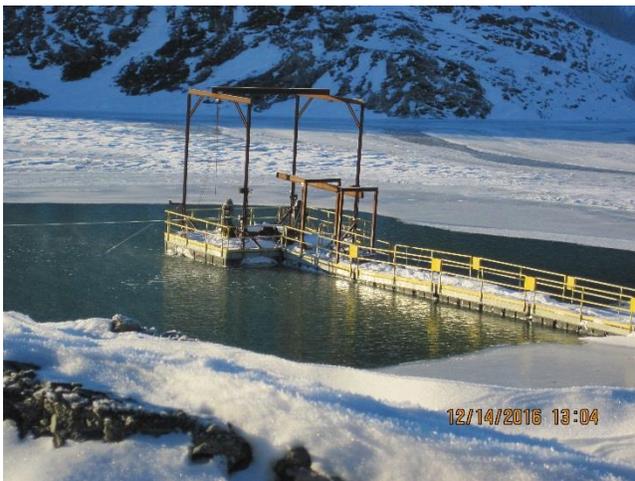
On the day of the inspection, the TTF's water level was at 696.1 feet. Coeur Alaska recently moved their water reclaim barge (Photo 8) to the south end of the TTF, and is now depositing tailings to the north. This was due the most recent bathymetry survey conducted at the TTF. The data from the survey showed 40-foot depressions in northern sections of the TTF. The water agitator installed in the dam plunge pool was properly working (Photo 9) to prevent ice from jamming the water transfer pipe. The TTF's water treatment plant was tidy and in order (Photo 10). In the northern TTF, the Seep plant was inactive due to the freezing conditions and snow cover. Acid Rock Drainage (ARD) is not actively seeping out, and there is no need for treatment.

Photo 8. TTF water reclaim barge

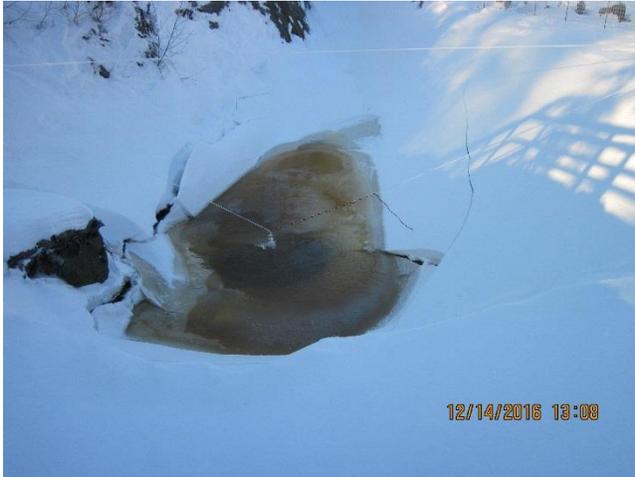
Photo 9. A water agitator was installed and is properly working in the TTF dam plunge pool.

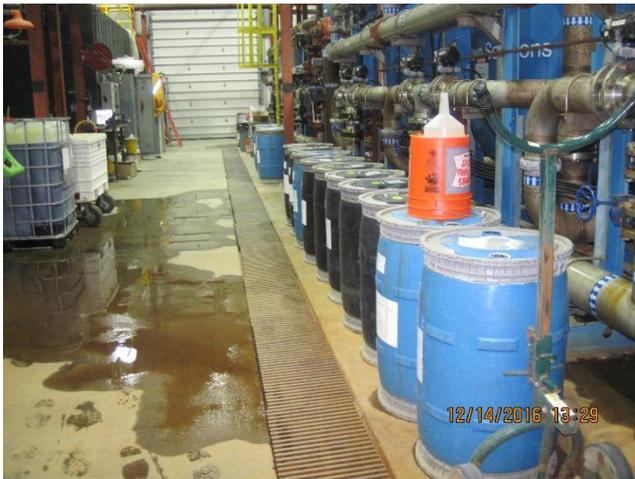
Photo 10. Liquid and dry chemicals are staged for use at the TTF water treatment plant.

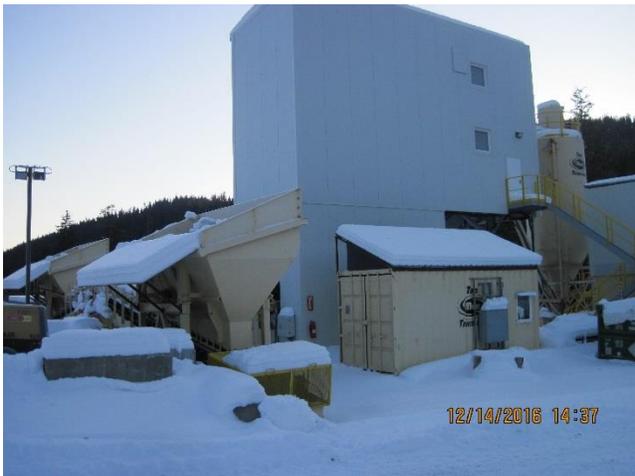
The Pug plant (Photo 11) is temporarily shut down for the winter months. In 2016, approximately 7,500 tons of Graphitic Phyllite (GP) was removed from Pit 4 for backfill material in the underground stopes. There is approximately 55,000 tons of GP material remaining at two mine-site locations (Pit 4 and Pit 7).

Photo 11. Pug plant at Pit 4.

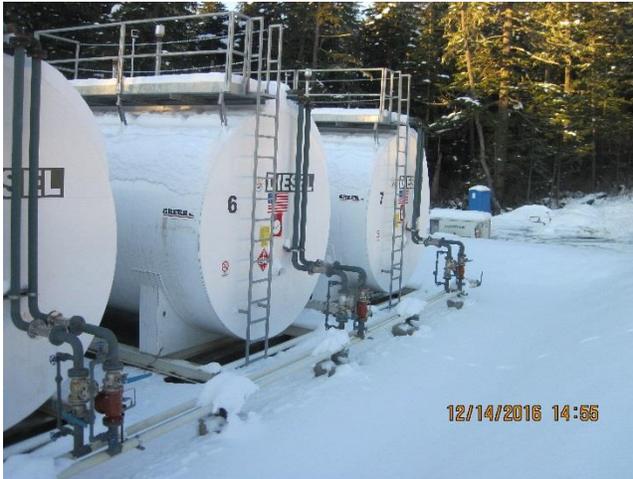
The first fuel (Photo 12) delivery is scheduled for mid-January 2017. The skiff was relocated from the Kensington Port to the Fuel Depot. In the event of a fuel spill during refueling, the fuel transfer line would block the skiff and cause a delay in the response time. The 18-foot skiff is for deploying an oil containment boom (Photo 13) in the event of a fuel spill (2016 (FRP).

Photo 12. Coeur Alaska's fuel depot.

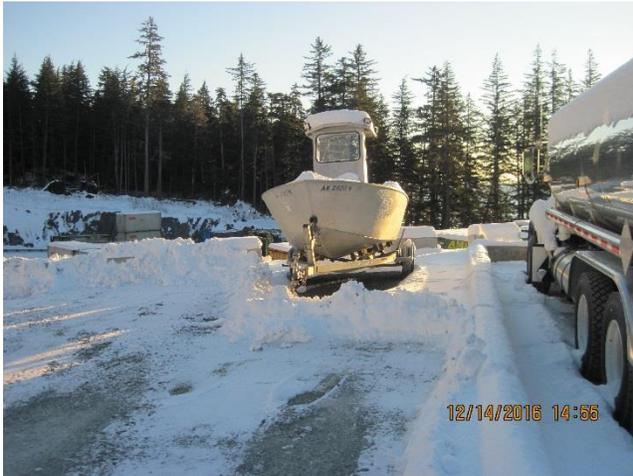
Photo 13. 18-foot skiff is now staged at the fuel depot.

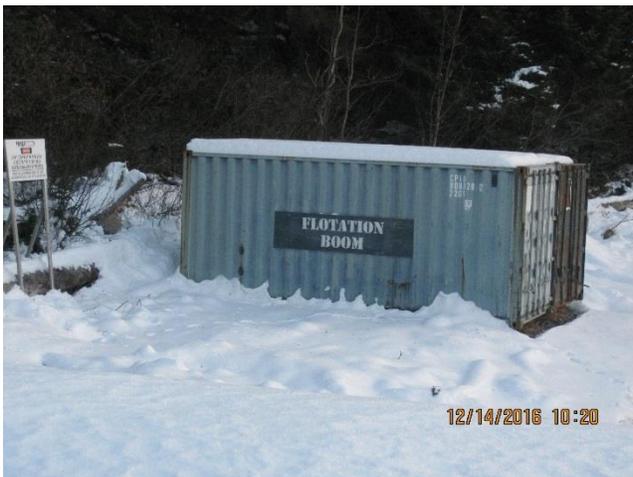
The spill response kits required in the event of a fuel spill (2016 FRP) are stored in two sea vans and are staged at the Kensington Beach (Photo 14).

Photo 14. Kensington Beach sea vans containing spill response kits.
