INSPECTION REPORT: KENSINGTON GOLD MINE

Tongass National Forest Minerals Group
8510 Mendenhall Loop Rd
Juneau, AK 99801
(907) 789-6275– office
(907) 586-8808 – fax

Date of Inspection: Tuesday April 18, 2017
Date of Report: Tuesday May 2, 2017
USDA Forest Service Inspector: Richard Dudek

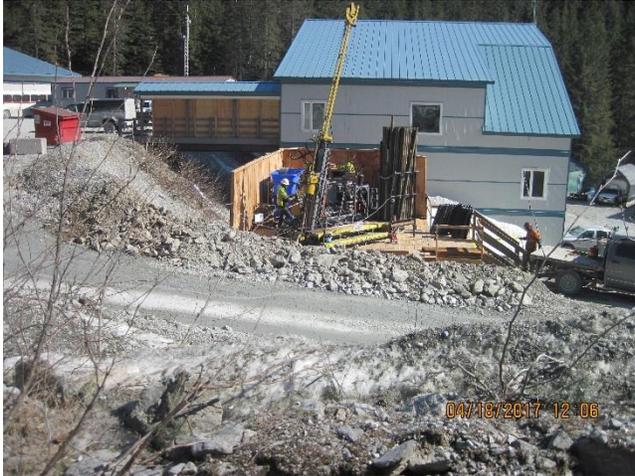
The Pug plant and X-ray sorter will be online and operating at the end of April.
The 2017 surface exploration has begun at the Kensington Gold Mine (Photo 1).

Photo 1. Surface exploration drill staged near the Kensington camp buildings.

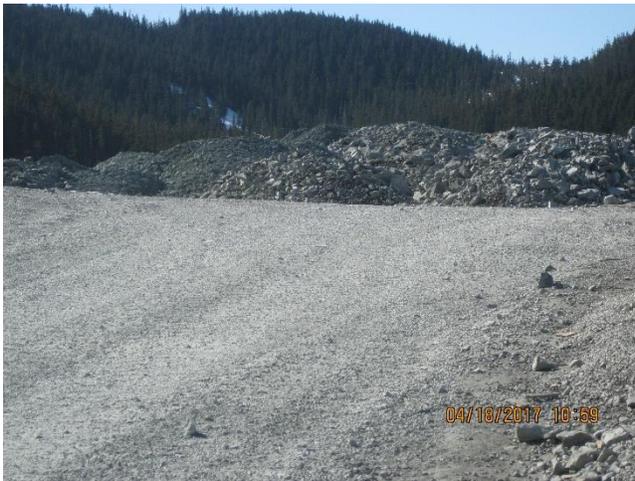
Coeur personnel continue to deposit waste rock from the Raven drift at the southern end of the development pile (Photo 2).

Photo 2. Waste rock from the Raven drift.

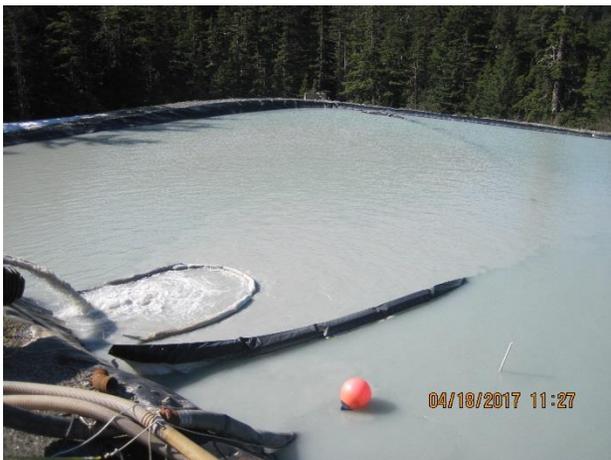
Ponds 1 and 2 were receiving mine drainage (Photos 3-4). An underground fuel spill occurred and Coeur personnel placed a hydrocarbon containment boom in near outlet pipe for Pond-1 (See photo 3). A section of silt curtain in Pond 1 (See photo 3) is below water and needs to be raised up. The purpose of the silt curtain is to minimize the surface area for sediment accumulation in Pond-1.

Photo 3. Comet water treatment plant Pond-1.

The silt curtain in Pond-1 is effectively working.

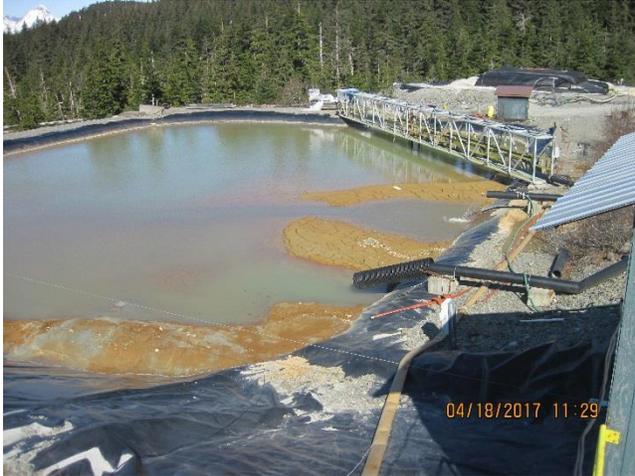
Photo 4. Comet water treatment plant Pond-2.

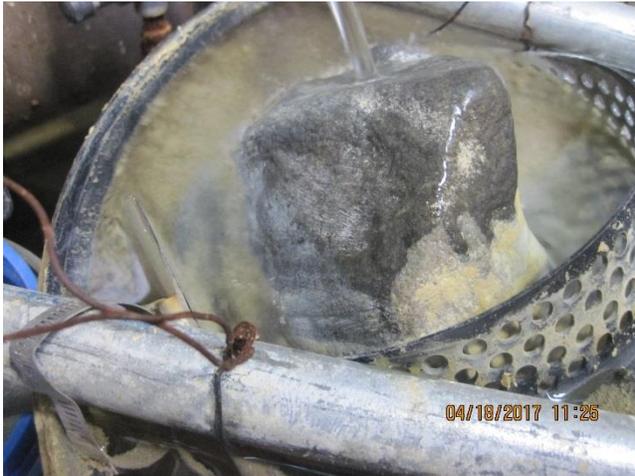
The Comet water treatment plant was treating 900 gallons of water per minute (gpm). Coeur Alaska continues weekly monitoring of a rock suspended (Photo 5) above the test barrel to precipitate white material from treated mine water. The Comet water treatment plant personnel are currently bench-testing potassium chloride (KCl) as a coagulant due to its strong bond. Coeur Alaska anticipates that KCl may help remove the white material out of solution. A dewatering bag is still being used near the underground 445 level sump. Coeur anticipates that over time the dewatering bag may help reduce the amount of white material in solution prior to the water treatment process.

Photo 5. Suspended rock used for monitoring white material accumulation.

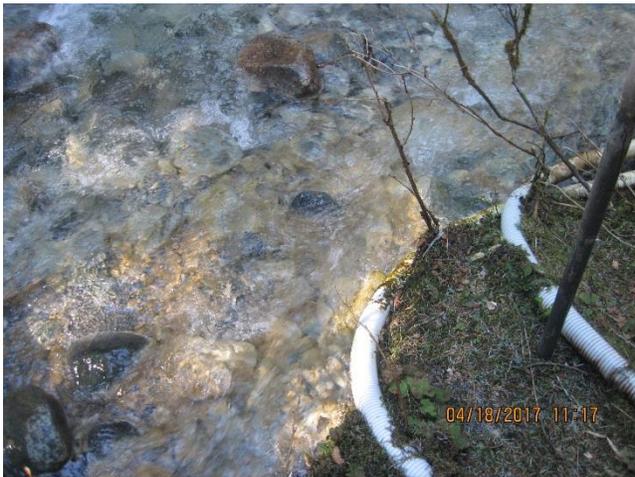
White material continues to precipitate in the creek bed (Photo 6).

Photo 6. White material observed in Sherman Creek.

Forest Service will continue observations for white material accumulation within Sherman Creek.

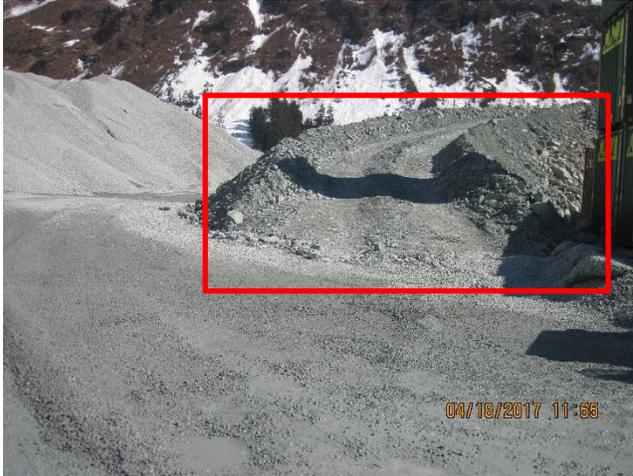
Coeur Alaska continues to deposit waste rock at the Kensington development pile (Photos 7-8).

Photo 7. Highlighted in red is the access ramp for the Kensington waste rock pile.

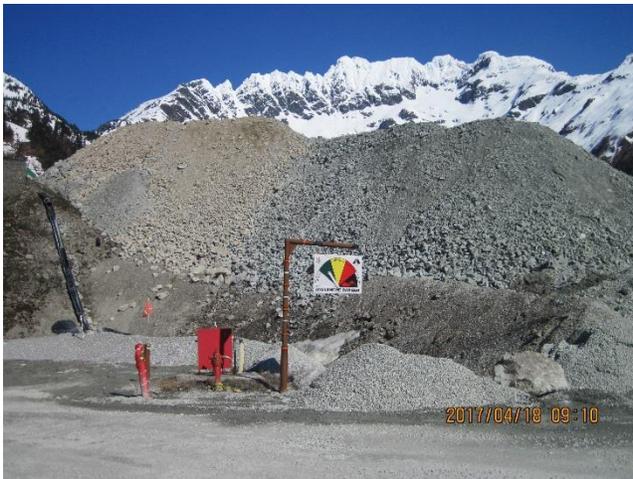
Photo 8. Kensington waste rock pile near the mill.

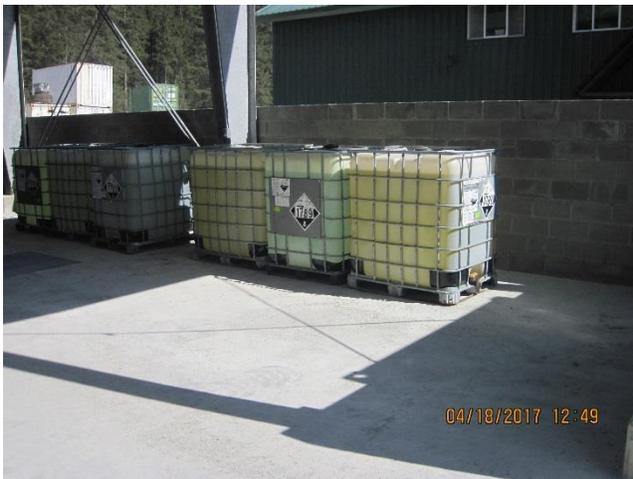
Coeur Alaska has begun storing chemicals for water treatment in the cold storage facility with secondary containment (Photo 9). Additional steel shelving will be eventually placed inside the facility to maximize the storage.

Photo 9. Kensington warehouse cold storage facility.

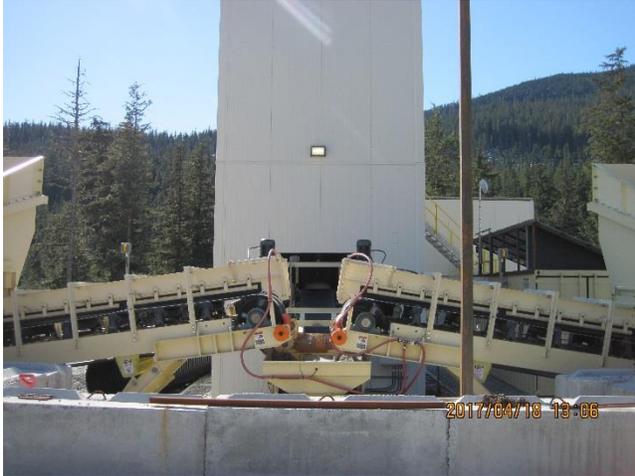
Coeur personnel were inspecting and performing maintenance on the Pug plant prior to bringing the plant online for the summer season (Photo 10). Coeur Alaska submitted a revised proposal for waste rock storage at Pit-4 (Photos 11). The State of Alaska agencies and the United States Forest Service are currently reviewing the proposal.

Photo 10. Pug plant at Pit-4. Coeur Alaska personnel were conducting inspections and maintenance prior operating the plant for the summer season.

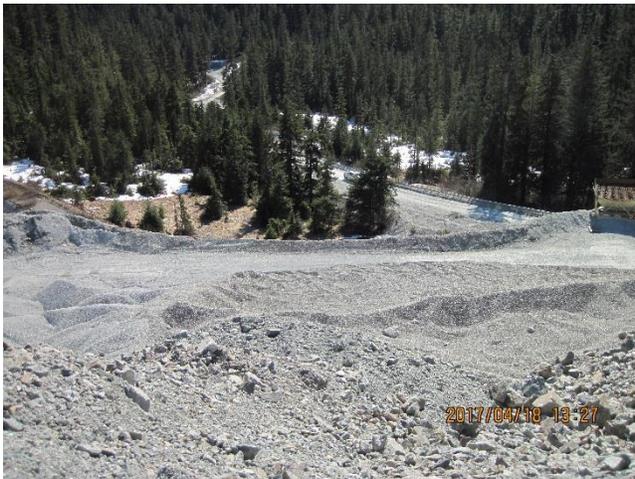
Photo 11. Coeur Alaska's proposed area for Pit-4 waste rock storage.

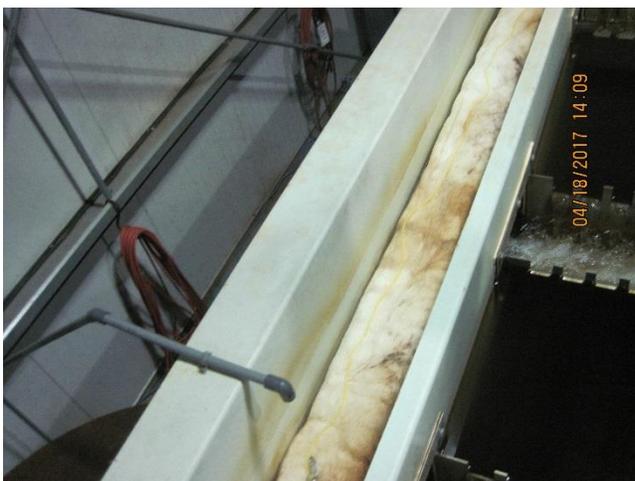
A diesel fuel spill occurred on 12/22/2016 at the "day tank", and diesel fuel was observed in the tailings thickener and possibly made its way into the TTF. Since the spill occurred, no fuel sheening has been observed in the TTF. As a mitigation control, TTF water treatment plant's personnel keep a hydrocarbon containment boom in the water clarifier's outlet for possibly absorbing hydrocarbons (Photo 12). A

hydrocarbon containment boom will remain in the outlet until the TTF ice thaws and the surface can be thoroughly inspected for fuel sheening.

Photo 12. A hydrocarbon containment boom placed in the TTF water treatment plant clarifier.

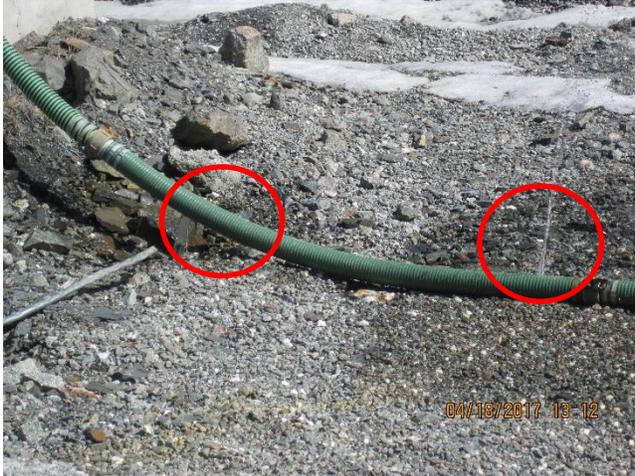
The TTF dam's pump back water line has leaks in it and needs to be repaired (Photo 13).

Photo 13. Highlighted in the red circles are the two leaks in the waterline for the TTF back pump.

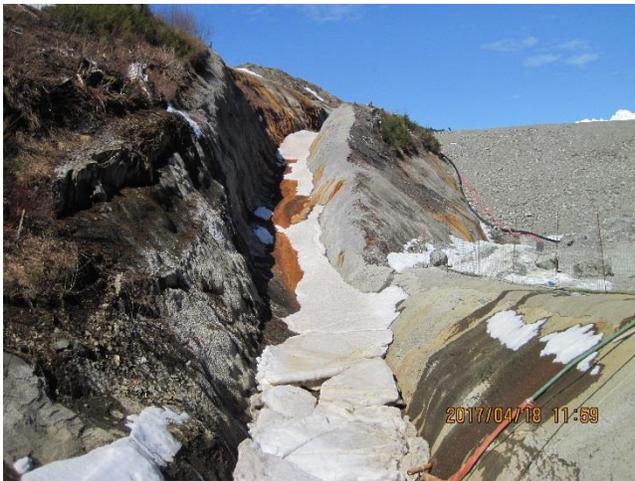
Due to warming temperatures, the seep plant was being brought online for treating acid rock drainage (ARD). The ARD is collected from the TTF dam plunge pool (Photo 14), and from the ARD catchments in the northern TTF area. The waste collected from the water treatment process is utilized as underground backfill and the treated water is discharged into the infiltration gallery near the TTF.

Photo 14. TTF dam plunge pool.

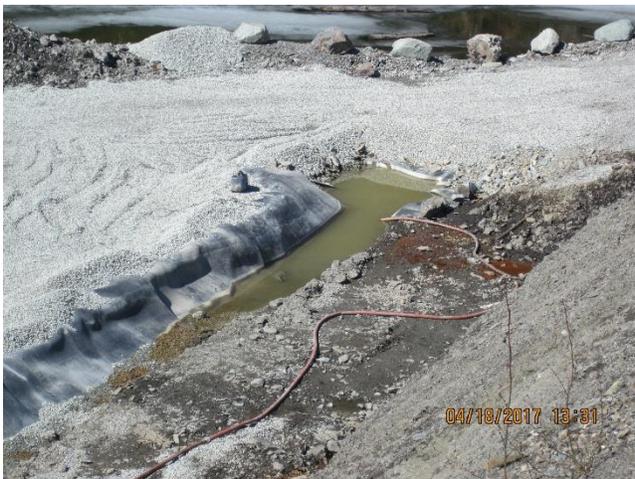
Due to the water level increasing in the northern TTF area, Coeur Alaska recently constructed a new ARD catchment (Photo 15).

Photo 15. A new ARD catchment located in the Northern TTF area.

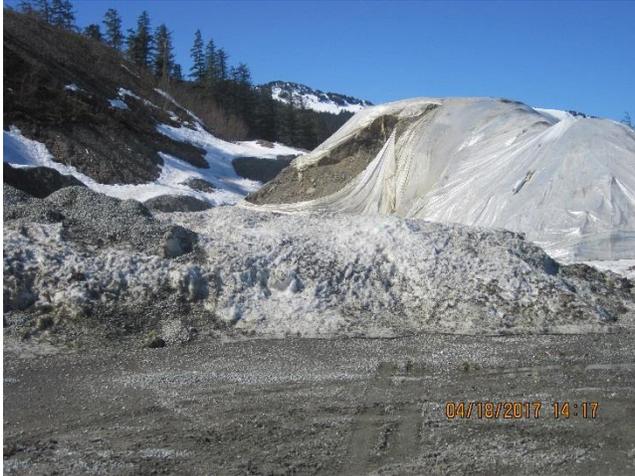
A section of the liner for the GP stockpile has separated (Photo 16). The purpose of the liner is to minimize exposure of the GP to atmospheric conditions, which reduces oxidation and ARD generation.

Photo 16. A GP stockpile at Pit-7.

A liner completely covers the GP stockpile at Pit-7.

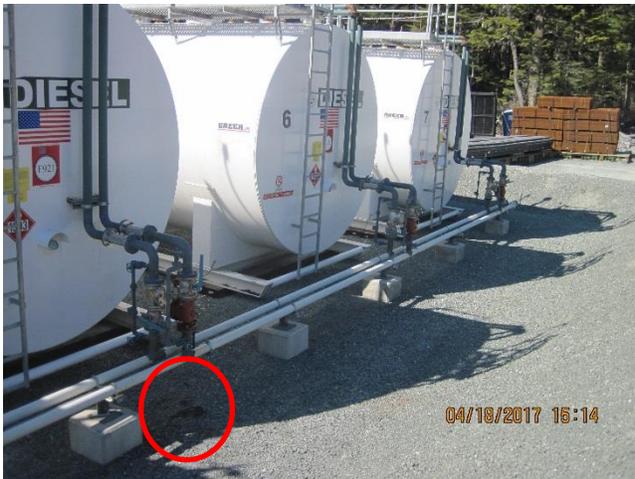
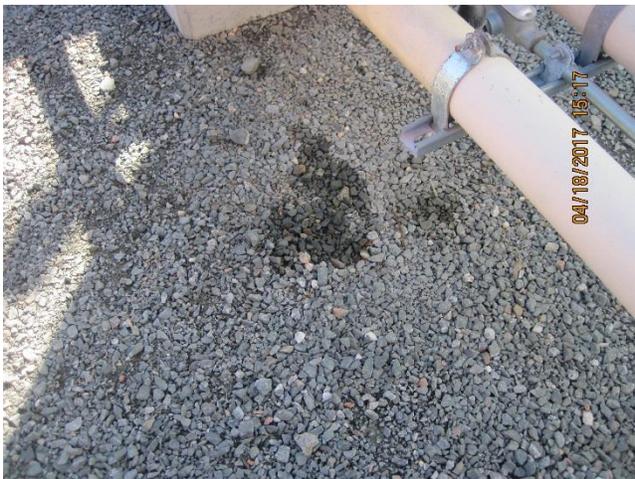
Approximately 8 ounces of diesel fuel was observed below the fuel line for tank-5 (Photos 17-18). The leak possibly occurred at the gasket between two pipes near tank-5. An absorbent pad was immediately placed on the area where the leak occurred (Photo 19). The total discharge of fuel was less than one gallon and the leak occurred within the secondary containment area. Spills less than one gallon do not need to be reported. The following is the Alaska Department of Environmental Conservation (ADEC) regulatory requirements for reporting spills. Spills over one gallon reporting to land, spills over 55-gallons within secondary containment, and any spill reporting to water are reported to ADEC (Coeur Alaska 2016 Plan of Operations).

Photo 17. A small fuel leak was observed below the fuel line near tank-5.

Photo 18. The fuel leaked onto the gravel bed of the fuel depot.

Inspect for possible leaks at the Fuel Depot.

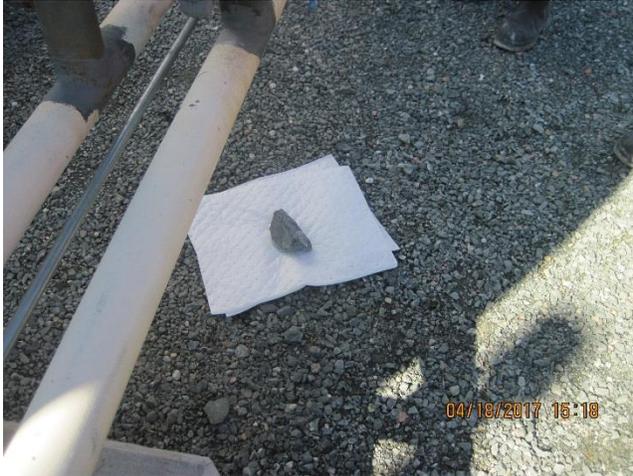
Photo 19. Hydrocarbon absorbent pads were placed on the area where the fuel leaked onto the ground.
