APMA A20196118- FIELD SUMMARY REPORT

Inspection Date: October 21, 2019
Weather: Broken Skies Progressing to Scattered, Winds Variable to 10 mph, Air Temp. Average 34° F
Agency Personnel: Hollie Chalup (Mining Section), Joshua Brekken (ADFG)
Operator Contact: Tim Havey, Director of Environment and Permitting, Pebble Limited Partnership
Pilot: Solomon Loop, Soloy Helicopters
Inspection Objectives: Annual Inspection

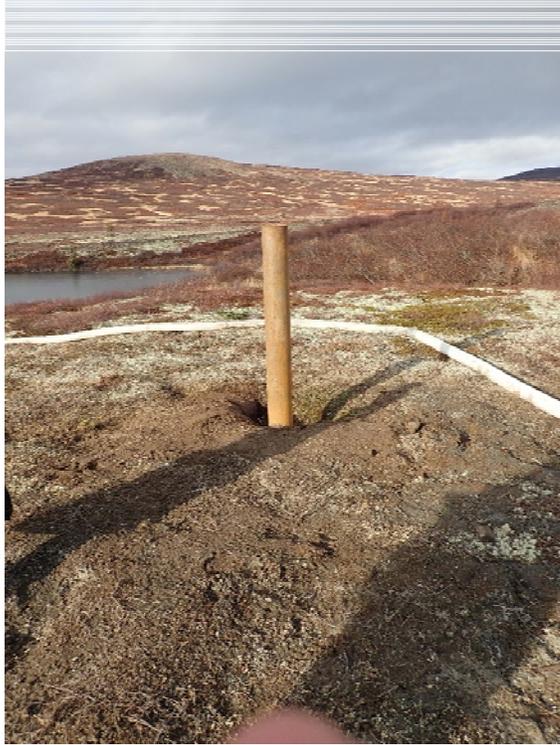
1. P-19-90

1.1 Borehole P-19-90 (ADL 540399, Figure: 1) and Borehole P-19-92 (ADL 540399, Figure: 3)

The P-19-90 boring was installed in late September 2019. The P-19-92 boring was installed in early October 2019. At the time of inspection, a casing was installed at each borehole, and reclamation efforts had begun. The sumps were undergoing reclamation activities at the time of inspection as well. Overburden stockpiles were placed on liners. The reclamation conducted in 2019 will be inspected and evaluated again in 2020 or earlier as need warrants.

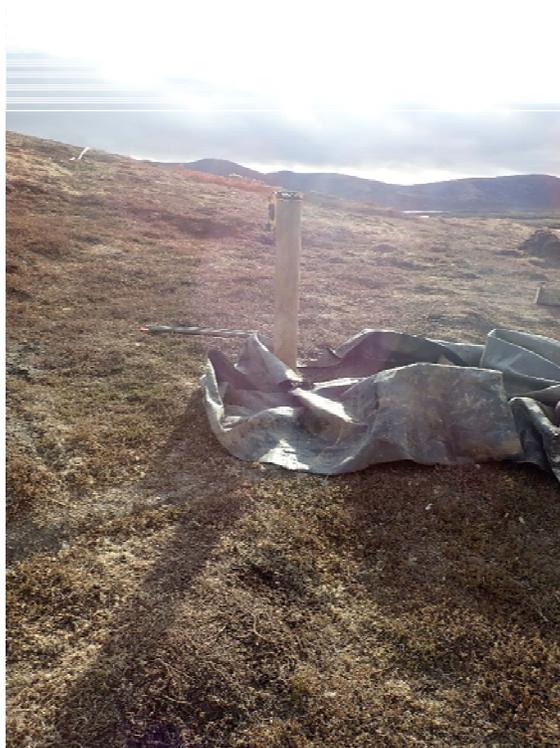
2. P-19-91

1.2 Borehole P-19-91 (ADL 540399, Figure: 2) and Borehole P-19-93 (ADL 540399, Figure: 4)

Borehole P-19-91 was installed in early October and P-19-93 was installed mid-October. The sumps were undergoing reclamation at the time of inspection. Surface reclamation was also ongoing at the borehole collars. Overburden stockpiles were placed on a lined barrier. The reclamation conducted in 2019 will be inspected and evaluated again in 2020 or earlier as need warrants.

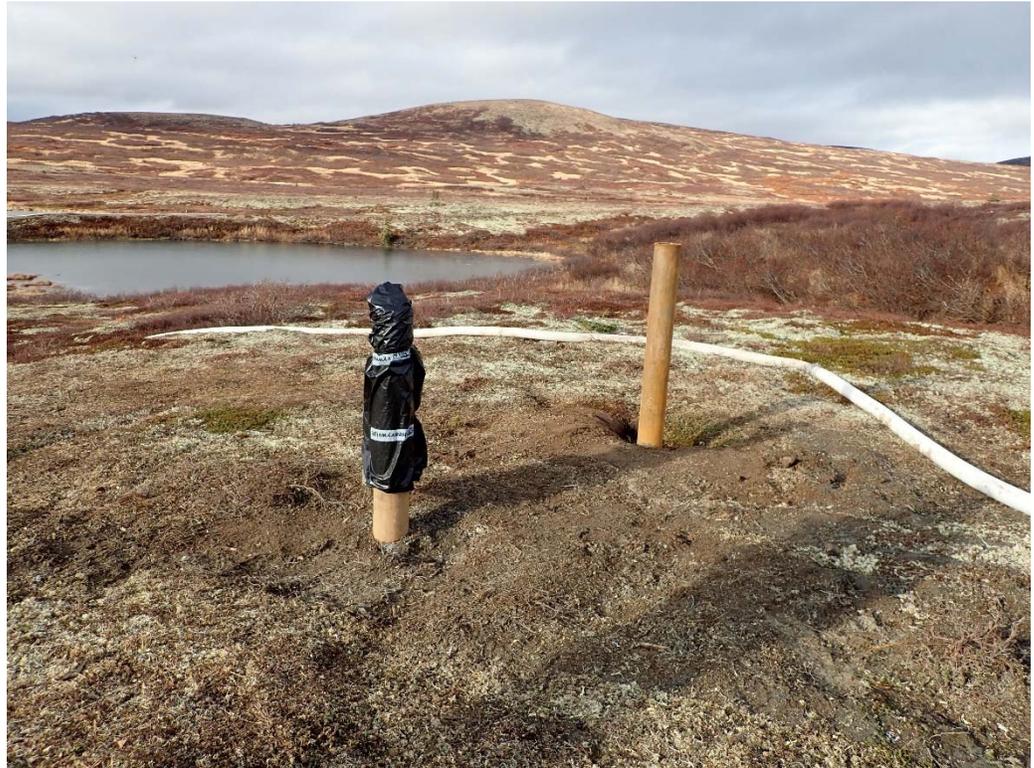
3. P-19-92 (wrapped in plastic)
21 October 2019

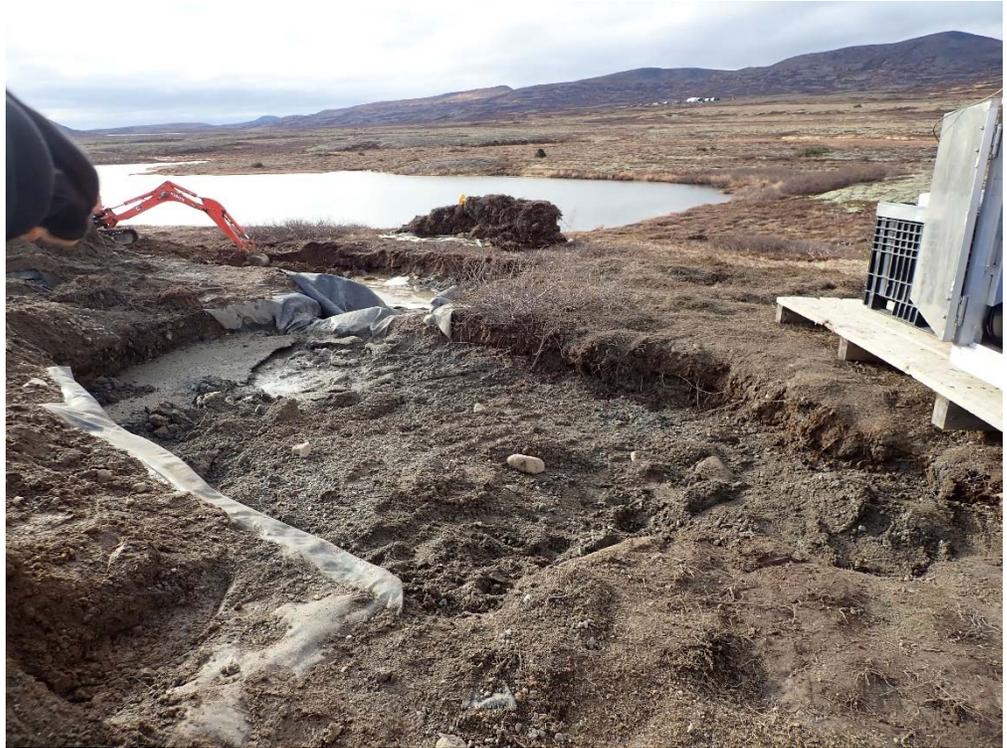
**5. PW-19-11 and
PW-19-12 Sump
Reclamation**

1.5 Borehole PW-19-11 (ADL 540399, Figure: 5) and Borehole PW-19-12 (ADL 540399, Figure: 5)

Borehole PW-19-11 was completed in mid-September 2019 and was undergoing an active pump test during the time of inspection. PW-19-12 was installed in early October 2019 and was observed in a stable inactive state. Due to the increased diameter borings, the sumps are larger than customarily observed at the Project, however, well within the dimensions of comparable exploration activities across the State. The sumps were undergoing active reclamation with a miniature excavator. The pump test platform and supporting facilities were elevated on tundra pads and kept in a neat and orderly manner.

Casings for PW-19-11 and PW-19-12 were located upslope from photo on the pump test platform.

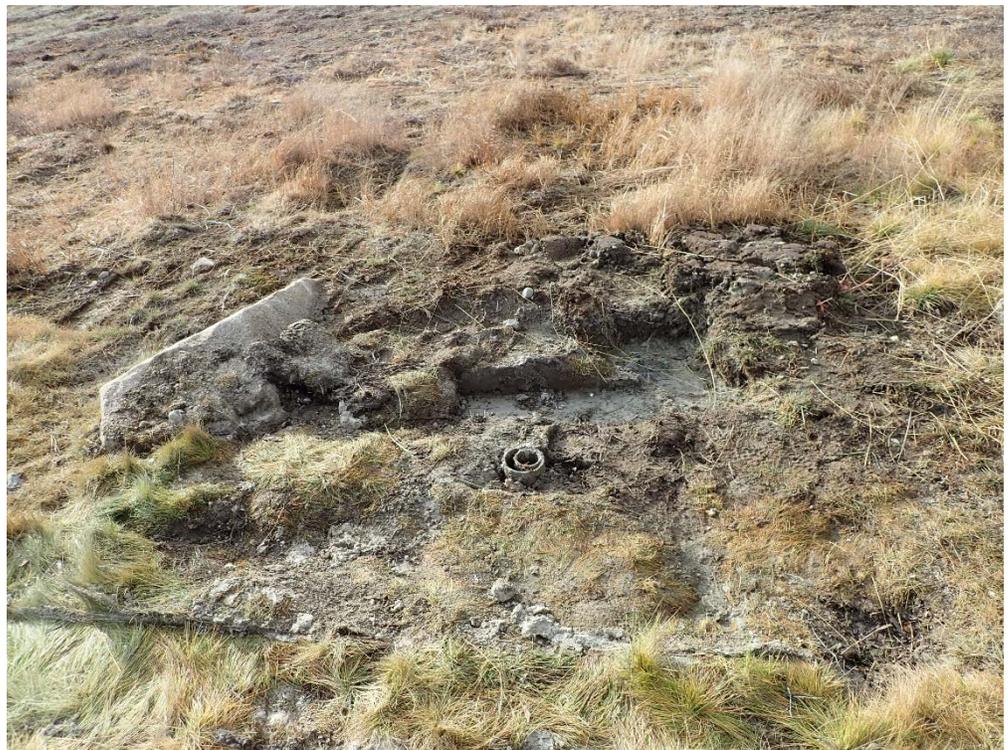
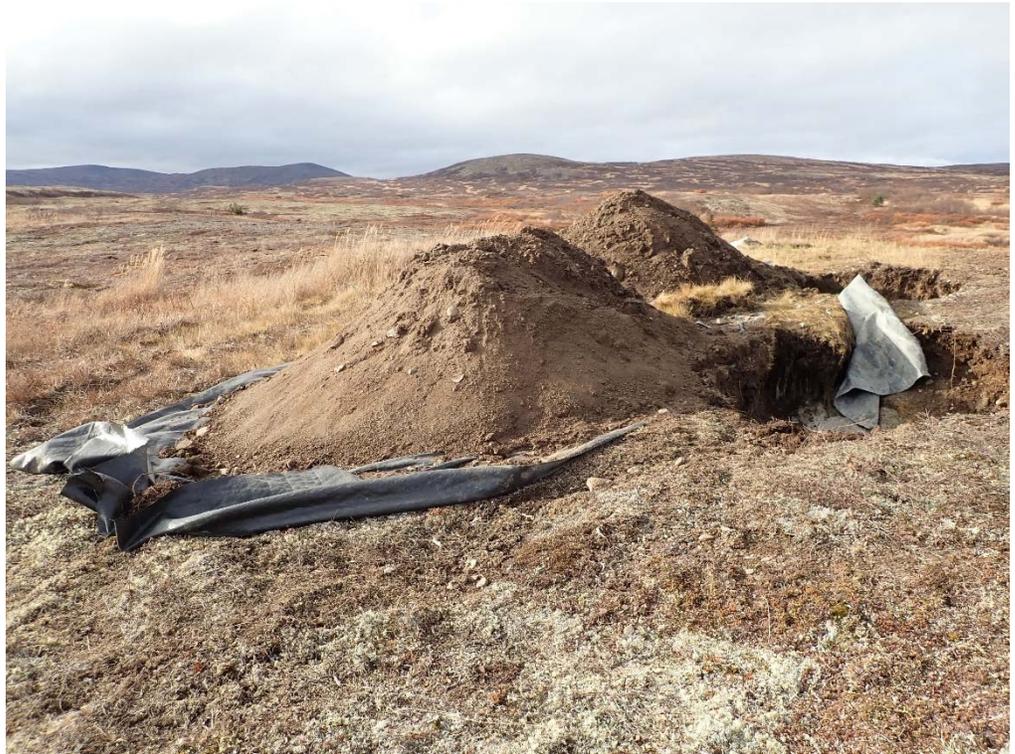
6. Borehole 9475

2.1 Borehole 9475 (ADL 540422, Figure: 6-7)

Borehole 9475 has produced water at its surface for several years. The operator has attempted multiple repairs using pressure grouting techniques between the surface and confining layers. This year, the operator planned to re-drill the hole reestablishing the entry point in bedrock, removing all material within the boring to the extent practicable and cementing the borehole from maximum depth to the ground surface to provide

for a continual material plug. At the time of inspection, two conjoined sumps were constructed, both approximately six feet long by four feet wide. Overburden stockpiles were placed on a lined barrier. The operator stated approximately 900 feet of cement and grout was injected into the borehole. There was no surface expression of water at the time of inspection. The operator is not required to cap the collar as the borehole is completed with a material plug. This site will be re-inspected to confirm successful closure and surface reclamation.

**7. Borehole 9475
Sump**
21 October 2019

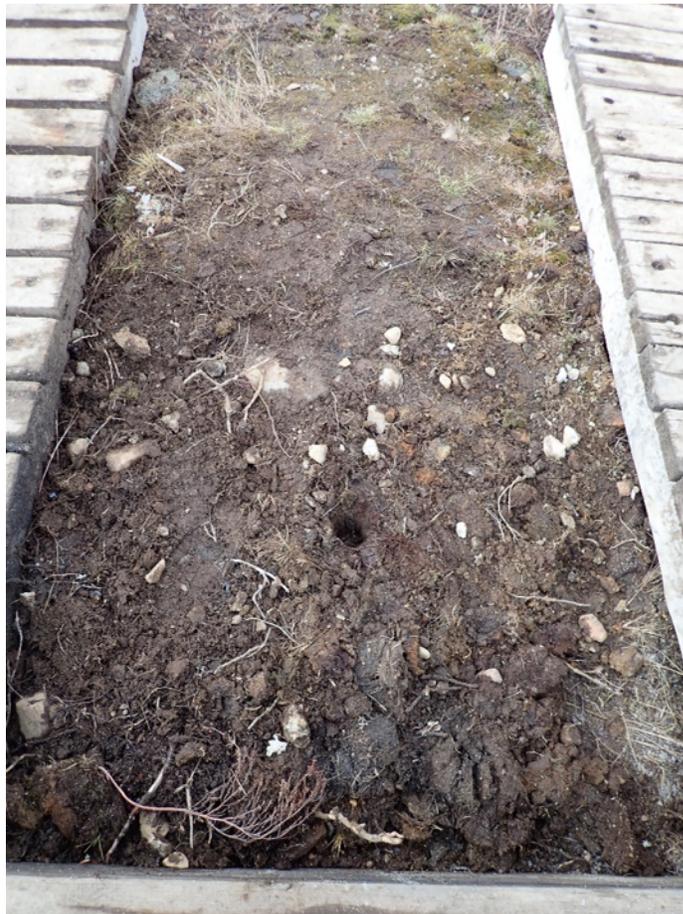
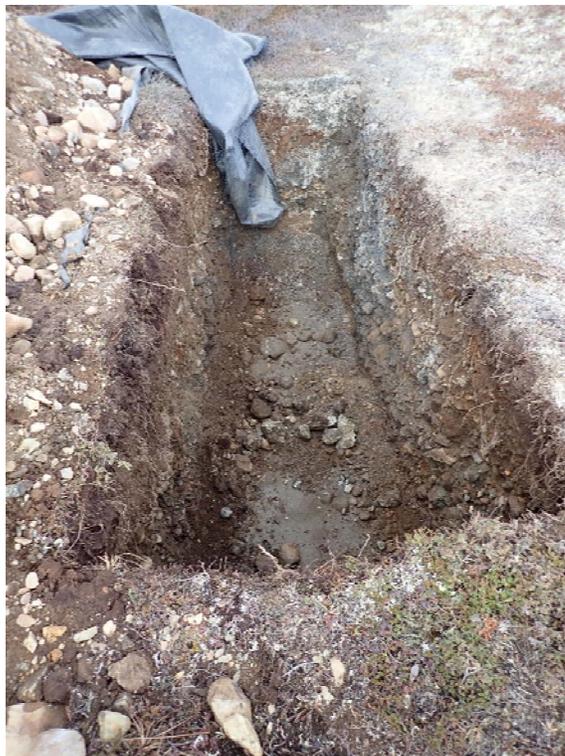
8. Borehole 3127
21 October 2019

2.2 Borehole 3127 (ADL 516873, Figure: 8-9)

Borehole 3127 also exhibited surface expression of water surrounding the borehole. Repair efforts at this site mimic those employed at 9475 summarized above with the addition of sand material. The drill platform was still in place at the time of inspection and the borehole casing appeared to have been removed. The sump was nearly dry and stockpiled overburden was available to finish reclamation. This site will be re-inspected to confirm successful closure and surface reclamation.

9. Borehole 3127 sump
21 October 2019

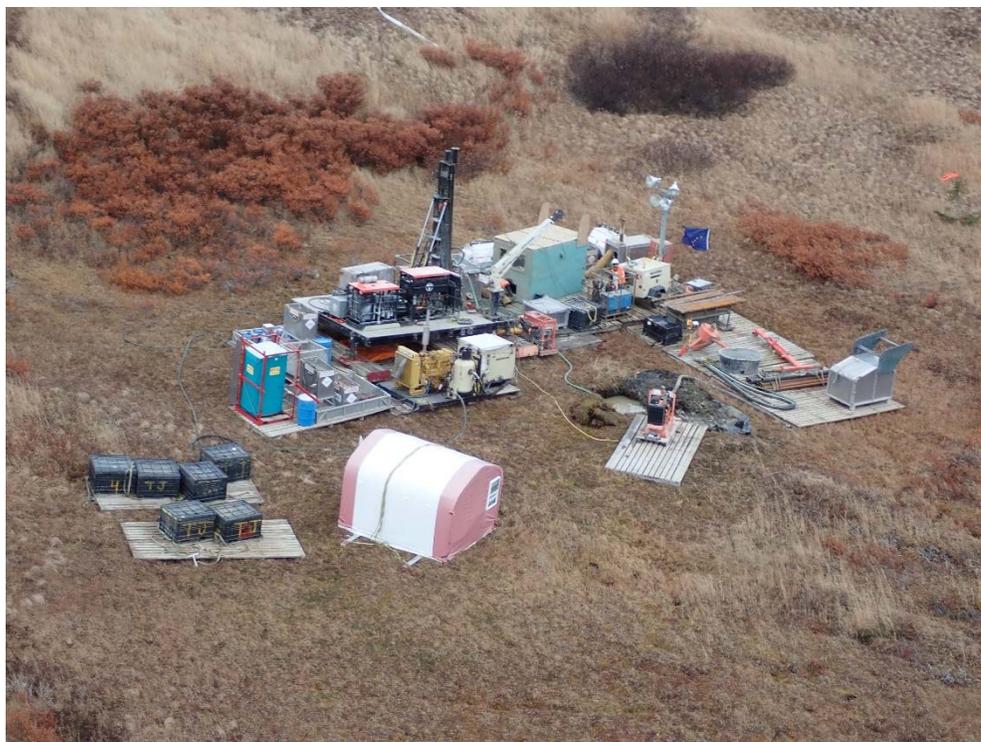
10. GH08-156
21 October 2019

2.3 Borehole GH08-156 (ADL 642443, Figure: 10)

Borehole GH08-156 has exhibited influence of surface water flow since 2016. Several attempts to repair in 2017 and 2018 were unsuccessful. The borehole was under active repair drilling at the time of inspection. The drill and supporting facilities were placed on elevated tundra mats. A small sump was in operation and overburden was stockpiled on a liner. This site will be re-inspected to confirm successful closure and surface reclamation.

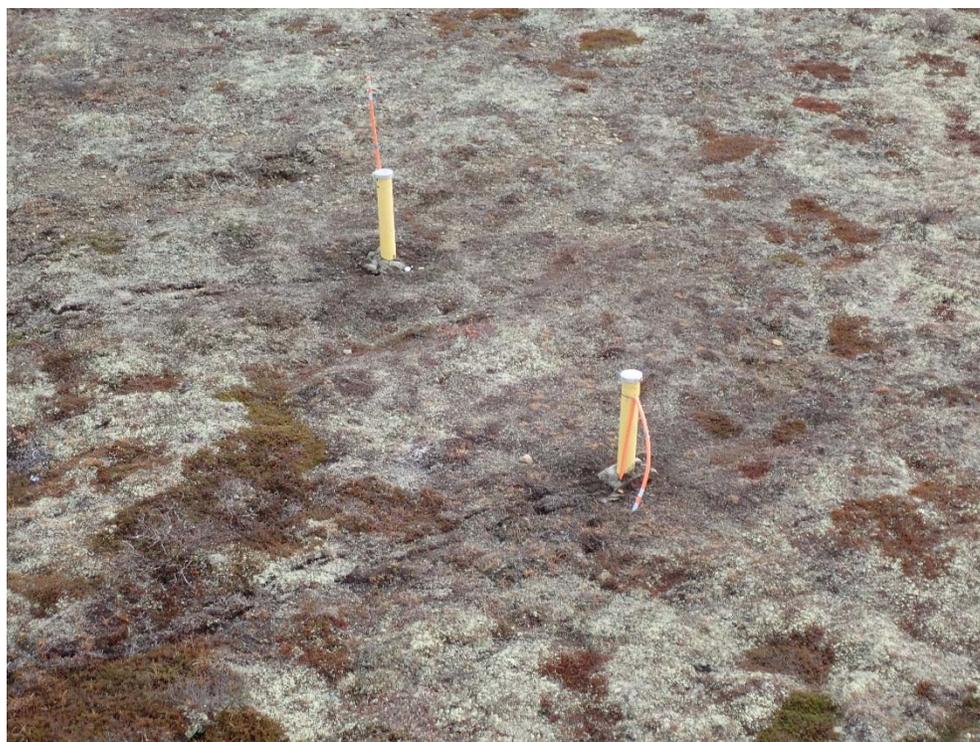
14. Boreholes
GH18-401S,
GH18-403S,
GH18-405S
21 October 2019

As viewed from
upper left to
lower right.
Borehole GH18-
401S does not
have a surface
structure.

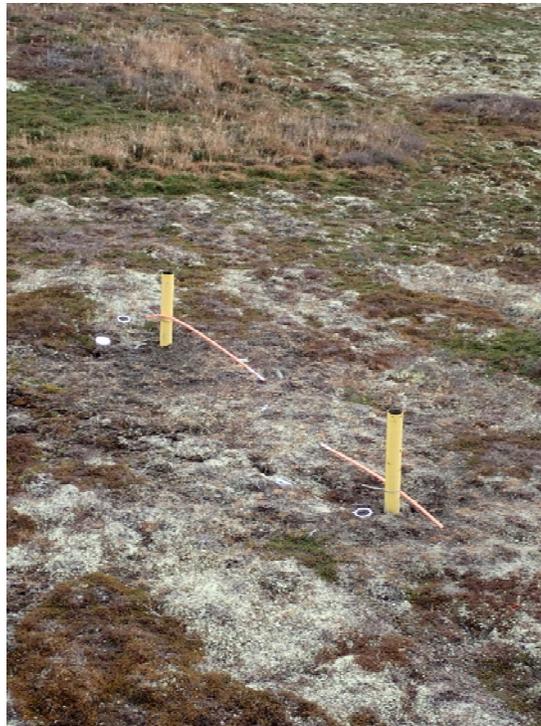
**16. GH18-408S and
GH18-407S L to R.**
21 October 2019

Engineering crews were actively collecting data at the time of inspection. The operator was reminded to replace caps and subsequently provided photo documentation of cap replacement post inspection.

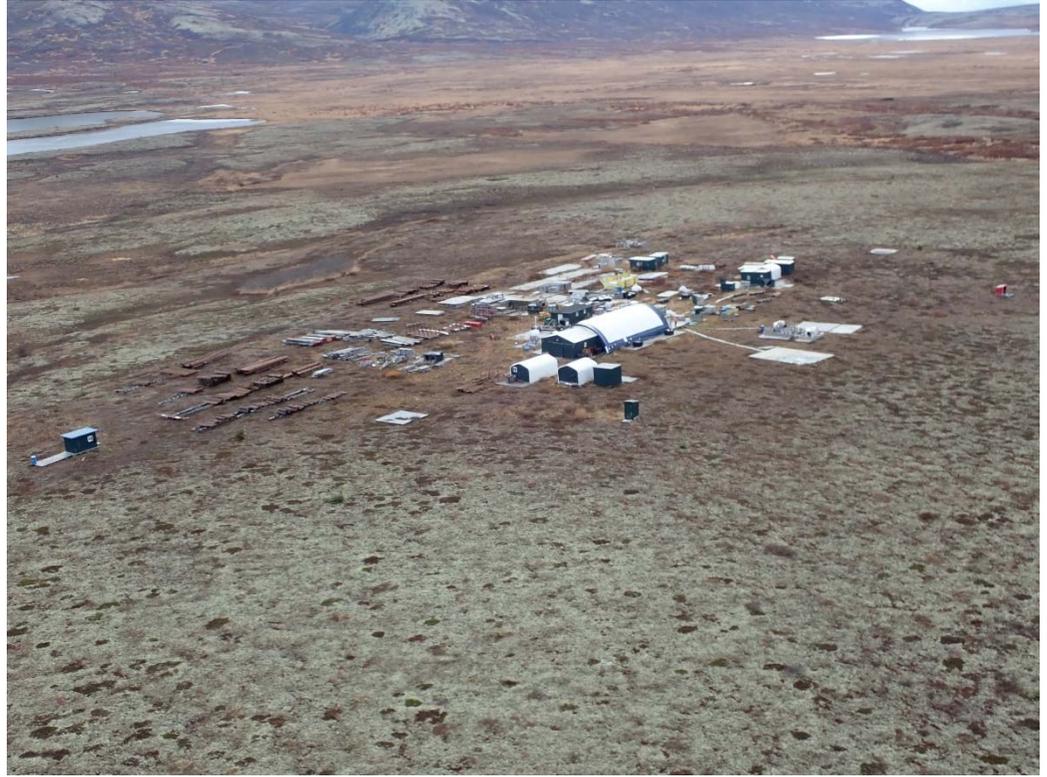
**33. Main Supply Depot
and Westbay 4**
21 October 2019

The Main Supply Depot including West Bay 4, West Bay 1, Watershed, the ARD Test Site and South Kaktuli Mountain Repeater Station were observed. Structures are in acceptable condition, are adequately maintained and in support of drilling, maintenance, and repair activities conducted by the operator. All structures observed were temporary in nature and construction. Significant consolidation and removal of material from the Main Supply Depot was observed (Figure 33). Materials that were no longer necessary for support of exploration activities were burned onsite or backhauled to an appropriate disposal location in Iliamna.
