# **Pebble Project Inspection**

## **June 14, 2006**

### **Bill Cole**

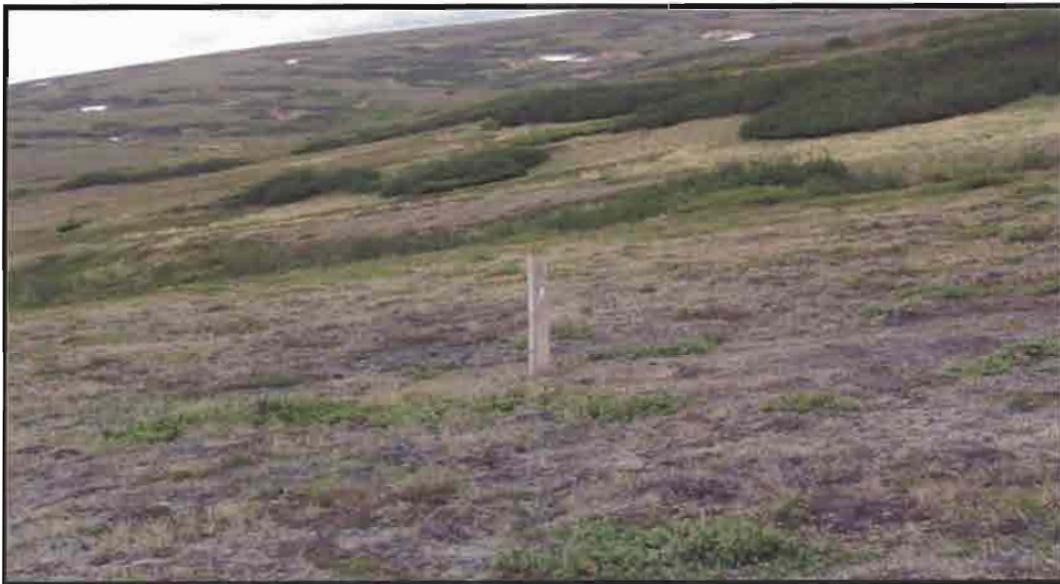
Photo #2. Taken 6/14/06. 2004 drill hole site at Pebble project.

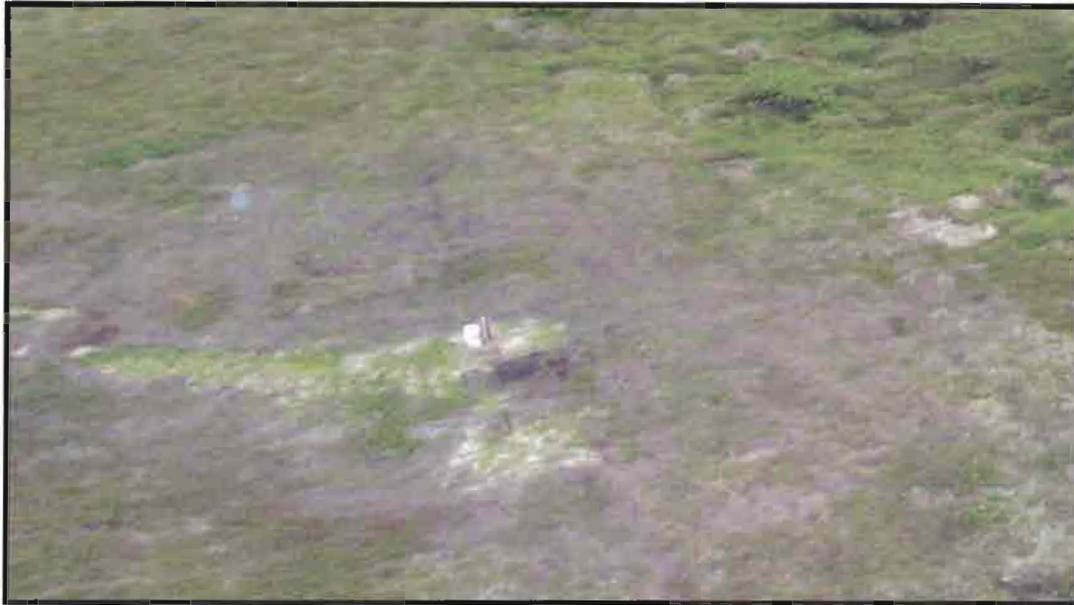
Photo #3. Taken 6/14/06. 2005 drill hole location. Northern Dynasty built a camp with 8-10 small buildings for use in 2004. The facility is no longer used as a camp, but Northern dynasty has left the structures in place for storage and a possible shelter in bad weather. (See photo #4 below.)

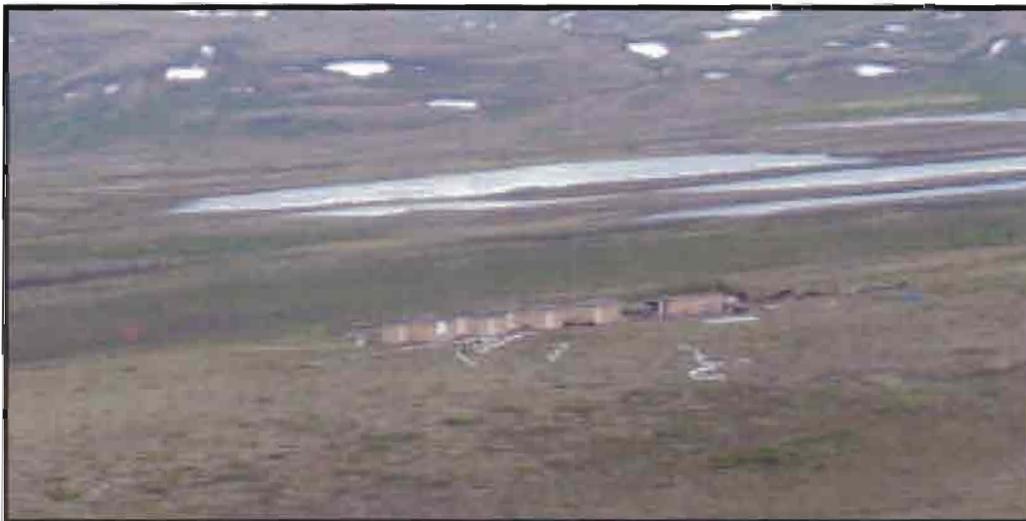
Photo #4. Taken 6/14/06. 2004 camp site at Pebble.

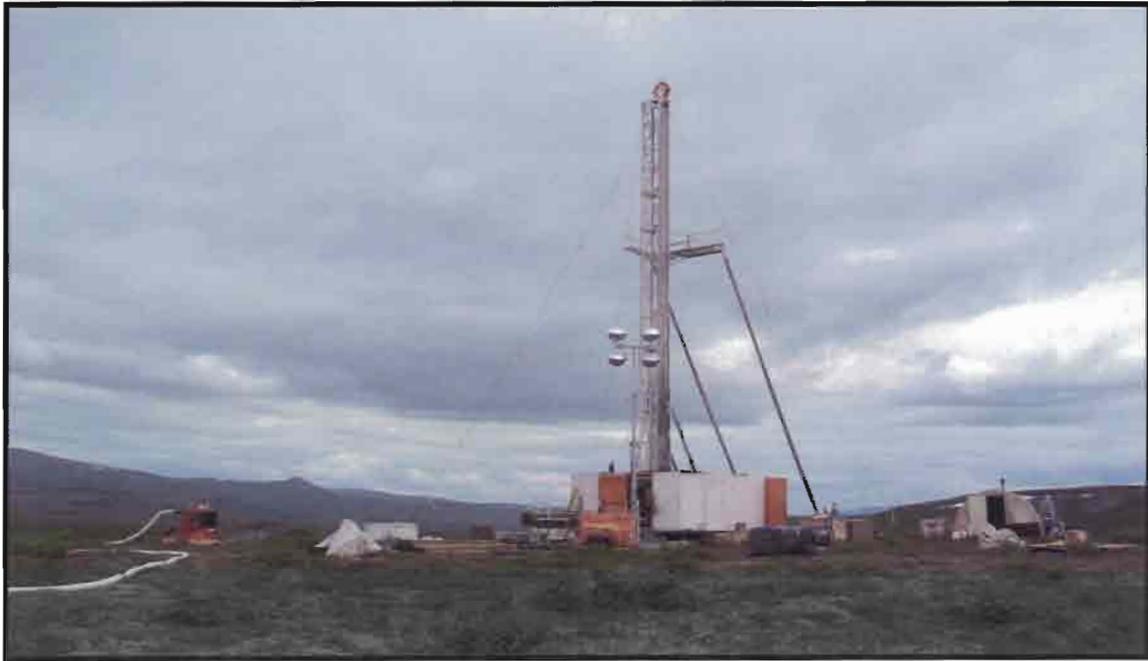
Photo #5. Taken 6/14/06. Longyear drill rig on Pebble Prospect.

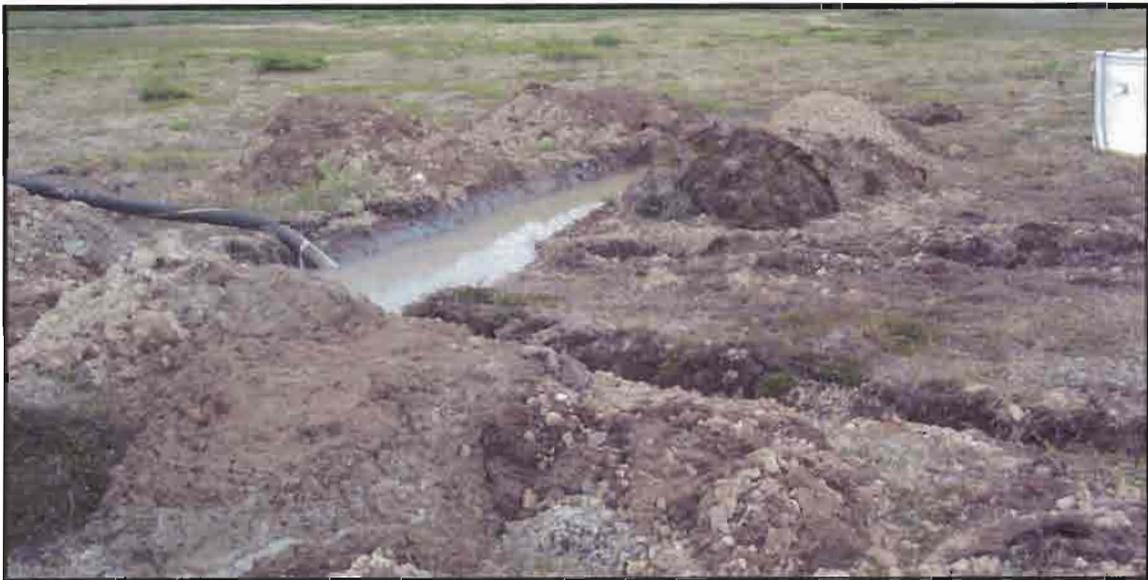
Photo #6. Taken 6/14/06. Mud pit for above drill site.

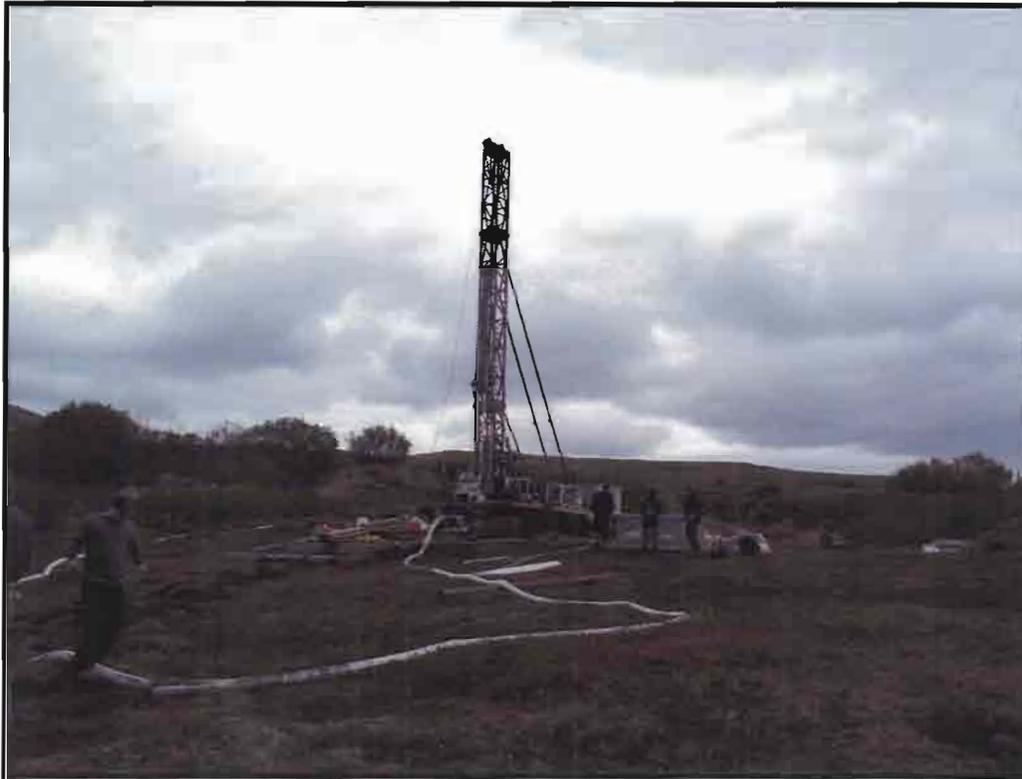
The flow was stopped by grouting with a bentonite mud. DH 6340 produced 80-130 gallons per minute. Water was initially encountered at a depth of 150', and the flow increased to a depth of 275'. According to Richard Moses, this water is surface water that has infiltrated overburden. The well was still flowing during our visit. (See photos #7 and 8.) The water was clear. The flow has since been stopped by grouting with cement. Richard informs us that no water from either well entered wetlands or any moving surface water. No signs of damage were seen during our visit to the project.

Photo #7. Taken 6/14/06. Drill on DH 6340.

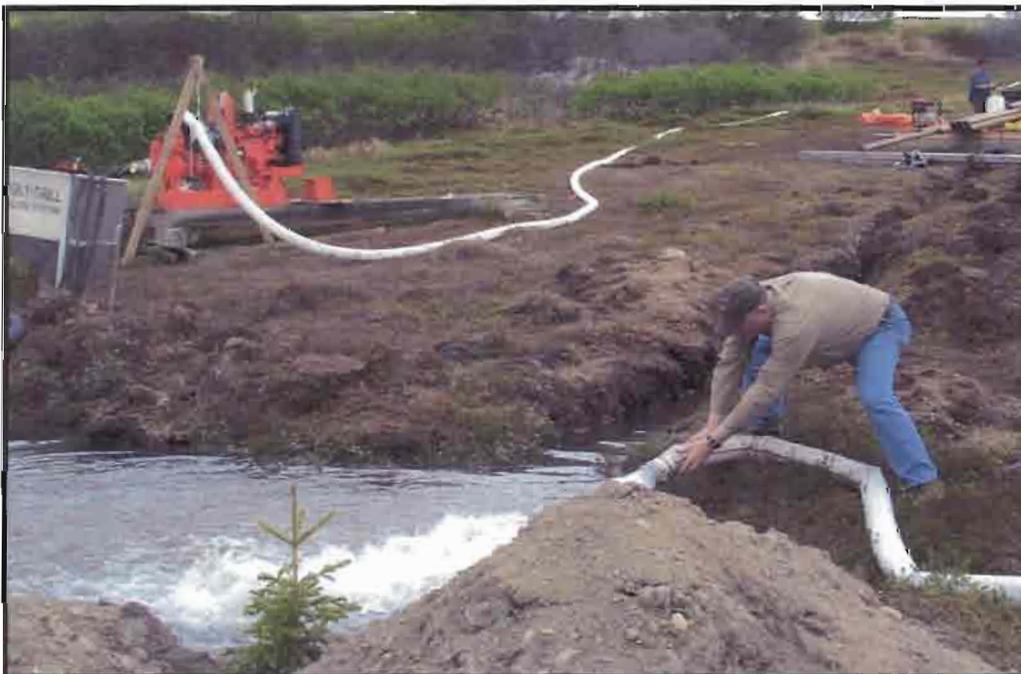
Photo #8. Taken 6/14/06. Richard Moses with hose carrying artesian flow from DH 6340.
