Field Monitoring Report -- Pebble Copper/Gold Exploration Project --

Personnel:	Inspection Date: August 31, 2010
Kerwin Krause, DNR-DMLW	Site Contact: Jeff Norberg
	APMA #: A106118
■ Inspection Type:	■ Wildlife Observed: None
○ Complete: Yes	○ Bear:
○ Partial:	○ Caribou:
○ Follow-up:	○ Moose:
○ Response to Public Complaint:	○ Waterfowl:
	○ Fish:
■ Weather Conditions:	○ Other:
○ Temperature: 40-50 F	
○ Wind: 20 South	■ Water level at Frying Pan Lake: N/A
○ Precipitation: Light	○ Observed inflow:
○ Visibility: Good at lower elevations	○ Observed outflow:
○ Sky Conditions: Overcast with low clouds	
○ Ground Conditions: Normal	
<p>Comments: PLP mineral exploration activity limited to core drilling (up to 1,600') exploration holes of anomalies resulting from airborne and ground electrical resistivity surveys. Some soil sampling related to geotechnical studies was also being done.</p>	
<p>Recommendations: None – all exploration activity was in compliance with permits.</p>	
<p>Actions Needed: None</p>

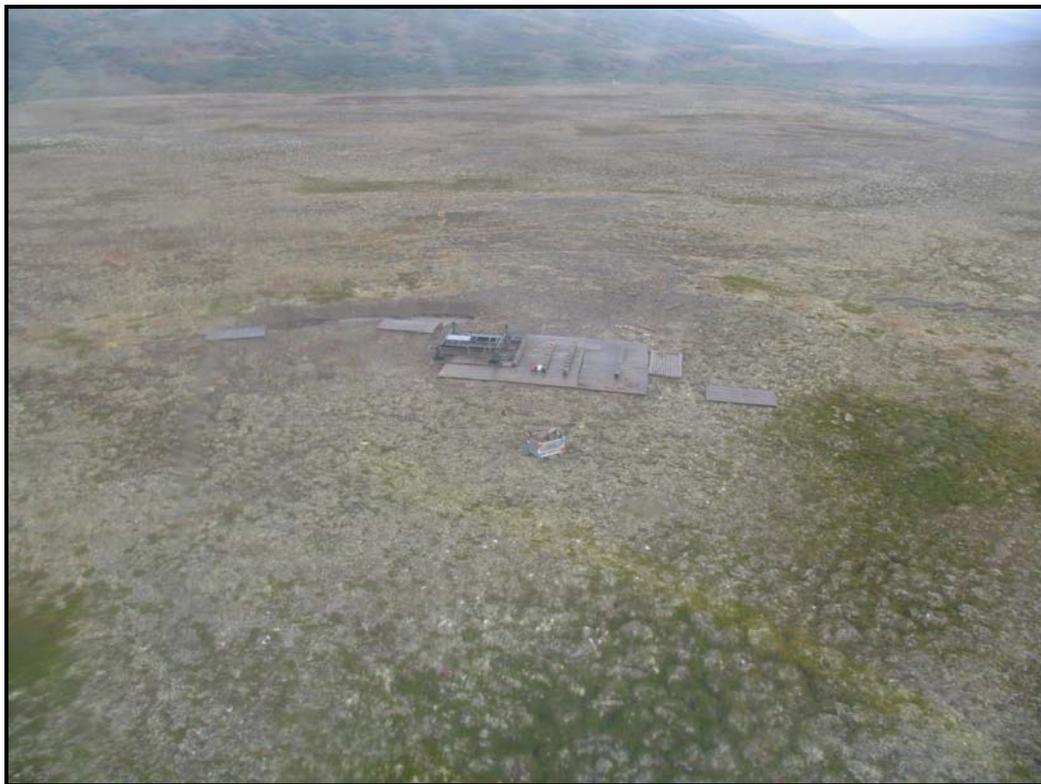
Photo 1 - Hole # 10506 EX 2010 CF

- Plugged: Didn't land but believe so
- Cemented: Didn't land but believe so
- Standing pipe: Yes
- Sump pit filled in: Not yet
- Water discharge trench filled in: Not yet
- Site revegetated: Not yet
- Artesian water present: No
- Any spills or staining: No
- Comments/General impression: Site ready for final demobilization and reclamation (see photo 1)

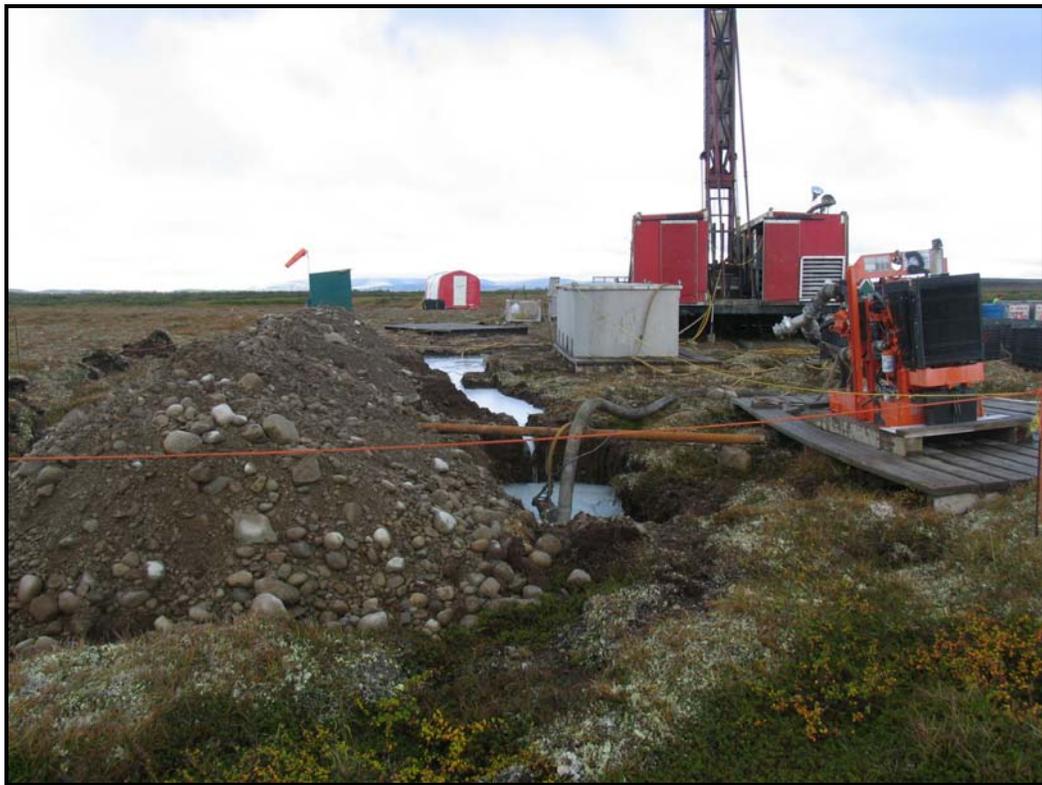
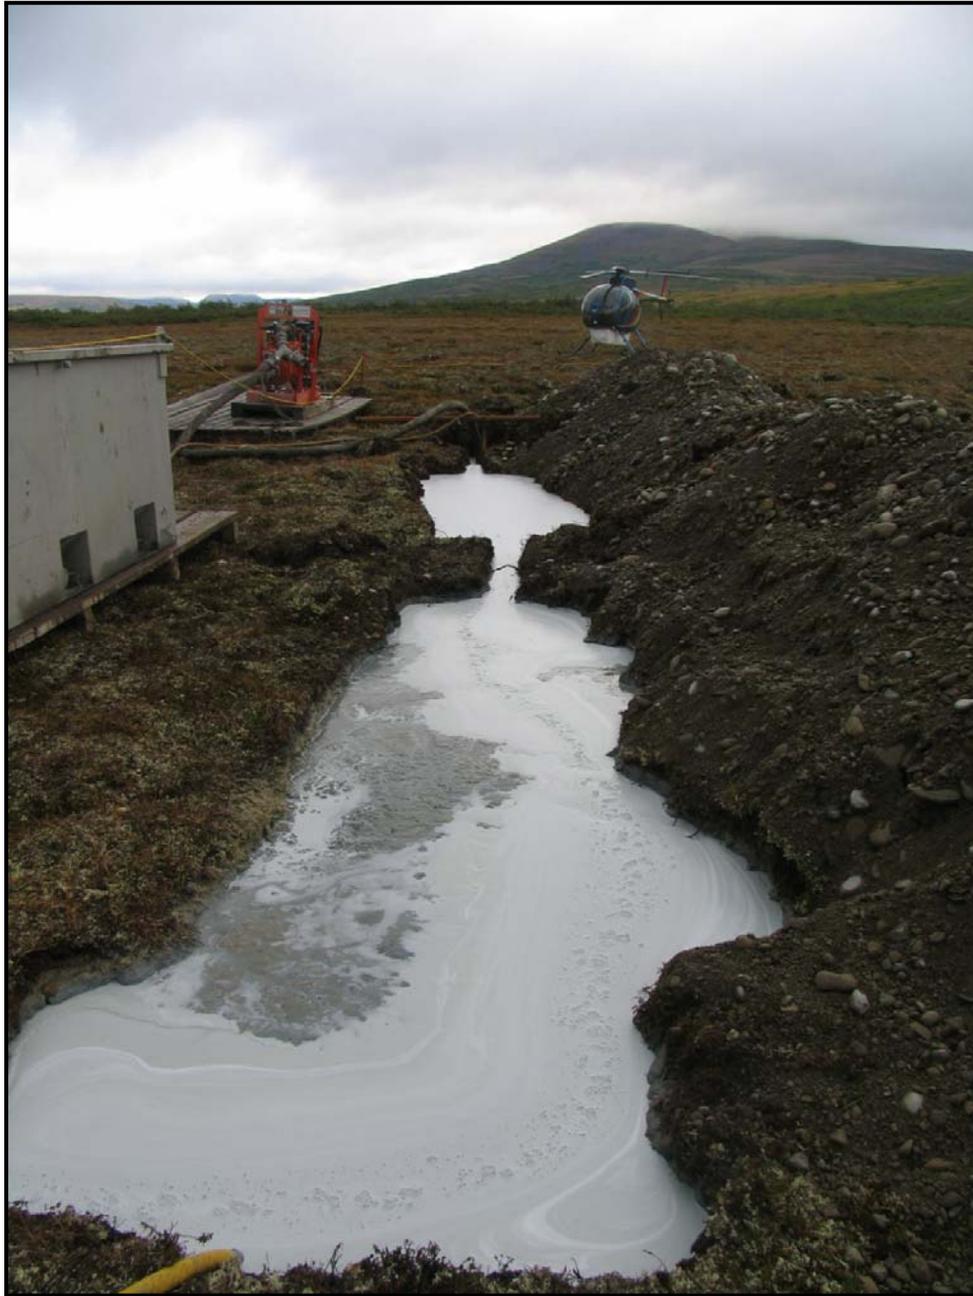
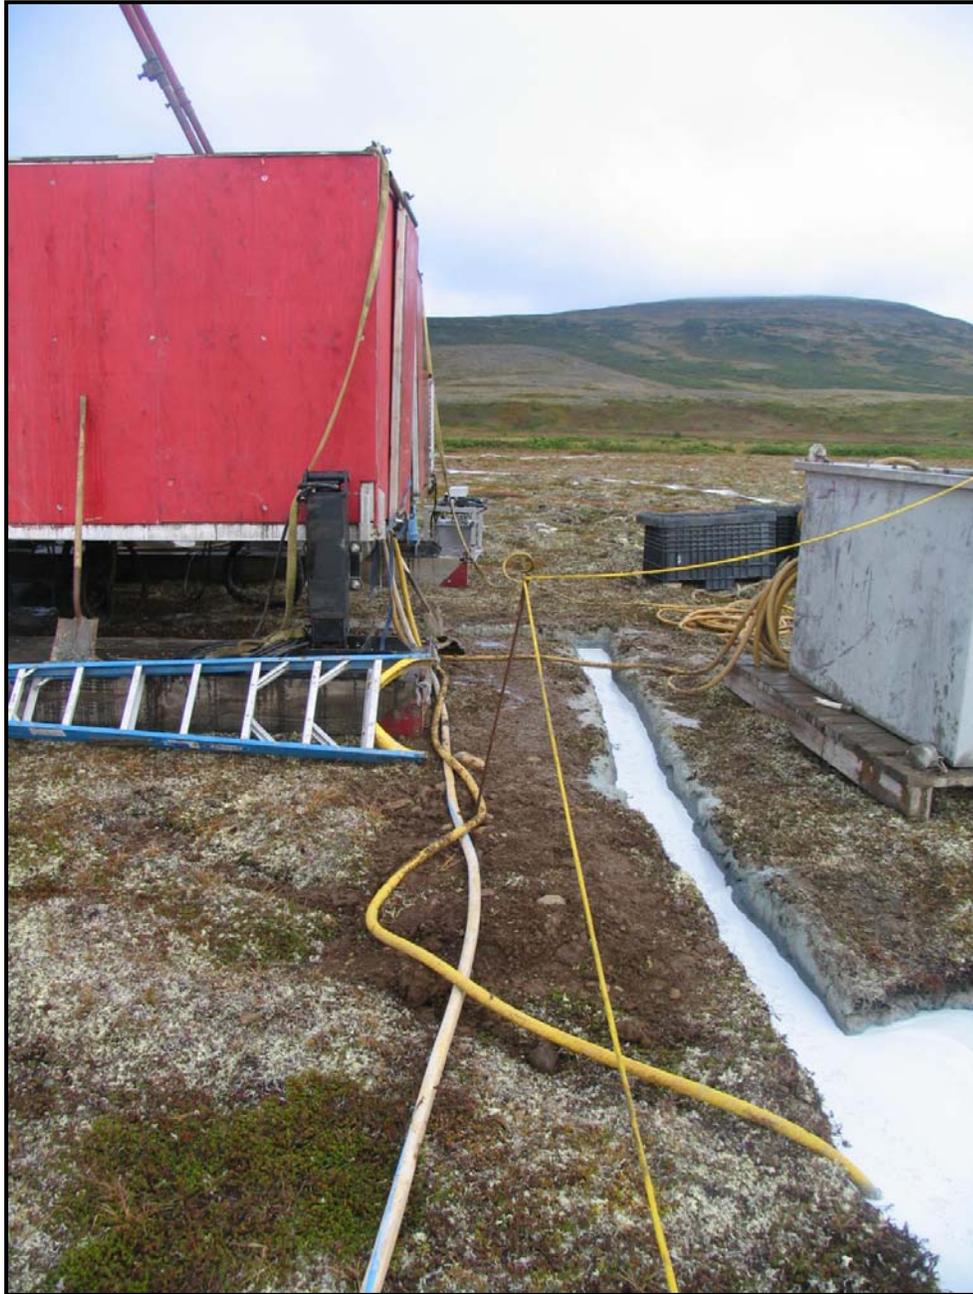
<ul style="list-style-type: none"> ○Water recirculation: Yes w/500 gallon tank 	<ul style="list-style-type: none"> ○Structure clear of debris: Yes
<ul style="list-style-type: none"> ○Water discharged: Yes to sump 	<ul style="list-style-type: none"> ○Mesh size: ? but F&G authorized
<ul style="list-style-type: none"> ○Artesian zone encountered: No 	<ul style="list-style-type: none"> ○Submerged: Yes
	<ul style="list-style-type: none"> ○Pump location to source: N/A
<ul style="list-style-type: none"> ■ Sump Pit: 	<ul style="list-style-type: none"> ○Catch basin for fuel supply: Yes
<ul style="list-style-type: none"> ○Location: adjacent to casing 	<ul style="list-style-type: none"> ○Sorbent pads: Yes
<ul style="list-style-type: none"> ○Discharge trench: Yes 	<ul style="list-style-type: none"> ○Hose color: Yellow
<ul style="list-style-type: none"> ○Dimensions of pit: 4'x5'x40' 	
<ul style="list-style-type: none"> ○In use: Yes, see Pictures 3-5

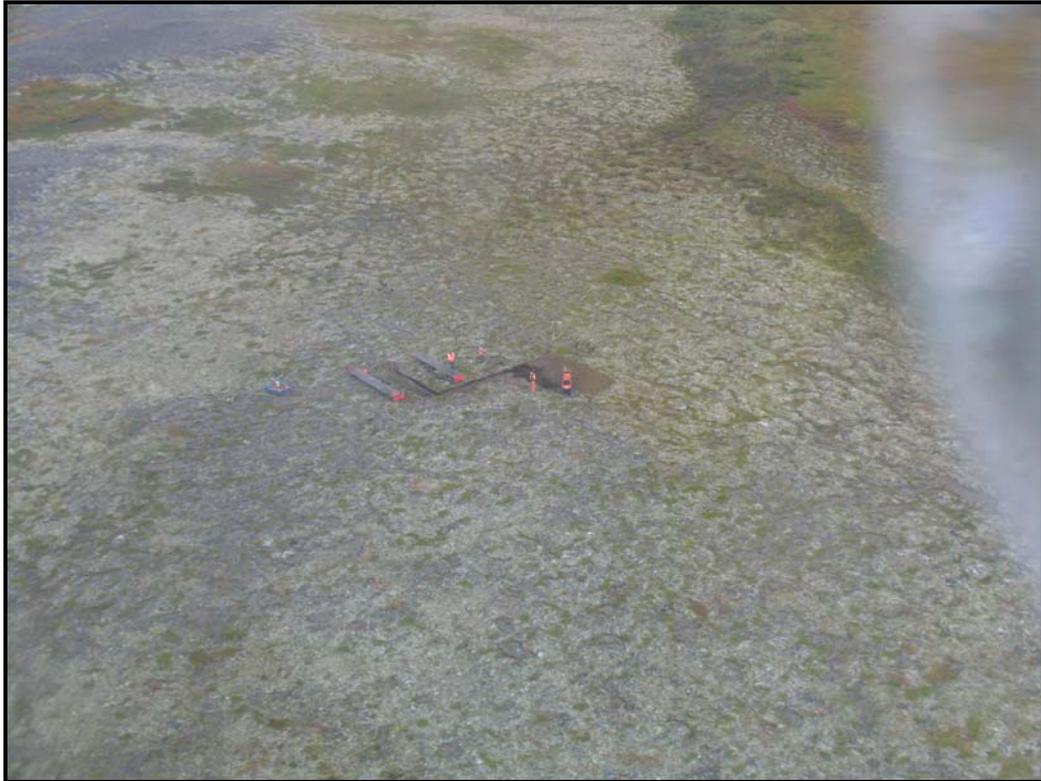
Photo 10 – Drill site being prepared for DDH Hole EX 2010 D

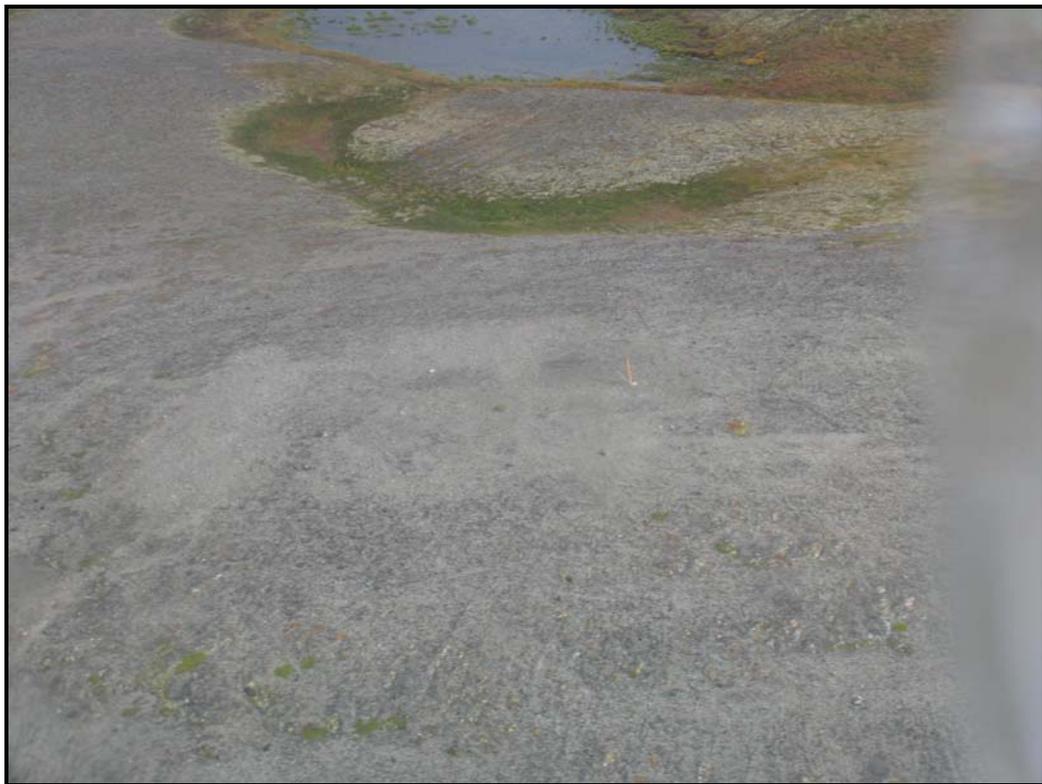
Photo 11 – Abandoned/Reclaimed DDH site # 10489

Abandoned Drill Hole/Site No.: 10489	Date: August 31, 2010
■ Plugged: Believe so	
■ Cemented: Believe so	
■ Standing pipe: No	
■ Sump pit filled in: Yes	
■ Water discharge trench filled in: Yes	
■ Site revegetated: N/A – Barren gravel knob	
■ Artesian water present: No	
■ Any spills or staining: No	
■ Comments/General impression: Good reclamation – hard to identify abandoned DDH site except for the ground post identifying the location

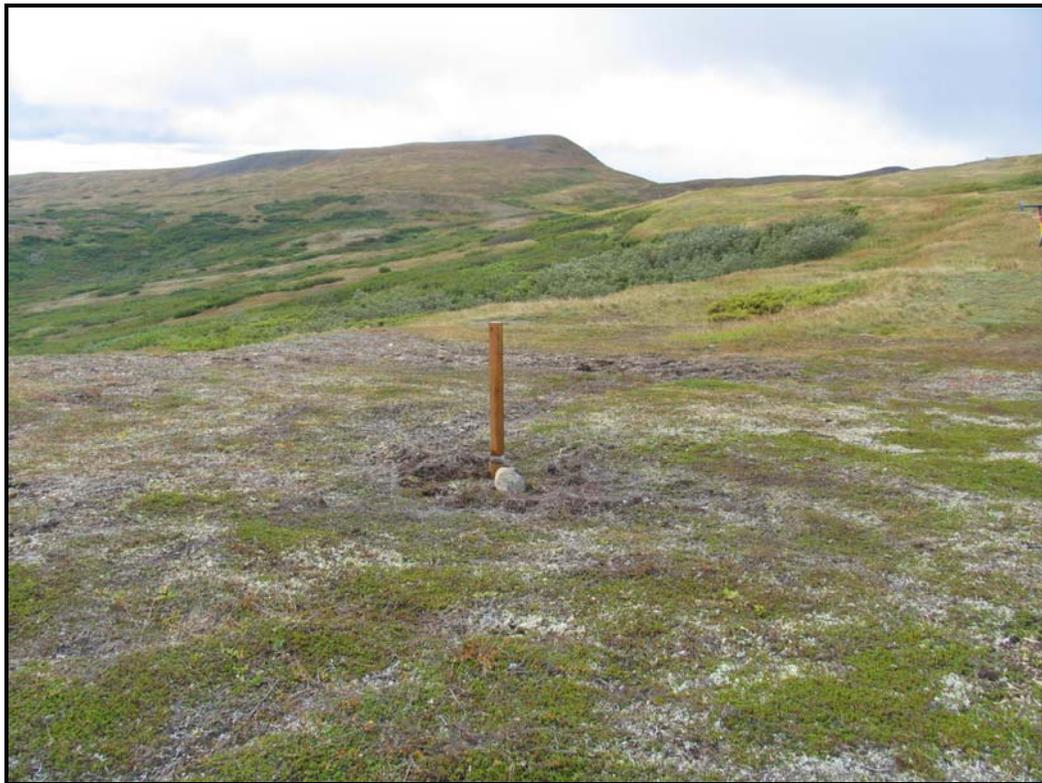
Photo 12 – Abandoned/Reclaimed DDH site # 10495 (EX 2010 R)

Abandoned Drill Hole/Site No.: 10495 (EX 2010 R)	Date: August 31, 2010
<ul style="list-style-type: none"> ■ Plugged: Yes ■ Cemented: Yes ■ Standing pipe: No ■ Sump pit filled in: Yes ■ Water discharge trench filled in: Yes ■ Site revegetated: Yes ■ Artesian water present: No ■ Any spills or staining: No ■ Comments/General impression: Good reclamation – hard to identify abandoned DDH site except for the ground post identifying the location

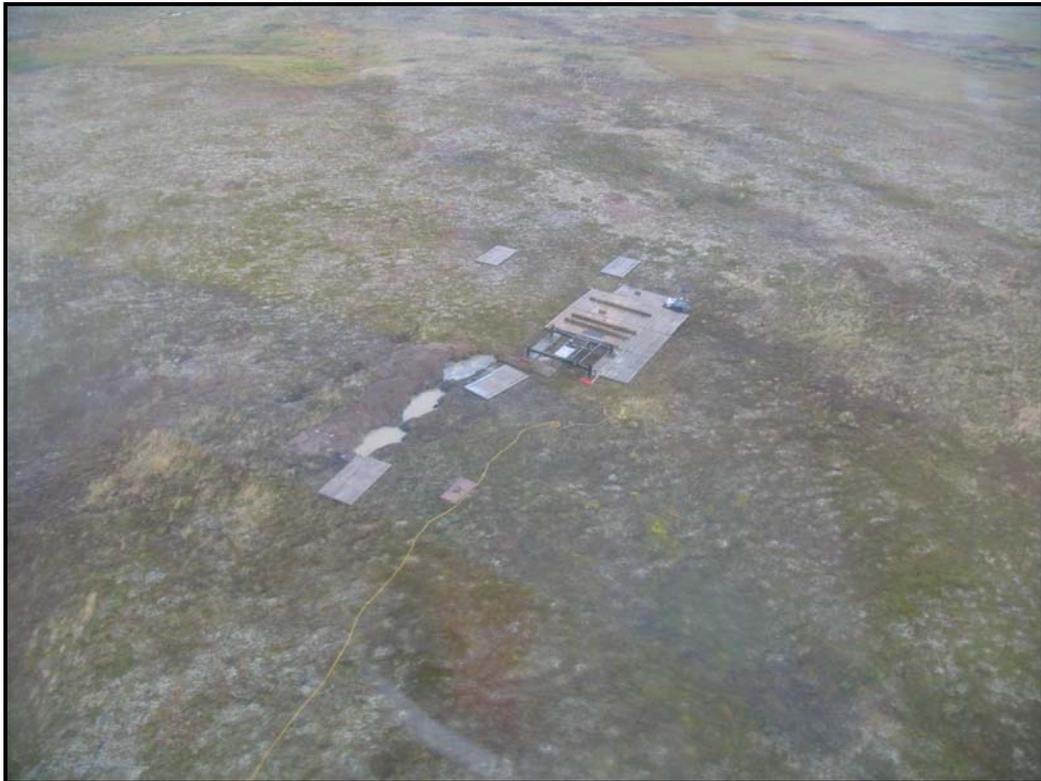
Photo 20 – DDH site # EX 2010 DO

Abandoned Drill Hole/Site No.: EX 2010 DO	Date: August 31, 2010
<ul style="list-style-type: none"> ■ Plugged: ? ■ Cemented: ? ■ Standing pipe: ? ■ Sump pit filled in: No ■ Water discharge trench filled in: No ■ Site revegetated: No ■ Artesian water present: No ■ Any spills or staining: No ■ Comments/General impression: DDH site being de-commissioned. Drill support footings and tundra pads waiting to be removed and sumps waiting to be reclaimed.

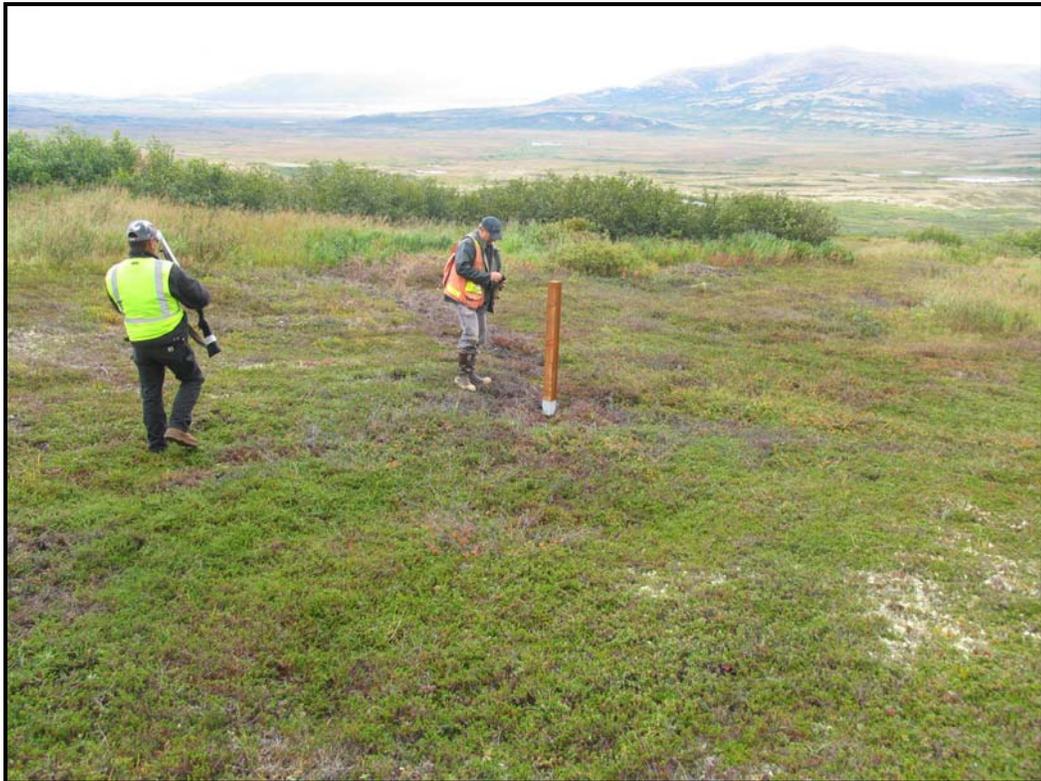
Photo 21 – DDH site # 9463 (2009)

Abandoned Drill Hole/Site No.: 9463 (2009)	Date: August 31, 2010
■ Plugged: Yes	
■ Cemented: Yes	
■ Standing pipe: No	
■ Sump pit filled in: Yes	
■ Water discharge trench filled in: Yes	
■ Site revegetated: Yes	
■ Artesian water present: Yes	
■ Any spills or staining: Yes	
■ Comments/General impression: Good Reclamation

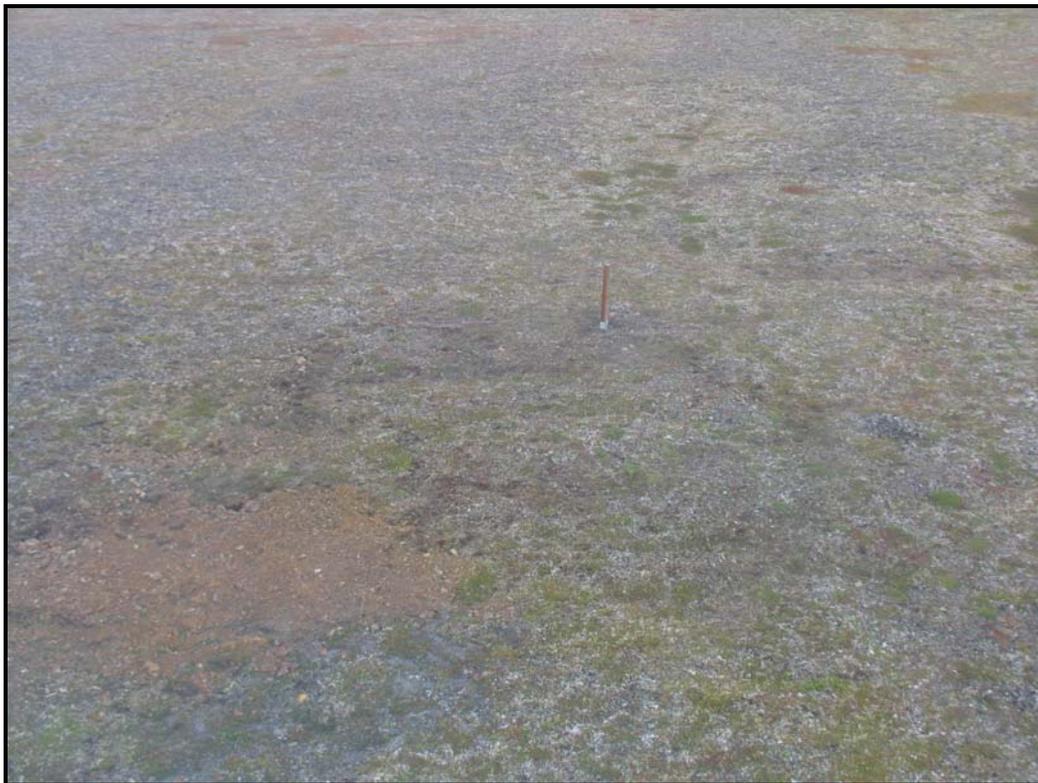
Photo 22 – DDH site # 9452 (2009)

Abandoned Drill Hole/Site No.: 9452 (2009)	Date: August 31, 2010
■ Plugged: Yes	
■ Cemented: Yes	
■ Standing pipe: No	
■ Sump pit filled in: Yes	
■ Water discharge trench filled in: Yes	
■ Site revegetated: Yes	
■ Artesian water present: Yes	
■ Any spills or staining: Yes	
■ Comments/General impression: Good Reclamation

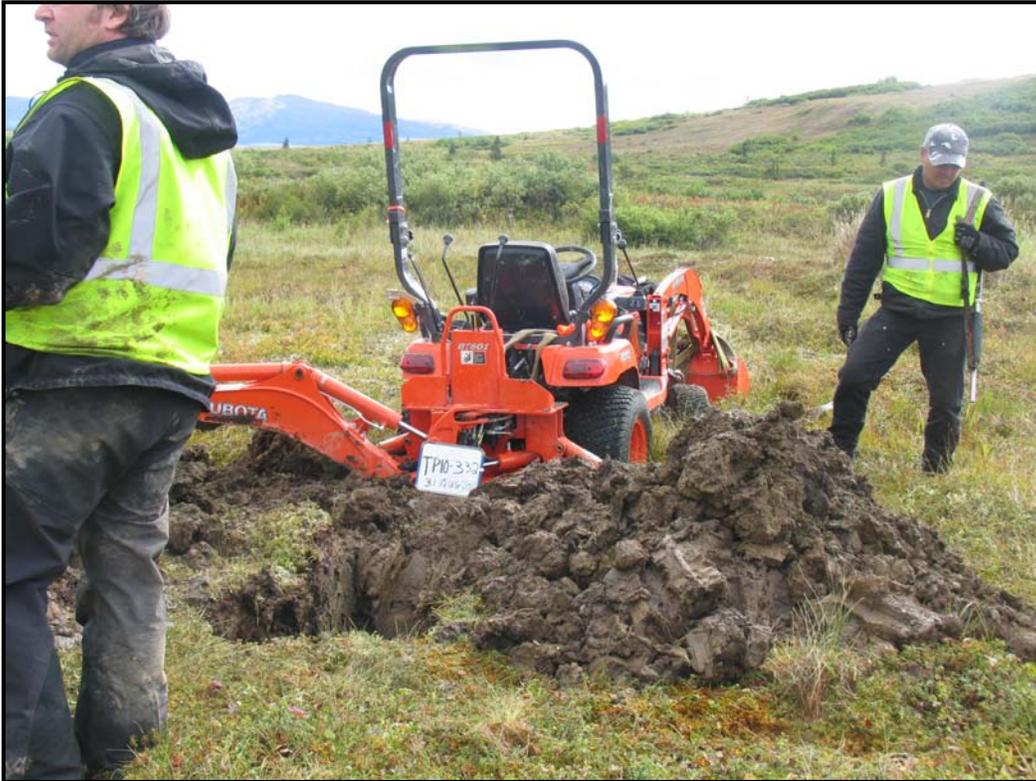
Photo 23 – Contractor digging and sampling a test pit for a geotechnical study
