Field Monitoring Report -- Pebble Copper/Gold Exploration Project --

Personnel: Jeanette Alas (ADF&G)	Inspection Date: September 9, 2013
	Site Contact: Jeff Norberg, Manager, Site Compliance and Reclamation, PLP
	APMA #: A136118
■ Inspection Type:	■ Wildlife Observed: None
○ Complete: One active rig site (GH13-383)	○ Bear:
○ Partial: Two reclamation sites (GH 13-358 and GH 13-376)	○ Caribou:
○ Follow-up:	○ Moose:
○ Response to Public Complaint:	○ Waterfowl:
	○ Fish:
■ Weather Conditions:	○ Other:
○ Temperature: 52°F	
○ Wind: 18 mph	
○ Precipitation: Rain	
○ Visibility: Varied	
○ Sky Conditions: Overcast	
○ Ground Conditions: Wet	
<p>■ Comments: Active rig site looked clean and no issues were encountered. No problems were visible from the air for the two reclamation sites.</p>	
<p>■ Recommendations: None</p>	
<p>■ Actions Needed: None</p>

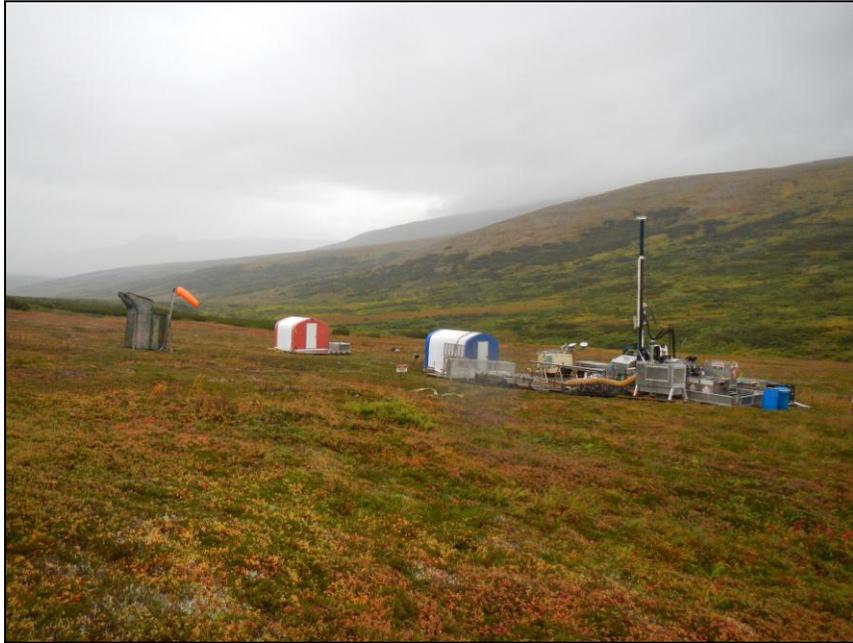
Drill Hole/Site No.: GH 13-383	Date: September 9, 2013
Rig No.: 4	Time: 3:49 PM
Activity: Packer test. Depth about 100 ft	
<ul style="list-style-type: none"> ■ Condition of Drilling Site: See Photograph 1 	<ul style="list-style-type: none"> ■ Sump Pit (continued):
<ul style="list-style-type: none"> ○ Distance from waterbody: ~1,500 ft 	<ul style="list-style-type: none"> ○ Location and extent of discharged material: ~200 ft northeast of rig (Photograph 4)
<ul style="list-style-type: none"> ○ Location of fuel storage: Adjacent to rig 	<ul style="list-style-type: none"> ○ Topsoil, muck, tundra stockpiled: Yes
<ul style="list-style-type: none"> ○ Sorbent pads present: Yes 	<ul style="list-style-type: none"> ○ Hose color: White
<ul style="list-style-type: none"> ○ Tundra mat: Yes (see Photograph 2) 	
<ul style="list-style-type: none"> ○ Pipe off tundra: Yes 	<ul style="list-style-type: none"> ■ Drill Water Supply:

Photograph 1: View of rig site from sump discharge (GH 13-383).

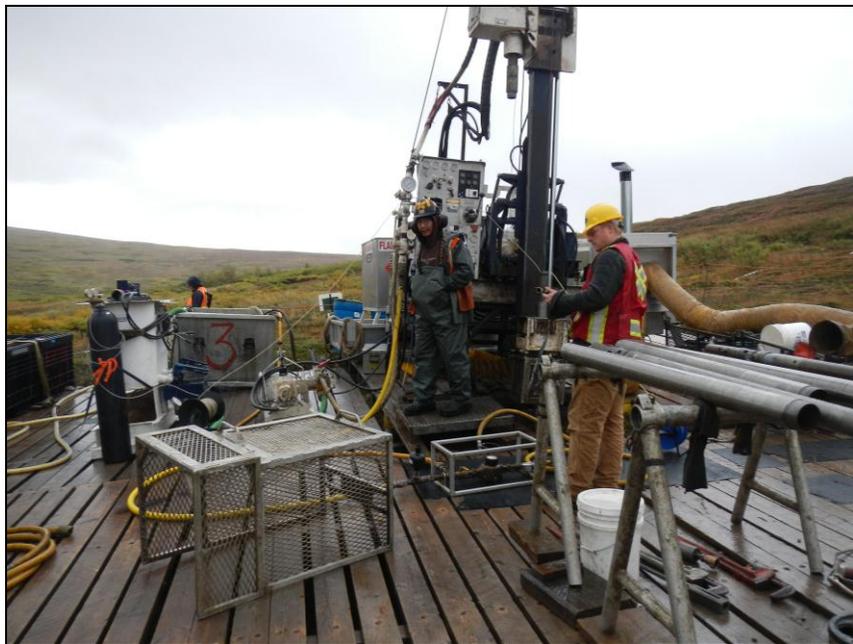
Photograph 2: Drill rig on tundra mat (GH 13-383).

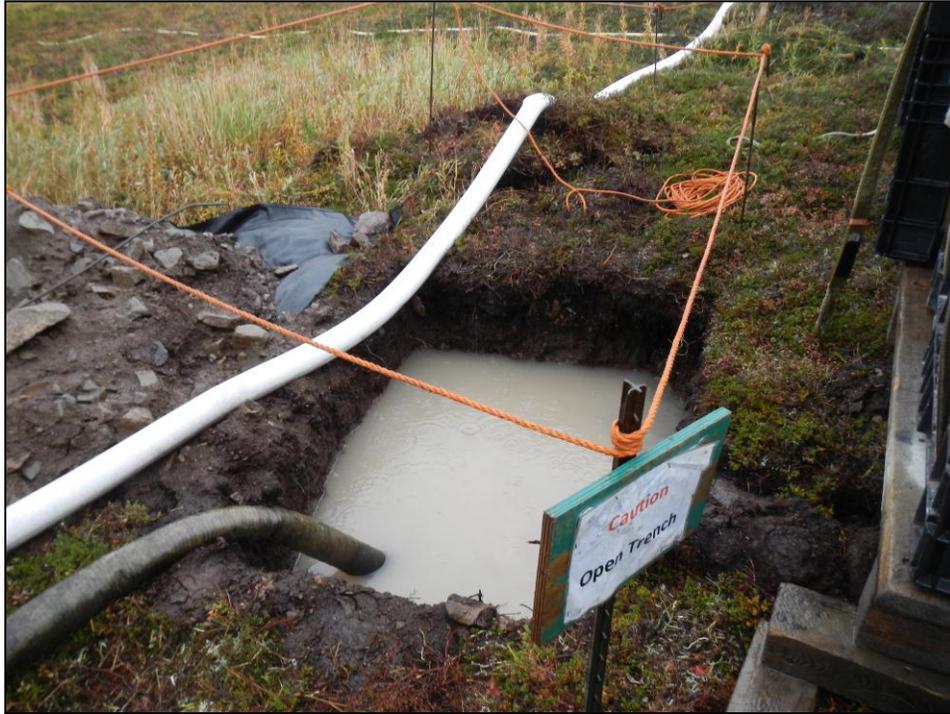
<ul style="list-style-type: none"> ■ Sump Pit: Yes, one pit (see Photograph 3) 	<ul style="list-style-type: none"> ○ Hose color: Light yellow
<ul style="list-style-type: none"> ○ Location: Adjacent to rig and tundra mat 	
<ul style="list-style-type: none"> ○ Discharge trench: Yes 	<ul style="list-style-type: none"> ■ Other Comments:
<ul style="list-style-type: none"> ○ Dimensions of pit: about 5 ft by 6 ft 	
<ul style="list-style-type: none"> ○ In use: Yes

Photograph 3: Sump pit with tundra mat in background and topsoil pile to left (GH 13-383).

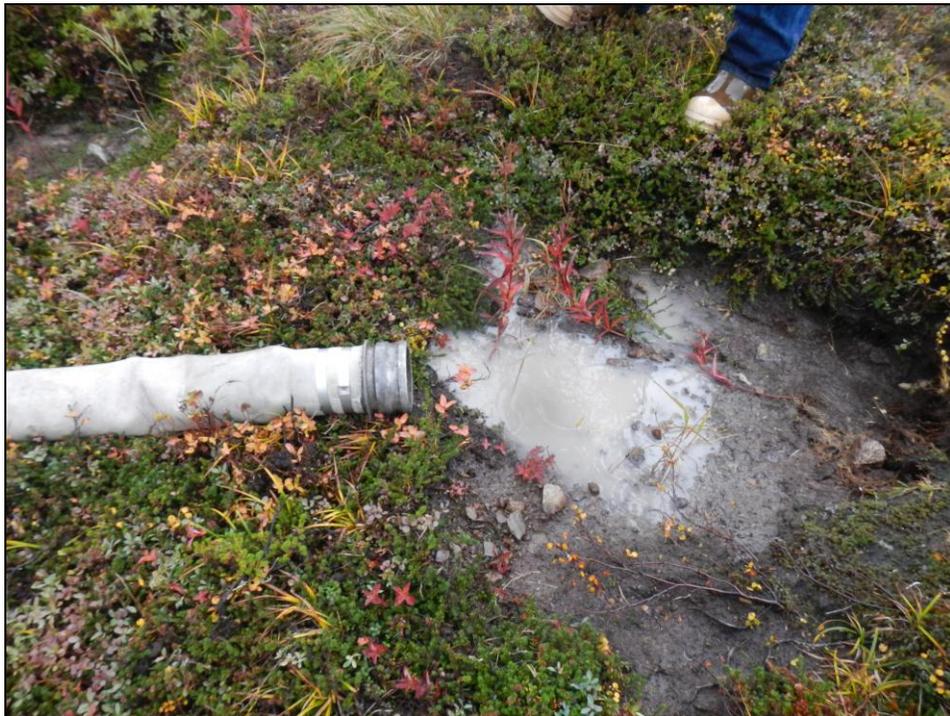
Photograph 4: Discharge from sump pit (GH 13-383).

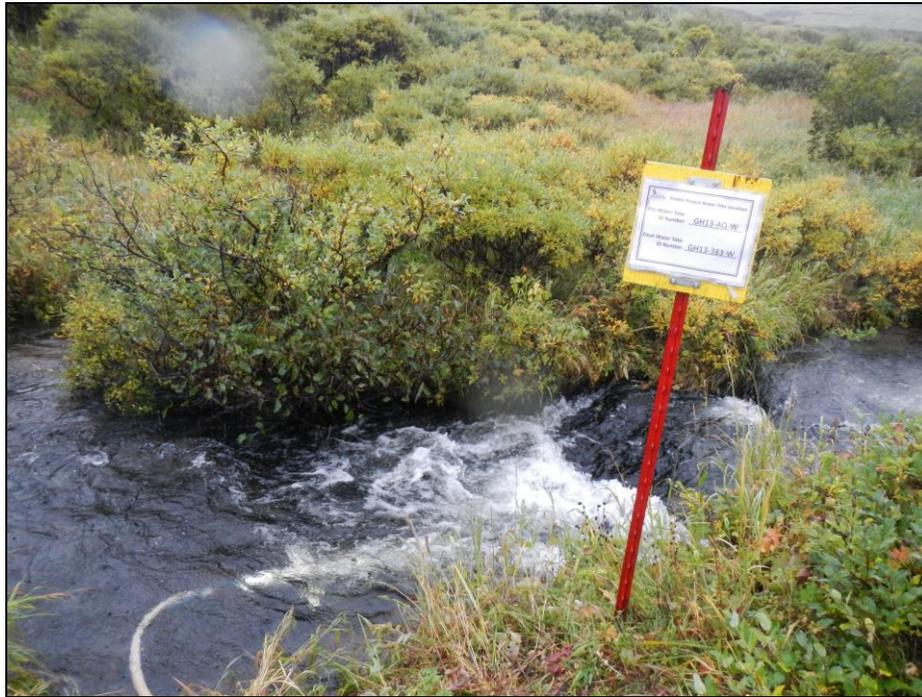
<ul style="list-style-type: none"> ○ Litter: One piece of cardboard when walking to water source. 	<ul style="list-style-type: none"> ○ Stream, lake/pond: Unnamed tributary to South Fork Koktuli River
<ul style="list-style-type: none"> ○ Trash containment: Yes 	<ul style="list-style-type: none"> ○ Location: About 1,500 ft northwest and downhill of rig.
<ul style="list-style-type: none"> ○ Sanitary facilities: Yes, privy 	<ul style="list-style-type: none"> ○ Adequate water flow and depth for fish passage in streams: Yes
<ul style="list-style-type: none"> ○ Any spills or staining: None 	<ul style="list-style-type: none"> ○ Evidence of significant impacts to riparian vegetation or stream banks: None
<ul style="list-style-type: none"> ○ General impression: Clean 	<ul style="list-style-type: none"> ○ General impression of water body (i.e. clear, turbid, tannic): Tannic
	<ul style="list-style-type: none"> ○ Intake description: ADF&G-approved screened intake (see Photograph 5)

Photograph 5: Water intake with signage (GH 13-383).

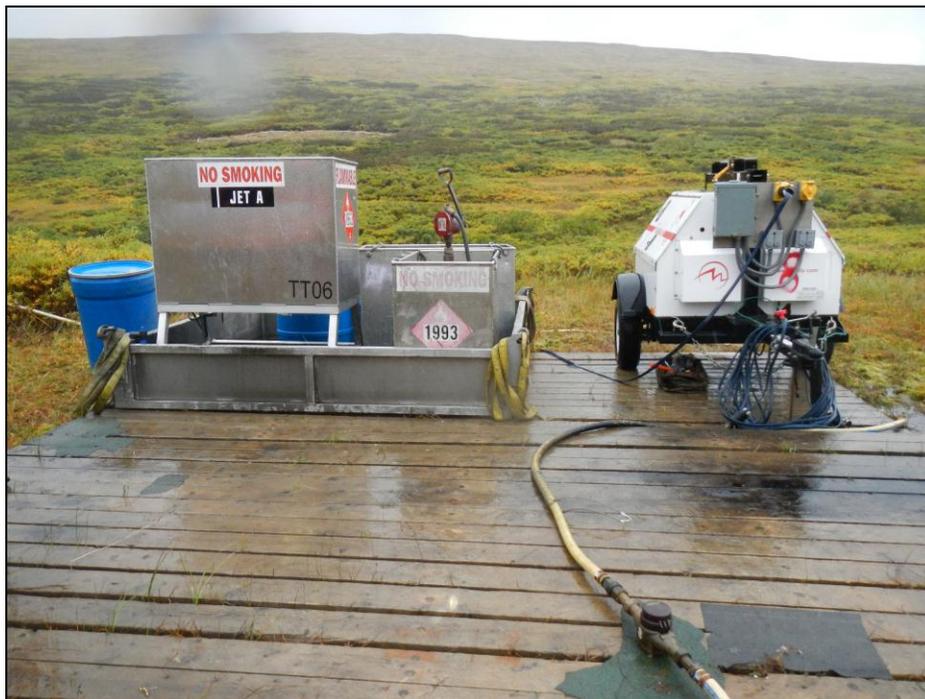
Photograph 6: Fuel/generator and tundra pad for water intake (GH 13-383).

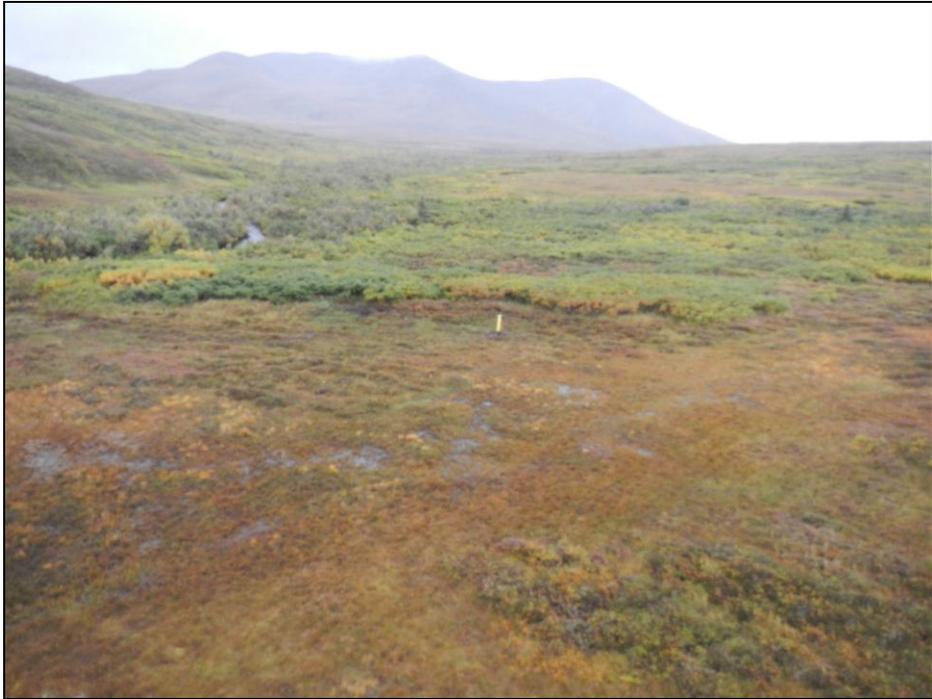
Abandoned Drill Hole/Site No.: GH 13-358	Date: September 9, 2013
	Time: 3:40 PM
■ Plugged: Yes (per J. Norberg)	
■ Cemented: Grout and cement (per J. Norberg)	
■ Standing pipe: Yes (see Photograph 7)	
■ Sump pit filled in: Yes (see Photograph 8)	
■ Water discharge trench filled in: Yes	
■ Site revegetated: Yes (see Photograph 8)	
■ Date revegetated/reclaimed: August 12, 2013 (per J. Norberg)	
■ Artesian water present: None visible from the air.	
■ Any spills or staining: None visible from the air.	
■ Comments/General impression: We flew over this site and I did an aerial inspection only. Site looked good from the air (see Photographs 7-8).

Photograph 7: Reclaimed site (GH 13-358).

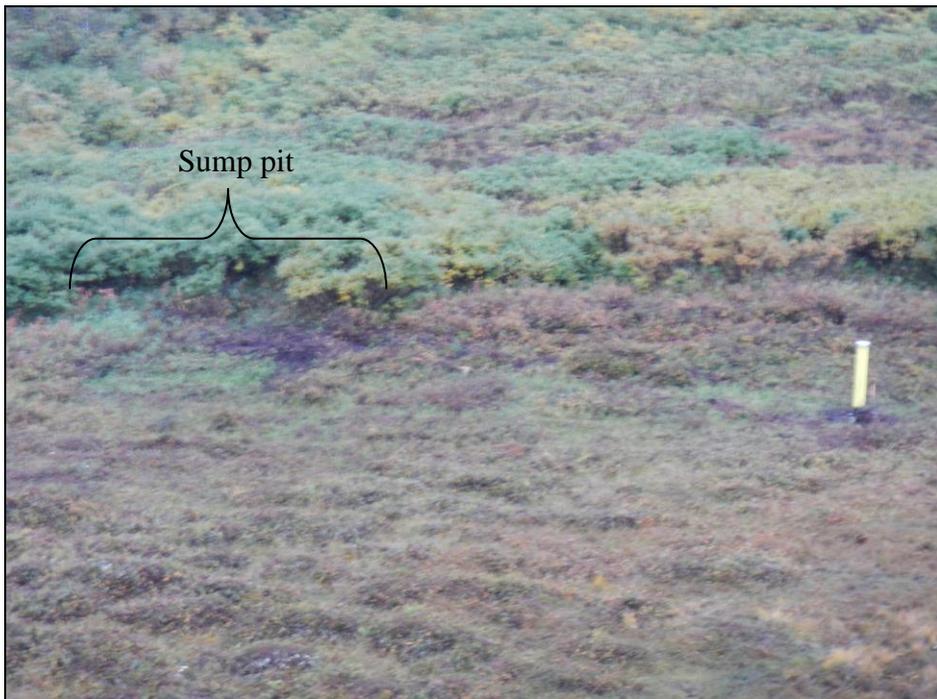
Photograph 8: Revegetated sump pit (GH 13-358).

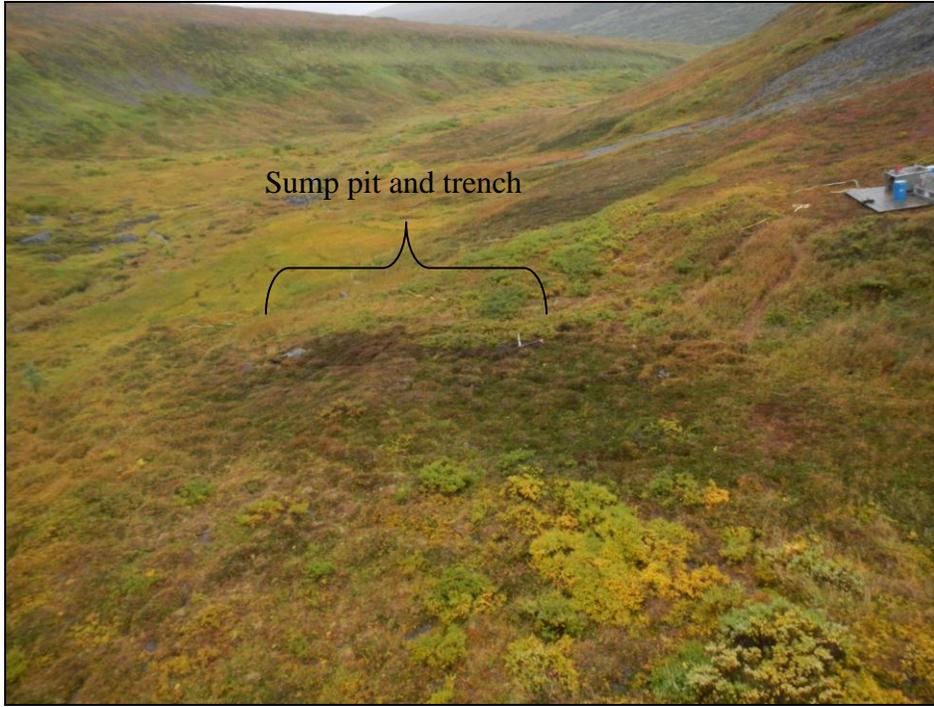
Abandoned Drill Hole/Site No.: GH 13-376	Date: September 9, 2013
	Time: 3:41 PM
<ul style="list-style-type: none"> ■ Plugged: Yes (per J. Norberg) ■ Cemented: Yes (per J. Norberg) ■ Standing pipe: Yes ■ Sump pit filled in: Yes (see Photograph 9) ■ Water discharge trench filled in: Yes ■ Site revegetated: Yes (see Photograph 9) ■ Date revegetated/reclaimed: August 30, 2013 (per J. Norberg) ■ Artesian water present: None visible from the air. ■ Any spills or staining: None visible from the air. ■ Comments/General impression: We flew over this site and I did an aerial inspection only. Site looked good from the air (see Photograph 9).

Photograph 9: Reclaimed site (GH 13-376).
