Field Monitoring Report -- Pebble Copper/Gold Exploration Project --

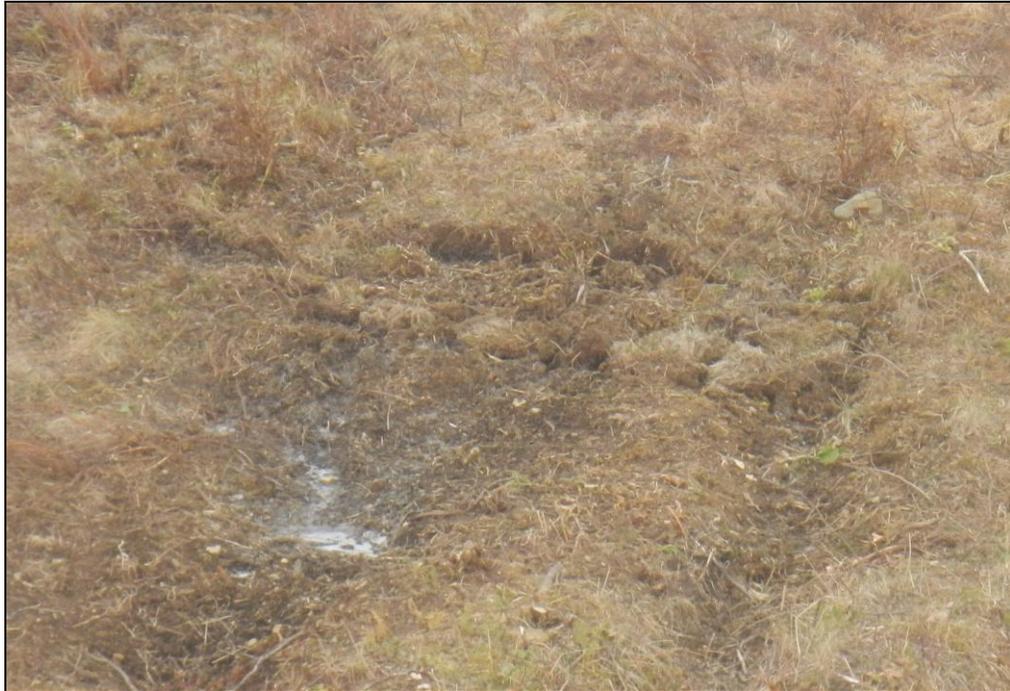
Abandoned Drill Hole/Site No.: GH 13-BK	Date: October 1, 2013
	Time: 1220
■ Plugged: N/A	
■ Cemented: N/A	
■ Standing pipe: N/A	
■ Sump pit filled in: Yes (see Photograph 1)	
■ Water discharge trench filled in: Yes (see Photograph 1)	
■ Site revegetated: See comments below (see Photograph 1)	
■ Date revegetated/reclaimed: sometime between September 26-27, 2013 (per J. Male)	
■ Artesian water present: N/A	
■ Any spills or staining: N/A	
<p>■ Comments/General impression: We conducted an aerial inspection of this reclamation site. No drilling activity was conducted at this site (per J. Male). The sump pit and trench had been dug, and the topsoil and tundra mat was replaced (see Photograph 1). The area surrounding the site had been cleared of shrubs and bushes (see Photograph 2). The tundra was dormant and will likely take time to determine whether or not it will properly revegetate.</p>

Photograph 1: Tundra mat cover on sump pit (GH 13-BK).

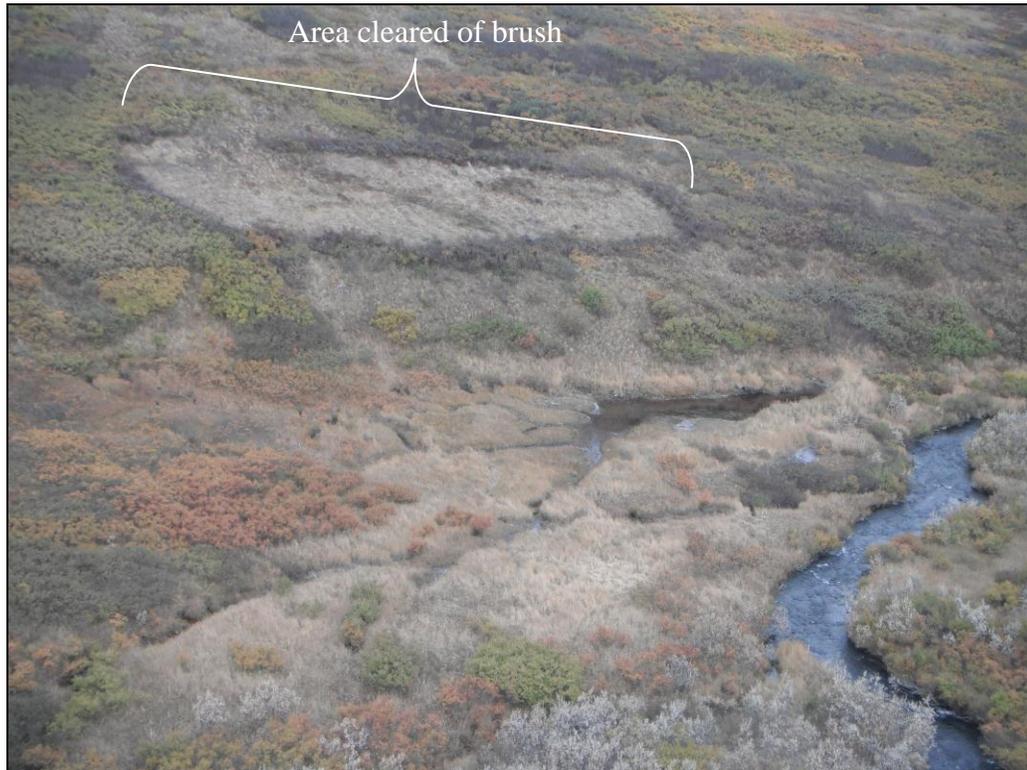
Photograph 2: Aerial view of drill rig site (GH 13-BK).
