Field Monitoring Report
-- Pebble Copper/Gold Exploration Project --

Personnel: Jeanette Alas and Josh Brekken - ADF&G, Jeff Norberg - PLP	Inspection Date: 10/17/2012
	Site Contact: Jeff Norberg
	APMA #: A126118
<ul style="list-style-type: none"> ■ Inspection Type: 	<ul style="list-style-type: none"> ■ Wildlife Observed:
<ul style="list-style-type: none"> ○ Complete: Inspected four active drill rigs and 1 abandoned site. 	<ul style="list-style-type: none"> ○ Bear: None
<ul style="list-style-type: none"> ○ Partial: 	<ul style="list-style-type: none"> ○ Caribou: None
<ul style="list-style-type: none"> ○ Follow-up: 	<ul style="list-style-type: none"> ○ Moose: None
<ul style="list-style-type: none"> ○ Response to Public Complaint: 	<ul style="list-style-type: none"> ○ Waterfowl: One loon of unknown species observed while flying.
<ul style="list-style-type: none"> ■ Weather Conditions: 	<ul style="list-style-type: none"> ○ Fish: None
<ul style="list-style-type: none"> ○ Temperature: Approximately 25° F 	<ul style="list-style-type: none"> ○ Other: Red fox ran by us at Rig #6 location

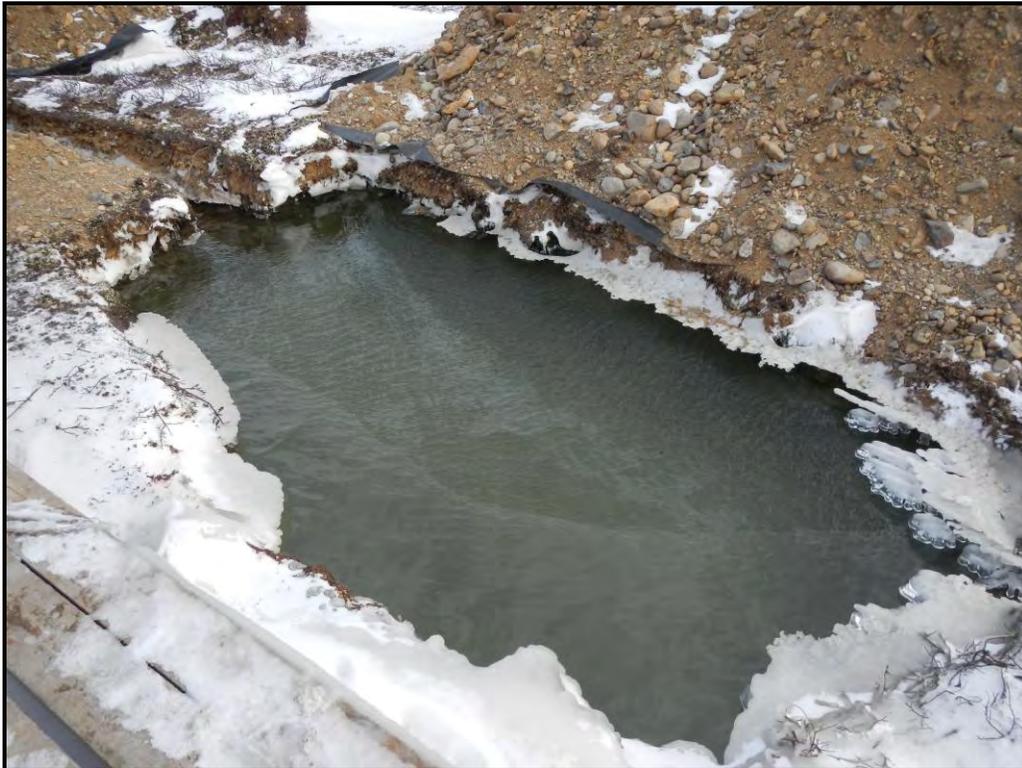
Figure 4. Sump pit three at Drill Rig #3 on DDH-12551 with sheen on water (PLP indicated that the sheen is likely from linseed oil).

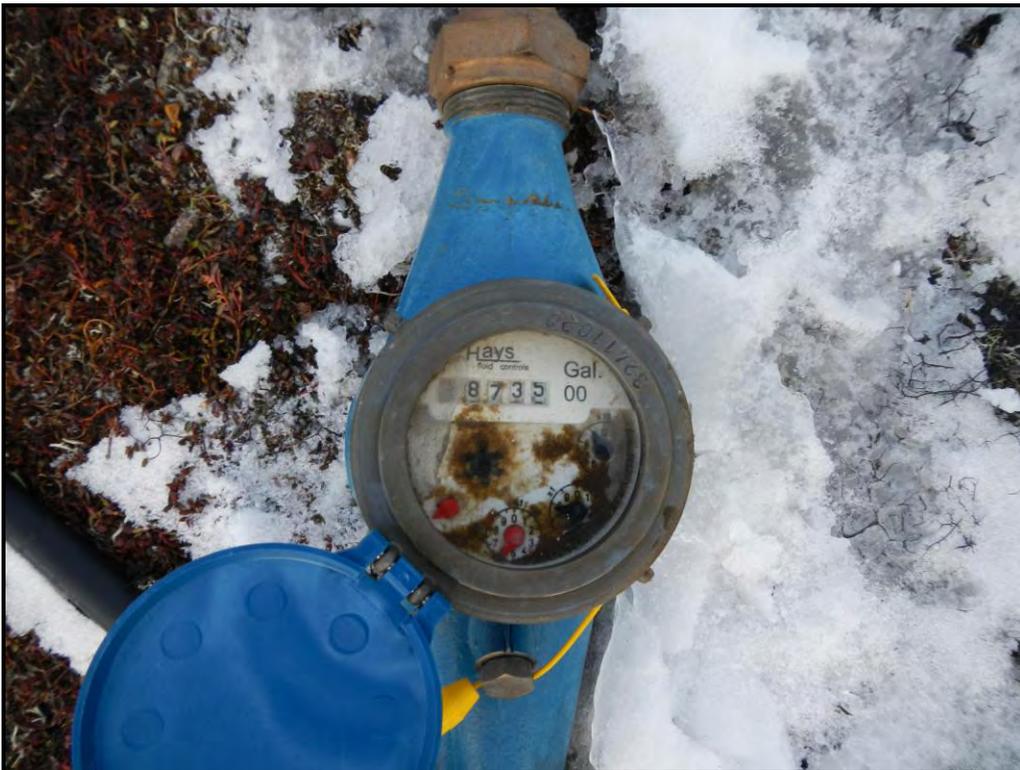
Figure 6. Totalizer connected to water intake line for Drill Rig #3 on DDH-12551 – totalizer was broken or frozen and consequently water withdrawal rate was not estimated.

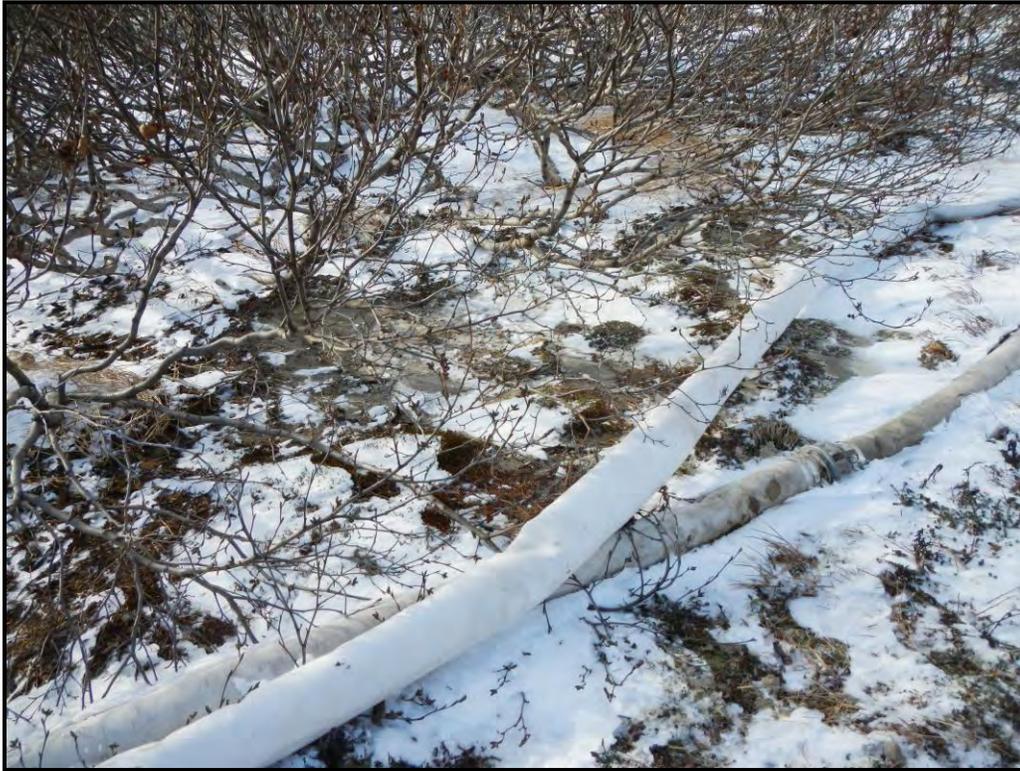
Figure 12. Discharge hose with leaky connections at Drill Rig #2.

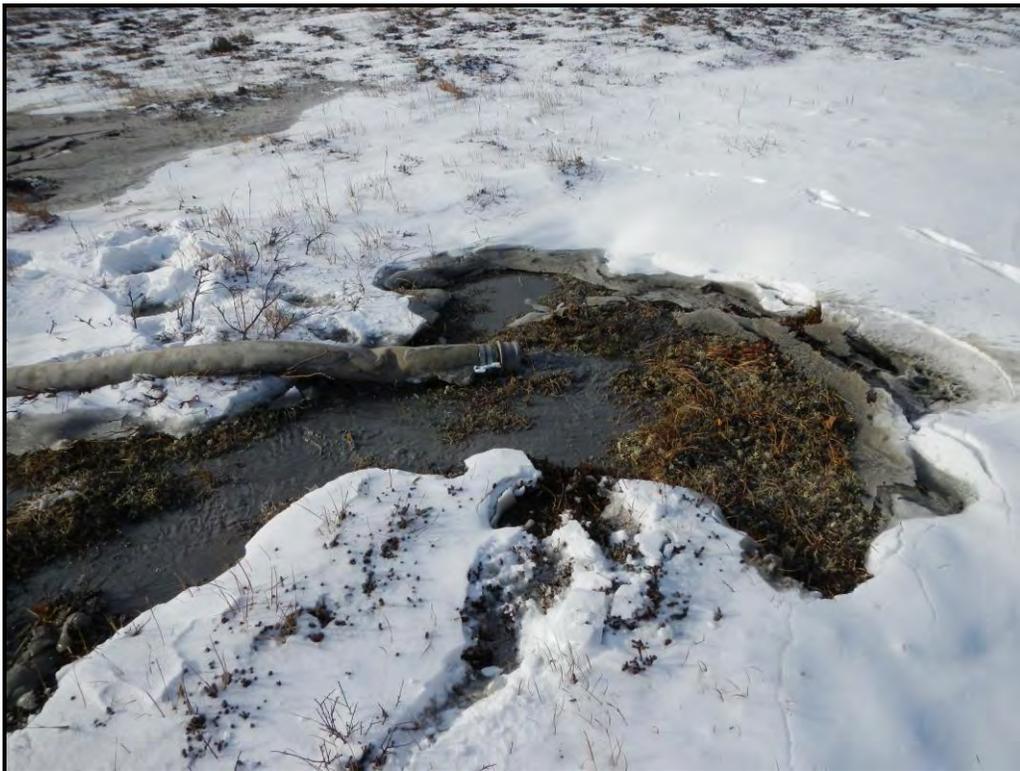
Figure 13. Discharge from drilling sumps to tundra at Drill Rig #2 (~200 feet south of rig).

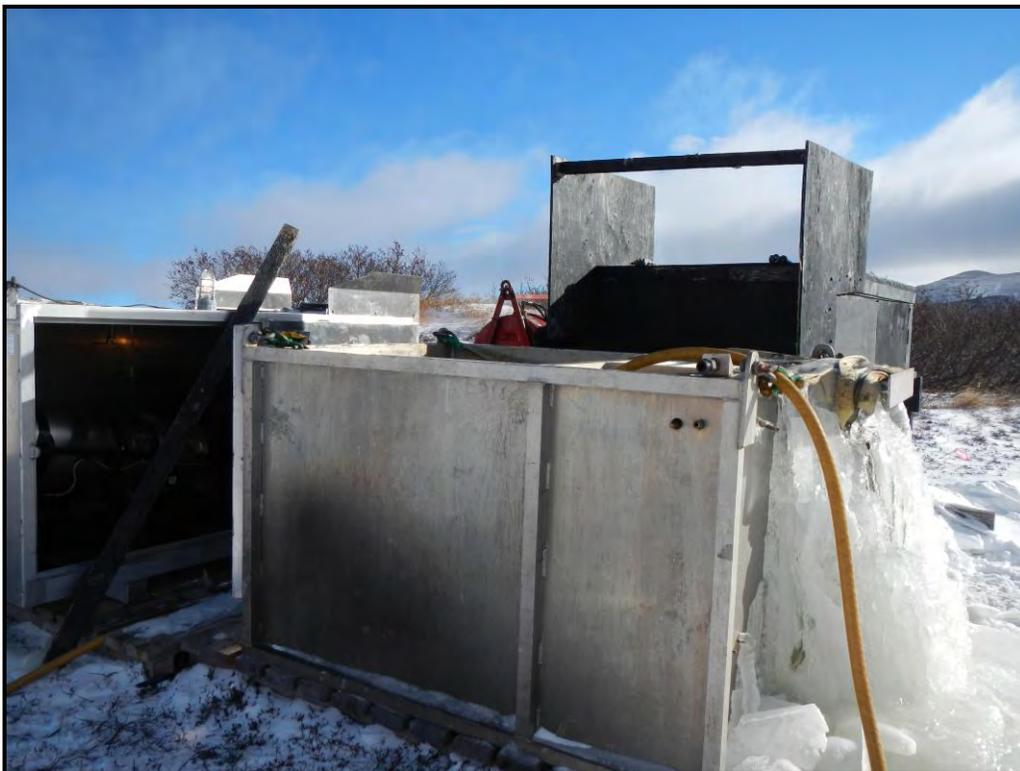
○ Water discharged: Into sumps and then pumped and discharged to tundra approx. 200' south of rig	○ Pump/fuel location to water source: exactly 100' to fuel tank and containment; water heater and generator are located 87 to 95 feet from water source)
○ Artesian zone encountered: None	○ Catch basin for fuel supply: Yes, dbl-wall tank
○ Sump Pit: Yes, three	○ Sorbent pads: Present
Location: ~40 ft. east of drill rig	○ Hose color: Yellow
■ Discharge trench: Adjacent	■ Other Comments: Identification signage missing from water withdrawal source – we found a sign at fuel and generator location, but for a different site (#DDH-12556).
○ Dimensions of pit: 3 pits ~4'x20'	
○ In use: Yes

Figure 15. Water withdrawal equipment (water heater, fuel tank, generator, and water tank) for Drill Rig #2 – water withdrawal source is behind the photographer. Note: fuel tank (in secondary containment) is exactly 100 feet from water source, with heater and generator closer (95 to 87 feet from water) and within 100 foot buffer for surface water (gas fueled generator is directly on tundra mat/not in secondary containment basin).

- Ensure crews are establishing fuel and fueled equipment at least or greater than 100 feet from water sources.
- Protect or cover tundra mat stockpiles at sites where high winds are possible.
- Keep Ice Melt off of the tundra (possibly place Visqueen under/around rig mats when using Ice Melt and the tundra is frozen/dormant).
- Keep loose items and trash contained, especially in high winds.

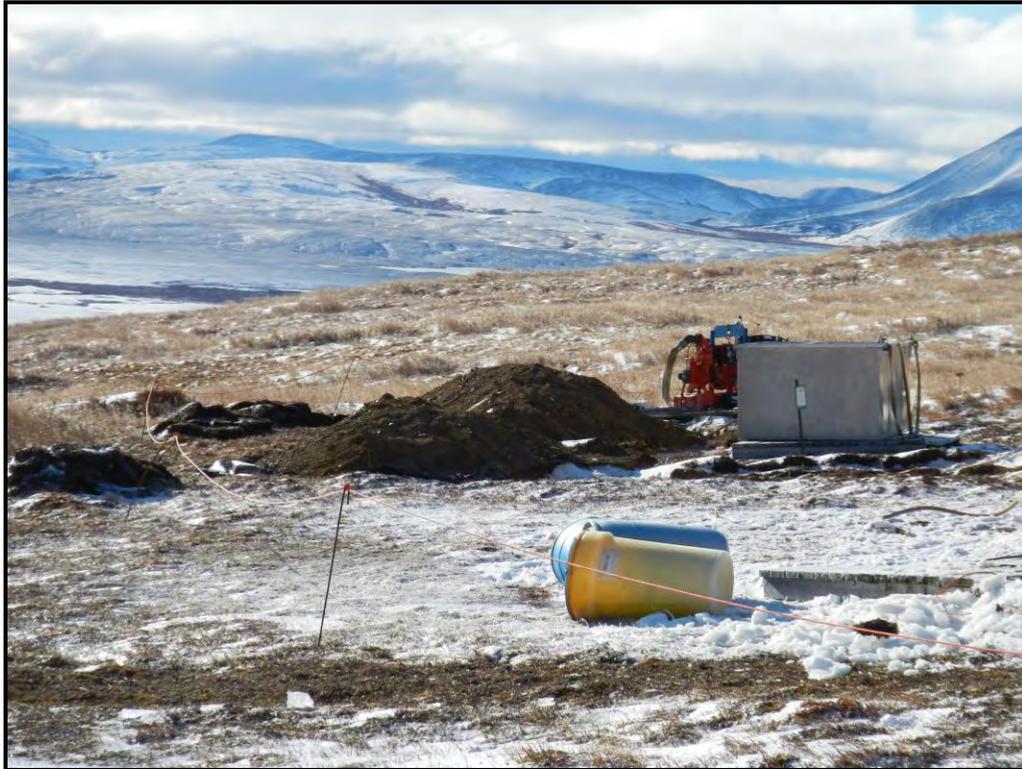
Drill Hole/Site No.: DDH-12560	Rig No.: 6 (Quest)
Activity: Drilling Current Depth: 918' Initial Target Depth: 2000'	Date: 10/17/2012 Time: 1255-1325
<ul style="list-style-type: none"> ■ Condition of Drilling Site: Generally well-kept and tidy, some loose items/trash on tundra around site 	<ul style="list-style-type: none"> ■ Sump Pit (continued):
<ul style="list-style-type: none"> ○ Distance from waterbody: no water bodies in site – water withdrawal source approx. 4,000 feet away, over a ridge to the west 	<ul style="list-style-type: none"> ○ Location and extent of discharged material: Sump pits located south of drill; discharged via hose and pump ~200' south of rig to tundra
<ul style="list-style-type: none"> ○ Location of fuel storage: Adjacent to rig and adjacent to generator near water withdrawal location – both in secondary containment 	<ul style="list-style-type: none"> ○ Topsoil, muck, tundra stockpiled: Yes, tundra vegetation mats frozen in piles above ground – some of the mats were loose and overturned by the wind (scattered from initial piles)

Figure 19. Sumps and stockpiled soils at Drill Rig #6 on DDH-12560 (view to the south).

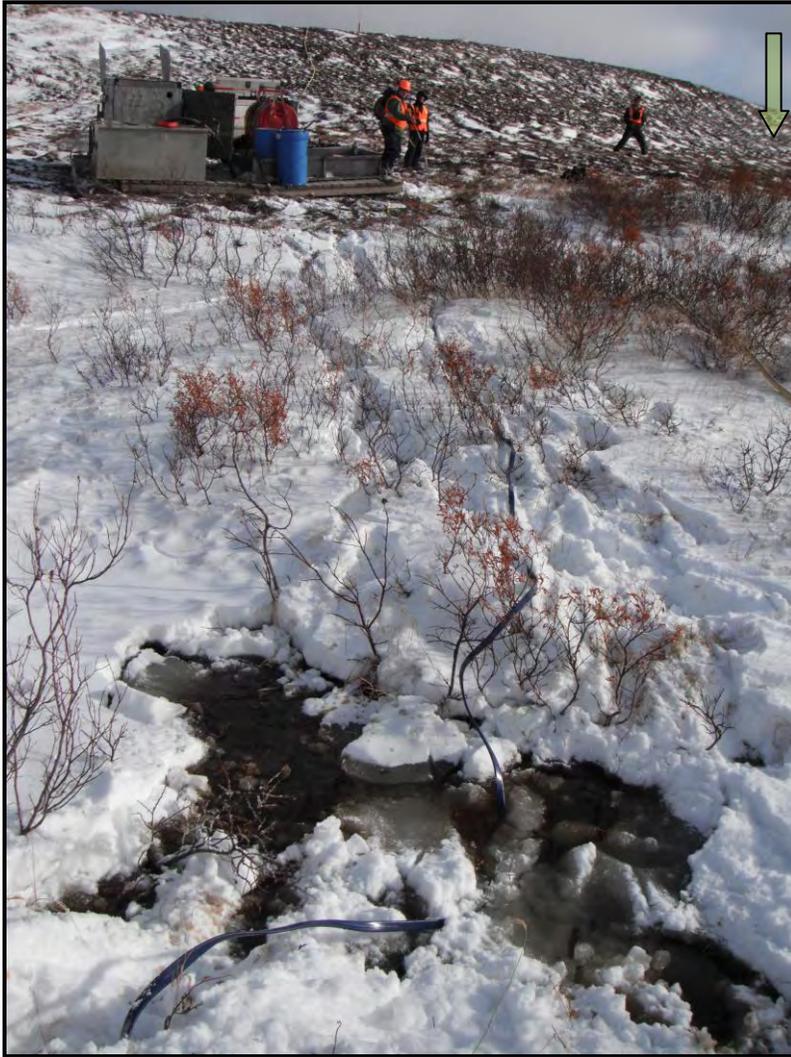
○ Artesian zone encountered: None	○ Catch basin for fuel supply: Yes, dbl-wall tank
○ Sump Pit: Yes, one	○ Sorbent pads: Present
Location: Adjacent to drill rig	○ Hose color: Yellow
■ Discharge trench: Adjacent – leads to sump	■ Other Comments: Drill rig crew had initially set-up fuel, generator, and water heater system within 100 feet (i.e. 66') of water withdrawal source, but worked to move it the proper distance away after this was pointed out to them.
○ Dimensions of pit: 1 pit ~5'x10'	
○ In use: Not yet

Figure 31. Fuel and generator for Drill Rig #5 water withdrawal being set-up 66 feet from surface water – after this was pointed out to PLP, the crews began moving set-up >100 feet from water near green arrow in picture.

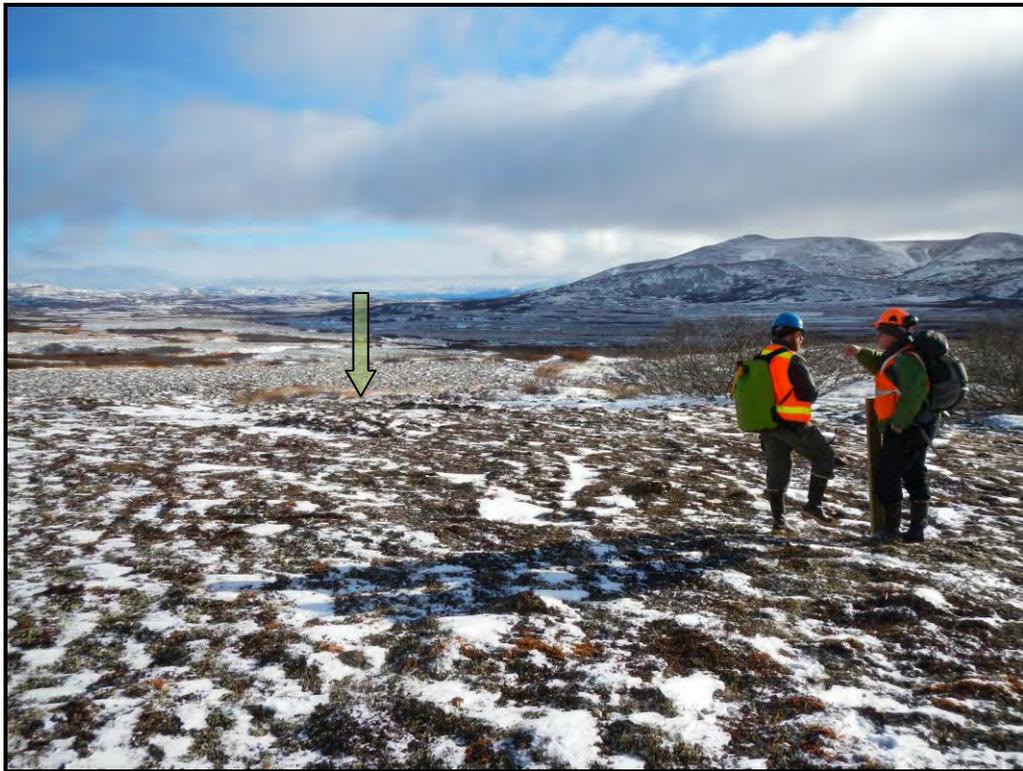
Abandoned Drill Hole/Site No.: DDH12544	Date: 10/17/2012
<ul style="list-style-type: none"> ■ Plugged: Not observed ■ Cemented: Not observed ■ Standing pipe: Casing not visible ■ Sump pit filled in: Yes ■ Water discharge trench filled in: Yes ■ Site revegetated: Unable to determine sufficiently with dormant plants and partial snow cover, but overall impression was that the site looked pretty good and is likely to revegetate. ■ Artesian water present: None ■ Any spills or staining: None visible – most of ground covered in snow. ■ Comments/General impression: Mounds of soil are the main indicator of past drill activity at this site, but do not appear unnatural in present condition. Site was reclaimed six to eight weeks earlier according to J. Norberg.

Figure 32. Reclamation site for abandoned drill hole DDH125544 on October 17, 2012 – the location of the drill hole is between the two people in the picture and the location of an old sump is indicated by the green arrow.

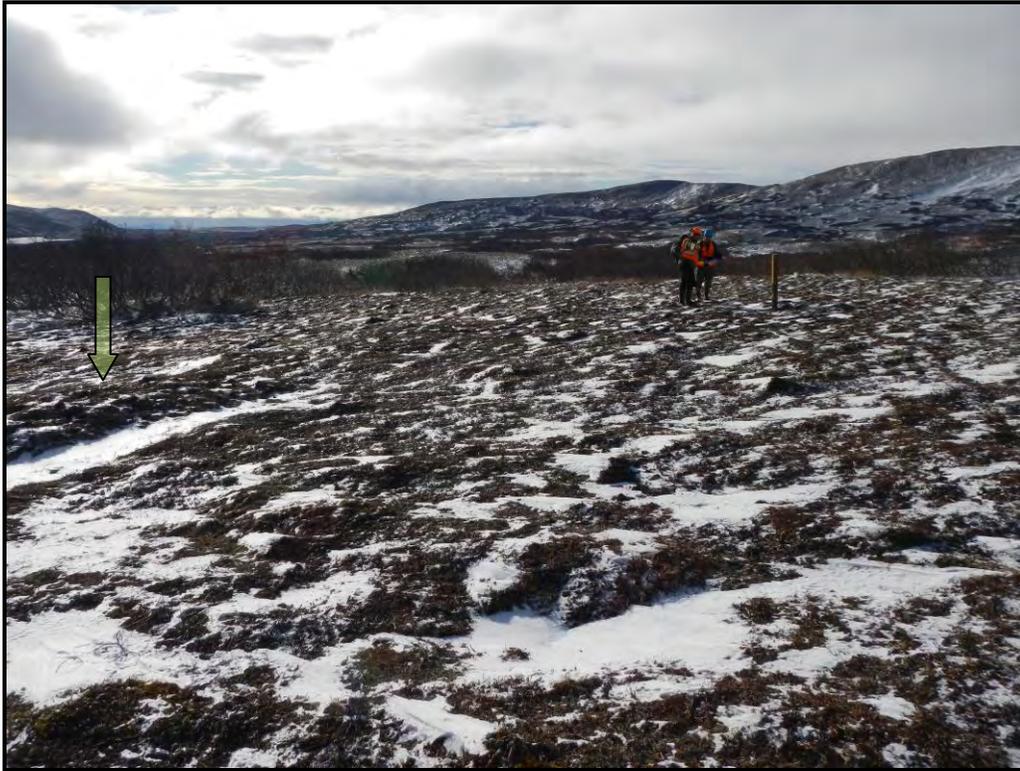
Figure 33. Reclamation site for abandoned drill hole DDH125544 on October 17, 2012 – the location of the drill hole is just right (at post) of the two people in the picture and the location of an old sump is indicated by the green arrow.

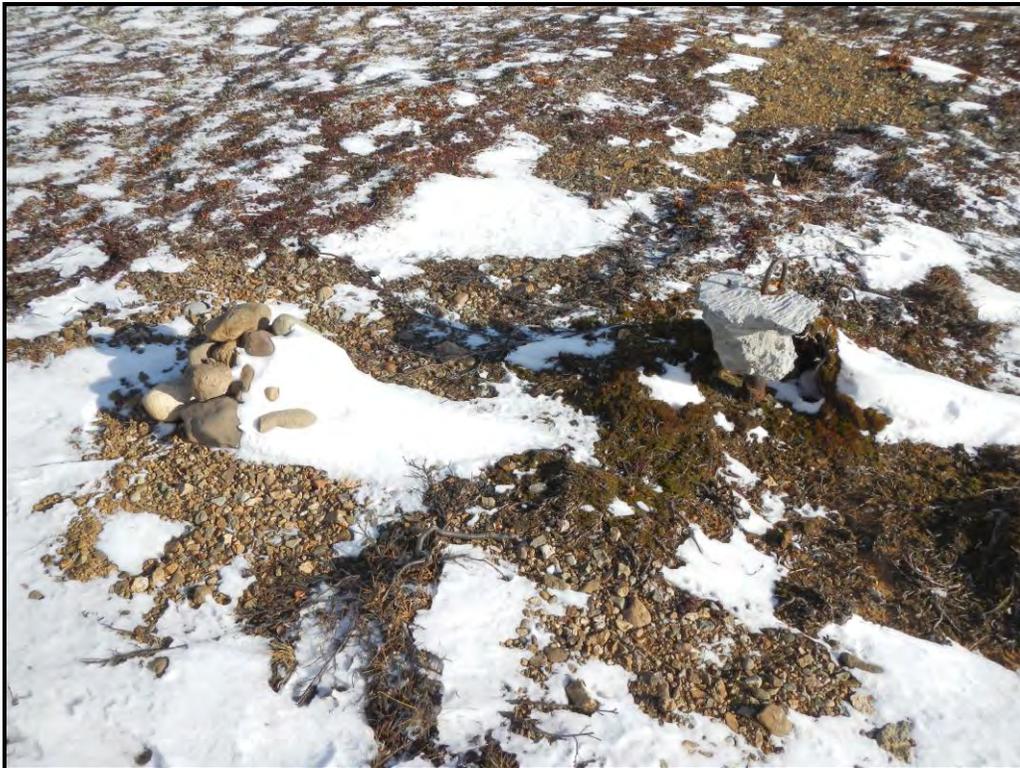
Figure 34. Remnants of an old monitoring well adjacent to abandoned drill hole DDH125544 on October 17, 2012 – metal pipe and concrete above tundra.
