2011 Annual Reclamation Report

The Pebble Project

Iliamna, Alaska

Prepared by: JBN Consultants, Inc.
Eagle River, Alaska

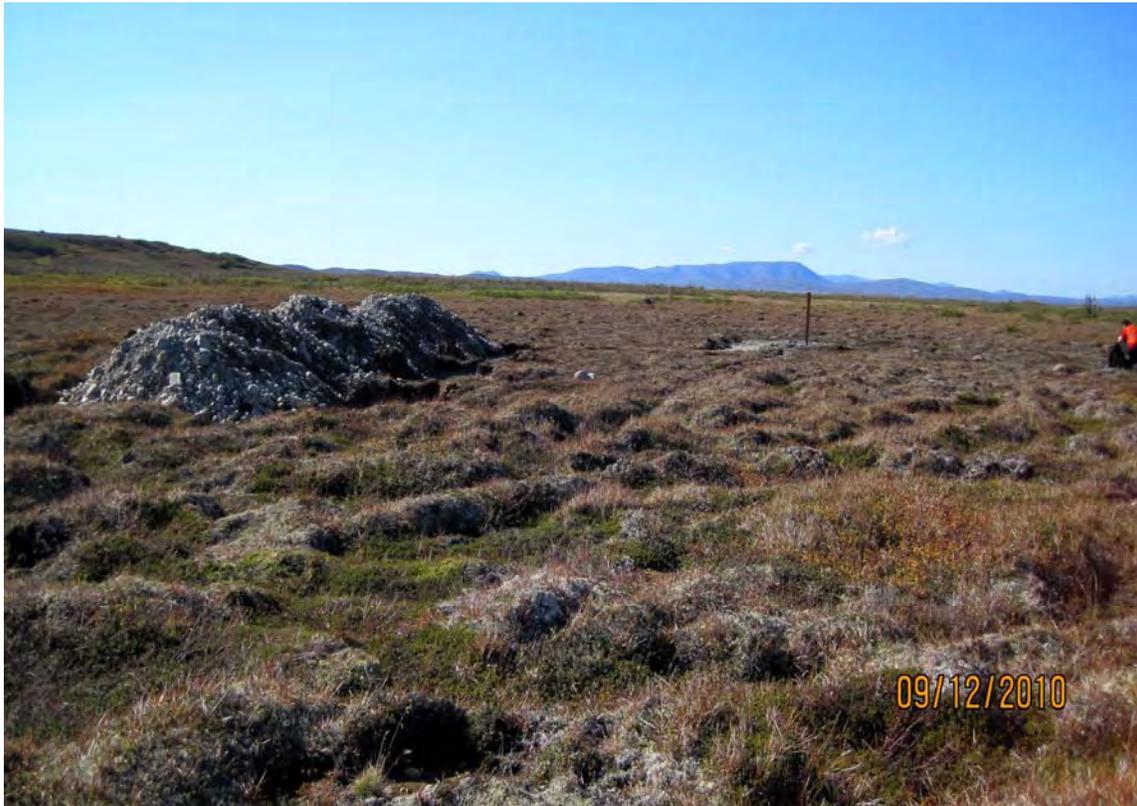
Photo 1: DDH 10507 – Drilled 2010 / Reclaimed 2011; Photo Taken Post Drilling on 12 September 2010; Looking West.

Eleven diamond core boreholes remaining from the 2010 field season were reclaimed during 2011 (i.e., DDH 10504, 10506, 10507, 10511, 10512, 10513, 10515, 10517, 10518, 10520, and 10525).

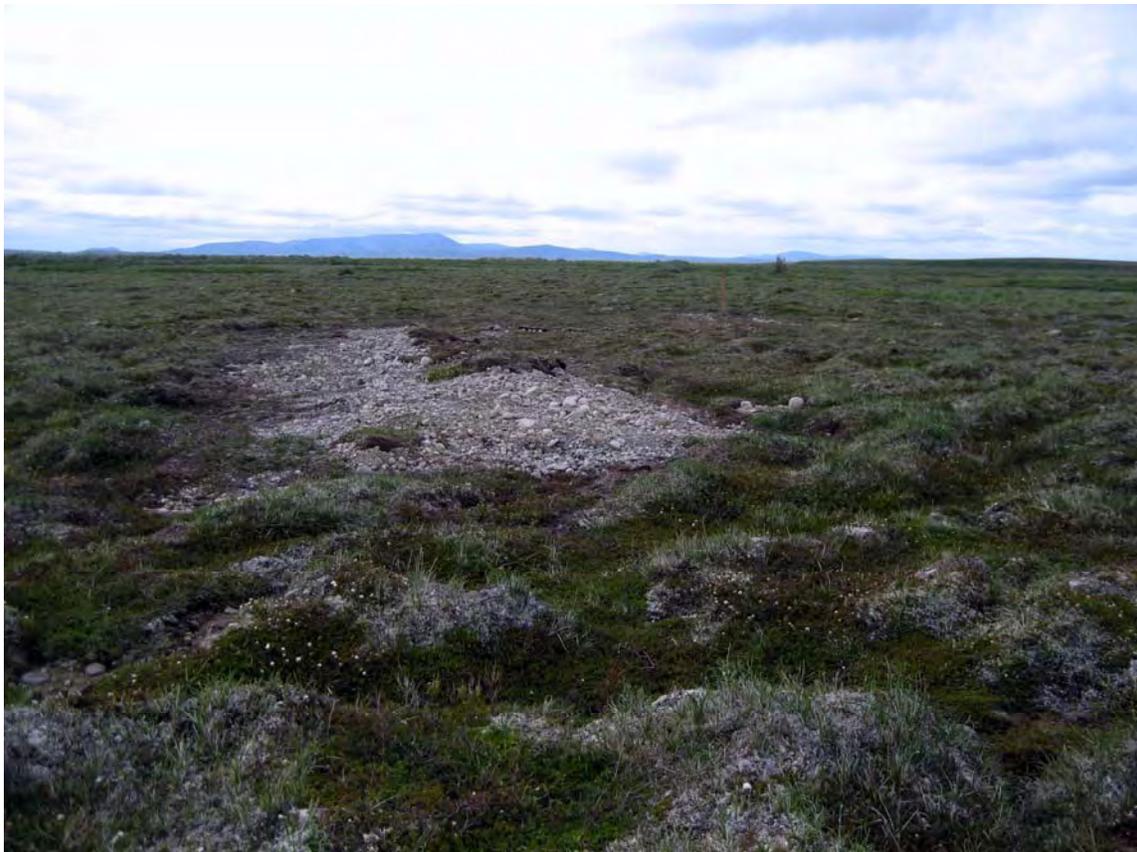
Photo 2: DDH 10507 – Photo Taken Post Reclamation on 8 July 2011; See Photo 1 for Reference; Looking West.

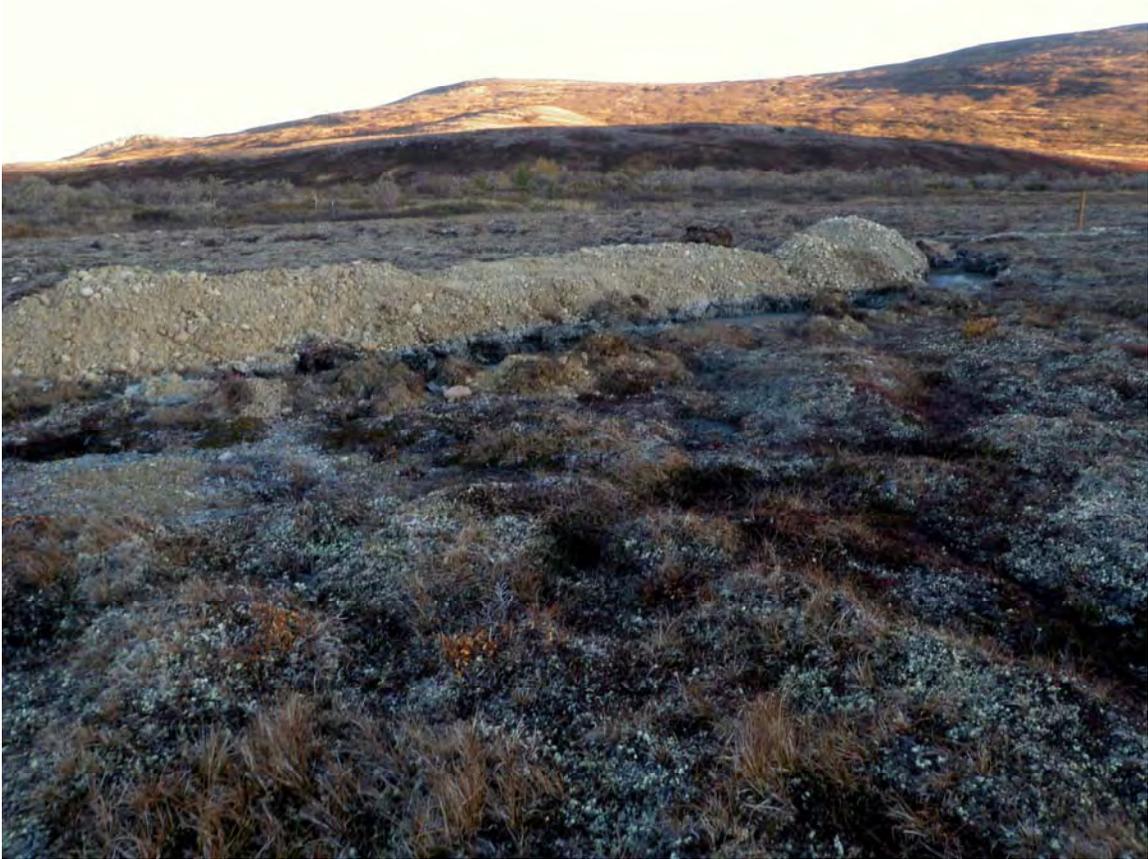
Photo 3: DDH 10511 – Drilled 2010 / Reclaimed 2011; Photo Taken Post Drilling on 27 September 2010; Looking North.

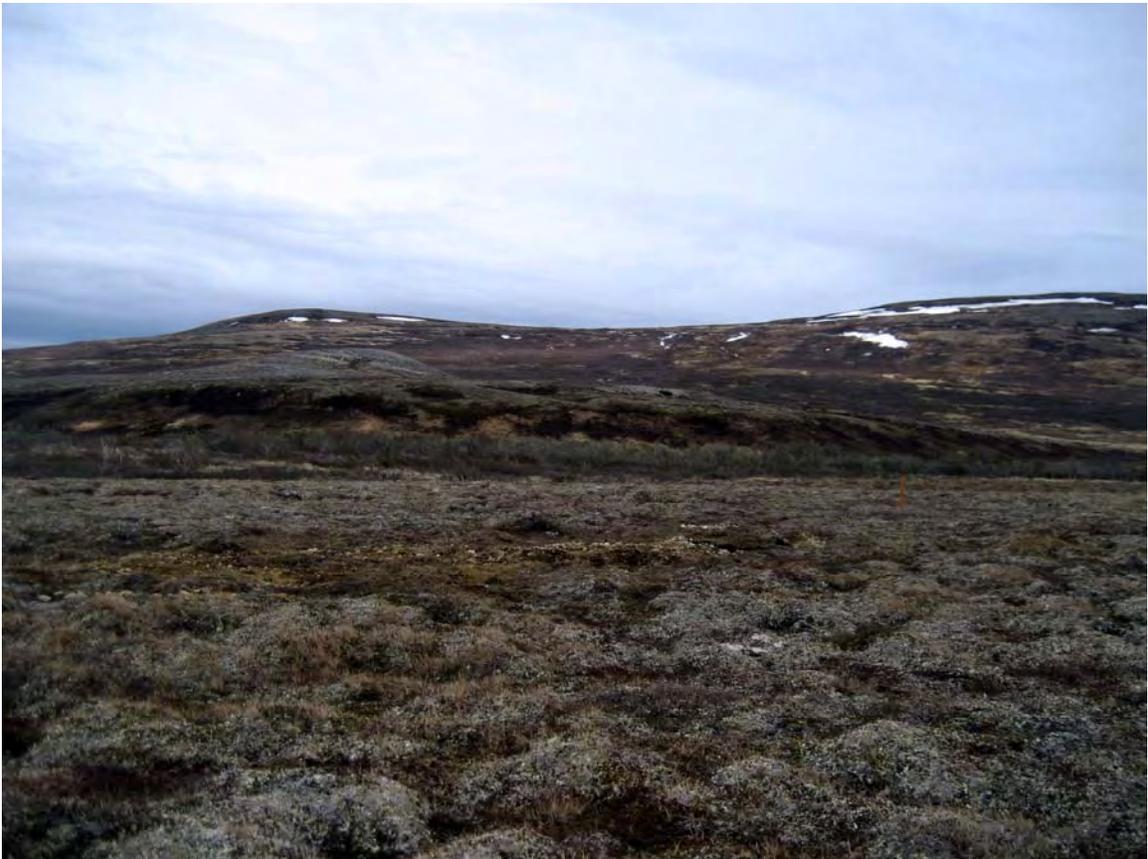
Photo 4: DDH 10511 – Photo Taken Post Reclamation on 29 May 2011; See Photo 3 for Reference; Looking North.

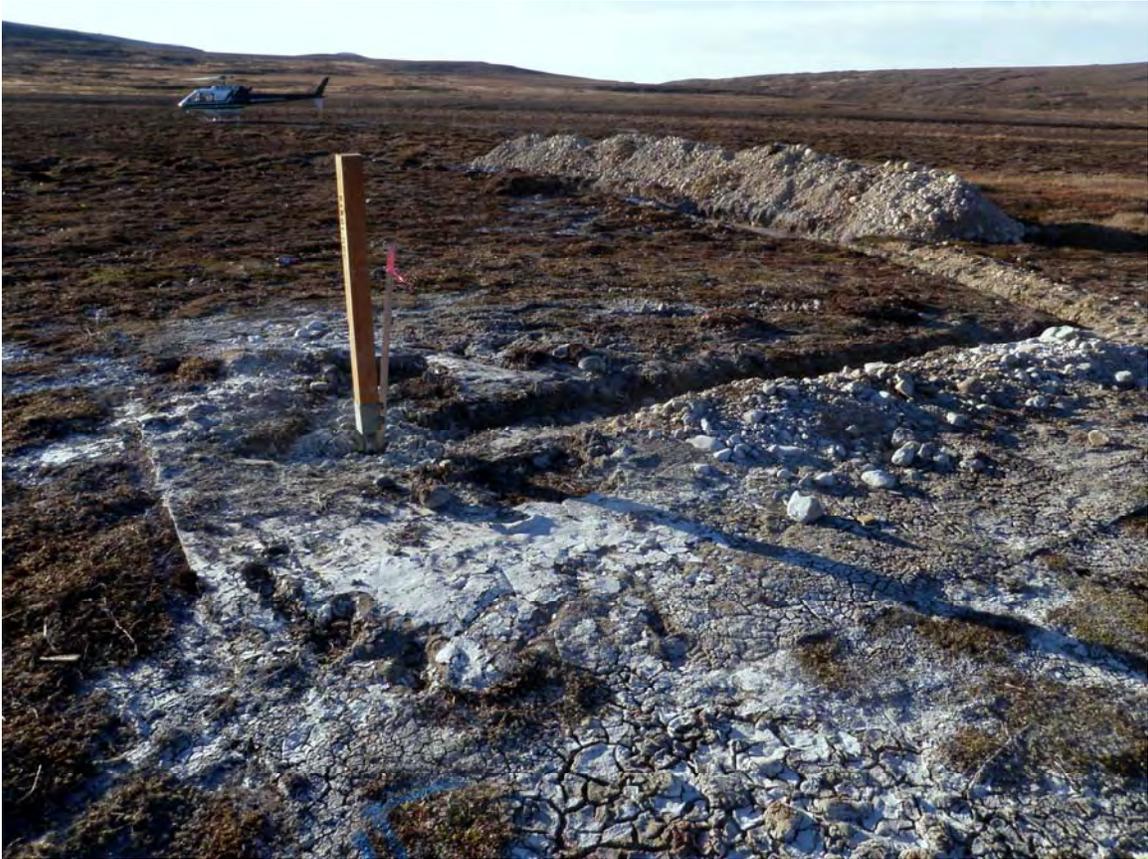
Photo 5: DDH 10513 – Drilled 2010 / Reclaimed 2011; Photo Taken Post Drilling on 27 September 2010; Looking South.

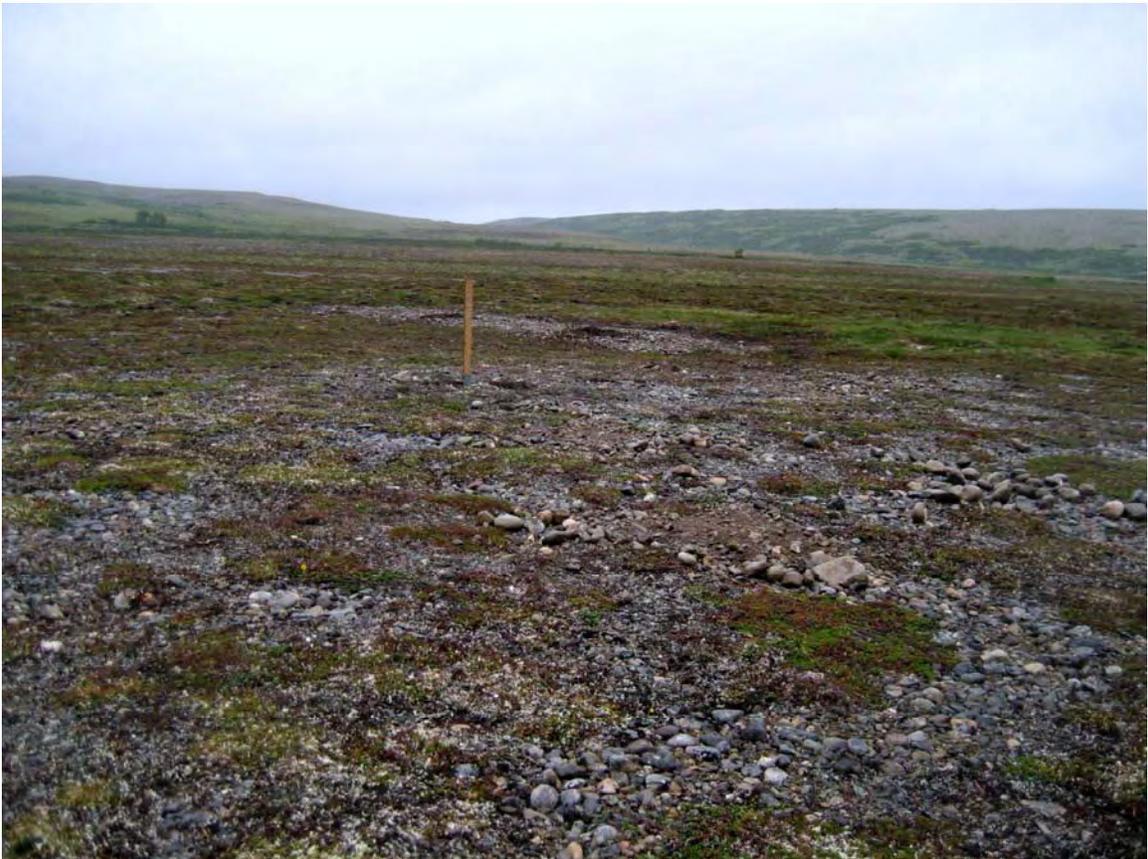
Photo 6: DDH 10513 – Photo Taken Post Reclamation on 9 July 2011; See Photo 5 for Reference; Looking South.

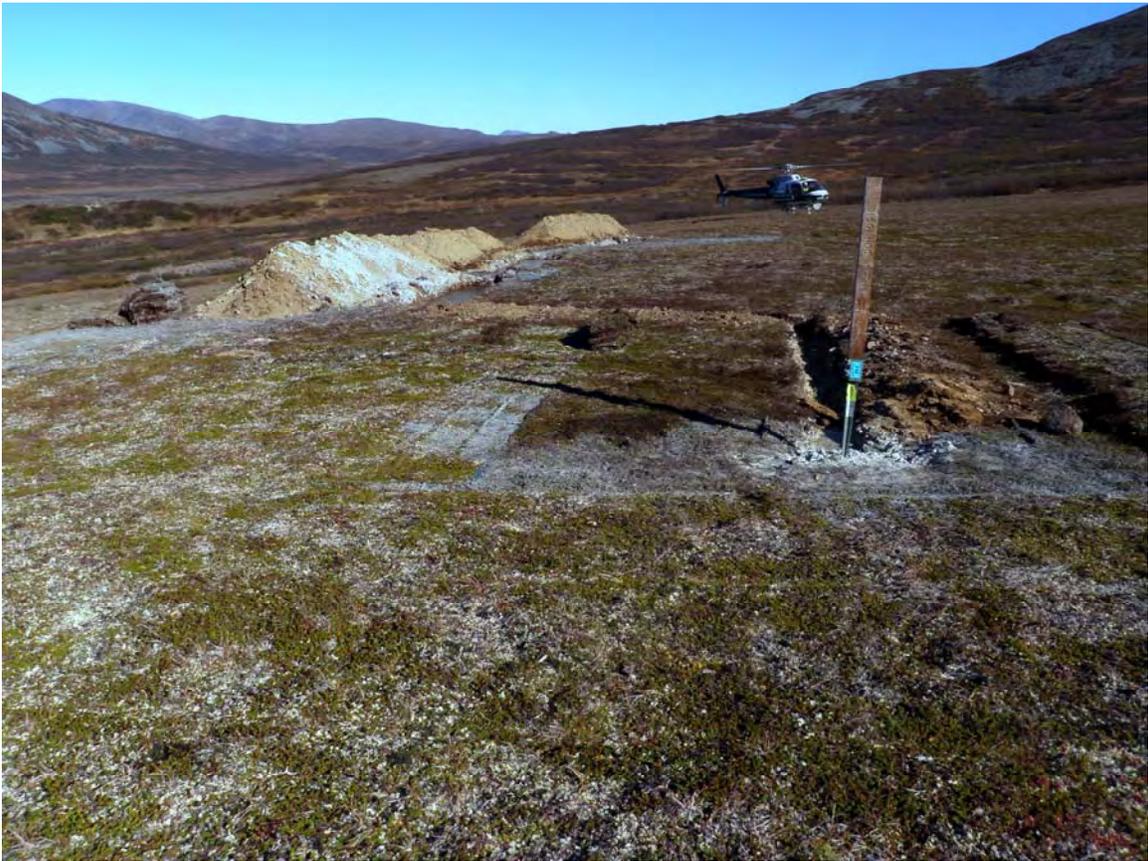
Photo 7: DDH 10515 – Drilled 2010 / Reclaimed 2011; Photo Taken Post Drilling on 27 September 2010; Looking East.

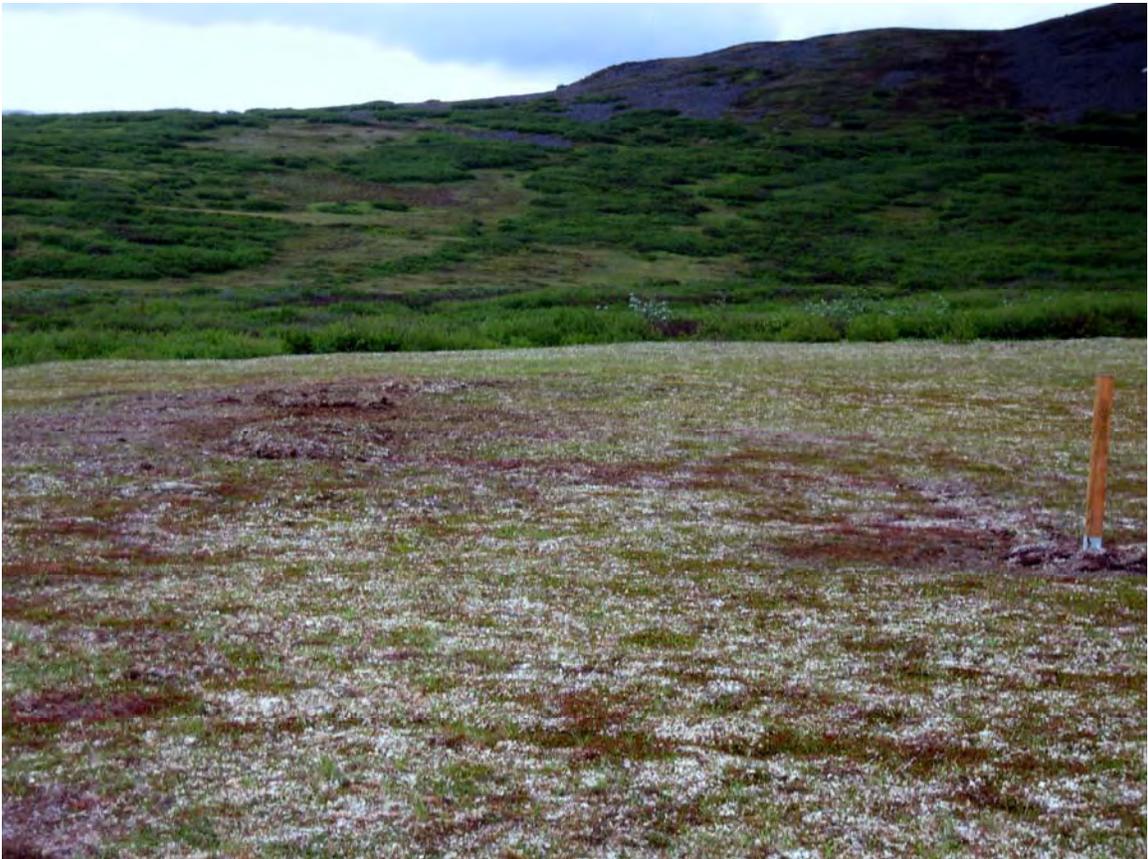
Photo 8: DDH 10515 – Photo Taken Post Reclamation on 29 June 2011; See Photo 7 for Reference; Looking East.

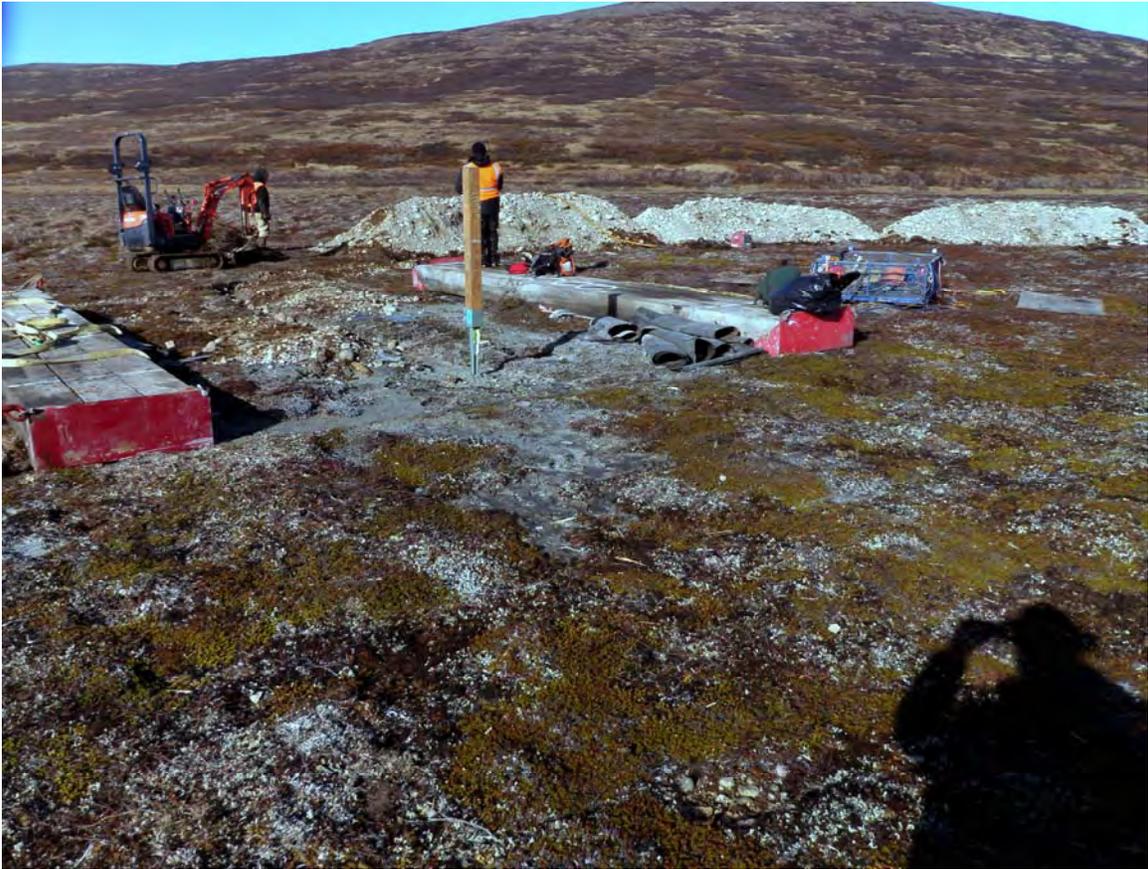
Photo 9: DDH 10517 – Drilled 2010 / Reclaimed 2011; Photo Taken Post Drilling on 5 October 2010; Looking North.

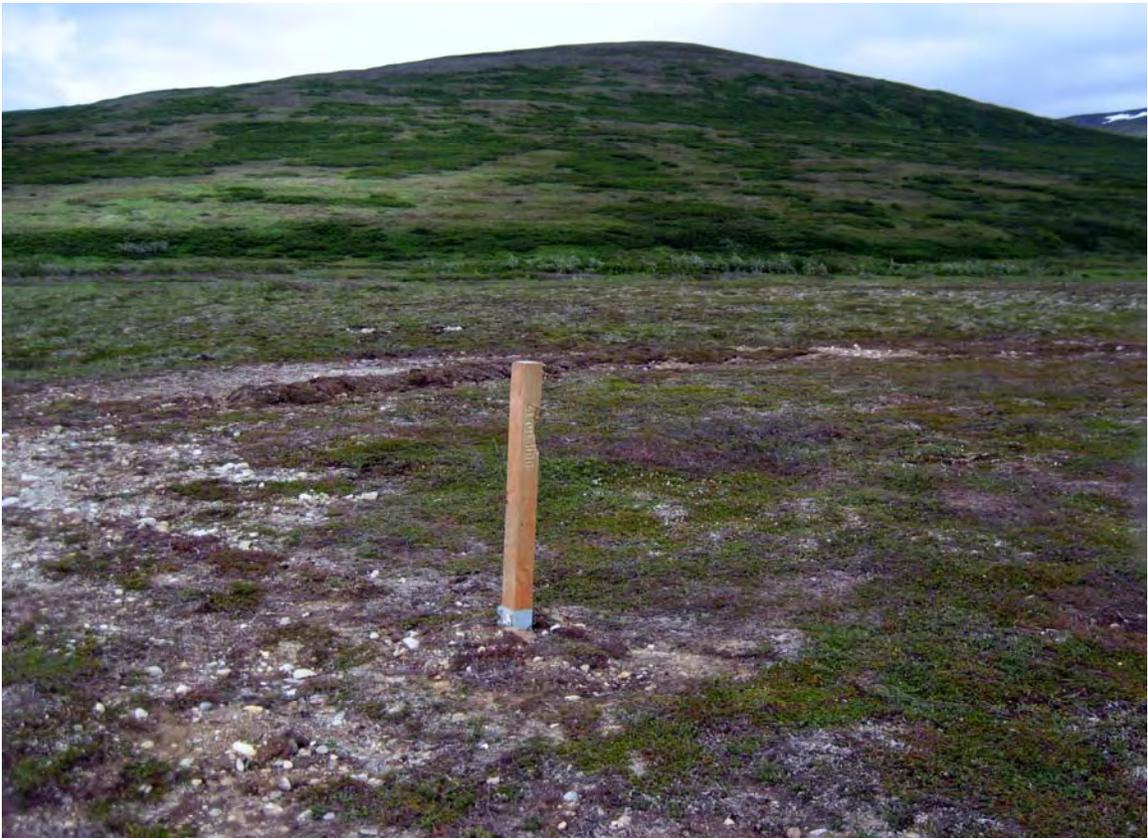
Photo 10: DDH 10517 – Photo Taken Post Reclamation on 8 July 2011; See Photo 9 for Reference; Looking North.

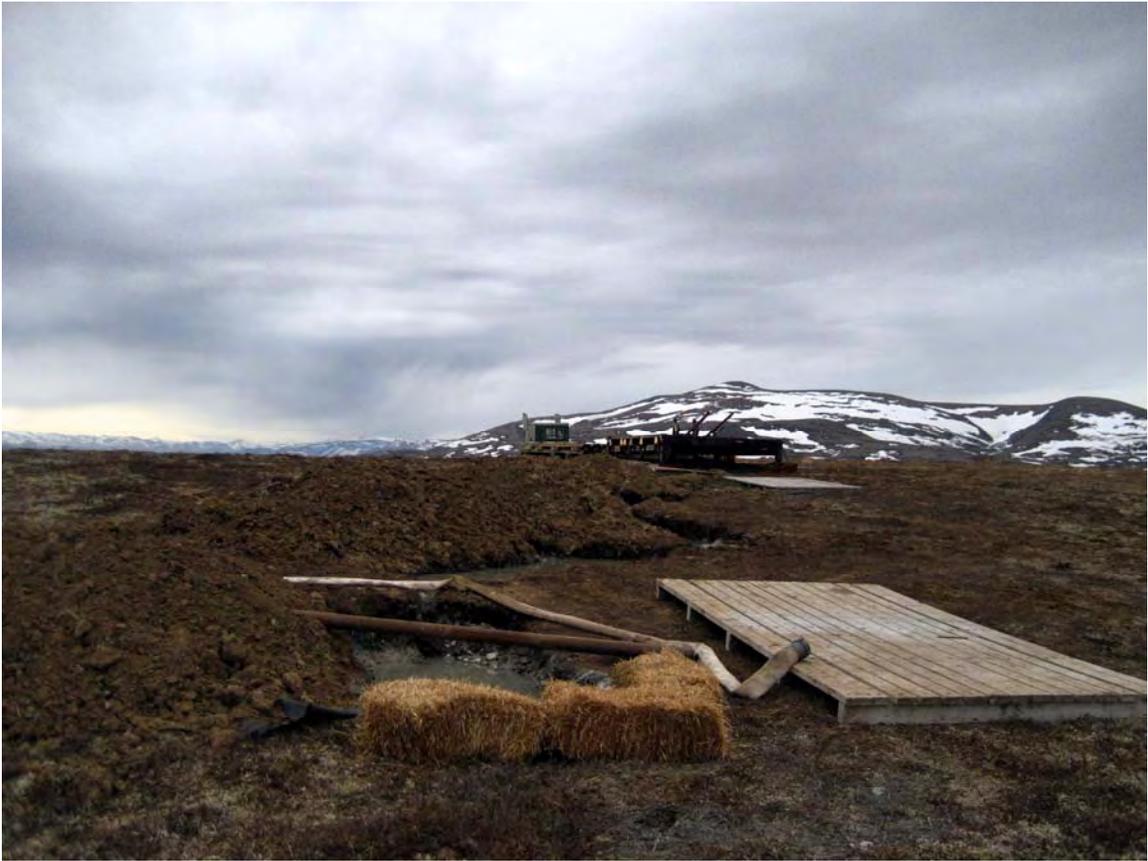
Photo 11: DDH 11526 & 11527 – Drilled / Reclaimed 2011; Photo Taken Post Drilling on 28 May 2011; Looking East.

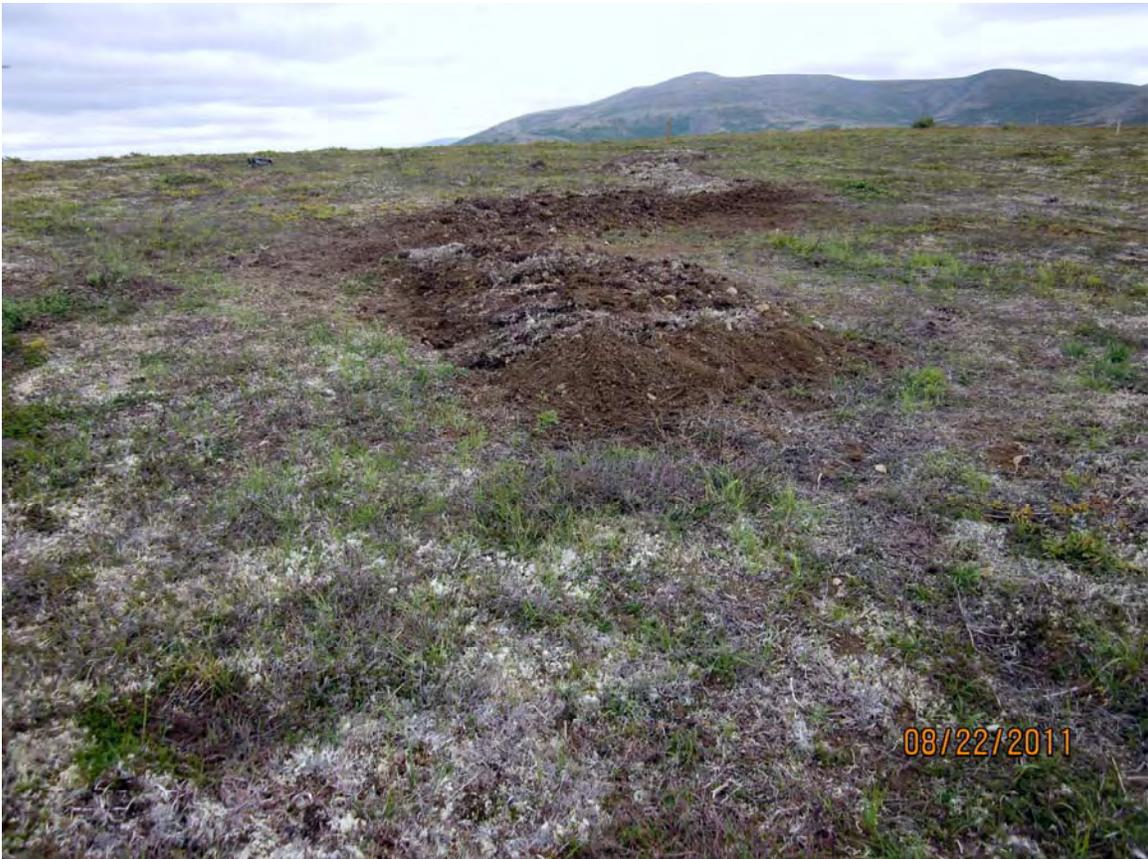
Photo 12: DDH 11526 & 11527 – Photo Taken Post Reclamation on 22 August 2011; See Photo 11 for Reference; Looking East.

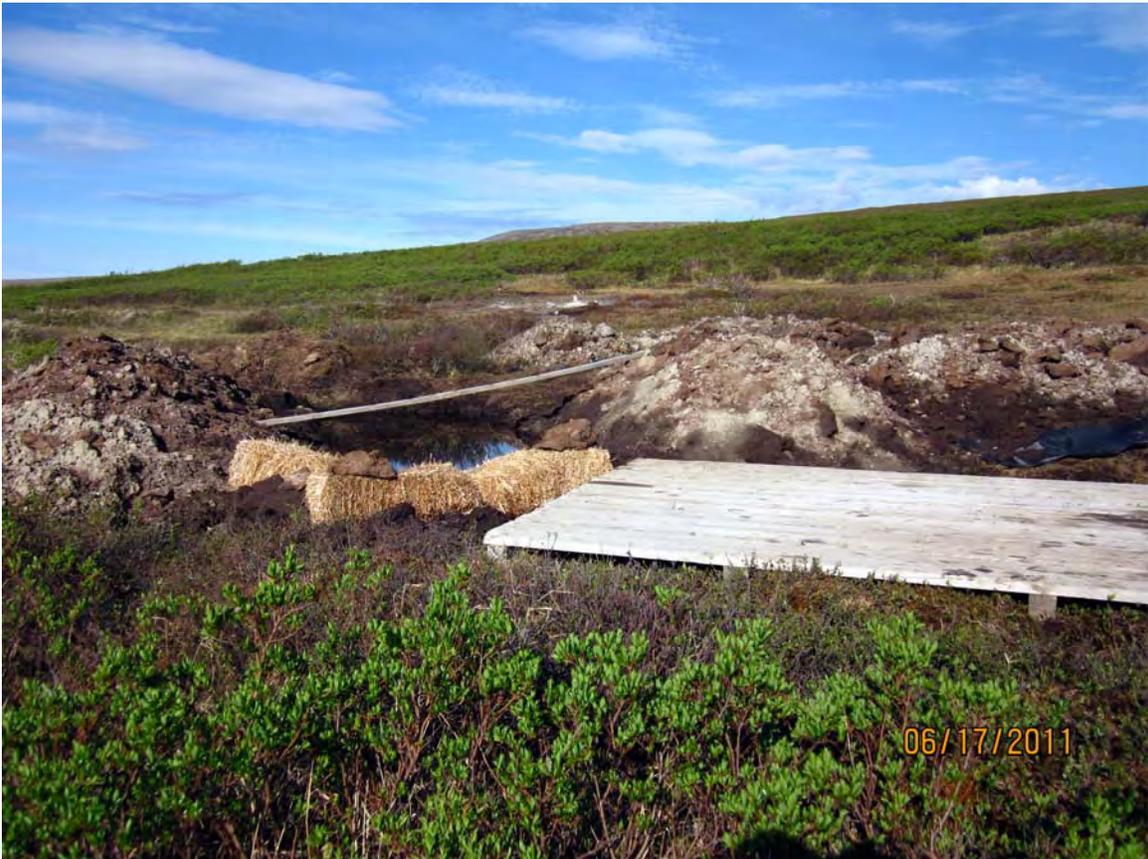
Photo 13: DDH 11528 – Drilled / Reclaimed 2011; Photo Taken Post Drilling on 17 June 2011; Looking West.

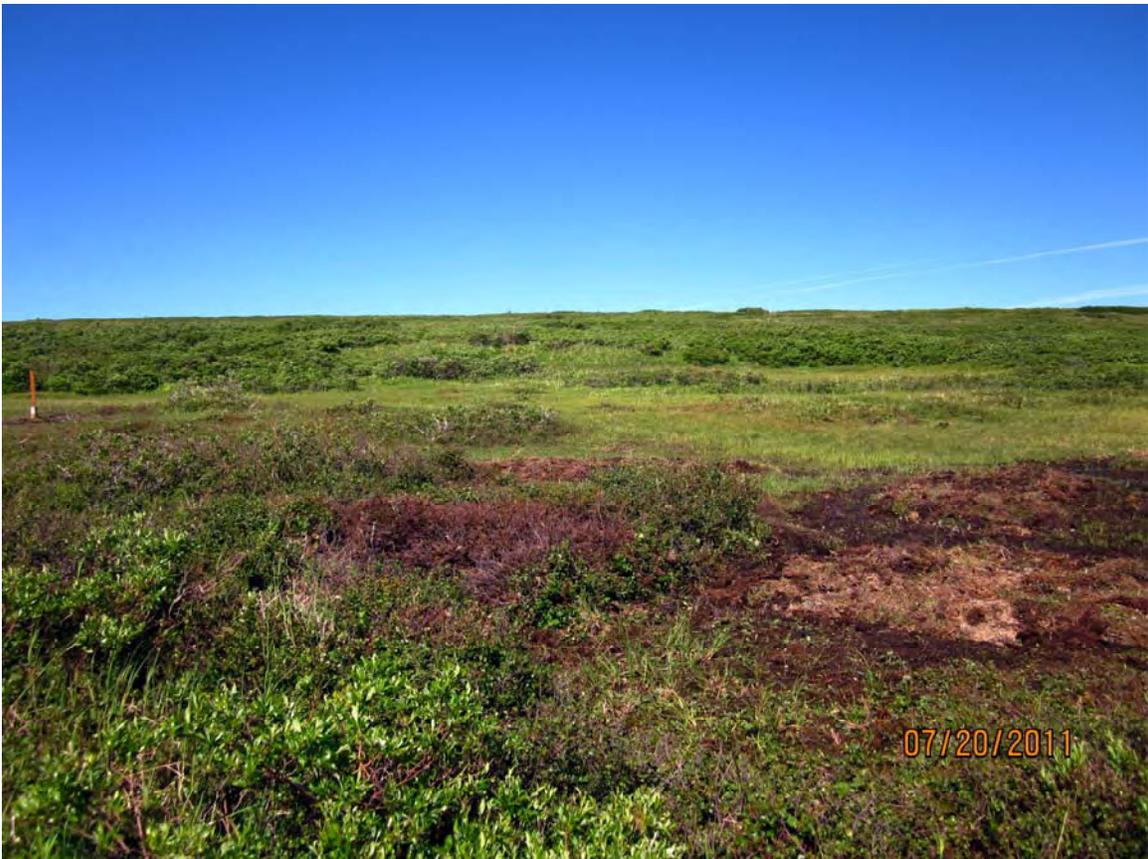
Photo 14: DDH 11528 – Photo Taken Post Reclamation on 20 July 2011; See Photo 13 for Reference; Looking West.

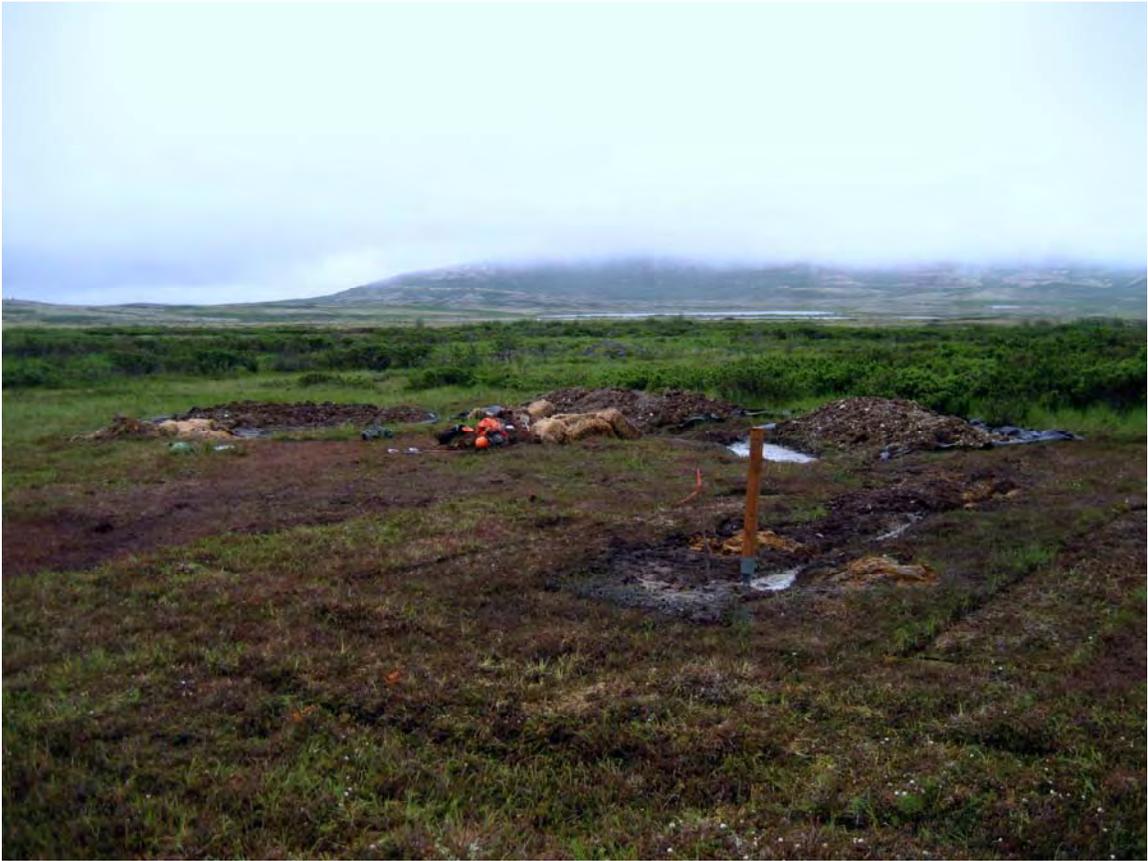
Photo 15: DDH 11529 – Drilled / Reclaimed 2011; Photo Taken Post Drilling on 4 July 2011; Looking East.

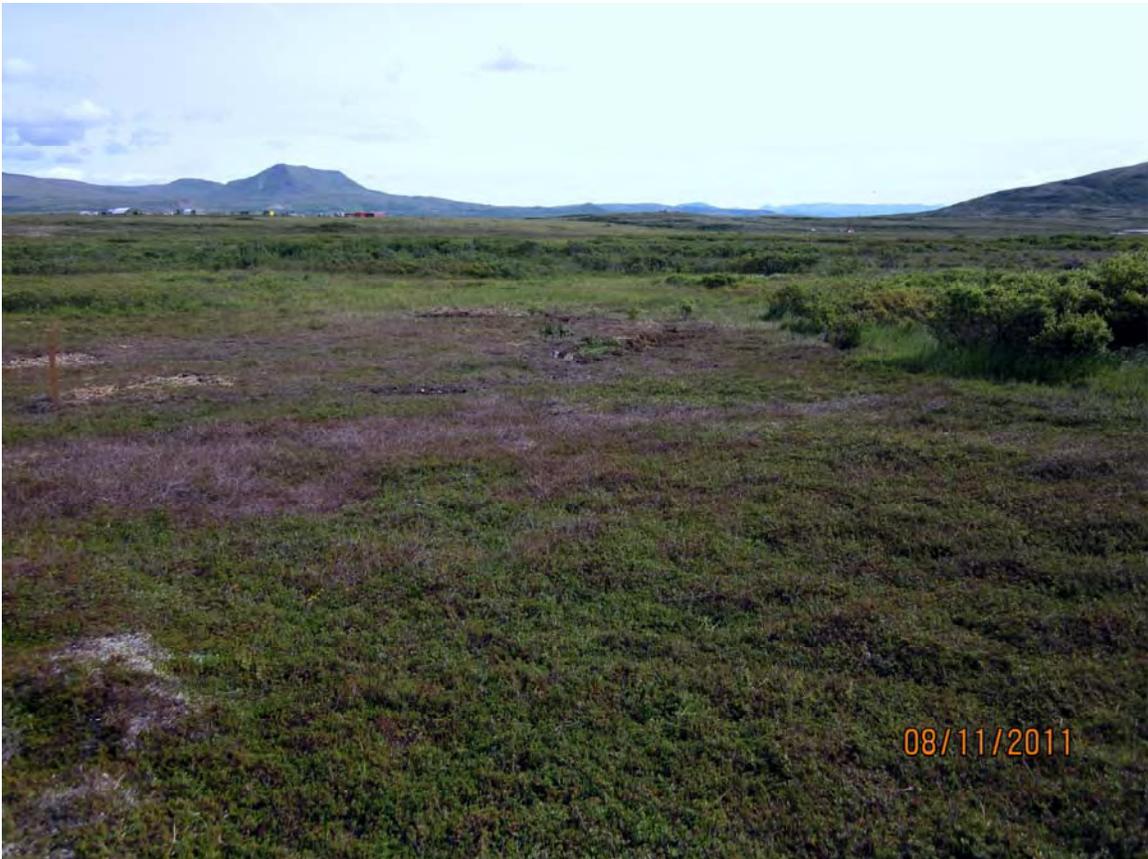
Photo 16: DDH 11529 – Photo Taken Post Reclamation on 11 August 2011; See Photo 15 for Reference; Looking East.

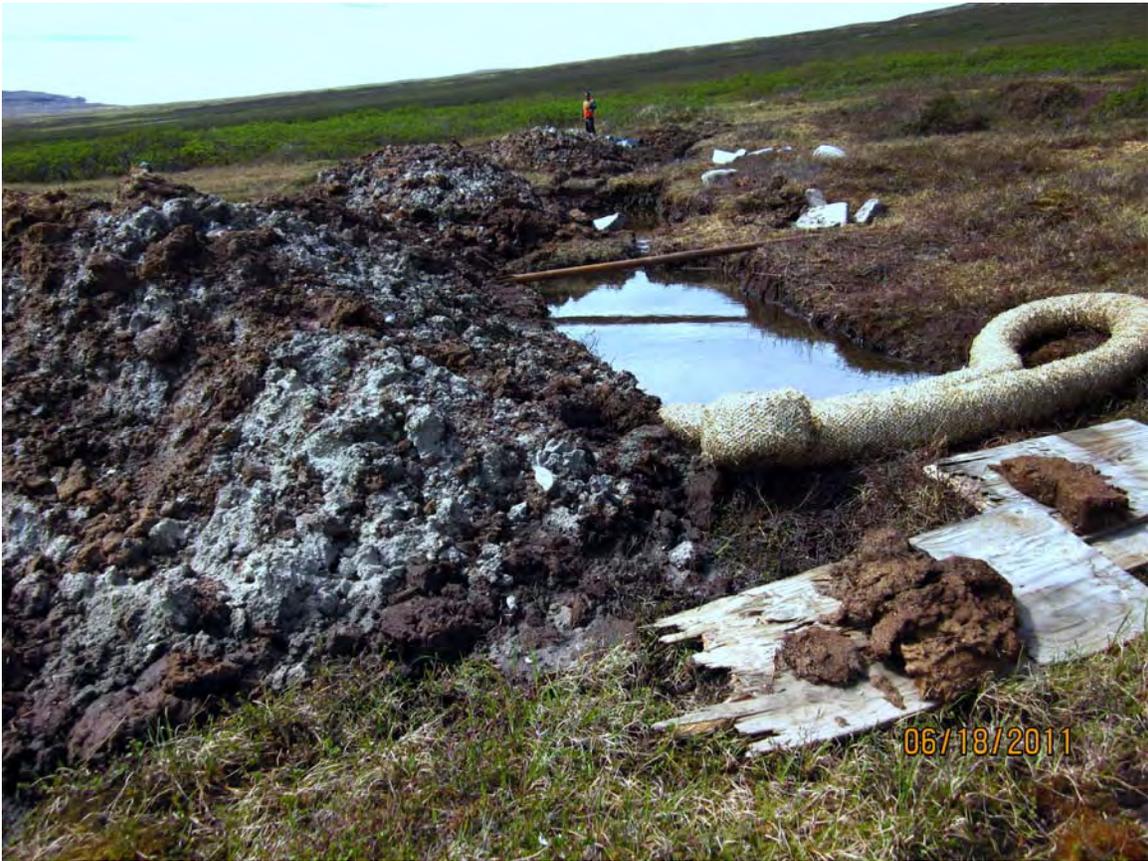
Photo 17: DDH 11530 – Drilled / Reclaimed 2011; Photo Taken Post Drilling on 18 June 2011; Looking West.

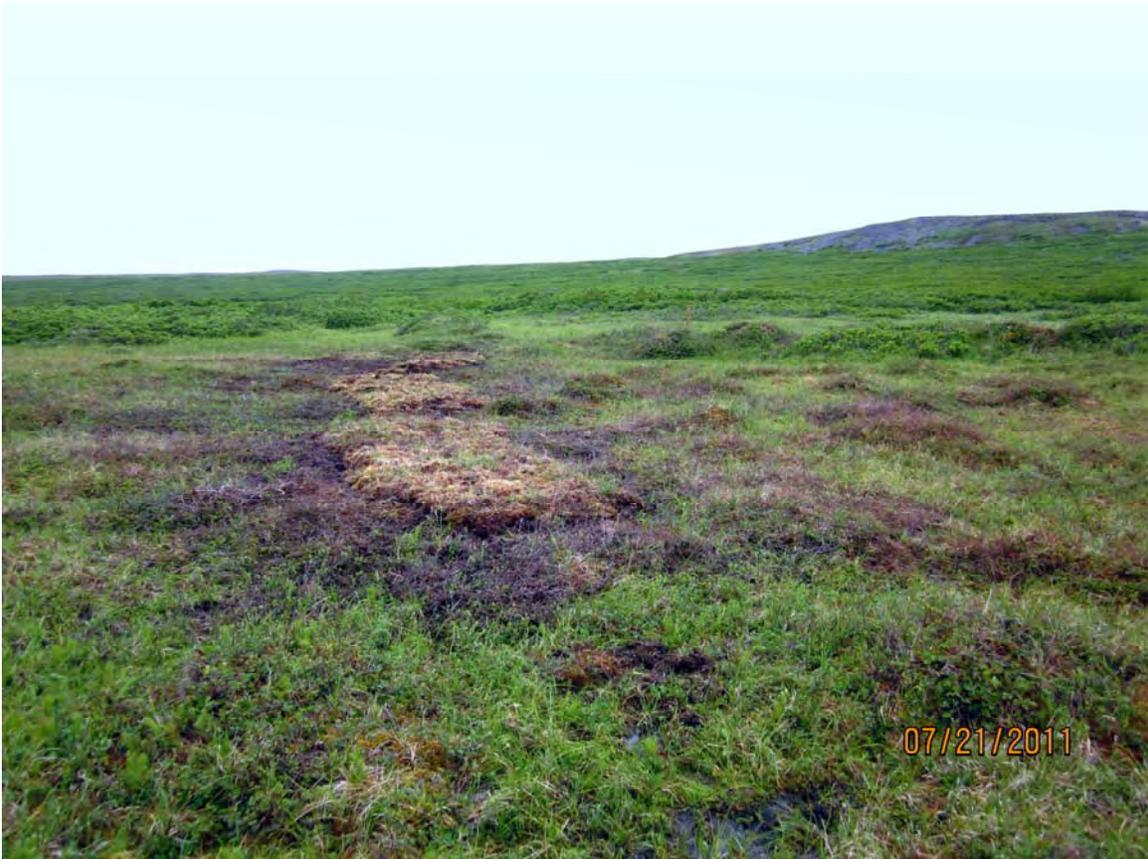
Photo 18: DDH 11530 – Photo Taken Post Reclamation on 21 July 2011; See Photo 17 for Reference; Looking West.

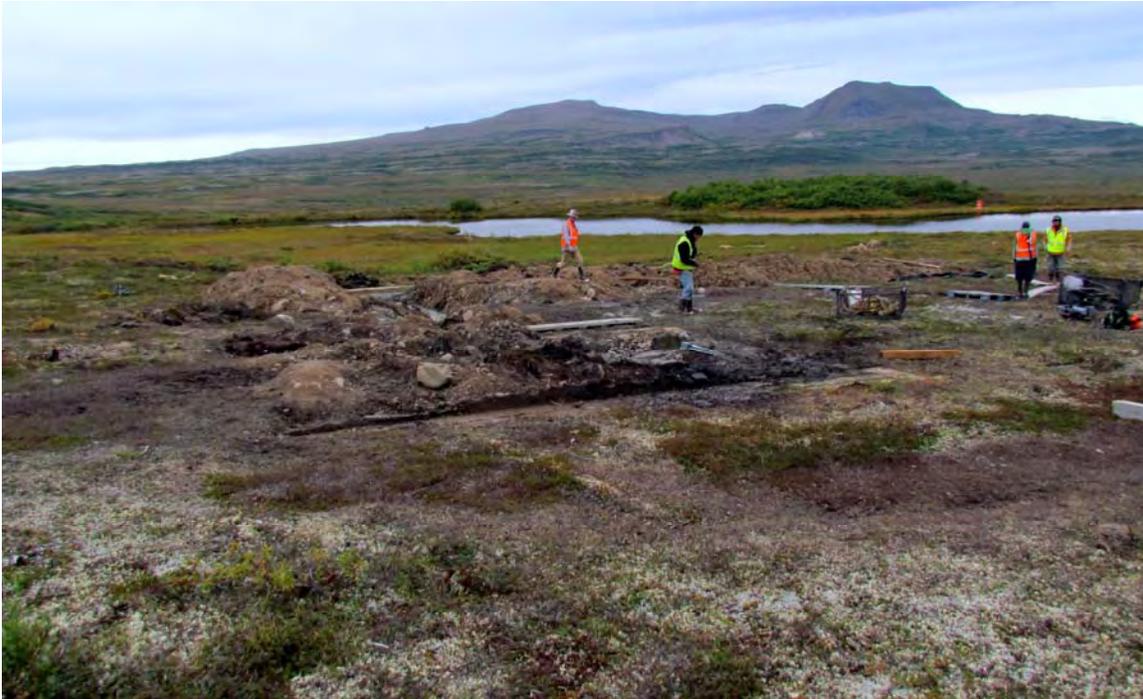
Photo 19: DDH 11533 – Drilled / Reclaimed 2011; Photo Taken Post Drilling on 5 September 2011; Looking North.

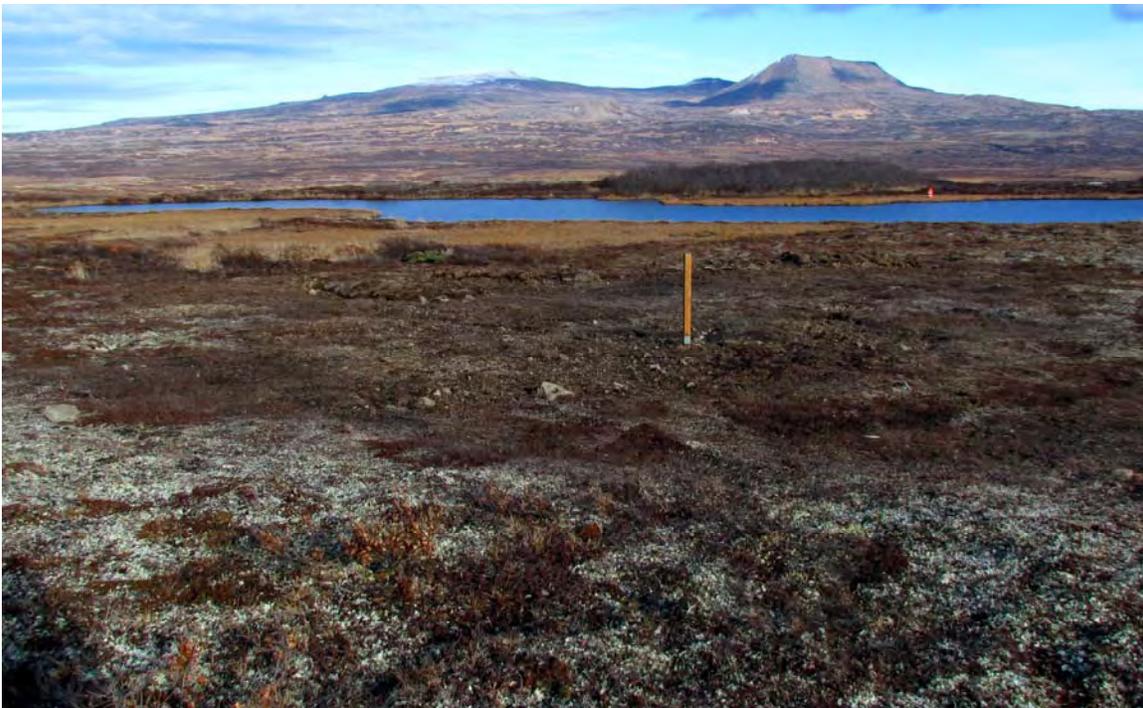
Photo 20: DDH 11533 – Photo Taken Post Reclamation on 22 October 2011; See Photo 19 for Reference; Looking North.

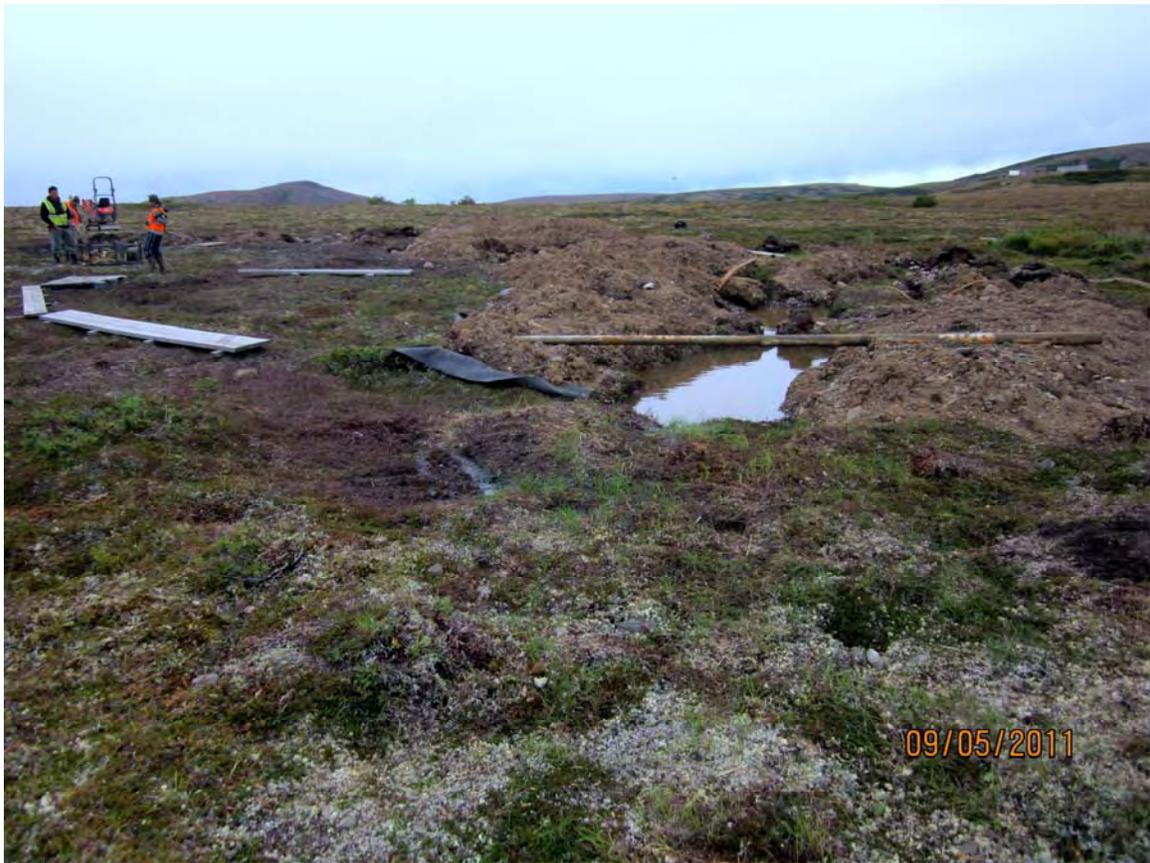
Photo 21: DDH 11533 – Drilled / Reclaimed 2011; Photo Taken Post Drilling on 5 September 2011; Looking West.

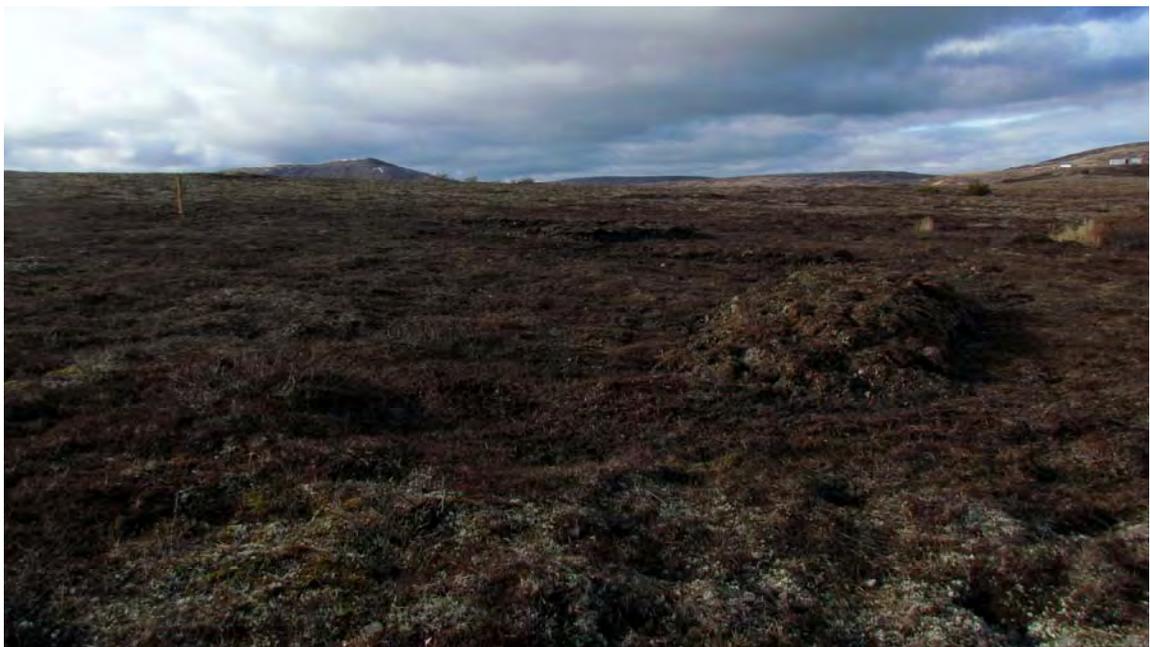
Photo 22: DDH 11533 – Photo Taken Post Reclamation on 22 October 2011; See Photo 21 for Reference; Looking West.

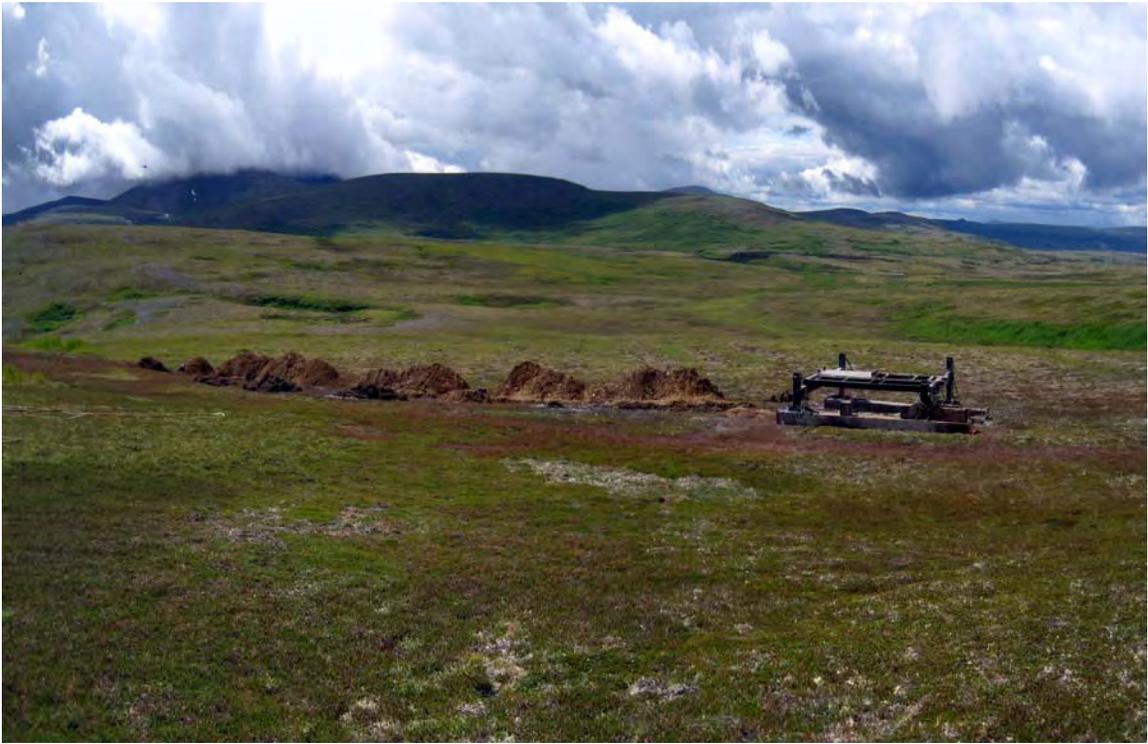
Photo 23: DDH 11534 – Drilled / Reclaimed 2011; Photo Taken Post Drilling on 25 July 2011; Looking West.
