2011 Annual Reclamation Report

The Pebble Project

Iliamna, Alaska

Prepared by: JBN Consultants, Inc.
Eagle River, Alaska

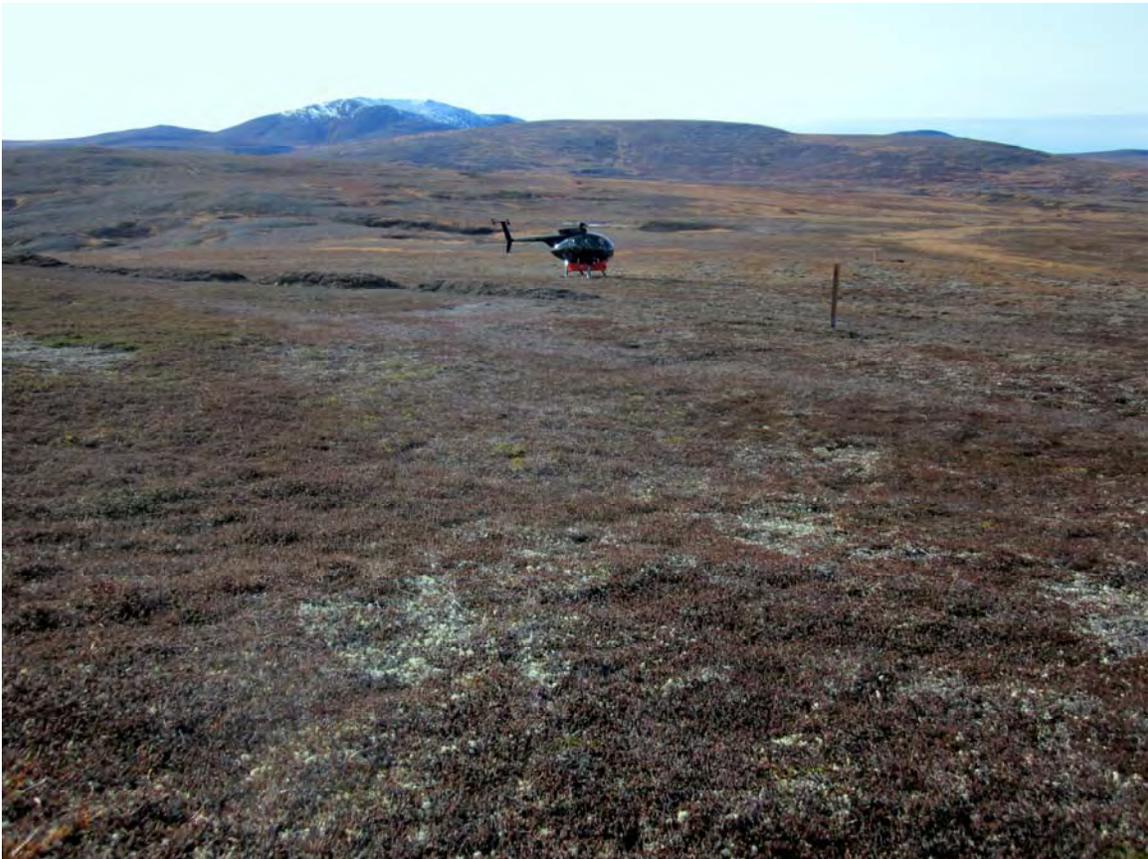
Photo 24: DDH 11534 – Photo Taken Post Reclamation on 12 October 2011; See Photo 23 for Reference; Looking West.

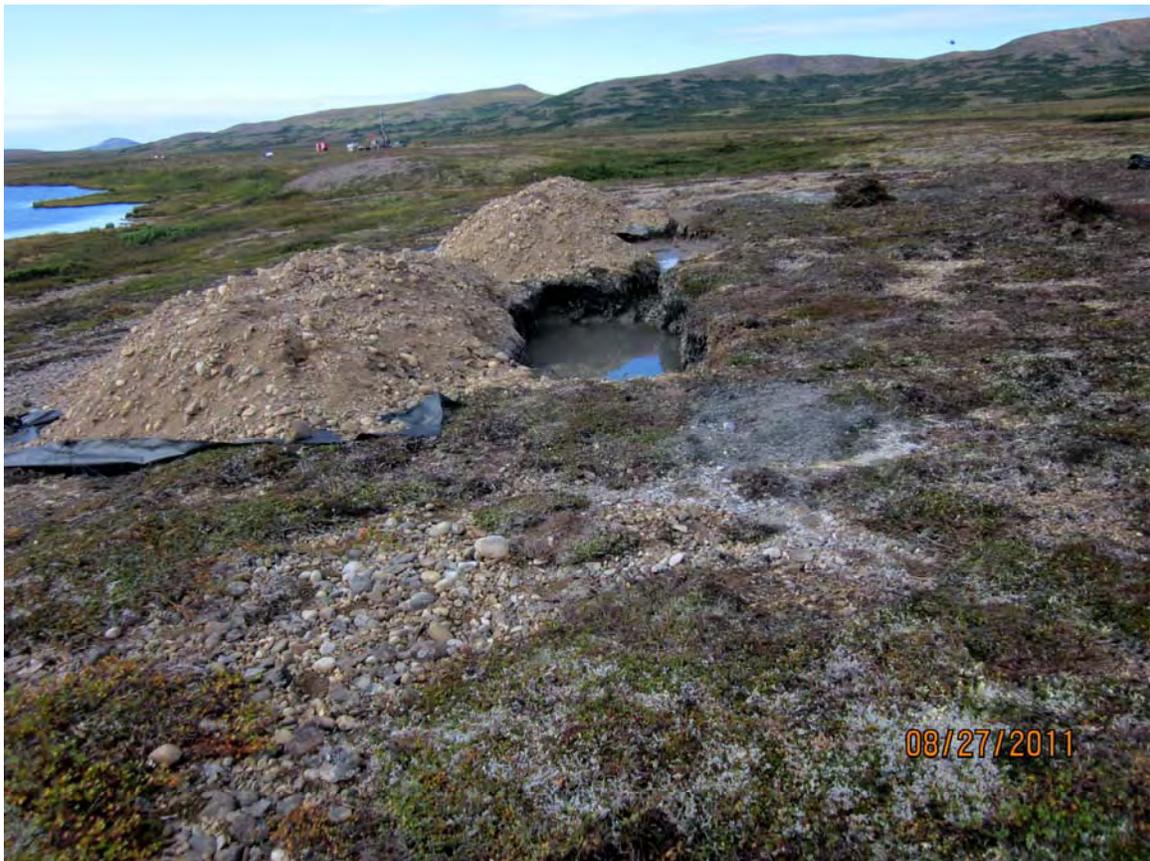
Photo 25: DDH 11535 – Drilled / Reclaimed 2011; Photo Taken Post Drilling on 27 August 2011; Looking South.

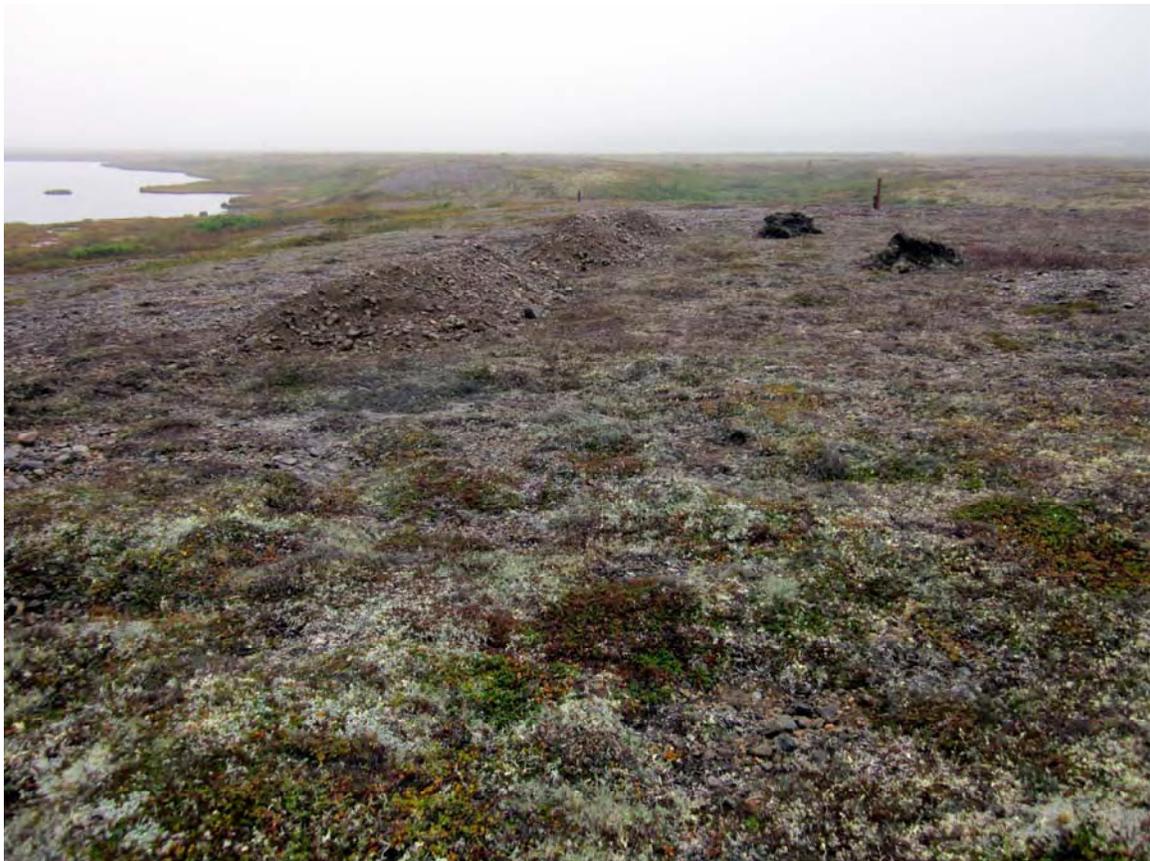
Photo 26: DDH 11535 – Photo Taken Post Reclamation on 31 August 2011; See Photo 25 for Reference; Looking South.

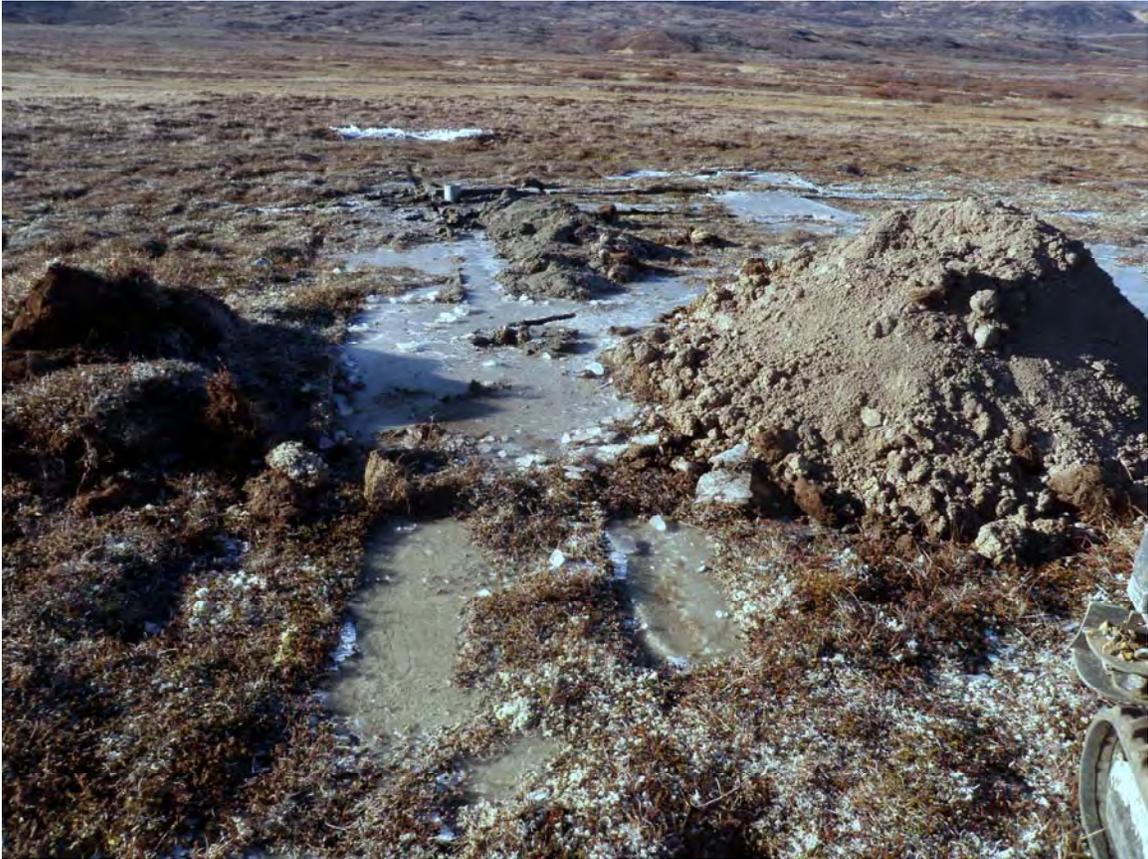
Photo 27: GH10-226 – Drilled 2010 / Reclaimed 2011; Photo Taken Post Drilling on 15 October 2010; Looking West.

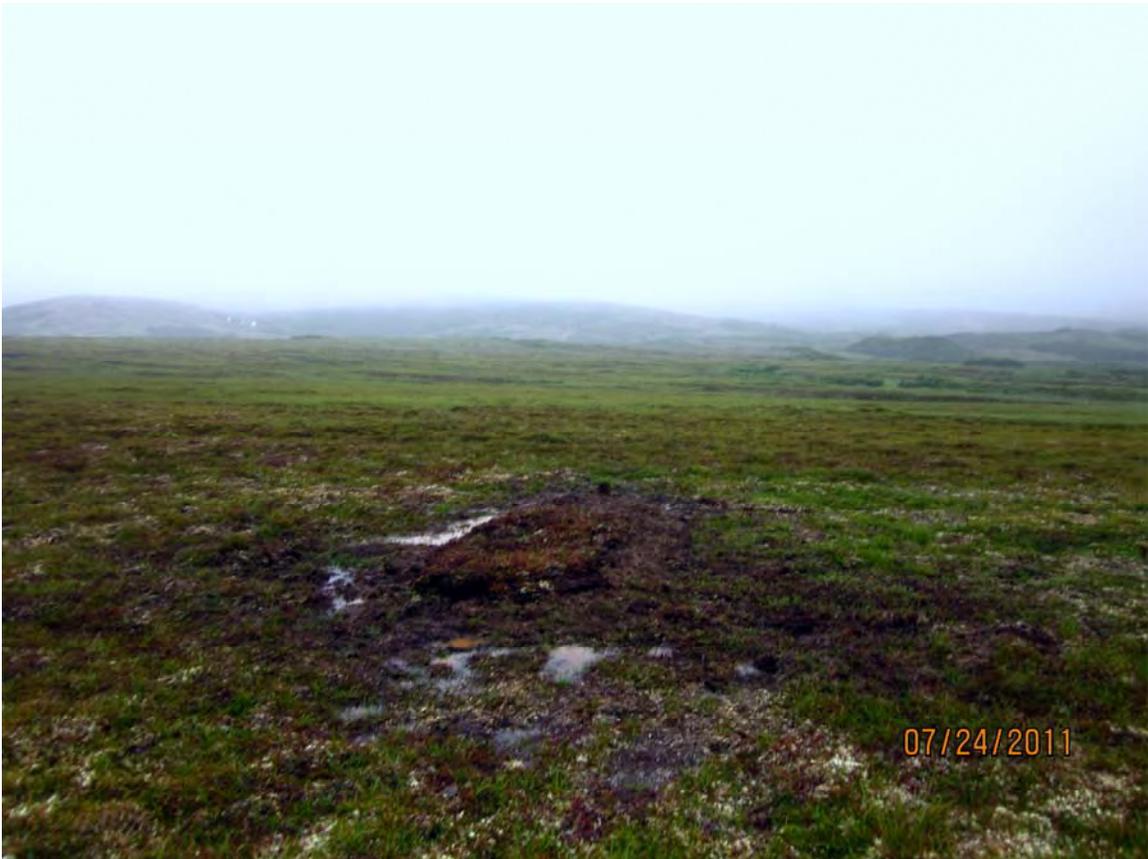
Photo 28: GH10-226 – Photo Taken Post Reclamation on 24 July 2011; See Photo 27 for Reference; Looking West.

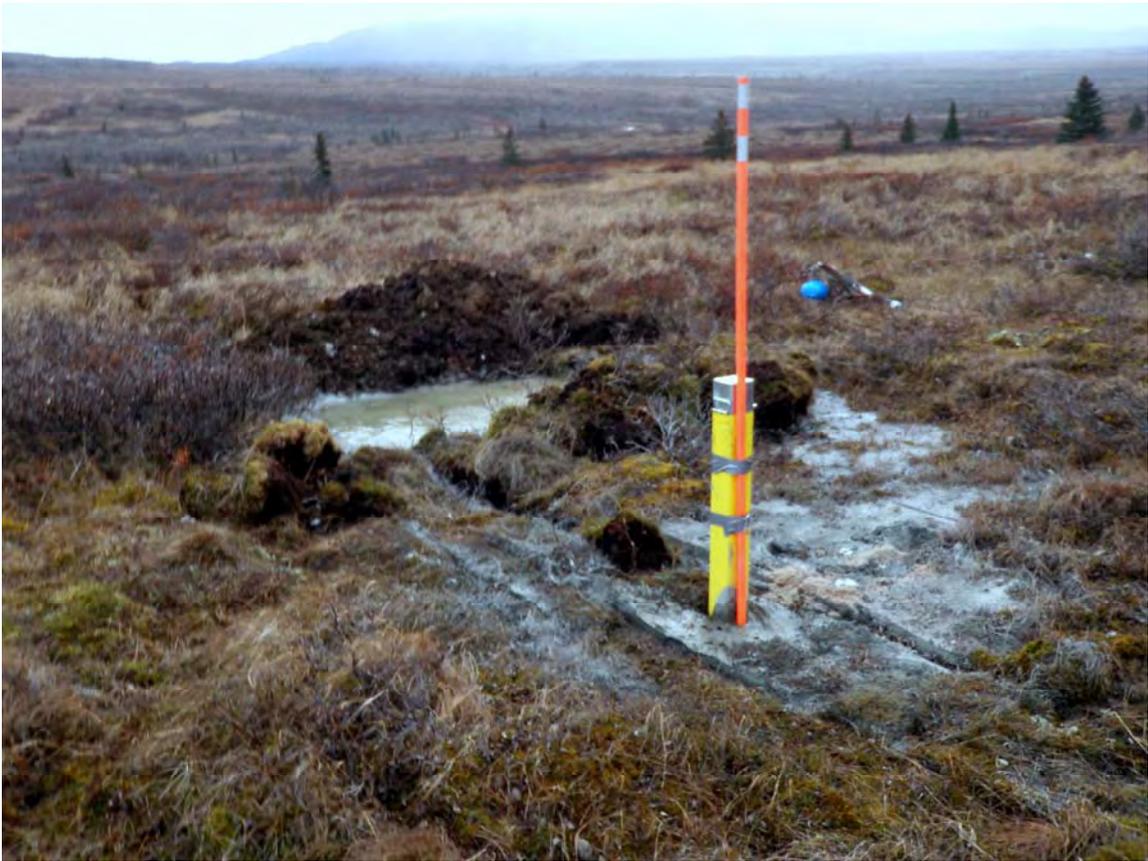
Photo 29: GH10-227 – Drilled 2010 / Reclaimed 2011; Photo Taken Post Drilling on 21 October 2010; Looking East.

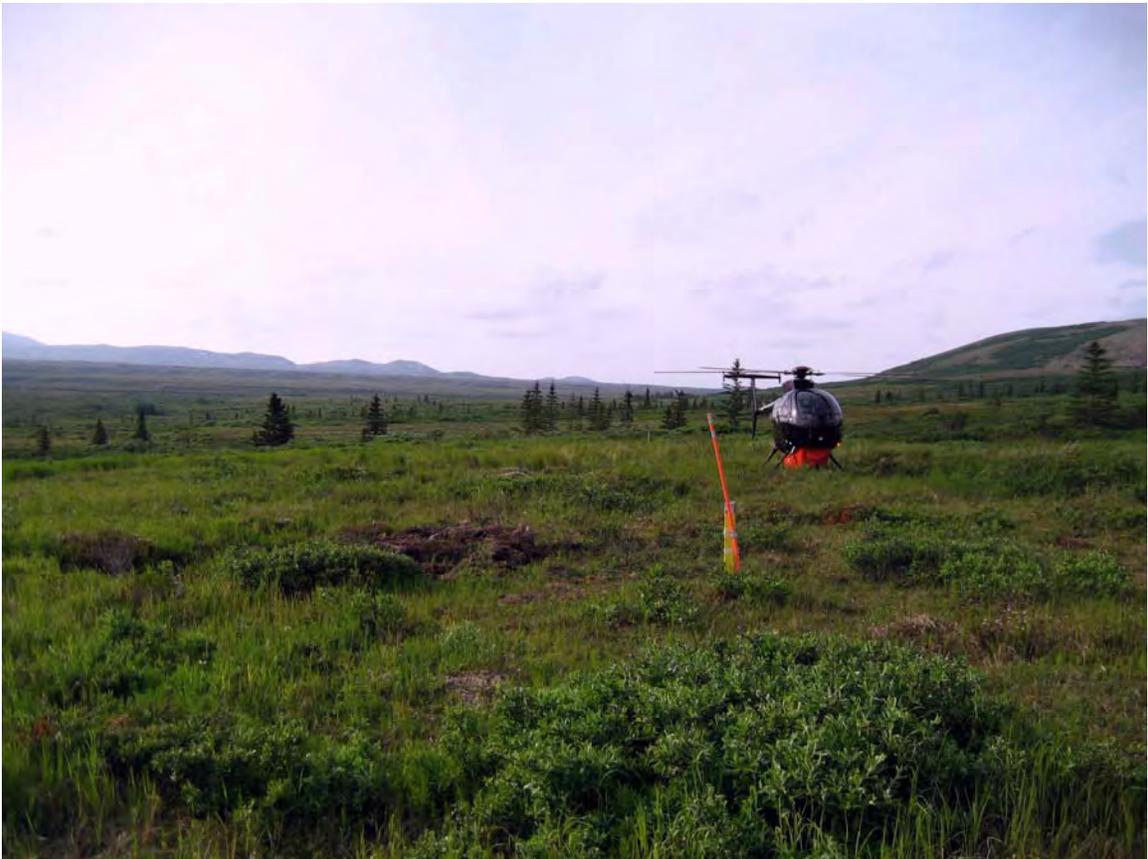
Photo 30: GH10-227 – Photo Taken Post Reclamation on 6 July 2011; See Photo 29 for Reference; Looking East.

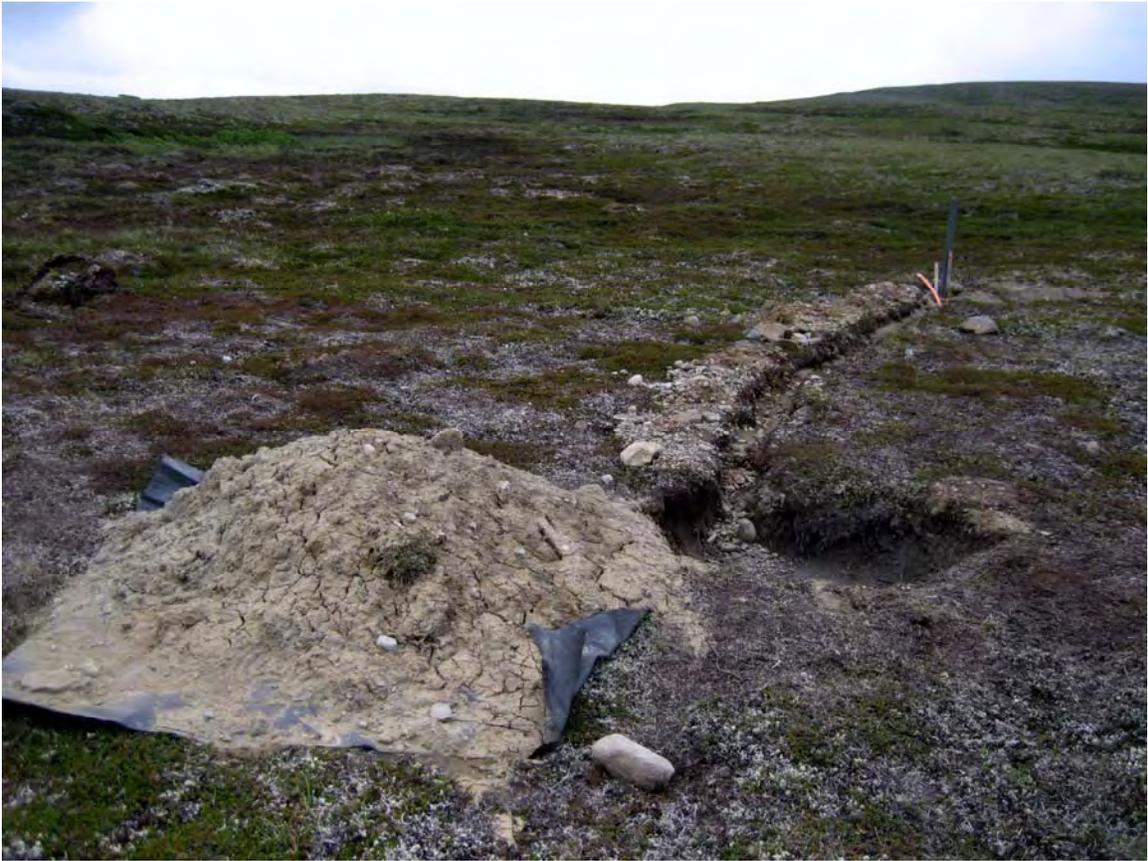
Photo 31: GH11-236 – Drilled / Reclaimed 2011; Photo Taken Post Drilling on 16 July 2011; Looking North.

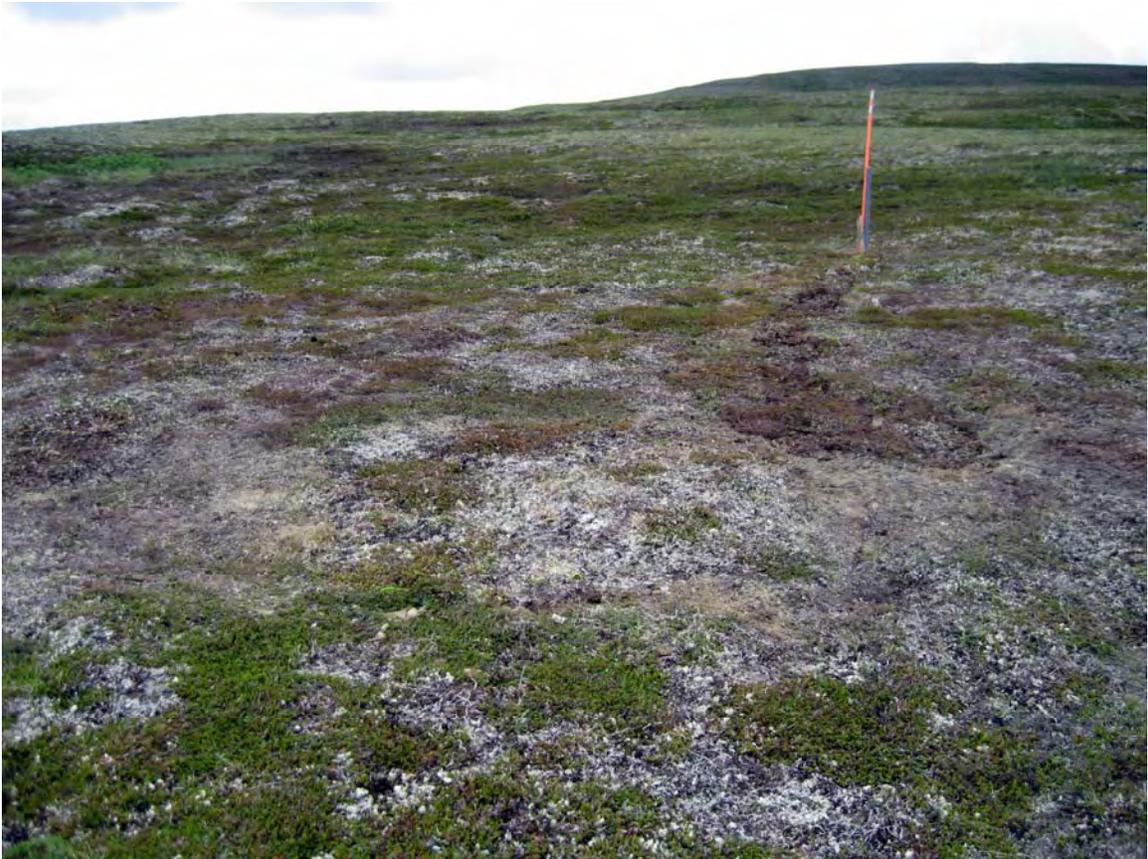
Photo 32: GH11-236 – Photo Taken Post Reclamation on 16 July 2011; See Photo 31 for Reference; Looking North.

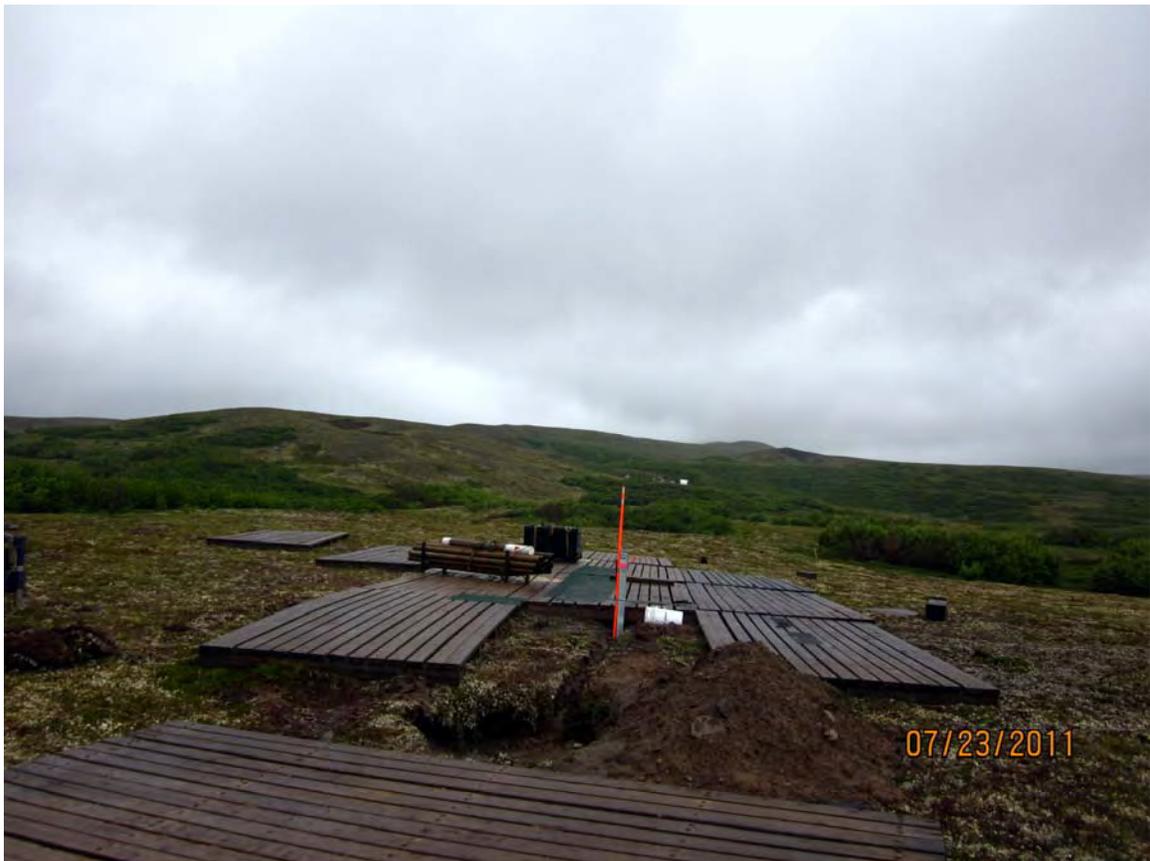
Photo 33: GH11-241 – Drilled / Reclaimed 2011; Photo Taken Post Drilling on 23 July 2011; Looking West.

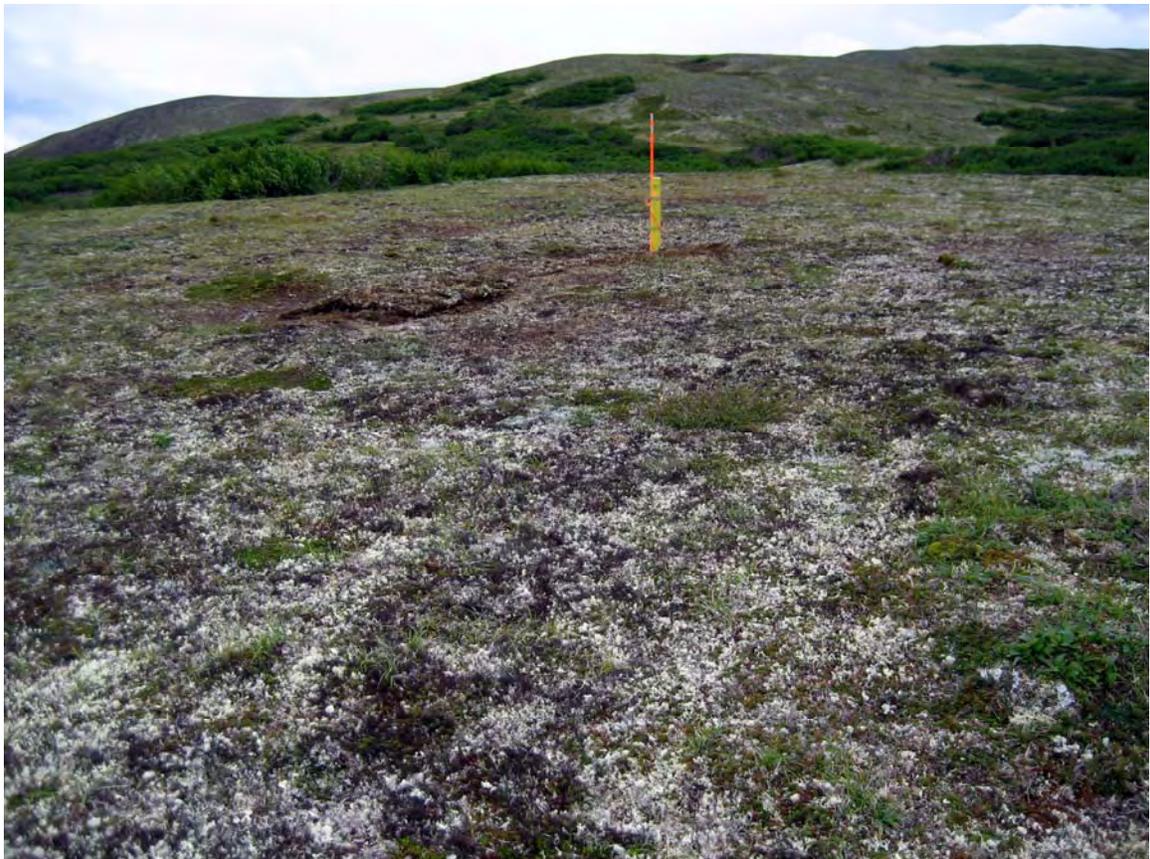
Photo 34: GH11-241 – Photo Taken Post Reclamation on 14 August 2011; See Photo 33 for Reference; Looking West.

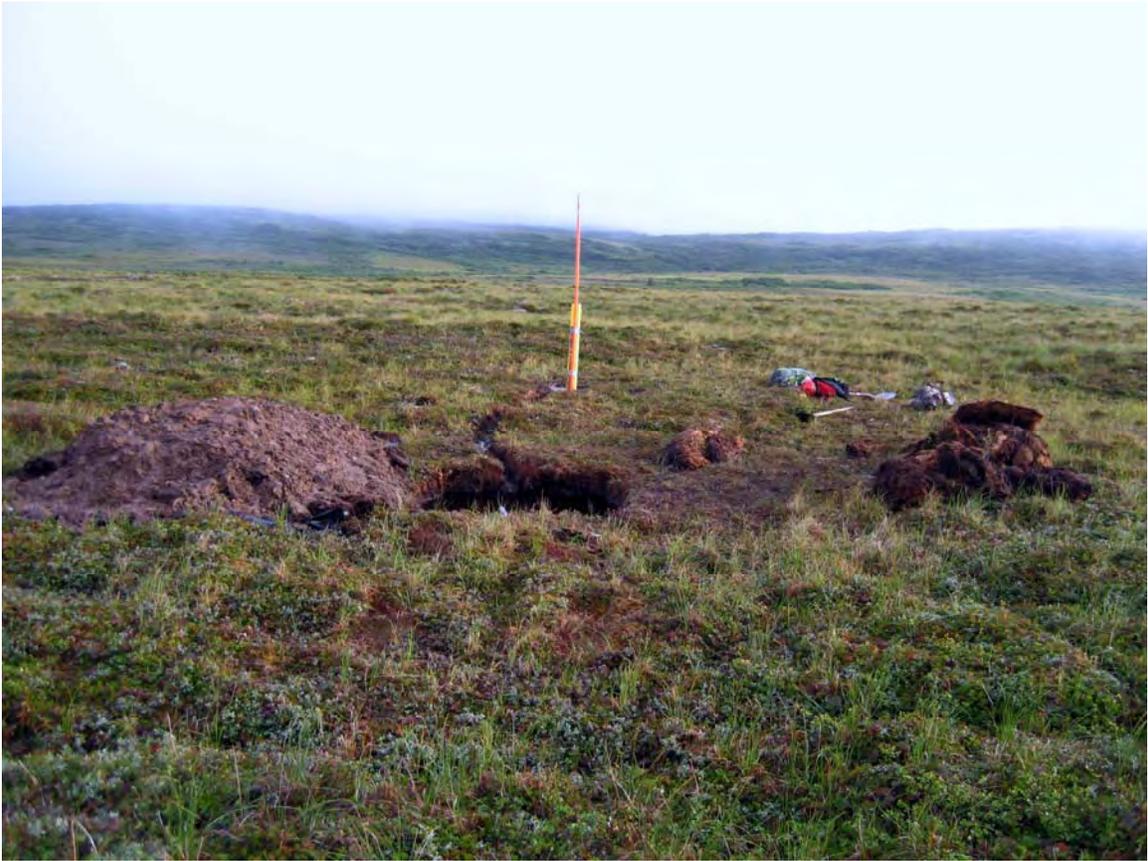
Photo 35: GH11-243 – Drilled / Reclaimed 2011; Photo Taken Post Drilling on 10 August 2011; Looking North.

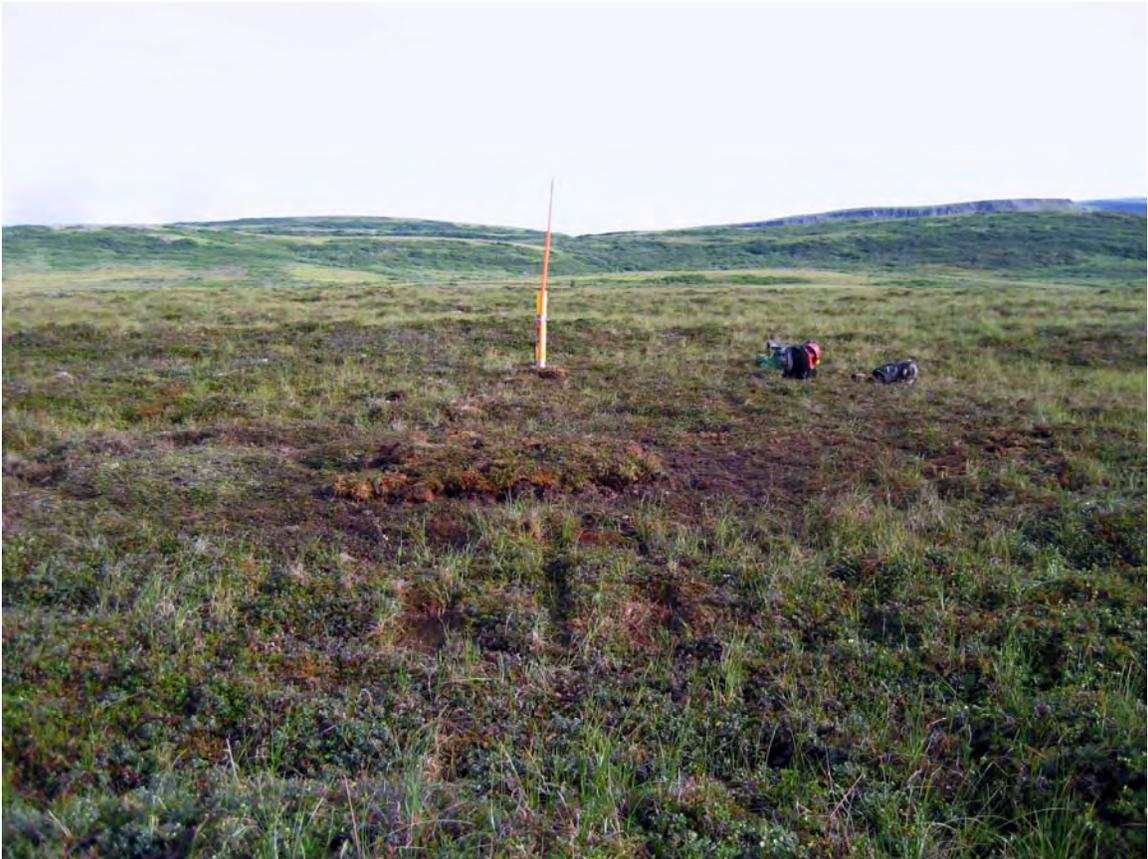
Photo 36: GH11-243 – Photo Taken Post Reclamation on 10 August 2011; See Photo 35 for Reference; Looking North.

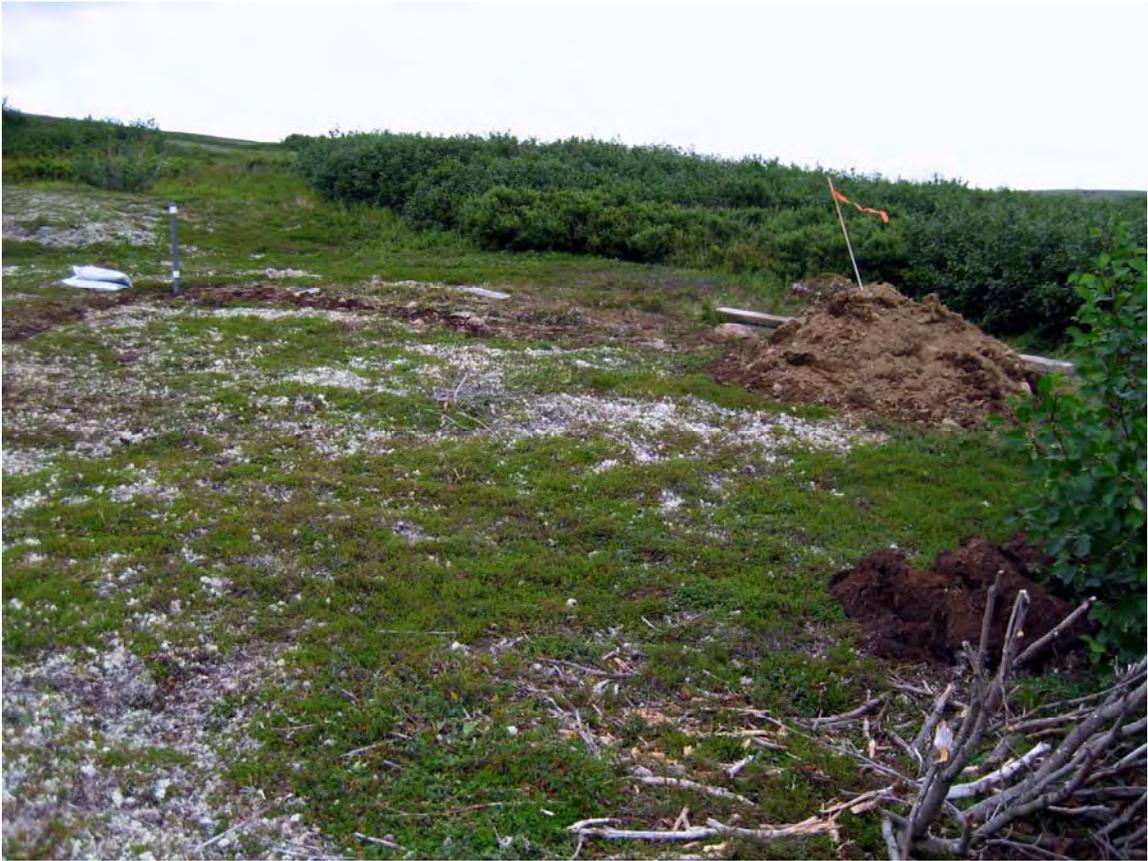
Photo 37: GH11-251S – Drilled / Reclaimed 2011; Photo Taken Post Drilling on 14 August 2011; Looking West.

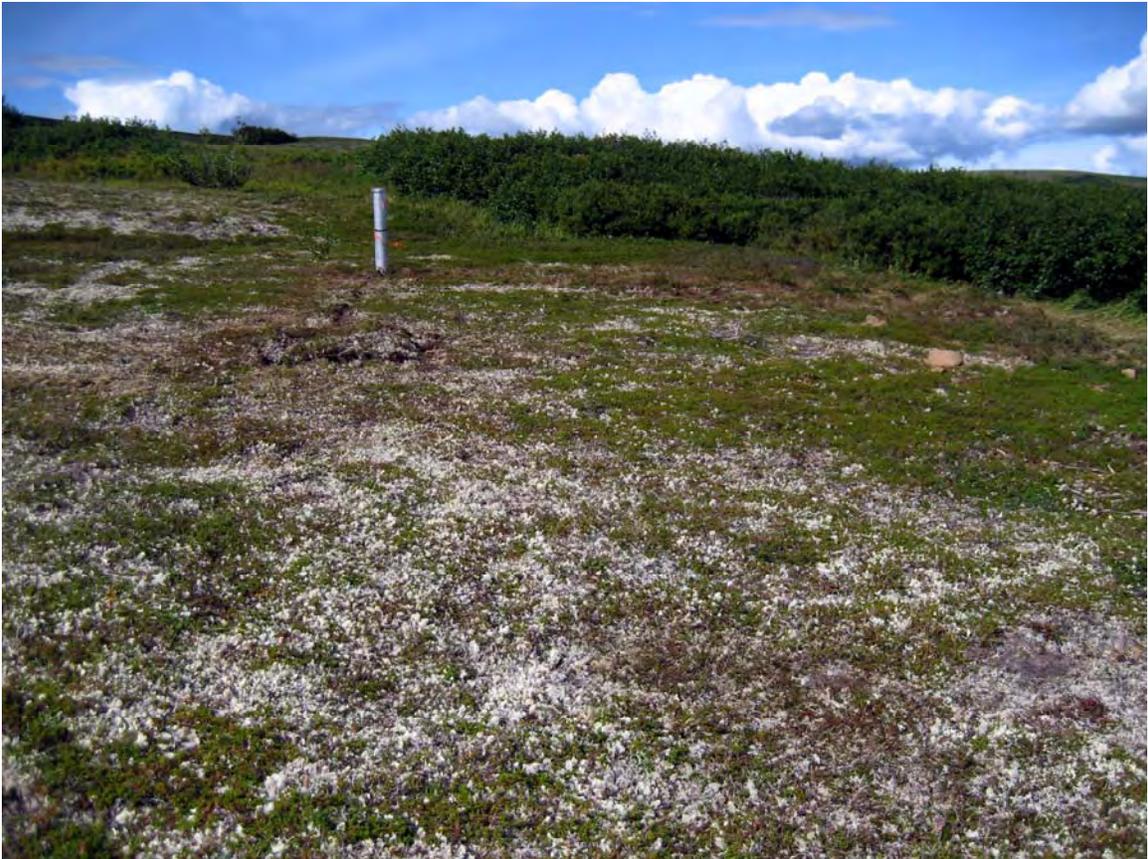
Photo 38: GH11-251S – Photo Taken Post Reclamation on 16 August 2011; See Photo 37 for Reference; Looking West.

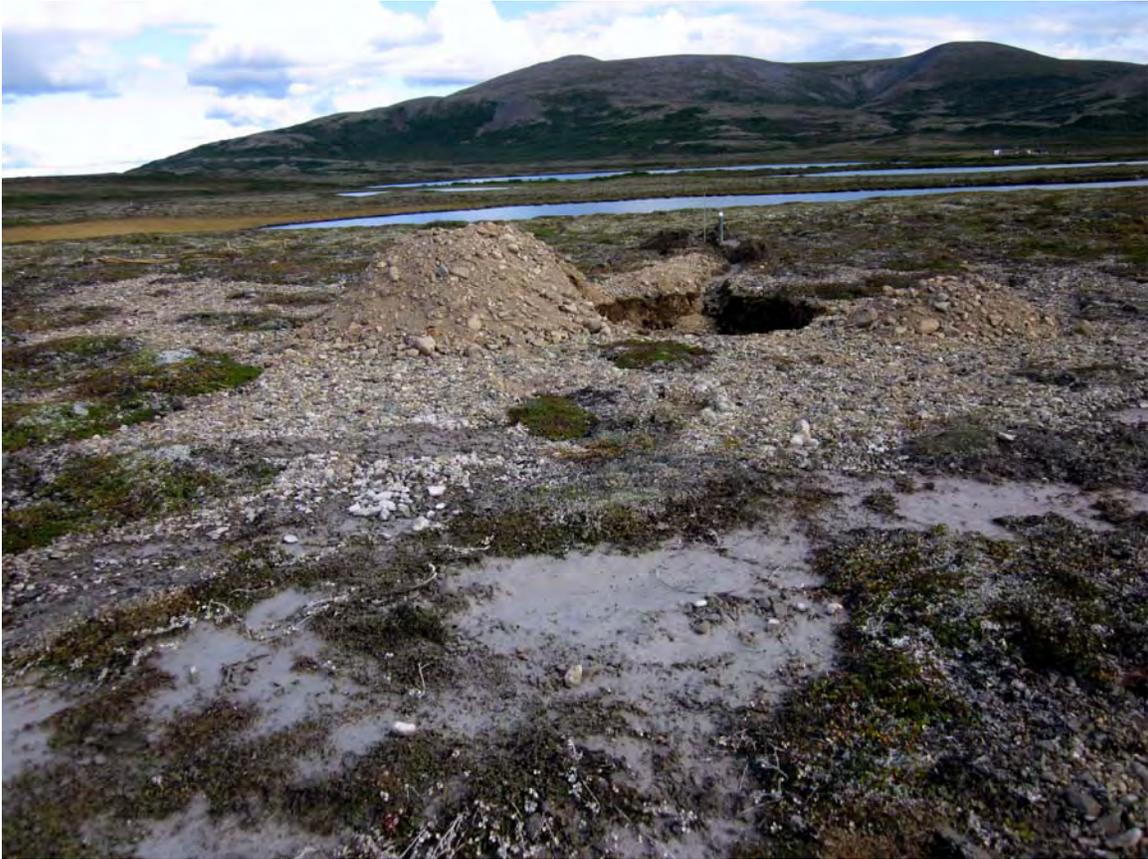
Photo 39: GH11-260S – Drilled / Reclaimed 2011; Photo Taken Post Drilling on 28 August 2011; Looking East.

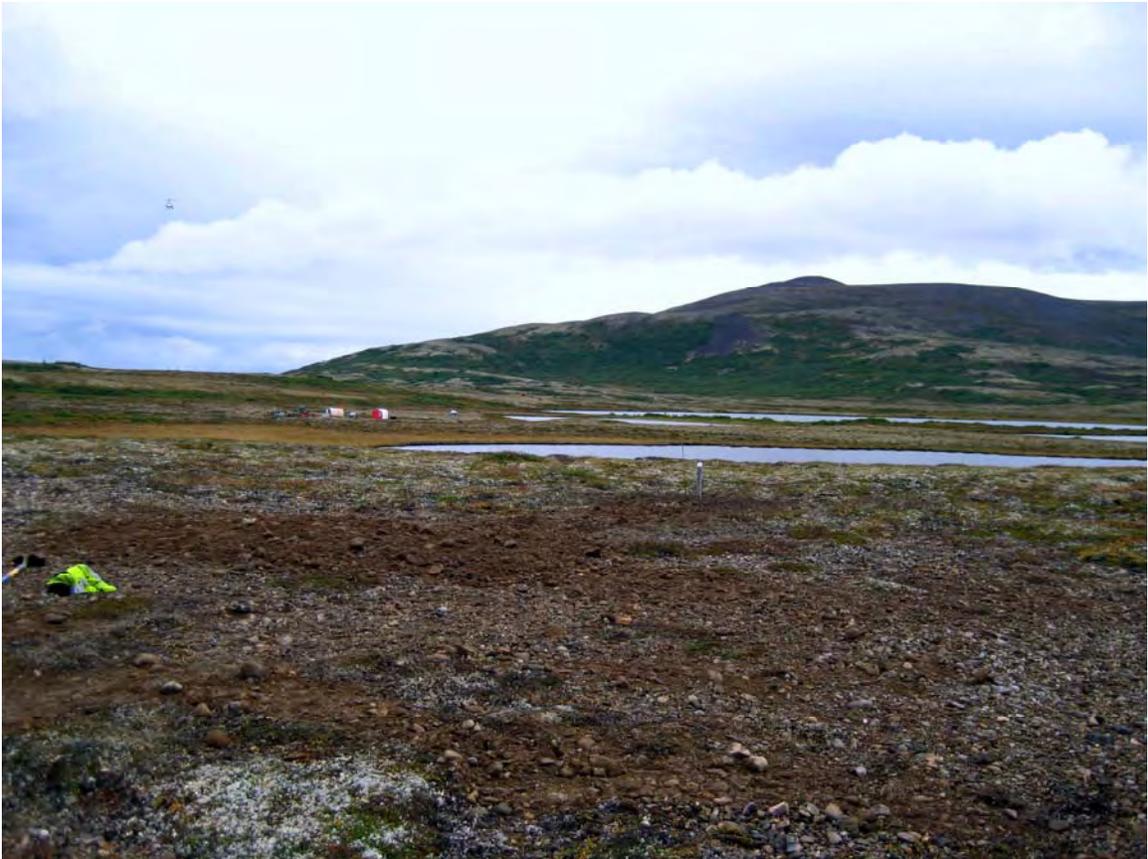
Photo 40: GH11-260S – Photo Taken Post Reclamation on 31 August 2011; See Photo 39 for Reference; Looking East.

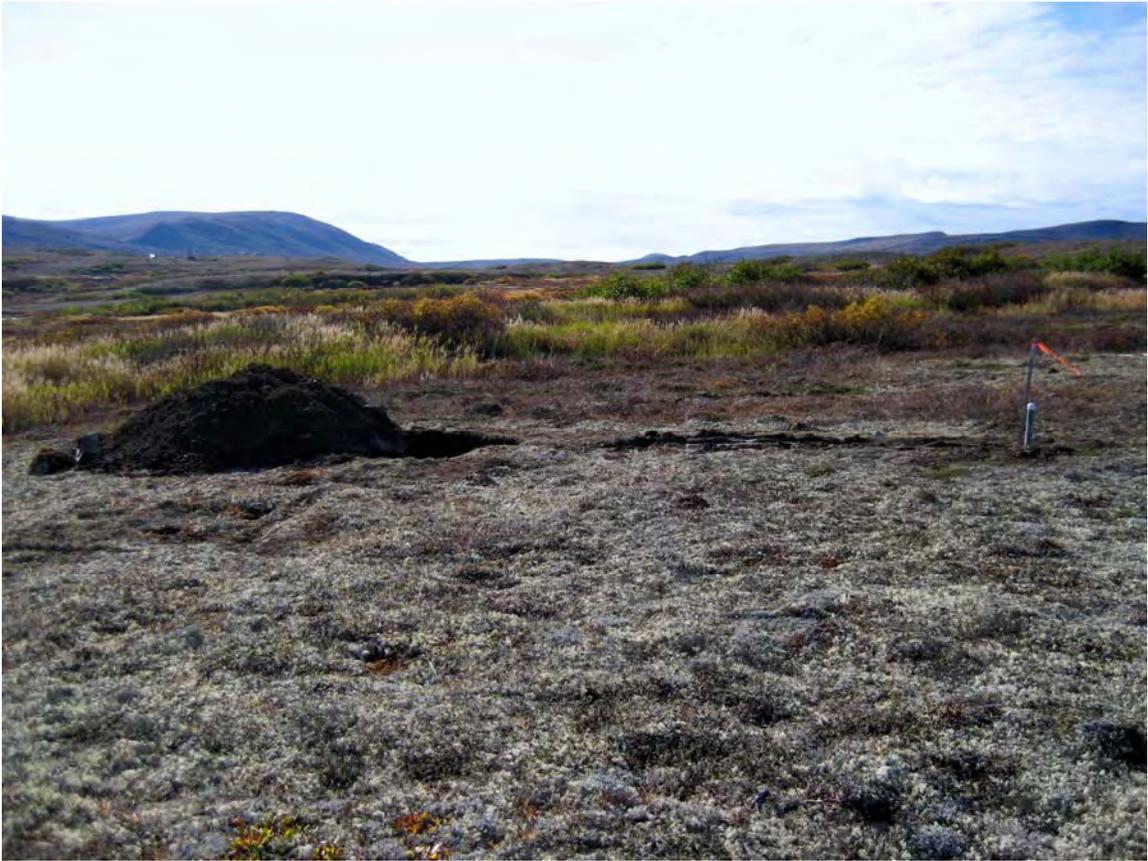
Photo 41: GH11-279S – Drilled / Reclaimed 2011; Photo Taken Post Drilling on 26 September 2011; Looking North.

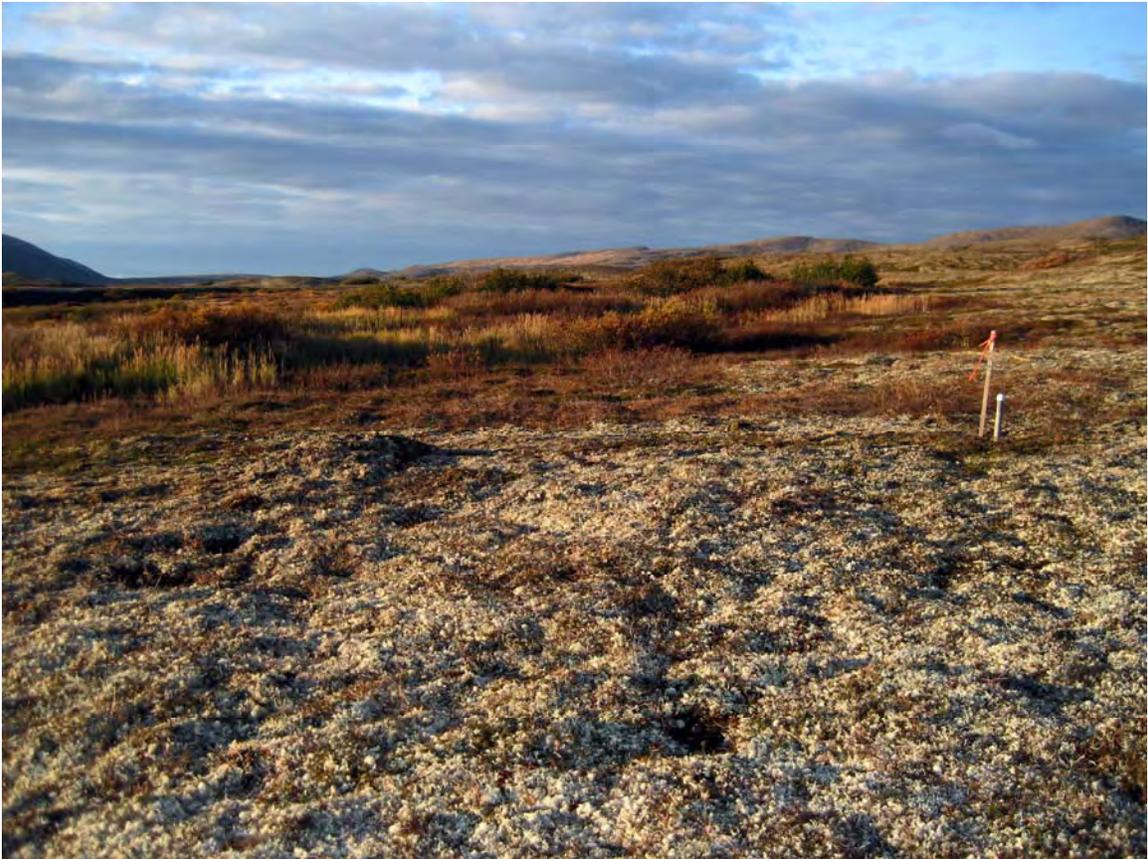
Photo 42: GH11-279S – Photo Taken Post Reclamation on 27 September 2011; See Photo 41 for Reference; Looking North.

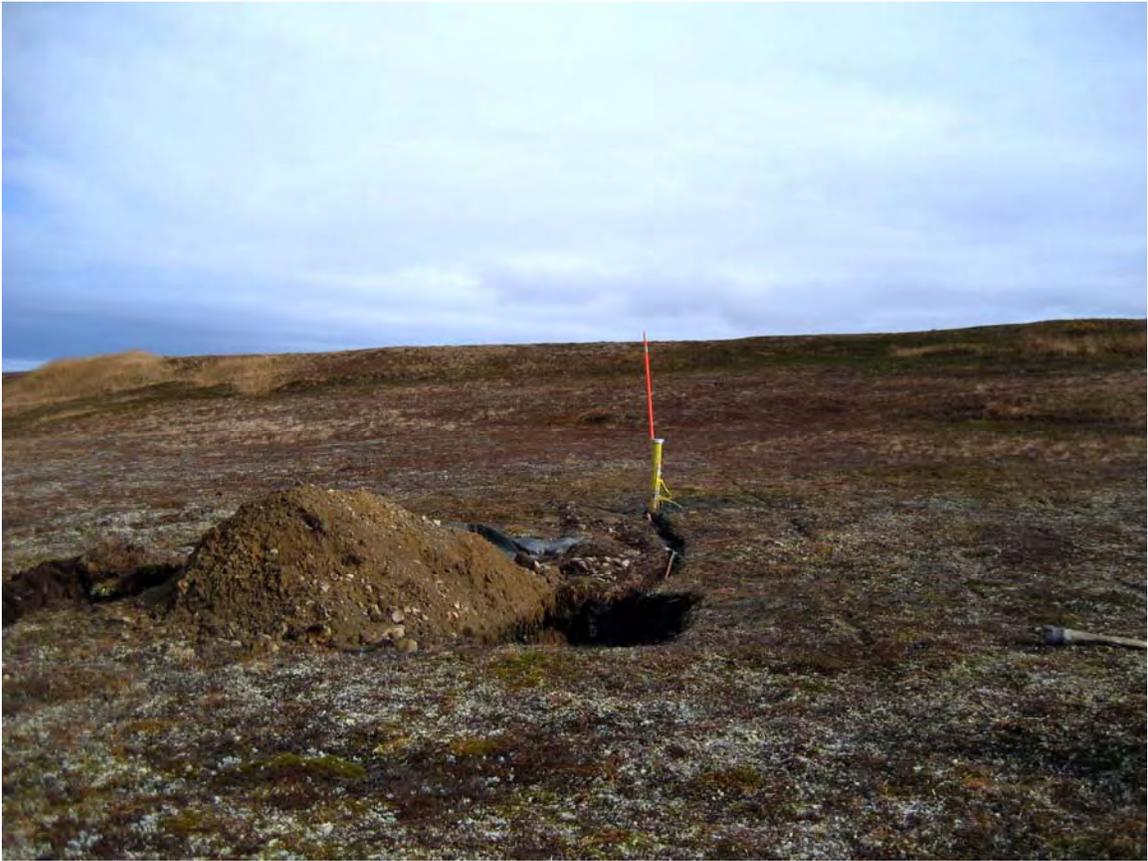
Photo 43: GH11-287 – Drilled / Reclaimed 2011; Photo Taken Post Drilling on 6 October 2011; Looking North.

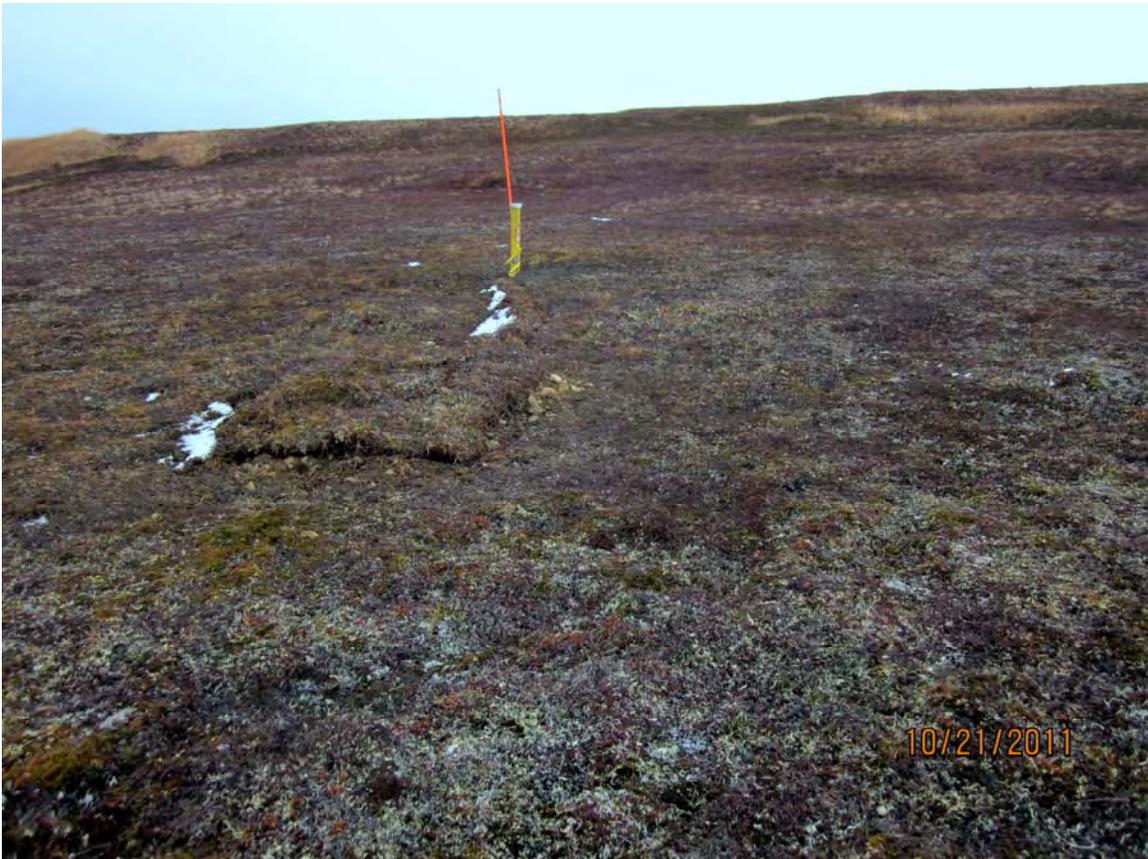
Photo 44: GH11-287 – Photo Taken Post Reclamation on 21 October 2011; See Photo 43 for Reference; Looking North.

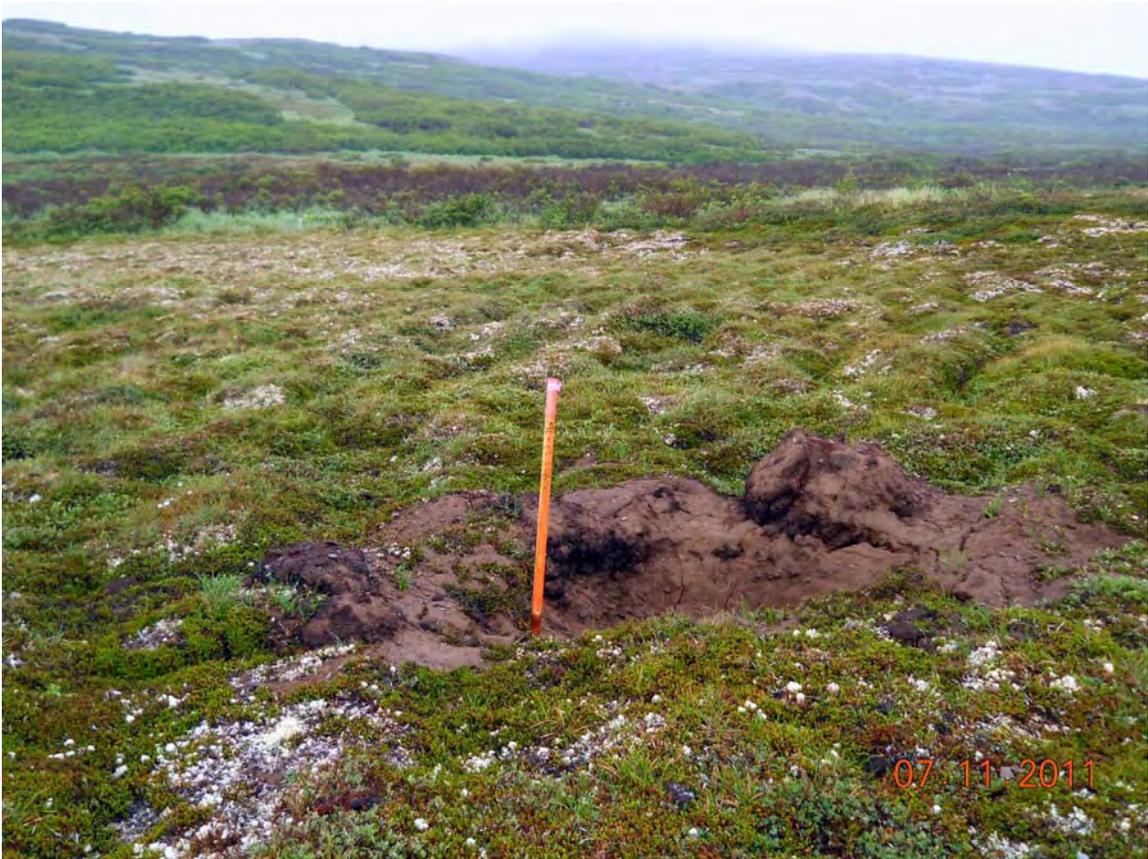
Photo 45: Seismic Line SL-39 (Pre-Site Designation SL-C) – Completed 2010 / Reclaimed 2011; Photo Taken on 11 July 2011; Looking Northwest.

Reclamation consisted of smoothing and rounding each shot hole using hand-tools. The retained surface vegetation was replaced and /or replanted to inhibit erosion and enhance natural revegetation. As the seismic program was helicopter supported, no ground footprint was left other than the blast hole.
