2011 Annual Reclamation Report

The Pebble Project

Iliamna, Alaska

Prepared by: JBN Consultants, Inc.
Eagle River, Alaska

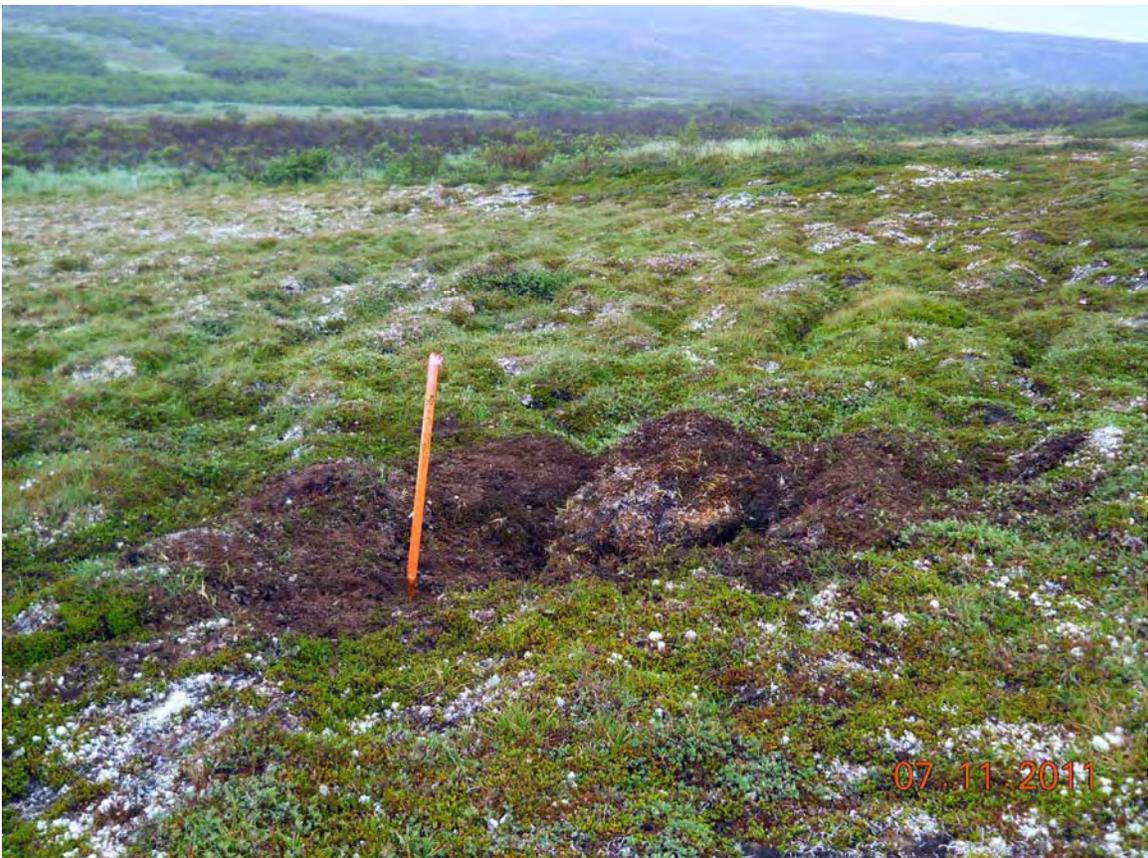
Photo 46: Seismic Line SL-39 (Pre-Site Designation SL-C) – Photo Taken Post Reclamation on 11 July 2011; Looking Northwest.

Reclamation consisted of smoothing and rounding each shot hole using hand-tools. The retained surface vegetation was replaced and /or replanted to inhibit erosion and enhance natural revegetation. As the seismic program was helicopter supported, no ground footprint was left other than the blast hole.

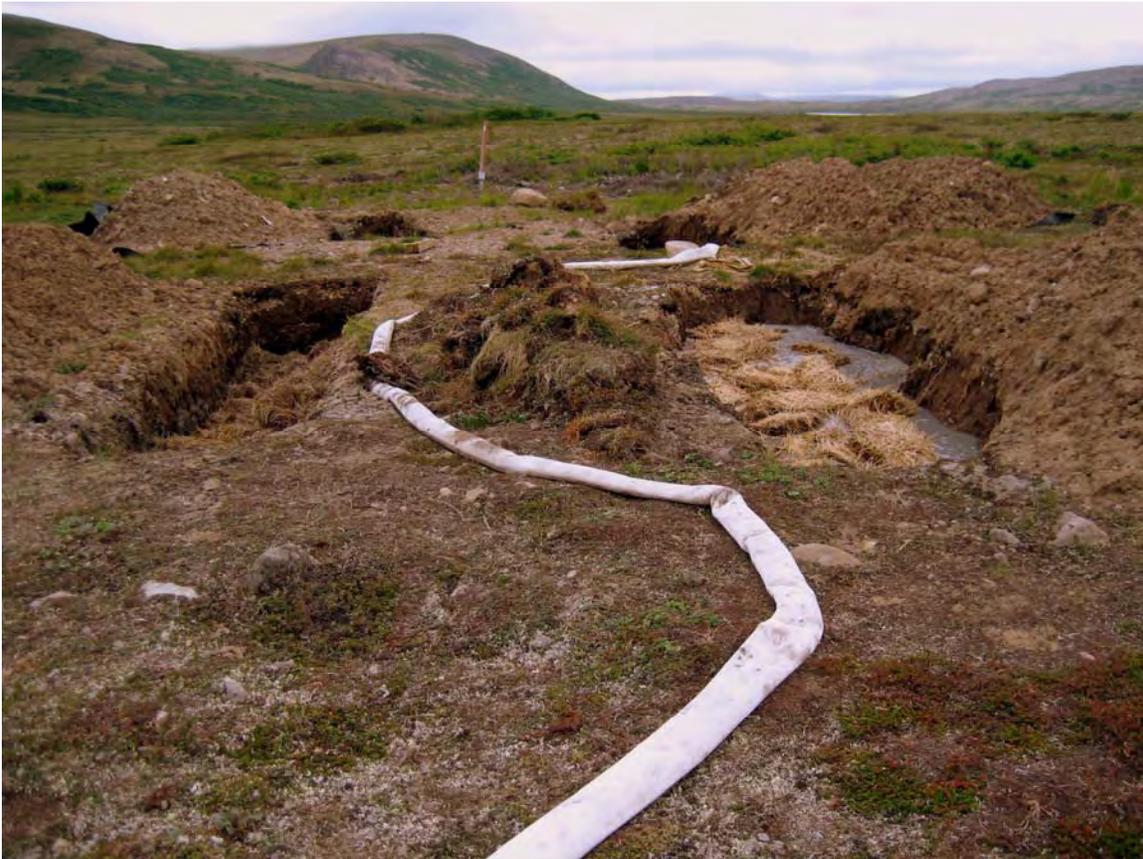
During the 2011 field season, additional sumps were excavated upgradient of two drill sites (i.e., DDH 11533 and 11536). The Reclamation Crew excavated these upland drill water sump locations as a proactive measure to direct drill water and cuttings away from streams, lakes, and wetlands for natural infiltration to the ground. These upland sumps were reclaimed in 2011 and are depicted in Photos 47, 48, 51, and 52, in Appendix A.

Photo 47: Upland Sump Location for DDH 11533 near former borehole DDH 8422 – Excavated/Reclaimed 2011; Photo Taken on 30 July 2011; Looking South.

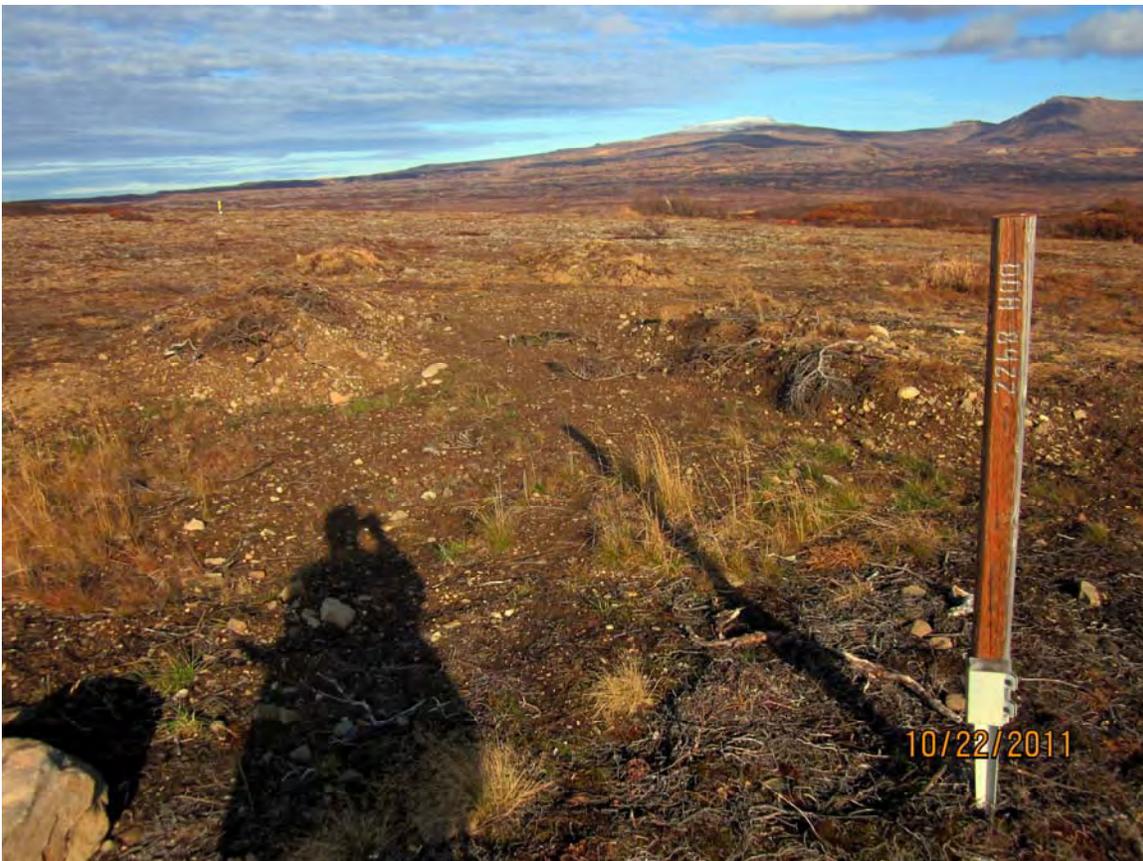
Photo 48: Upland Sump Location related to DDH 11533 near former borehole DDH 8422 – Photo Taken Post Reclamation on 22 October 2011; Looking North.

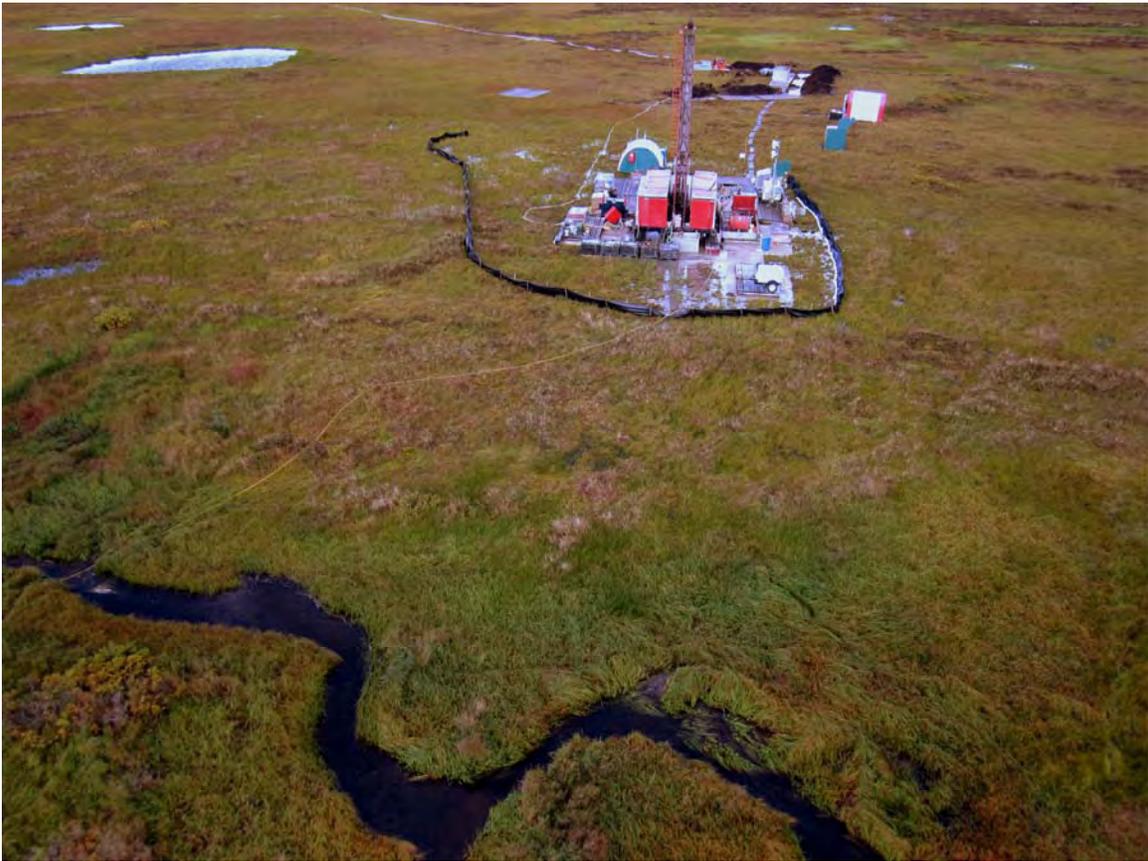
Photo 49: DDH 11536 – View of drill site looking north. Reclamation commenced 2011 (sumps backfilled); will complete in 2012. Photo Taken on 31 August 2011.

Given the saturated surface soil conditions in the vicinity of borehole DDH 11536, additional precautions were employed during drill rig set-up. As part of this process, crews set-up the drill rig on top of twenty 8-ft x 16-ft interlocking high density polyethylene mats to allow for a stable drilling platform. Similar to the tundra pads these mats were demobilized when the borehole was complete.

Once the tundra pads and the matting were removed project staff used the back of a rake to massage the tundra to spring back to its original position.

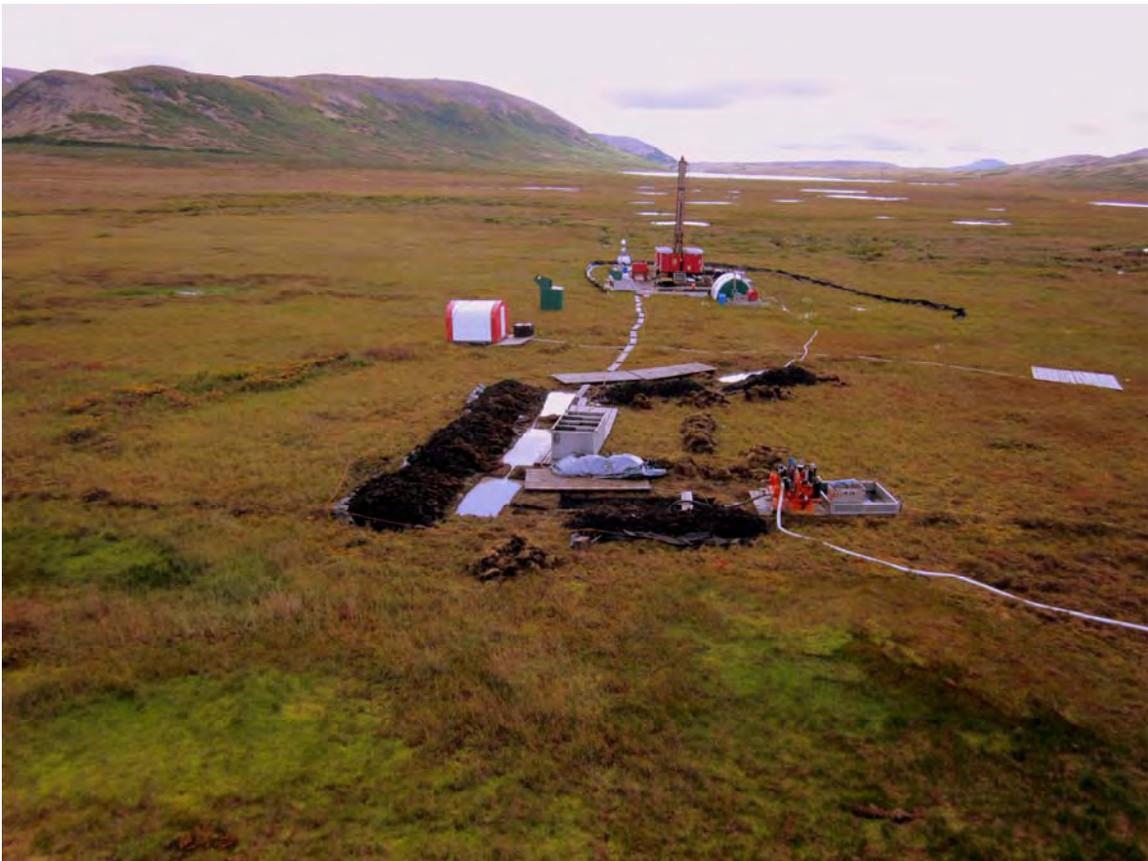
Photo 50: DDH 11536 – View of drill site looking south. Reclamation commenced 2011 (sumps backfilled); will complete in 2012. Photo Taken on 31 August 2011.

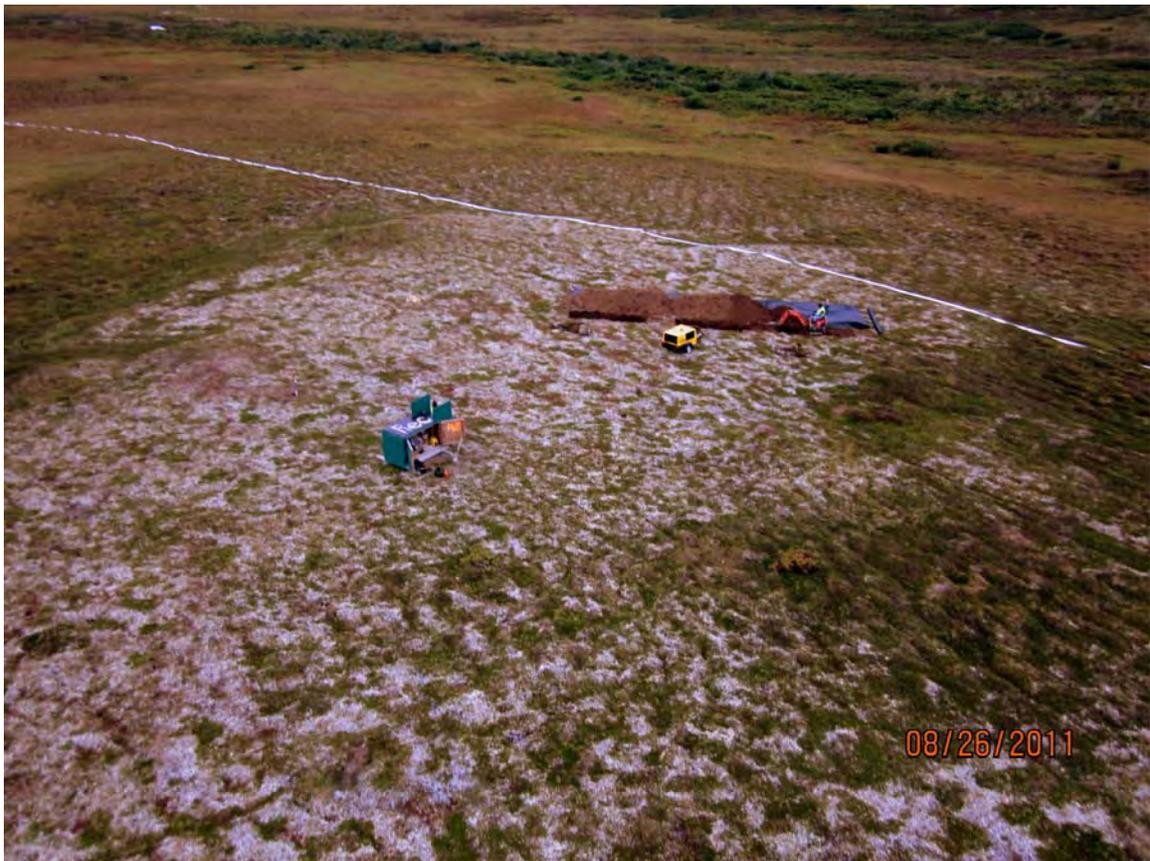
Photo 51: Excavating Upland Sump Location for DDH 11536 (i.e., Mid-Station 2,500 feet from borehole) – Photo taken on 26 August 2011; Looking South.

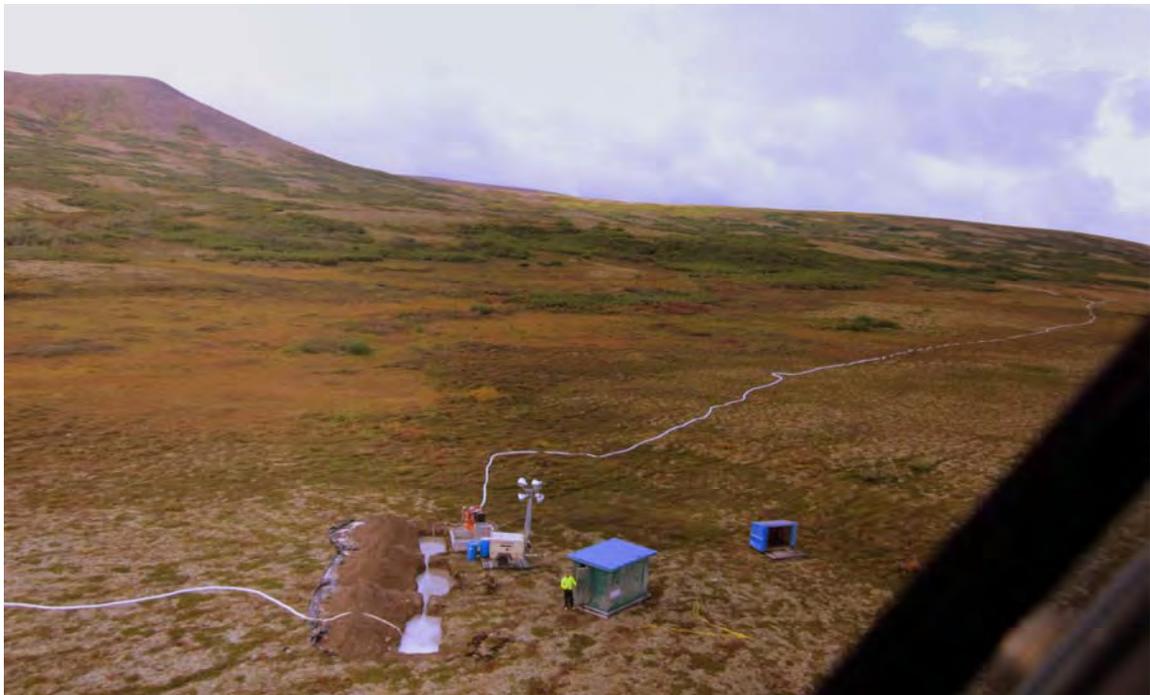
Photo 52: Upland Sump Location for DDH 11536 (Mid-Station). Drill water pumped a total of 4,500 feet from borehole away from streams, lakes, and wetlands for natural infiltration to the ground. – Reclamation complete October 2011. Photo taken on 31 August 2011; Looking West.
