# **Jumbo Mine Road Corridor**

**Part C: Environmental Resource  
Information**

**Permit Renewal**

**May 2018**

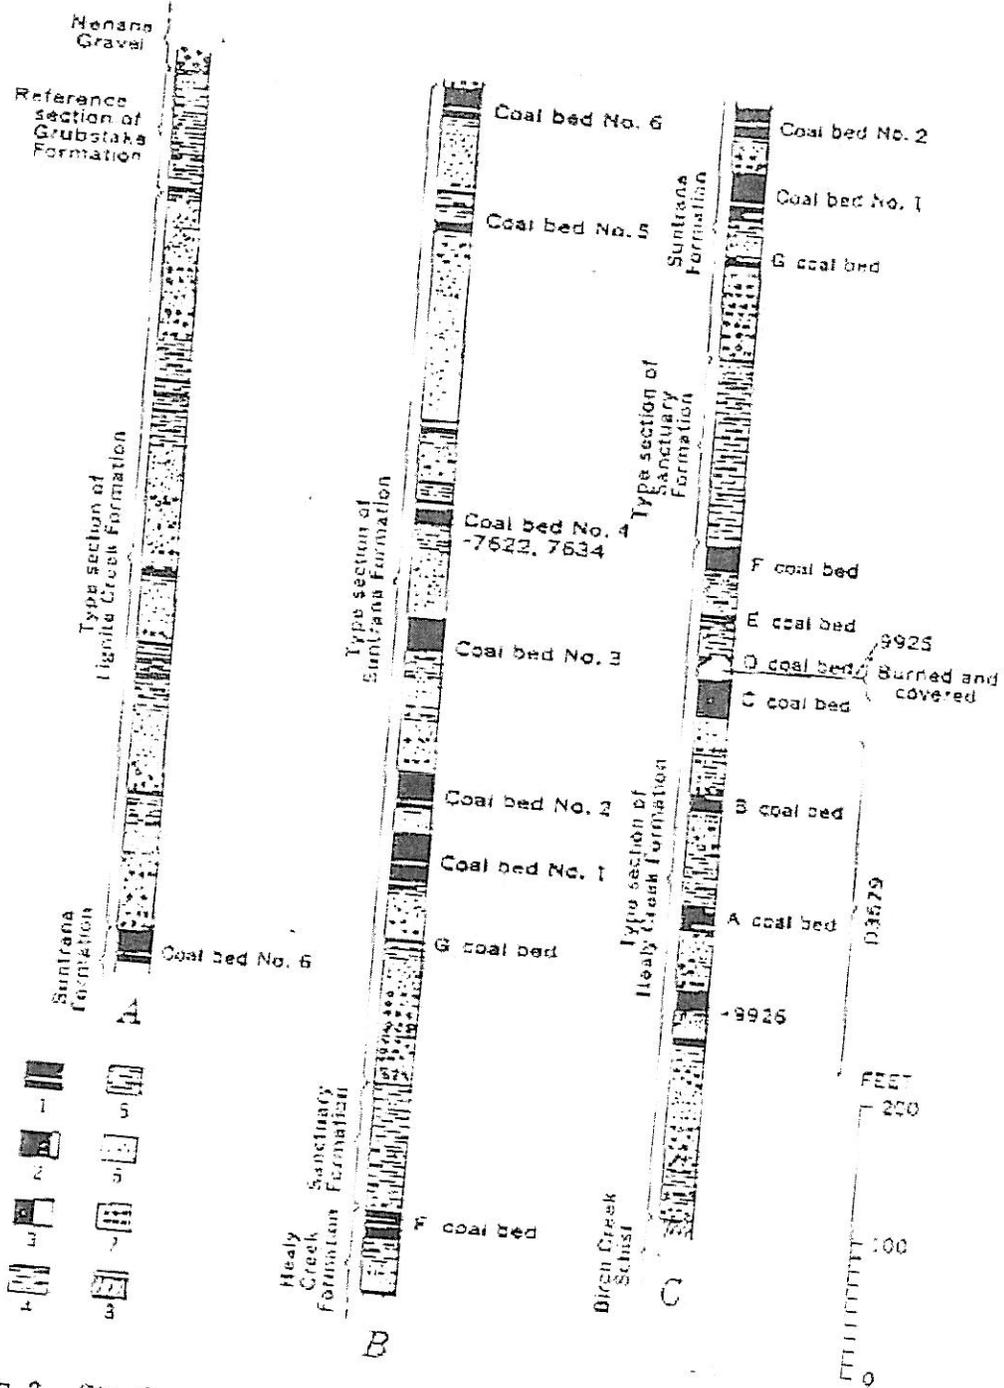
FIGURE CII-2  
STRATIGRAPHIC SECTION OF COAL  
BEARING GROUP

FIGURE 3.—Stratigraphic column of the type sections of the formations of the coal-bearing group at Suntrana, showing locations of plant megafossil localities and microfossil localities. Section A, measured along Suntrana Creek from coal bed No. 6 to the base of the Nenana Gravel; section B, measured along Suntrana Creek from near the railroad bridge to coal bed No. 5; section C, measured on the north bank of Healy Creek from the Usibelli tippie to top of the badland exposure east of the Suntrana mine. 1, coal (showing bone or clay parting); 2, bony coal; 3, bone; 4, claystone and shale; 5, siltstone; 6, sandstone, in part crossbedded; 7, pebbles and conglomerate; 8, schist (unconformity at top).

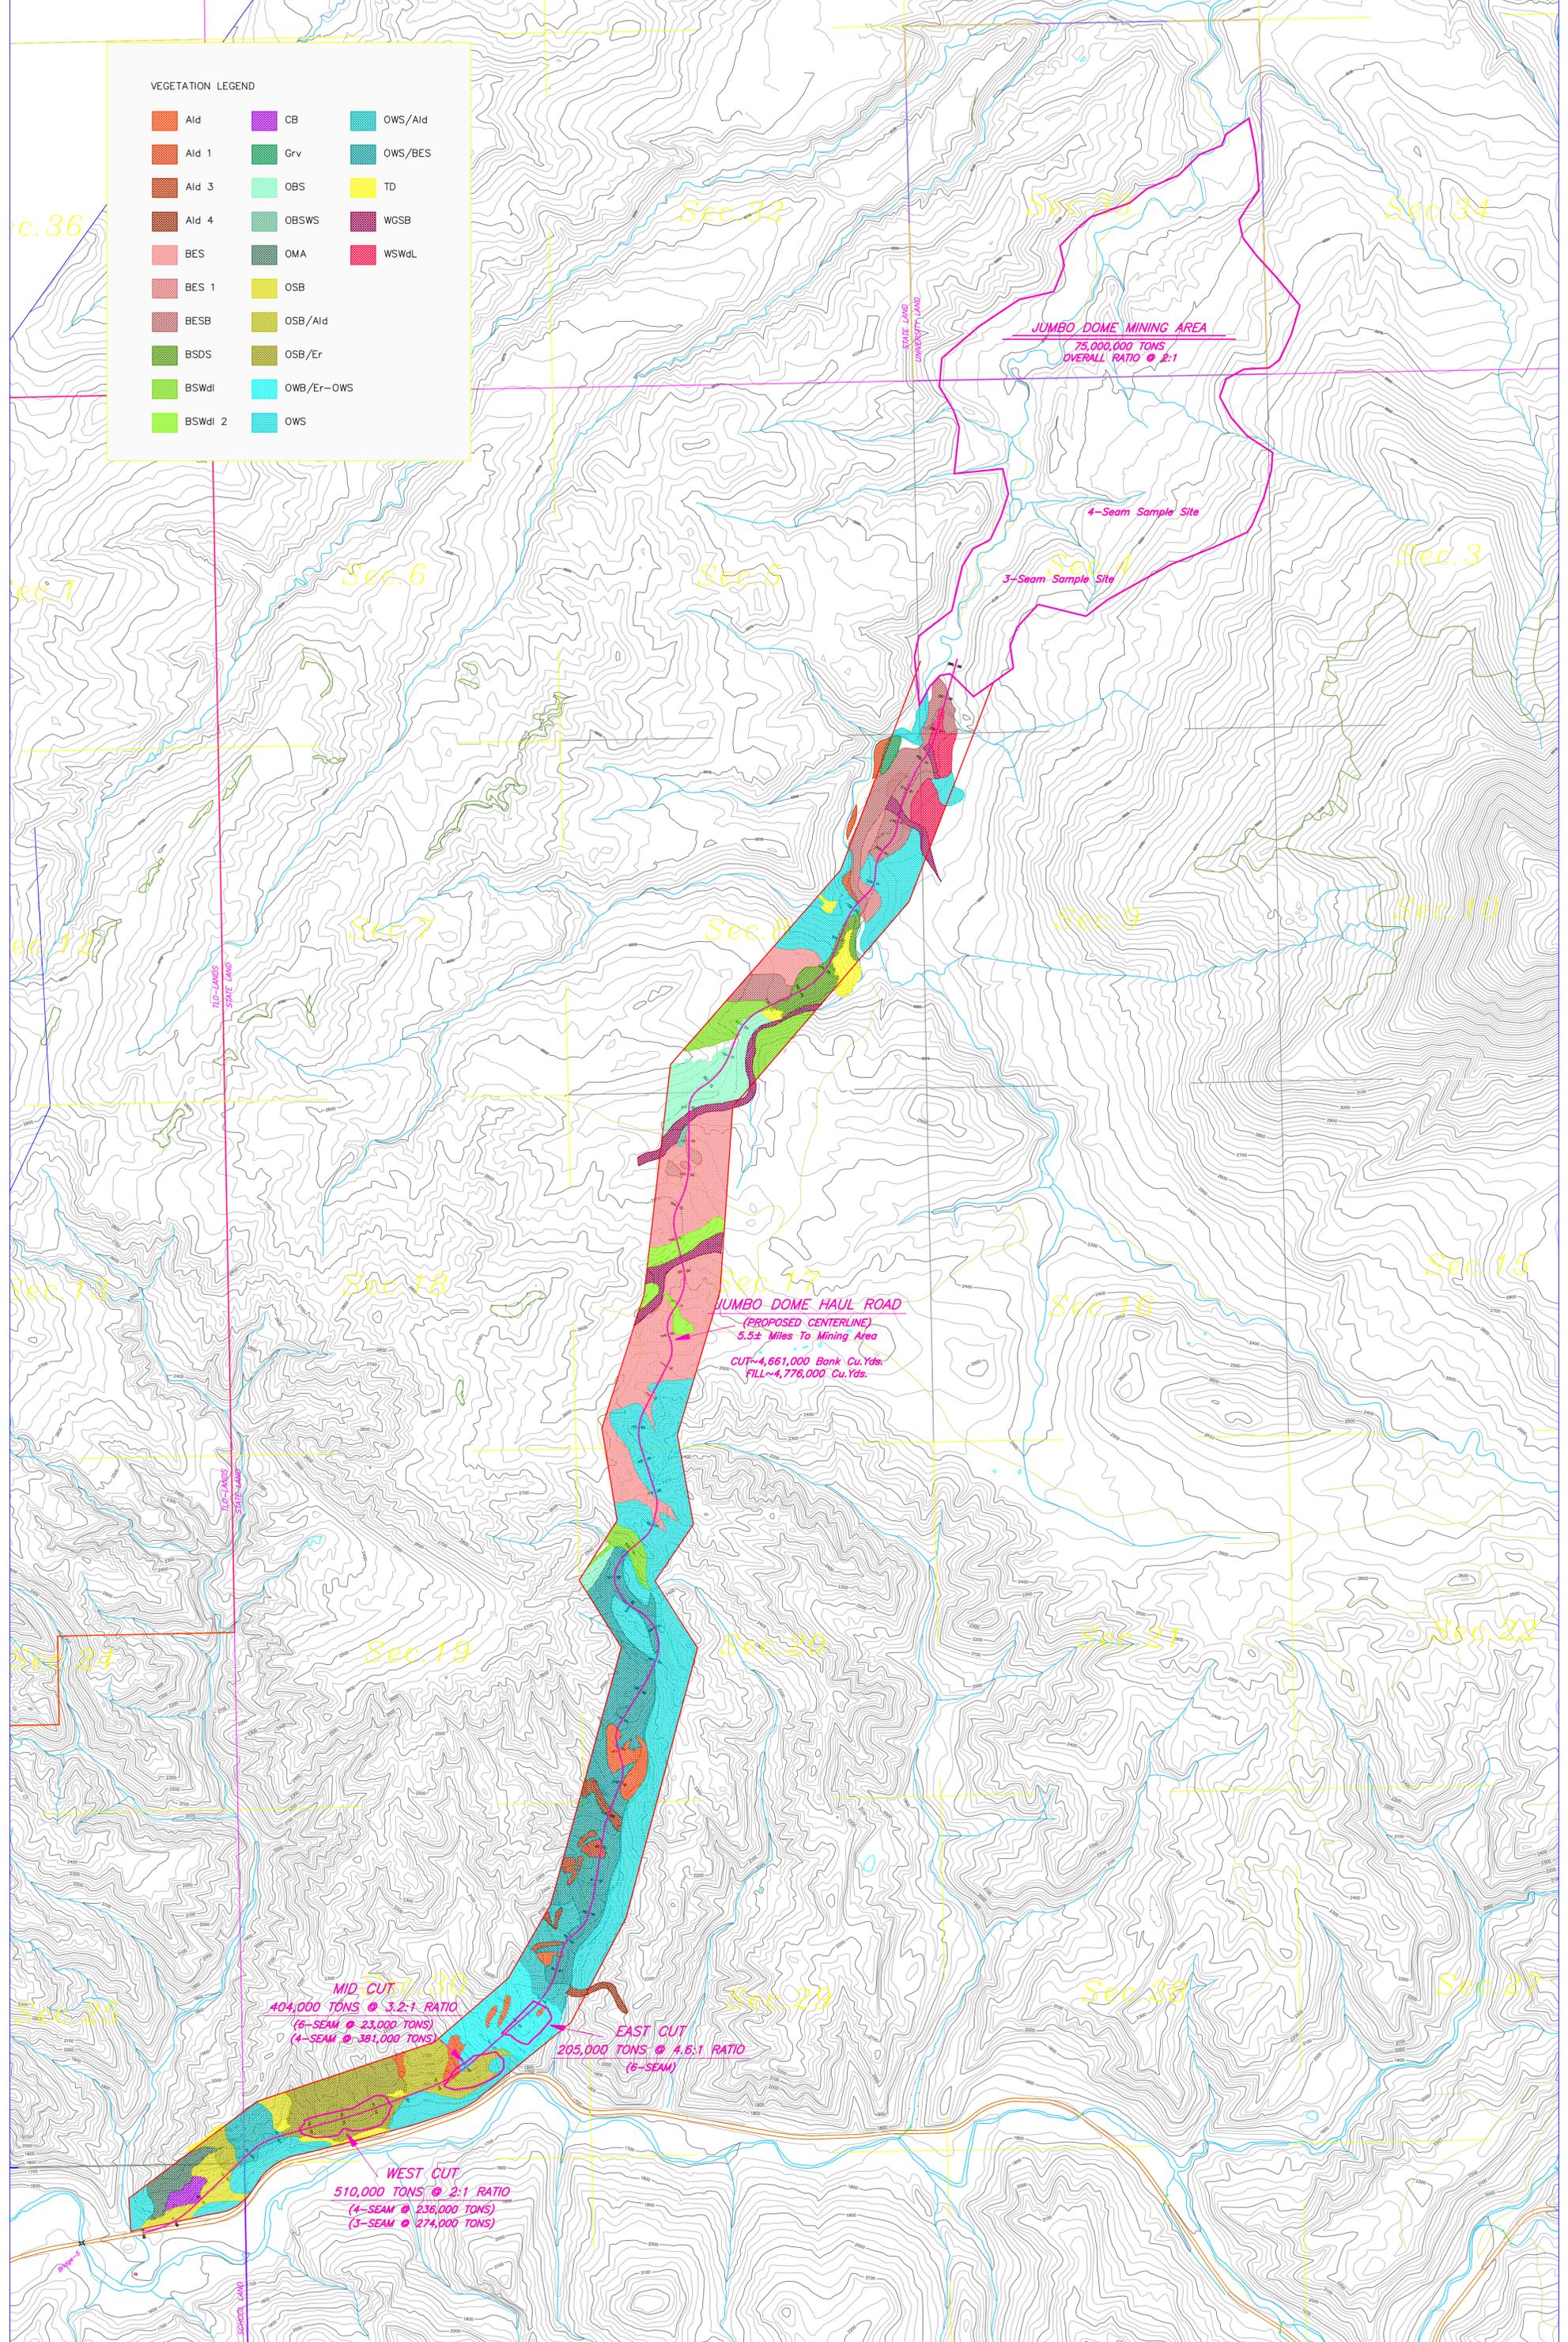
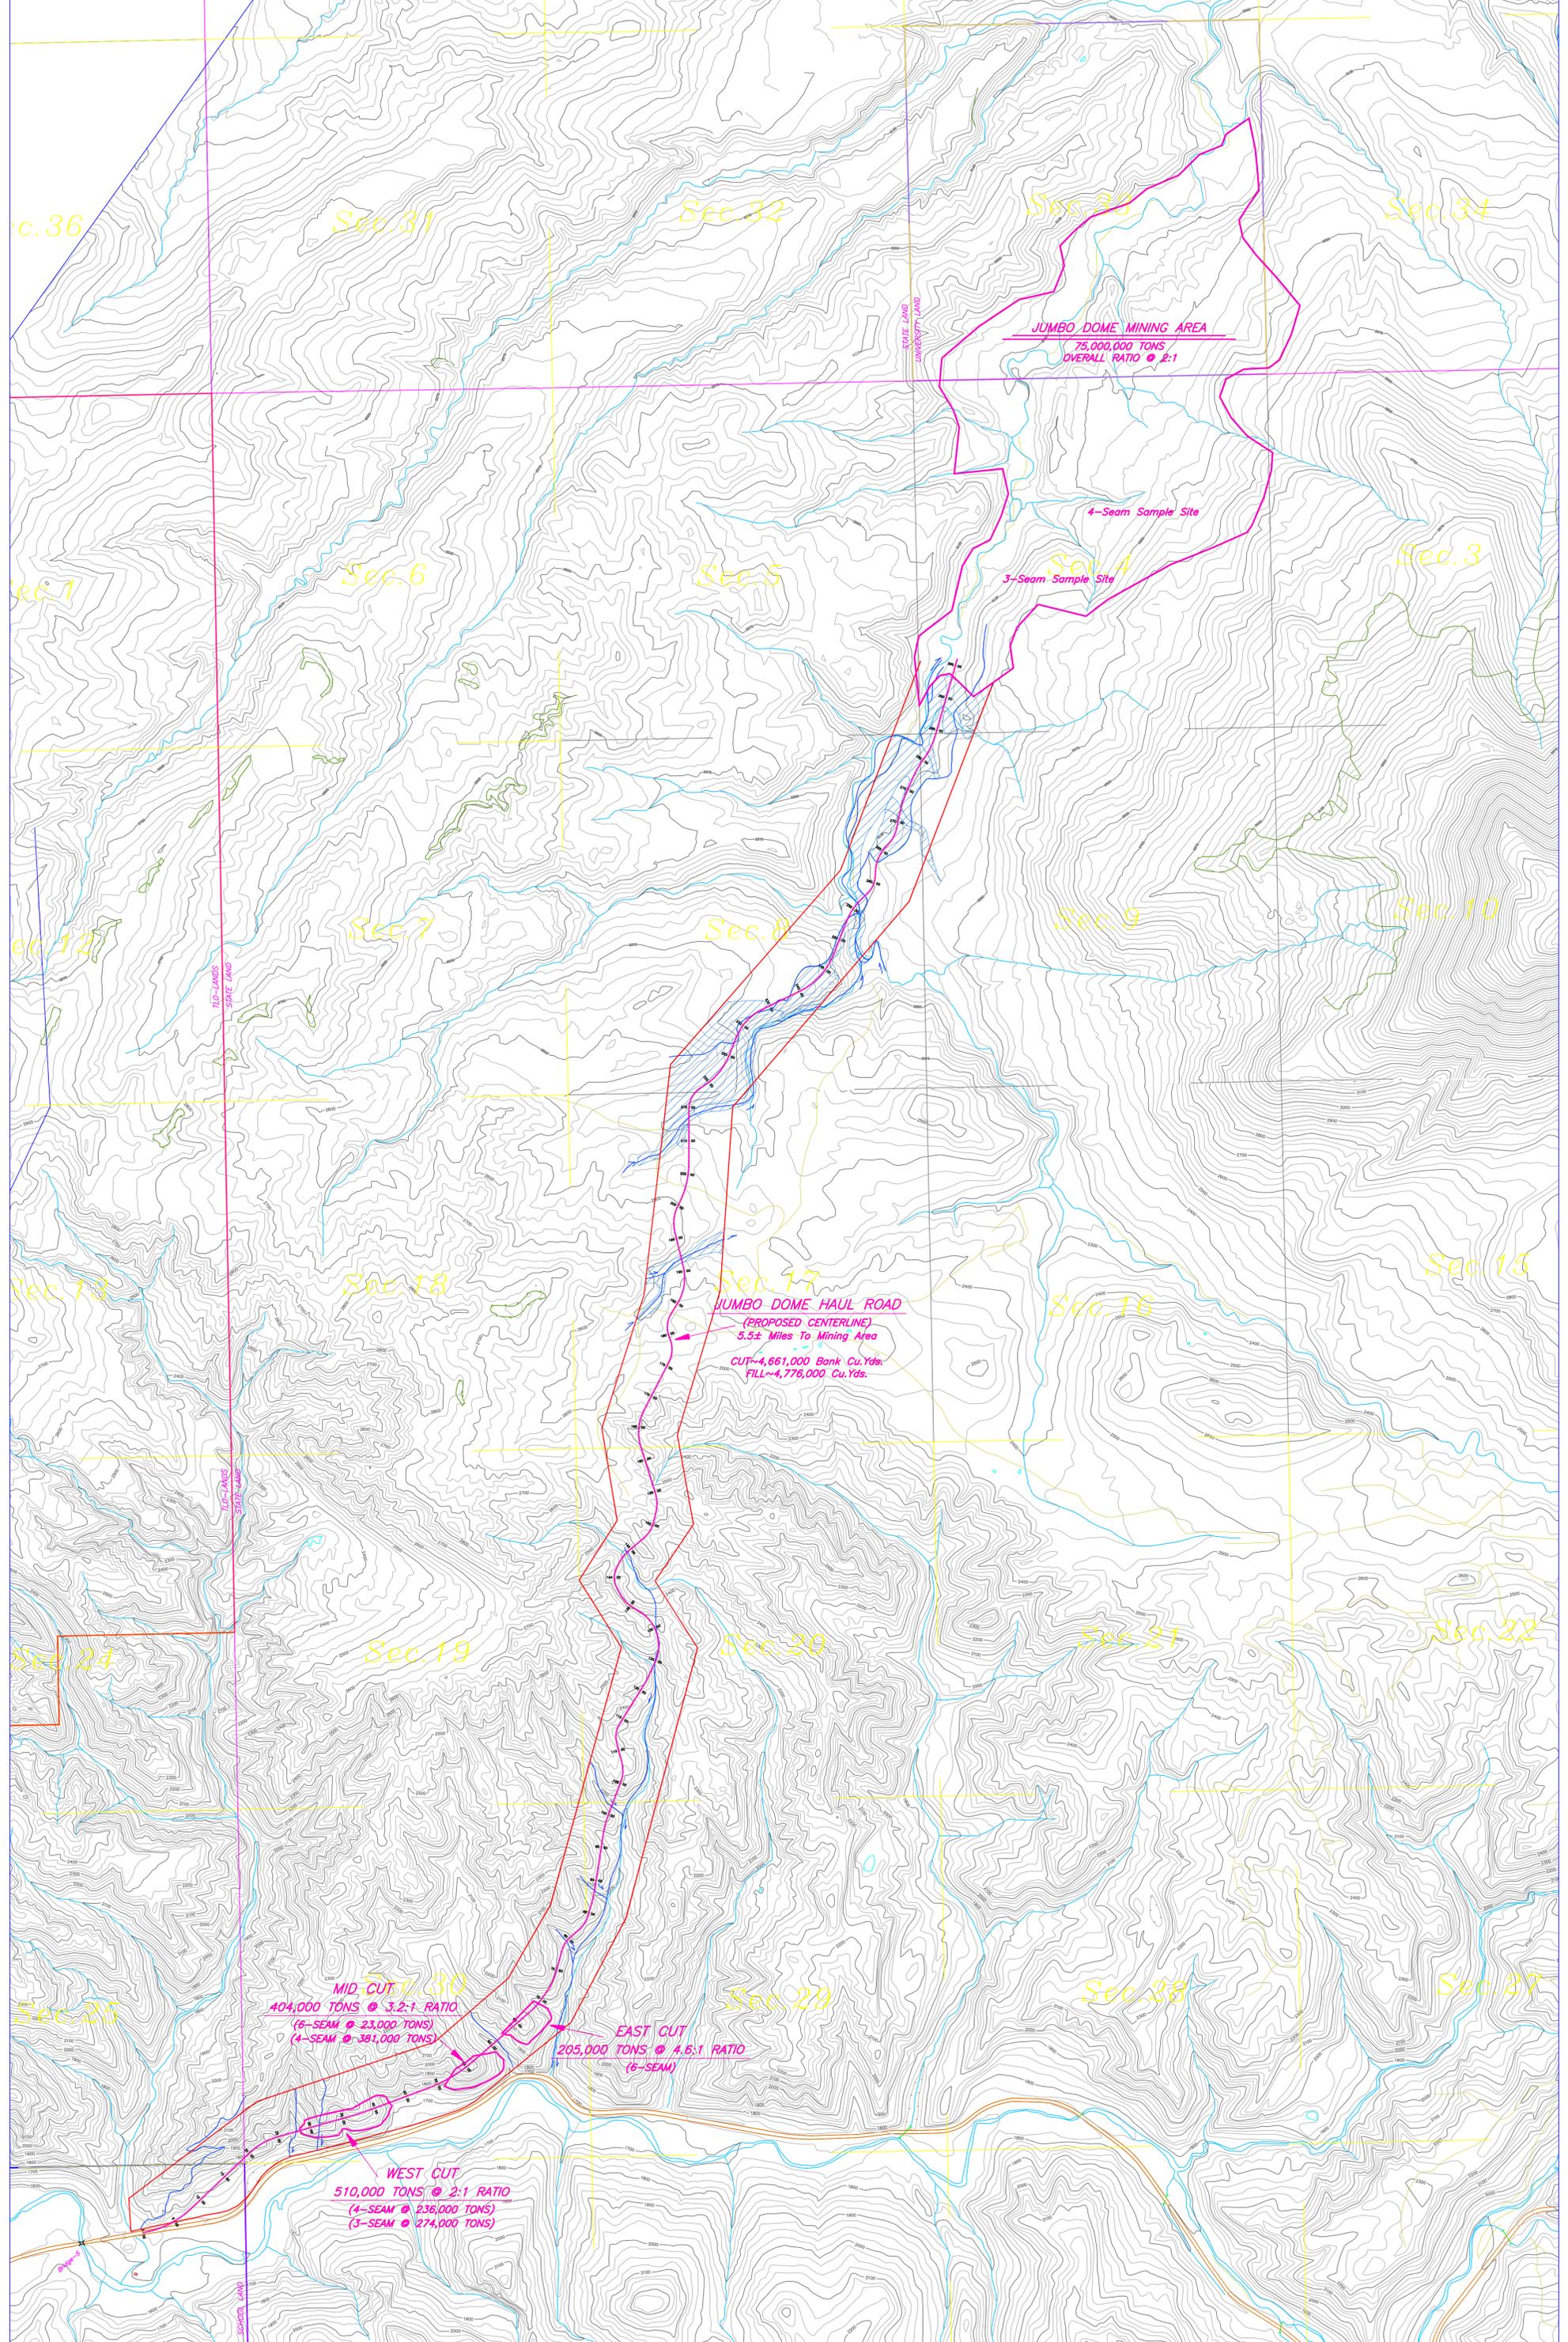
The two attached figures show the 2005 wetland mapping and the revisions made by HDR in 2011. The total road corridor mapping area, not counting area mapped by HDR in 2010 is 709.4. The mapping revisions have reduced wetland area by 49.6 acres. The table below shows the difference in wetland and upland acreage between the mapping done with 1987 Corps Manual and the Regional Supplement.

The other plot that disagrees with the revised wetland boundaries is JDRC-026. This plot is on a 15% slope (documented by TPECI and verified with existing contours) between the road and a tributary to Marguerite Creek. The 1987 data form completed by TPECI shows the area as having hydrophytic vegetation, wetland hydrology, and hydric soils. The vegetation is hydrophytic according to both the dominance test (75%) and the prevalence index (2.7). The plot was marked as saturated in the upper 12 inches; however the actual depth of saturation was not recorded. Rainfall records show that 0.2 inches of rain fell on the same day as this data was collected. The hydric soil indicators marked are “Aquic Moisture Regime” and “Gleyed or Low-Chroma Colors”. As the soil horizons are described on the data sheet, no hydric soil indicators are met for the Regional Supplement. The 1987 indicator “Aquic Moisture Regime does not occur in the 2007 Regional Supplement and no other hydric soil indicator applies. The soil horizons described do not actually meet the 1987 criteria for “Gleyed or Low-Chroma Colors”. This indicator requires the soil to be on the gley page or have a chroma below 2. All of the horizons have a chroma of 3 or higher and none of them are on the gley page. In fact, most of the layers are brightly colored. Since this plot is located on a steep slope, has no hydric soil indicators (according to the Regional Supplement) and was collected during a period of high rainfall, the plot is determined to be upland. This revises the area of wetland previously mapped by TPECI, changing the wetland status of the entire south slope of the Marguerite Valley tributary. See attached figures for example of the mapping differences.

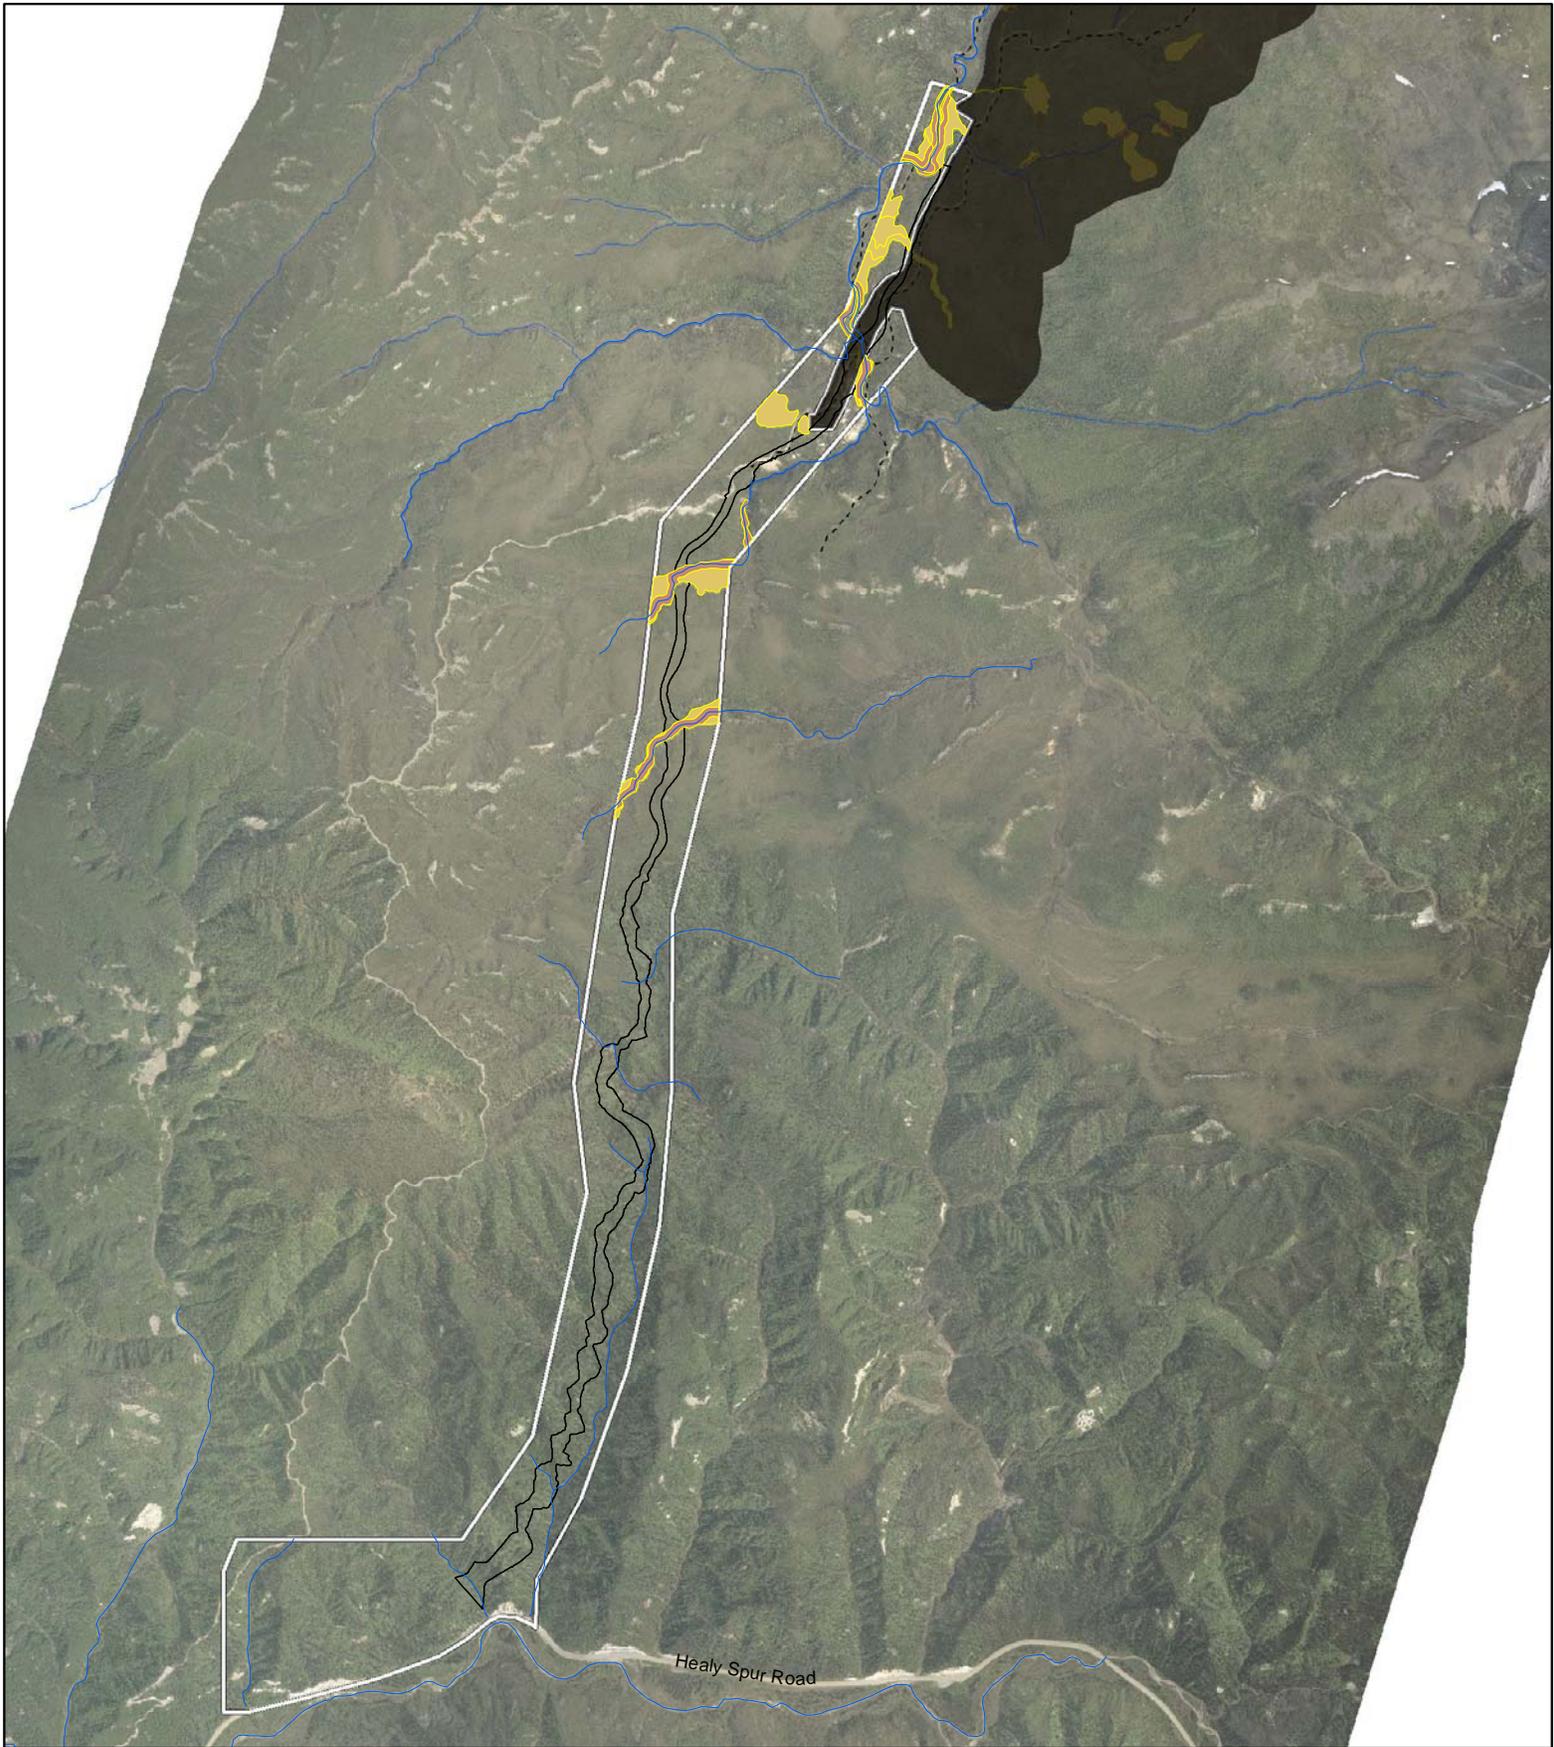
**FIGURE 1 AND WETLAND FUNCTION DATA FORMS**

1. Functional Categories were assigned to wetlands using guidance from the U.S. Army Corps of Engineers Alaska District Regulatory Guidance Letter ID No. 09-01.
2. Wetland mapping prepared by HDR Alaska, Inc. using field data from earlier Usibelli studies, aerial photograph interpretation, and a HDR field visit to the Mine Area during September 2010.
