**INACTIVE PRODUCTION ROCK SITES AND QUARRIES
2019 ANNUAL REPORT**

Hecla Greens Creek Mining Company

April 28, 2020

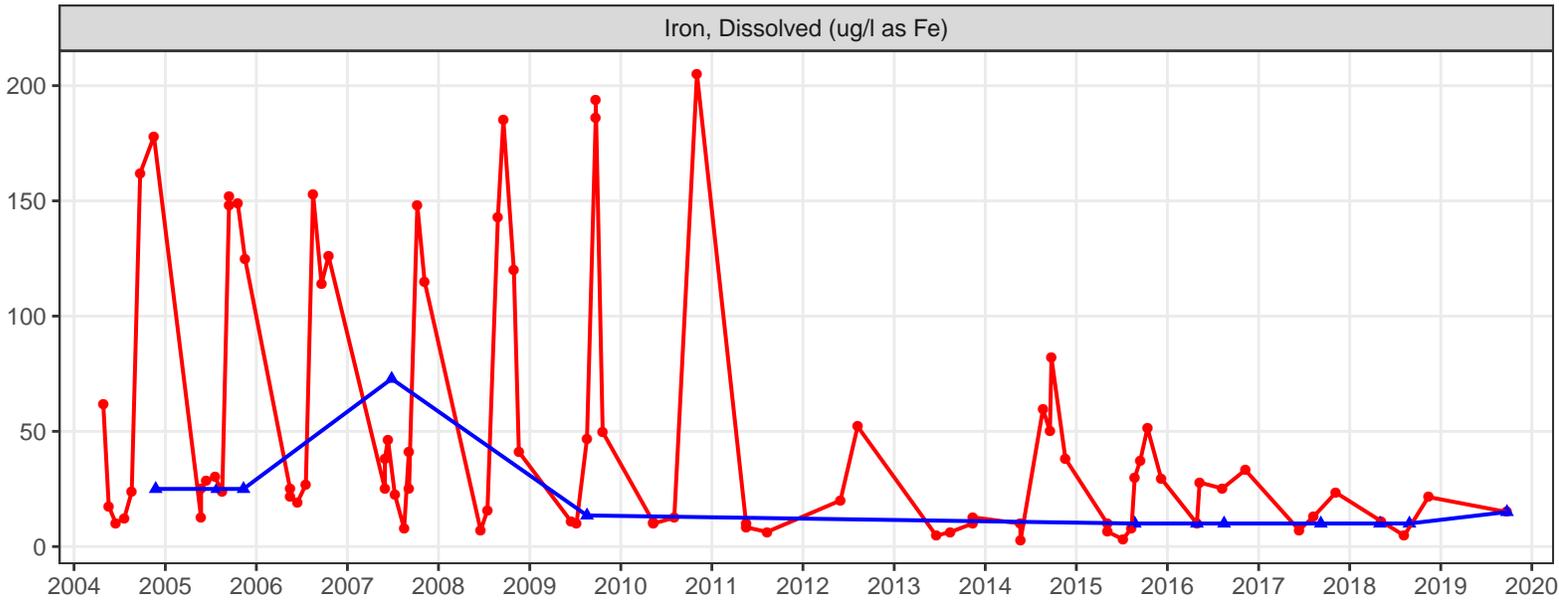
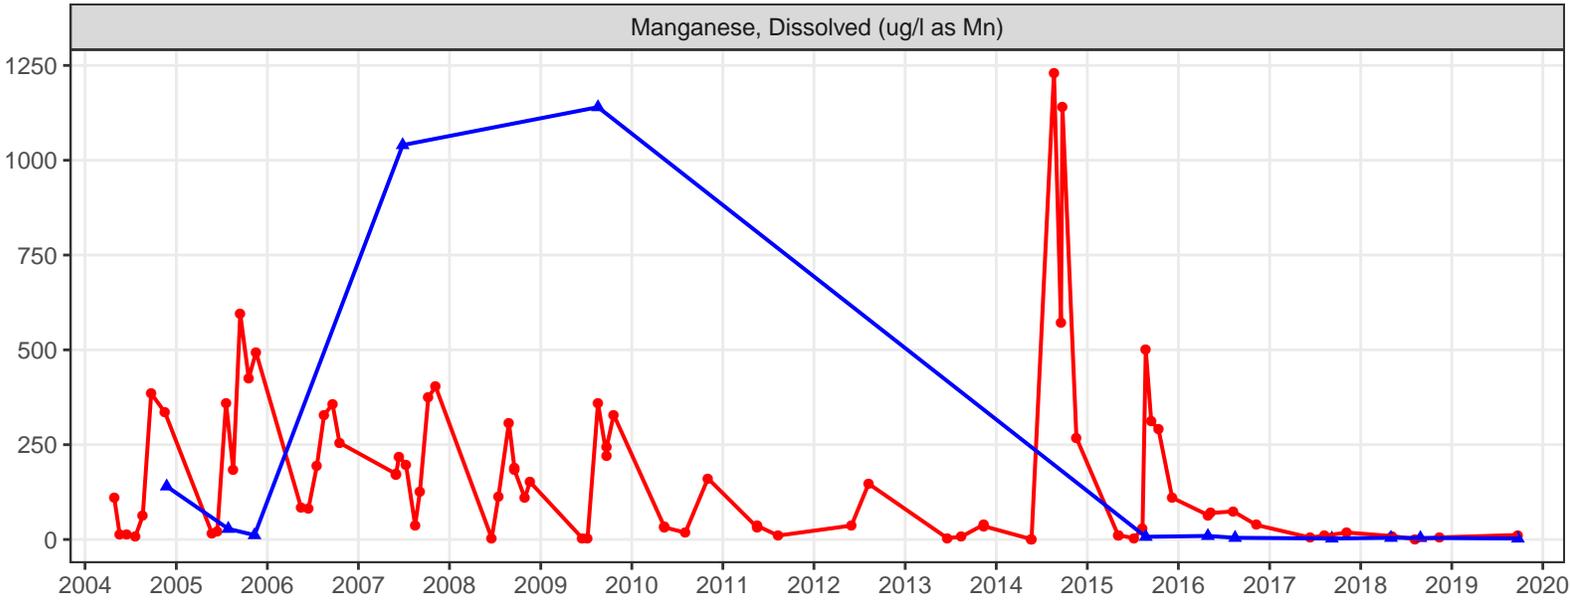
ATTACHMENT B 1350 Site

There are two surface water monitoring sites associated with the 1350 Site, designated as Site 13 and Site 307. Site 13, located in a drainage east of the 1350 adit, was established to monitor surface runoff quality from a large portion of the production rock pile. This site has been routinely monitored since 1985 and is included in the Fresh Water Monitoring Program, and is also a permitted storm water outfall in the HGCMC APDES Permit. Site 307 is a small seep located below what was called the east lobe of the production rock pile. This site was monitored periodically between 2003 and 2009, and has been monitored two times per year since 2015. Water quality graphs for these sites, provided in Attachment B, illustrate the benefits of the production rock removal and reclamation work.

The last, large production rock removal campaign occurred in June 2014. Approximately 11,200 cubic yards of material were removed, primarily from the runoff catchment that drains to water quality monitoring Site 13. Following completion of the 2014 removal activities, there was a substantial spike in metals concentrations at Site 13, including cadmium, copper, lead, manganese, nickel and zinc. This was expected since the removal activities were up-gradient of the monitoring site and resulted in exposing relatively unoxidized production rock at the edge of the removal area near the 1350 adit. It was also expected that there would be a relatively short flushing period of residual oxidation products from the underlying soils beneath the recently removed production rock. A similar spike in metals was observed in 2003 and 2004 at the 960 Site following production rock removal, and by 2005 concentrations decreased significantly to well below pre-removal levels. Monitoring results from Site 13 show that metals concentrations are trending downward. Measurements of conductivity, sulfate, and hardness in 2019 remained at the low levels measured in the previous year, which were the lowest seen since 1985.

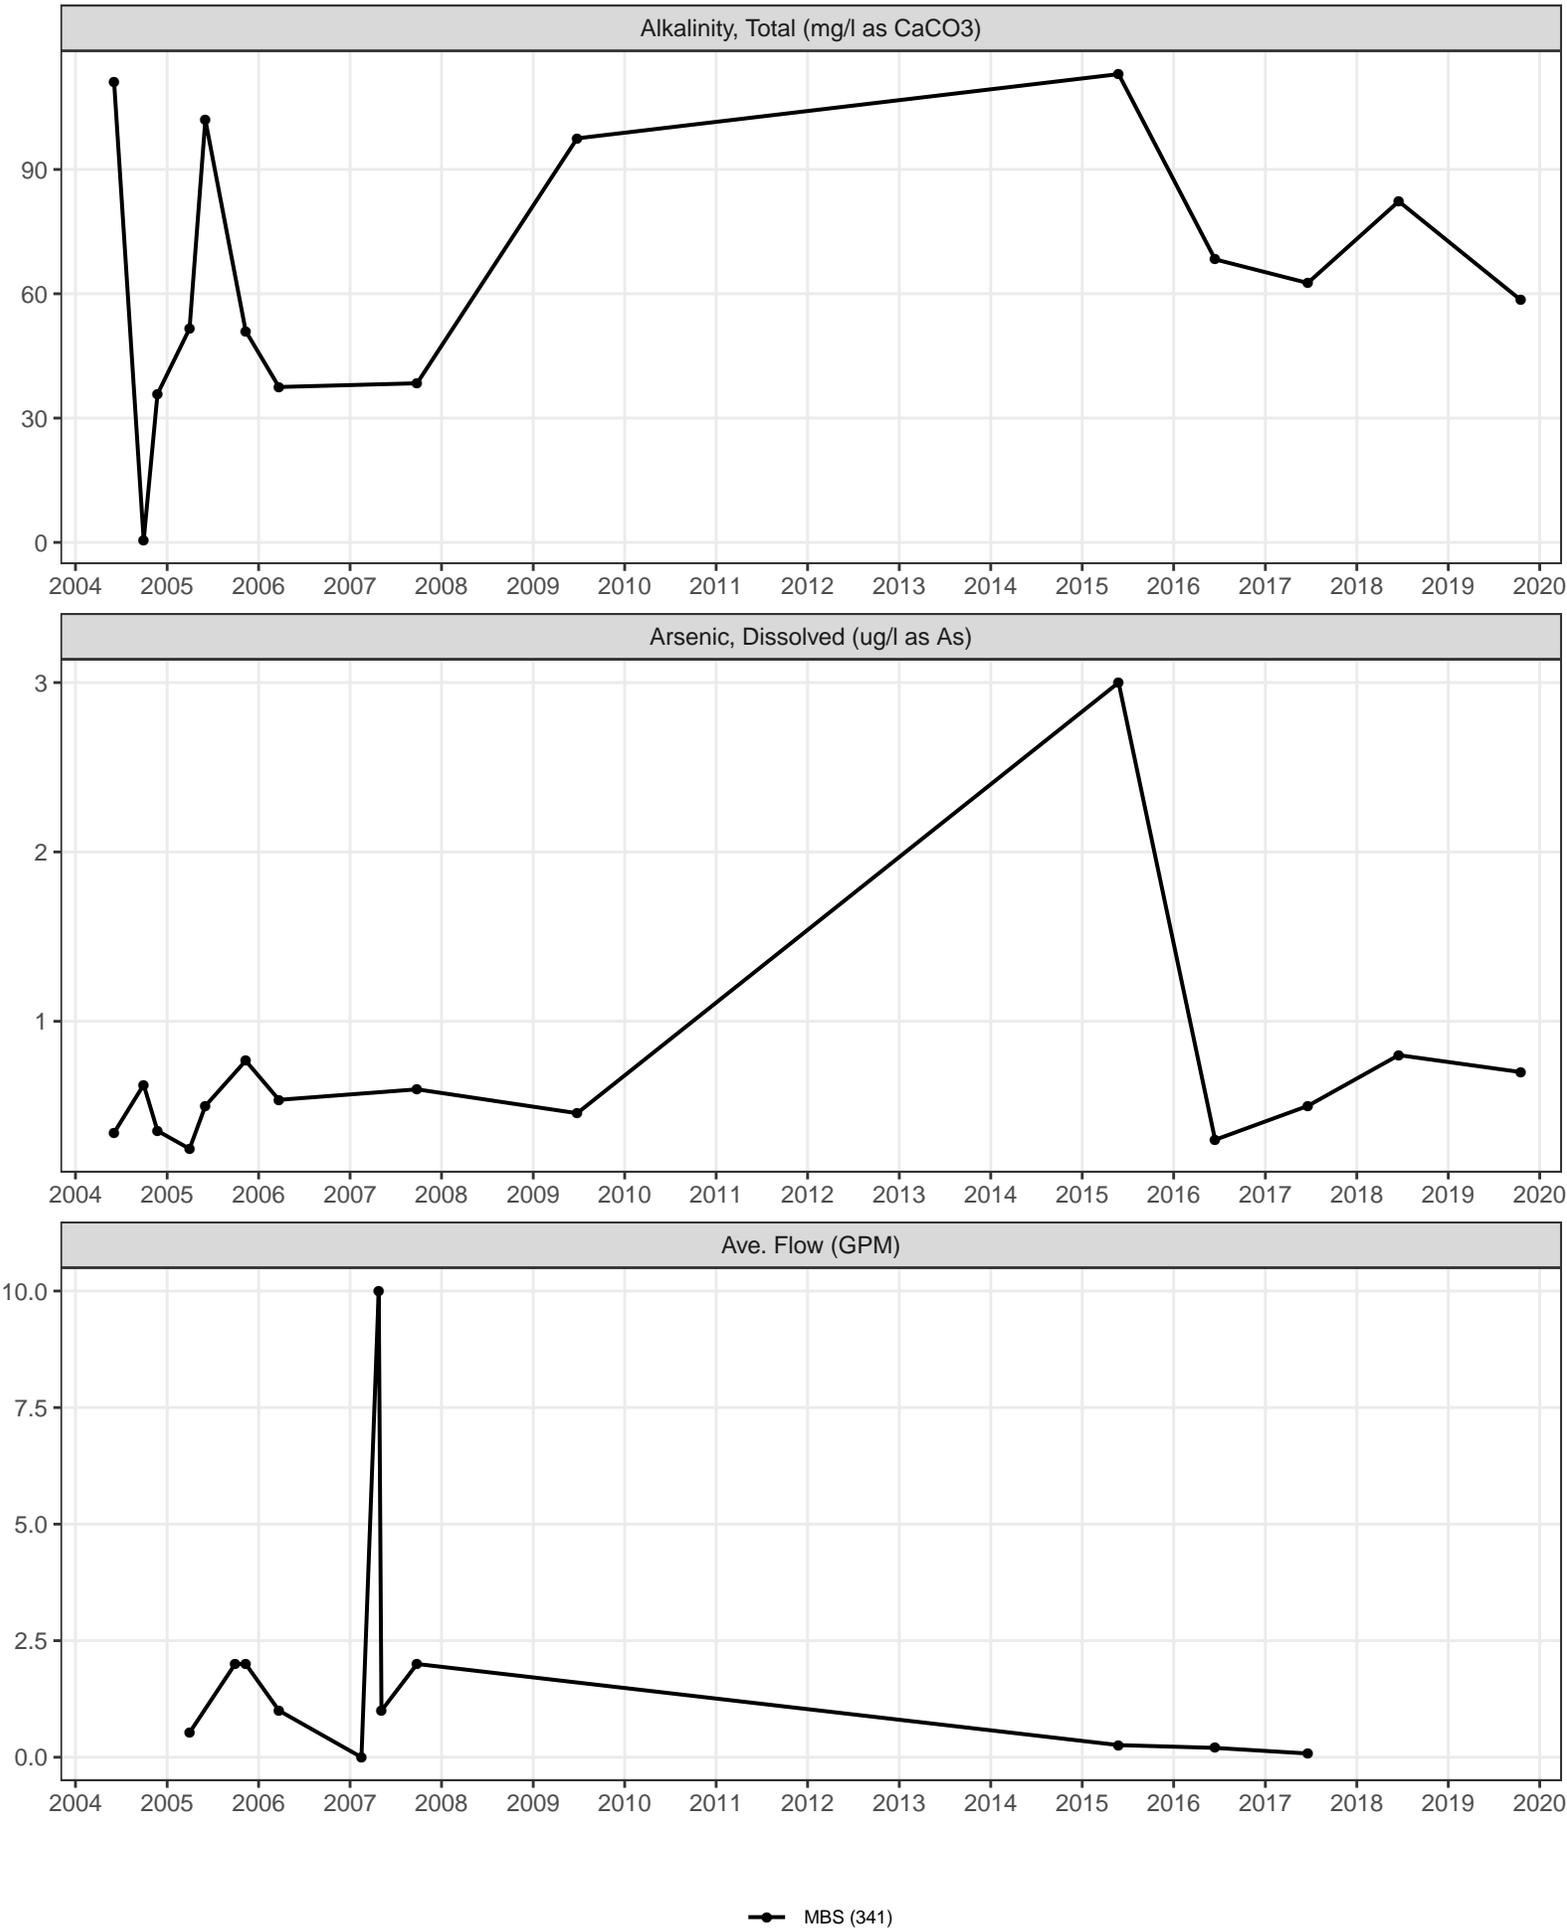
ATTACHMENT D Mill Backslope

Drainage from the Mill Backslope is a combination of groundwater intercepted by the dewatering drains, seepage from the surface expression of shallow groundwater, and surface runoff from precipitation. Average flows from combined Mill Backslope sources are low (less than 10 gpm). Sample site MBS 341 was established in 2003 and represents a composite of the groundwater and surface runoff. As shown on the water quality graphs provided in Attachment D, this site typically has the highest metals concentrations of all inactive production rocks sites. Water quality at site MBS 341 is monitored infrequently since all flow is captured and routed to water treatment facilities. This site was sampled once in 2019 and the results were generally consistent with past monitoring data.

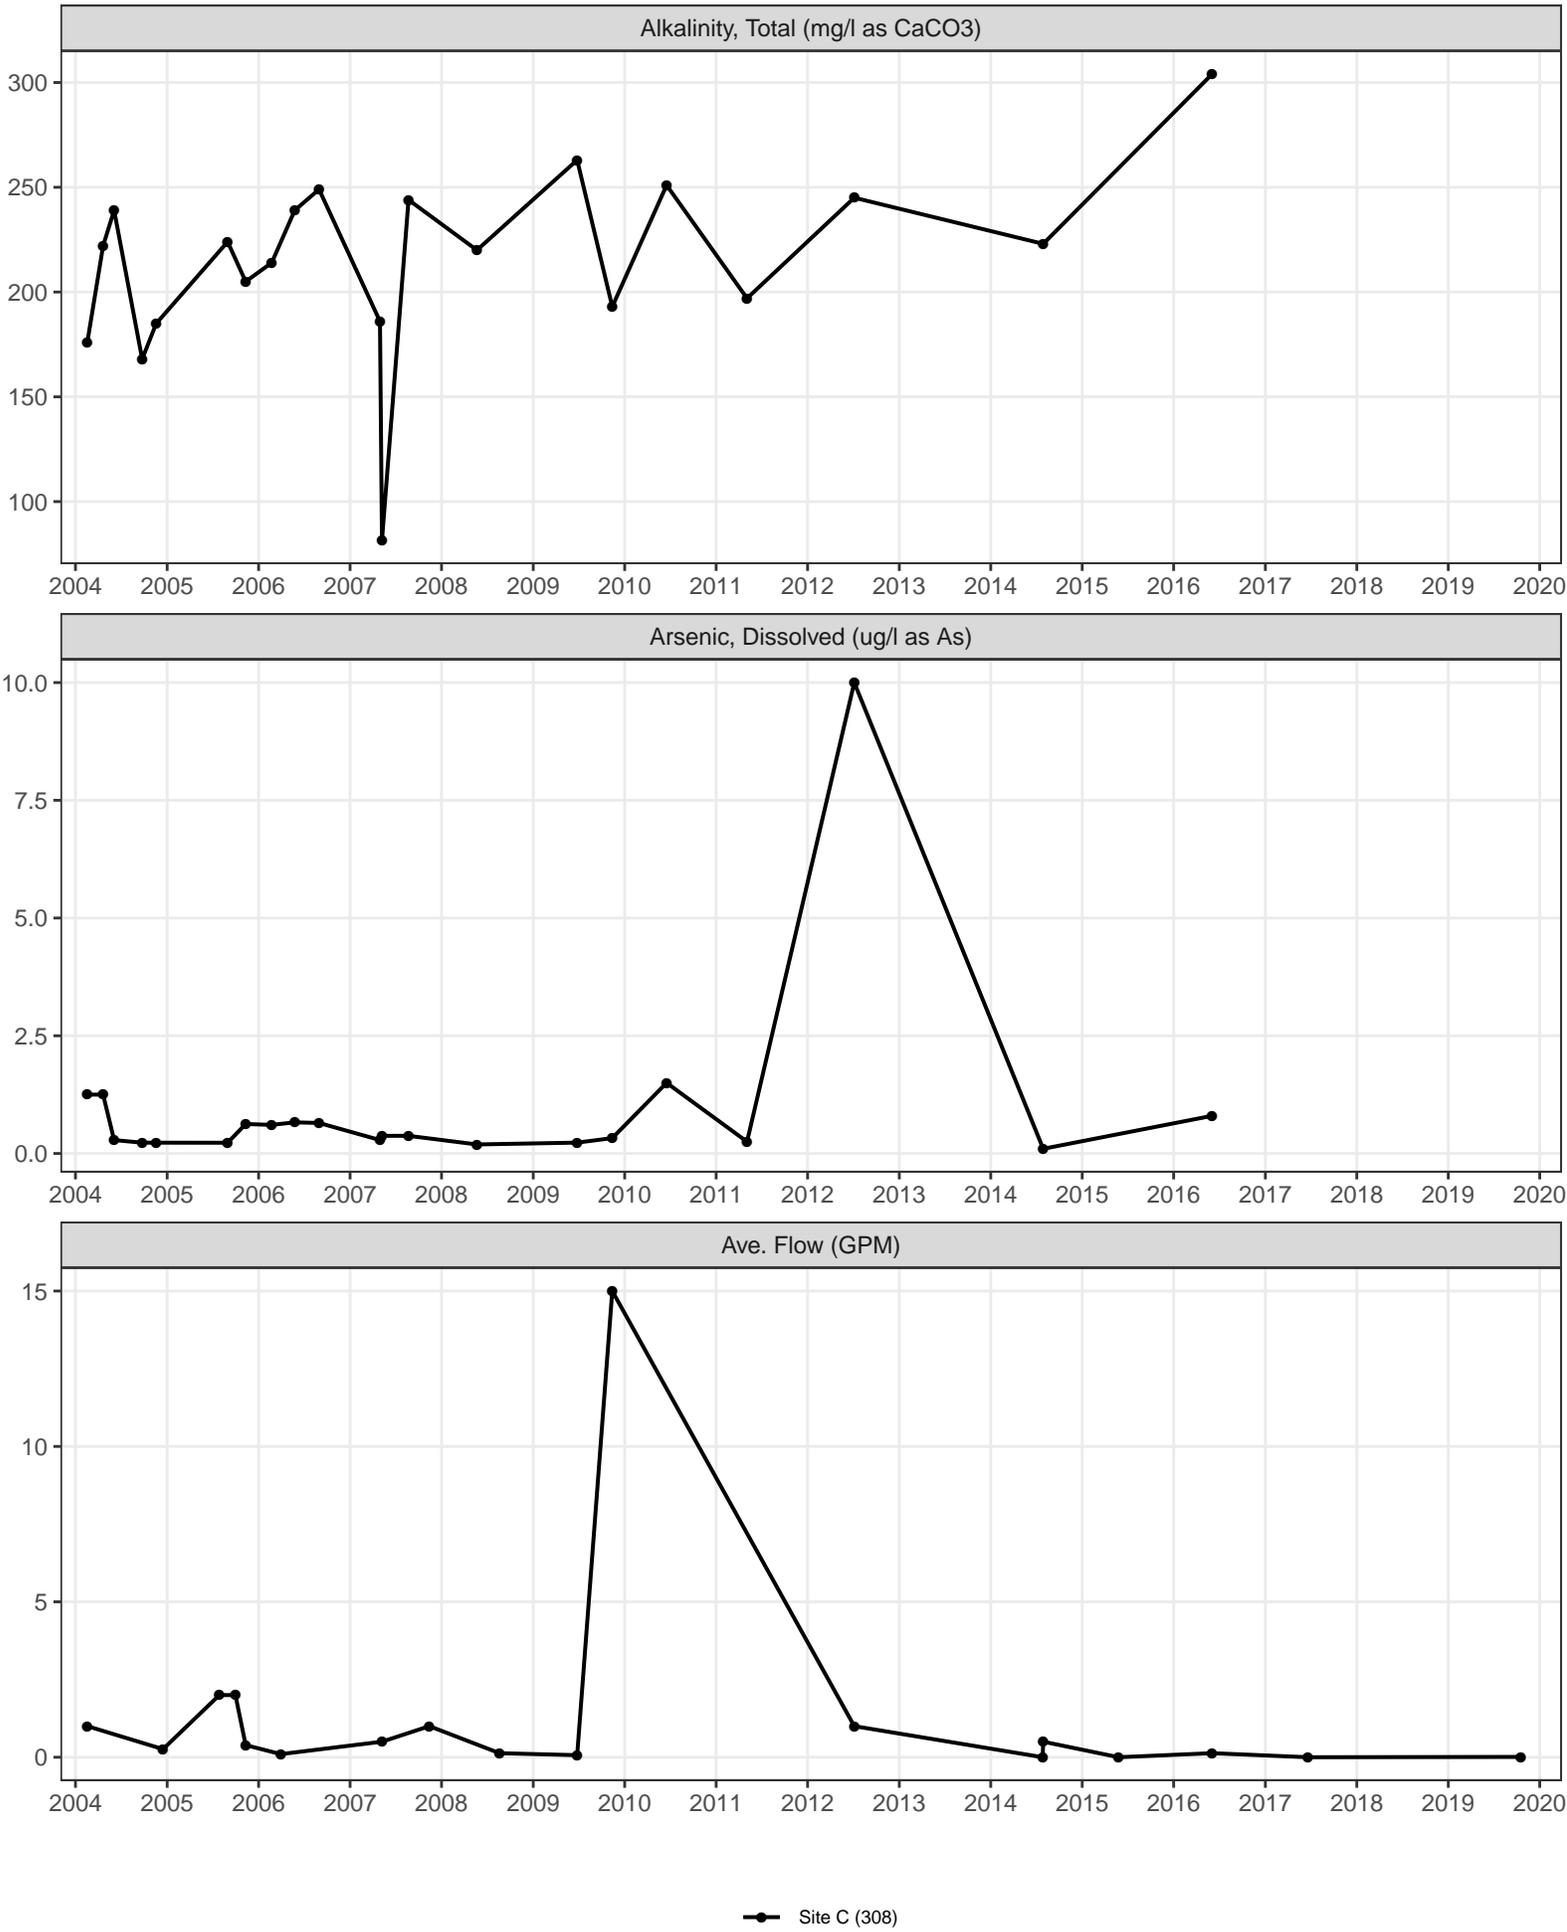
ATTACHMENT E

Drainage from Site C has been monitored routinely since 2002 from a seep located at the toe of the slope that is within the lower Pond C (Site 308). Flow at this site is low (generally less than 1 gpm), remains near-neutral, and contains elevated manganese concentrations, as well as moderate sulfate, zinc, cadmium and iron concentrations. Water quality graphs are provided as Attachment E.

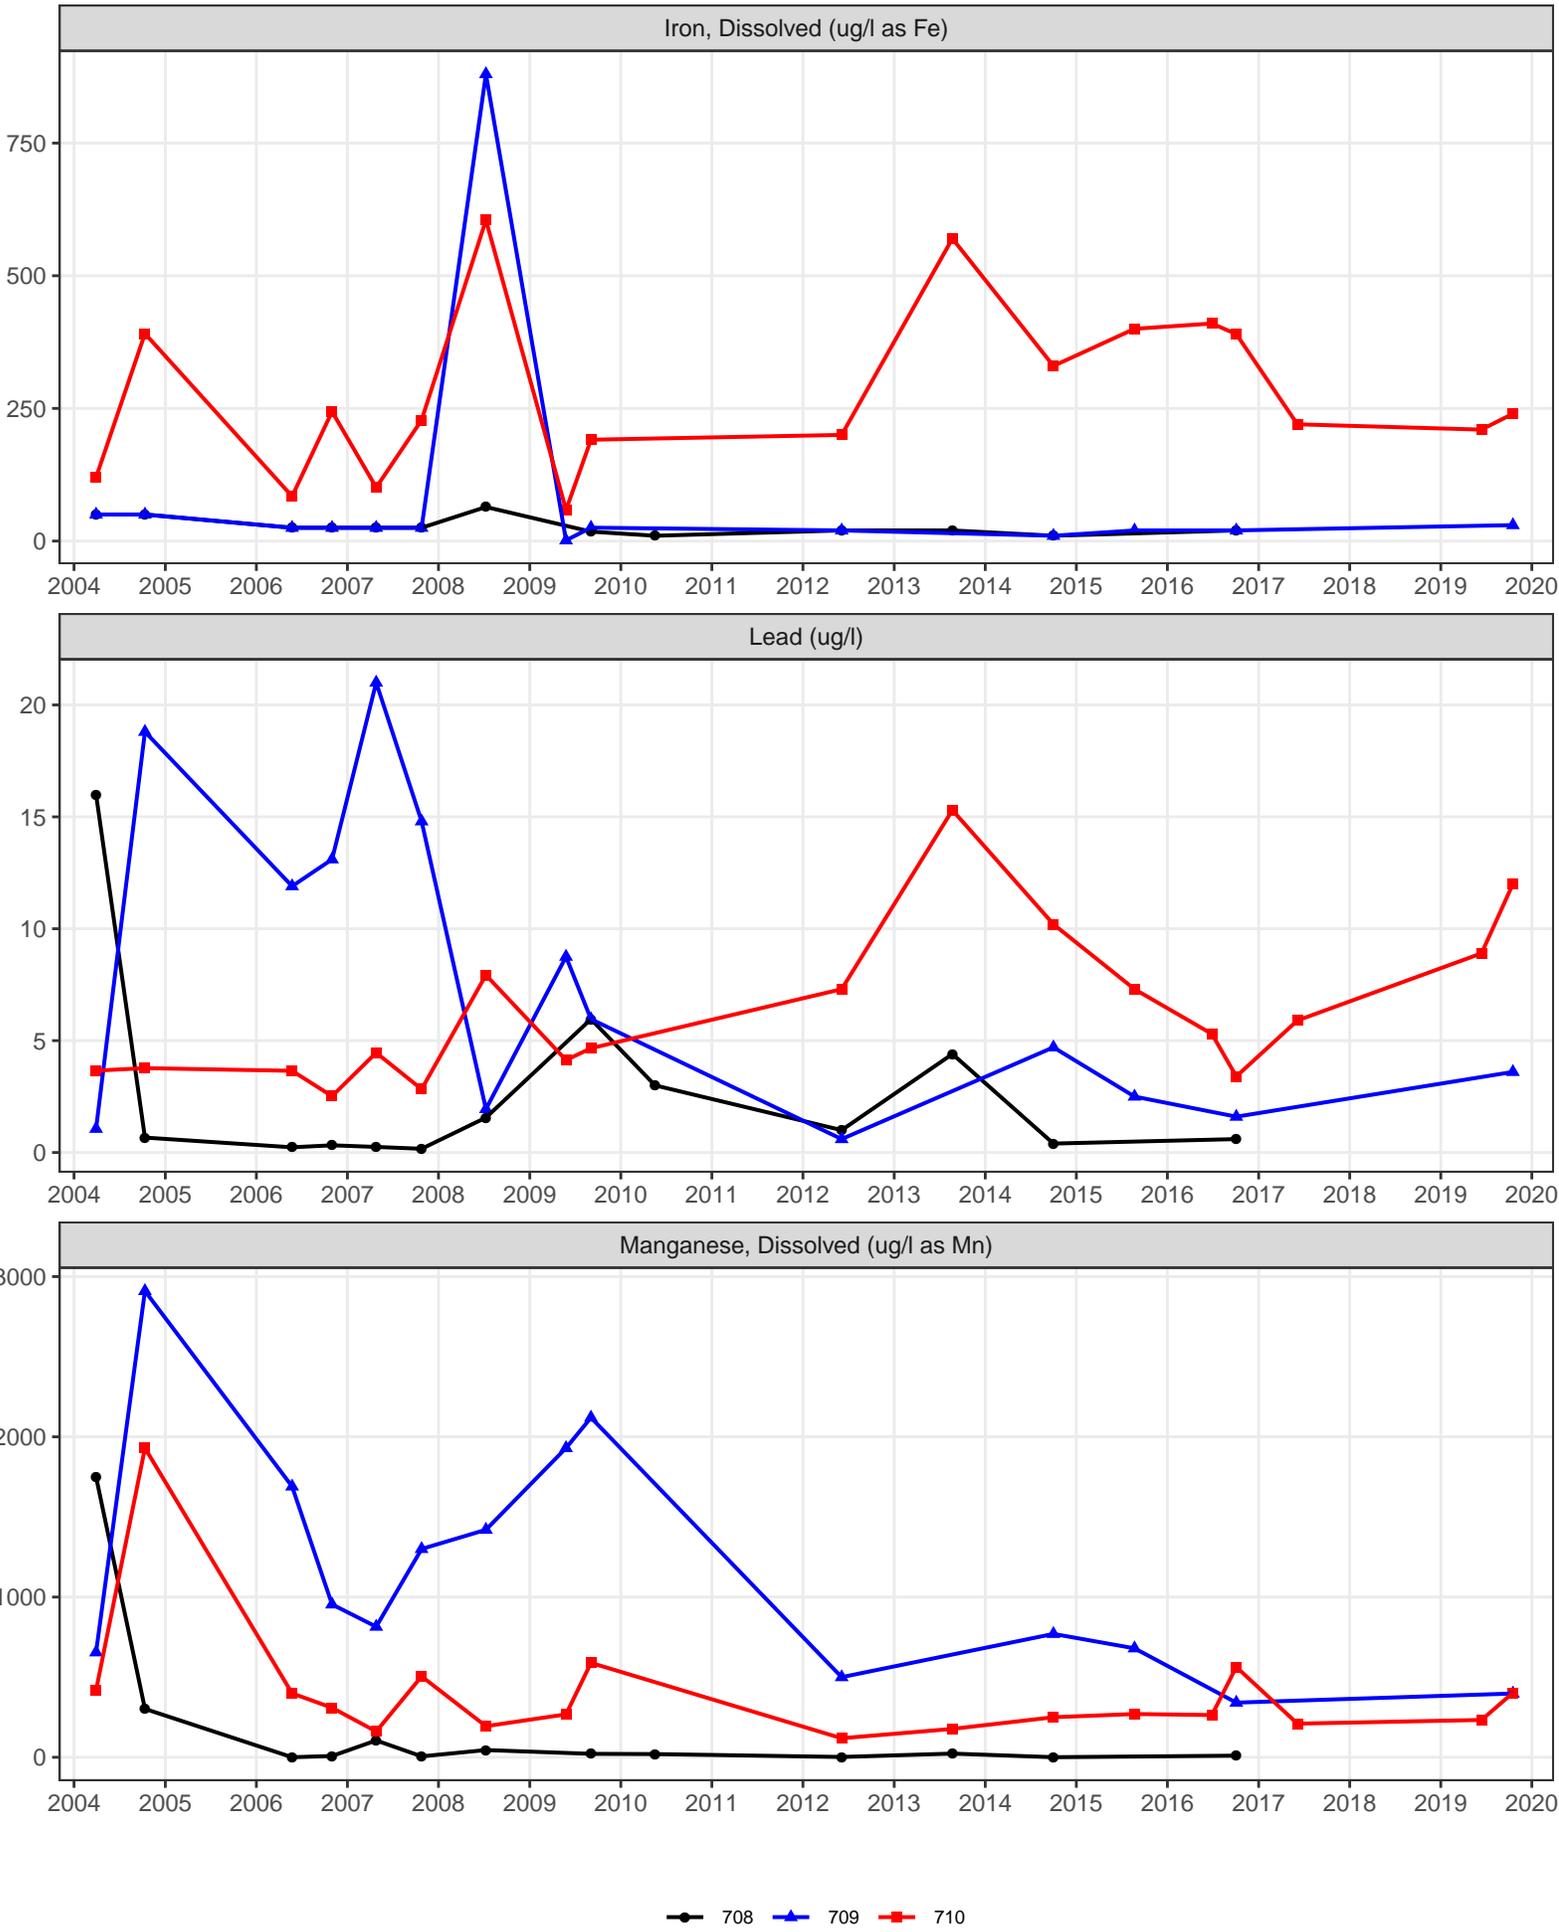
ATTACHMENT F Site E Perimeter Seeps

As shown in Attachment F, the water quality of the toe seeps is highly variable. This is likely attributed to the low flow rates where only a slight change in flow from precipitation events could cause a large change in concentration. The graphs indicate there has been a substantial decrease in concentration for several of the monitored constituents at site 709 when comparing the data from pre-2010 to the results from after 2010. Site 709 is a toe seep located on the east side of Site E. Most of the production rock removed from Site E was from the eastern portion of the pile, which eliminated a significant source of the chemical loading to this seep.

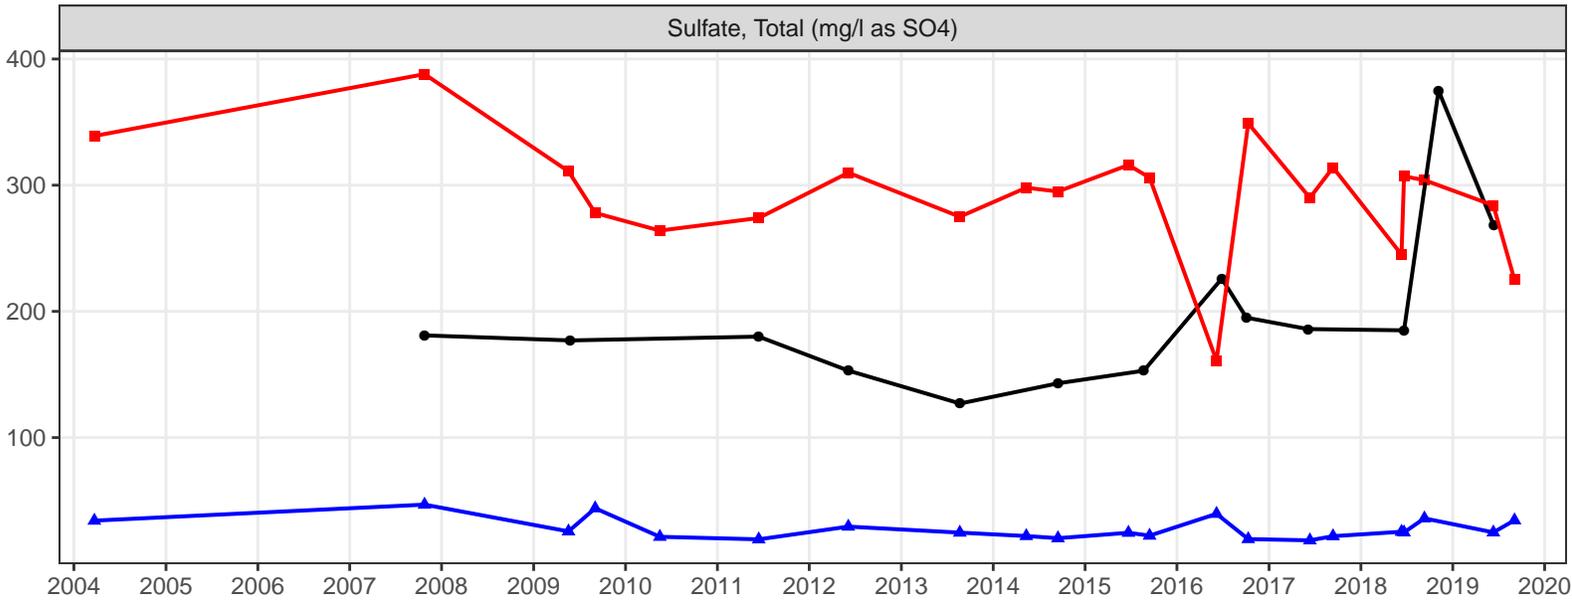
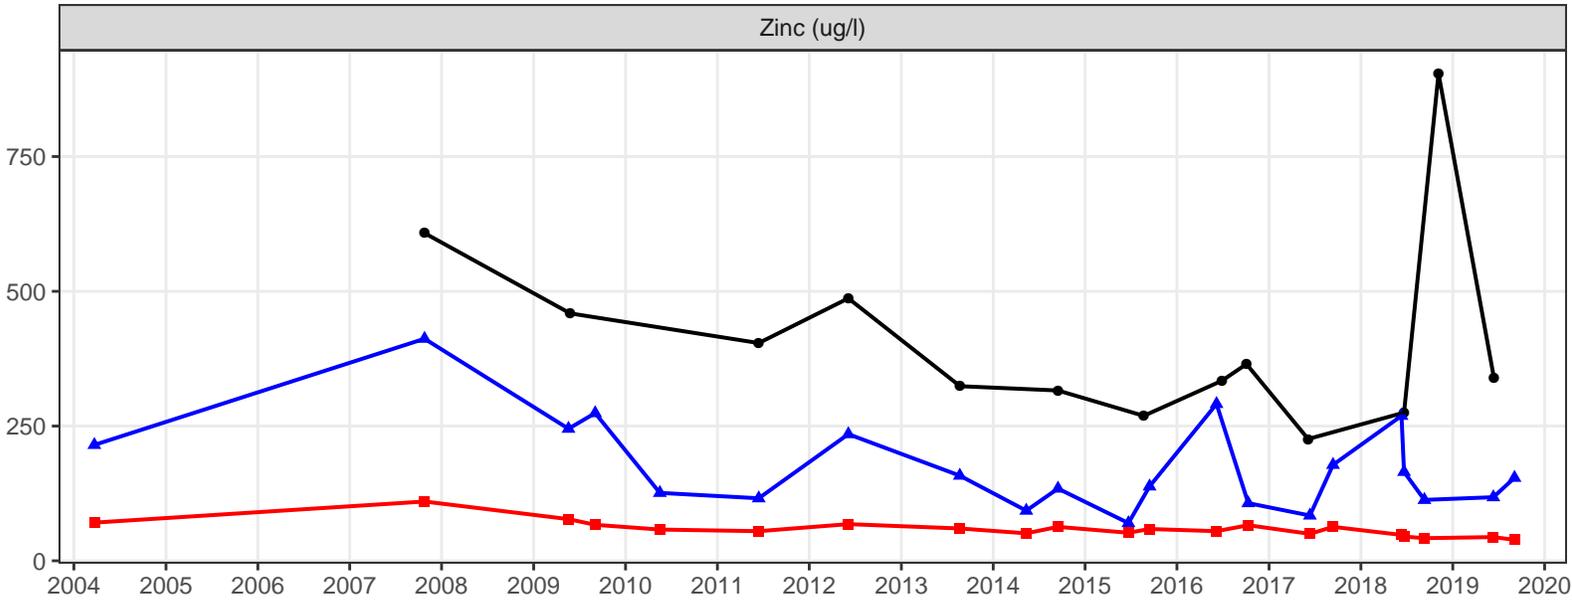
ATTACHMENT G Site E

The water quality of the three down-gradient drainages below Site E, shown in Attachment G, remains fairly consistent due to the higher flow rates. Of the three drainages, site 703 has the highest flows. Based on its location, site 703 is the most likely drainage to have been influenced by the production rock removal that has occurred. However, there are no obvious water quality trends due to the limited amount of data collected prior to 2009, which was the first year with large scale material removal.
