**INACTIVE PRODUCTION ROCK SITES AND QUARRIES  
2018 ANNUAL REPORT**

**Hecla Greens Creek Mining Company**

**April 30, 2019**

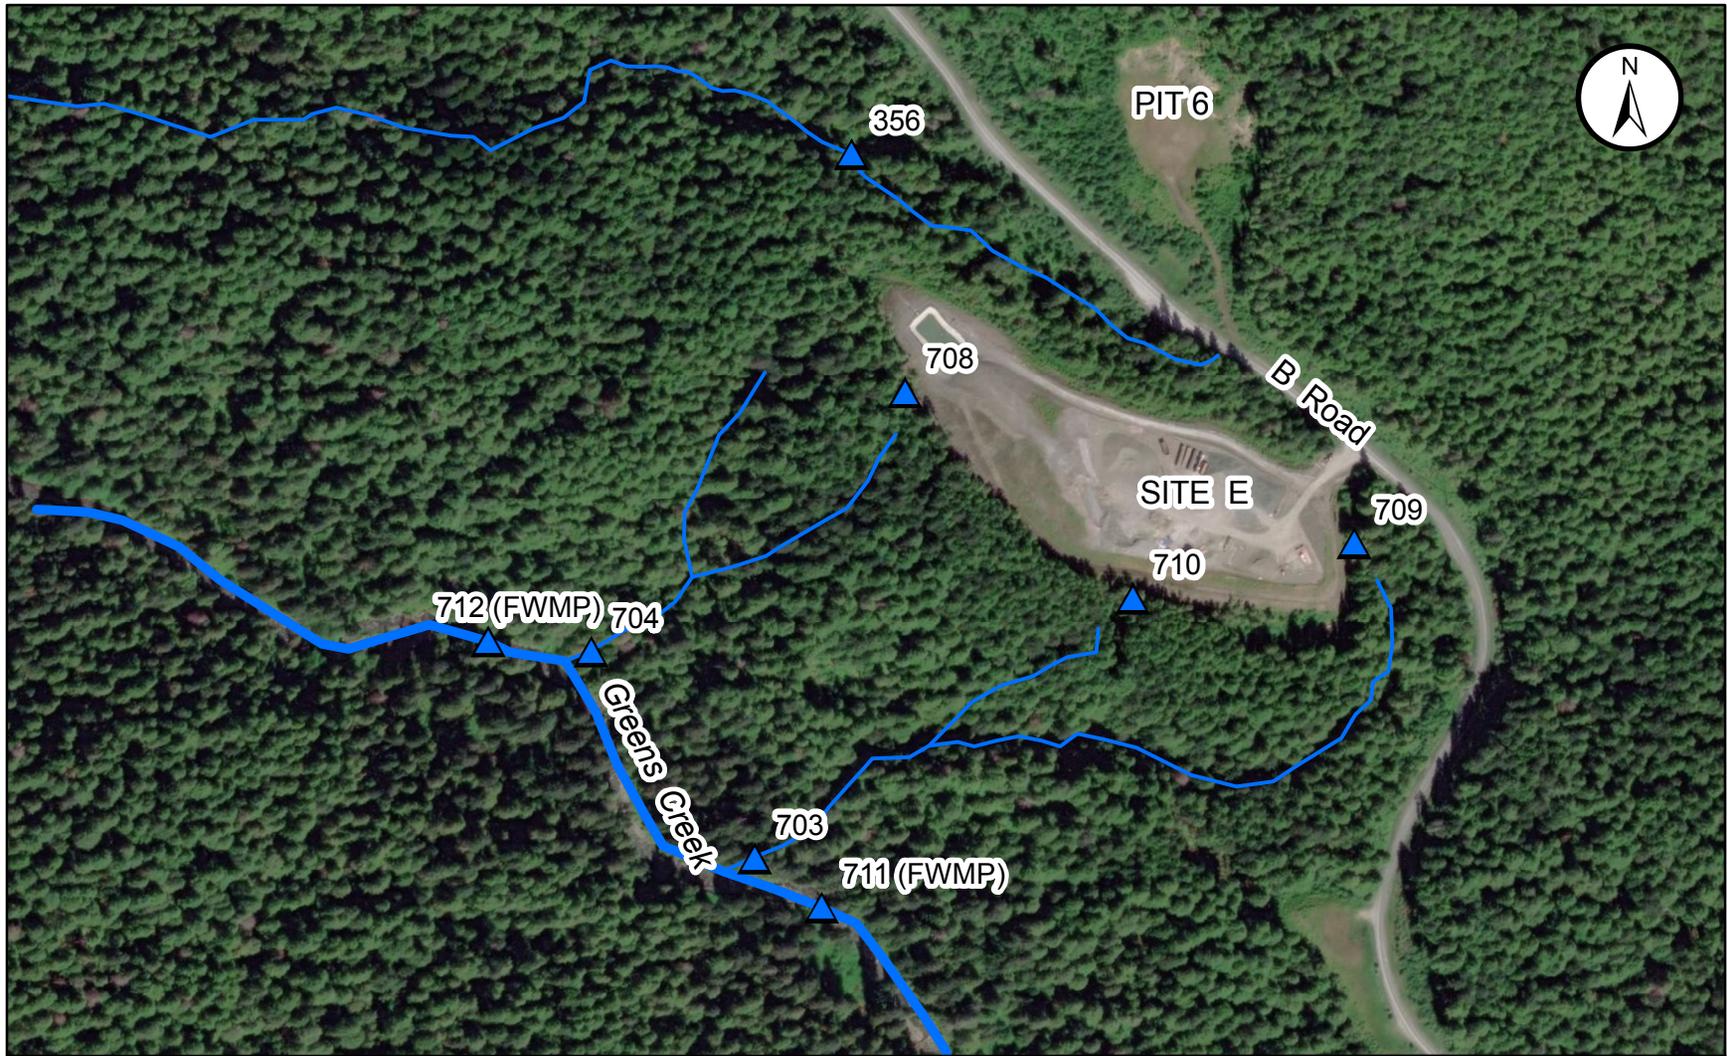
Attachment A  
Site E Monitoring Locations

The current water quality monitoring program associated with Site E consists of sampling six surface water sites. Three sites are intermittent low flow seeps around the toe of the production rock pile (sites 708, 709 and 710), and three sites are in drainages down-gradient from the pile that report to Greens Creek (sites 356, 703 and 704). A figure showing the monitoring locations is provided in Attachment A. There are also two sites in Greens Creek that are sampled under the Fresh Water Monitoring Program; water quality information for those site is provided in the annual FWMP report. Water quality graphs for the toe seeps are provided in Attachment F and water quality graphs for the down-gradient drainages are provided in Attachment G.

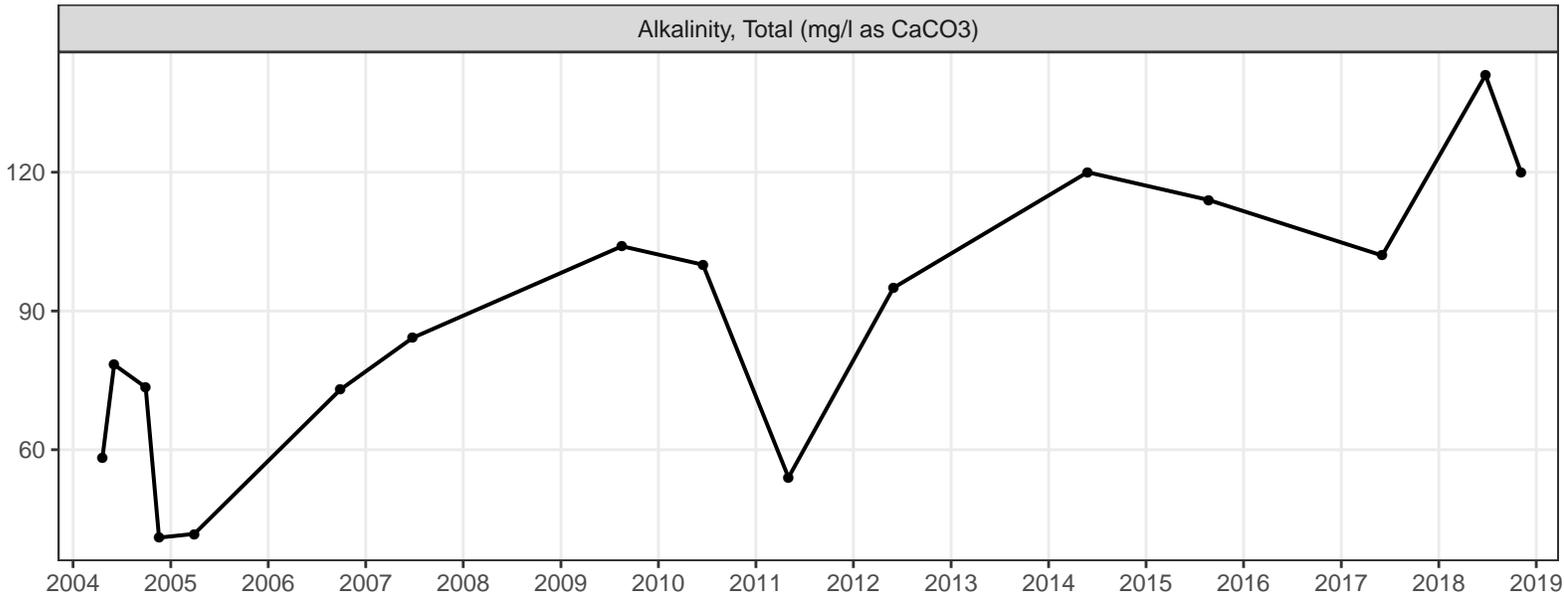
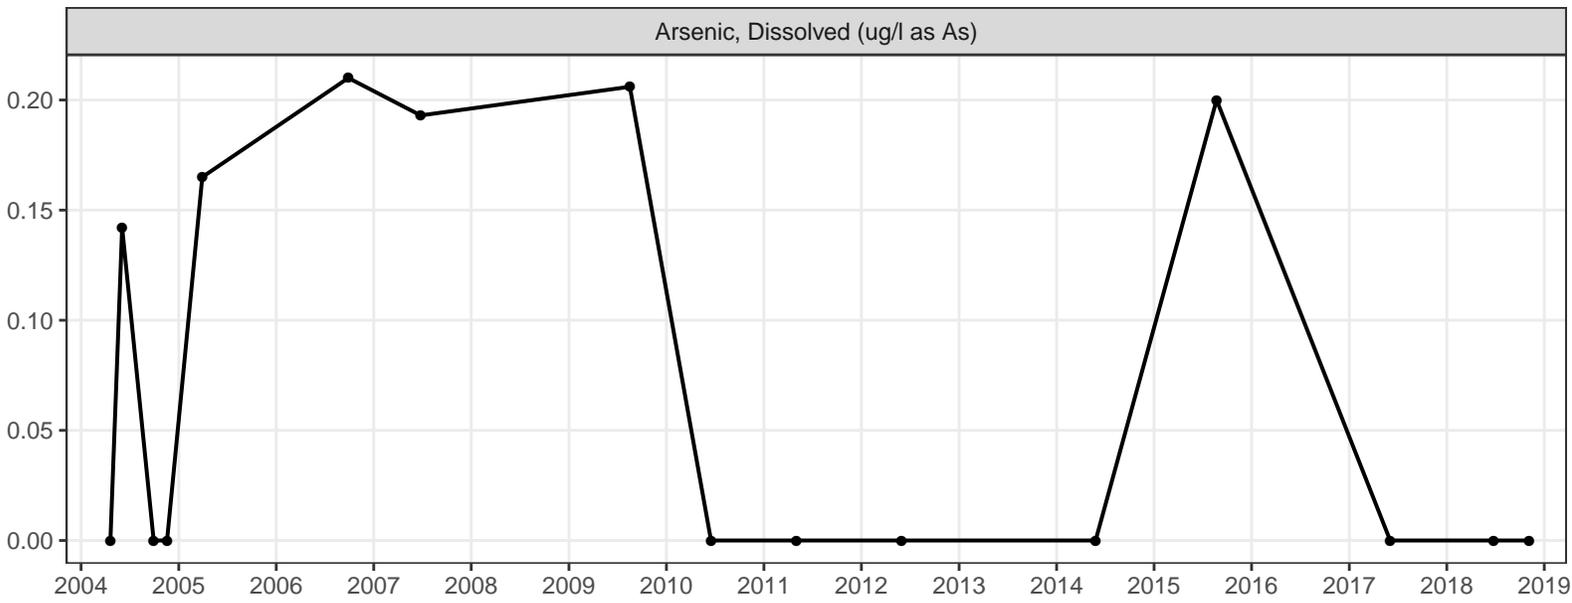
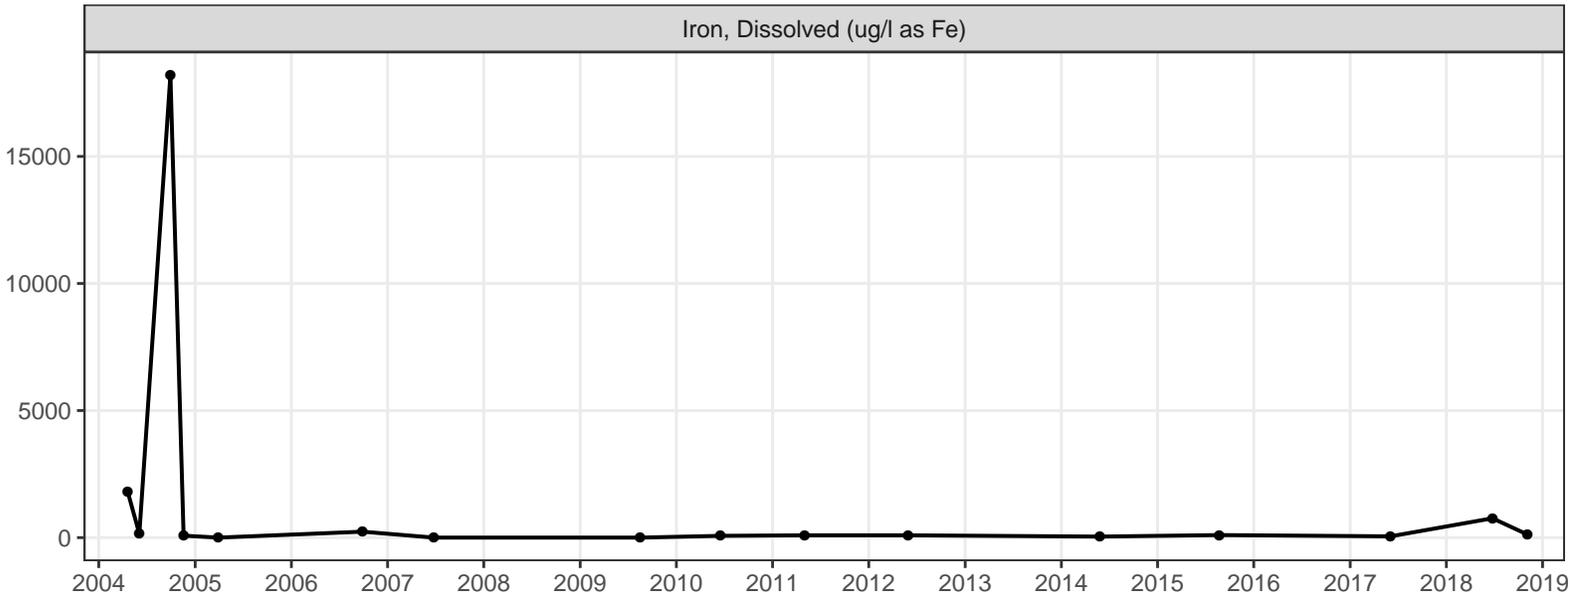
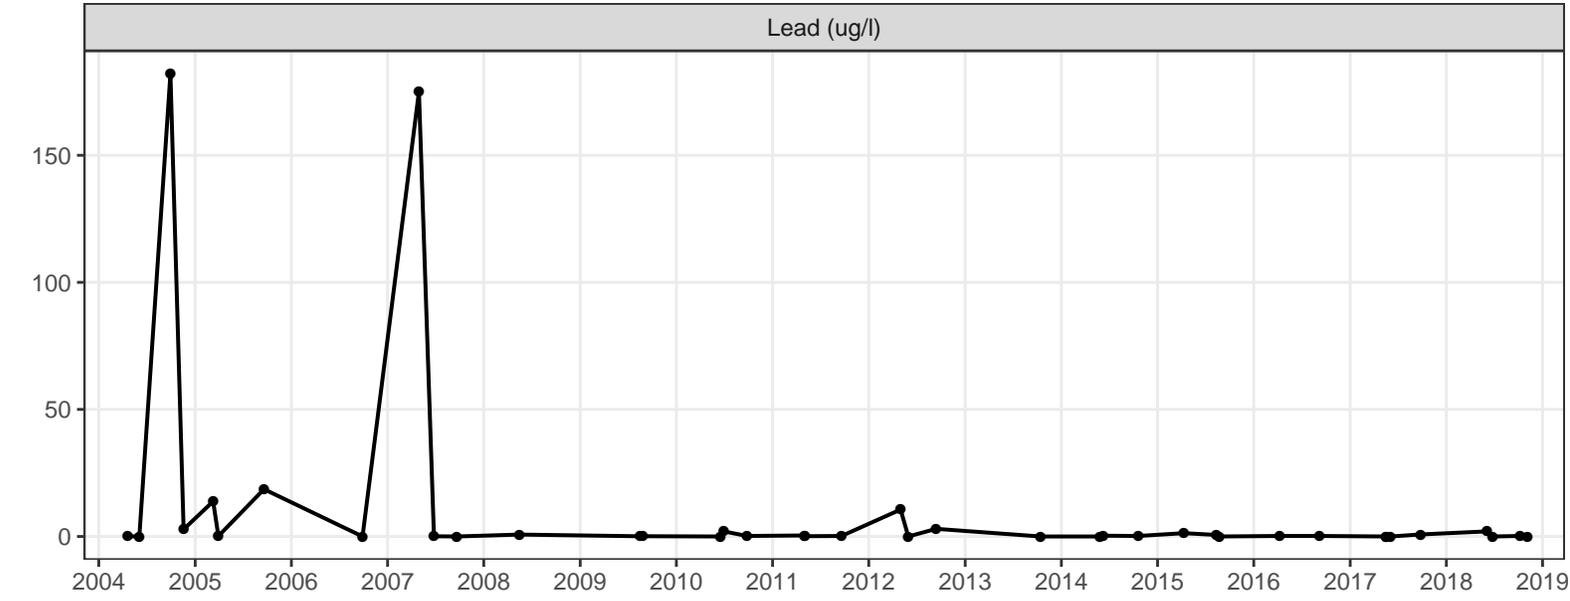
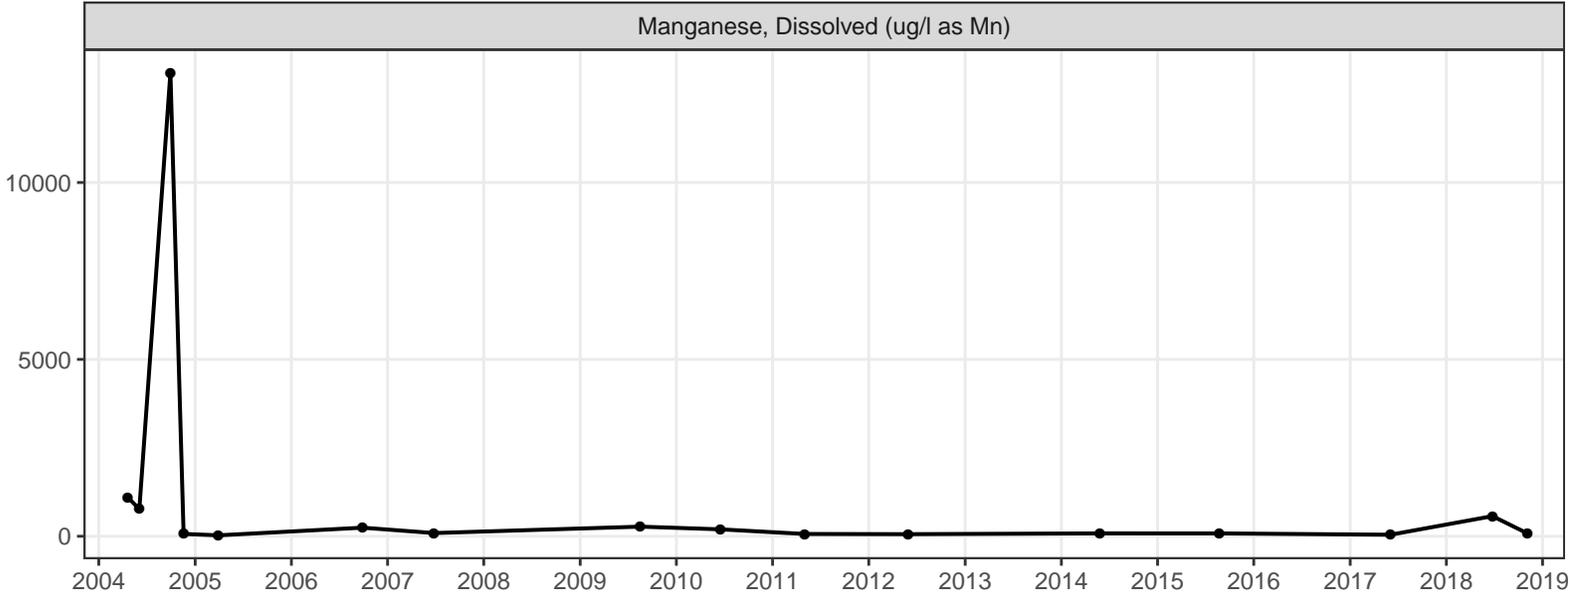
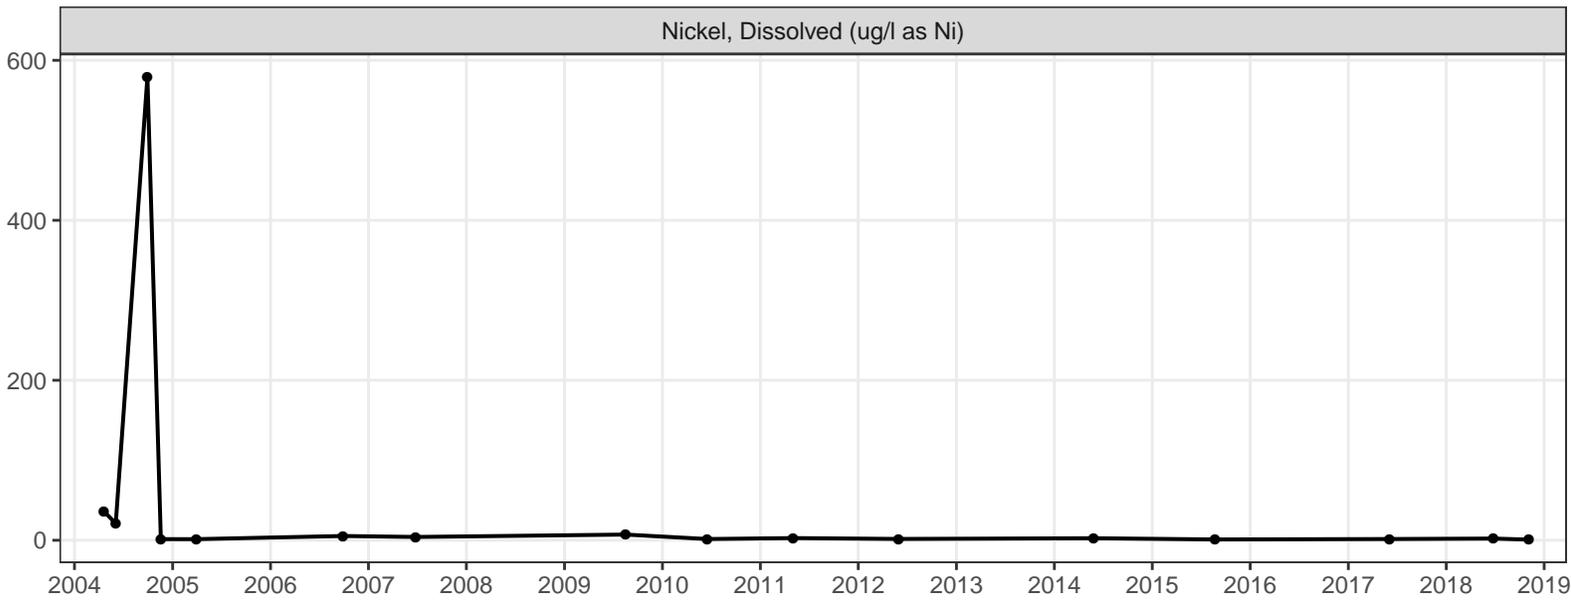
# ATTACHMENT C 960 Site

The 960 Site showed some elevated copper, zinc and cadmium concentrations in 2003 and 2004 as illustrated on the graphs provided in Attachment C. This was likely due to the removal activities, which exposed some additional production rock materials in the base of the road and altered drainage patterns. Water quality from this site has consistently met the Alaska Water Quality Standards for all measured parameters since 2005.

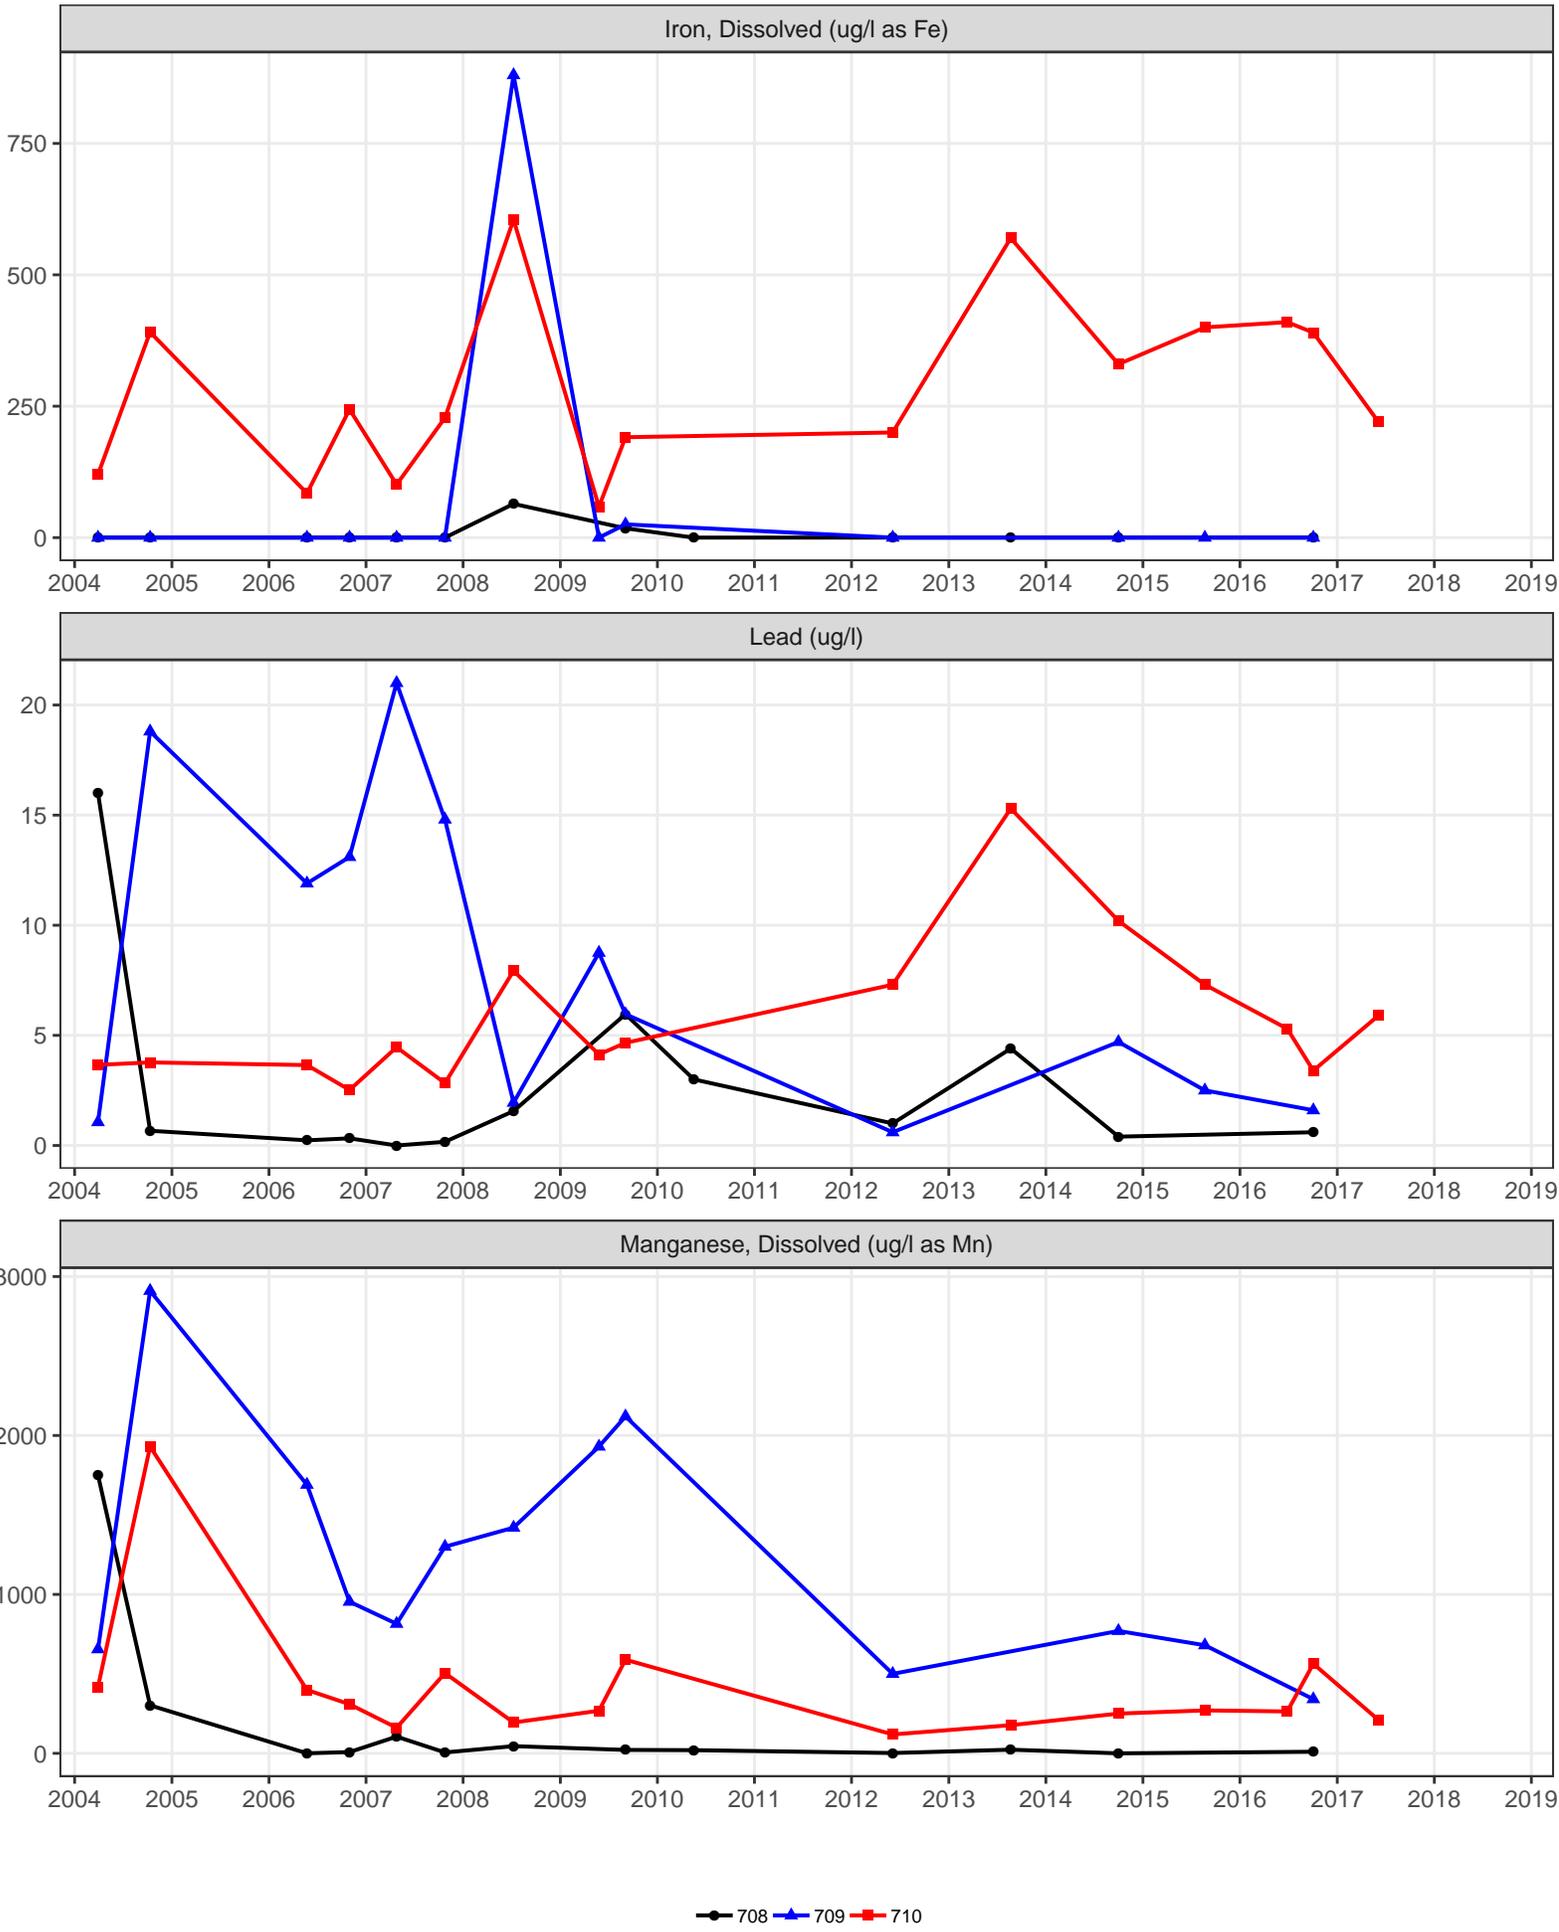
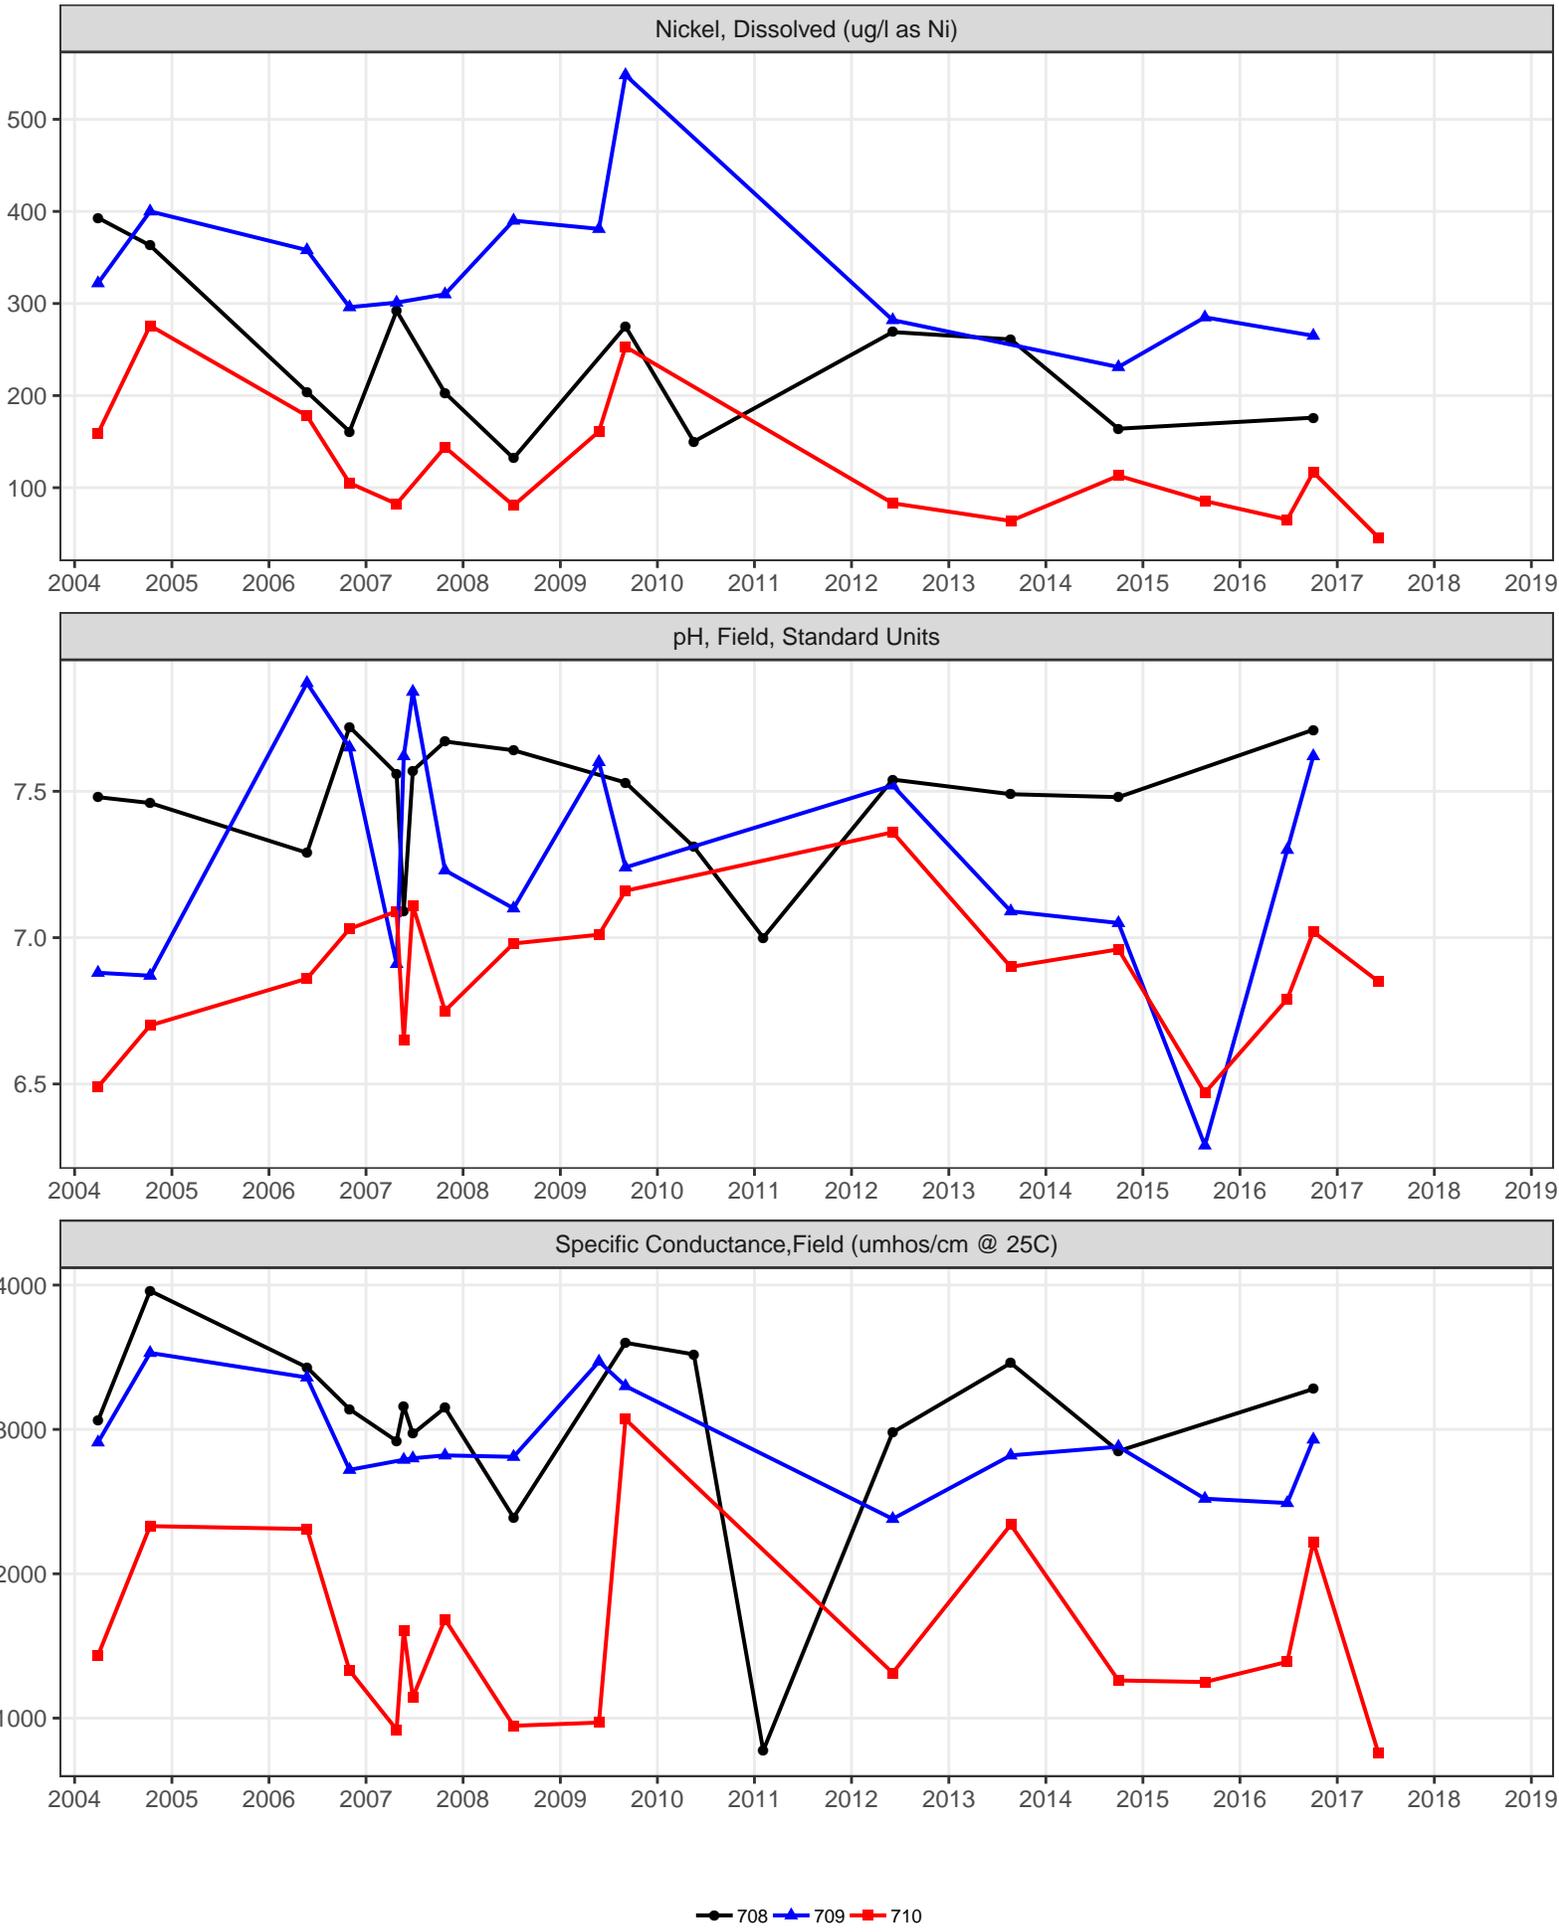
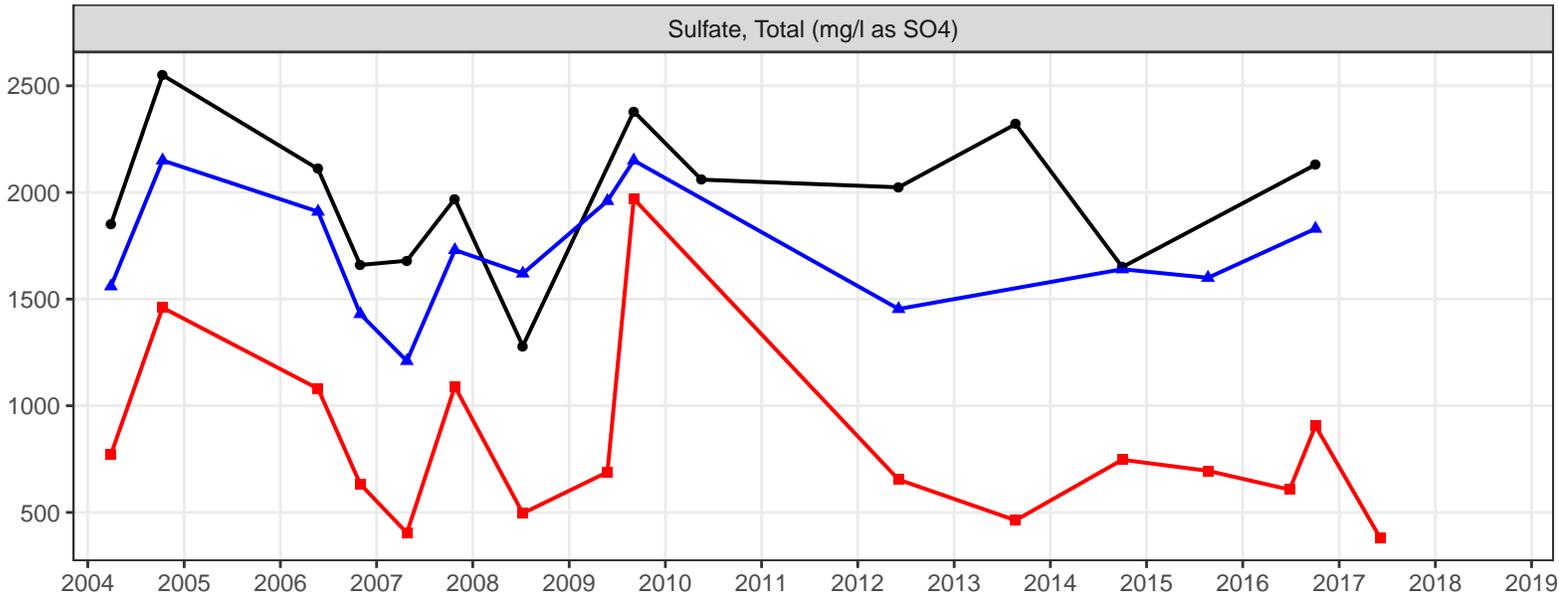
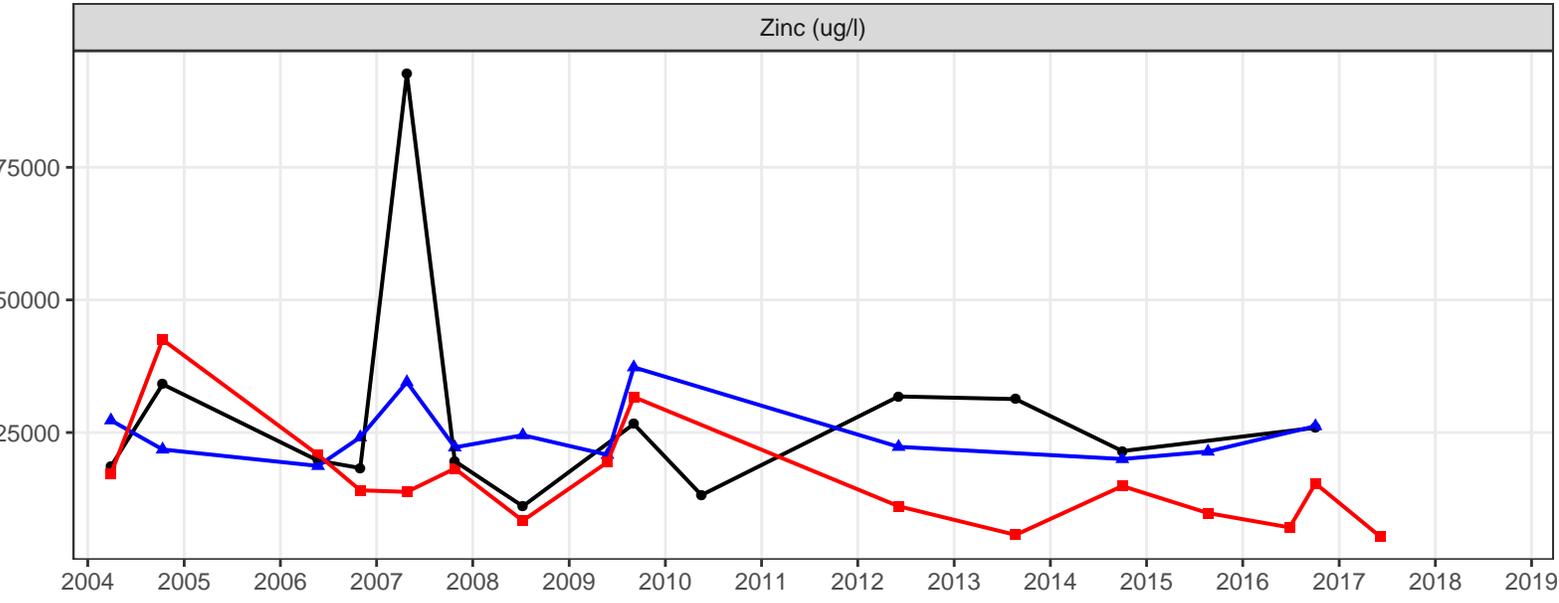
## Site E Perimeter Seeps

As shown in Attachment F, the water quality of the toe seeps is highly variable. This is likely attributed to the low flow rates where only a slight change in flow from precipitation events could cause a large change in concentration. The graphs indicate there has been a substantial decrease in concentration for several of the monitored constituents at site 709 when comparing the data from pre-2010 to the results from after 2010. Site 709 is a toe seep located on the east side of Site E. Most of the production rock removed from Site E was from the eastern portion of the pile, which eliminated a significant source of the chemical loading to this seep.

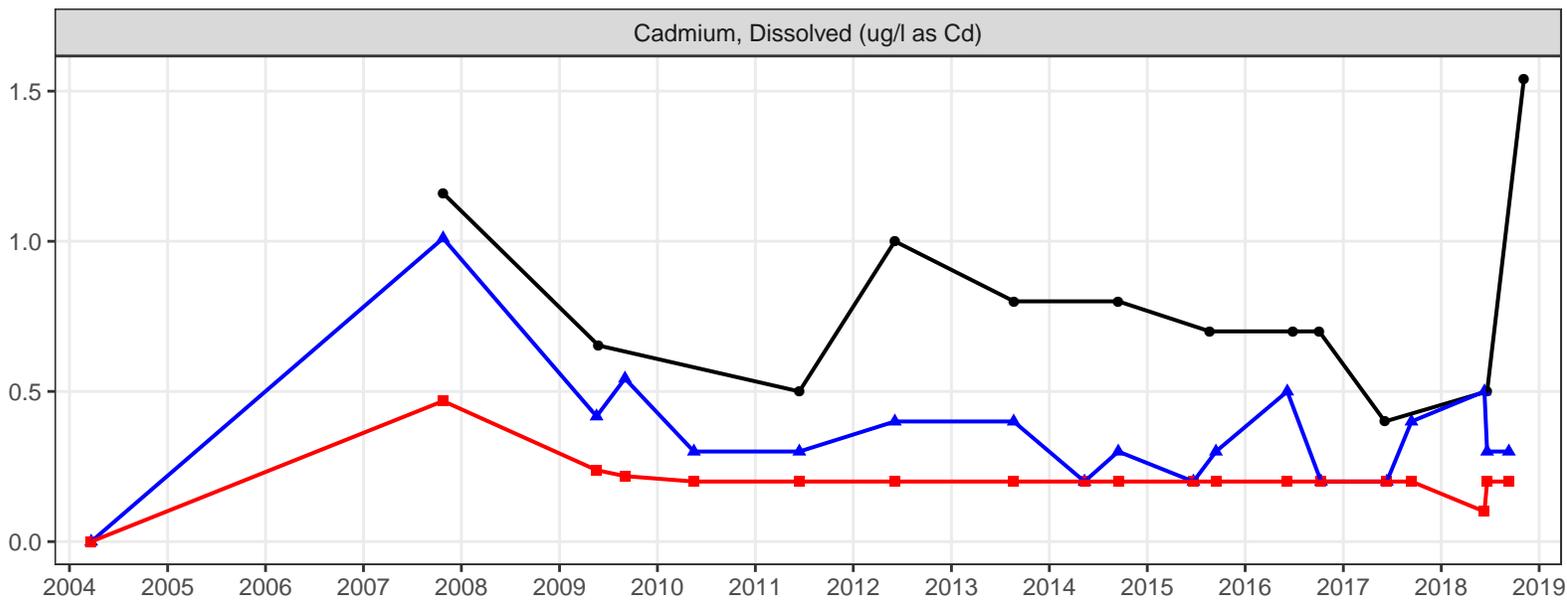
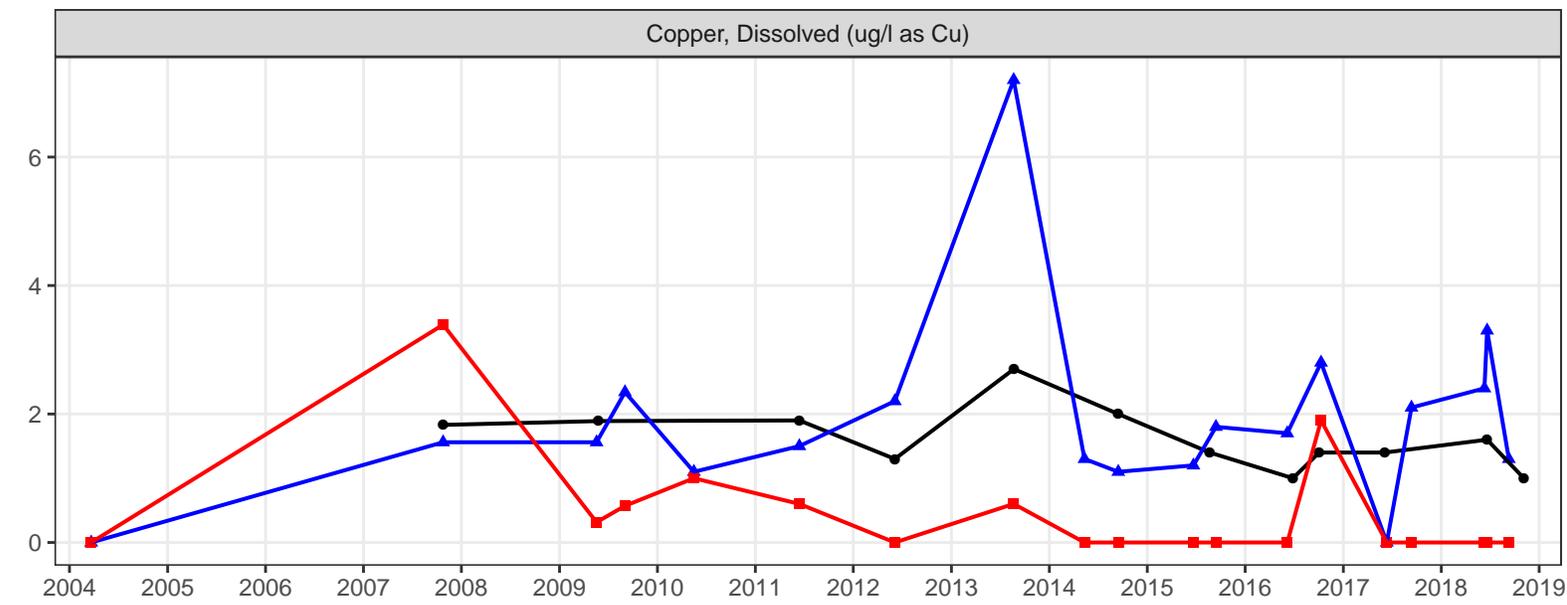
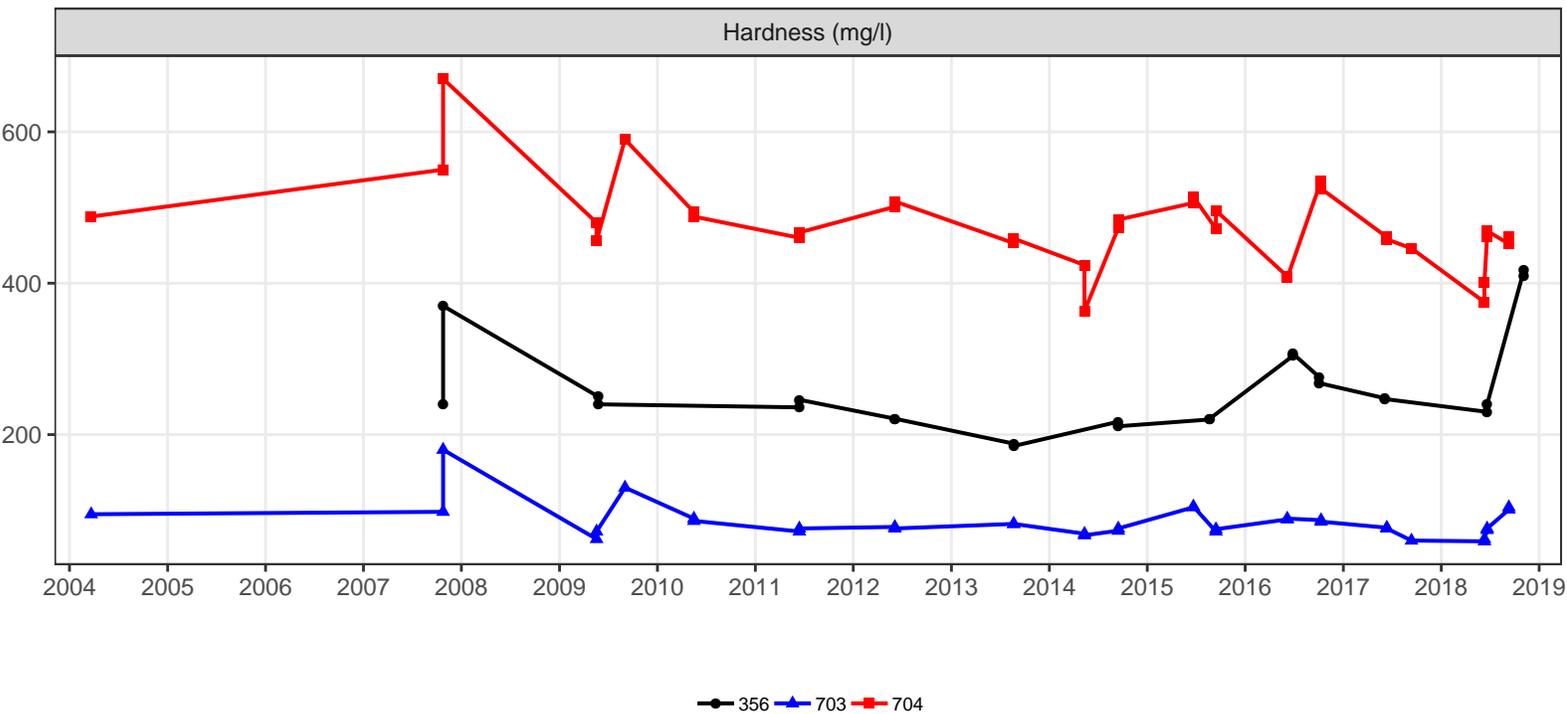
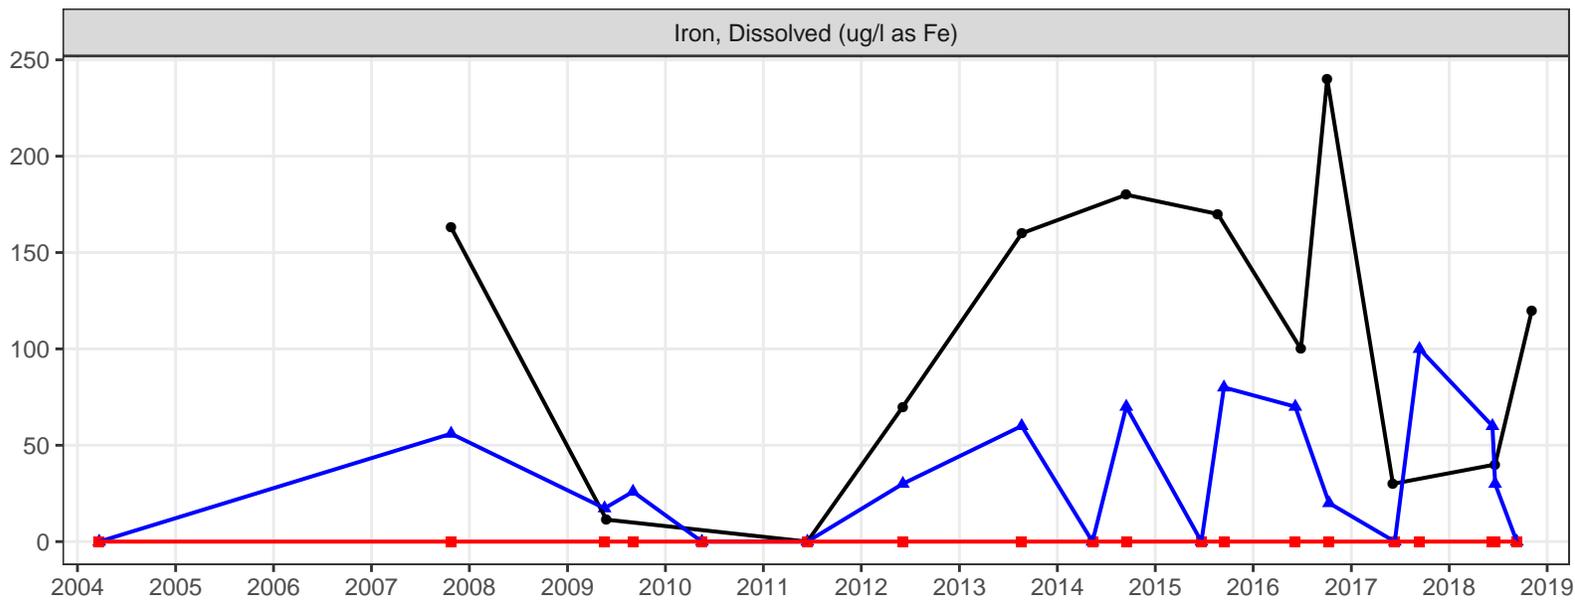
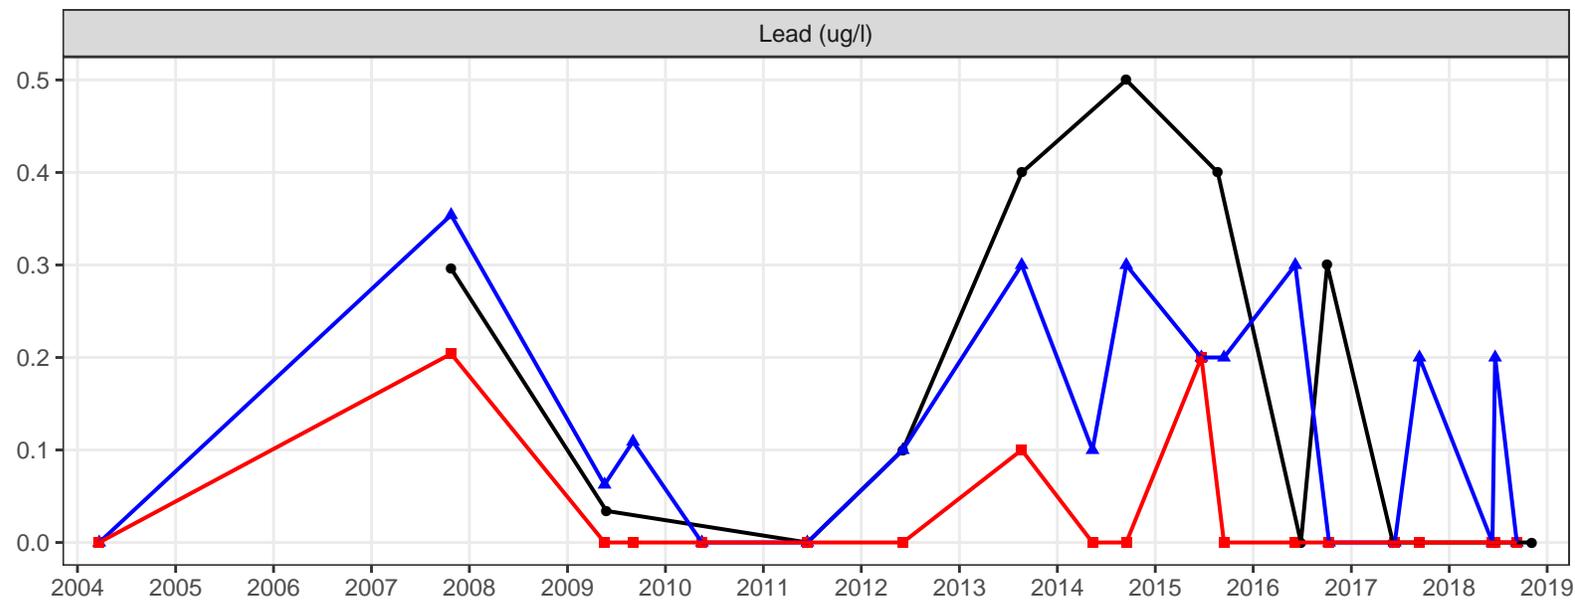
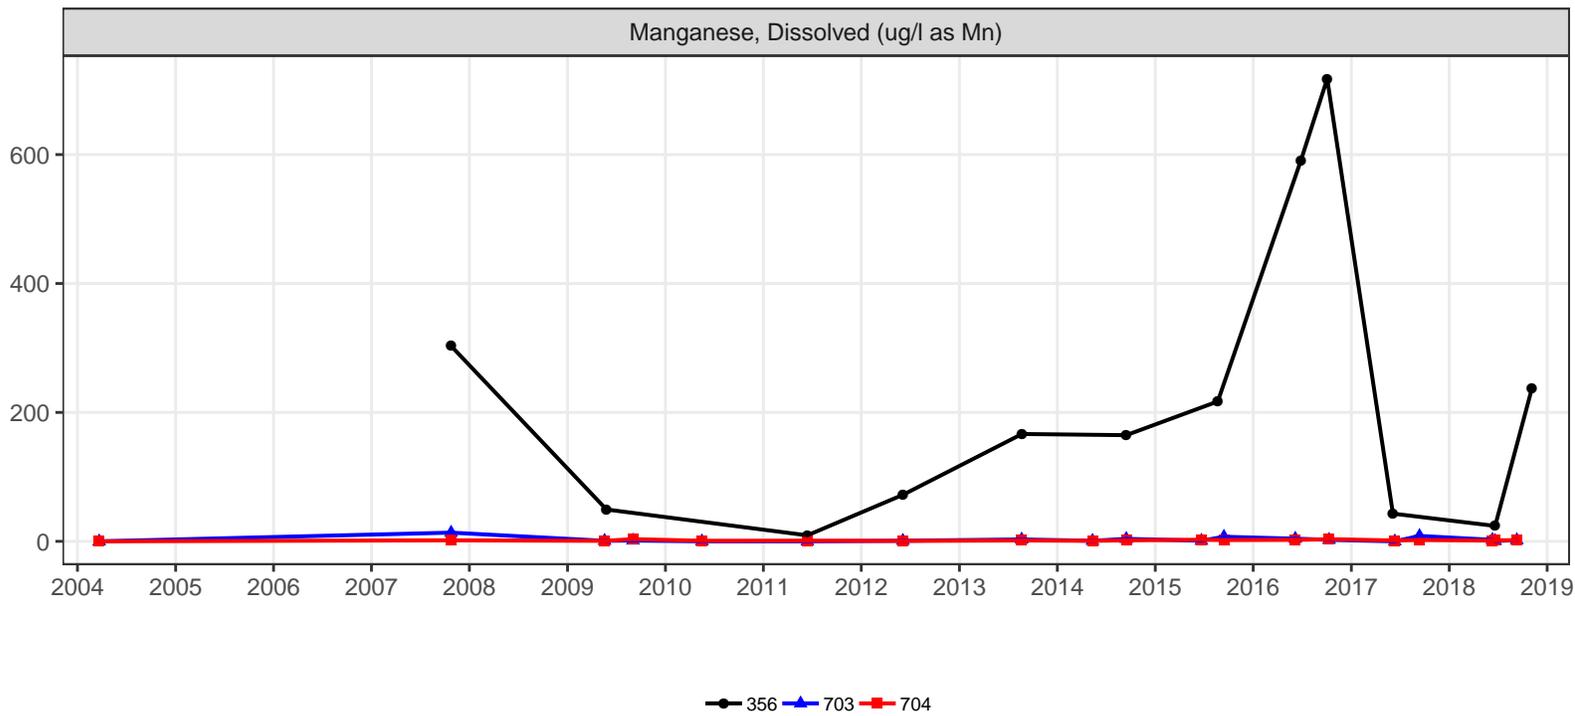
# ATTACHMENT G Site E

The water quality of the three down-gradient drainages below Site E, shown in Attachment G, remains fairly consistent due to the higher flow rates. Of the three drainages, site 703 has the

highest flows. Based on its location, site 703 is the most likely drainage to have been influenced by the production rock removal that has occurred. However, there are no obvious water quality trends due to the limited amount of data collected prior to 2009, which was the first year with large scale material removal.
