**INACTIVE PRODUCTION ROCK SITES AND QUARRIES  
2018 ANNUAL REPORT**

**Hecla Greens Creek Mining Company**

**April 30, 2019**

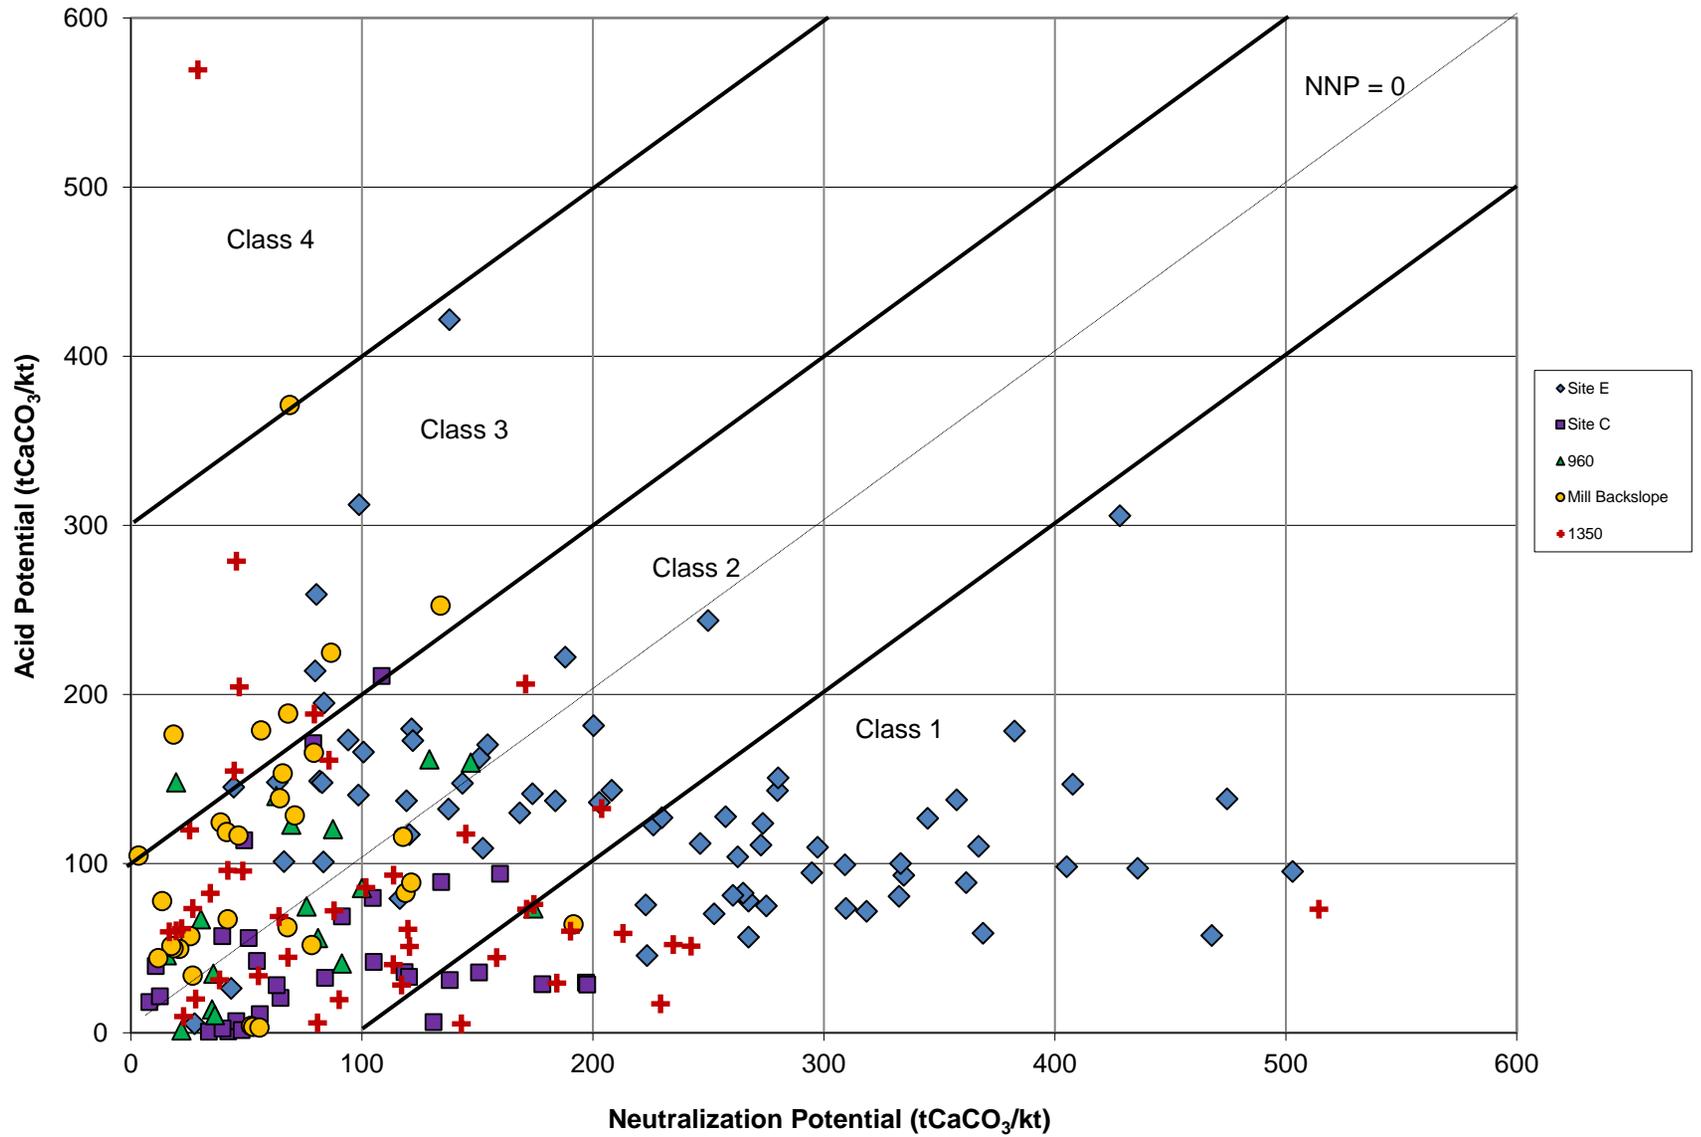
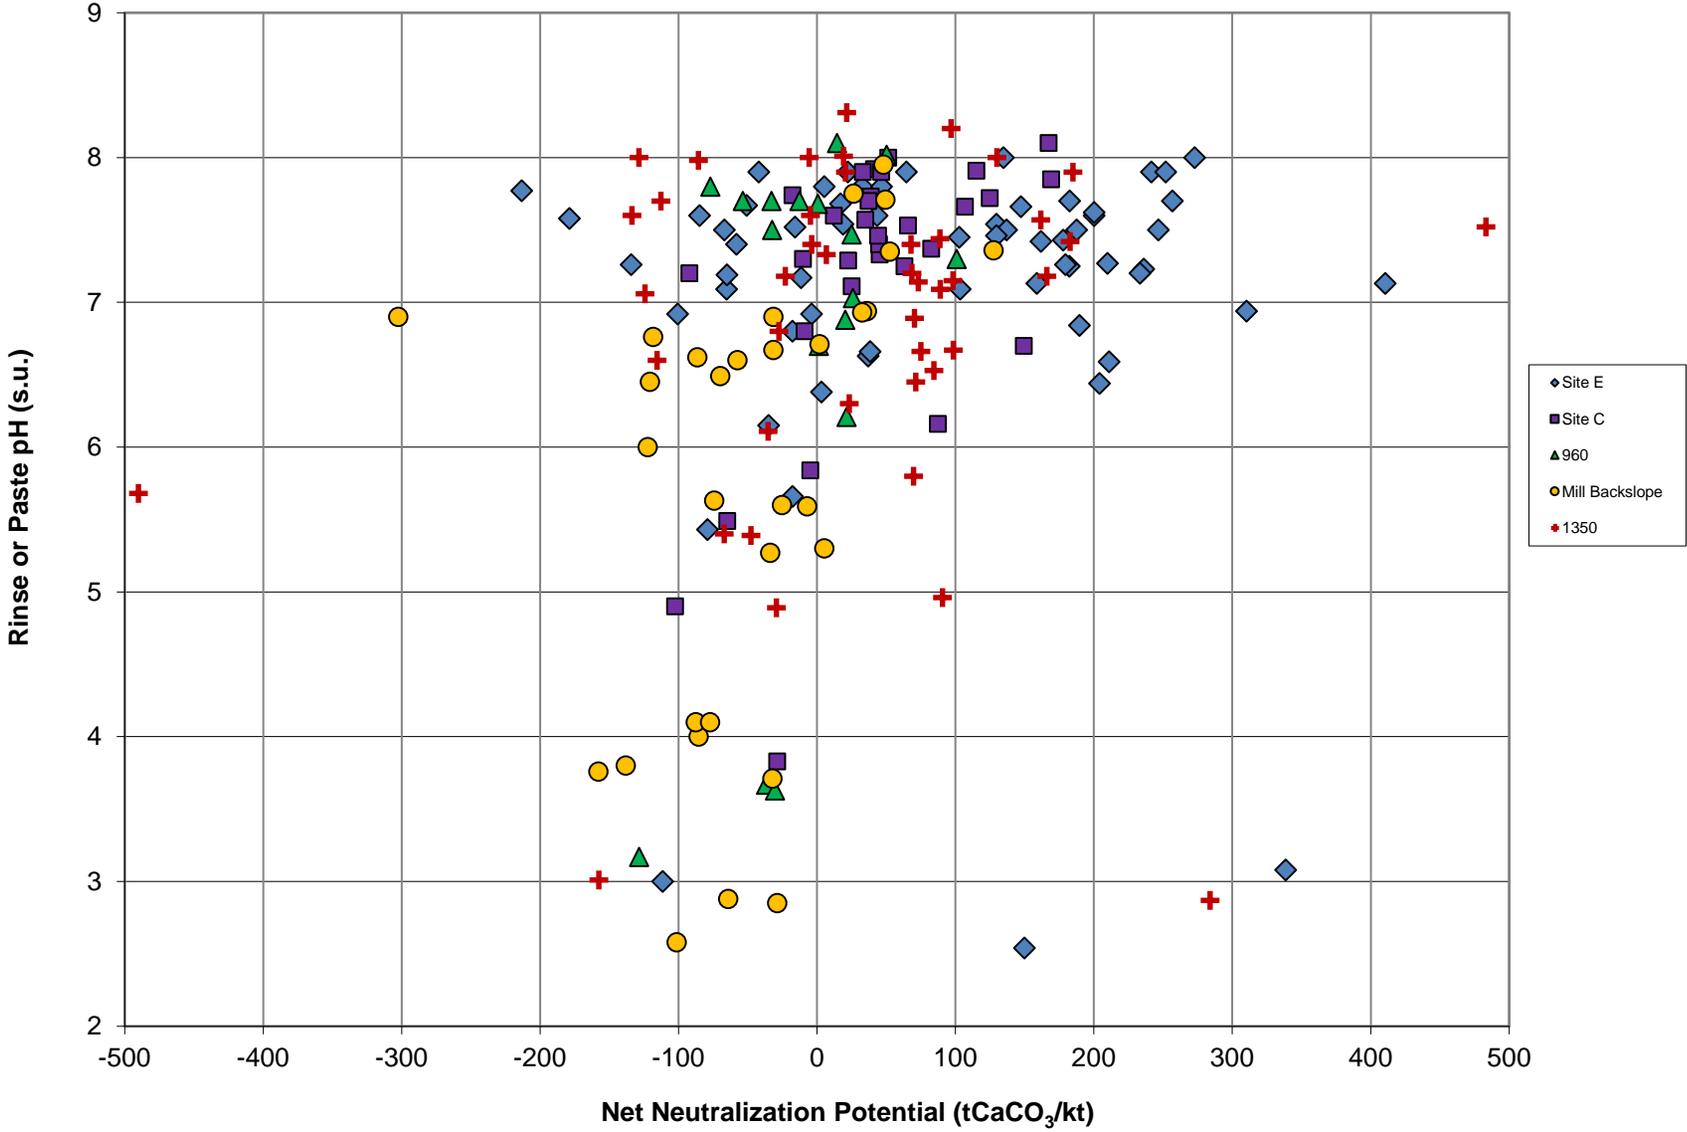
# ATTACHMENT J: 2002-2018 INACTIVE SITE ABA DATA

Sampling for Acid Base Accounting (ABA) from the quarry walls is performed on five-year intervals. ABA sampling was conducted at the Quarry sites in August 2018. Results are presented in Table 2.2 and graphs including ABA sample results dating back to 2002 are included in Attachment J in this report.

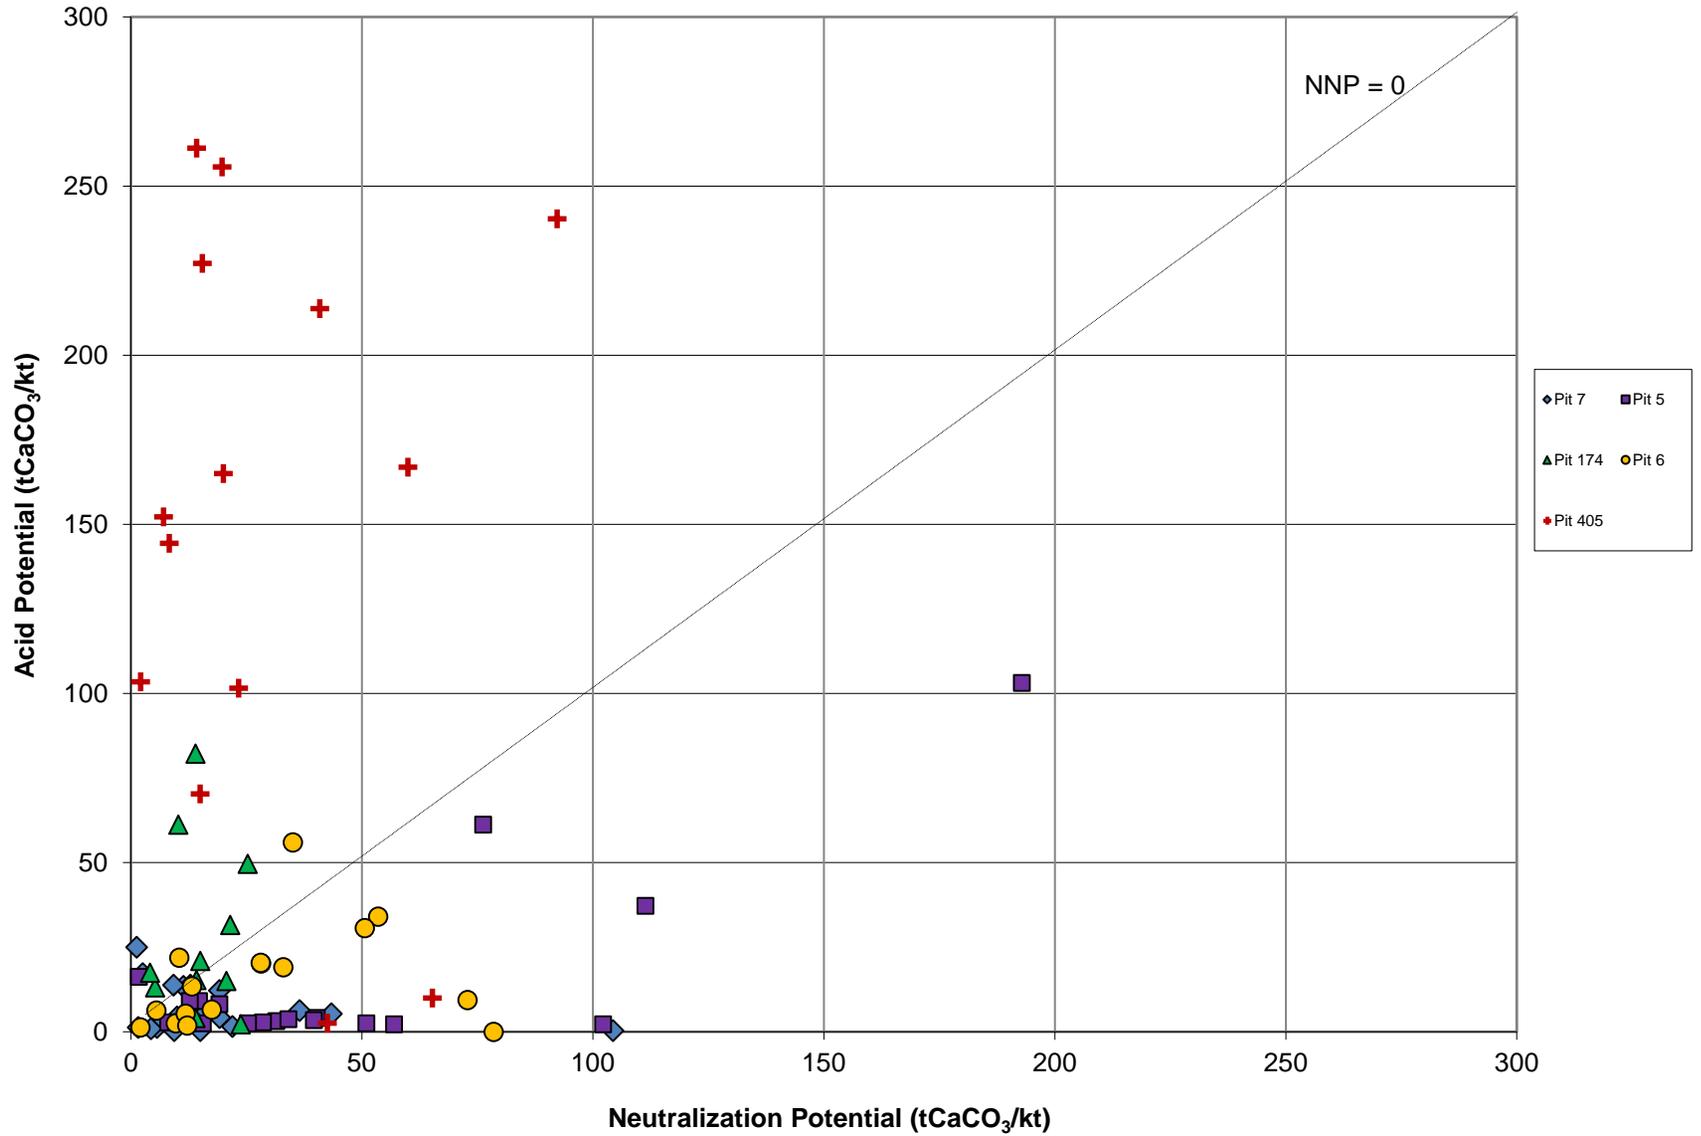
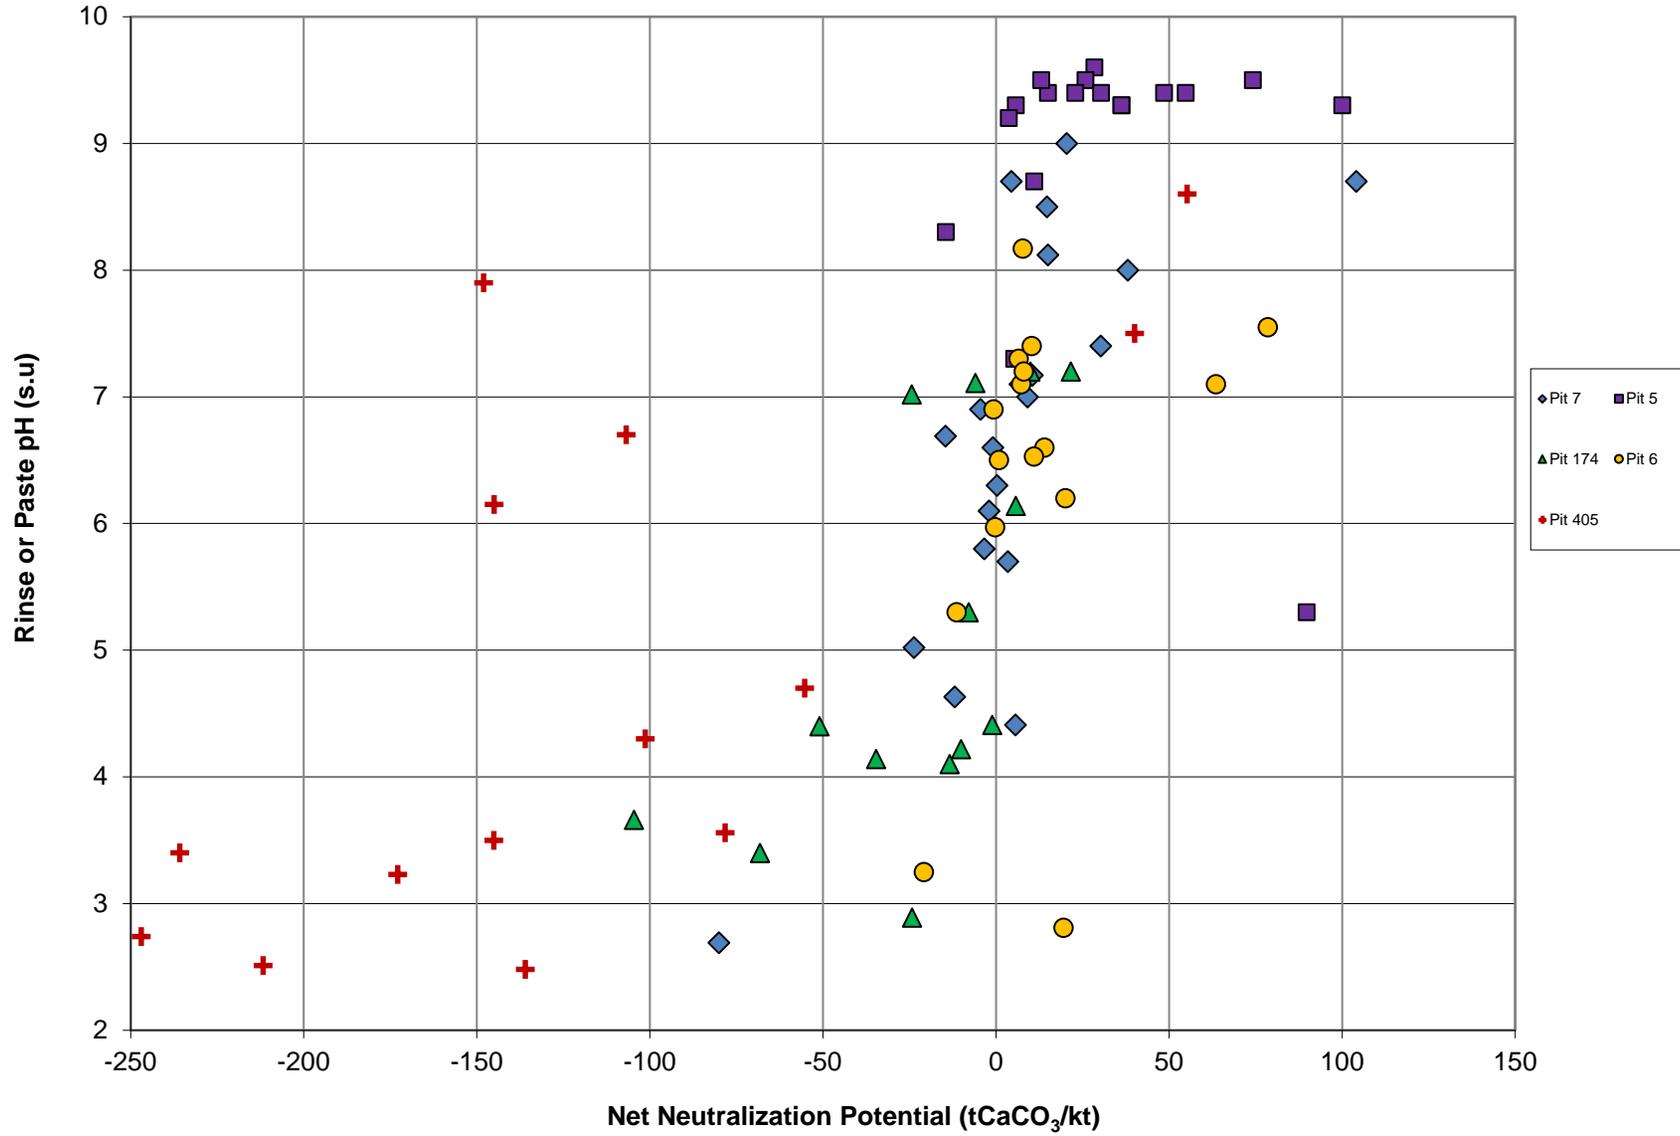
# ATTACHMENT J: 2002-2018 QUARRY SITE ABA DATA

Sampling for Acid Base Accounting (ABA) from the quarry walls is performed on five-year intervals. ABA sampling was conducted at the Quarry sites in August 2018. Results are presented in Table 3.2 and graphs including ABA sample results dating back to 2002 are included in Attachment J in this report.
