**INACTIVE PRODUCTION ROCK SITES AND QUARRIES
2015 ANNUAL REPORT**

Hecla Greens Creek Mining Company

April 15, 2016

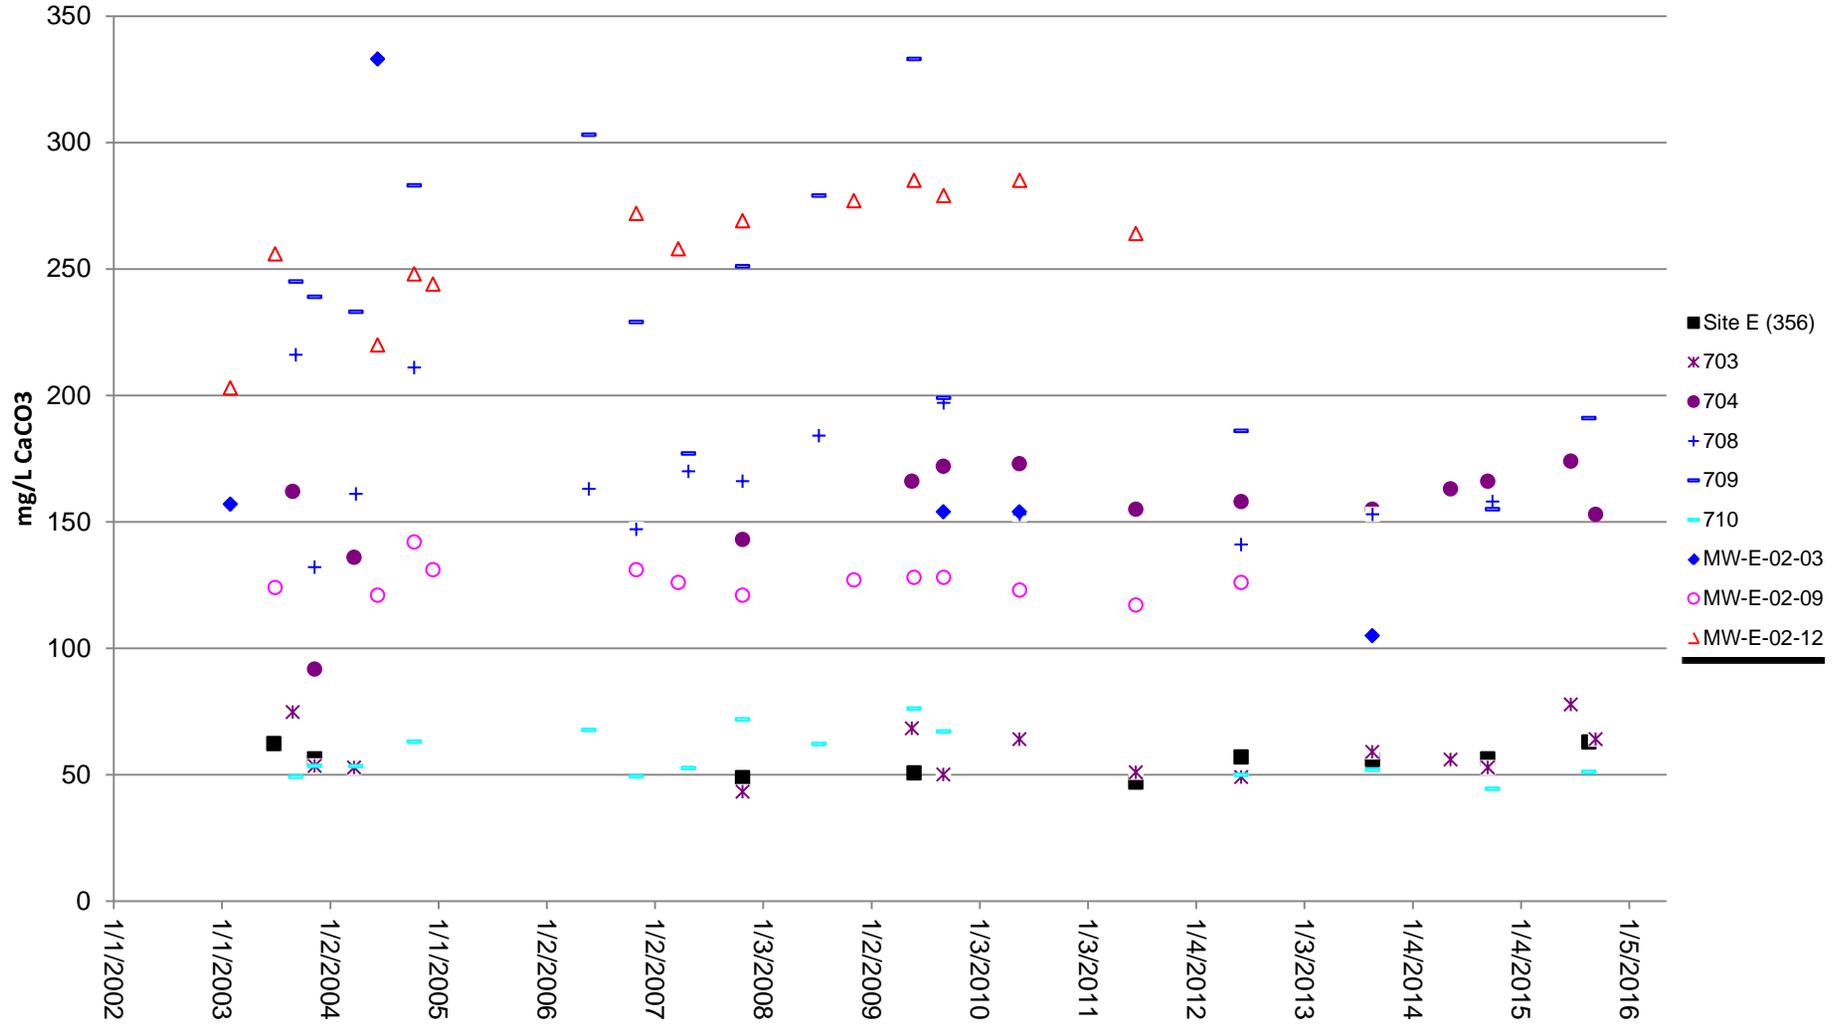
Figure 2.23 INACTIVE PRODUCTION ROCK SITE E CONDUCTIVITY DATA

Conductivity data are shown in Figures 2.8 and 2.23. Conductivity indicates the amount of dissolved constituents in the water. Samples showing higher conductivity values usually have elevated sulfate, calcium and magnesium (hardness) concentrations, reflecting influences from sulfide oxidation and carbonate mineral dissolution. Water that has contacted production rock is expected to have higher conductivity values than background waters. Drainage from the 960 (Sites 347 and 570) and 1350 (Sites 13 and 307) has shown a substantial decrease in conductivity following removal of the production rock. The decreasing trends apparent in Figures 2.8 and 2.23 are the result of decreasing reactive surface area available for oxidation and dissolution. The reactive surface area decreases as reactants are consumed and mineral surfaces become coated with oxidation products. The results for sulfate, magnesium and hardness, shown in Figures 2.9 and 2.24, 2.10 and 2.25, and 2.11 and 2.26, respectively, correlate with conductivity results and are consistent with the concept of generally decreasing or static reactive surface area.

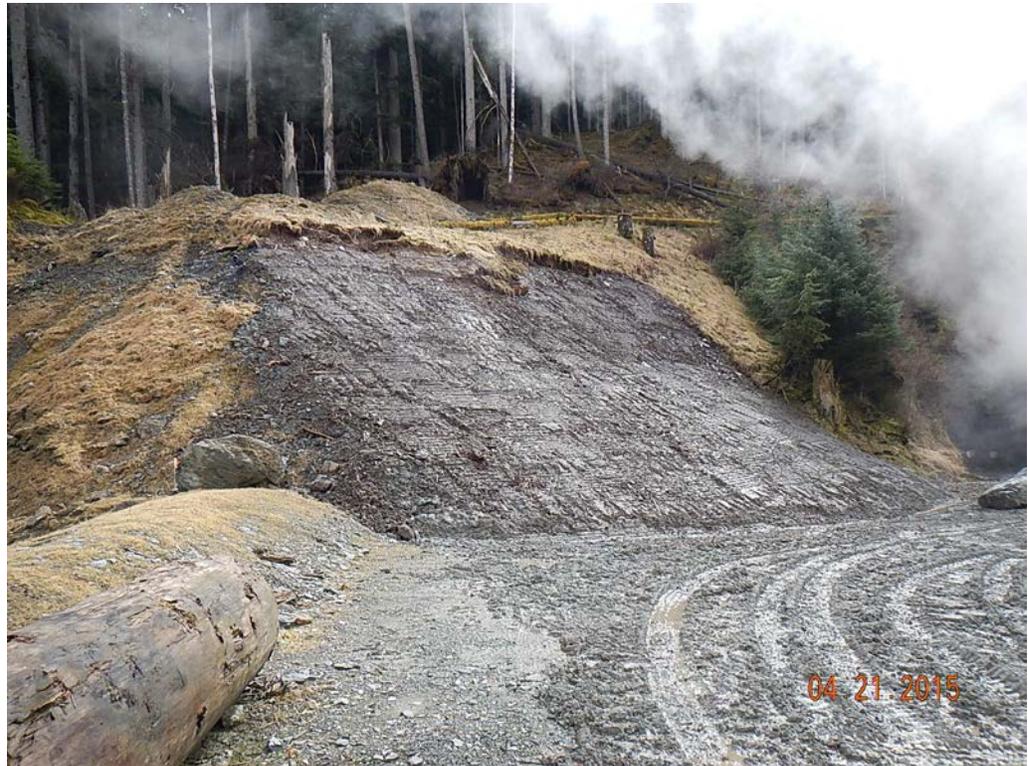
Activities in 2015 included removing approximately 160 cubic yards of acid generating production rock located on the slope adjacent to the 1350 adit. To maintain stability of the slope, the excavated area was backfilled with approximately 180 cubic yards of clean fill material. A photograph of the area after completing backfill is presented as Figure 2.35. Figure 2.36 shows a photo of the same area in October 2015 with vegetation established. Additional work in 2015 included hauling the remaining material from the temporary storage pad on Site 23 to the underground.

Figure 2.35: 1350 Site - 2015 Production Rock Removal Area (April)

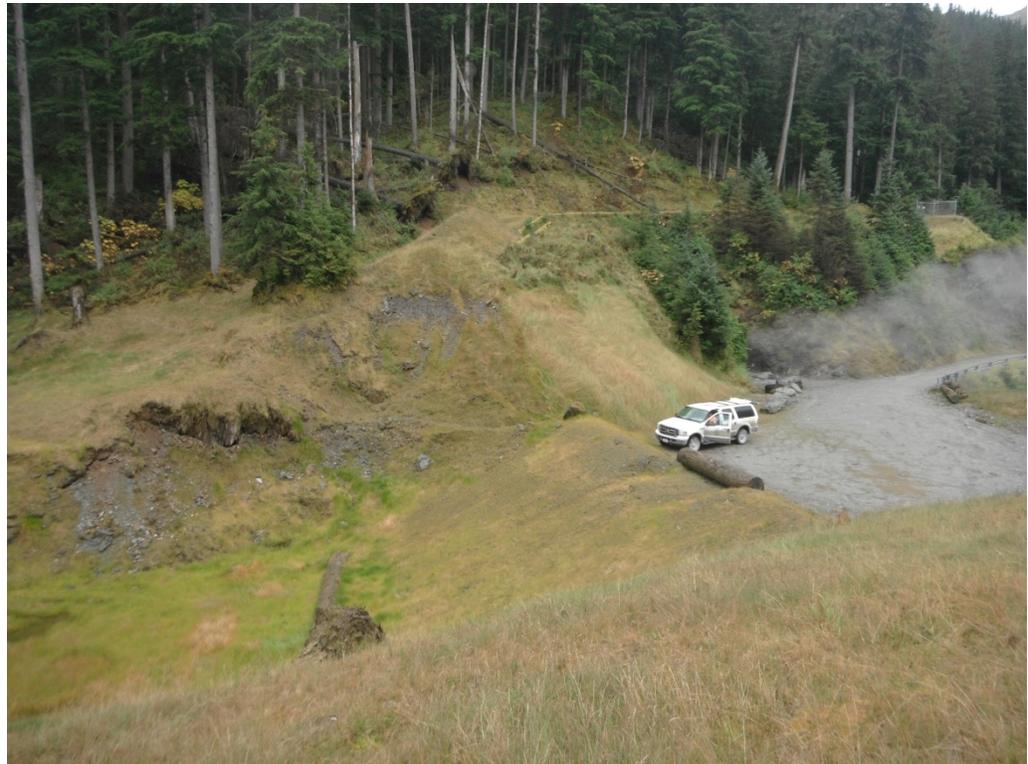
Figure 2.36: 1350 Site - 2015 Production Rock Removal Area (October)

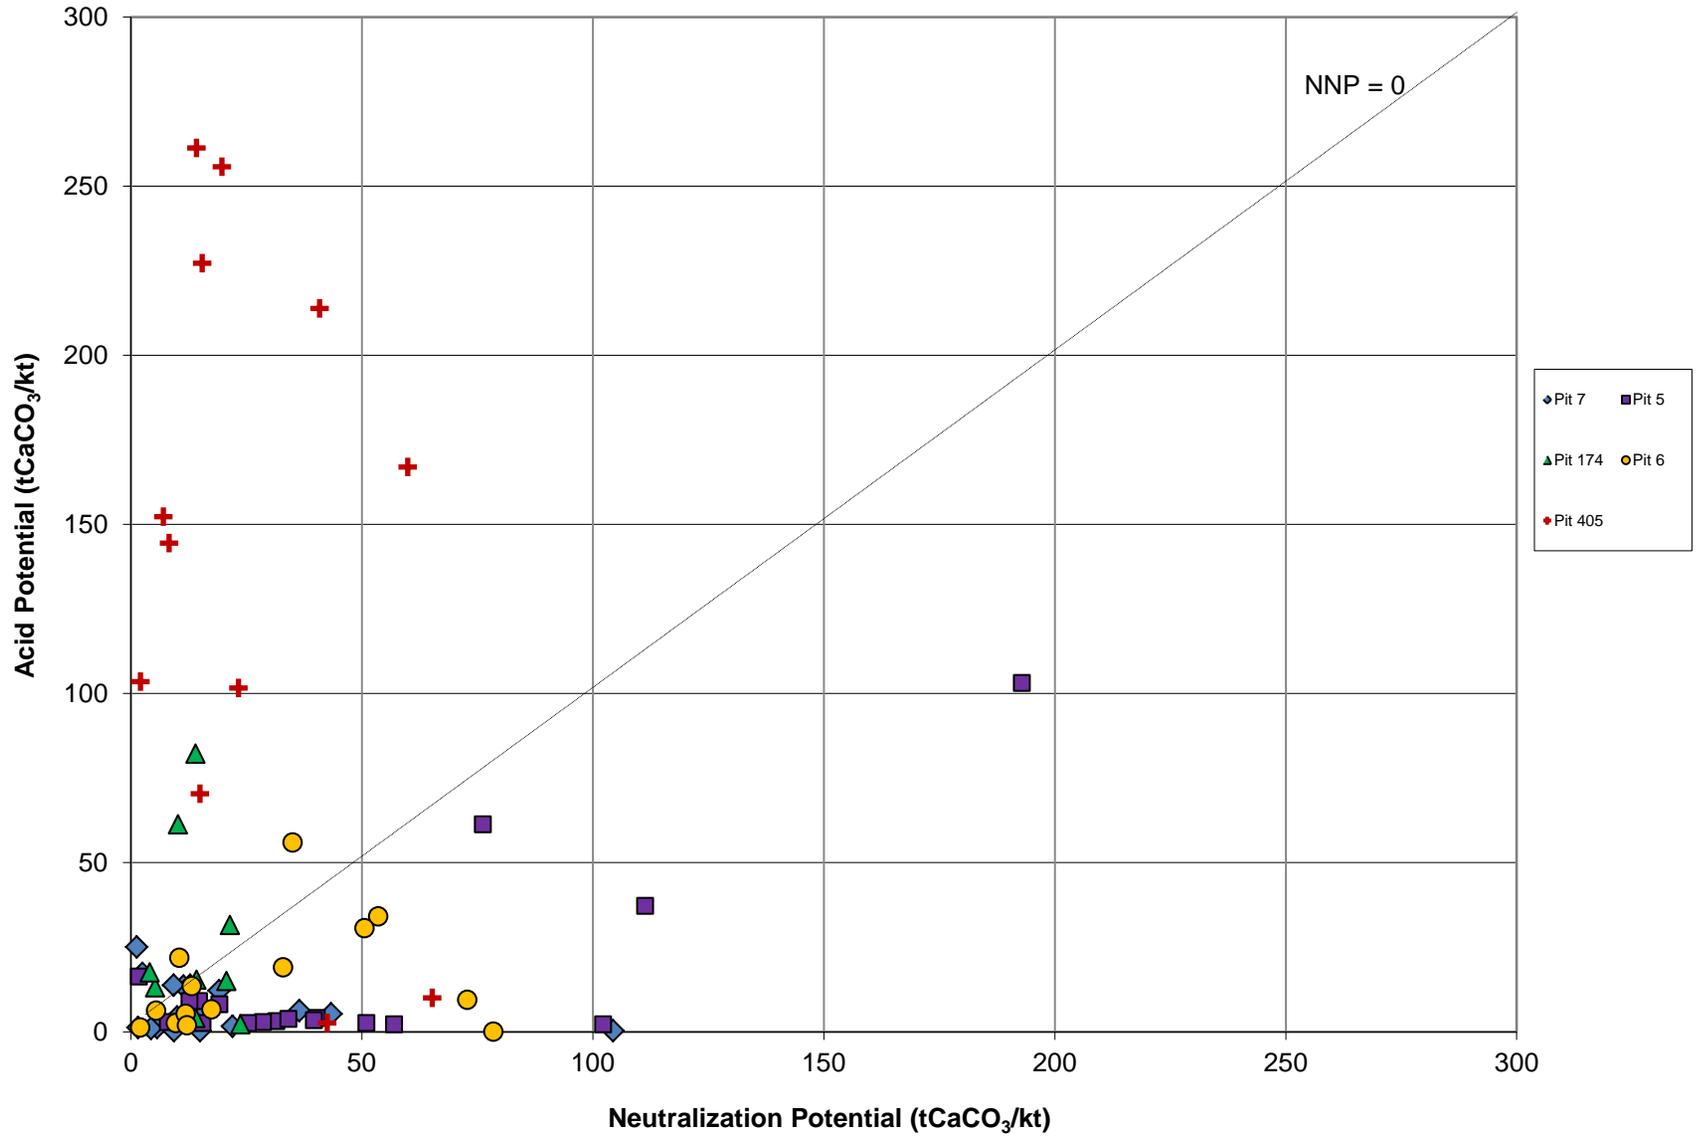
FIGURE 3.16 2002-2013 QUARRY SITE ABA DATA

Acid Base Accounting data collected from 2002 to 2013 are summarized in Figures 3.16 and 3.17. Pit 405 and Pit 174 have significant exposures of potentially acid generating rock and produced several samples with acidic rinse pH. Pit 6 and Pit 7 produced samples showing a broad distribution of NNP and rinse pH, and Pit 5 generally produced acid neutralizing samples with alkaline rinse pH. Buildup of oxidation products (salts) on overhanging quarry walls was noted at each of the five quarry sites and may have contributed to the lower rinse pH readings for several samples.
