# KENSINGTON MINE

COEUR  
THE PRECIOUS METALS COMPANY

# Project Overview

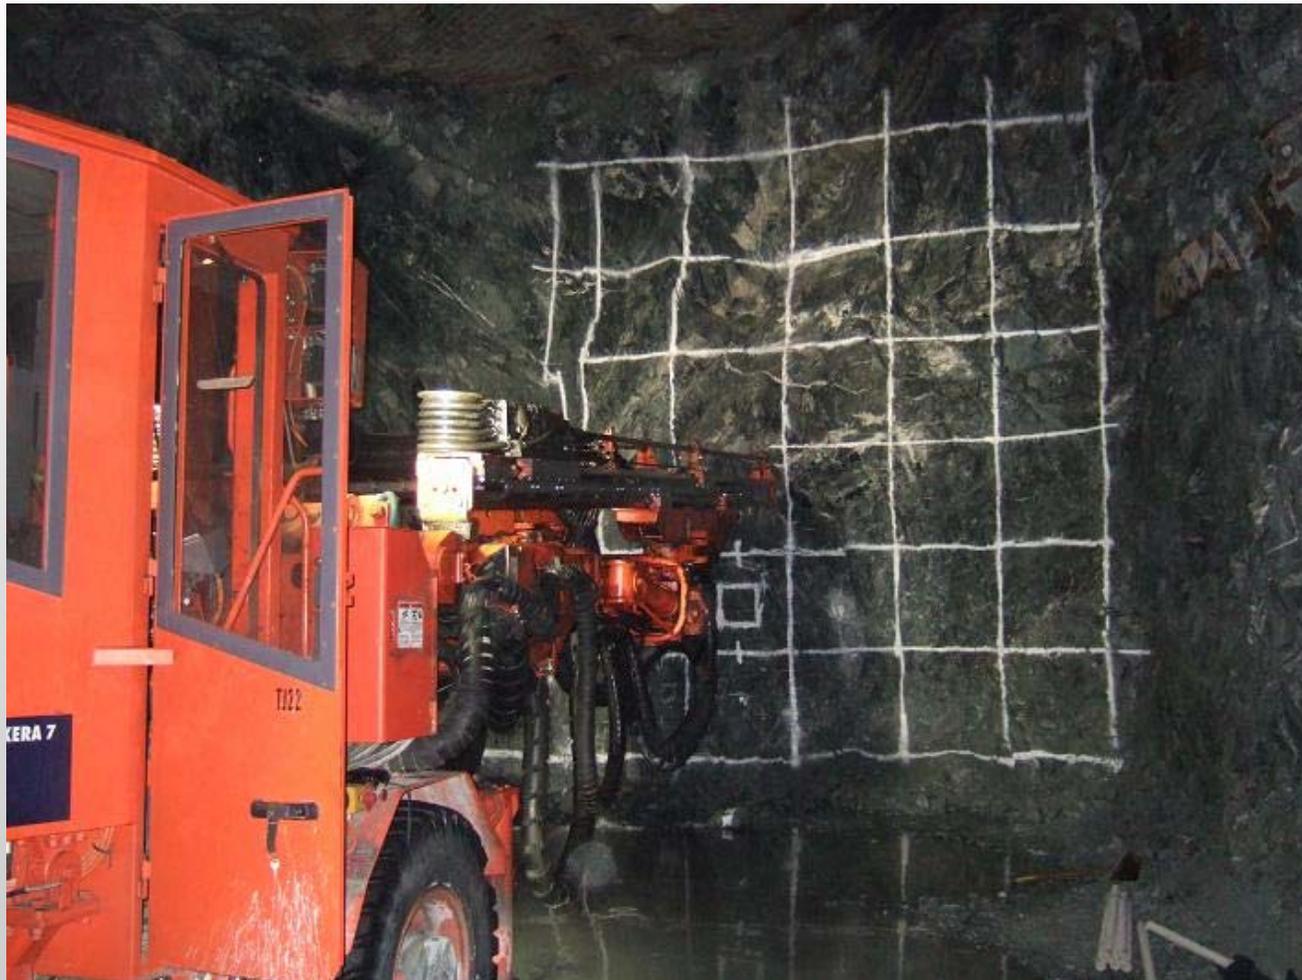
Jumbo drilling a face round

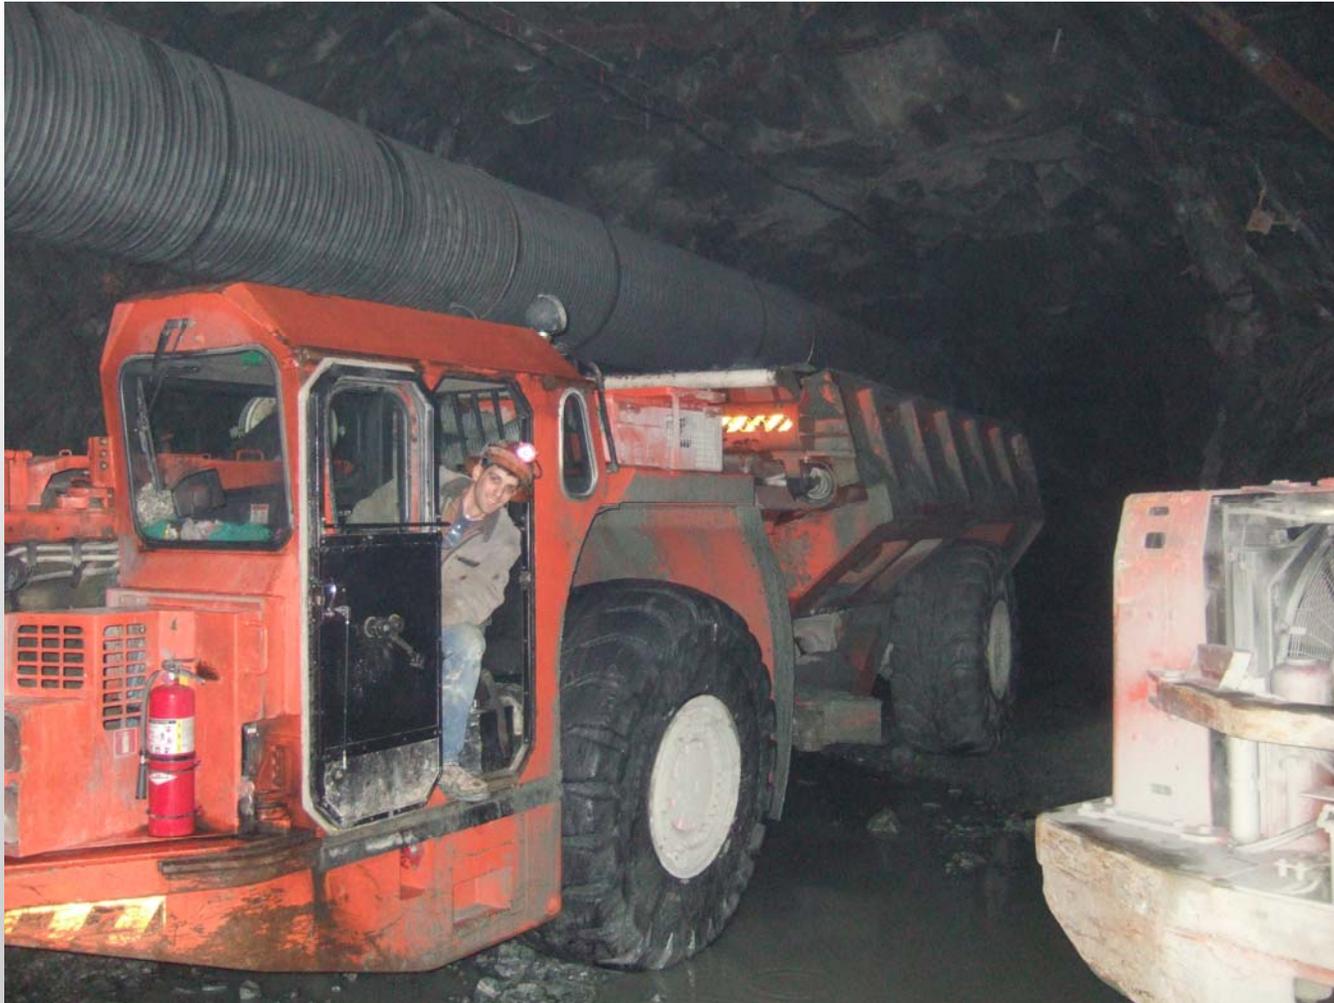
40 Tonne Haul Truck

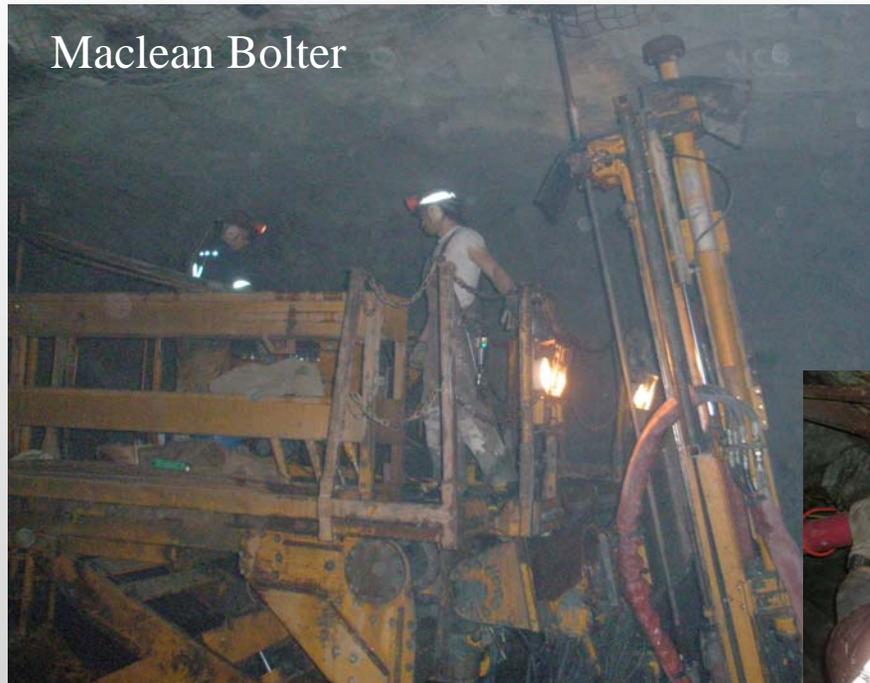
Maclean Bolter

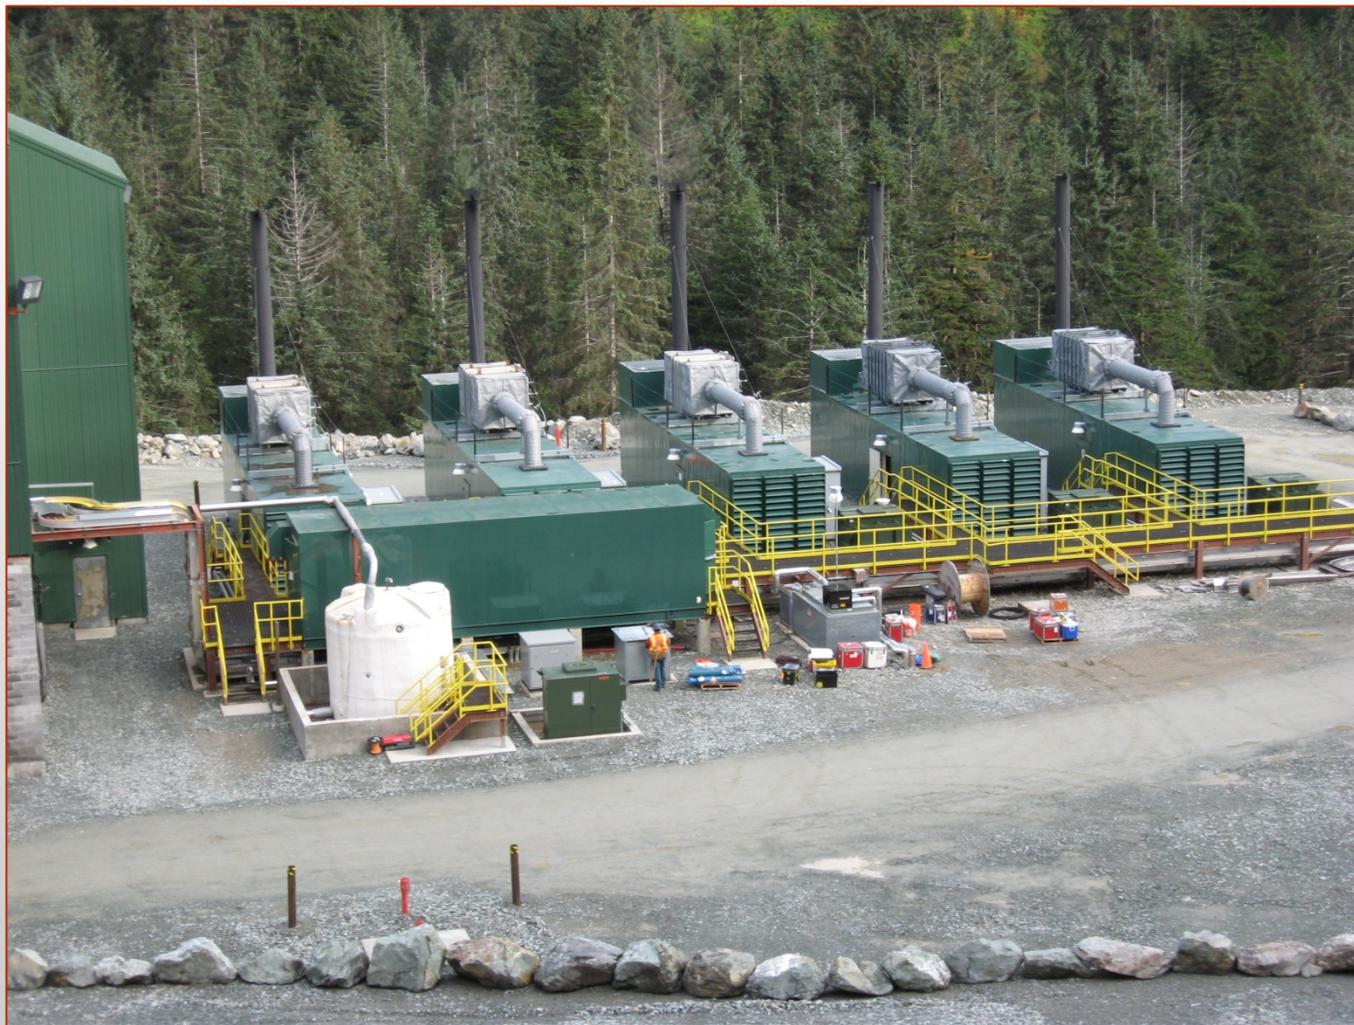
5 - 2 MW generators

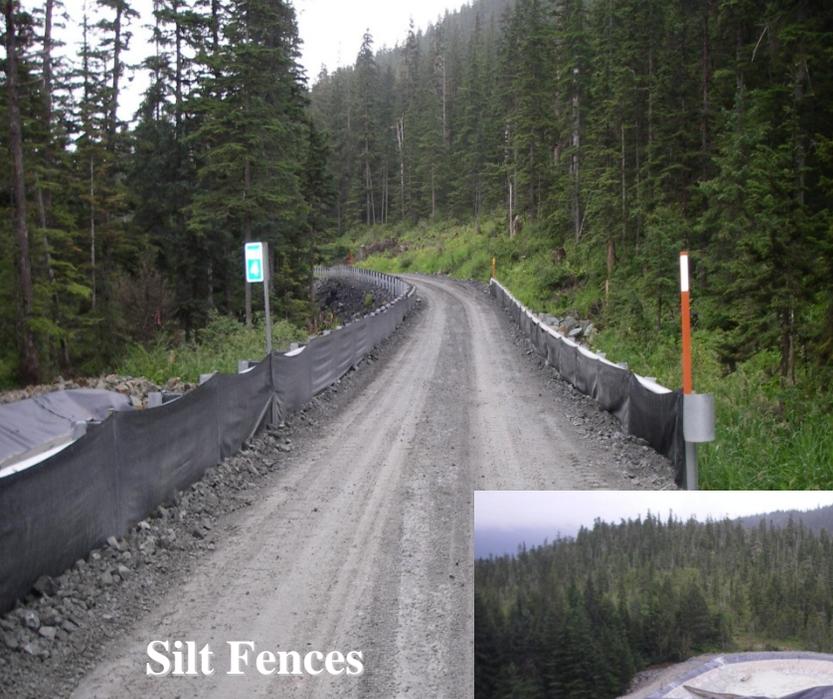
Silt Fences

✓ BMPs (Best Management Practices) both structural and non-structural devices/methods are utilized to prevent sediment migration into water.

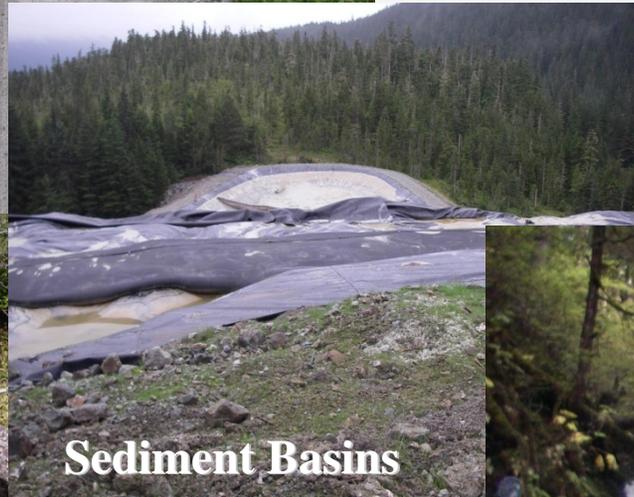
Sediment Basins

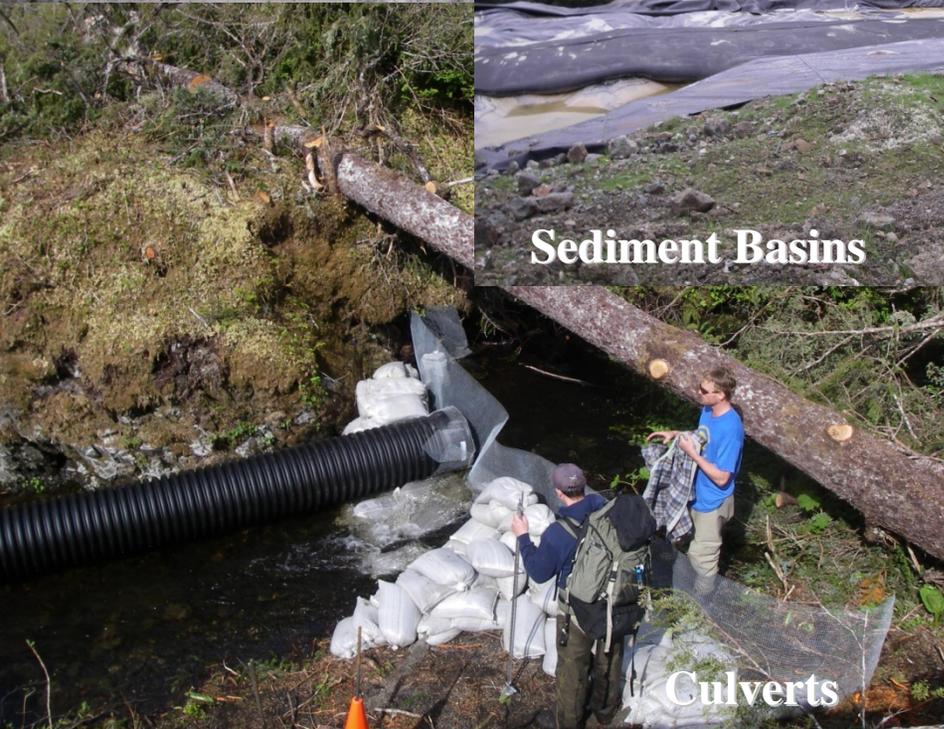
Culverts

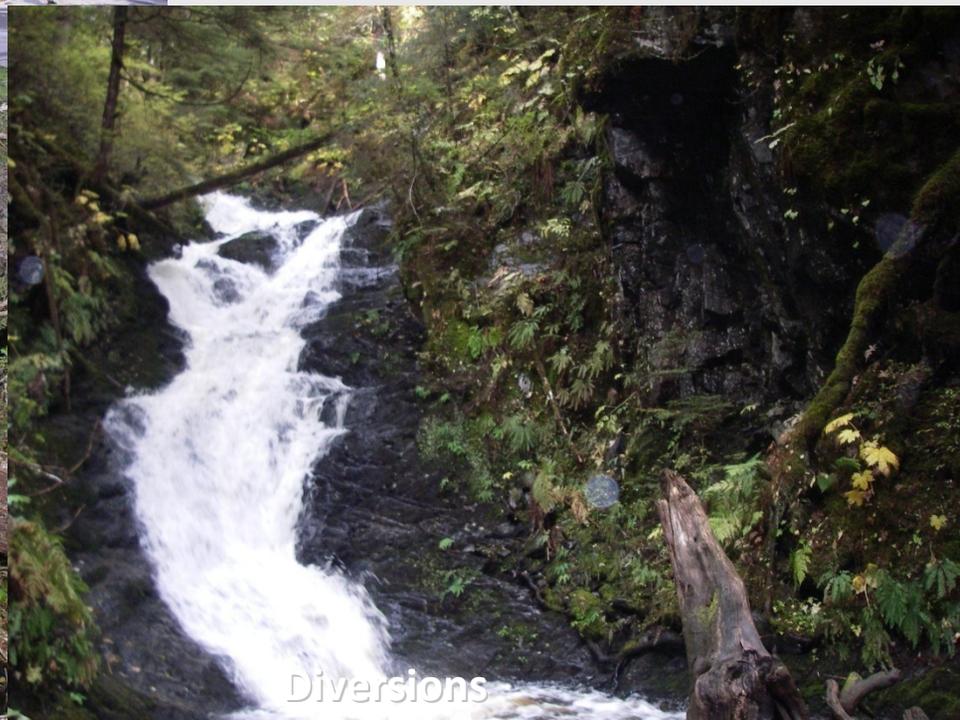
Diversions

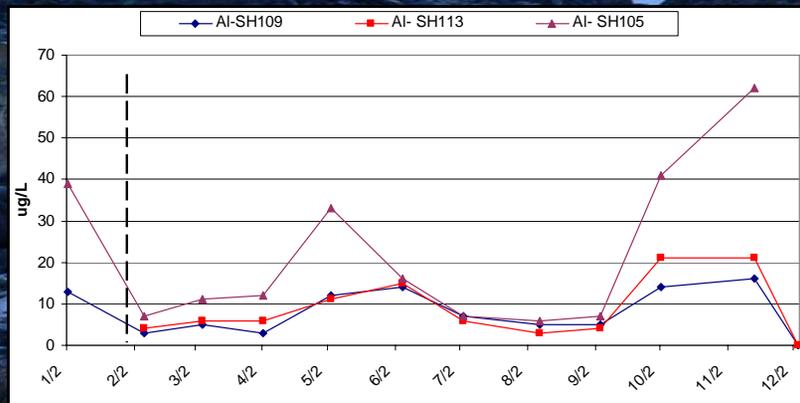
## DISSOLVED ALUMINUM *Sherman Creek*

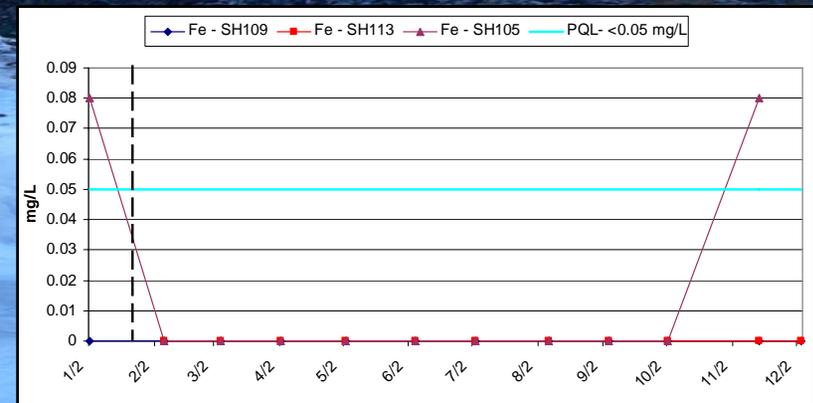
## DISSOLVED IRON *Sherman Creek*

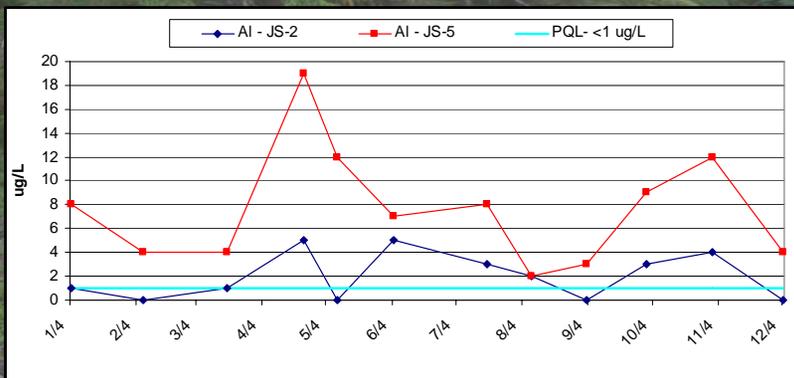
## DISSOLVED ALUMINUM *Johnson Creek*

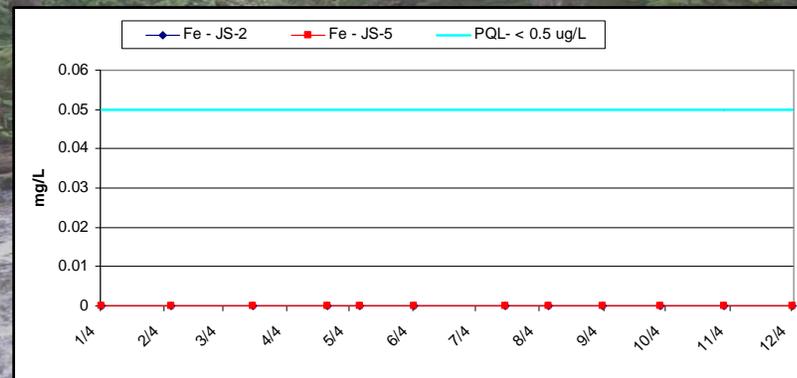
## DISSOLVED IRON *Johnson Creek*

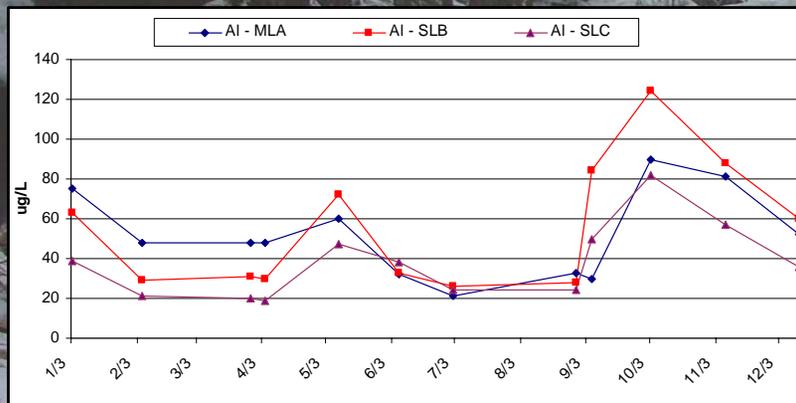
## DISSOLVED ALUMINUM *Slate Creek*

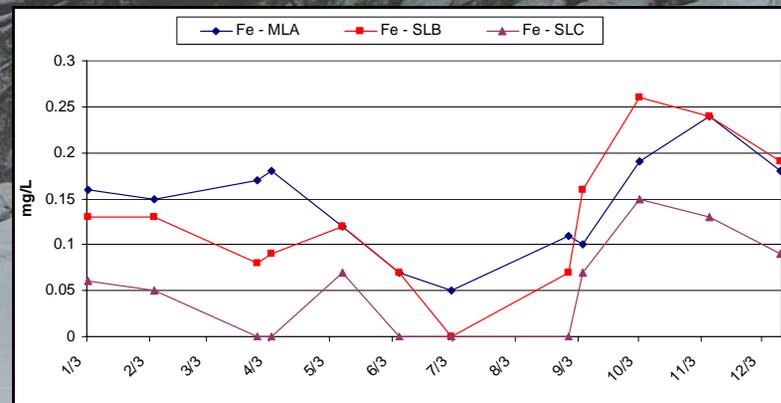
## DISSOLVED IRON *Slate Creek*

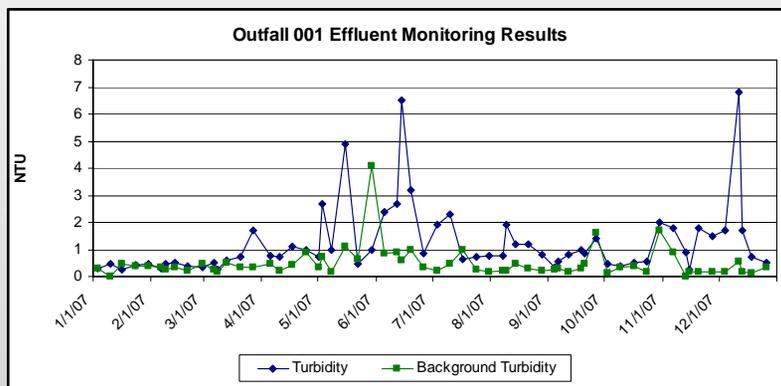
## TURBIDITY *Background and Effluent*

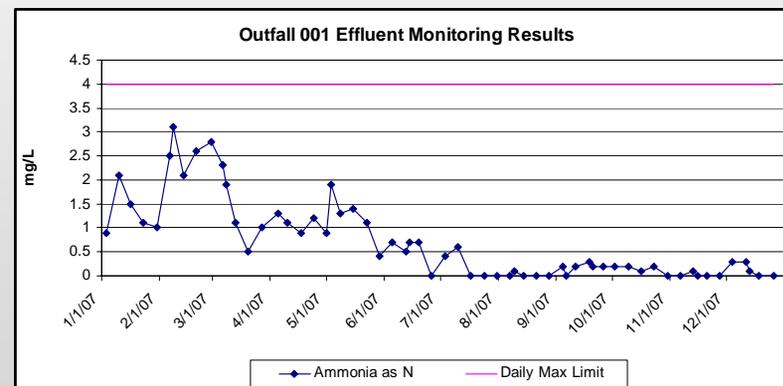
## AMMONIA as N *Effluent*

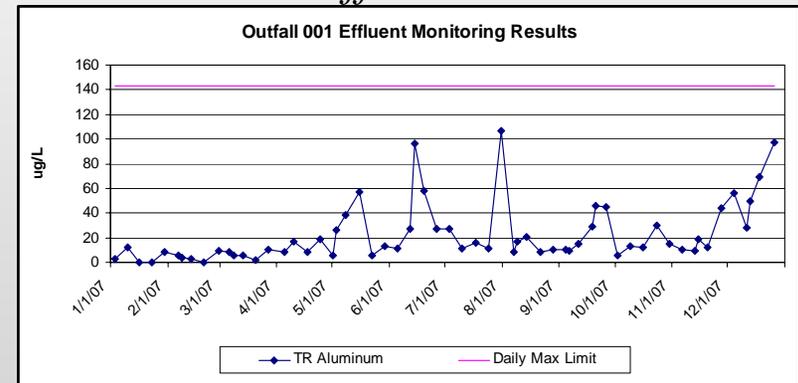
## TOTAL RECOVERABLE ALUMINUM *Effluent*

Average % Removal = 99.5%

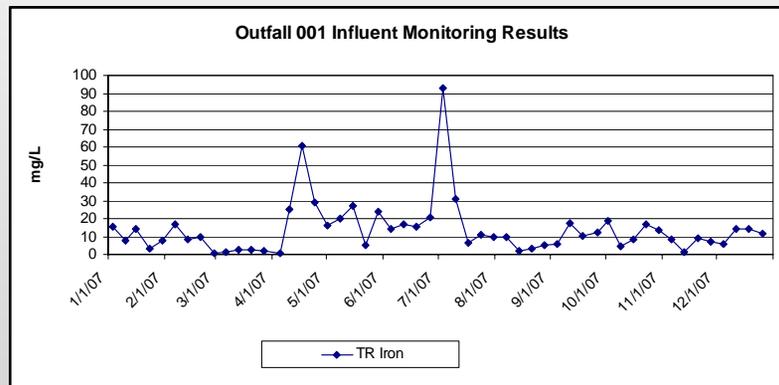
## TOTAL RECOVERABLE IRON *Influent*

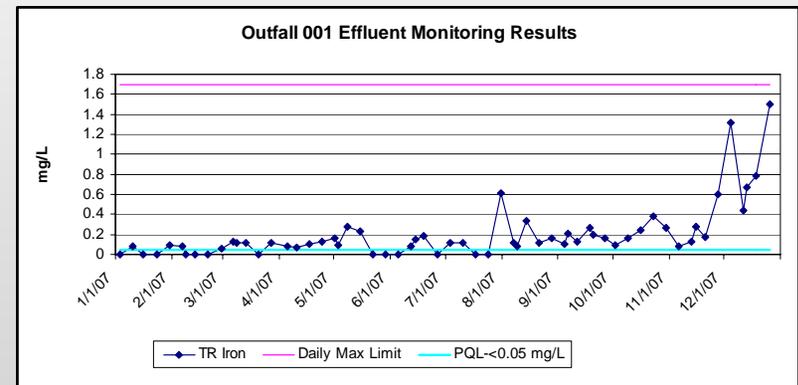
## TOTAL RECOVERABLE IRON *Effluent*

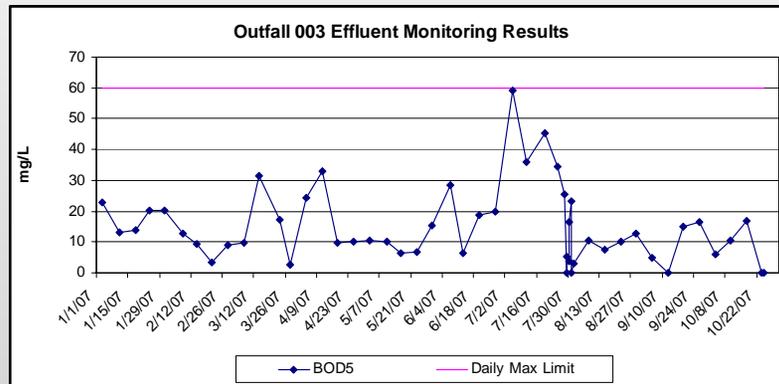
## BIOLOGICAL OXYGEN DEMAND *Effluent*

*Note: Variances in effluent data may reflect subtle changes to treatment techniques or changes in camp population*

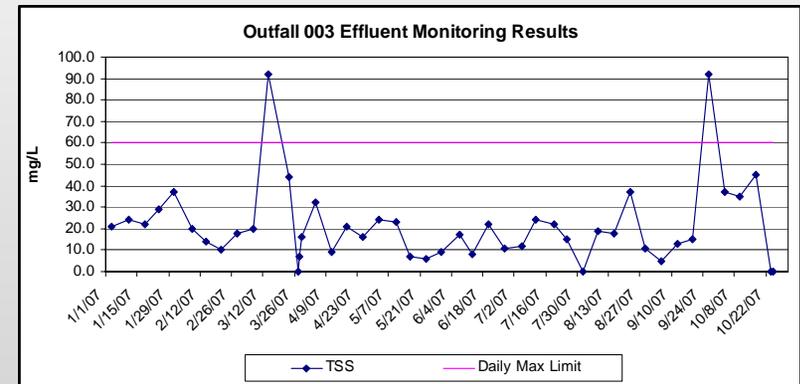
## TOTAL SUSPENDED SOLIDS *Effluent*

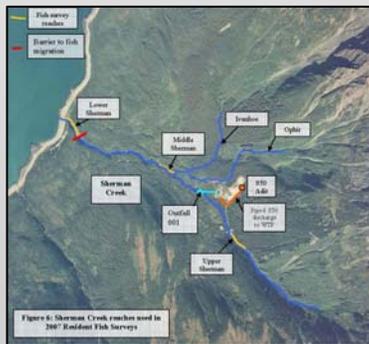
**Sherman Creek reaches used in the resident fish surveys**

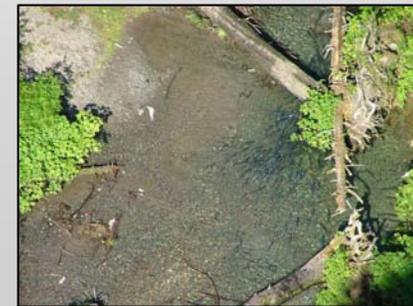
Pink salmon observed in Johnson Creek by helicopter
