KENSINGTON MINE ANNUAL MEETING for 2009

KENSINGTON GOLD MINE

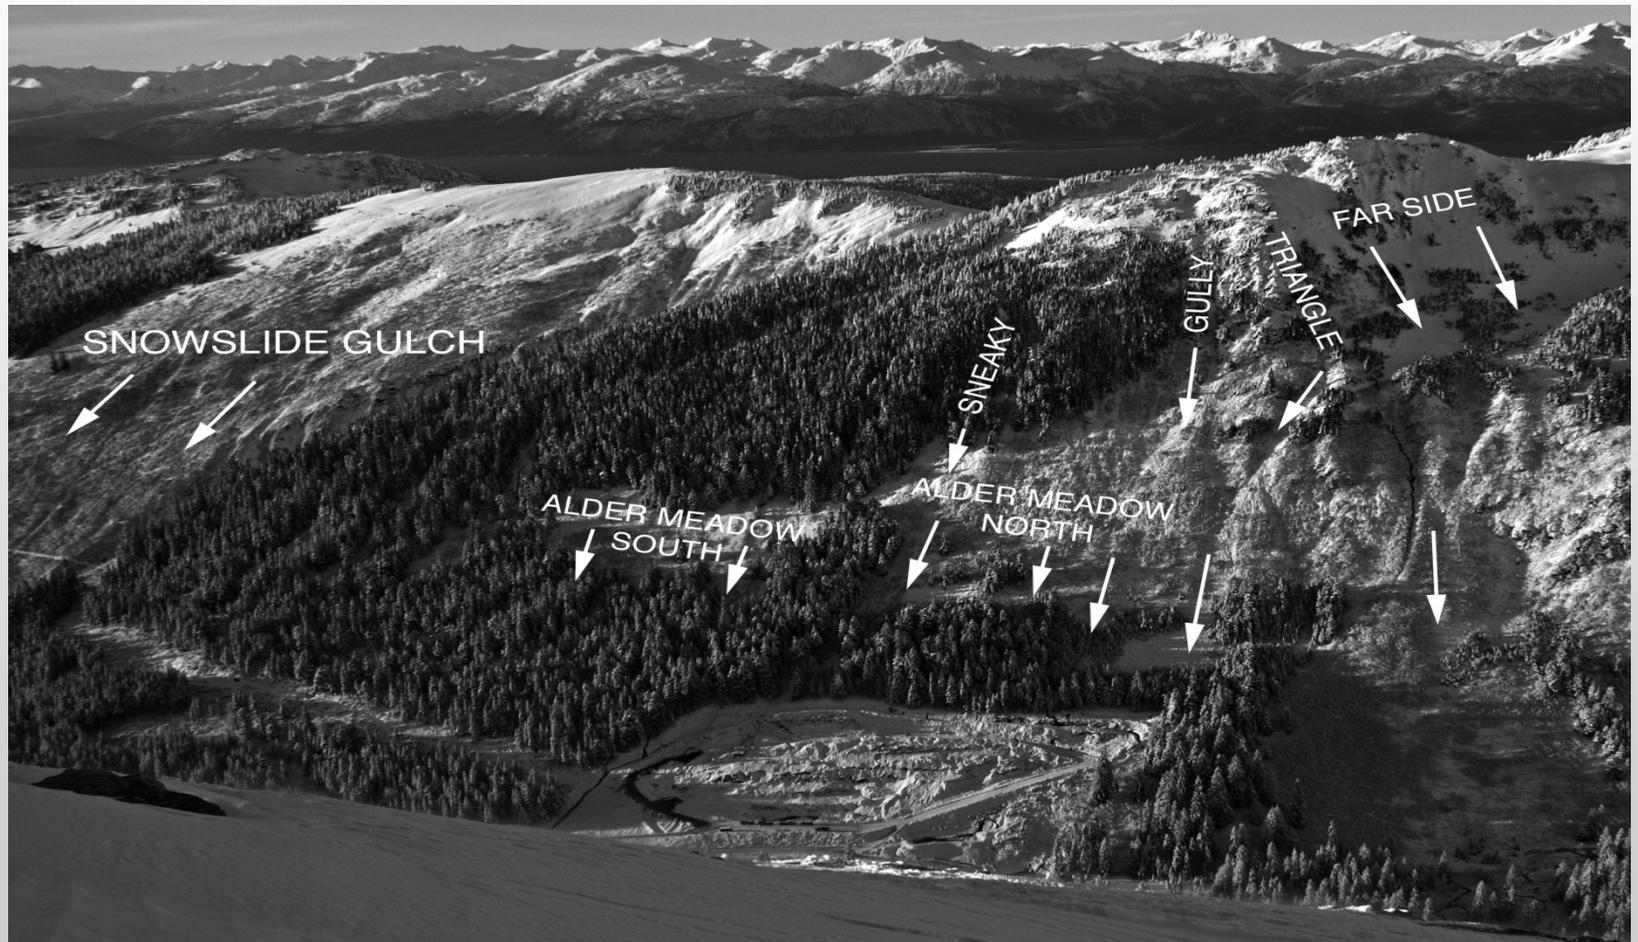
Sneaky, Gully, Triangle, & Alder Meadow North Avalanche Zones

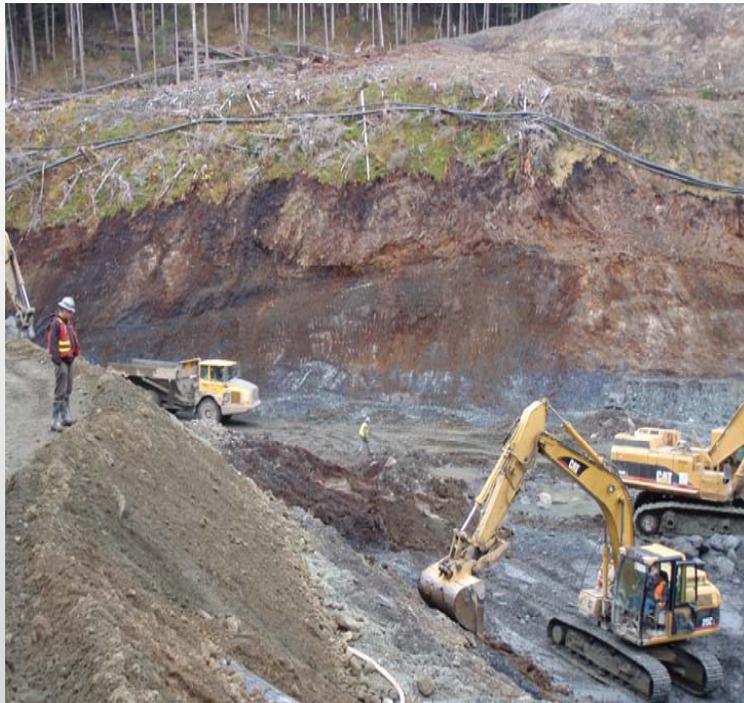
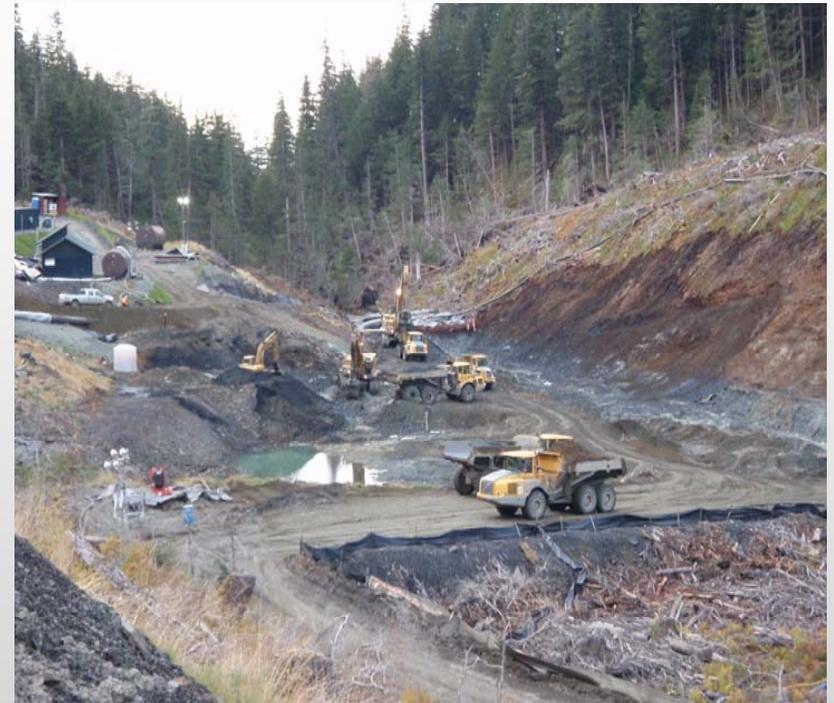
Dam Construction

- Unsuitable material was excavated from embankment footprint prior to fill placement
- Graphitic Phyllite was separated & transferred to Pit 3 for Temporary Storage

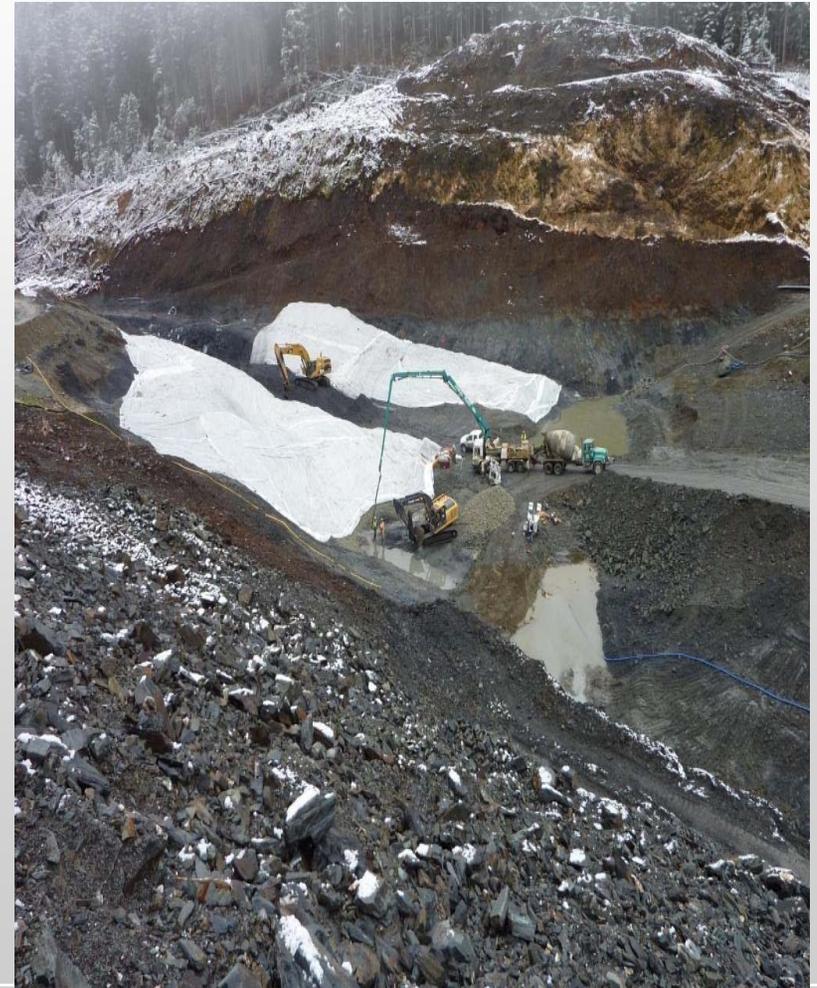
Dam Construction

- Placed Dental Grout on bedrock
 - Seal-Off Graphitic Phyllite
 - Due to Foundation Material not Meeting the Hardness Criteria

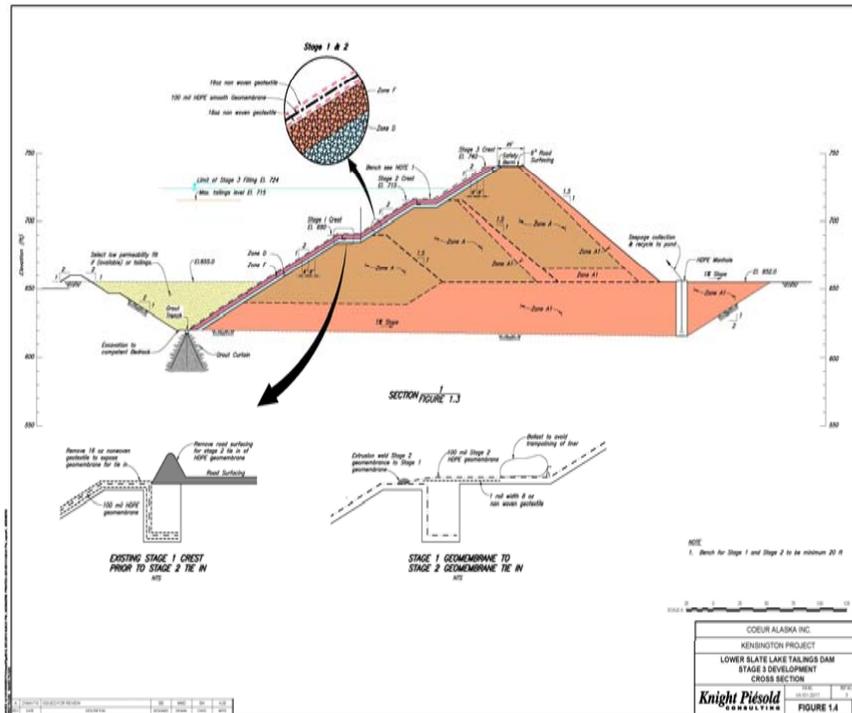
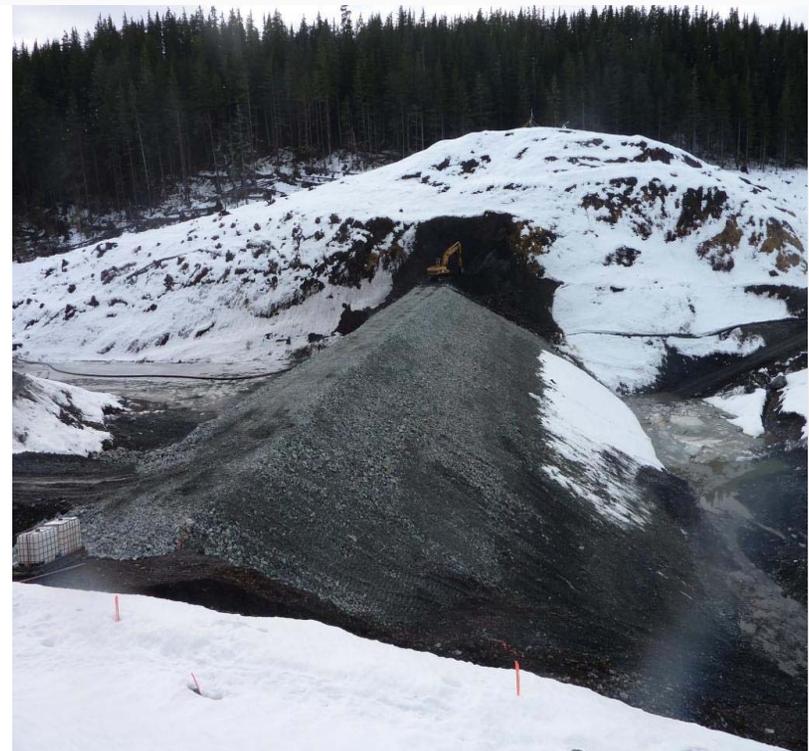
Dam Construction

- Placement of A and A1 Material
- Installation of Pump-Back System

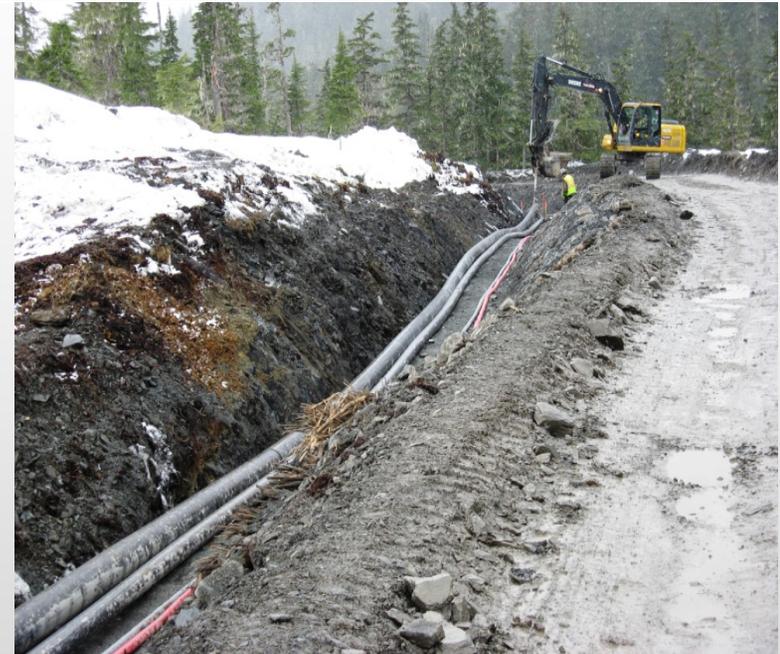
Tailings Conveyance Pipeline Road Construction

- Pioneer of Road to Snow-Slide Gulch
- Installation of Dual-Walled Tailings Conveyance Pipe-Line, Reclaim Pipeline, Power Cable, & Fibre Optic Cable

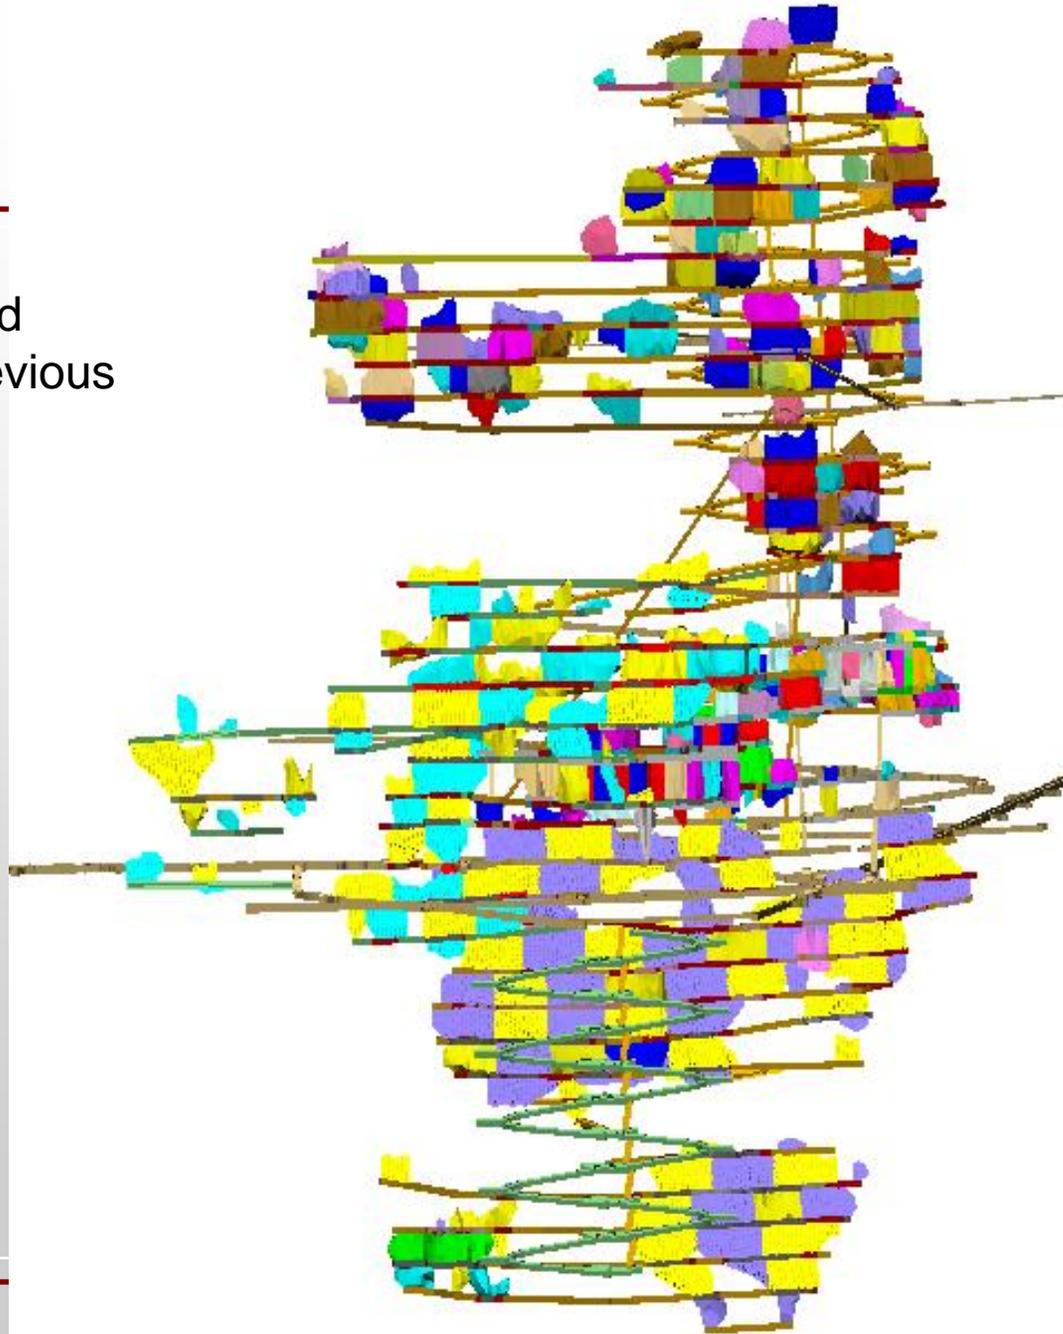
Existing and proposed development with previous COG stope shapes.

- Using a new Coeur block model, AMEC developed a new mining plan
- A Cut Off Grade (COG) of .17 opt resulted in new mining geometries, stope shapes, and reserves.

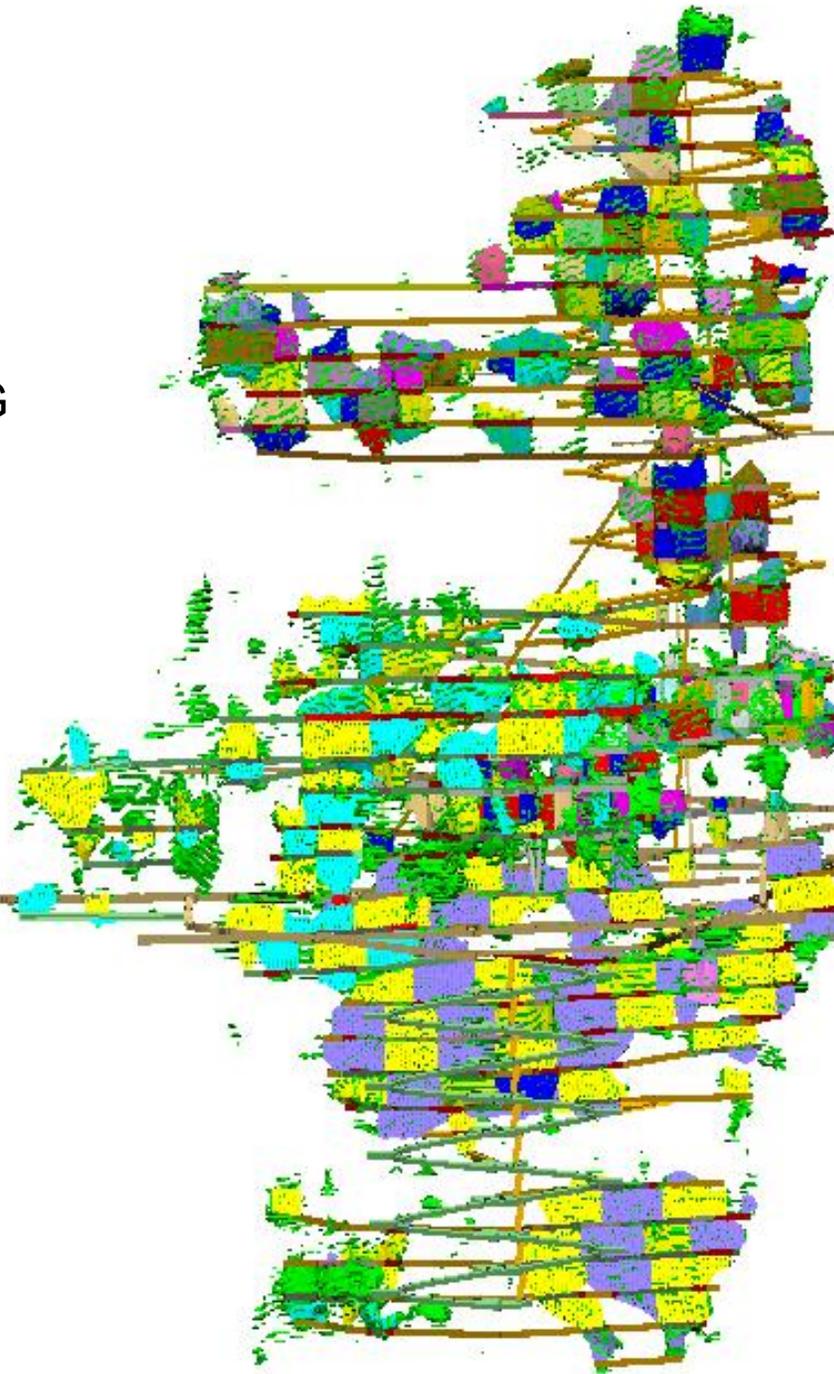
Existing and proposed development with .17 COG stope shapes.

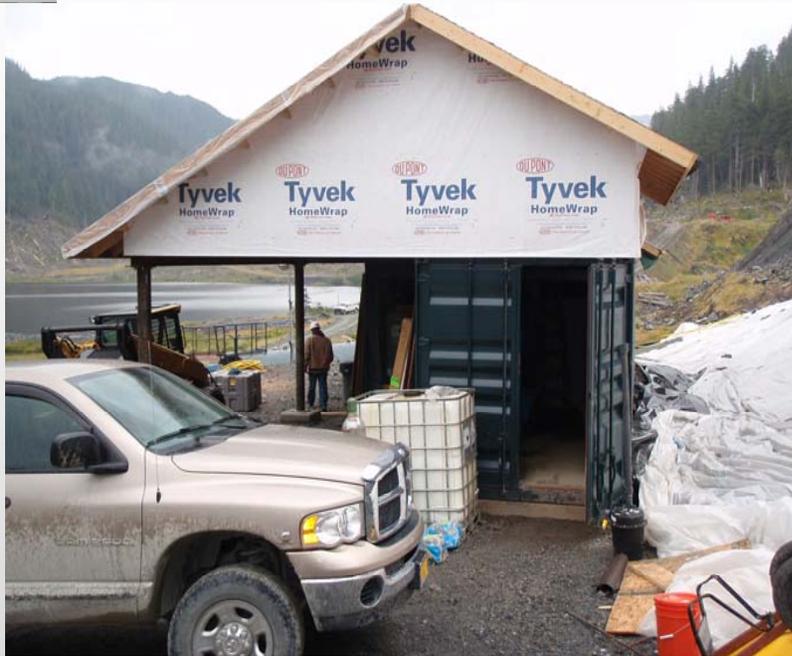
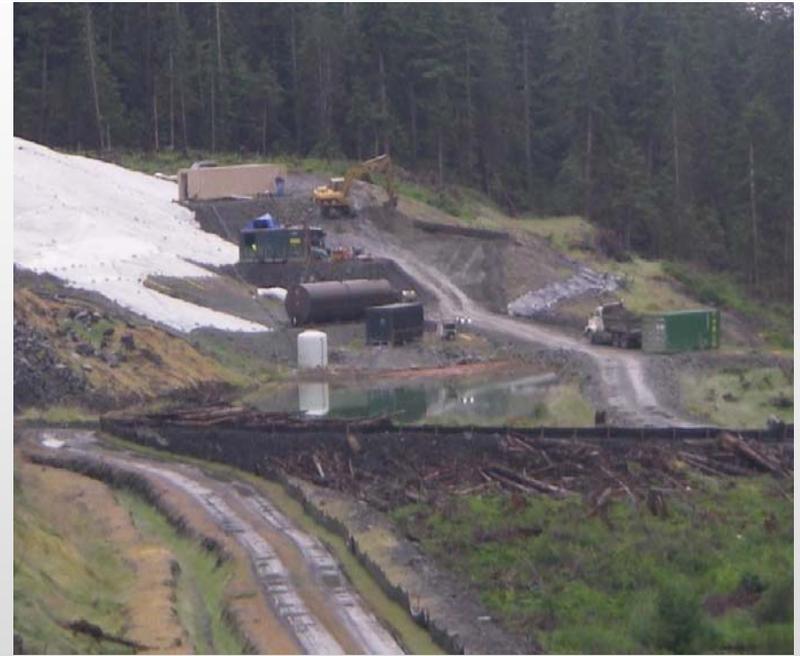
Temporary Package Water Treatment Plant at TTF

- Rotating Cylinder Treatment System (RCTS)
- Lime/Flocculant Addition
- Automated System

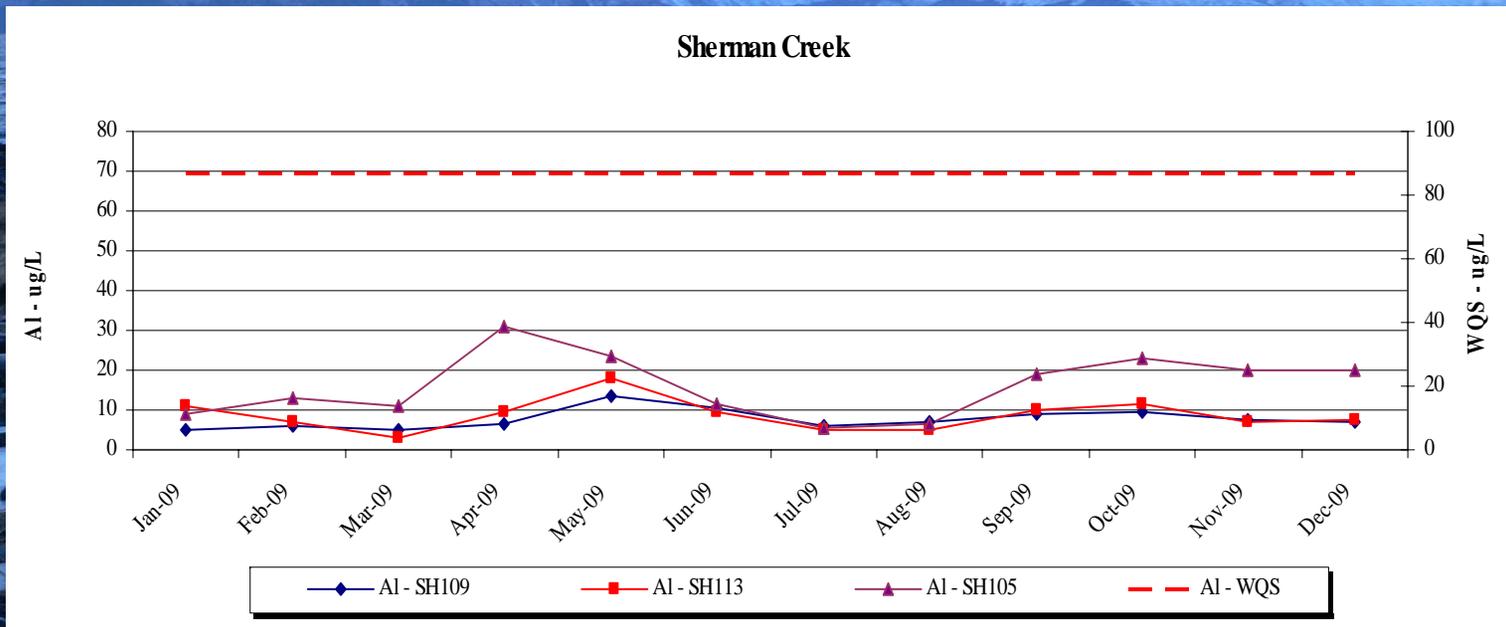
ALUMINUM, Dissolved

Water Quality – Sherman Creek

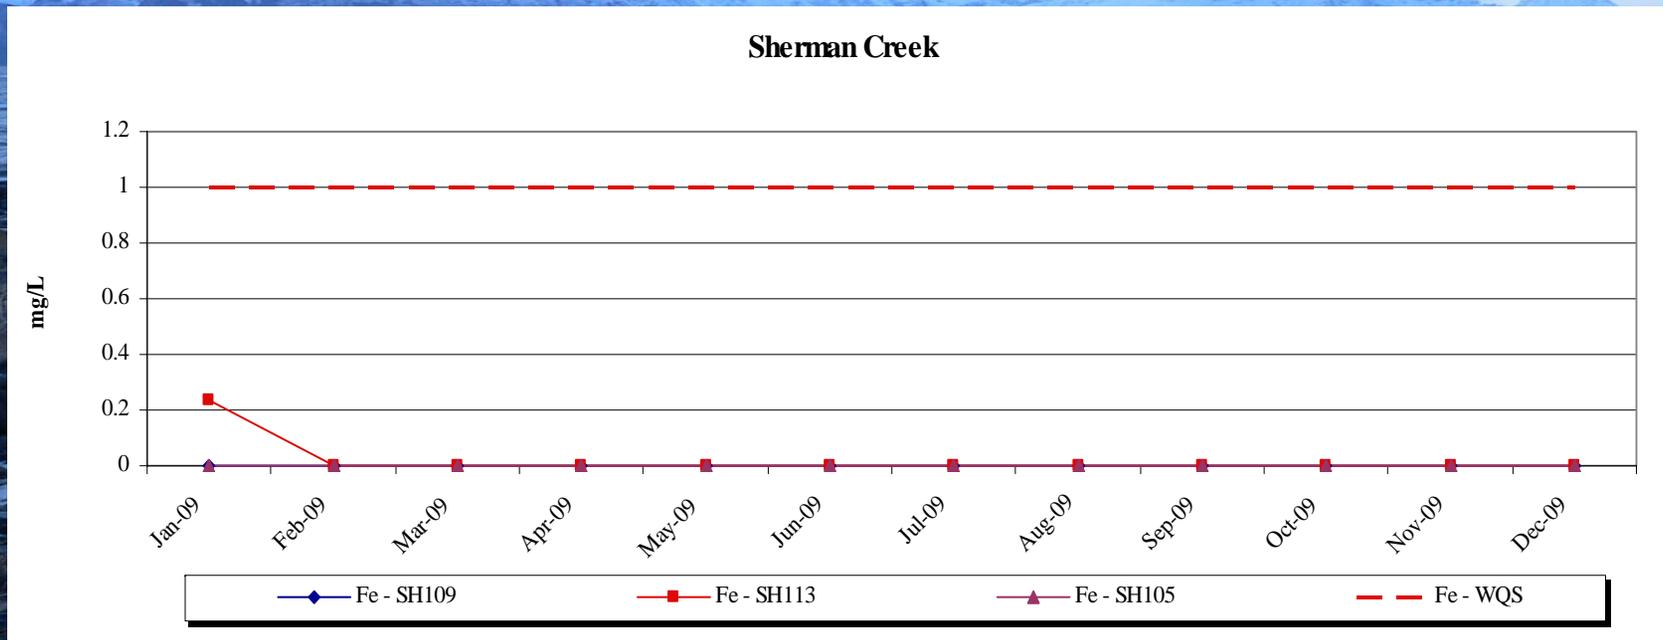
IRON, Dissolved

Sherman Creek

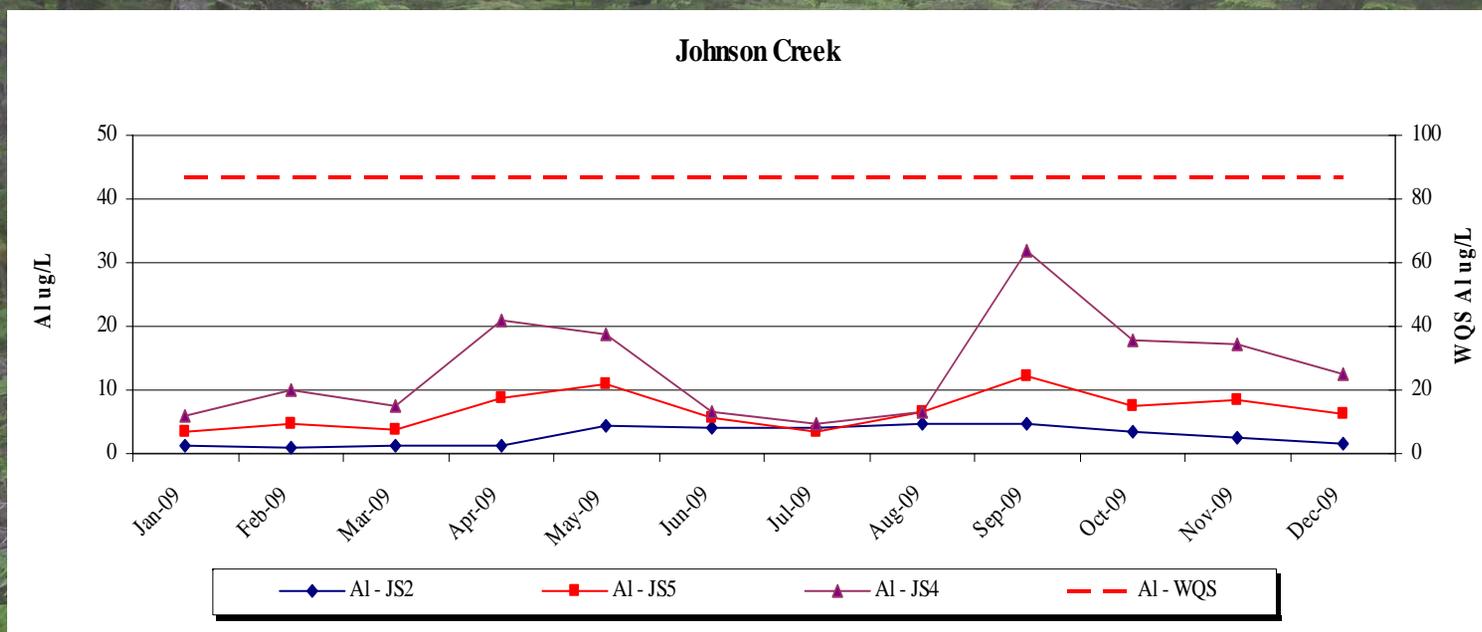
ALUMINUM, Dissolved

Water Quality –Johnson Creek

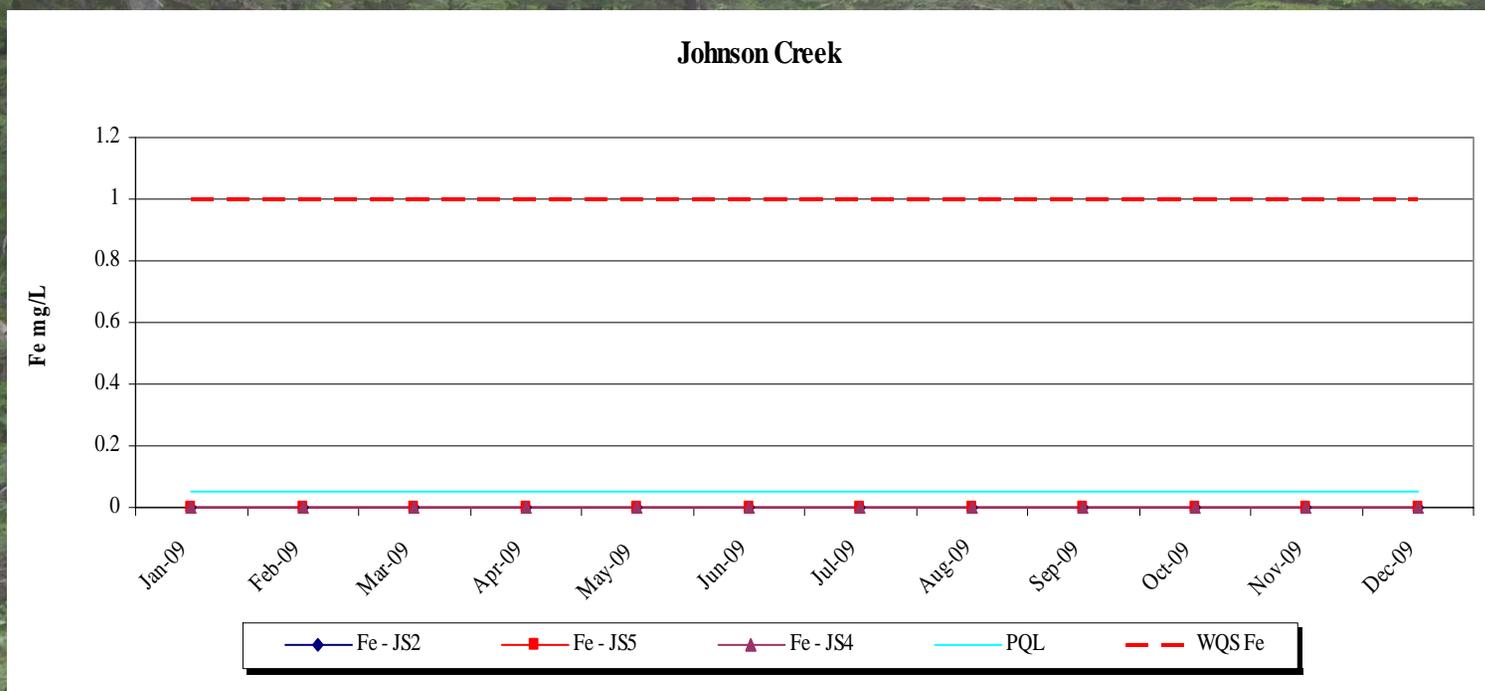
IRON, Dissolved

Water Quality –Johnson Creek

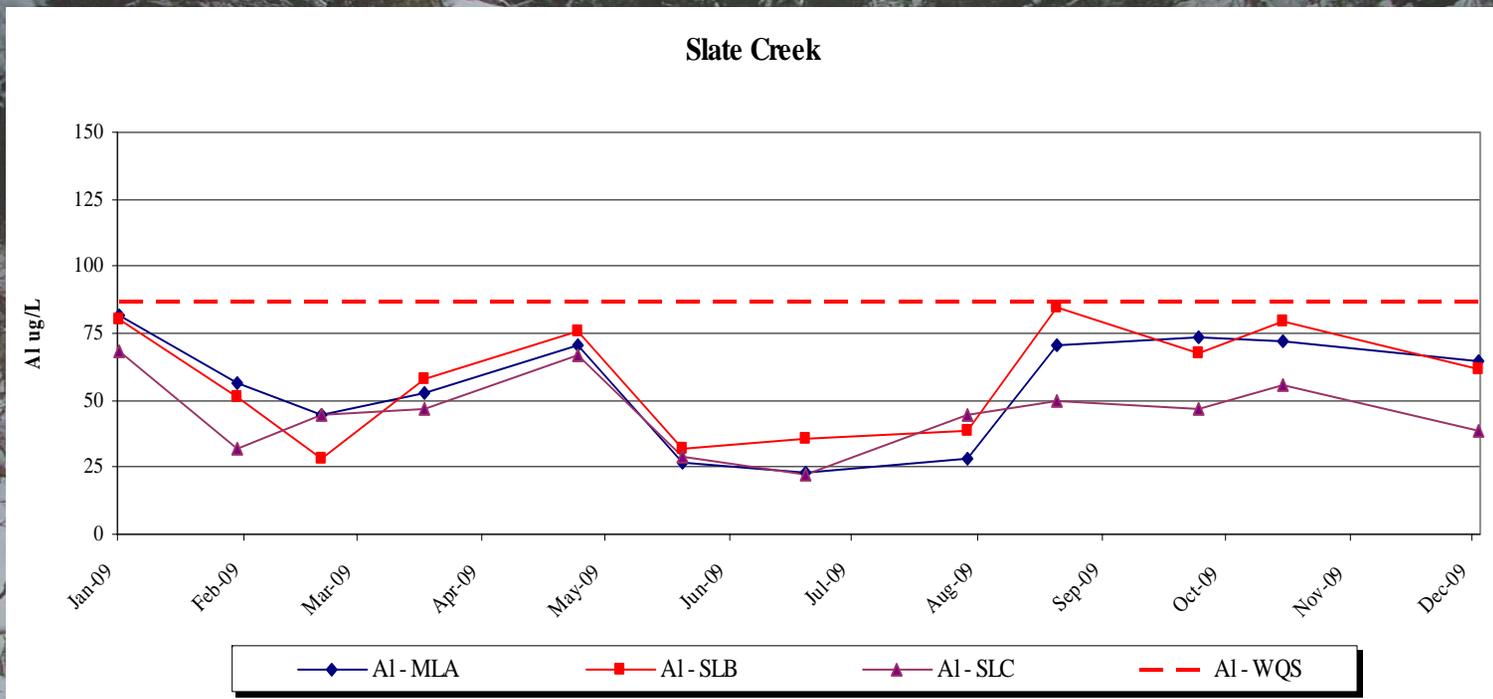
ALUMINUM, Dissolved

Water Quality – Slate Creek

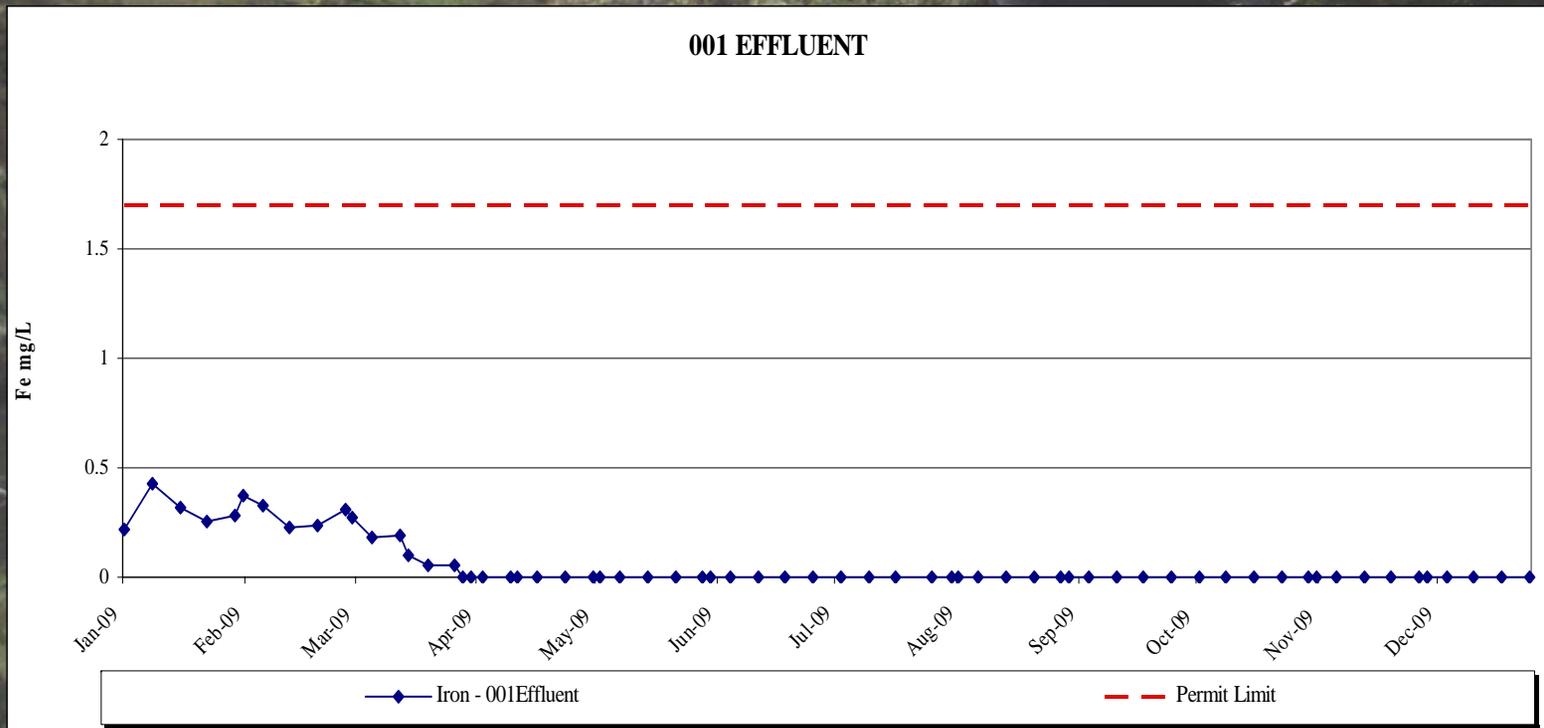
IRON , Total Recoverable

Water Quality – Outfall 001

- Follow seasonal cyclic trends for temperature and dissolved oxygen
- Typically have very low levels of turbidity
- Contain total recoverable metals mostly at or only slightly above detection limits
- Are monitored for constituents that are typically well under permitted limits

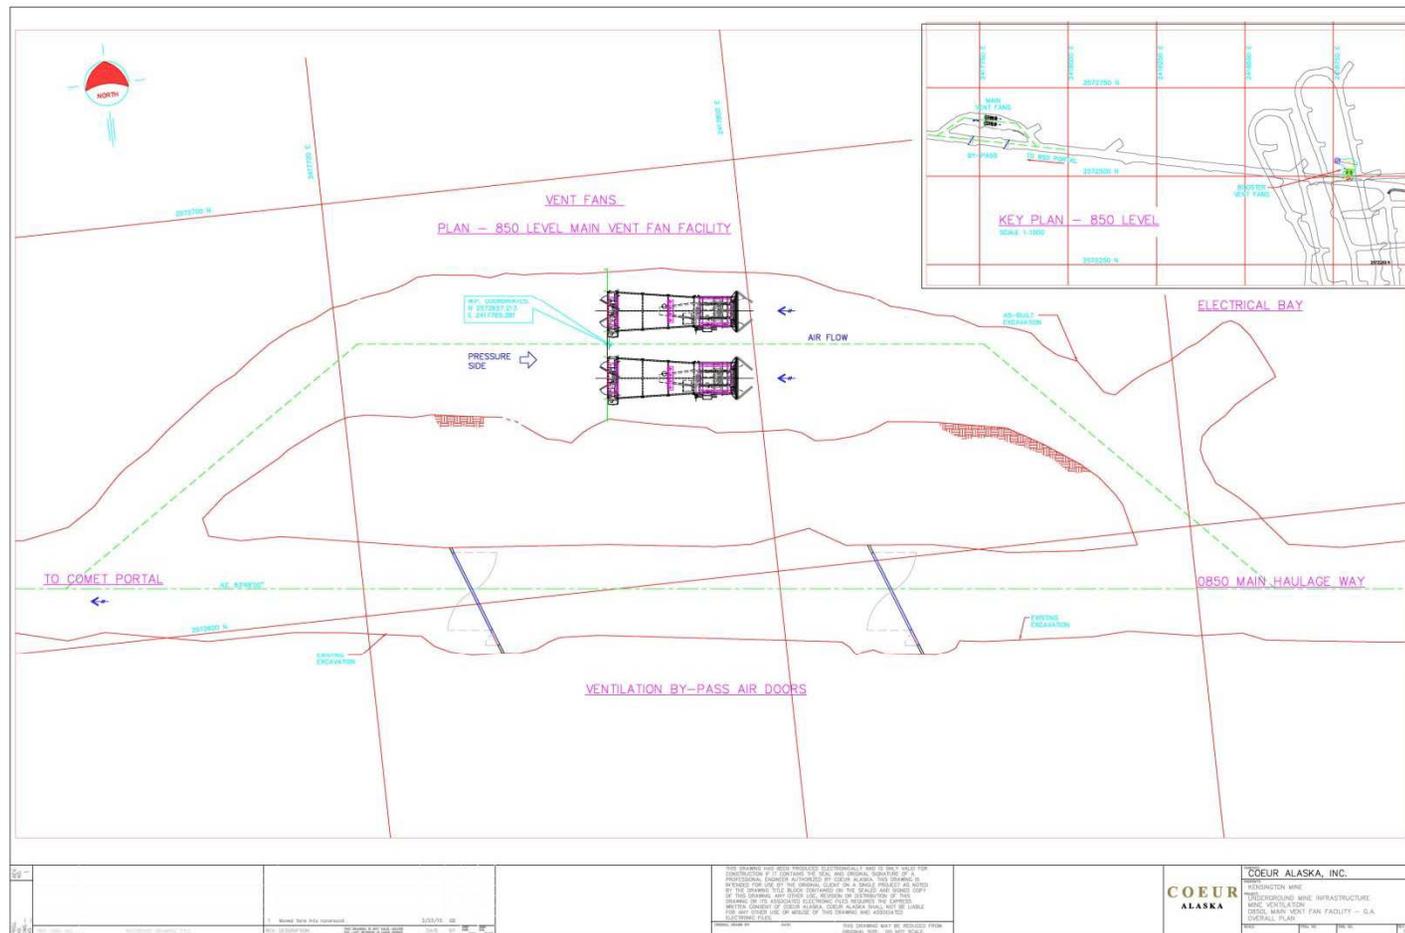
Upgraded Ventilation

Increase from 100 kcfm to 375 kcfm. Intake Jualin exhaust Comet.

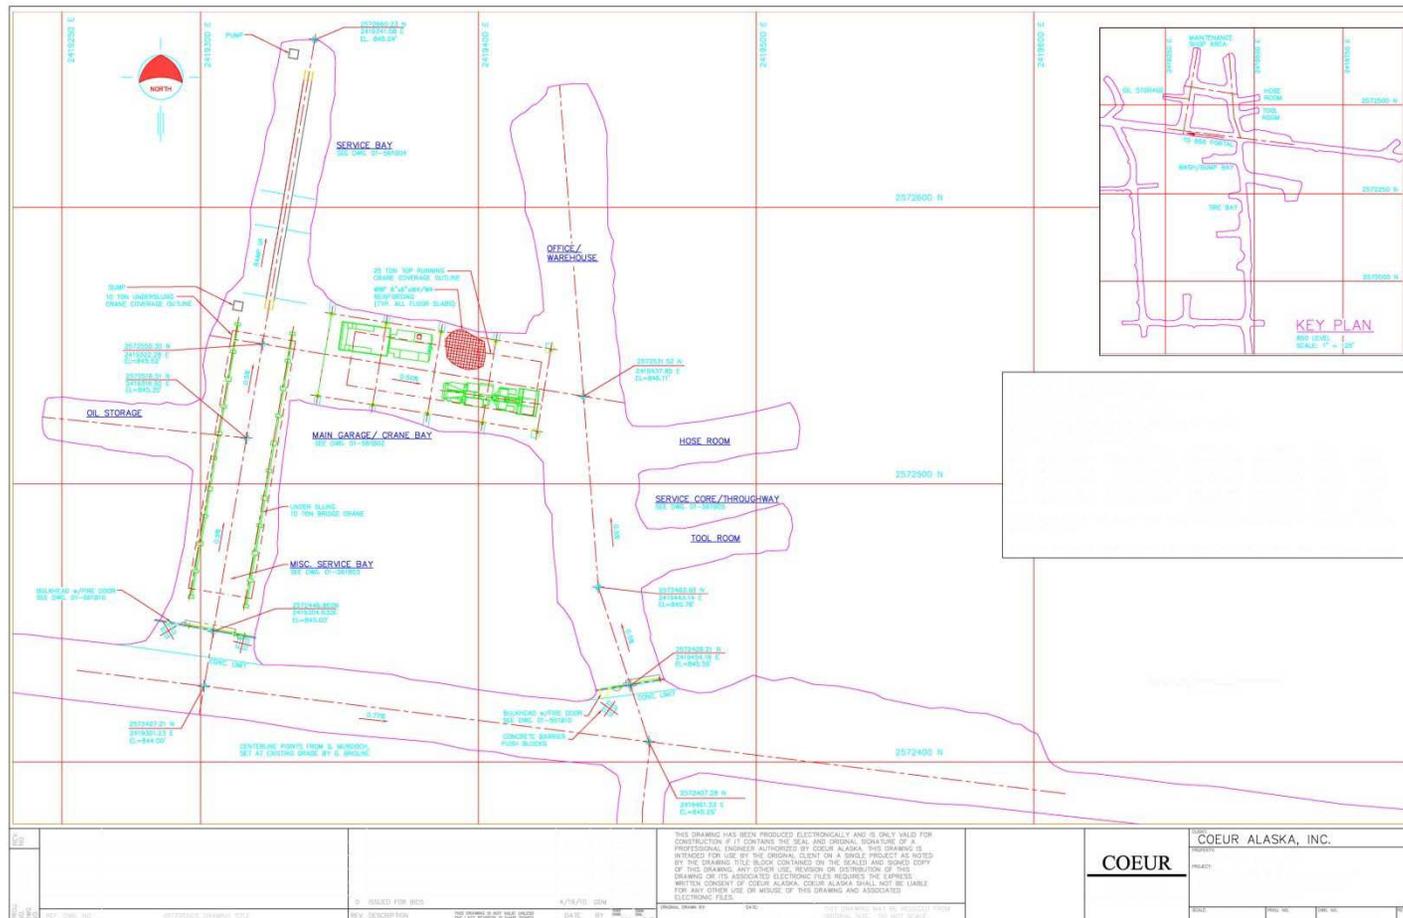
850 Level Maintenance Facility

18,000 ft² of workshop, service, and warehouse space. 25 and 10 ton cranes.
