Kensington Mine 2018 Annual Report

Prepared by:
Coeur Alaska, Inc.
3031 Clinton Drive, Suite 202
Juneau, AK 99801

For:
U.S. Forest Service
Alaska Region (R-10)
Tongass Minerals Group
Juneau Ranger District
8510 Mendenhall Loop Road
Juneau, AK 99801

January 2019

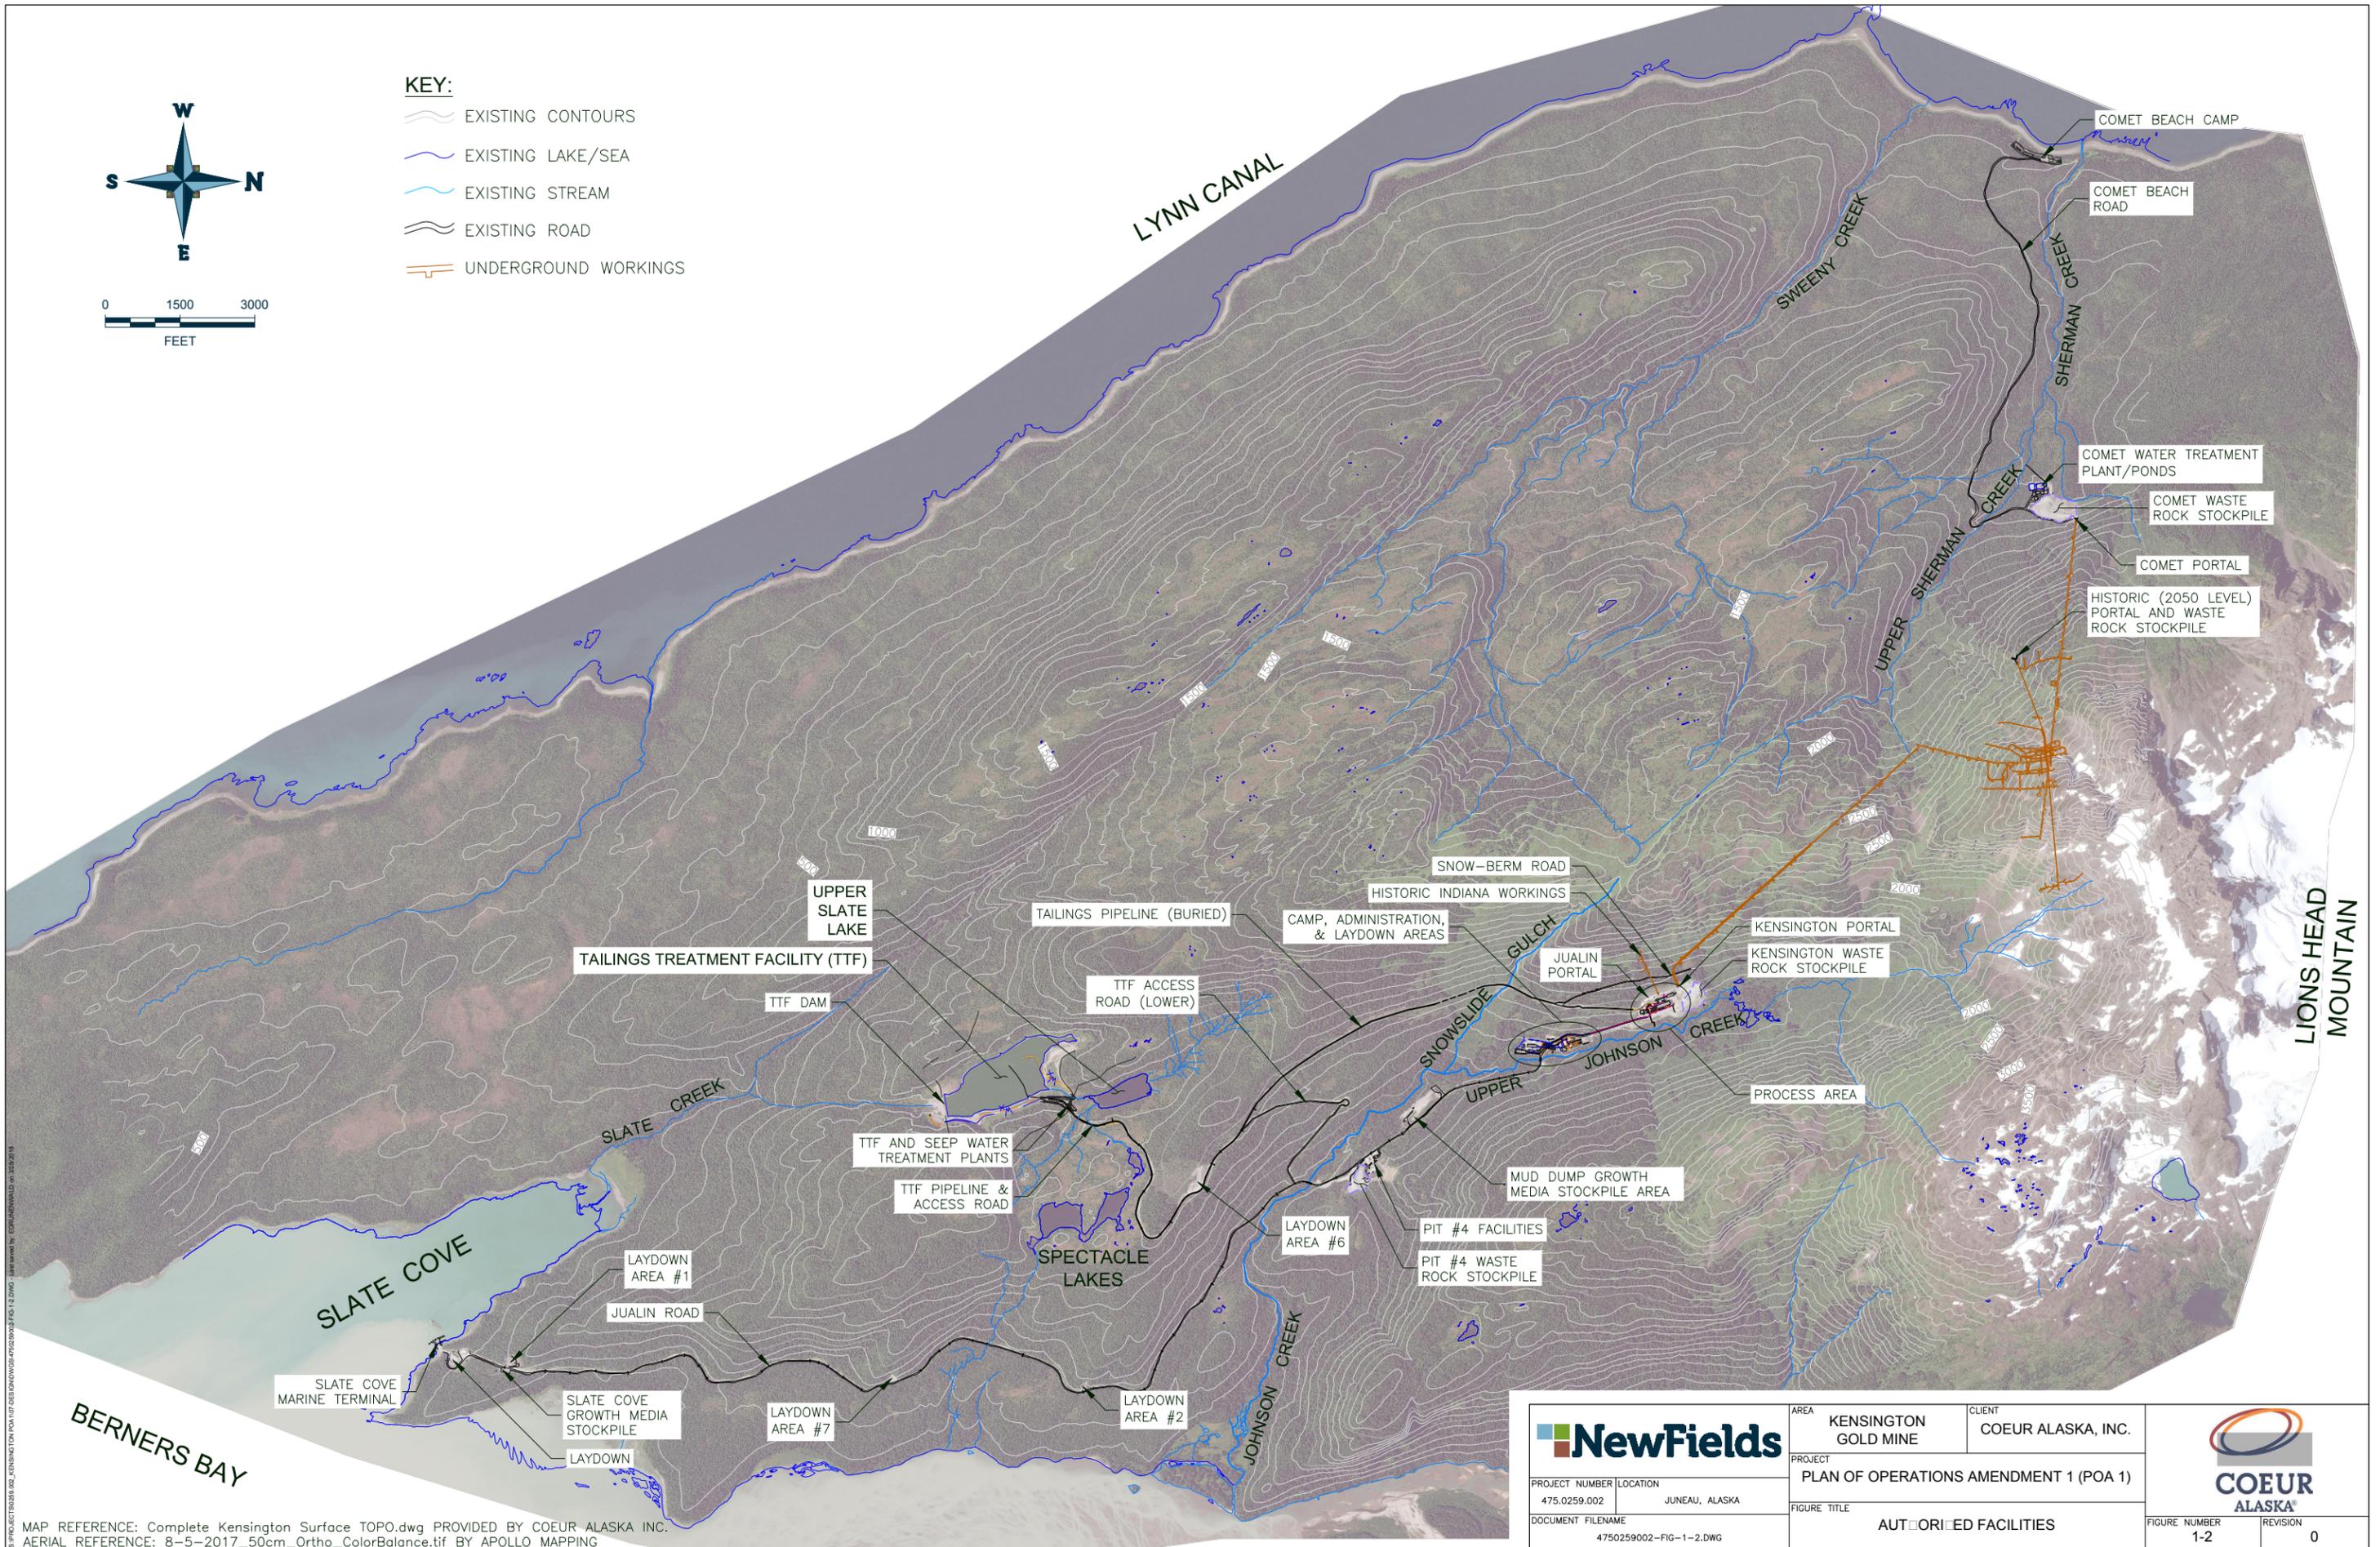
AREA KENSINGTON GOLD MINE	CLIENT COEUR ALASKA, INC.	
PROJECT PLAN OF OPERATIONS AMENDMENT 1 (POA 1)		FIGURE TITLE AUTHORIZED FACILITIES		
PROJECT NUMBER 475.0259.002	LOCATION JUNEAU, ALASKA	FIGURE NUMBER 1-2		REVISION 0
DOCUMENT FILENAME 4750259002-FIG-1-2.DWG

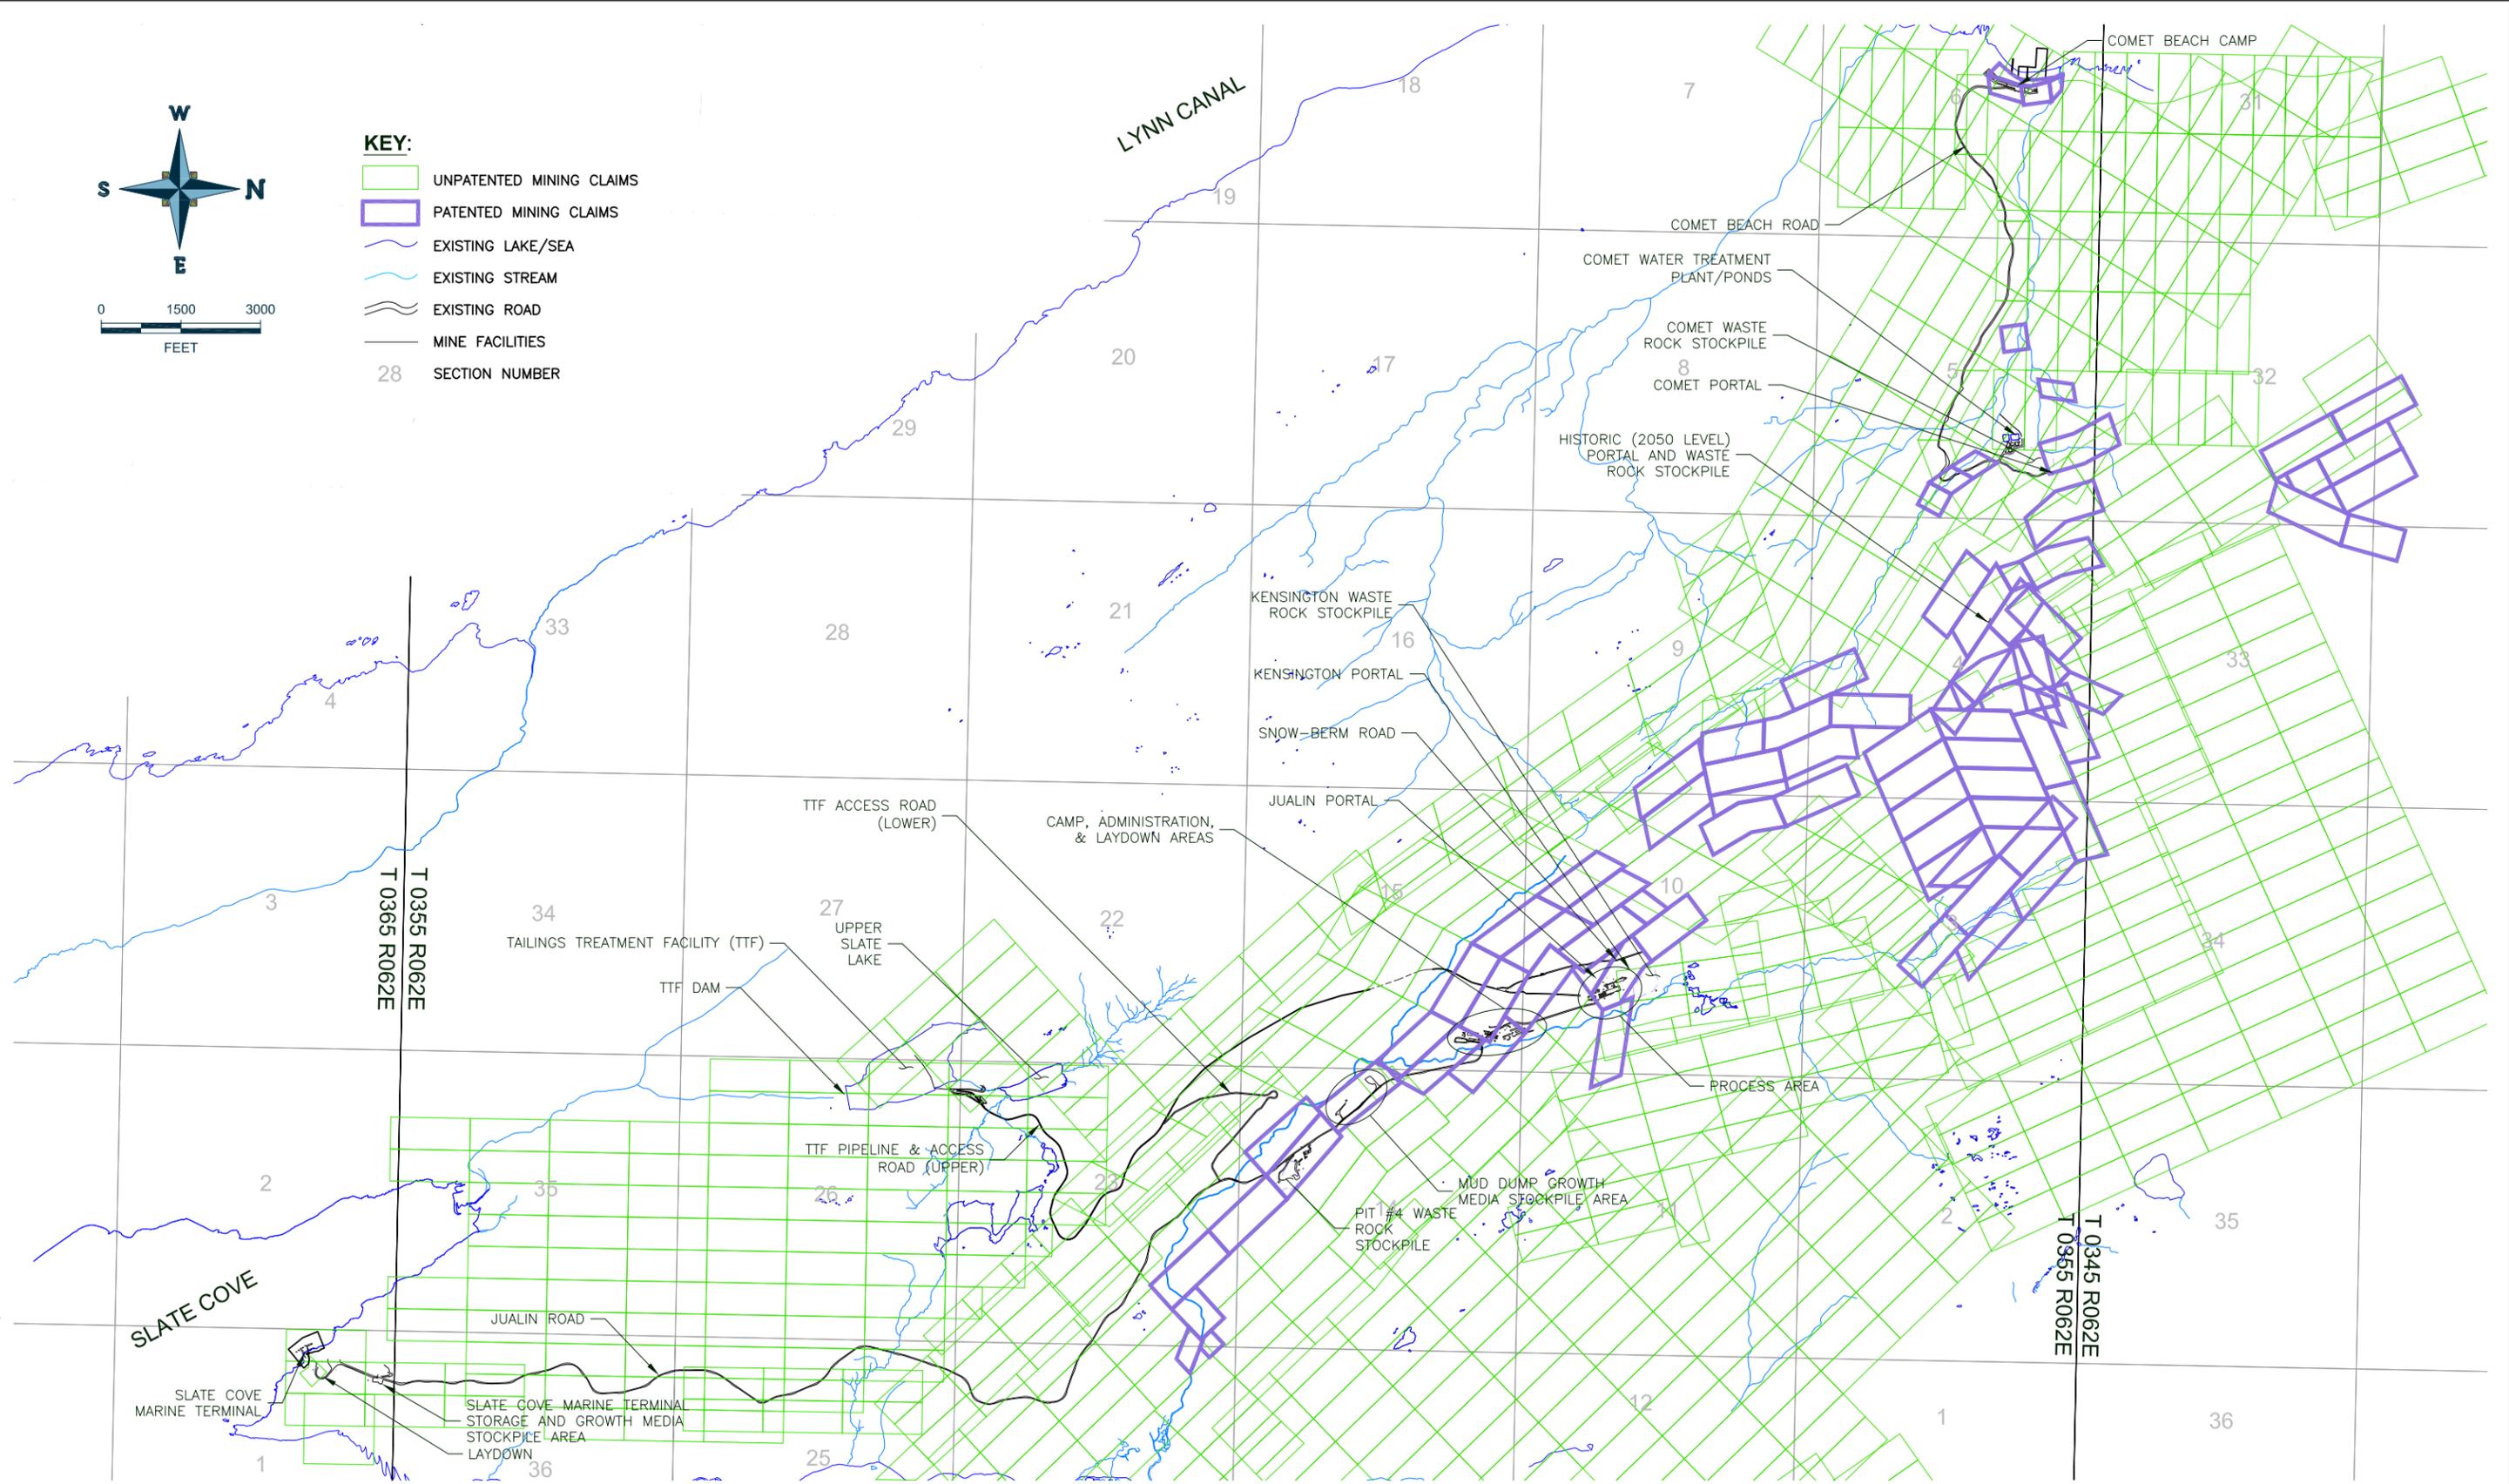
AREA KENSINGTON GOLD MINE	CLIENT COEUR ALASKA, INC.
PROJECT 475.0259.002		PROJECT PLAN OF OPERATIONS AMENDMENT 1 (POA 1)	
LOCATION JUNEAU, ALASKA		FIGURE TITLE CLAIM BOUNDARIES MAP - LAND OWNERSHIP	
DOCUMENT FILENAME 4750259002-FIG-1-3.DWG		FIGURE NUMBER 1-3	REVISION 0

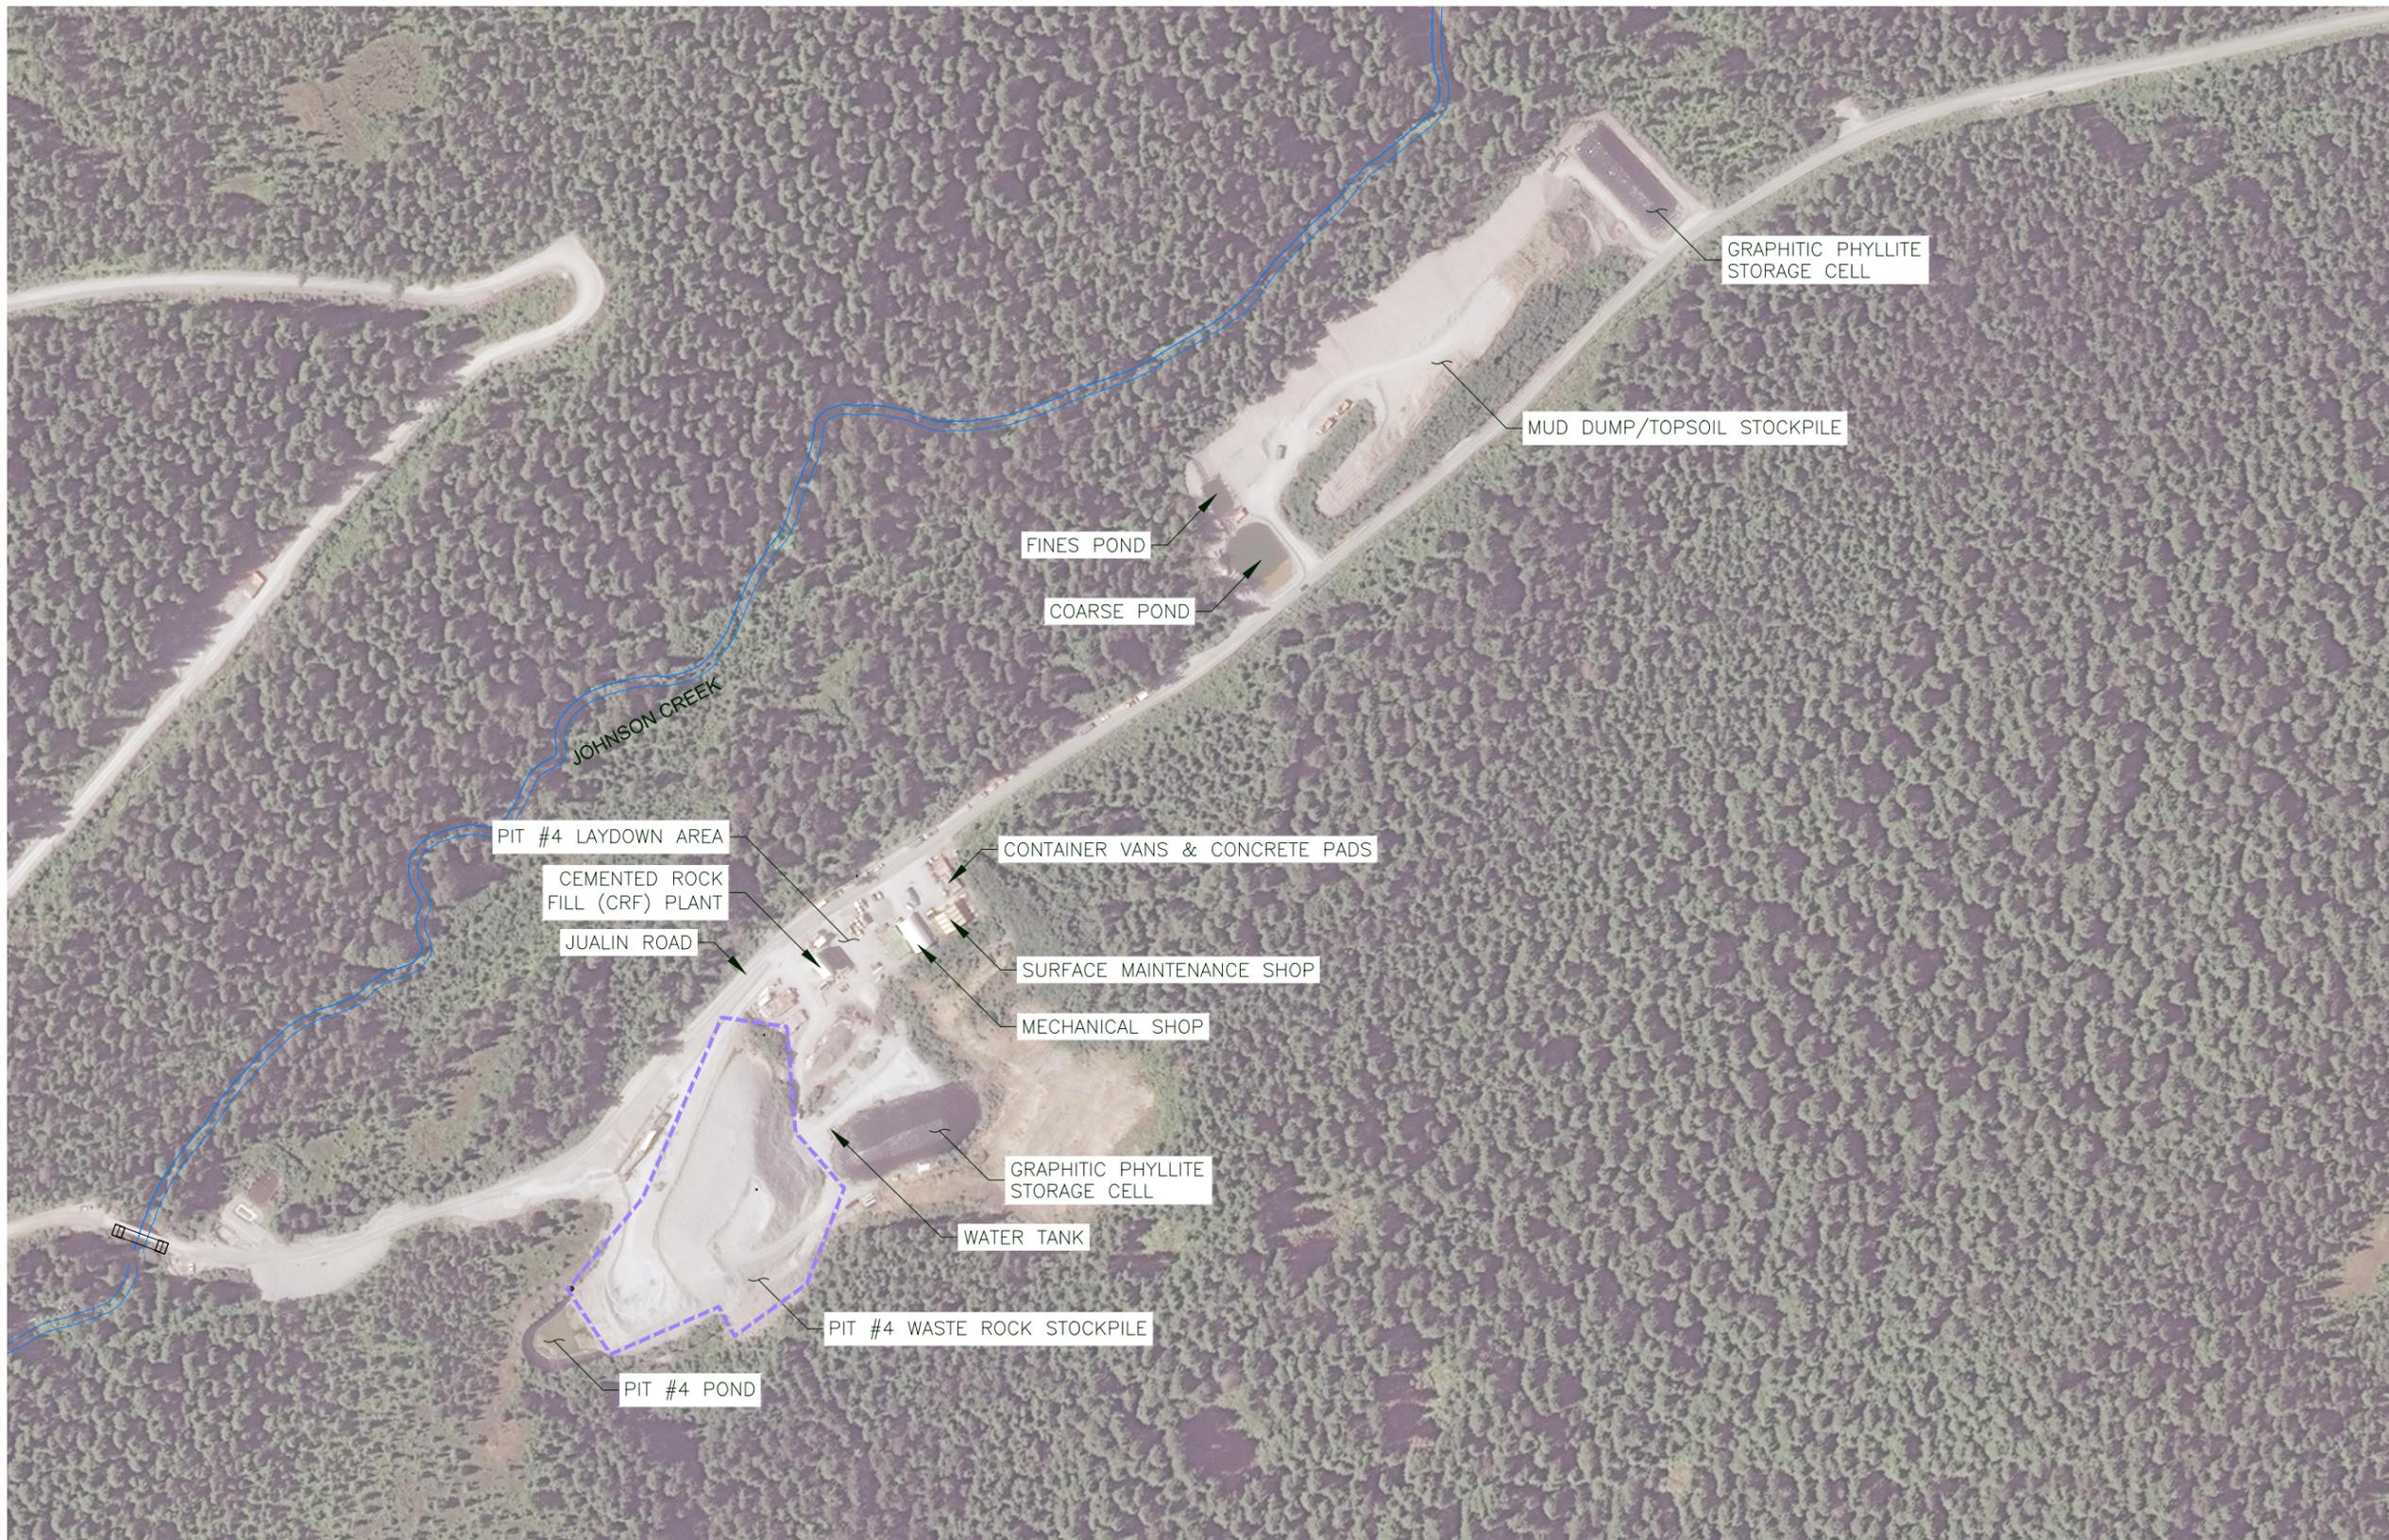
FIGURE NUMBER: 3-3
 REVISION: 0

PROJECT: PLAN OF OPERATIONS AMENDMENT 1 (POA 1)
 FIGURE TITLE: EXISTING FACILITIES - SLATE LAKES AREA DETAIL

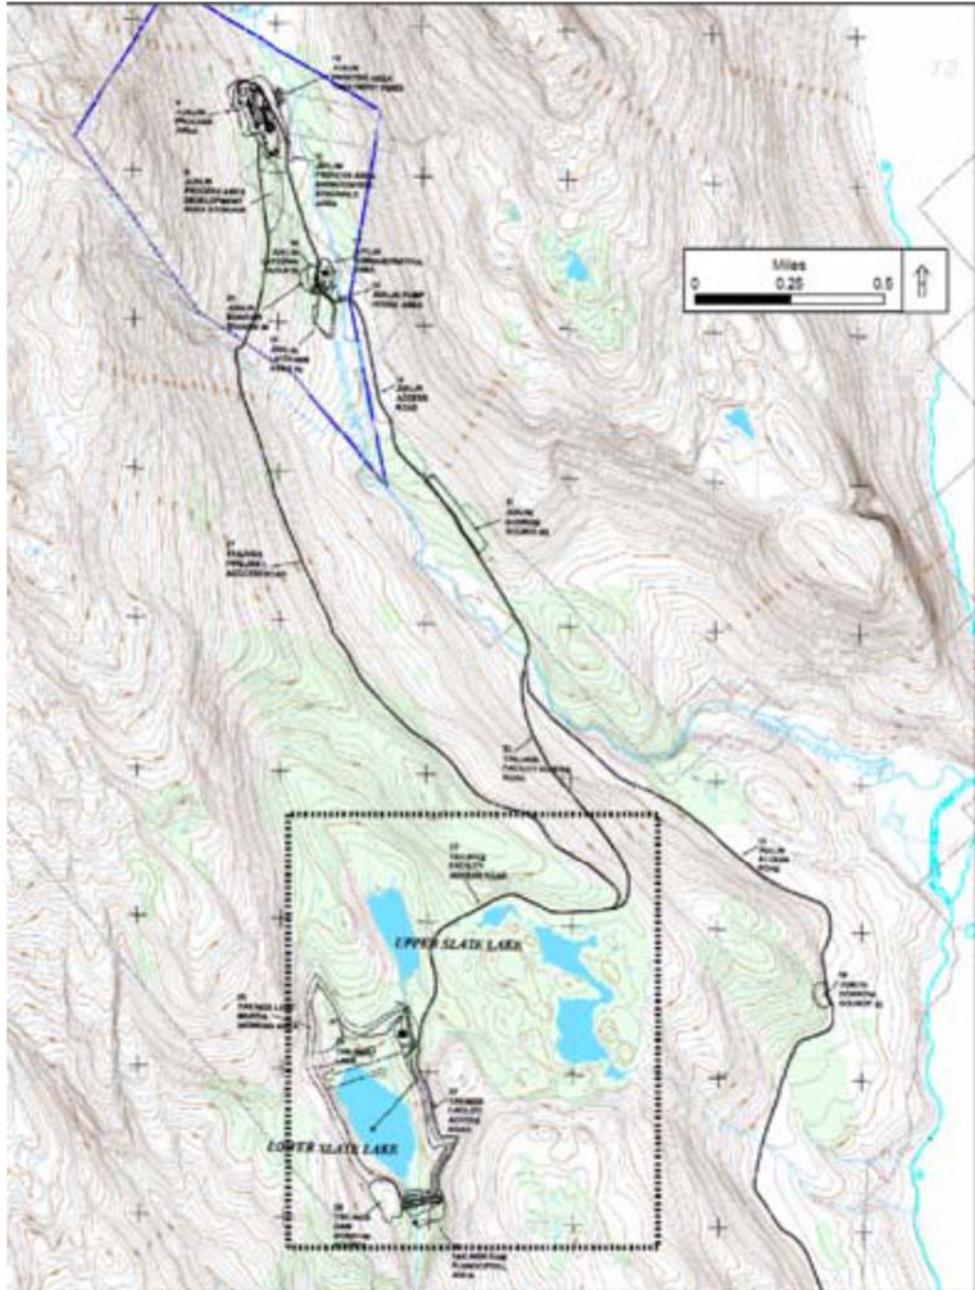
Figure 1: Slate Lakes basin in relation to access roads and the Tailings Treatment Facility (TTF). The access road to the TTF was constructed in 2006. The tailings dam was constructed between August 2009 and August 2010. Construction for the stage 3 tailings dam raise occurred February – December of 2018.

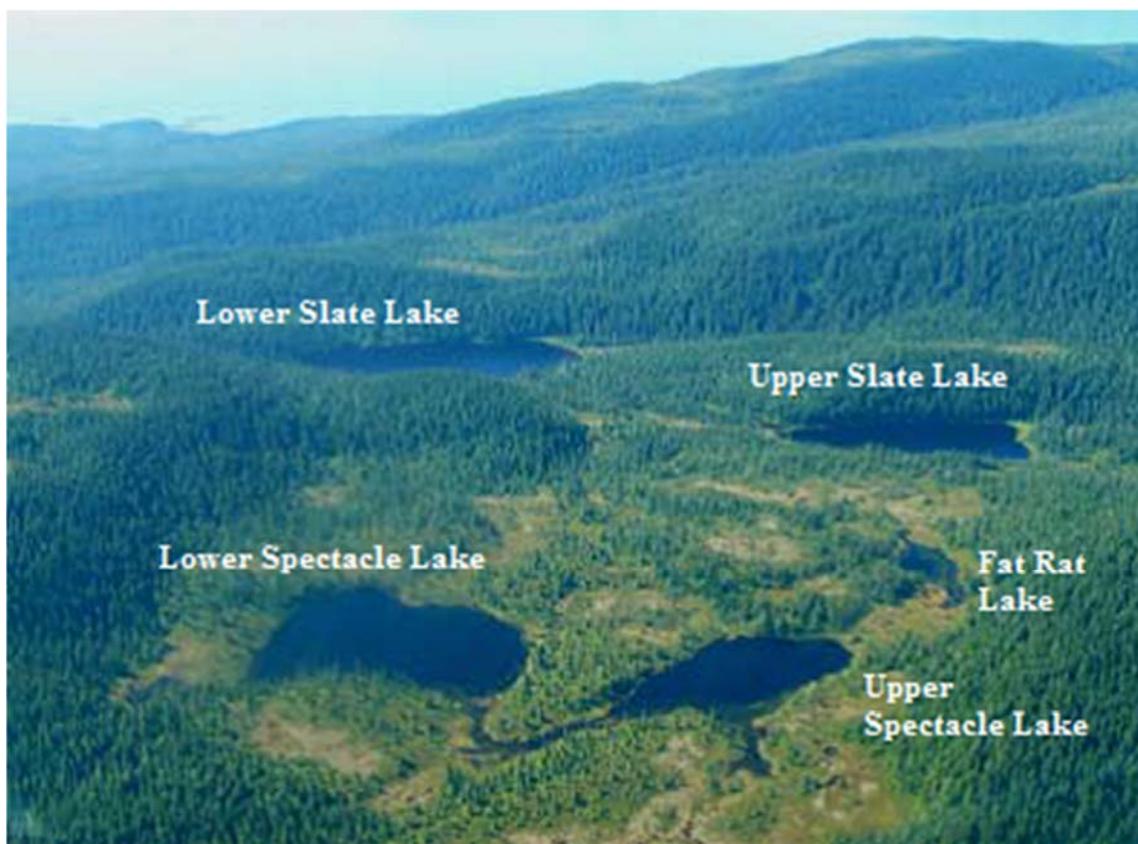
Figure 2: The Slate Lakes basin in 2005, prior to construction of the access road and the Lower Slate Lake Tailings Treatment Facility.

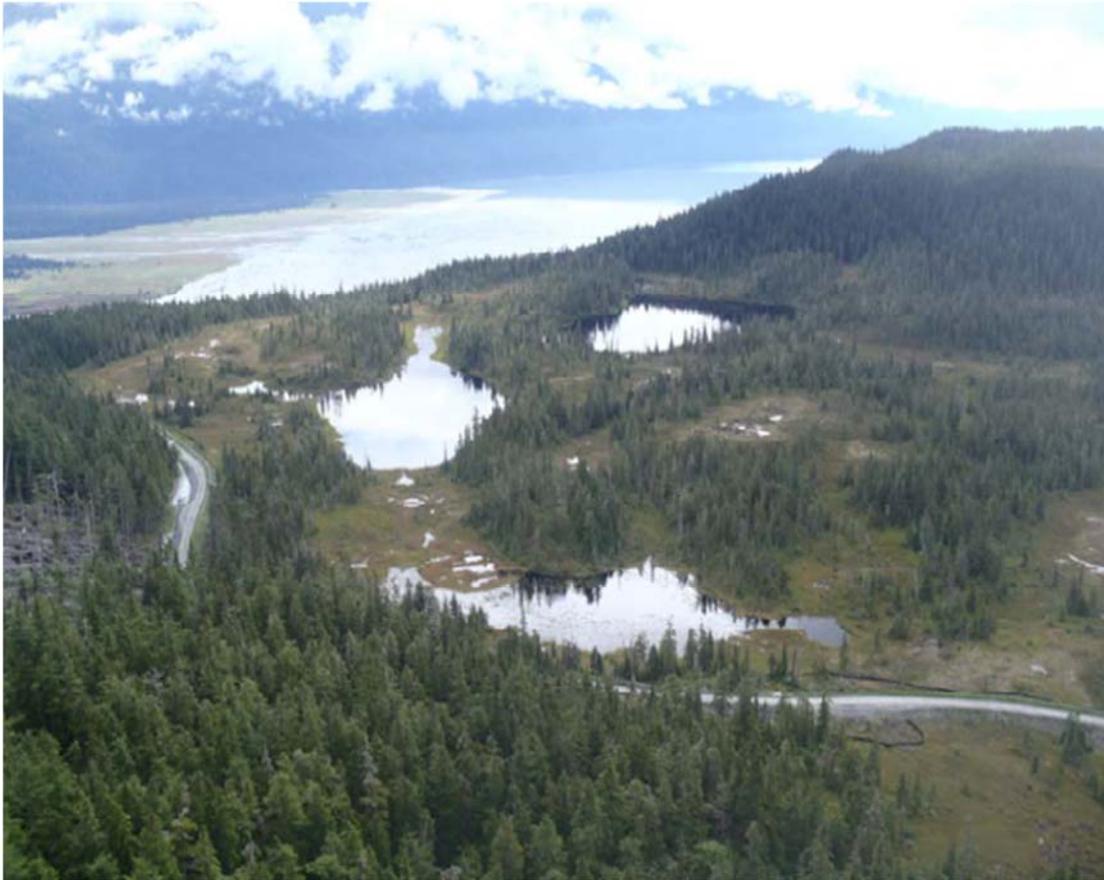
Figure 3: Spectacle Lakes basin with access road to the Tailings Treatment Facility (2010)

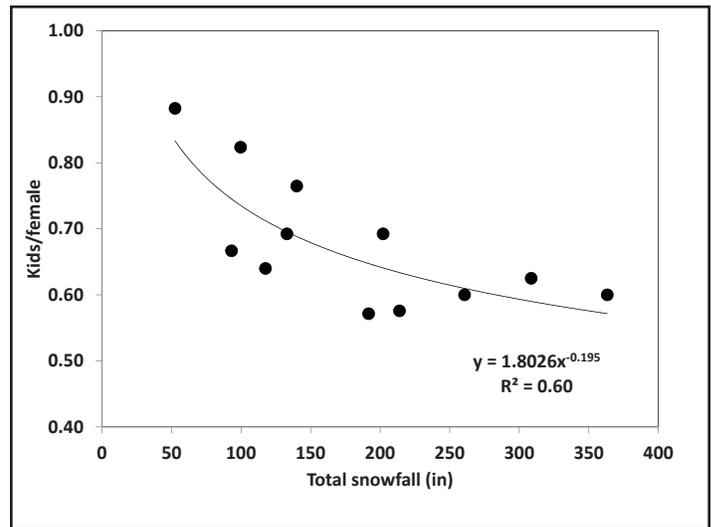
Figure 5. Relationship between total annual snowfall (Haines, AK) and the proportion of radio-marked females with kids during the parturition period during 2006-2017 in Lynn Canal, AK.

data). However, 3 of the last 4 winters have been below average, and included the winter of 2014/2015 which was exceptionally mild (54 inches of total snowfall, or 34% of normal).
