ALASKA DEPARTMENT OF TRANSPORTATION

Vegetated Riprap Survey of Highways in Southcentral and Interior Alaska

December 2005

FHWA-AK-RD-05-08

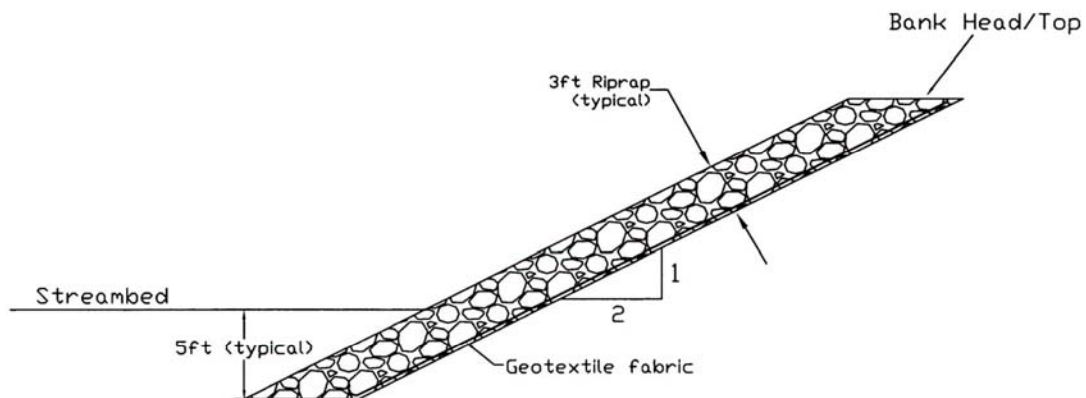
Figure 1 – Typical Riprapped Bank Cross-Section
(If used, Geotextile Fabric installation location is illustrated)

Typically designed highway stream bank protection consists of an embankment with a 2:1 or 1 ½: 1 slope; covered by a 3 to 5 foot thick layer of Class II riprap. A geotextile fabric lining between the embankment material and the riprap may be also used. The riprap toe is usually installed several feet below the low water level or streambed elevation. (**Figure 1**) Sites observed were consistently within specifications of a typically designed embankment slope.

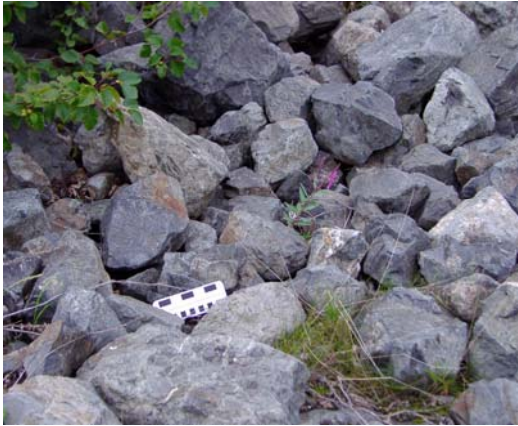
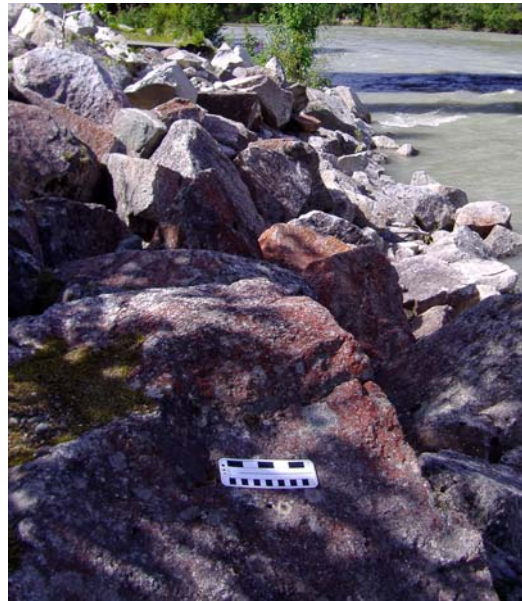
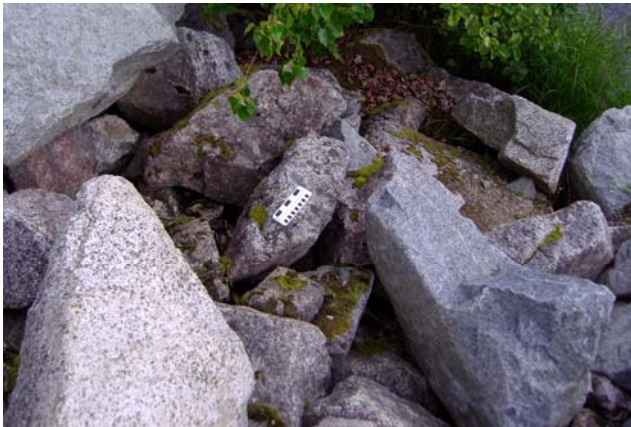
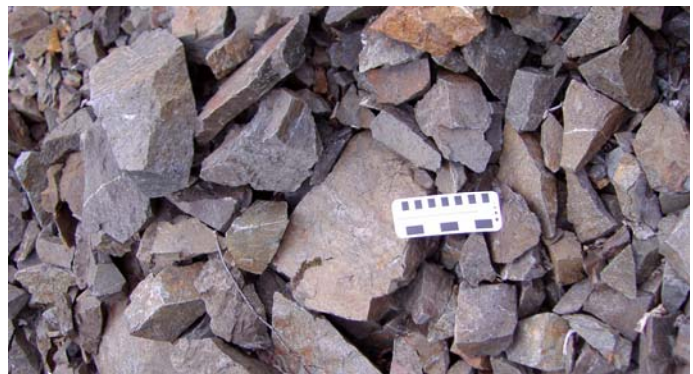
Figure 2 – Riprap Variations

Although within the basic typically designed specifications for stream bank protection, site investigations reveal that actual riprap size and gradation varied, probably due to the varied characteristics of individual material sources.

Alaska Department of Transportation and Public Facilities Standard Specifications for Highway Construction specifies riprap gradation by percent of total weight. (Green, 2004) Therefore, the varied densities of different mined material types govern the rock diameters of the installed riprap. **Figures 2-4** illustrate riprap size variations.

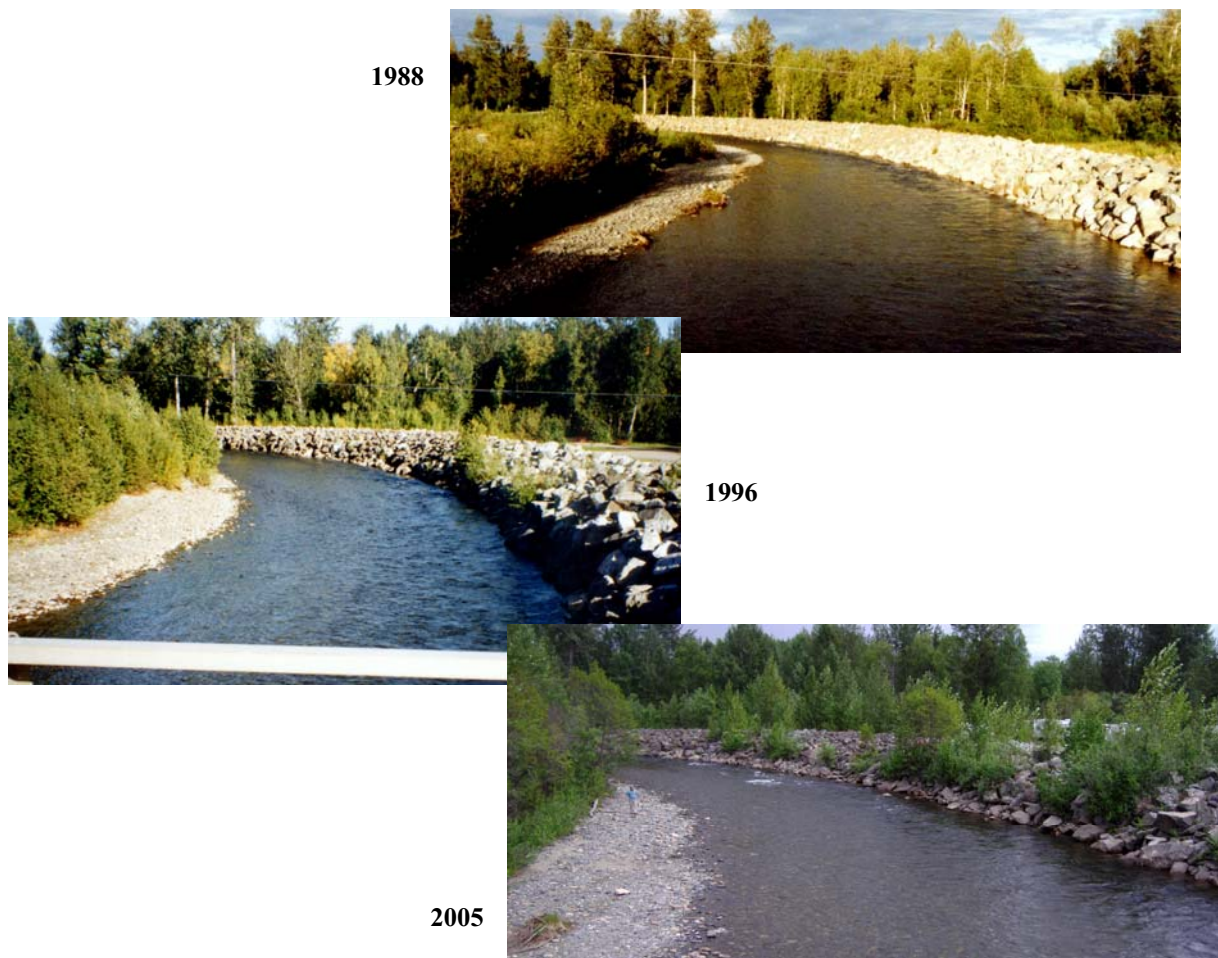
Figure 5 – Vegetative Progression Time Series;
Montana Creek (Parks Hwy)

Time is a significant limiting factor influencing the level of vegetation on a disturbed (constructed) site. By designing bank protection using hydraulic parameters specific to the stream, successful vegetation can result. Although bank protection is designed adequately, flood inundation destruction is possible. Whether planted manually or naturally, and within the universal and site specific limits discussed in this report, a specific flood event can occur and essentially wash away seedlings and sprouts, as well as fine grained bank material. Given sufficient time before an extreme event occurs, vegetation can become stable and, thus, flourish for healthy riparian habitat as well as provide reinforcement for the constructed bank armament. **Figures 5 and 6** illustrate time series vegetative progression.

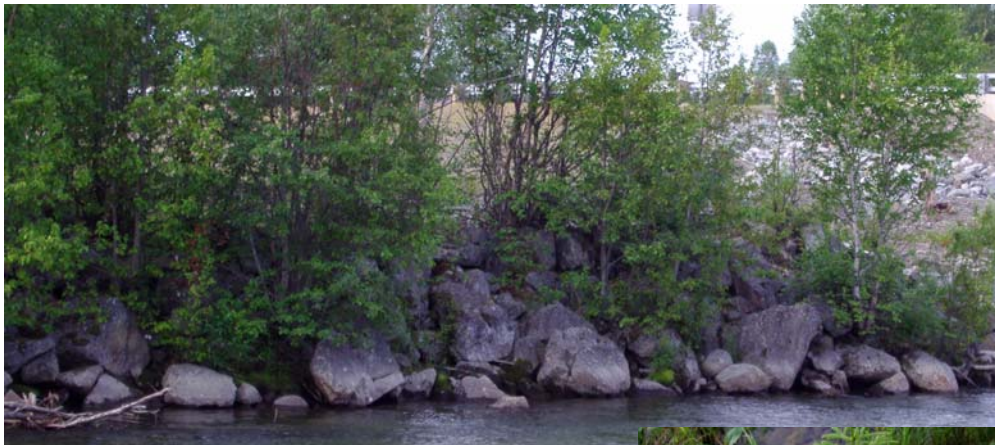
Figure 7 – Vegetated Voids
Willow Creek (Parks Hwy)

Poorly graded riprap is defined as riprap containing a high percentage of large diameter rock relative to the total quantity of rock present. The lack of smaller diameter rock leaves voids (areas, pockets, or spaces) where fine embankment material is exposed and/or fine material can be deposited manually, via sedimentation at various discharge stages, or via wind. If exposed to stream flow, the larger rock protects the void area behind or immediately downstream of it by reducing flow energy, shear stresses, and excessive ice forces. The protected space provides a stable environment for sedimentation and vegetation growth. Examples of successfully vegetated voids are in **Figures 7 - 9**.

At the time of this site survey, existing woody vegetation had not shown evidence of causing nearby riprap displacement. However, it should be noted that the possibility of further growth in the vegetation's stem diameter may potentially cause riprap instability.

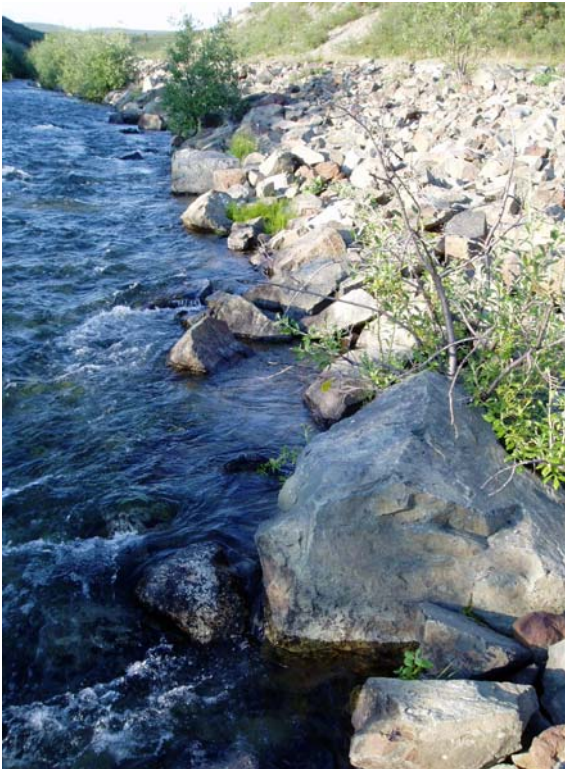
Photo 8 - Gulkana River (Richardson Hwy)

As illustrated in the sites observed with this configuration (**Photos 7 and 8, Figure 10**), rock diameter of the toe protection and the migrated in-stream structures is relatively large.

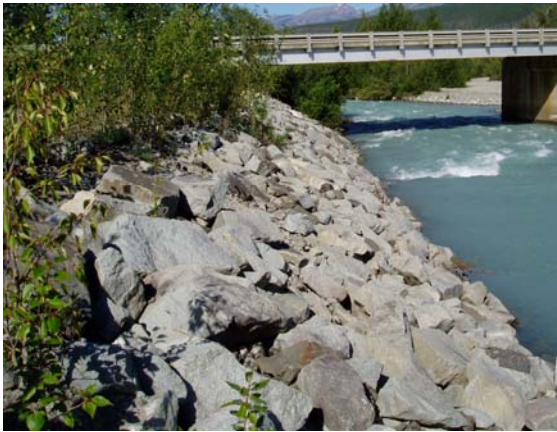
Photo 11 - King River (Glenn Hwy)

Sites with solid mass bank armament primarily allowed vegetative growth at the head of the embankment, where no riprap existed. **(Photo 11)**

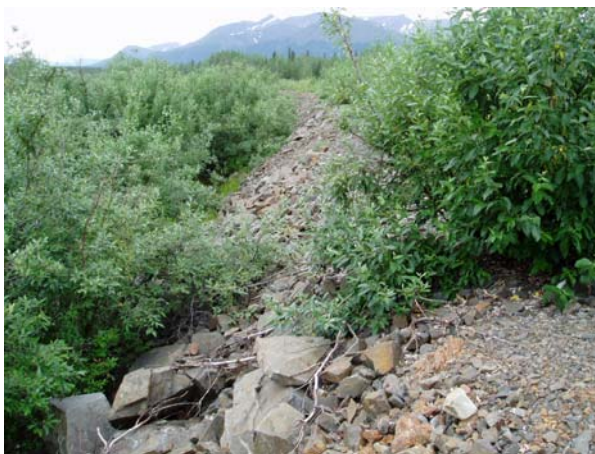
Photo 13 - Jack River (Parks Hwy)

Given time, vegetation at the base of a riprapped bank will grow enough to overhang an adjacent stream and cover the face of the bank. **(Photo 13)**

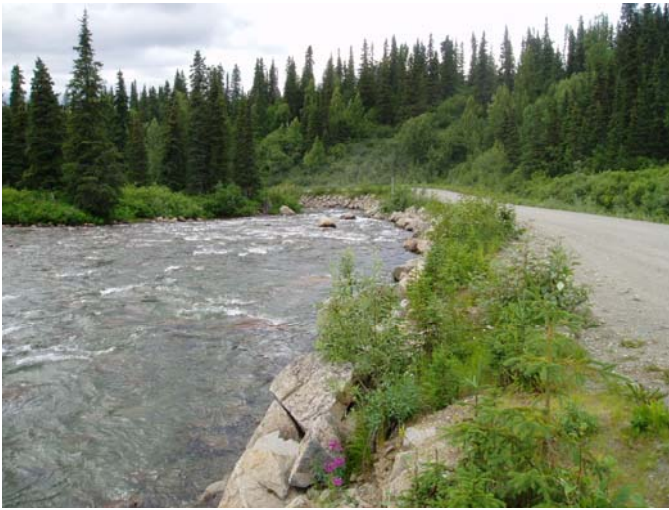
Photo A-9. Willow Creek, Hatcher Pass

Location	Structure	Description/Notes
Hatcher Pass Rd		
Willow Crk	embank along road	Fast stream; fines blown into cracks from road traffic
Glenn Highway		
Granite Crk	bridge & approach	kings spawning; sediment from wind and road-none under bridge
Matanuska R.	embank along road	no veg-steep slope-
Kings R.	dike & bridge	tight Riprap, veg at head, then riprap is more open graded and veg is growing ; slope of bank grades out a bit and allows more veg at water level.
Matanuska R.	embank along road	a buffer ledge constructed at toe of road embankment that allowed veg growth
Gulkana R.	approach banks	veg at toe and head; buffer ledge with no riprap and some veg
Tok Cutoff		
Chistochina	old dike	pattern of toe and head veg; under major construction-only looked at part of old dike
Richardson Highway		
Sourdough Ck	brdg approach	small stream -not much rock or flow; established veg in voids, not a steep slope
Gulkana R.	roadside	great ex. of half island ledg at foot of bank with well established veg; sparse veg throughout roc; veg at head.
