**TAILINGS AND PRODUCTION ROCK SITE
2011 ANNUAL REPORT**

Hecla Green Creek Mining Company

April 15, 2012

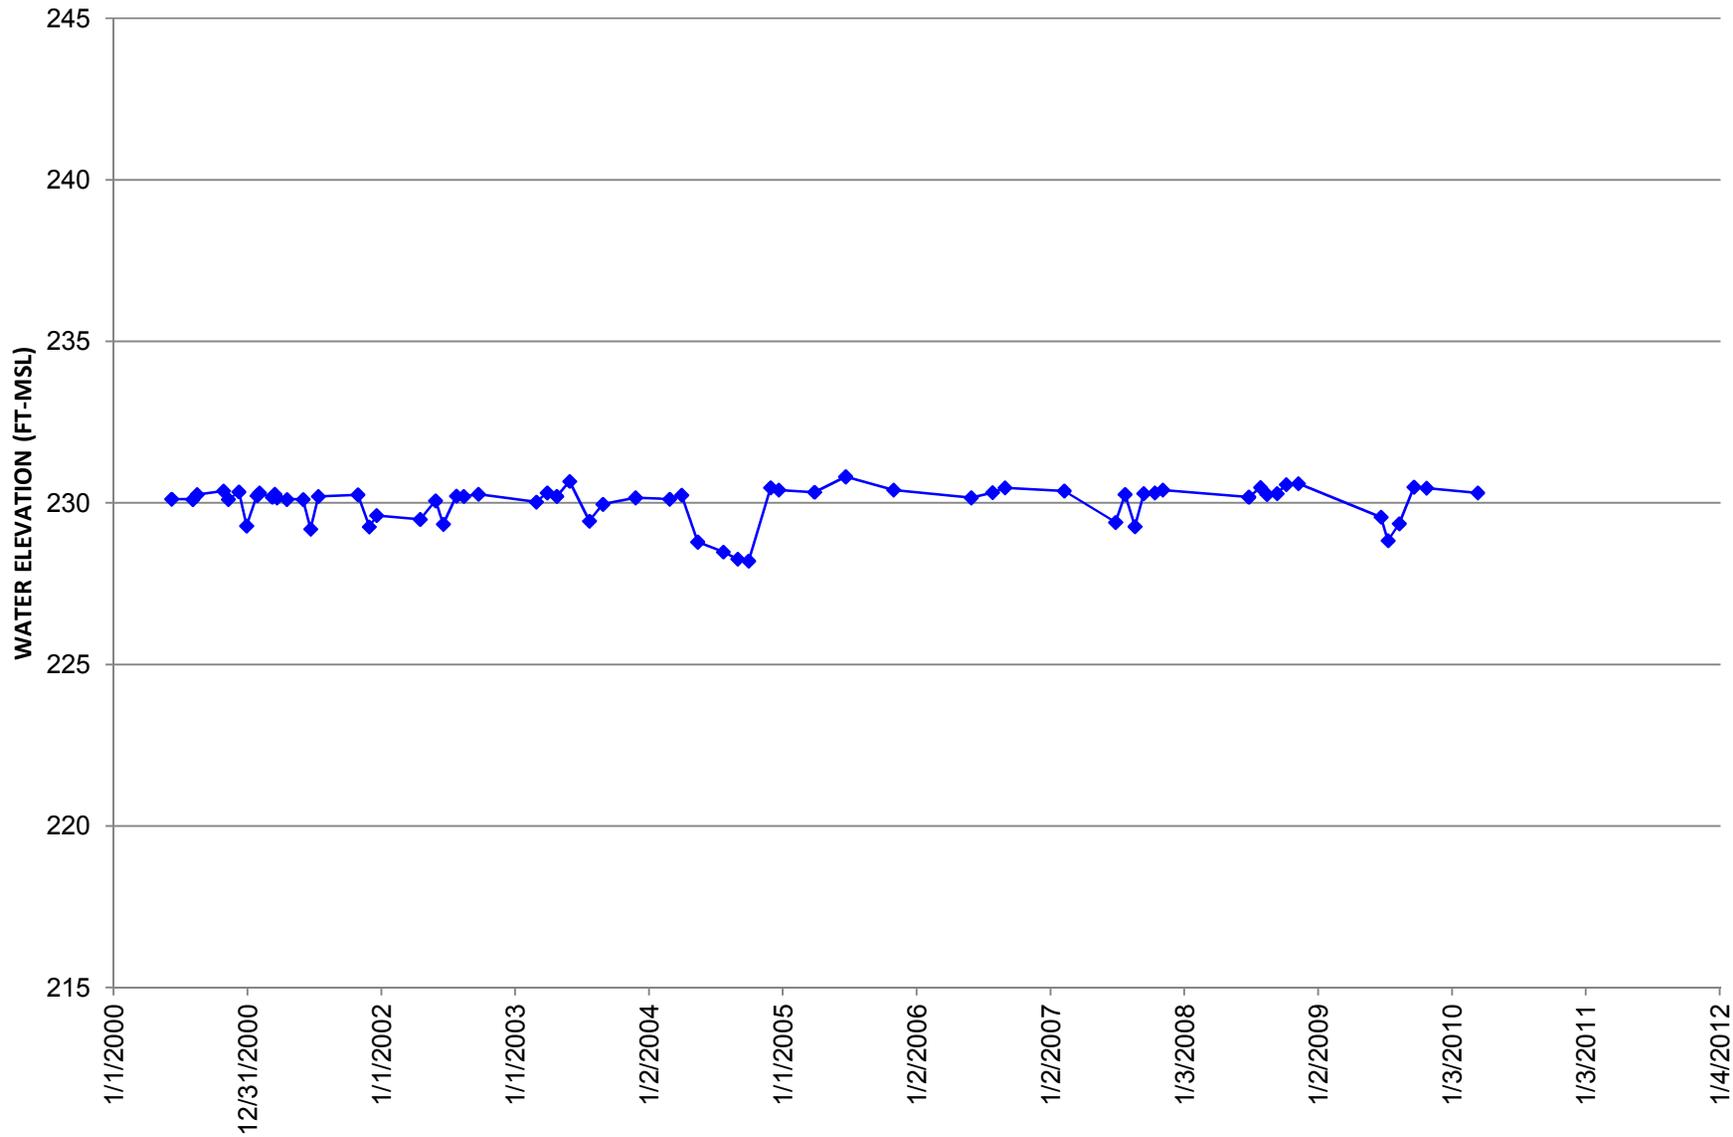
Figure 2.16 Water Level Data for Well MW-T-00-03B

Water levels in four wells completed east and west of the pile are shown for comparison in Figures 2.15 to 2.18. The eastern wells, MW-T-00-03A (Figure 2.15) and MW-T-00-03B (Figure 2.16), are completed in the shallow sands 12 and 17 feet, respectively, below ground surface. The figures for these wells show that the water elevation in shallow completions in native materials can be readily influenced by abnormal weather conditions. Wells MW-T-01-03A and MW-T-01-03B are installed west of the pile. Their water levels are shown in Figures 2.17 and 2.18, respectively. MW-T-01-03A is completed in bedrock to a depth of 20 feet and MW-T-01-03B is completed in clayey silt to a depth of 12 feet. These wells show similar water level fluctuations with weather conditions as the two eastern wells. However, the water level in MW-T-01-03B shows a larger differential than MW-T-01-03A because silts and clays hold more water in tension, so a small increase in water content causes a large change in head. The ground surface elevation is 134 feet in the proximity of these two wells. Both MW-T-01-03A and MW-T-01-03B were damaged by bears in 2006 and attempts to recover them were not successful until 2010. A rapid decrease followed by a gradual increase to levels above recent historical values occurred in MW-T-01-03A in 2011. The cause for the change is not known at this point, however this type of behavior has been documented in the companion well (MW-T-01-03B).

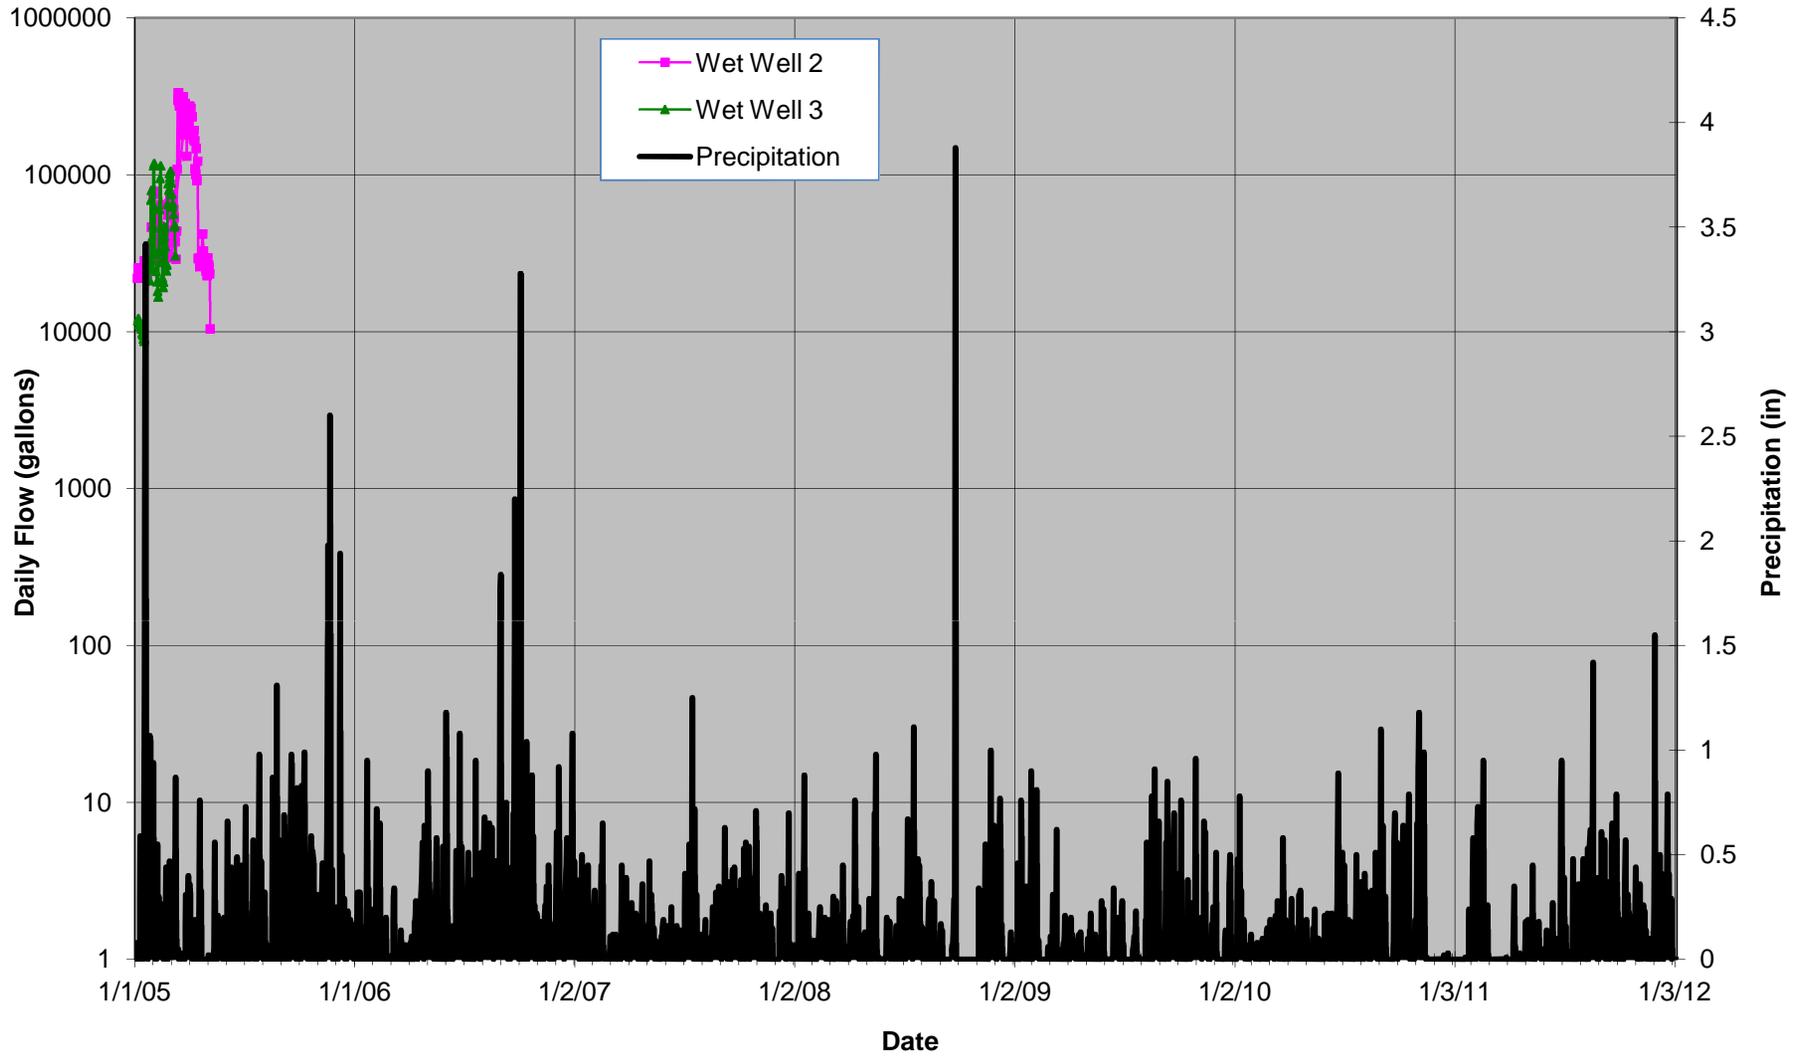
Figure 2.19 Tailings Area Wet Well Flow Data

Flow data from Wet Wells 2 and 3 are presented with the precipitation data for 2005 – 2011 in Figure 2.19. The wet well flows respond relatively quickly to precipitation events, demonstrating a significant contribution of surface water. The use of the wet well flow meters has been discontinued since 2005 as part of the tailings expansion activities.

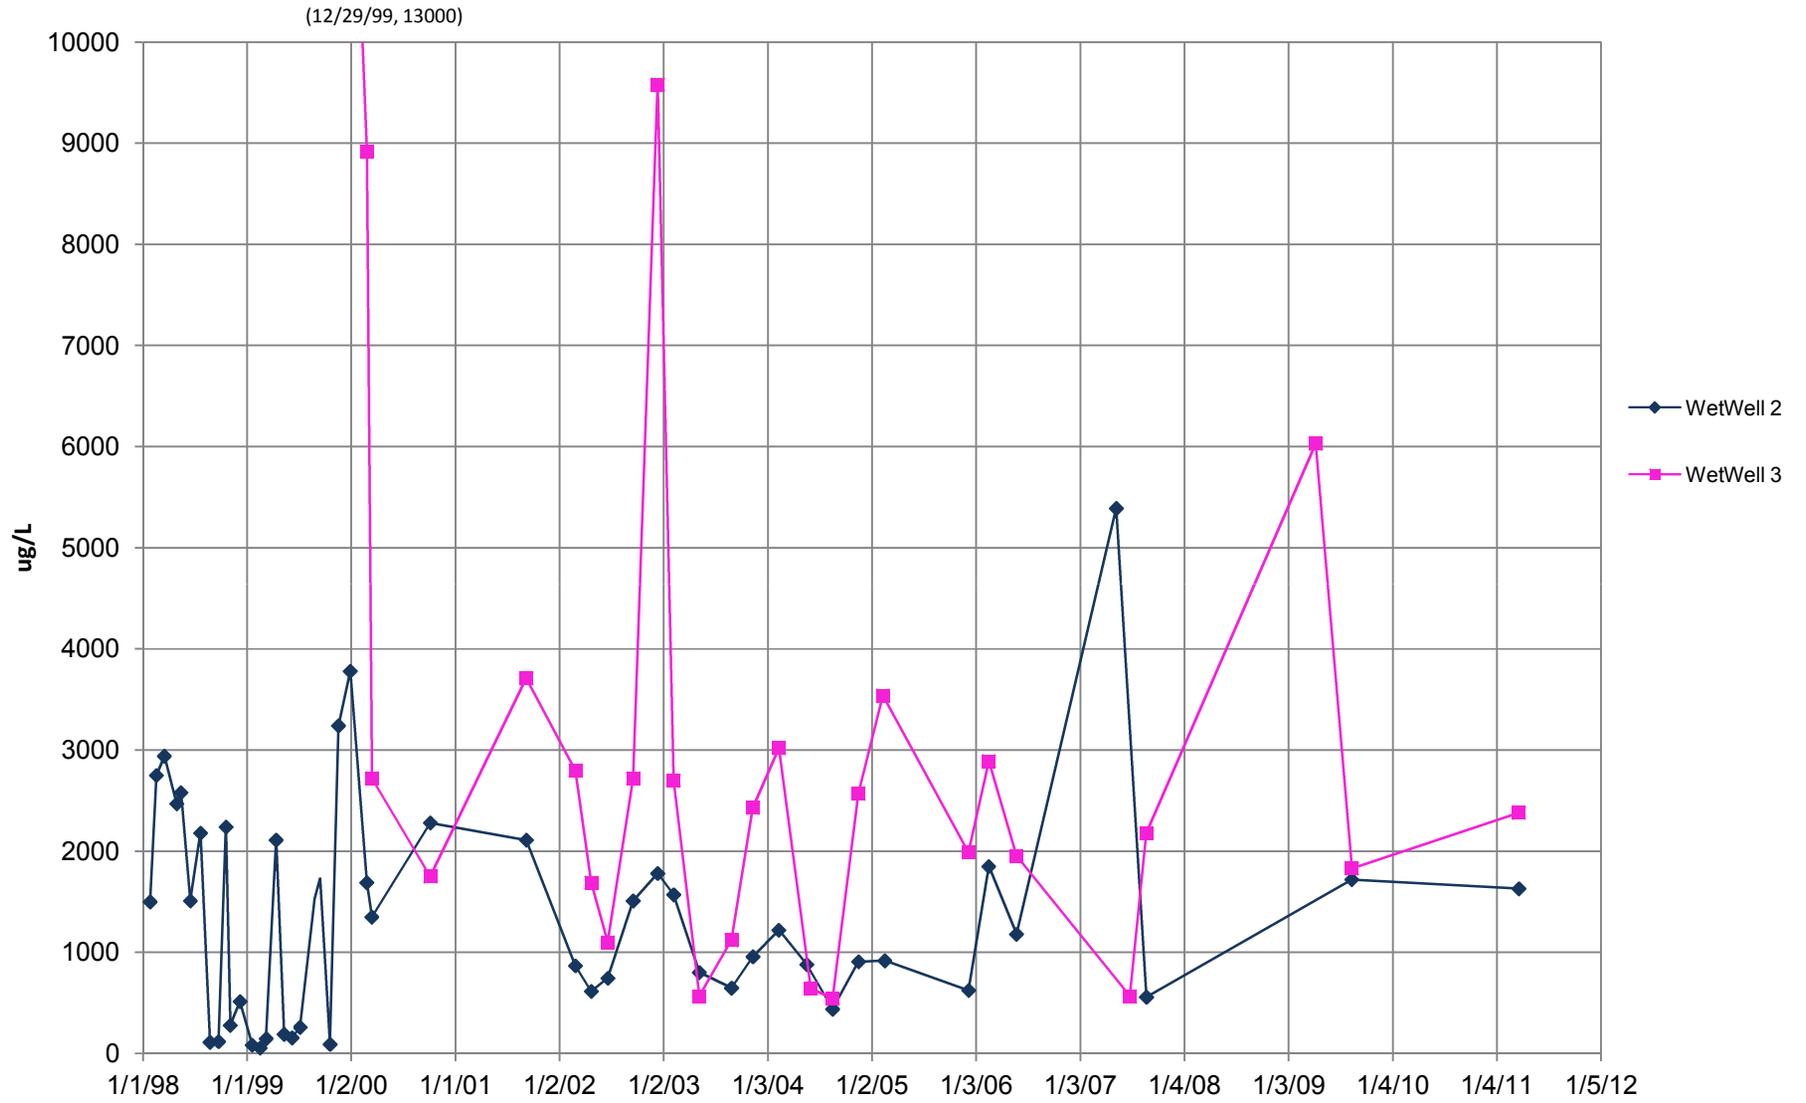
**Figure 2.26a GREENS CREEK TAILINGS INTERNAL MONITORING SITES:
WET WELLS - ZINC DATA
(Non-detectable analyses plotted as zero)**

Figures 2.26a, b and c show the concentration of zinc from the monitoring sites. Zinc levels from the saturated zone of the pile continue to remain low (Figure 2.26b), a result of sulfate reduction and/or thiosulfate disproportionation, which promote zinc sulfide precipitation. A zinc

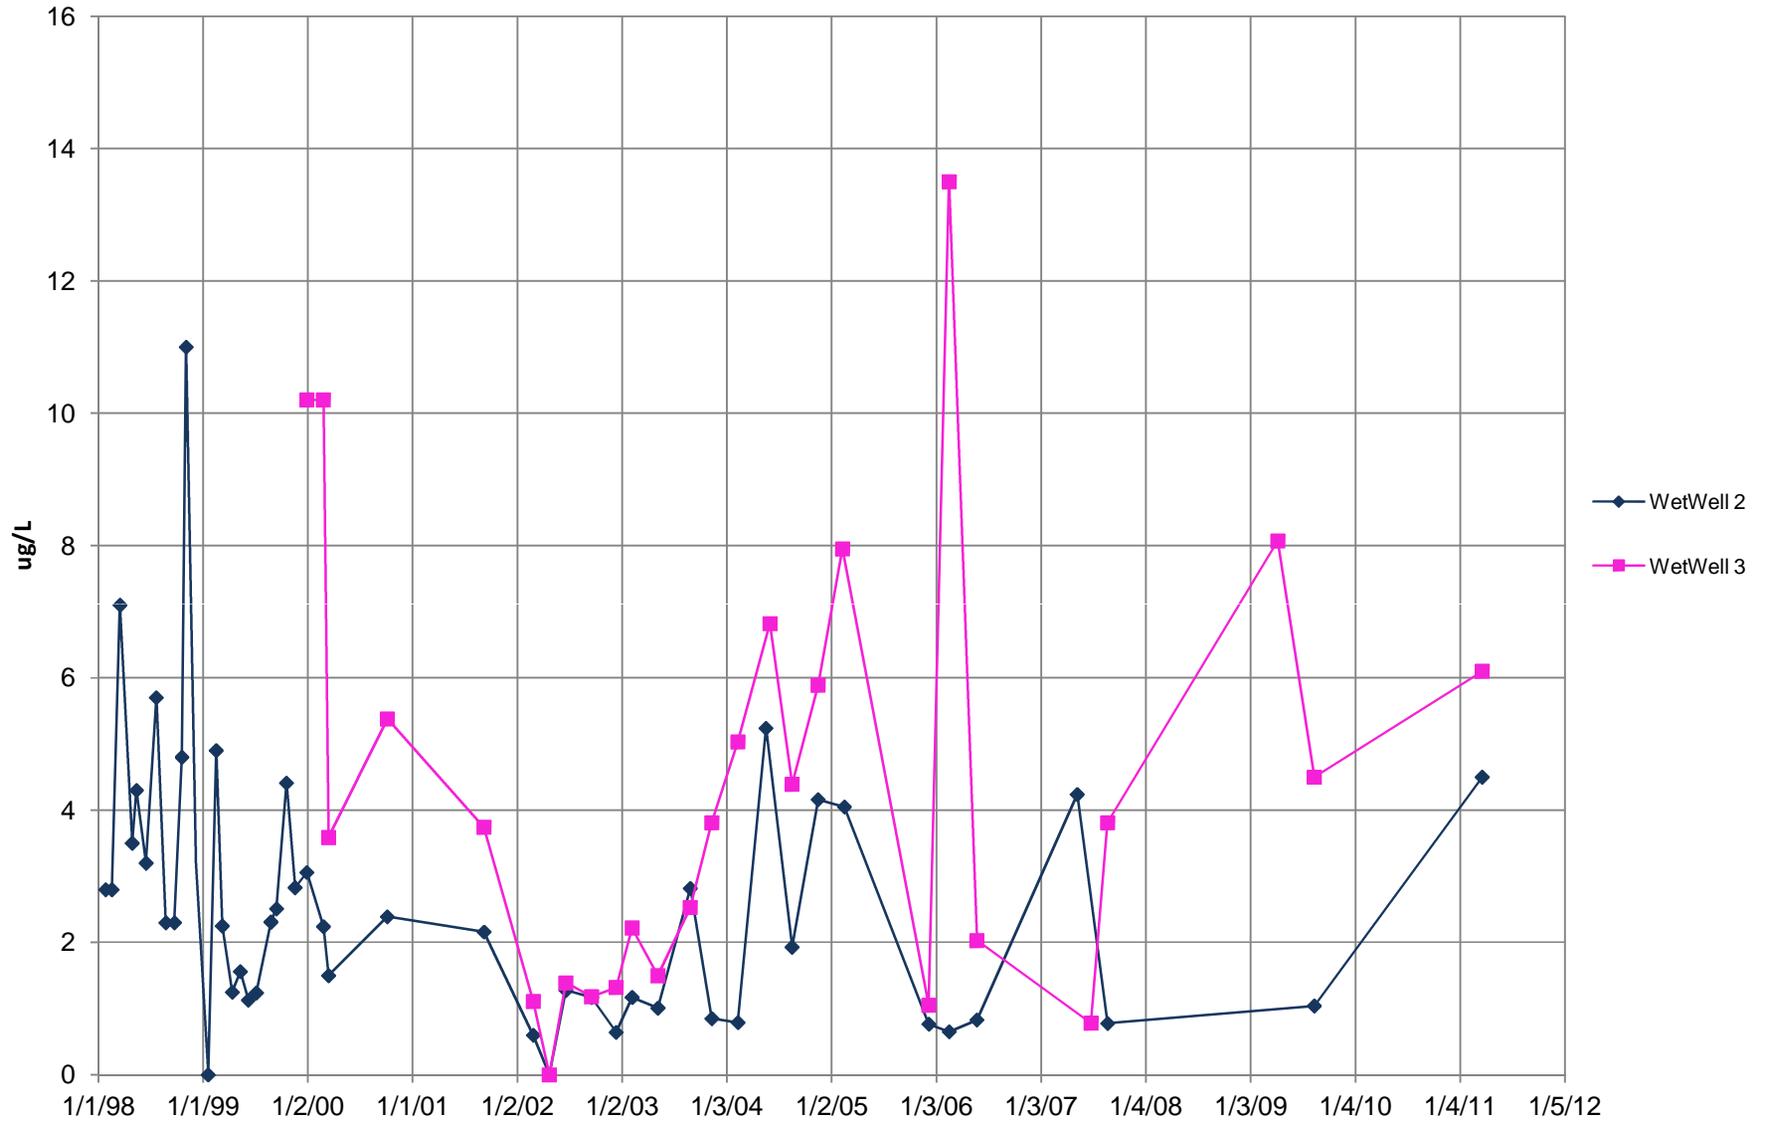
**Figure 2.27a GREENS CREEK TAILINGS INTERNAL MONITORING SITES:
WET WELLS - COPPER DATA
(Non-detectable analyses plotted as zero)**

The concentrations of copper and lead are considerably lower than that of zinc. Both of these metals' concentrations are generally less than 5 ug/L in water from each site (Figures 2.27a, b and c and 2.28a, b and c). Previous observations have shown that copper and lead mobility are greatest when the tailings are first placed, then decrease with time. Isolated instances of high lead concentrations (e.g. PZ-T-00-03, June 2011) may be due to laboratory error.

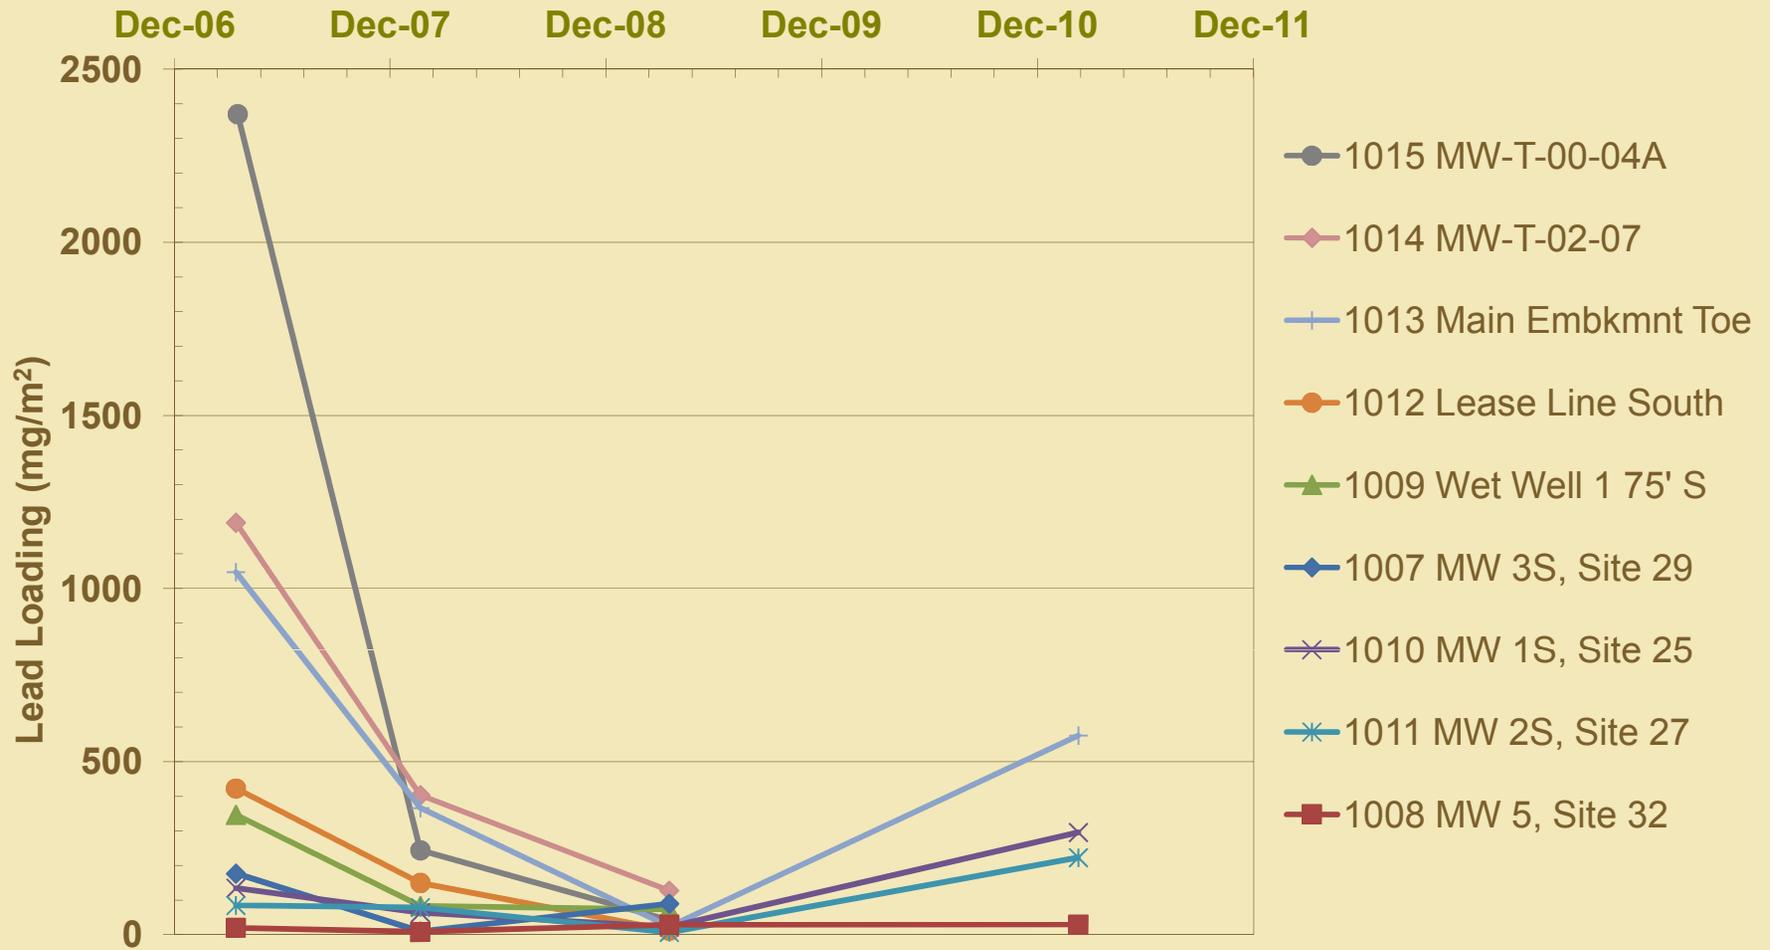
Figure 2.36 Tails Snow Dust Lead Load vs Distance

The data indicate that the loading is observable up to 1600 feet from the pile and that the loading has decreased each year since 2007 (Figure 2.36). Several factors, including fewer dust-producing weather events, a shorter snow accumulation period and improved abatement measures, likely contributed to the reduction in calculated loading values.

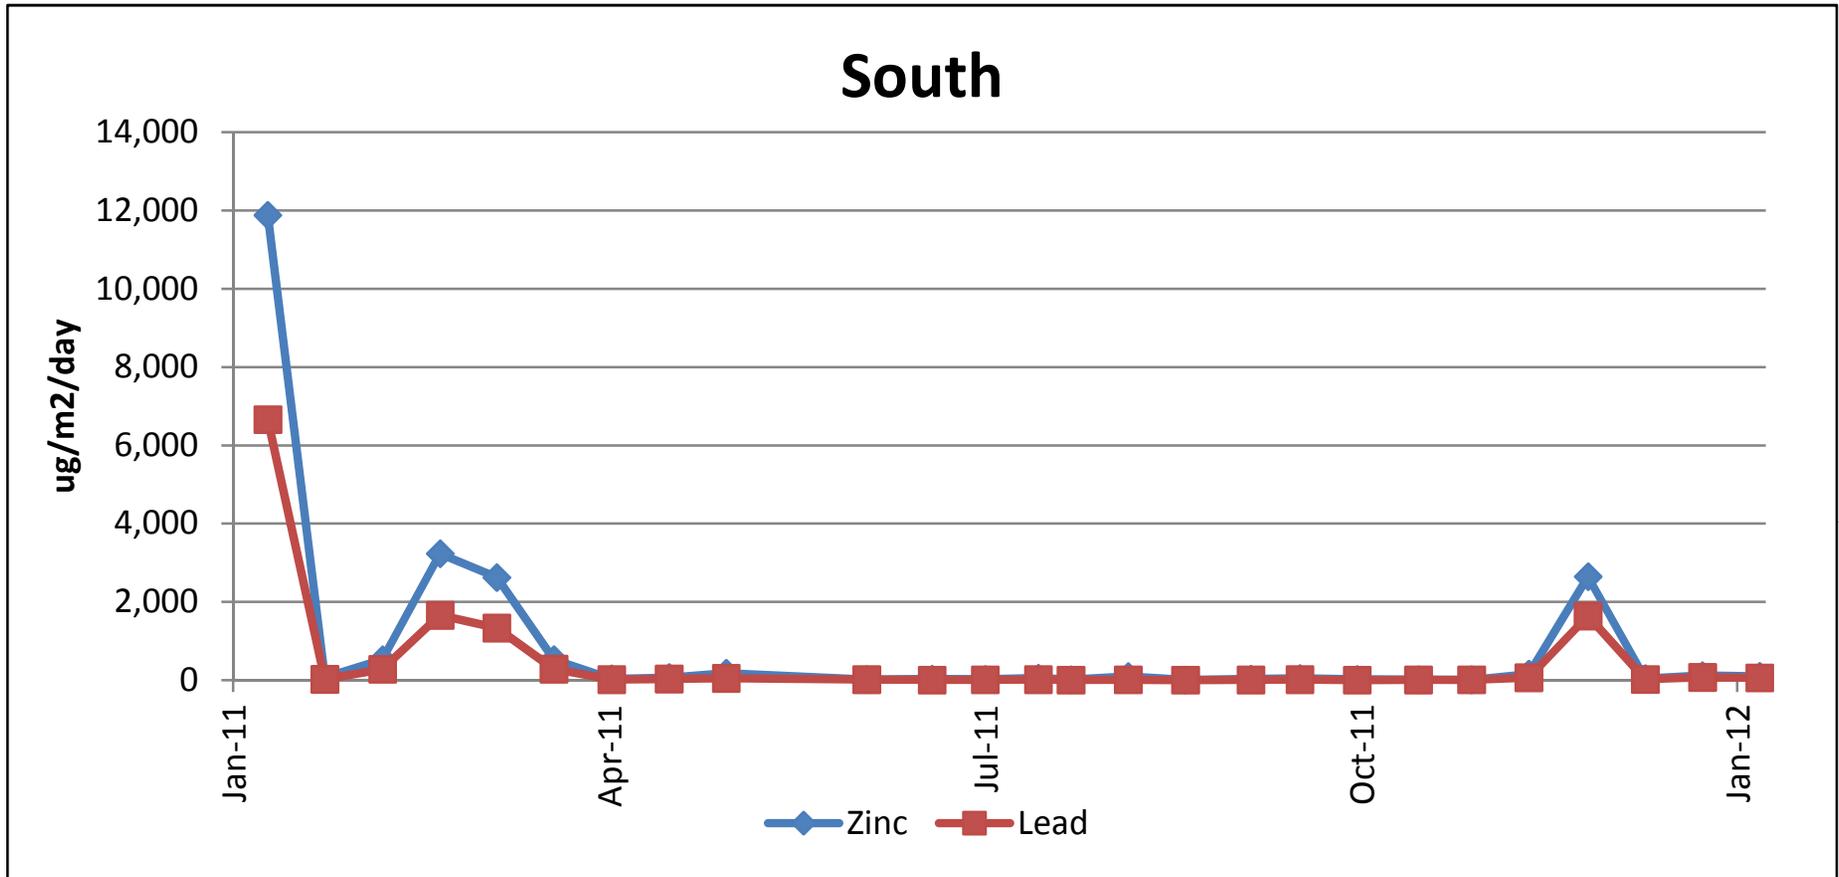
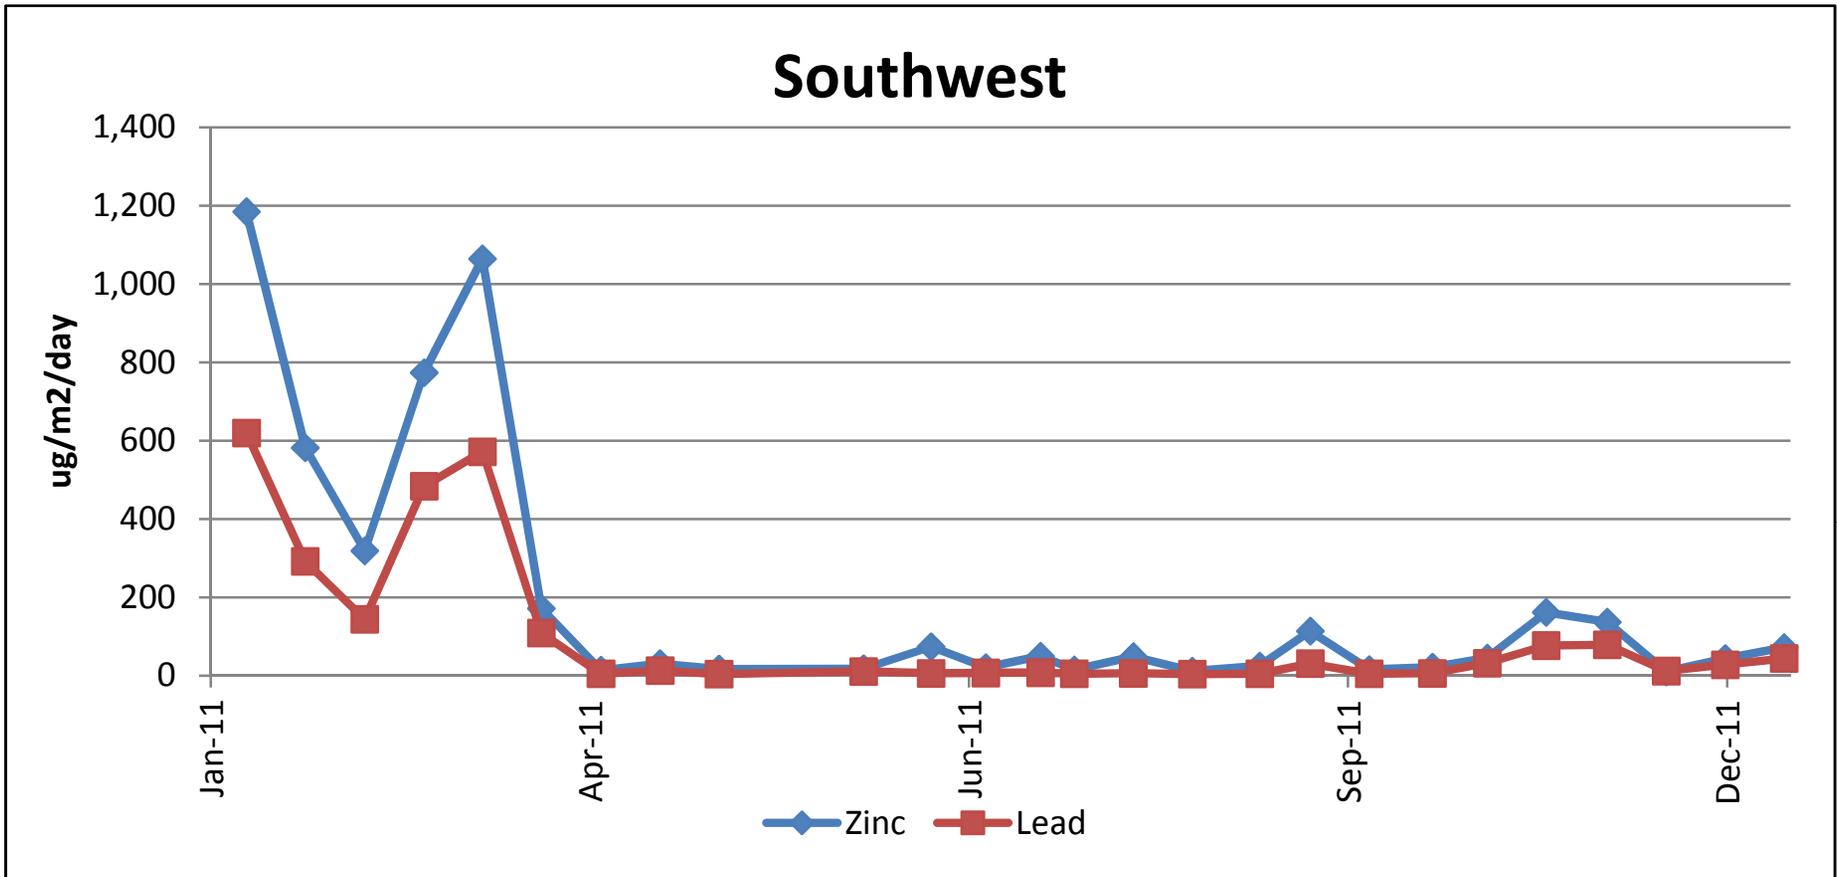
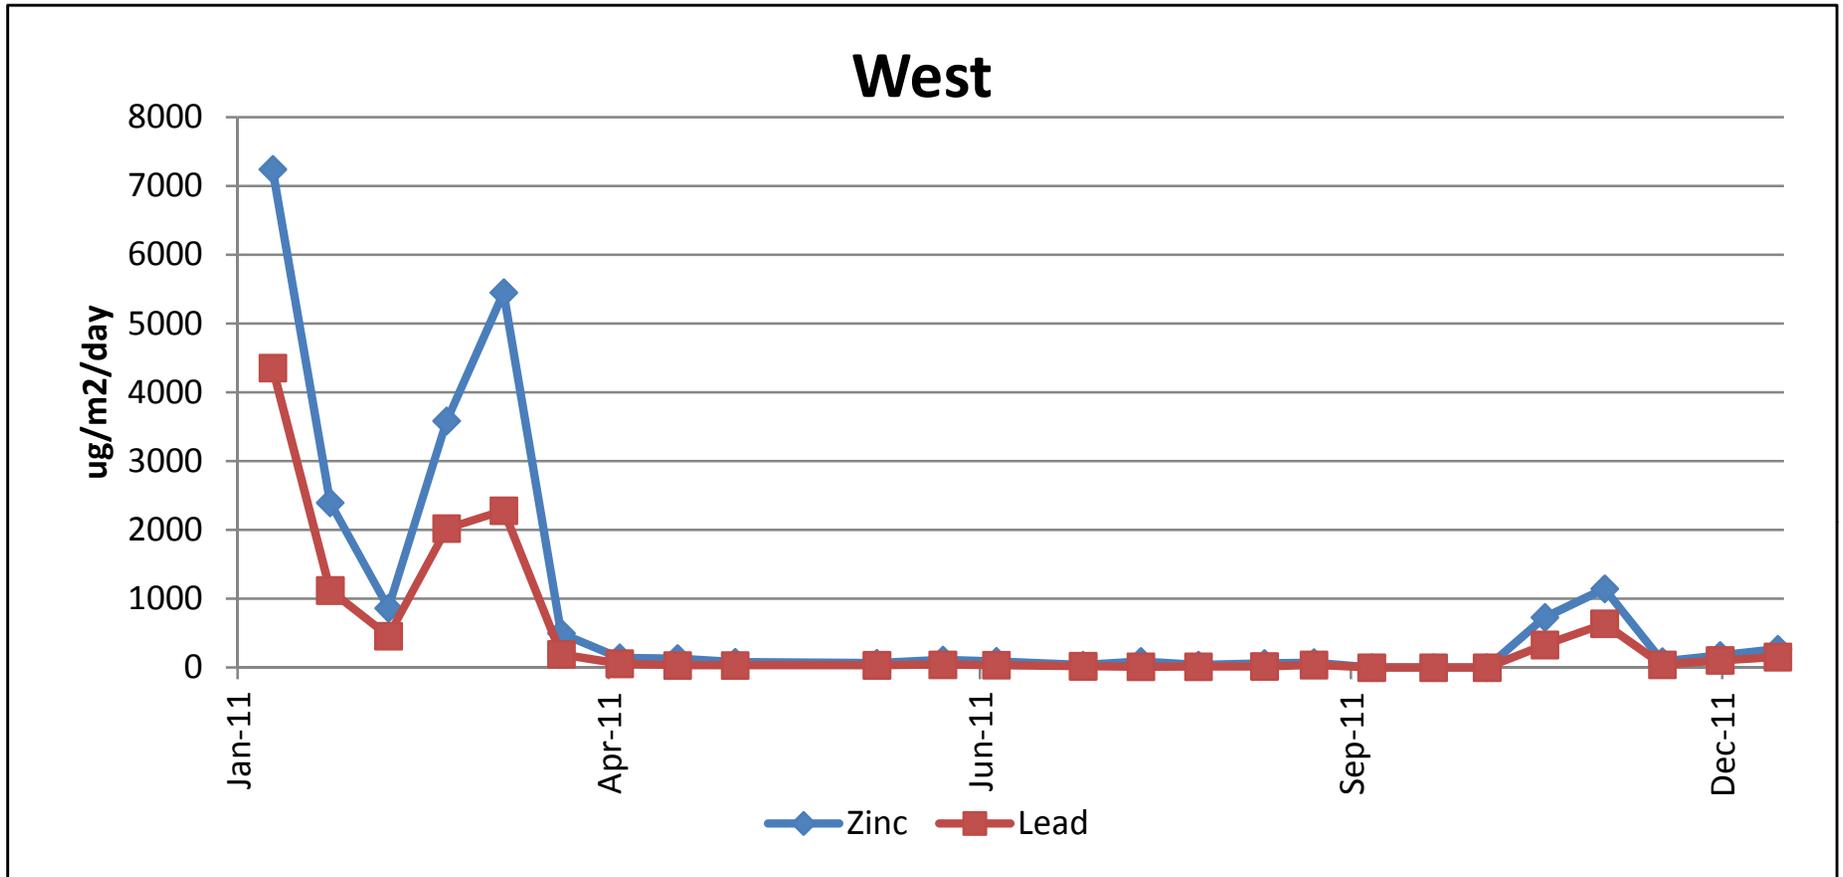
Figure 2.37 Average Daily Load of Lead and Zinc Captured by the Atmospheric Deposition Pails at the Tailings Facility - South

This data supports and verifies the statements made previously about the seasonality (winter) of this issue (Figure 2.37): it occurs under cold dry desiccating conditions with moderate wind speeds from the north or northeast. Out of the five ADP systems deployed in 2011, three received a higher rate of loading than the other two; they were ADP systems in the west, southwest, and south. Out of these three systems the south had the highest yearly accumulative lead load of 172,474 ug/m²/year and the west system was similar with accumulative lead load of 168,699 ug/m²/year. The system to the southwest was approximately 1/5th of these values with a lead load of 35,908 ug/m²/year (Table 2.9). This lower load may reflect that the ADP system here is farther away from the pile than the other two.
